HAZARDOUS MATERIALS PRE-DEMOLITION SURVEY

**CITY OF ALABASTER
FORMER POLICE STATION
201 1ST STREET NORTH
ALABASTER, ALABAMA**

PPM PROJECT NO. 40024103-HM

JANUARY 30, 2026

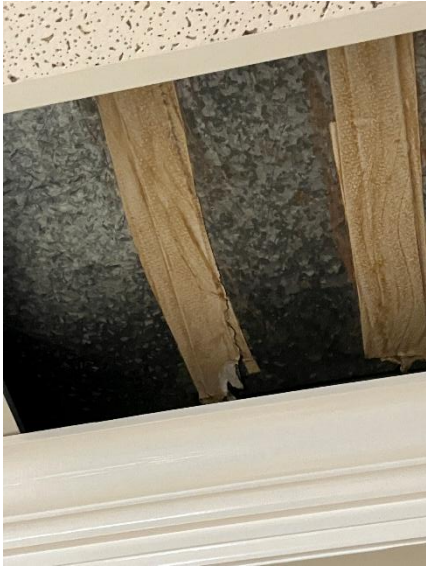
- Grey Duct Work Tape – hallway of main floor and air handler closet in basement – 80% Chrysotile
- Black and yellow mastic – main floor NE office, middle office, and hallway under dark brown wood flooring – 8% Chrysotile

Photo 1 – Grey Duct Work Tape in hallway of main floor and air handler closet in basement

Regulated Asbestos Containing Material (RACM) is required to be removed in accordance with OSHA, EPA and State of Alabama rules and regulations prior to disturbance from renovation or demolition activities. PPM recommends the asbestos containing materials be abated by a licensed asbestos abatement contractor.

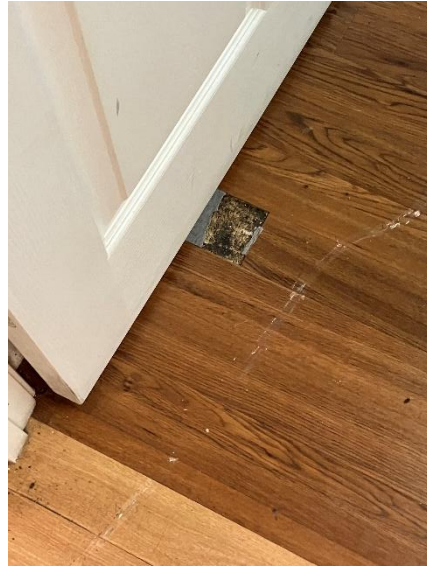
Photo 2 – Black and yellow mastic on main floor NE office, middle office, and hallway under dark brown wood flooring

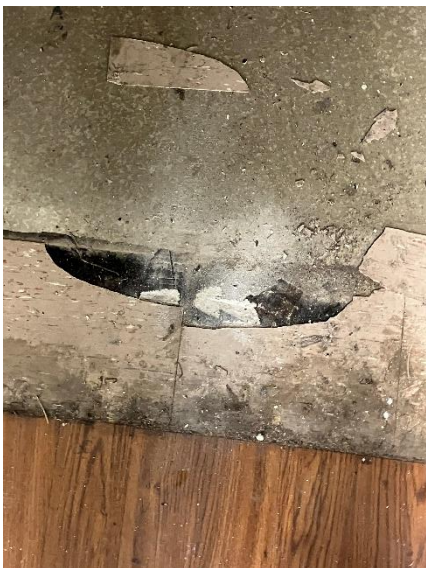
- Tan floor tile – main floor hallway and southeast closet – 2% Chrysotile
- Black mastic – under tan floor tile main floor hallway and southeast closet – 8% Chrysotile

Photo 3 – Tan floor tile and black mastic on main floor hallway and southeast closet

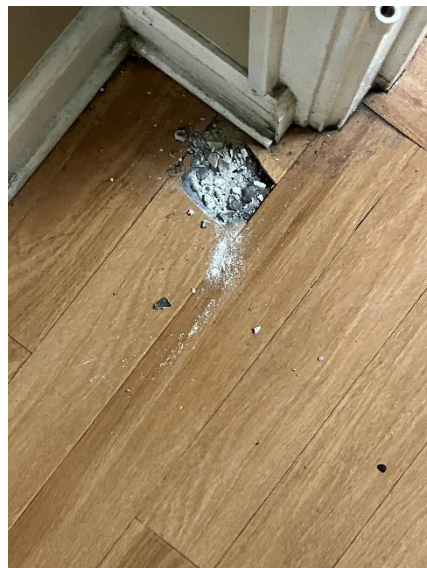
Photo 4 – Black mastic under light brown laminate flooring on main floor middle and south hallway

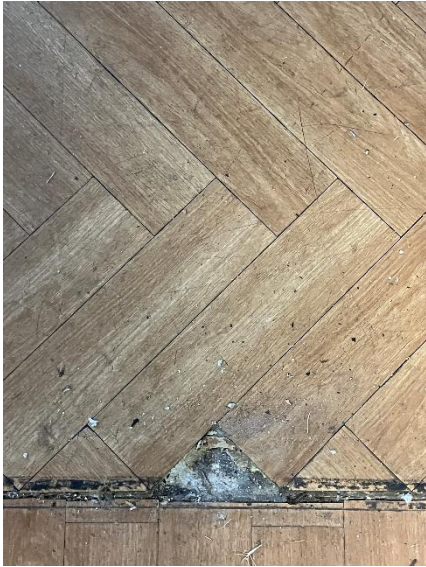
Photo 5 – Tan Herringbone Laminate flooring and black and yellow mastic in main entry at main floor

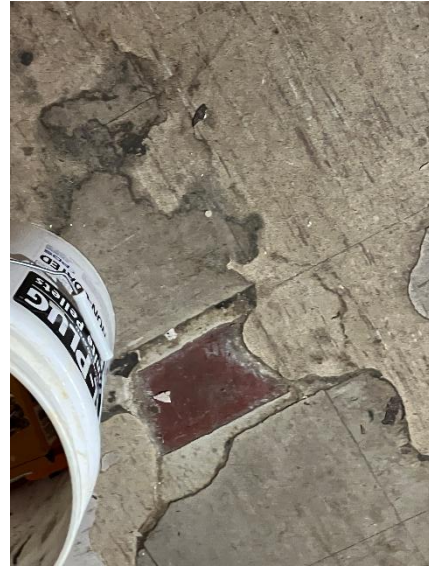
Photo 6 – Black mastic under tan tile (2nd layer) and grey tile in entry to and within dispatch office

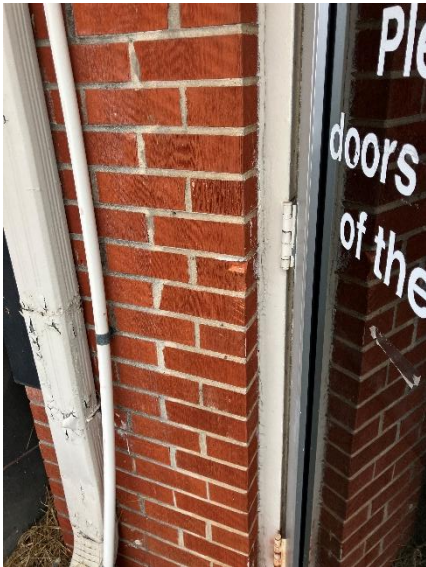
- Tan paint, metal gutter at west entry– 0.83% by weight
- Black paint, metal railing, and bollards at west entry– 0.56% by weight

Photo 7 – White exterior paint, west entry gutter

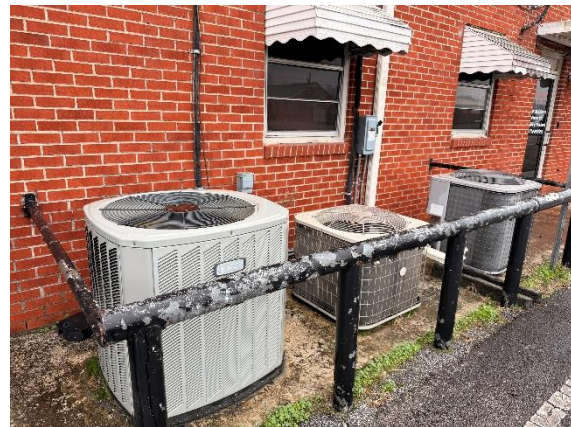
PPM identified heating, ventilation, and air conditioning (HVAC) equipment at the west side of the building and within the air handler rooms on both floors of the building, which could be potential sources of fluorocarbons during the survey.

Photo 8 – HVAC equipment and black exterior paint on the west side of the building

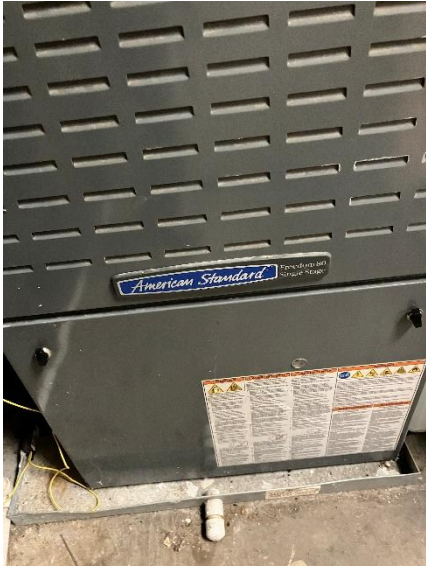
Photo 9 – Air handler on basement floor

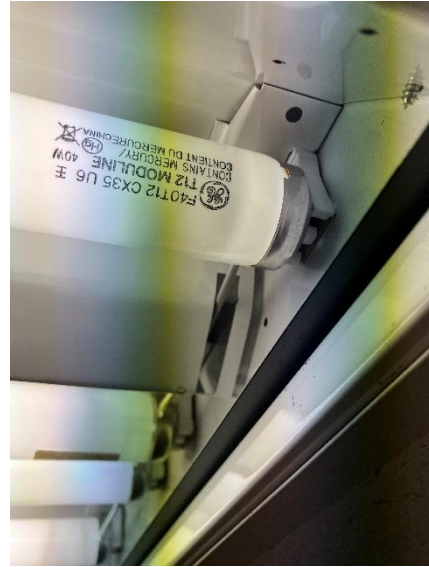
PPM identified fluorescent light tubes, some of which were marked as mercury-containing light bulbs, and potentially PCB containing ballasts throughout both floors of the building. These should be disposed of in accordance with applicable regulations.

Photo 10 – Fluorescent bulbs throughout building

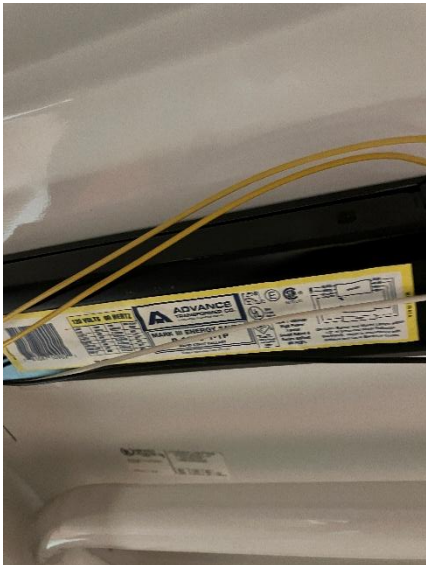
Photo 11 – Light ballasts throughout building

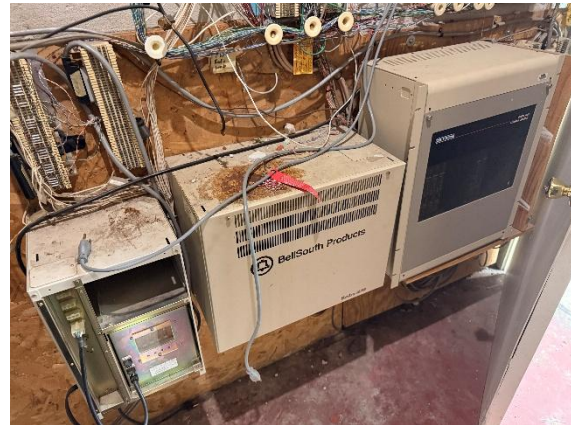
Photo 12 – Computer equipment in computer room on basement floor
