HAZARDOUS MATERIALS PRE-DEMOLITION SURVEY

**CITY OF ALABASTER
FORMER CITY HALL ANNEX
112 1ST AVENUE WEST
ALABASTER, ALABAMA**

PPM PROJECT NO. 40024104-HM

FEBRUARY 3, 2026

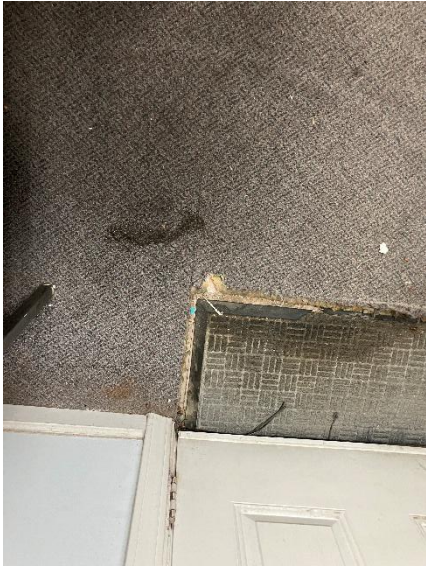
- Black mastic with linoleum – under tan 9x9 floor tile in south restroom, NW entrance, and NW staircase, main floor – 8% Chrysotile
- Tan 9x9 floor tile in south restroom, NW entrance, and NW staircase, main floor – 2% Chrysotile

Photo 1 – Black mastic with linoleum under tan 9x9 floor tile, south restroom, NW entrance, and NW staircase, main floor

Regulated Asbestos Containing Material (RACM) is required to be removed in accordance with OSHA, EPA and State of Alabama rules and regulations prior to disturbance from renovation or demolition activities. PPM recommends the asbestos containing materials be abated by a licensed asbestos abatement contractor.

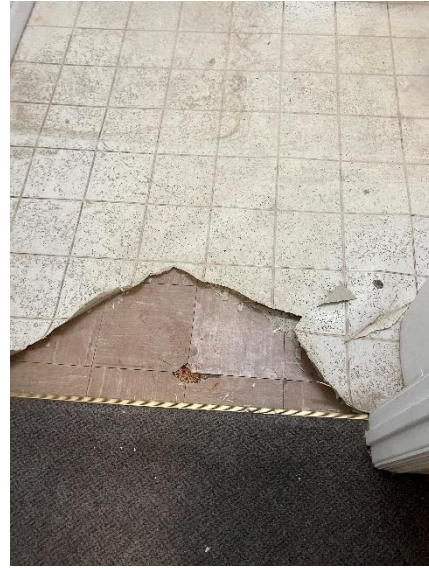
Photo 2 – Tan 9x9 floor tile in south restroom, NW entrance, and NW staircase, main floor

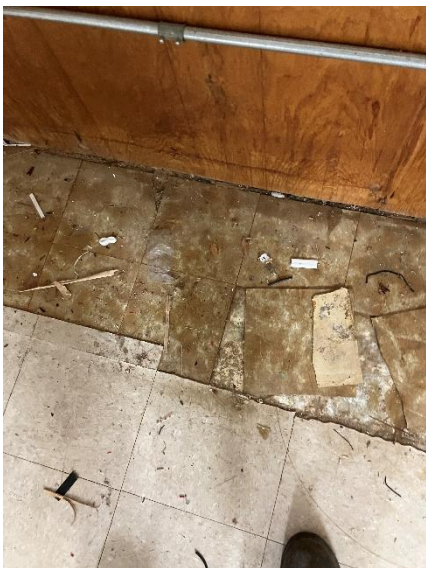
- Dark gray tile with white mastic– NW room 7 – 4% Chrysotile
- White mastic – under tan tile, western staircase closet, basement floor– 8% Chrysotile
- Red floor tile –air handler room entry, basement floor – 5% Chrysotile

Photo 3 – Dark gray tile with white mastic, NW room 7

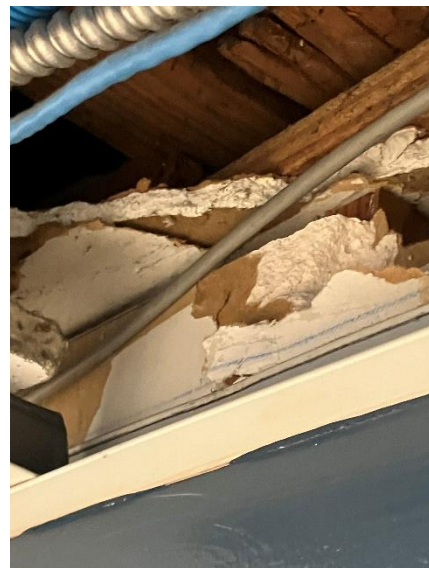
- White sheetrock joint compound – at SE corner of the open area, basement floor – 3% Chrysotile
- Red floor tile – SE corner of open area, basement floor – 5% Chrysotile

Photo 4 – White sheetrock joint compound – at SE corner of the open area, basement floor

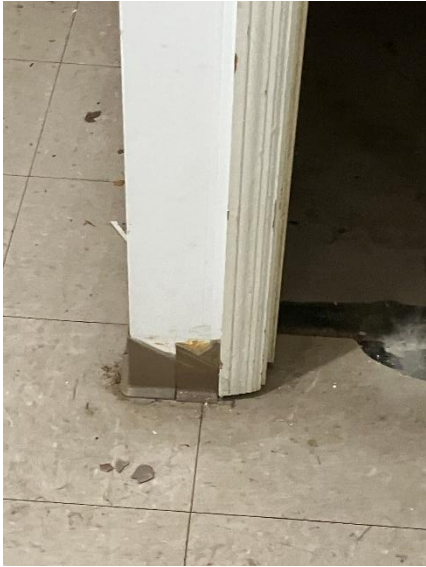
Photo 5 – Tan tile with white mastic, basement floor

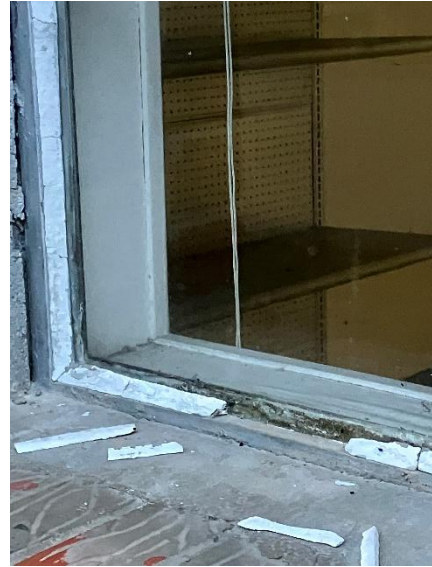
- Chalky white window caulk – NW corner near entrance, SE side exterior corner, and SW side exterior – 2% Chrysotile

Photo 6 – Chalky white window caulk, exterior windows

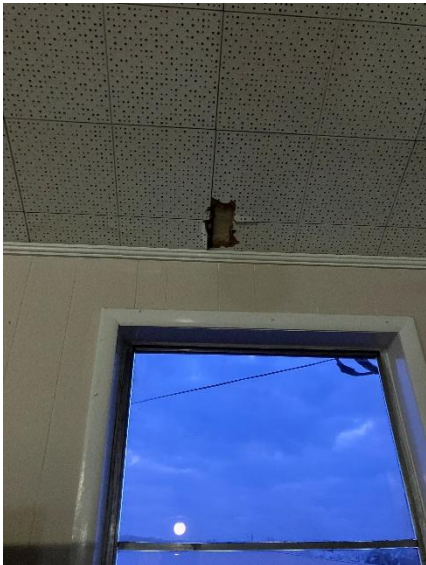
- Green ceiling paint, wood ceiling under ceiling tiles in sanctuary and wood wall in south entrance to sanctuary, main floor – 2.2% by weight
- Dark green paint, wood wall, south sanctuary entrance, main floor – 5.9% by weight

Photo 7 – Green ceiling paint, wood ceiling under ceiling tiles in sanctuary

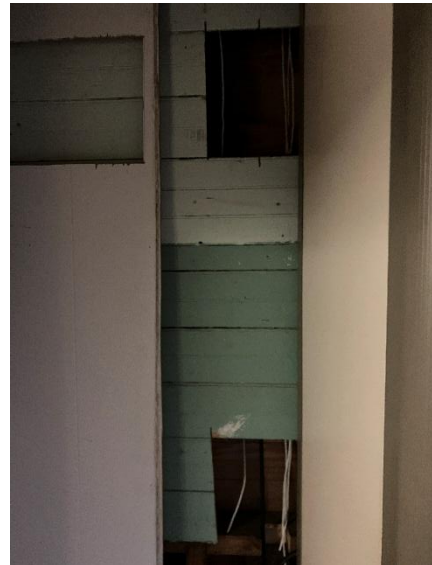
Photo 8 – Dark green paint, wood wall, south sanctuary entrance, main floor

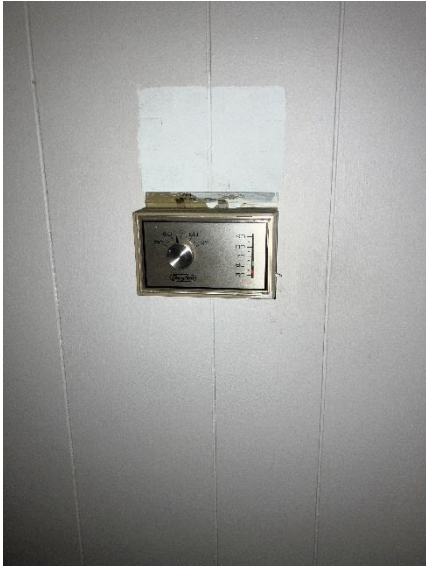
PPM identified two thermostats, in the sanctuary on the main floor and the open area on the basement floor, within the building.

Photo 9 – Thermostat in sanctuary, main floor

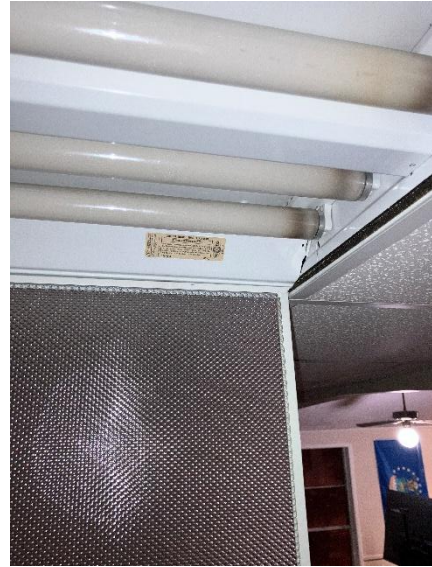
PPM identified fluorescent light tubes, some of which were marked as mercury-containing light bulbs, and potentially PCB containing ballasts throughout both floors of the building. These should be disposed of in accordance with applicable regulations.

Photo 10 – Fluorescent bulbs, throughout building

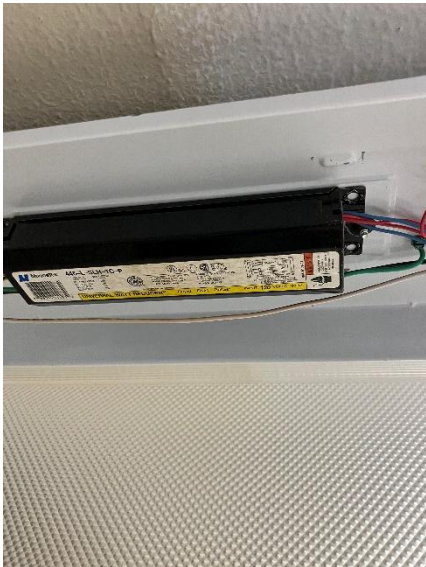
Photo 11 – Light ballast, throughout building

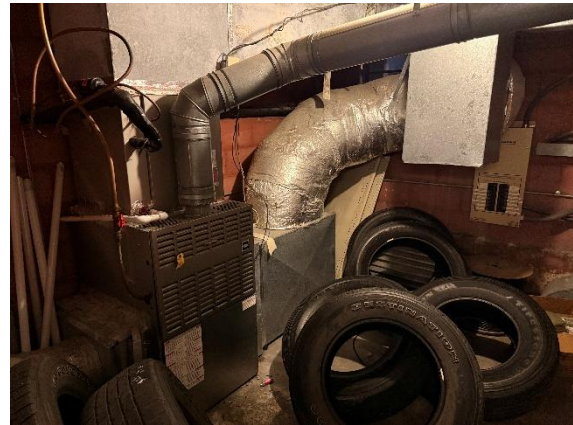
PPM identified heating, ventilation, and air conditioning (HVAC) equipment in the air handler room on the basement floor and outside the north side of the building during the survey.

Photo 12 – Air handler equipment, air handler room,
basement floor
