# Albion, NE

Fin Folk Underwater Services

# Tank information

- Year built 2000
- Max capacity- 300,000 gallons
- Type- pedosphere
- Height-80ft

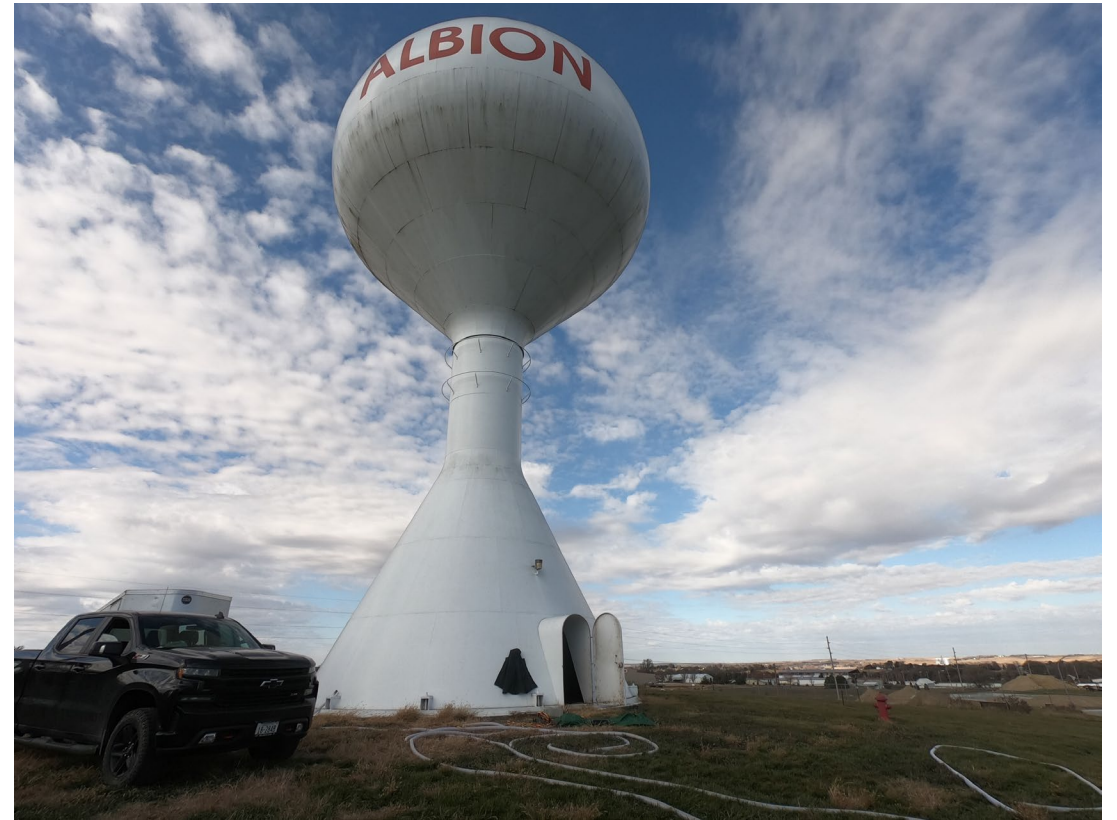
# Tower entry door

- Location- 12
- Rust grade- 8
- The door appears to be in good condition with little to no rusting or coating failures.

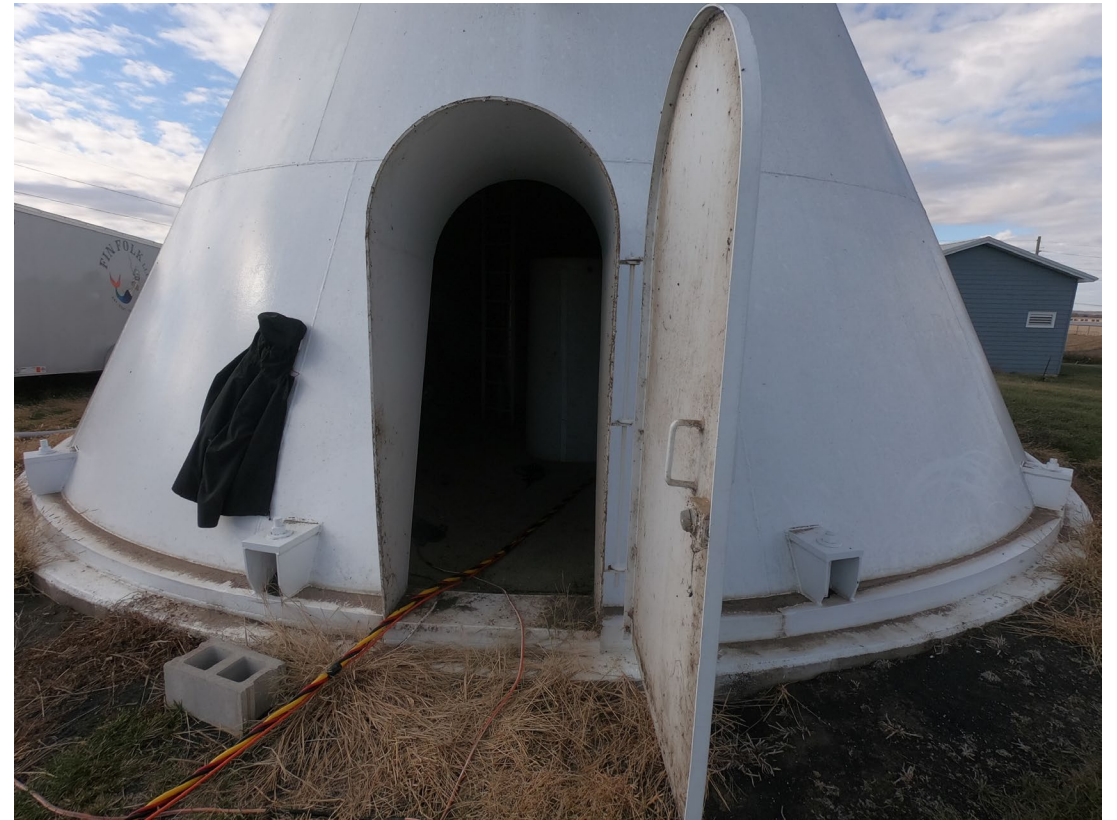
# Exterior base

- Location- 12
- Rust grade- 9
- Base appears to be in very good condition with little to no rust, pitting, or coating failures.

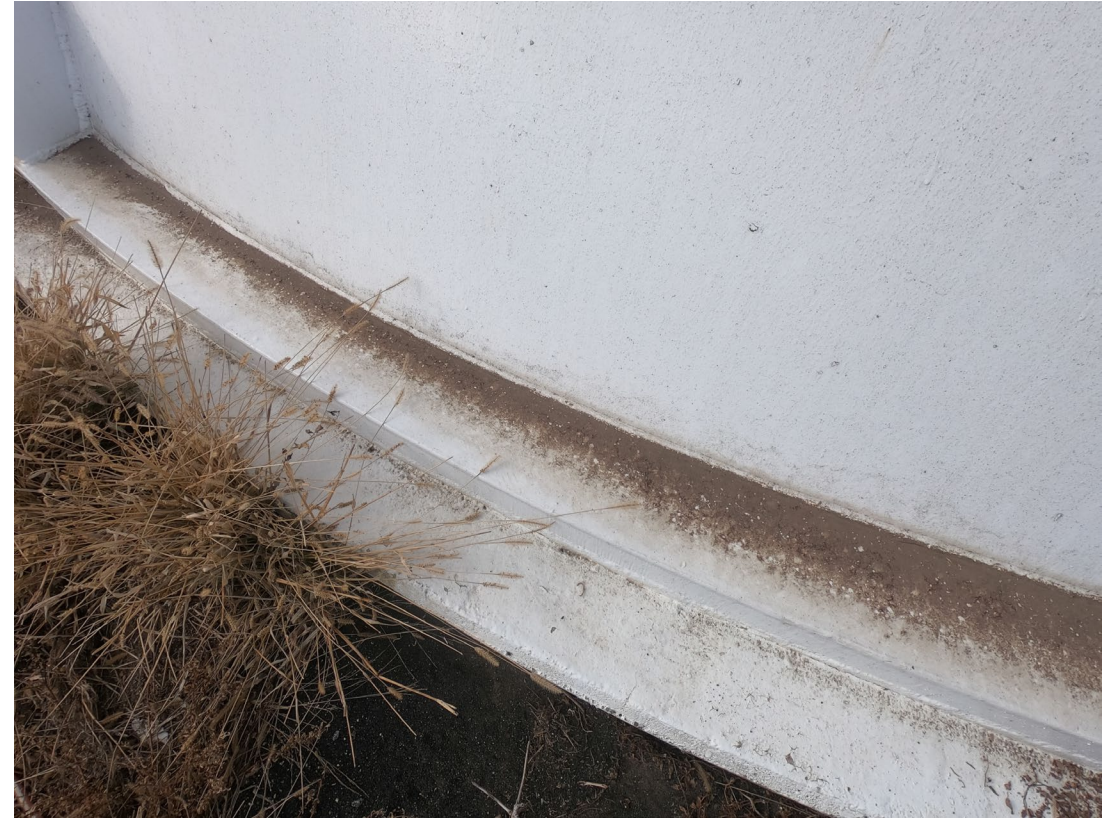
# Exterior wall

- Location- 3
- Rust grade- 9
- Wall appears to be in very good condition with little to no rust, pitting, or coating failures.

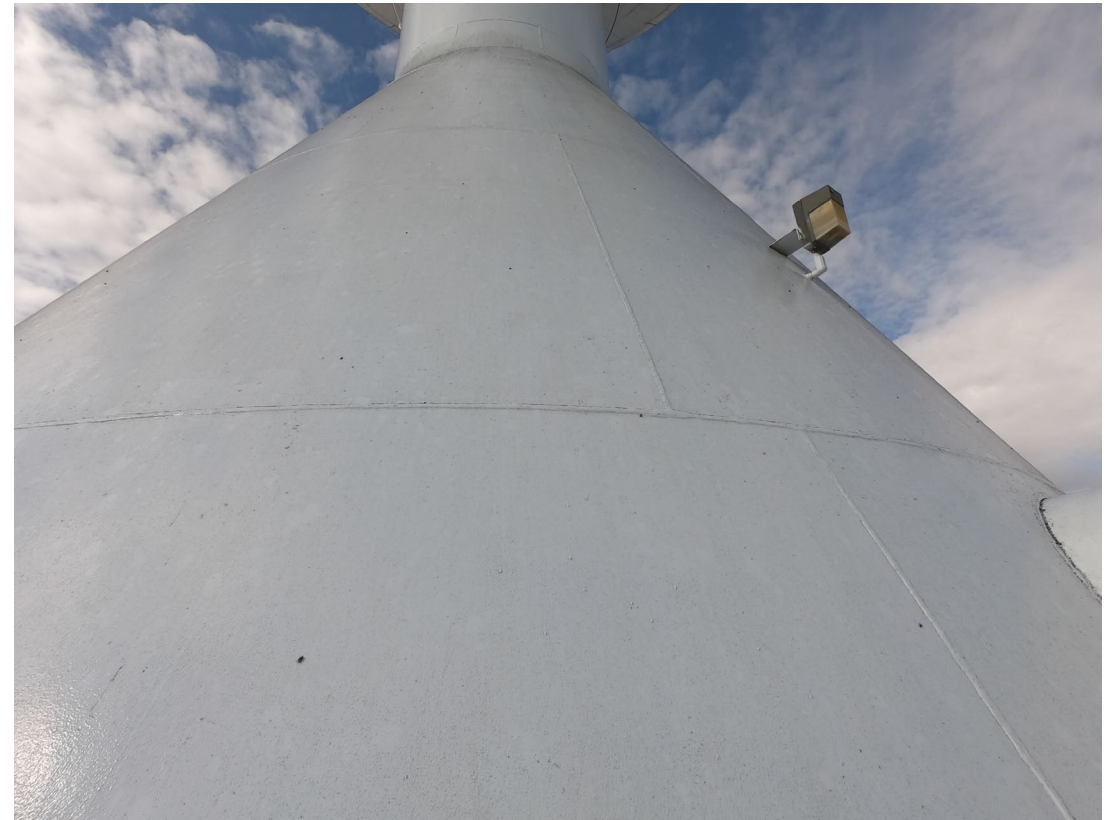
# Exterior base

- Location- 3
- Rust grade- 9
- Base appears to be in very good condition with little to no rust, pitting, or coating failures.

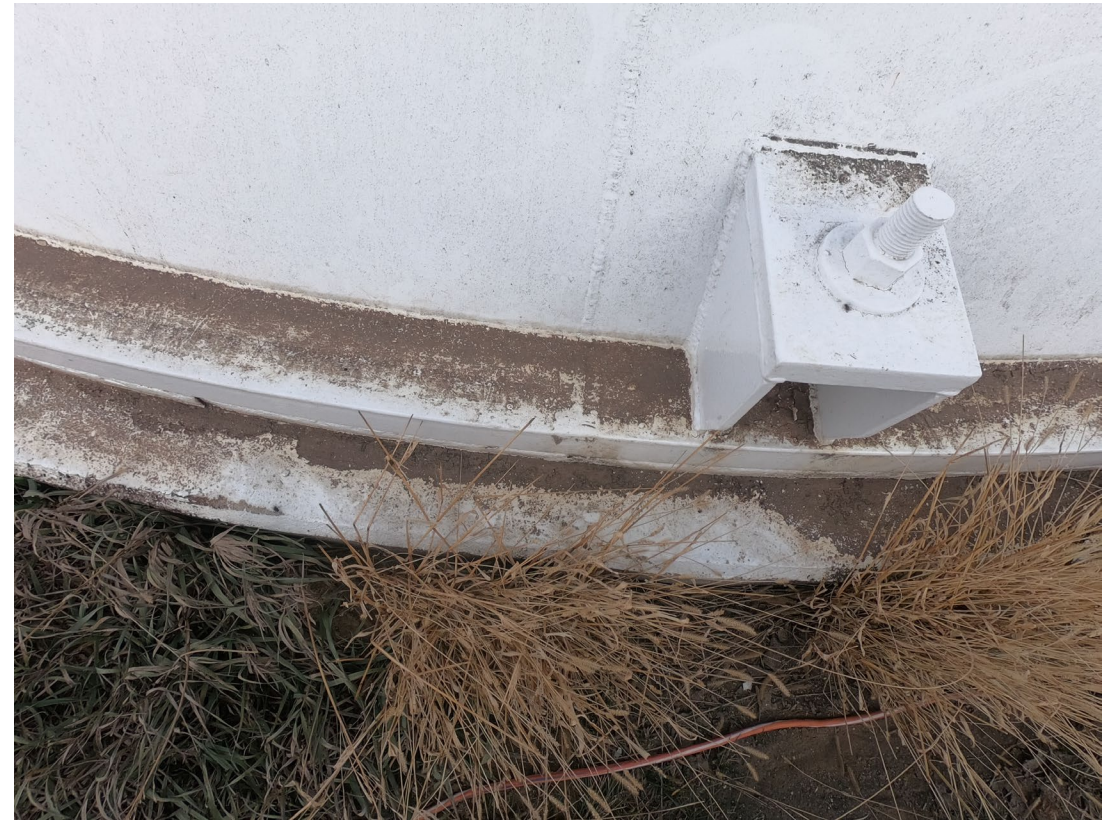
# Exterior wall

- Location- 6
- Rust grade- 9
- Wall appears to be in very good condition with little to no rusting, pitting, or coating failures.

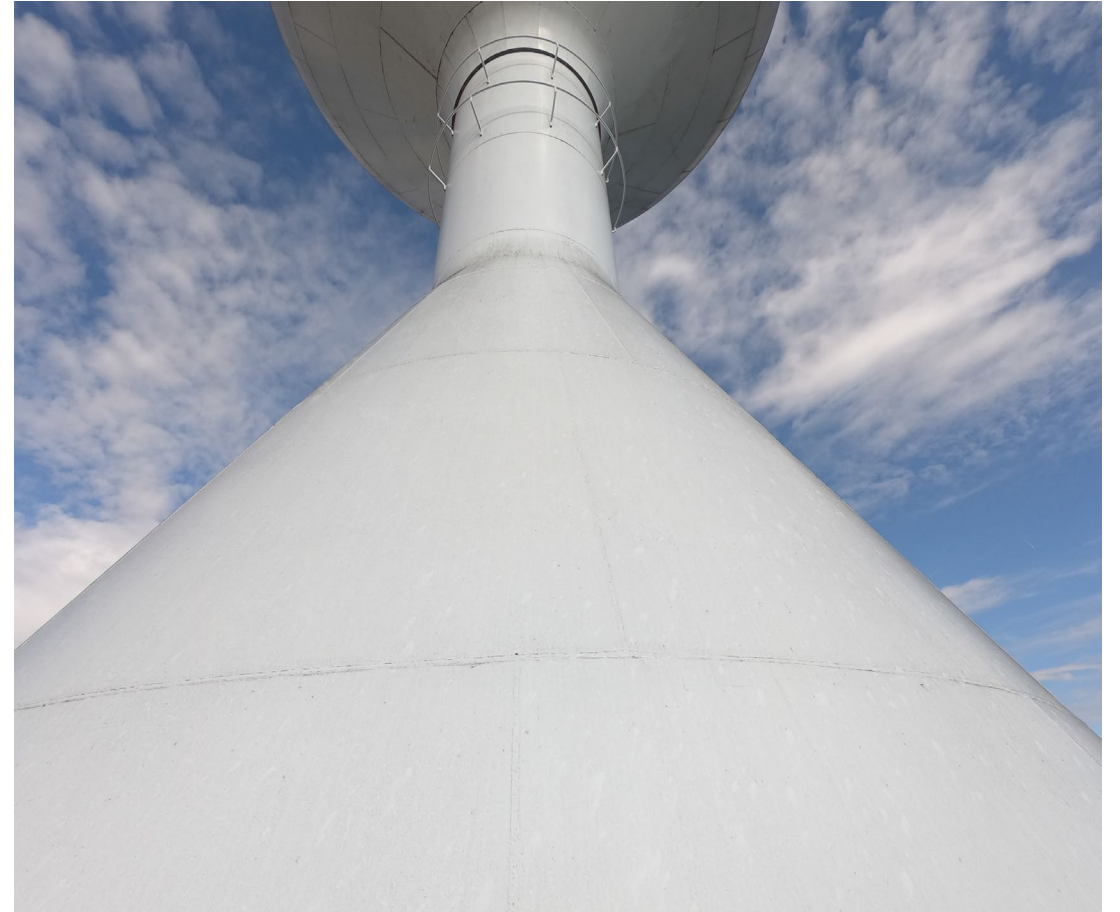
# Exterior base

- Location- 6
- Rust grade- 9
- Base appears to be in good condition with little to no rust, pitting, or coating failures.

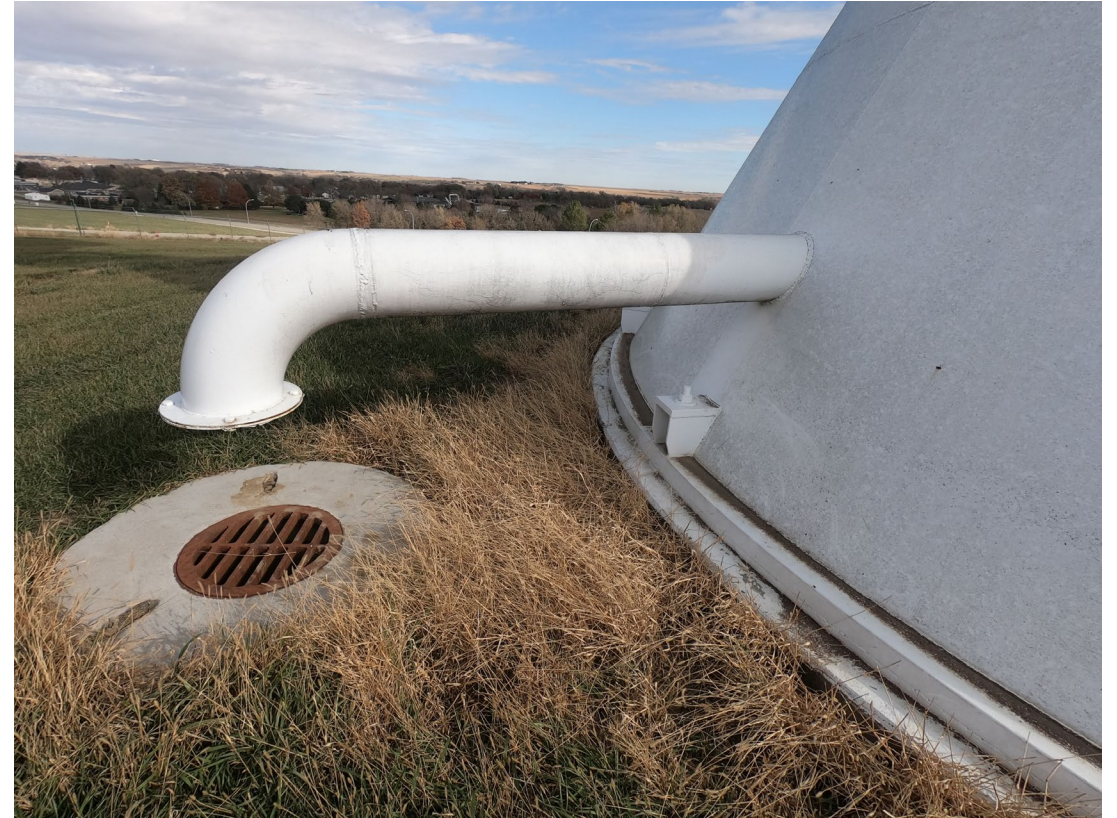
# Exterior wall

- Location- 9
- Rust grade- 9
- Wall appears to be in good condition with little to no rust, pitting, or coating failures.

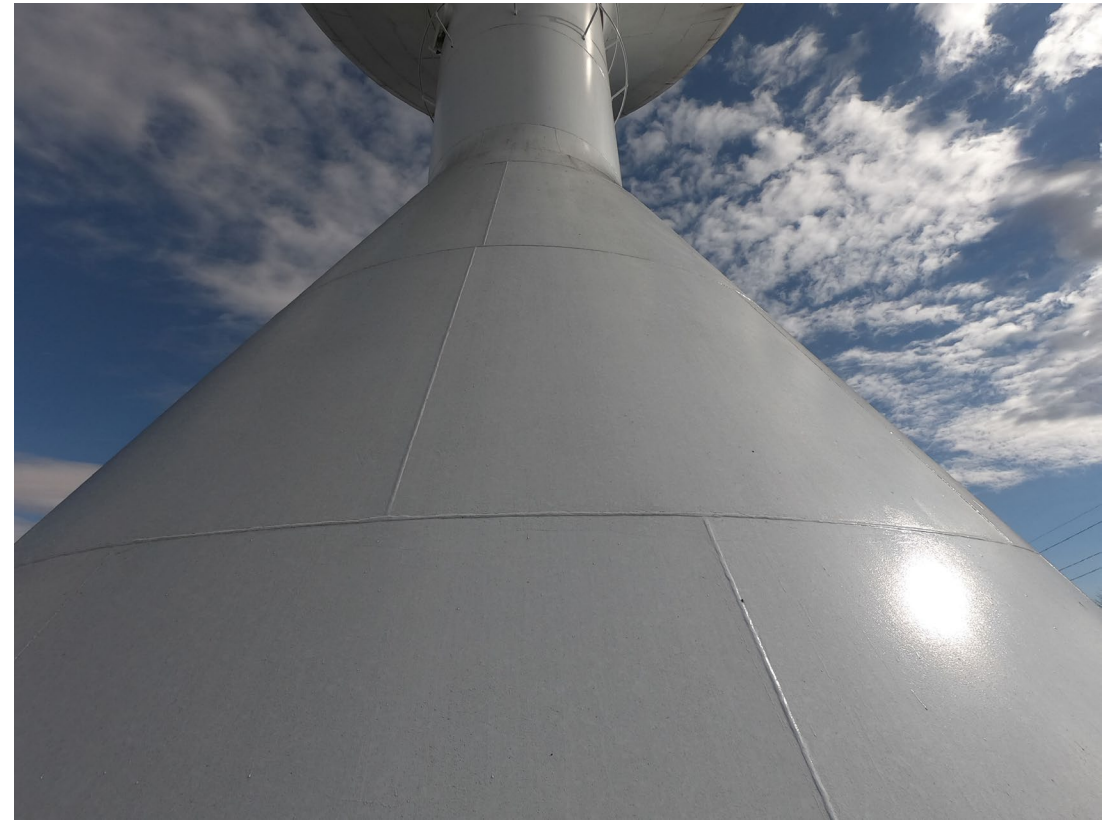
# Exterior base

- Location- 9
- Rust grade- 9
- Base appears to be in very good condition with little to no rust, pitting, or coating failures.

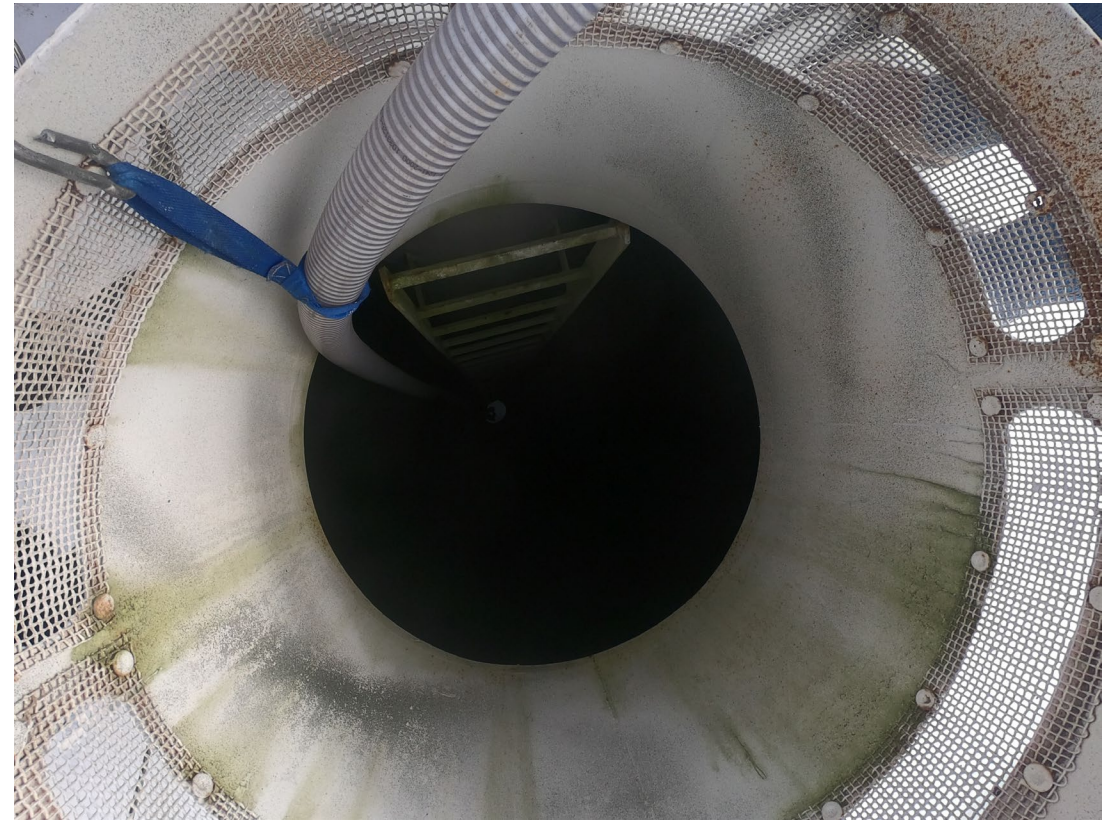
# VENT

- Location-9
- Rust grade- 9
- Vent appears to be in very good condition with little to no rust, pitting, or coating failures.
- Has fine mesh to prevent bugs form entering water.

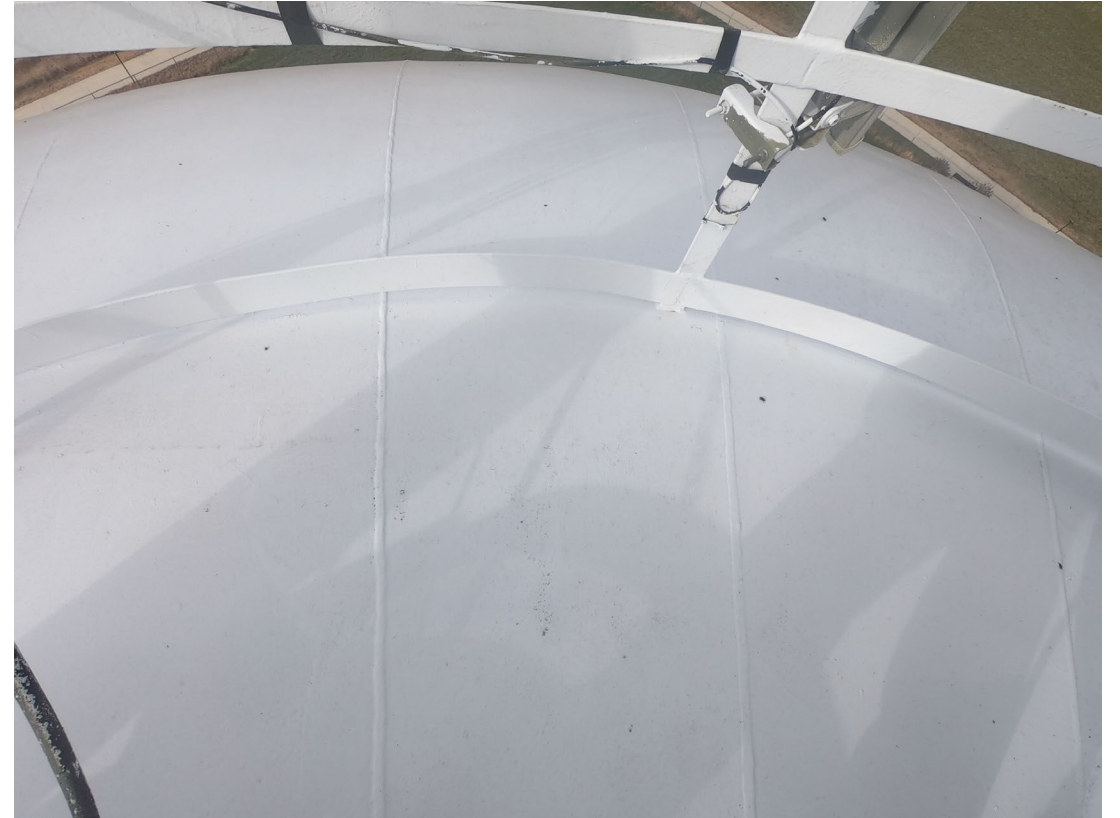
# Tower ceiling

- Location- 3
- Rust grade- 9
- Ceiling appears to be in very good condition with little to no rust, pitting, coating failures, or deformities.

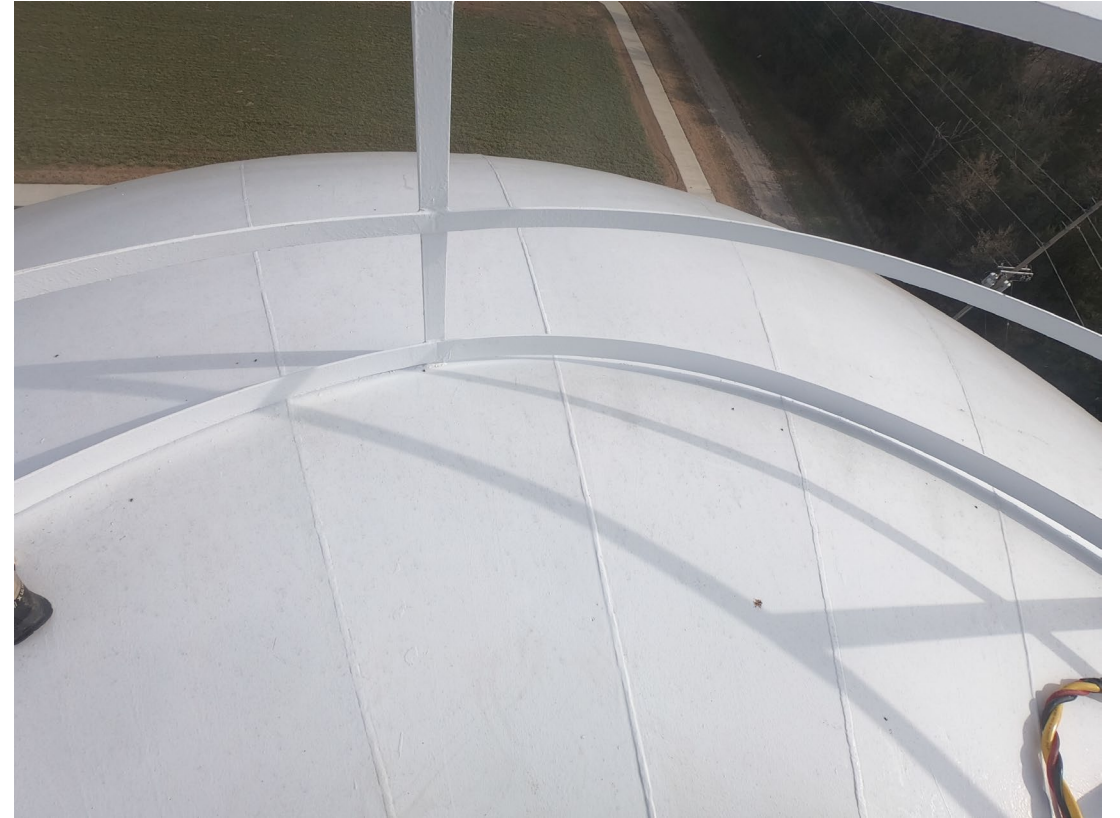
# Tower ceiling

- Location- 6
- Rust grade- 9
- Ceiling appears to be in very good condition with little to no rust, pitting, coating failures, or deformities.

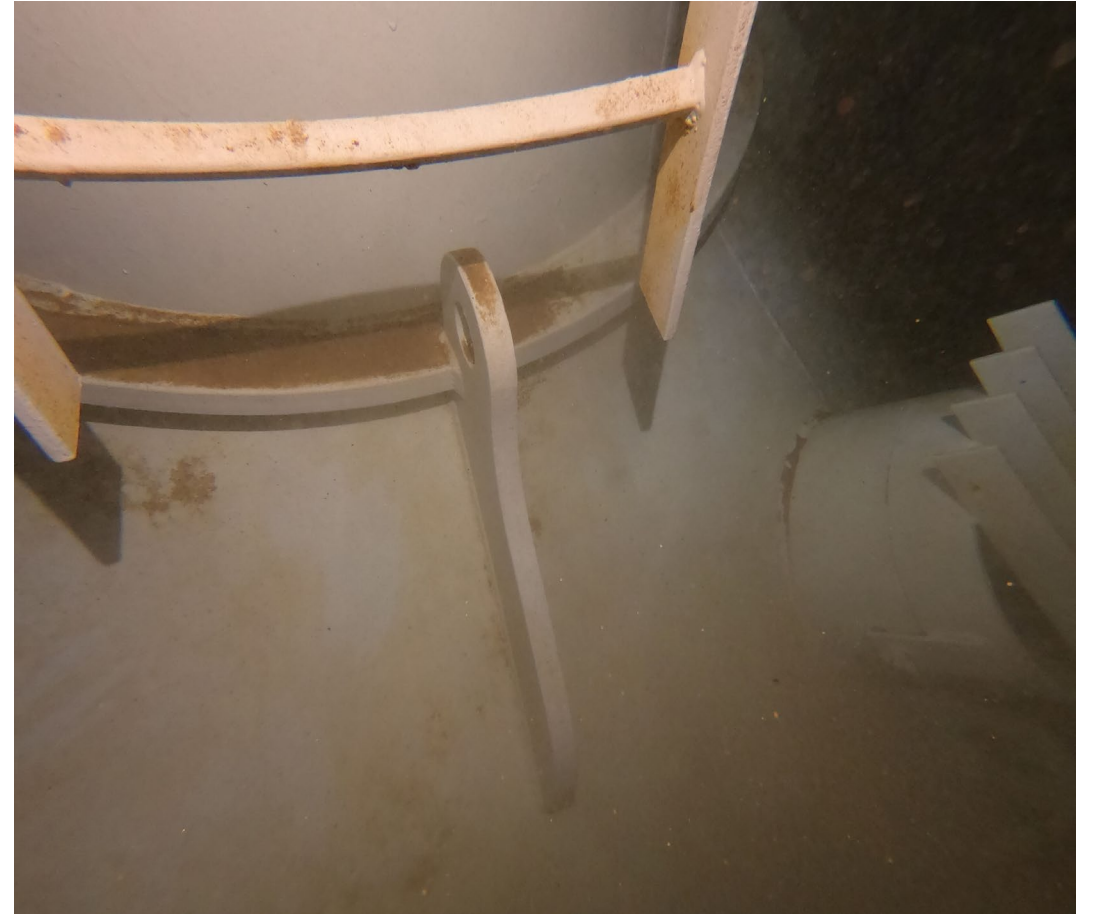
# Common inlet/outlet

- Location- 11
- Rust grade- 9
- Common inlet/outlet appears to be in very good condition with little to no rust or deformities.

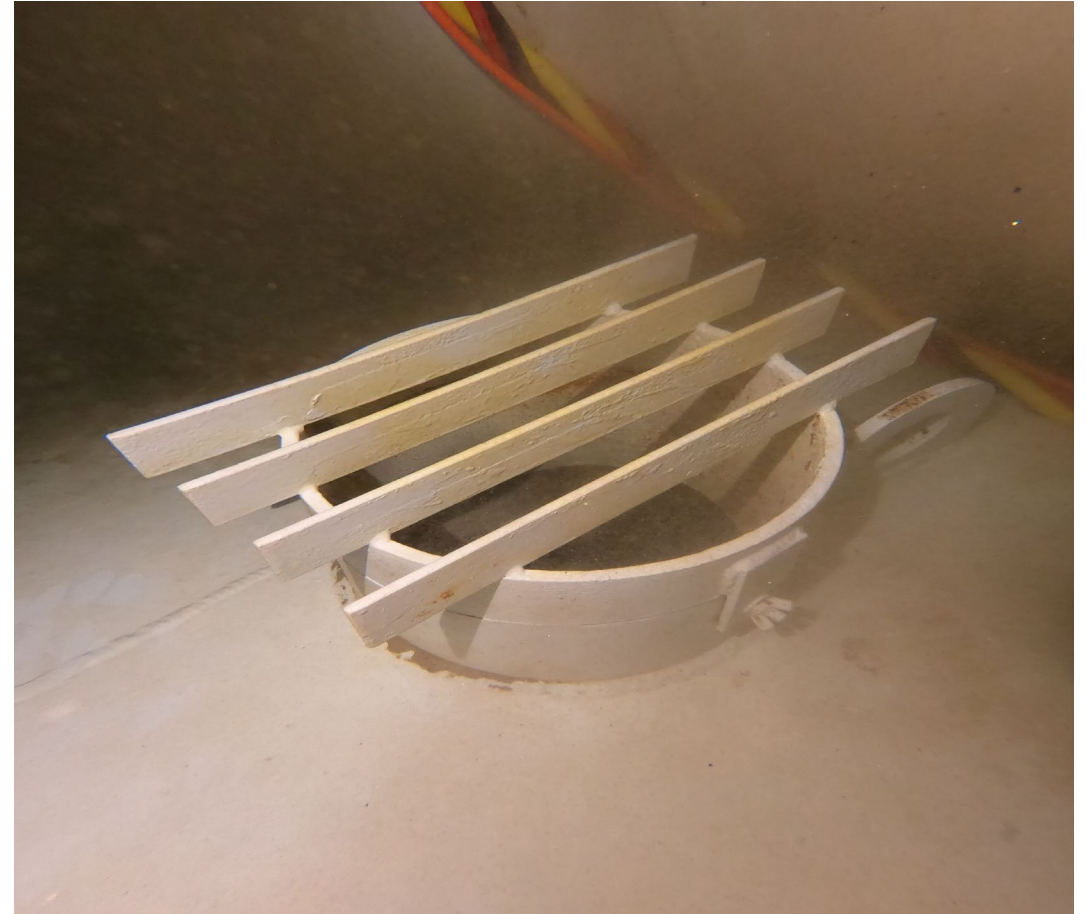
# Floor

- Location- 3
- Rust grade- 9
- Floor appears to be in very good condition with little to no rust or deformities.

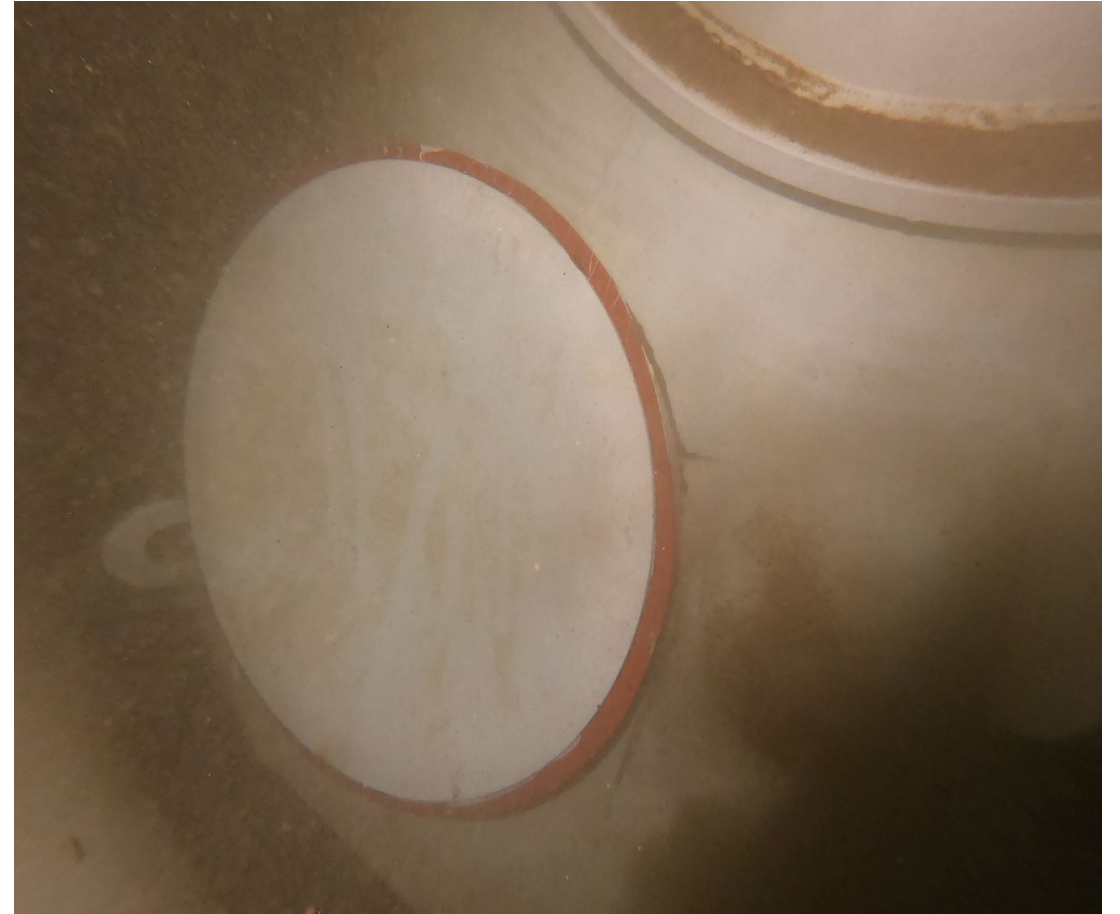
# Wall

- Location- 12
- Rust grade- 9
- Wall appears to be in very good condition with little to no rust or deformities.

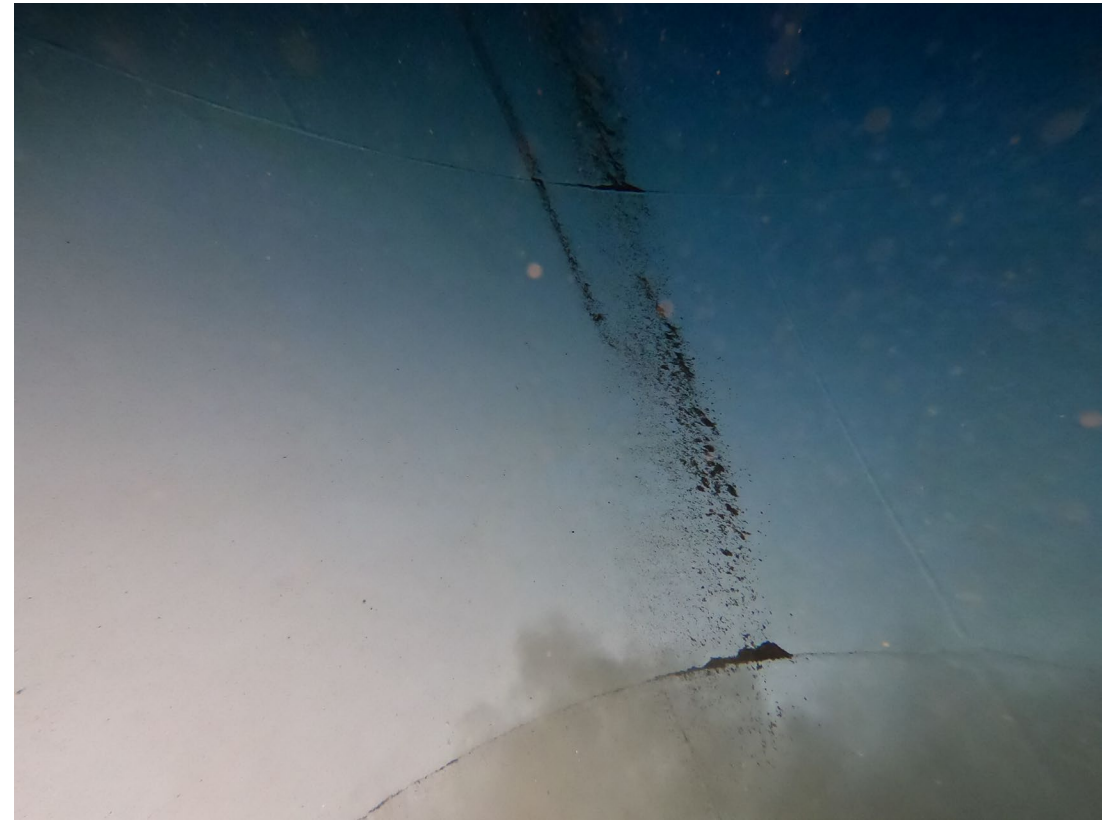
# Wall

- Location- 3
- Rust grade- 9
- Wall appears to be in very good condition with little to no rust or deformities.

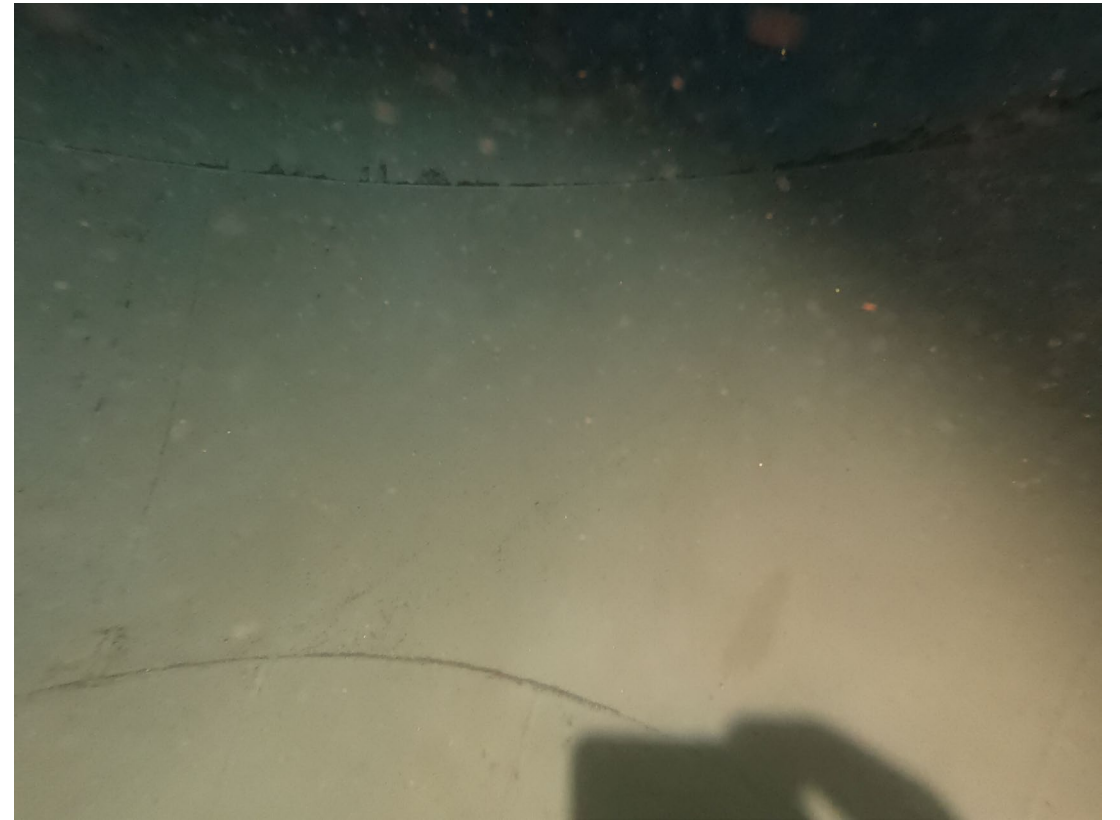
# Wall

- Location- 6
- Rust grade- 9
- Wall appears to be in very good condition with little to no rust or deformities.

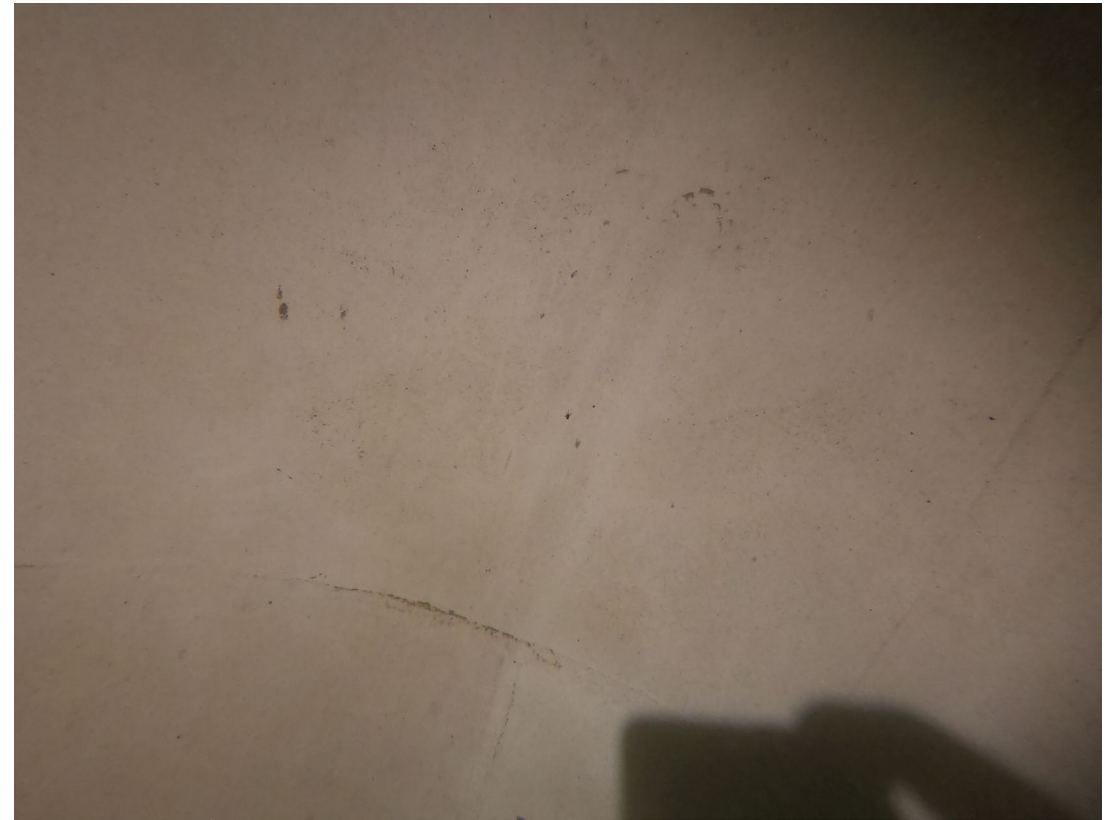
# Wall

- Location- 9
- Rust grade- 9
- Wall appears to be in very good condition with little to no rust or deformities.

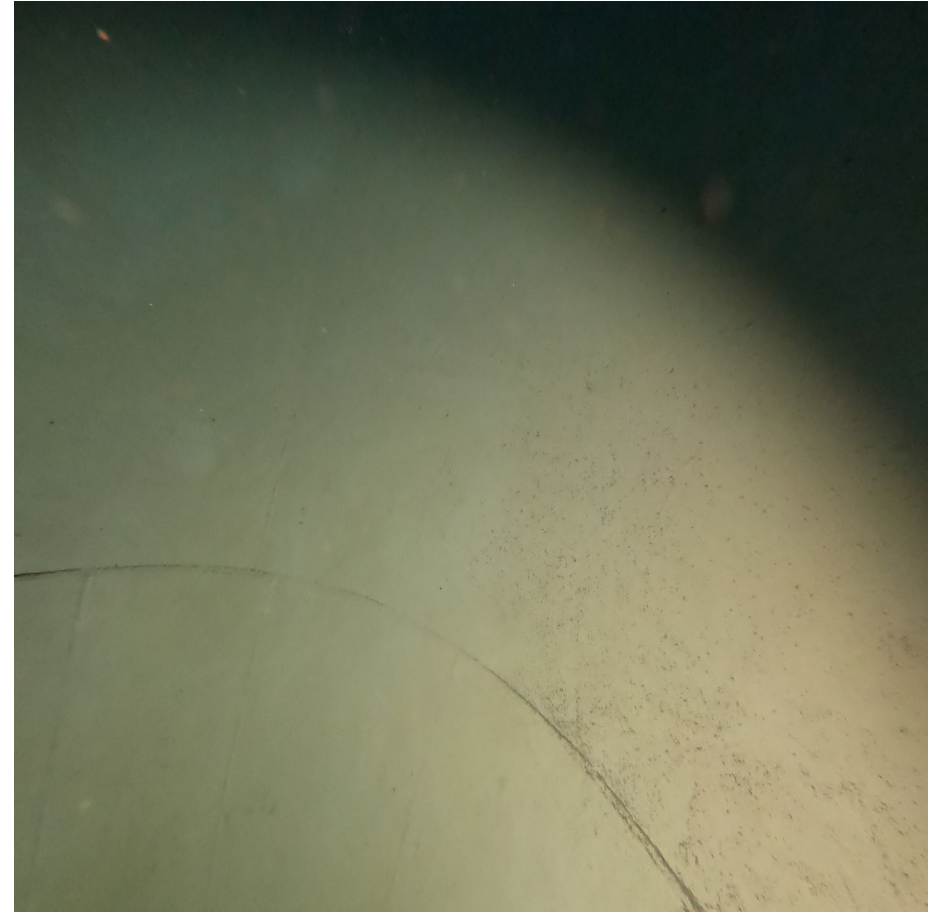
# Center Tube

- Location- Center
- Rust Grade- 9
- Center Tube appears to be in very good condition with little to no rust, pitting, or coating failures.
