Appendix A: Public Outreach

Site Accessibility Evaluation

Angleton Recreation Center & Natatorium

BG Peck Soccer Complex
709 Kelly Blvd
Angleton, TX 77515
Accessibility Evaluation
Evaluation Date: 03/24/2022
Evaluators: Kristi Avalos

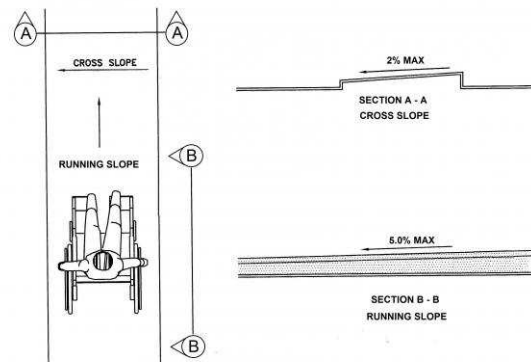
Current Condition:

Grate drain is set too low which causes a slope over 2%

Replace the plaza area between the fields to ensure the slope does not exceed 2% in any direction.

Alternatively, the area around the drain can be blocked so it's not part of the accessible route and the route around it can be made compliant.

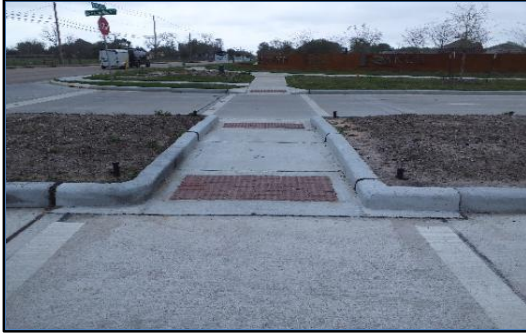
Curb ramp is compliant - bring DWS into compliance
