Formal Inspection Report No. 3

Aniak Levee

Aniak, Alaska

Inspection Date: July 24, 2024
Report Date: September 16, 2024

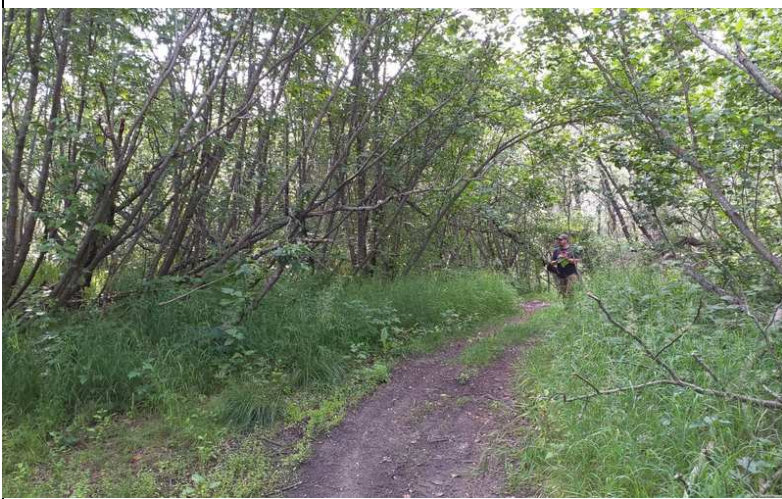
Inspect ID: 2024-0002

Caption: 0002 - Unacceptable - There is dense vegetation along the levee crest and slopes. Trees are greater than 2 inches in diameter, with most trees having diameters of 6 inches or greater. Cut vegetation along levee crest, side slopes, and within 15 feet of the toe on the land and river side of the levee.

- Dense vegetation was observed along the levee crest, side slopes, and within 15 feet of the toe. All vegetation, except for maintained grass, should be cut and/or removed to remain in compliance with EP 1110-2-18.

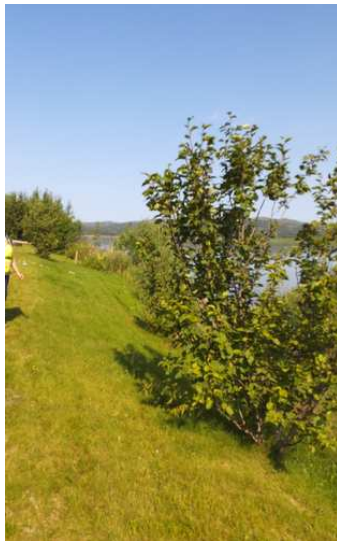
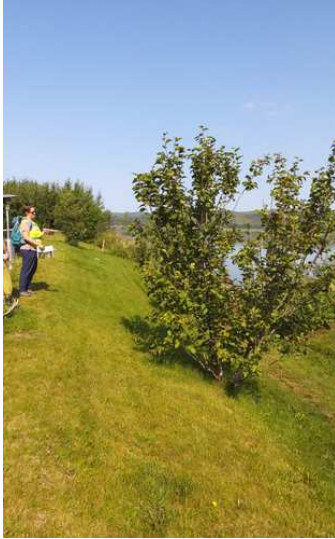
Inspect ID: 2024-0011

Caption: 0011 - Unacceptable - Trees greater than 2 inches in diameter along waterside slopes. Cut trees.

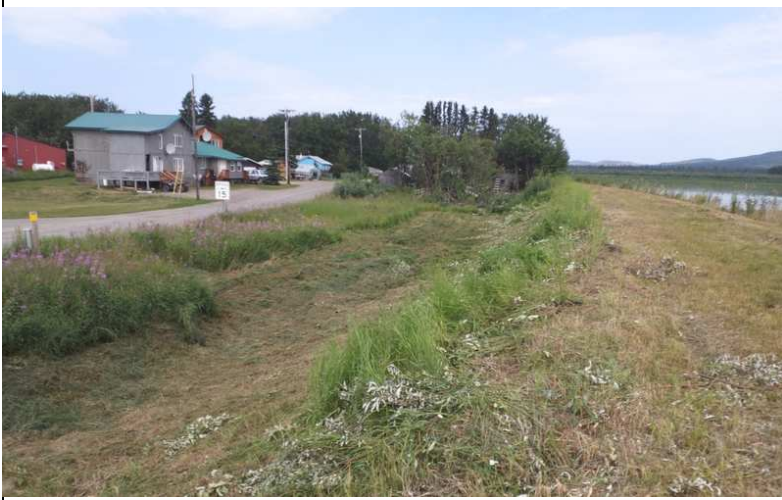
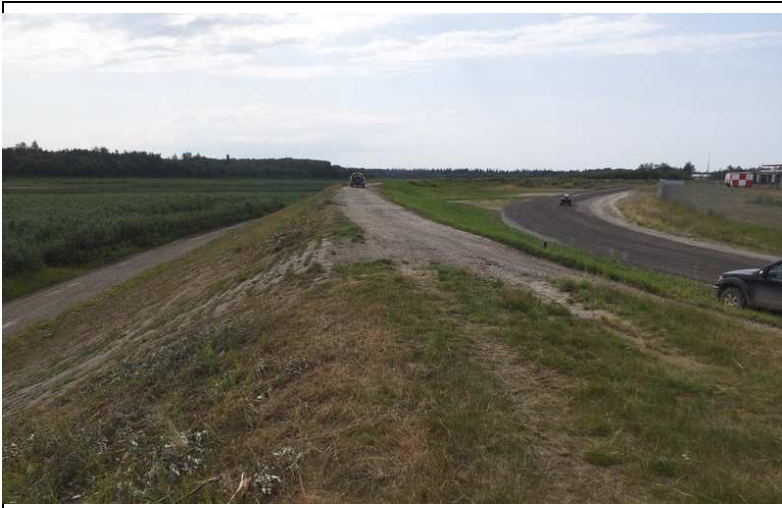
Inspect ID: 2024-0041

Caption: 0041 - Acceptable - Vegetation has been recently cut and is in acceptable condition.

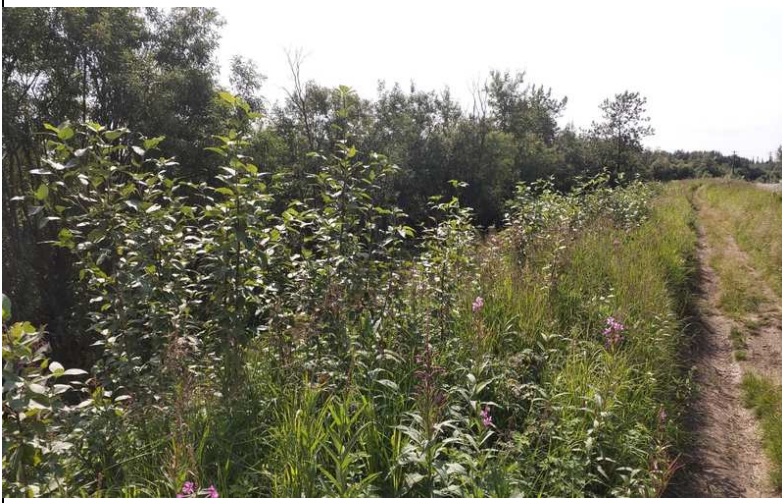
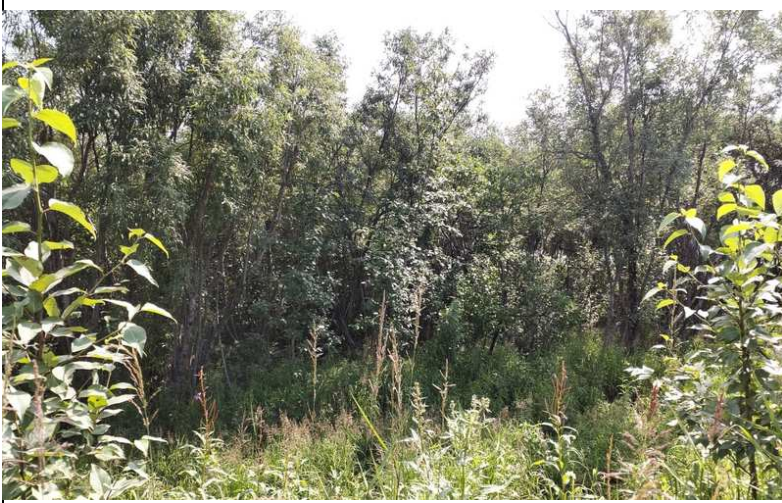
Inspect ID: 2024-0048

Caption: 0048 - Unacceptable - Dense vegetation along side slopes impacting ability to inspect levee. Waterside has trees greater than 2 inches in diameter within 15 feet of toe. Cut vegetation.

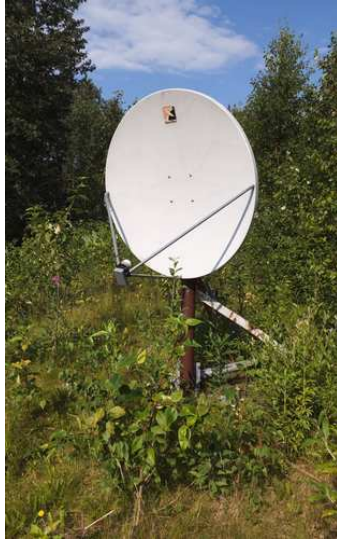
Inspect ID: 2024-0007
Feature Details: Levee Embankments - Encroachments - Crown
GPS Coordinates Start: 61.5840004, -159.541076
GPS Coordinates End:
Caption: 0007 - Unacceptable - Satellite dish on crown of levee

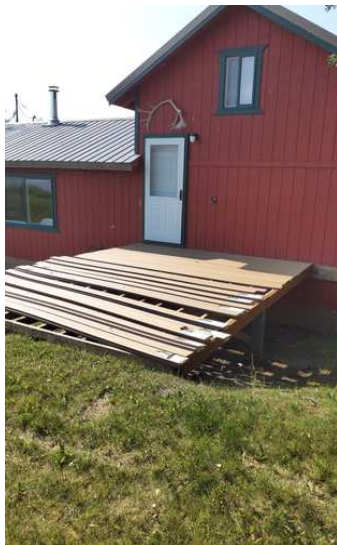
Inspect ID: 2024-0009
Feature Details: Levee Embankments - Encroachments - Landside
GPS Coordinates Start: 61.5839227, -159.5406081
GPS Coordinates End:
Caption: 0009 - Unacceptable - Deck built into levee side slope and house foundation within 15 feet of the toe as well

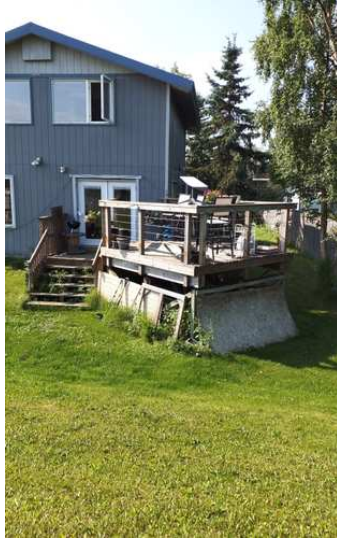
Inspect ID: 2024-0010
Feature Details: Levee Embankments - Encroachments - Landside Toe
GPS Coordinates Start: 61.5835382, -159.5393326
GPS Coordinates End:
Caption: 0010 - Unacceptable - deck within 15 feet of toe

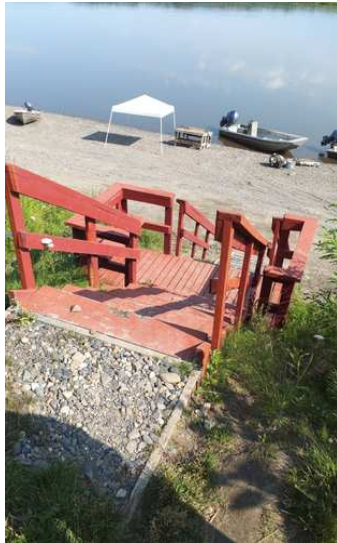
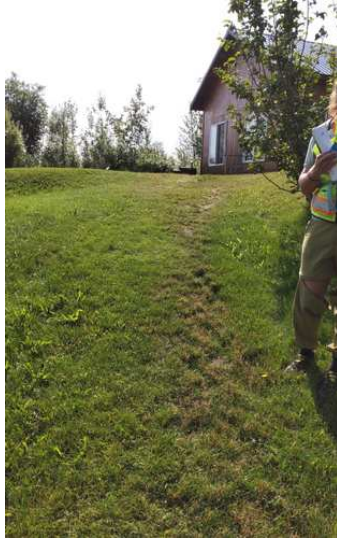
Inspect ID: 2024-0012
Feature Details: Levee Embankments - Encroachments - Waterside Toe
GPS Coordinates Start: 61.5834947, -159.5388353
GPS Coordinates End:
Caption: 0012 - Unacceptable - stairs built at levee toe, unknown where toe ends

Caption: 0012 - Unacceptable - stairs built at levee toe, unknown where toe ends

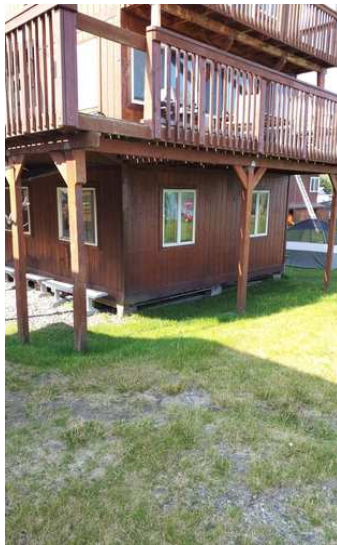
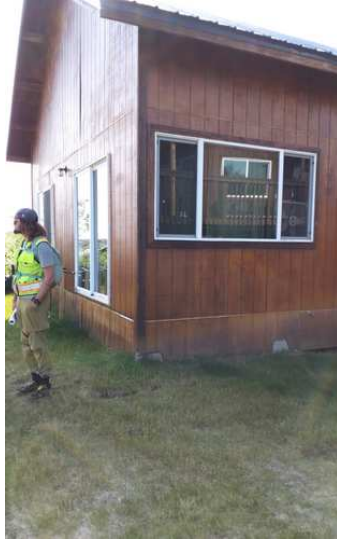
Inspect ID: 2024-0013

Caption: 0013 - Unacceptable - houses built on levee and within 15 feet of toe

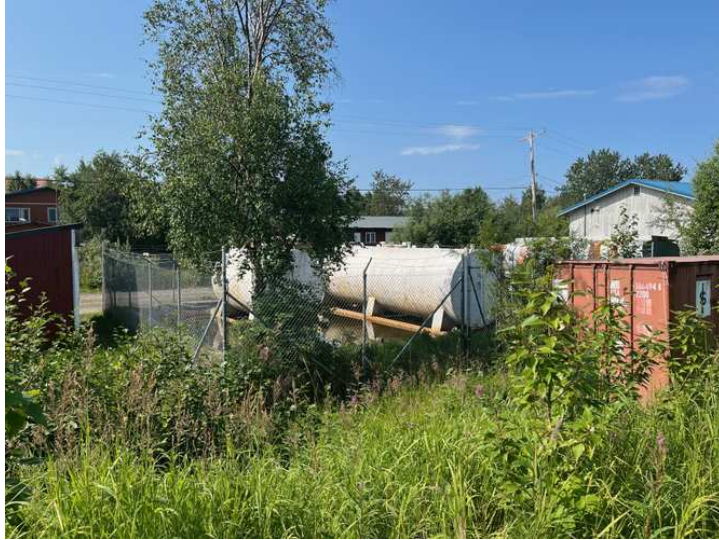
Inspect ID: 2024-0016
Feature Details: Levee Embankments - Encroachments - Landside
GPS Coordinates Start: 61.5828605, -159.5373646
GPS Coordinates End:
Caption: 0016 - Unacceptable - houses and fuel tanks within 15 feet of toe

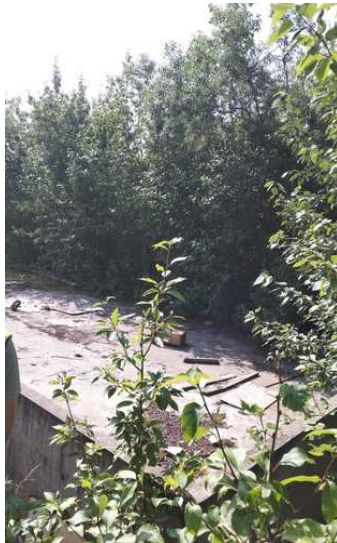
Inspect ID: 2024-0017
Feature Details: Levee Embankments - Encroachments - Landside
GPS Coordinates Start: 61.5827802347874, -159.536962780378
GPS Coordinates End:
Caption: 0017 - Unacceptable - building foundation along slope and toe

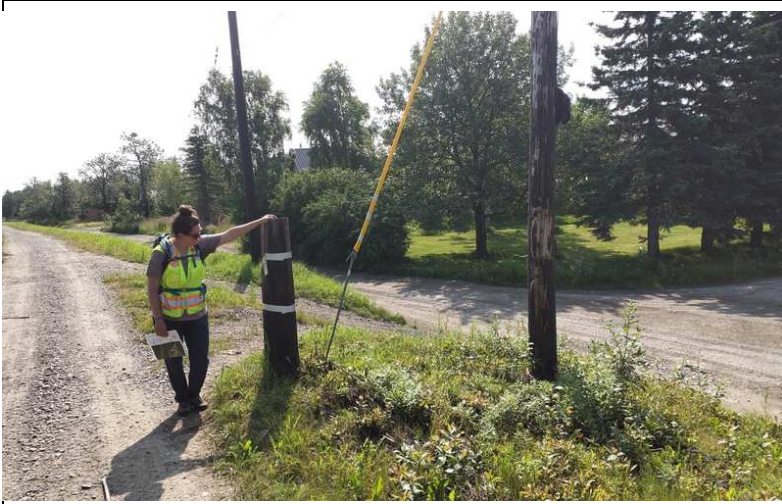
Inspect ID: 2024-0022

Caption: 0022 - Unacceptable - telephone poles through slopes

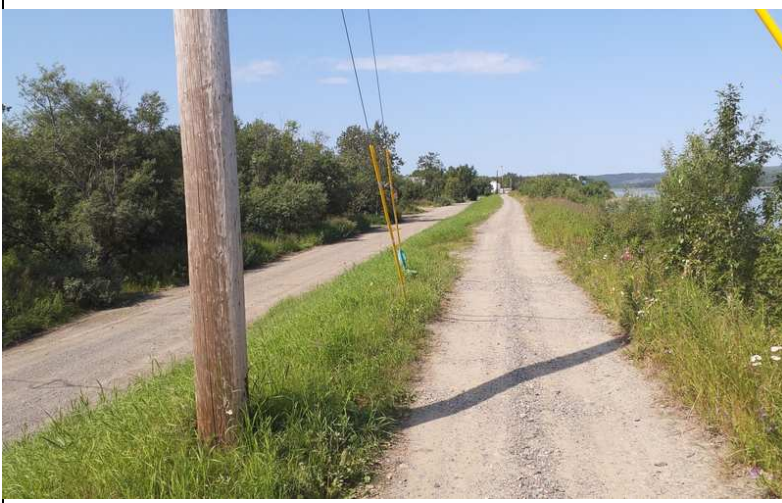
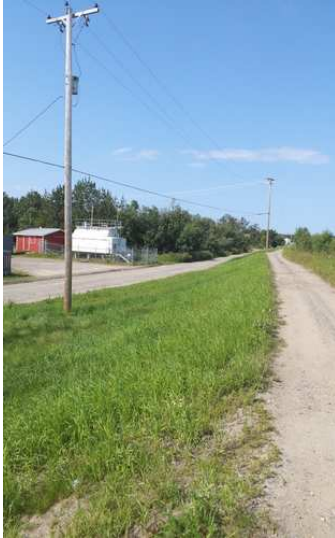
Inspect ID: 2024-0026

Caption: 0026 - Unacceptable - telephone poles through levee crest and at toe

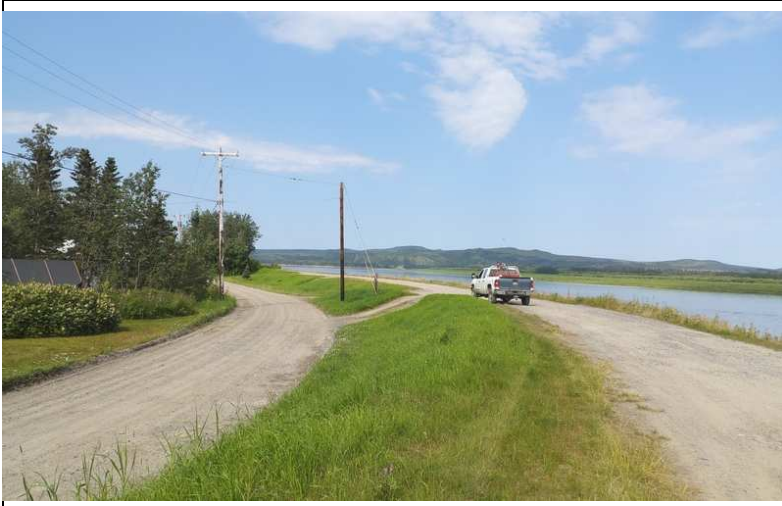
Inspect ID: 2024-0036
Feature Details: Levee Embankments - Encroachments - Landside Slope
GPS Coordinates Start: 61.5795488277199, -159.524208389984
GPS Coordinates End:
Caption: 0036 - Unacceptable - telephone poles through slope near toe

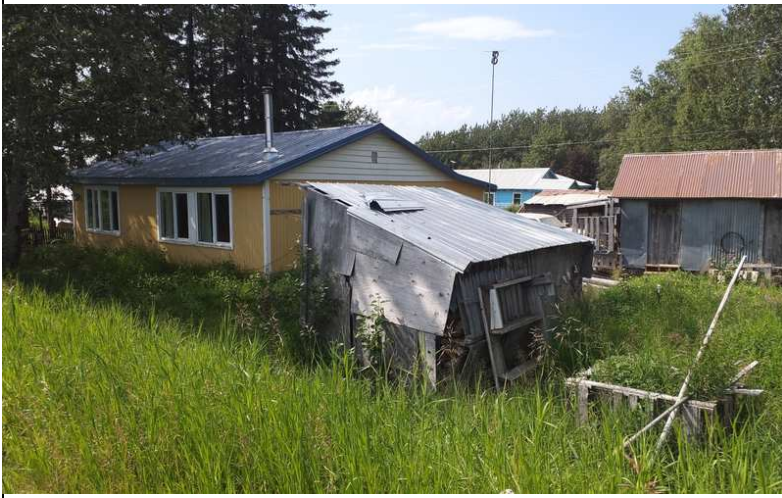
Inspect ID: 2024-0038
Feature Details: Levee Embankments - Encroachments - Landside Toe
GPS Coordinates Start: 61.5786726321674, -159.523633292219
GPS Coordinates End:
Caption: 0038 - Unacceptable - house within 15 feet of toe

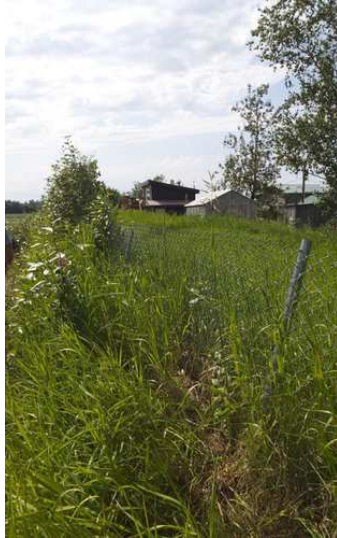
Inspect ID: 2024-0039
Feature Details: Levee Embankments - Encroachments - Crown
GPS Coordinates Start: 61.5783855713181, -159.523655934548
GPS Coordinates End:
Caption: 0039 - Unacceptable - fence on crown

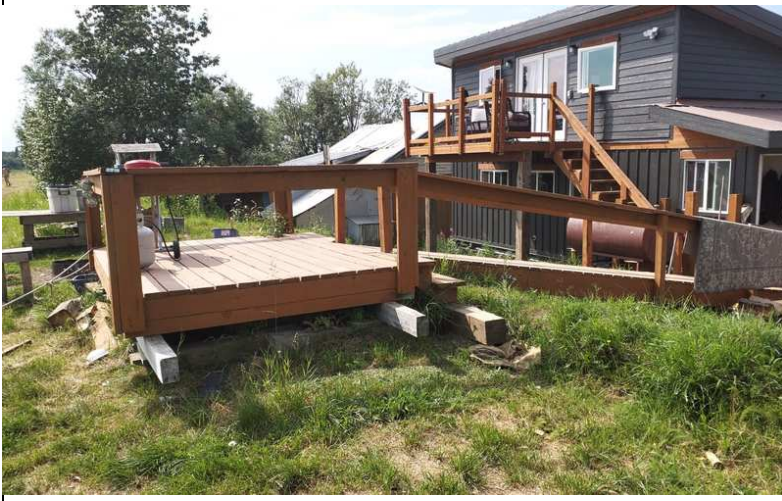
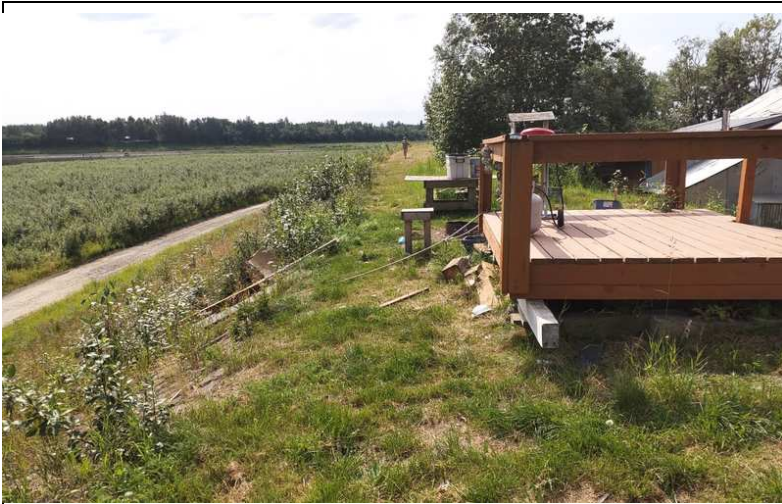
Inspect ID: 2024-0040
Feature Details: Levee Embankments - Encroachments - Slopes and Crown
GPS Coordinates Start: 61.5780609207814, -159.523751107599
GPS Coordinates End:
Caption: 0040 - Unacceptable - deck on levee crown into slope

Caption: 0040 - Unacceptable - deck on levee crown into slope

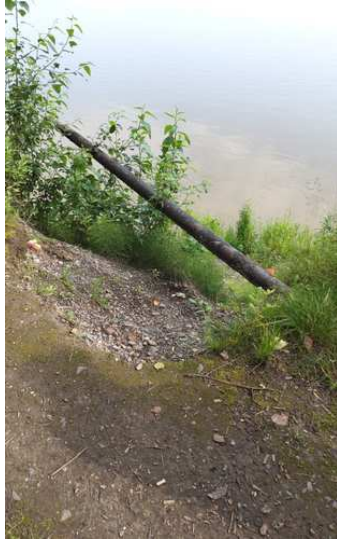
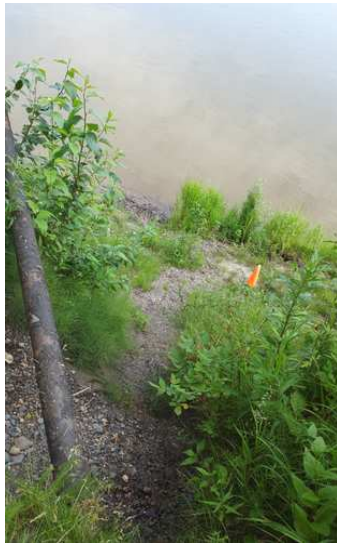
Inspect ID: 2024-0001
Feature Details: Levee Embankments - Erosion / Bank Caving - Waterside Slope and Crown
GPS Coordinates Start: 61.5865837925561, -159.55232788253
GPS Coordinates End:
Caption: 0001 - Unacceptable - erosion cutting into levee embankment and crest. slopes steeper than 2:1

- Several areas with ice scour and erosion should be repaired. Short term repairs could include filling in these areas with local fill. Long term solutions would include adding in erosion protection measures such as riprap to the side slopes.

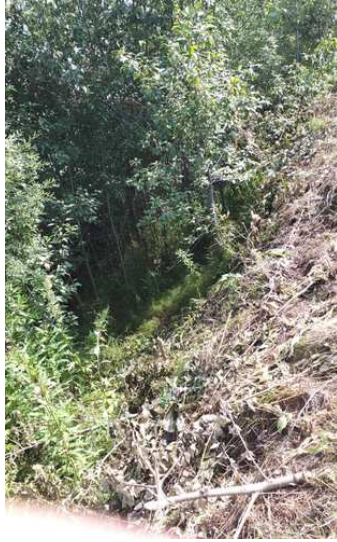
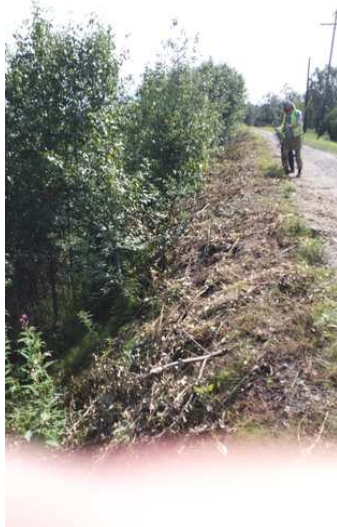
Inspect ID: 2024-0021
Feature Details: Levee Embankments - Erosion / Bank Caving - Waterside Slope
GPS Coordinates Start: 61.582047443963, -159.535020712518
GPS Coordinates End: 61.5819307983117, -159.534695366645
Caption: 0021 - Unacceptable - Banks over steepened from potential ice erosion. Banks are at almost a 1H:1V side slope.

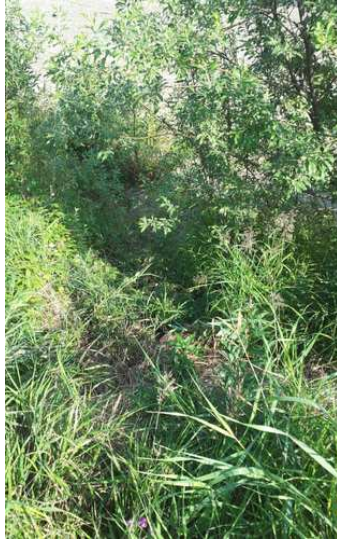
Inspect ID: 2024-0027

Caption: 0027 - Unacceptable - Banks are steepened along levee to almost 1H:1V side slopes potentially from ice erosion. Extent is unclear due to vegetation.

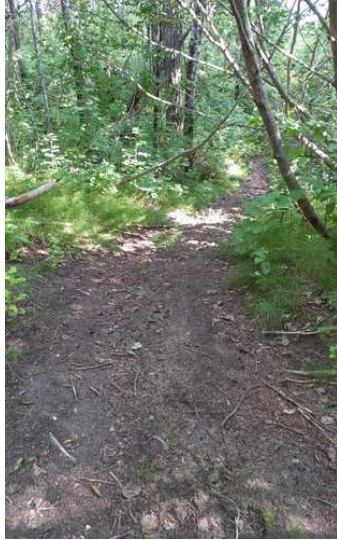
Inspect ID: 2024-0003
Feature Details: Levee Embankments - Depressions / Rutting - Waterside Toe and Slope
GPS Coordinates Start: 61.586011944608, -159.550993038576
GPS Coordinates End:
Caption: 0003 - Minimally Acceptable - Less than 6 inches of rutting along side slopes and toe from 4 wheeler access

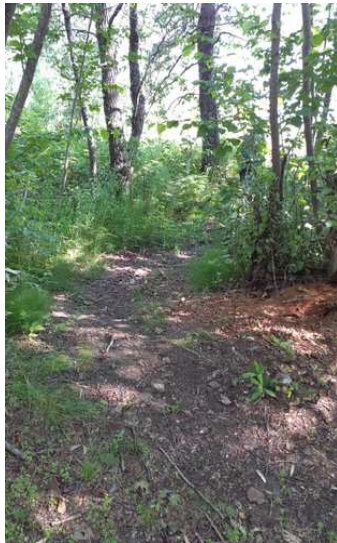
Inspect ID: 2024-0005
Feature Details: Levee Embankments - Depressions / Rutting - Waterside Slope
GPS Coordinates Start: 61.5841396, -159.5421721
GPS Coordinates End:
Caption: 0005 - Acceptable - Acceptable trail for 4 wheeler along side slope with no noticeable rutting.

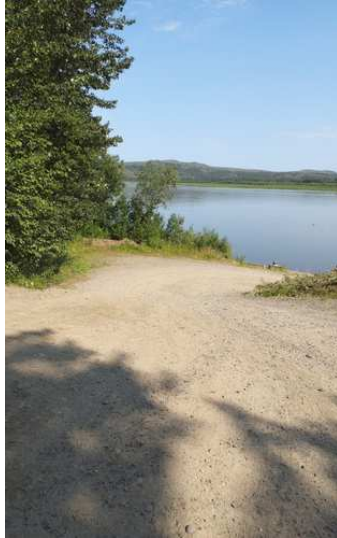
Inspect ID: 2024-0006
Feature Details: Levee Embankments - Depressions / Rutting - Waterside Slope
GPS Coordinates Start: 61.5840824, -159.5416683
GPS Coordinates End:
Caption: 0006 - Minimally Acceptable - Road going down the side slope of levee without significant rutting

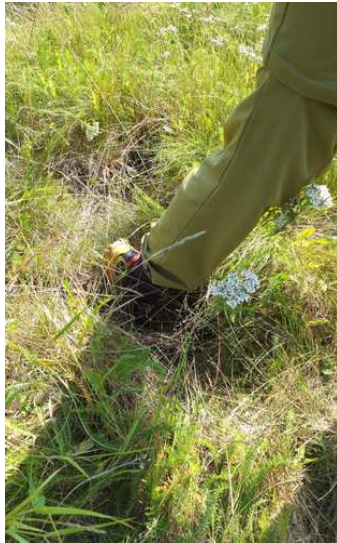
Inspect ID: 2024-0008
Feature Details: Levee Embankments - Depressions / Rutting - Slopes and Crown
GPS Coordinates Start: 61.5839883455511, -159.540962026609
GPS Coordinates End:
Caption: 0008 - Minimally Acceptable - Depressions close to 6 inches deep on both slopes and crown from possibly pedestrian foot traffic.

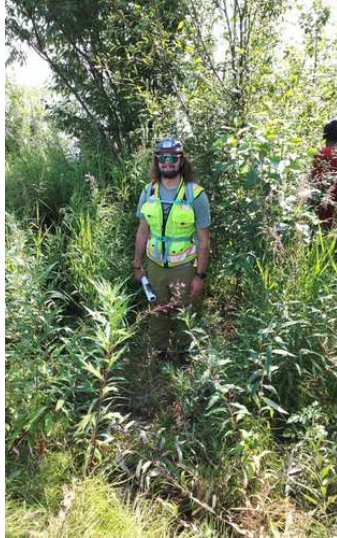
Inspect ID: 2024-0014

Caption: 0014 - Unacceptable - Depression from where house was removed along levee crest and slope. Depth of depression roughly 1.5 feet deep.

- Depressions and rutting along numerous locations that either lower the crown elevation or narrow the crown width should be filled to its original design elevation and side slopes regraded.

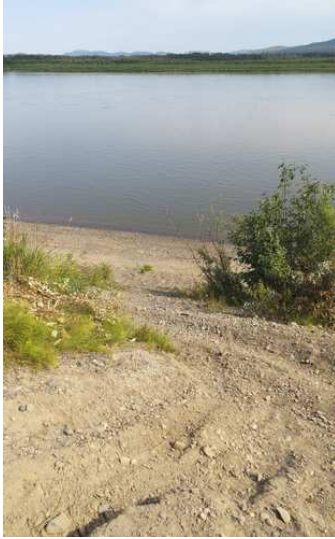
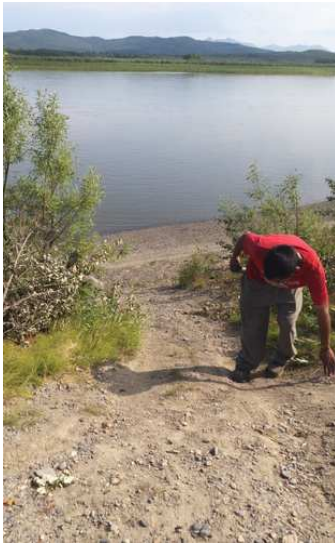
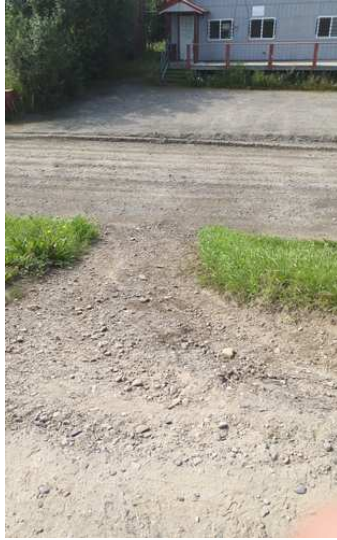
Caption: 0019 - Unacceptable - ATV path rutting greater than 6" in sections.

Inspect ID: 2024-0019
Feature Details: Levee Embankments - Depressions / Rutting - Waterside Toe and Slope
GPS Coordinates Start: 61.5822035111833, -159.535526824283
GPS Coordinates End:
Caption: 0019 - Unacceptable - ATV path rutting greater than 6" in sections.

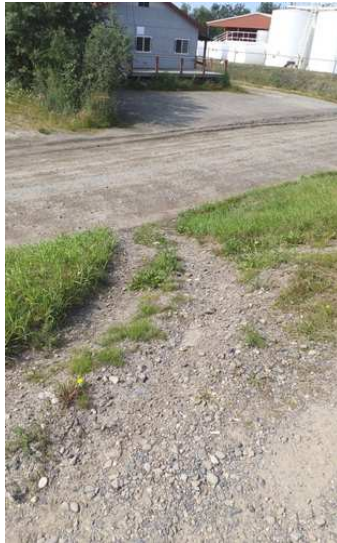
Inspect ID: 2024-0020
Feature Details: Levee Embankments - Depressions / Rutting - Landside Slope
GPS Coordinates Start: 61.5820712578179, -159.535111593399
GPS Coordinates End:
Caption: 0020 - Minimally Acceptable - ATV trail along side slope with less than 6 inches of rutting.

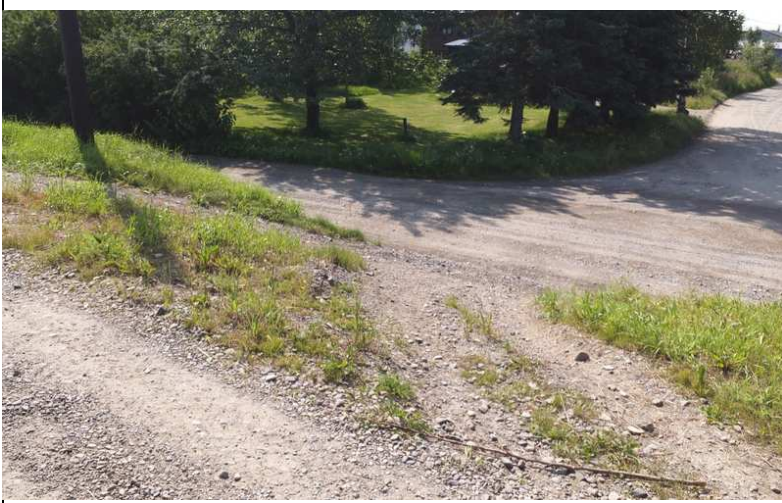
Inspect ID: 2024-0023

Caption: 0023 - Minimally Acceptable - ATV trail along side slopes with less than 6 inches of rutting.

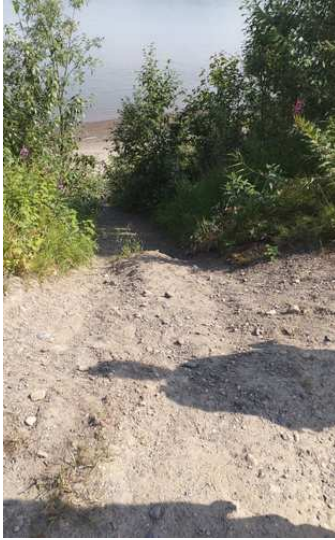
Inspect ID: 2024-0025
Feature Details: Levee Embankments - Depressions / Rutting - Waterside Slope
GPS Coordinates Start: 61.5810921227112, -159.530821400053
GPS Coordinates End:
Caption: 0025 - Minimally Acceptable - ATV rutting less than 6 inches deep.

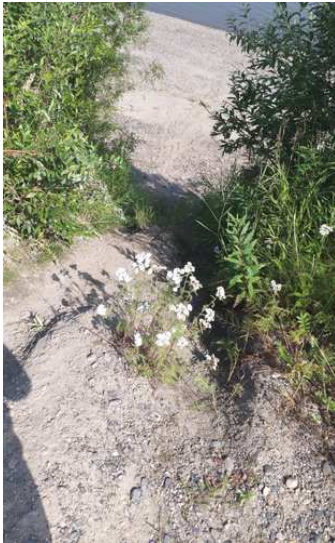
Inspect ID: 2024-0028
Feature Details: Levee Embankments - Depressions / Rutting - Waterside Toe and Slope
GPS Coordinates Start: 61.5806281, -159.5282954
GPS Coordinates End:
Caption: 0028 - Unacceptable - Steep bank and deep rutting from ATV use.

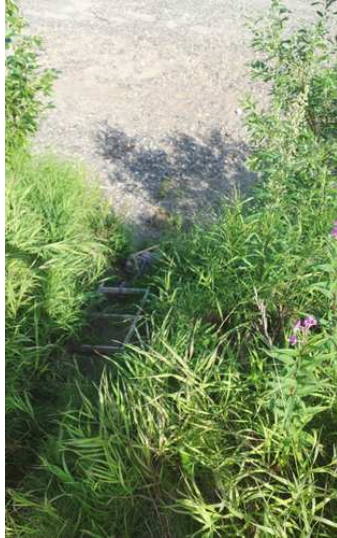
Rated Item	Rating	Rating Guidelines	Observation Locations with Descriptions and Resulting Item Rating Justification
			<p>2024-0030 : Pedestrian traffic caused deep rutting and use of ladders to get down steep side slopes of levee.(U)</p> <p>2024-0032 : ATV rutting created steep side slopes with simultaneous erosion from ice and bank undercutting.(U)</p> <p>2024-0035 : ATV trails along side slope with less than 6 inches of rutting.(M)</p> <p>2024-0042 : Road access has caused minor lowering of the crest and lowering of side slopes.(M)</p> <p>2024-0043 : Minor depressions from vehicle traffic on crown.(M)</p> <p>2024-0044 : ATV use along side slope causing minor rutting.(M)</p> <p>2024-0045 : Minor rutting from vehicle traffic on crown.(M)</p> <p>2024-0046 : Road over levee has lowered crown almost a foot.(U)</p> <p>2024-0049 : Minor rutting along crest from vehicle traffic.(M)</p> <p>Justification: Several sections along the levee have areas with depressions greater than 6 inches deep and need to be filled in with gravel.</p>

Inspect ID: 2024-0030
Feature Details: Levee Embankments - Depressions / Rutting - Waterside Toe and Slope
GPS Coordinates Start: 61.5804875, -159.5274792
GPS Coordinates End:
Caption: 0030 - Unacceptable - Pedestrian traffic caused deep rutting and use of ladders to get down steep side slopes of levee.

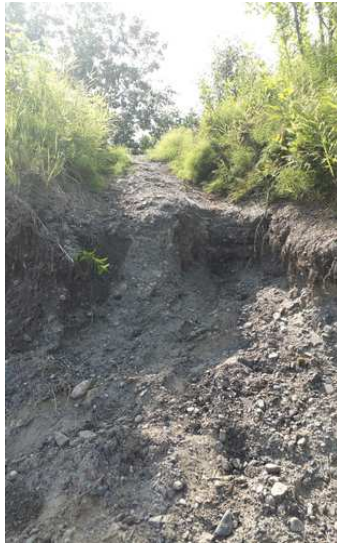
Inspect ID: 2024-0032
Feature Details: Levee Embankments - Depressions / Rutting - Waterside Toe and Slope
GPS Coordinates Start: 61.5804244572605, -159.526995369844
GPS Coordinates End:
Caption: 0032 - Unacceptable - ATV rutting created steep side slopes with simultaneous erosion from ice and bank undercutting.

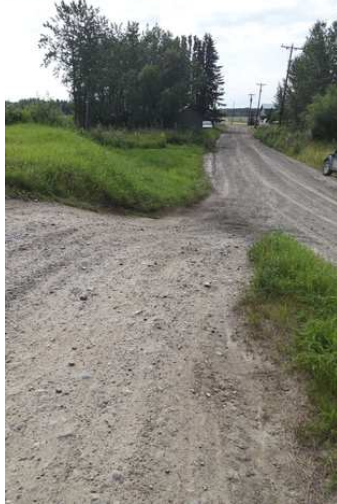
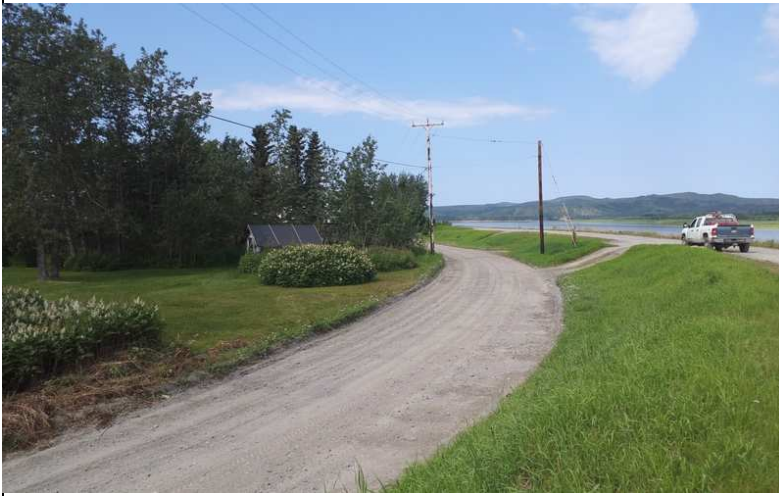
Inspect ID: 2024-0035

Caption: 0035 - Minimally Acceptable - ATV trails along side slope with less than 6 inches of rutting.

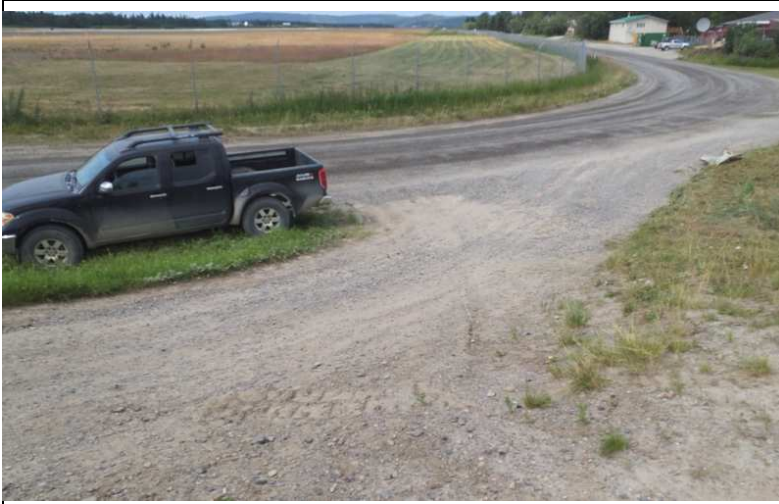
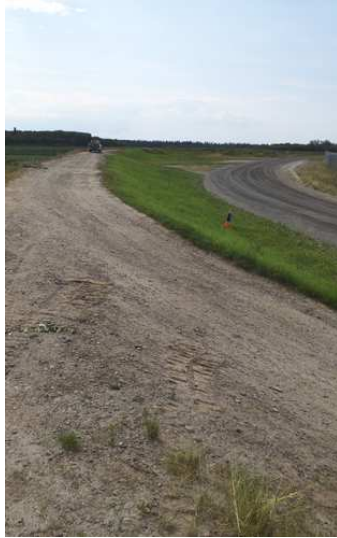
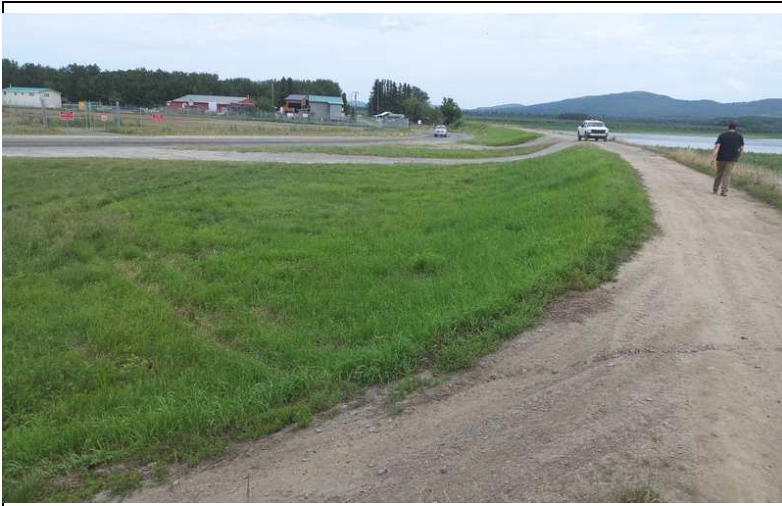
Caption: 0042 - Minimally Acceptable - Road access has caused minor lowering of the crest and lowering of side slopes.

Inspect ID: 2024-0042
Feature Details: Levee Embankments - Depressions / Rutting - Landside Slope
GPS Coordinates Start: 61.577013821613, -159.524250036967
GPS Coordinates End:
Caption: 0042 - Minimally Acceptable - Road access has caused minor lowering of the crest and lowering of side slopes.

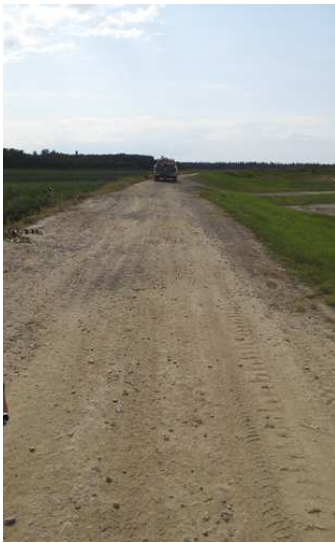
Inspect ID: 2024-0043
Feature Details: Levee Embankments - Depressions / Rutting - Crown
GPS Coordinates Start: 61.576661, -159.5245142
GPS Coordinates End:
Caption: 0043 - Minimally Acceptable - Minor depressions from vehicle traffic on crown.

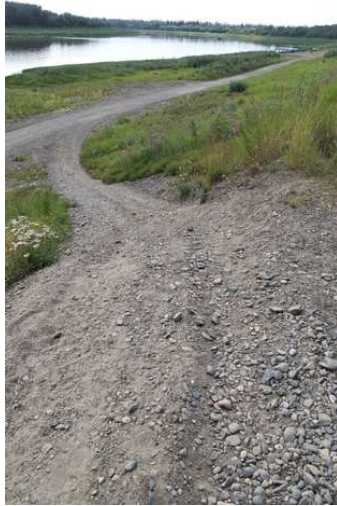
Inspect ID: 2024-0044

Caption: 0044 - Minimally Acceptable - ATV use along side slope causing minor rutting.

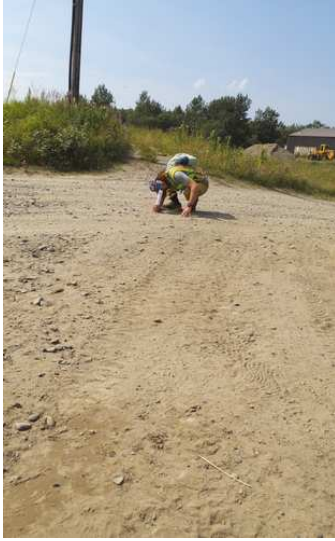
Inspect ID: 2024-0046

Caption: 0046 - Unacceptable - Road over levee has lowered crown almost a foot.

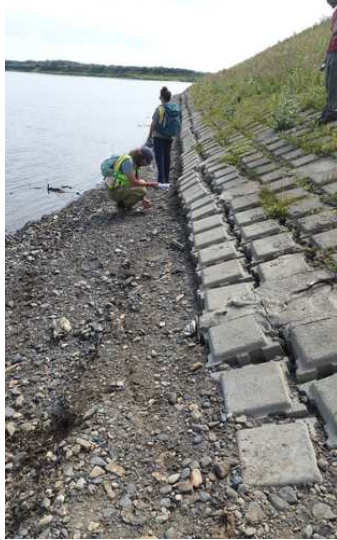
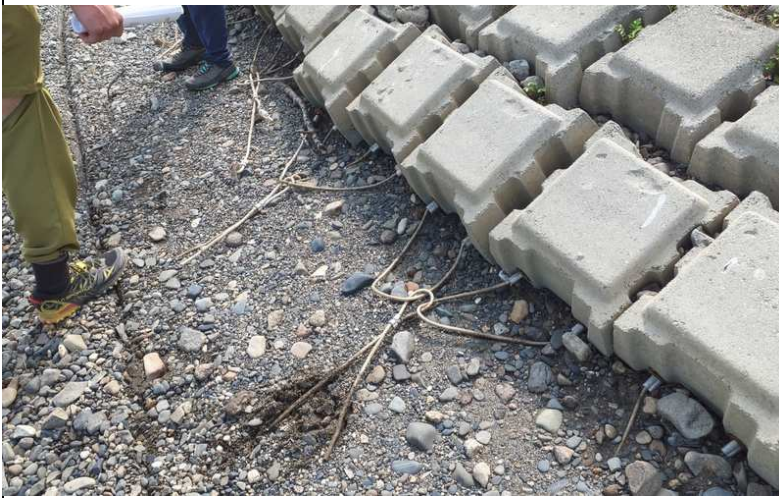
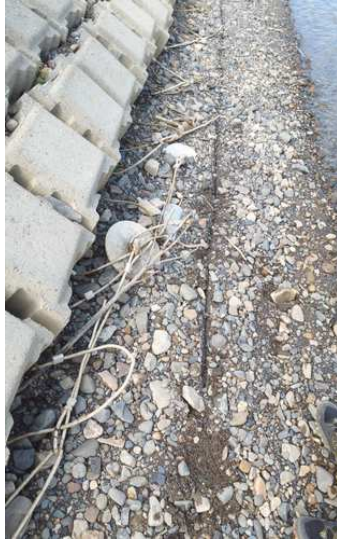
Inspect ID: 2024-0033

Caption: 0033 - Minimally Acceptable - Articulated concrete blocks (ACB) section is starting to erode at the toe. Anchors are exposed in sections.

- Articulated concrete mat has exposed ends and toe that should be covered. Some blocks are missing at the toe and need to be replaced.

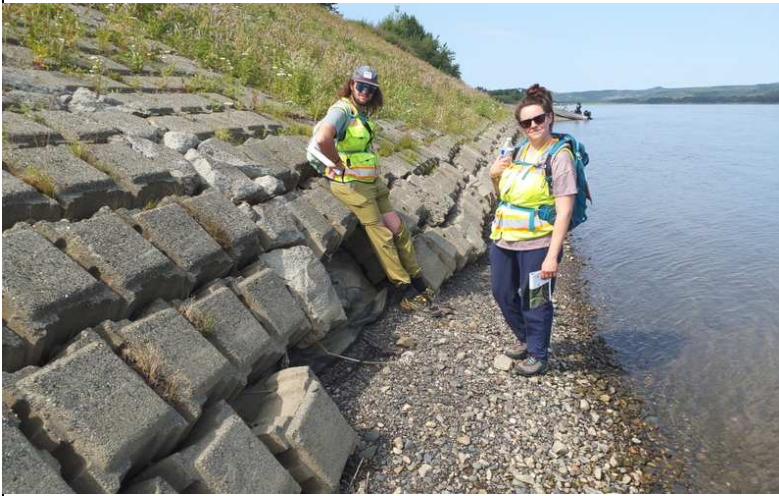
Inspect ID: 2024-0034

Caption: 0034 - Unacceptable - Missing concrete blocks at toe and missing anchors.
