FACILITY EVALUATION REPORT

ARKANSAS CITY, KANSAS

PARIS PARK POOL

**FACILITY EVALUATION REPORT
OF
PARIS PARK POOL
FOR THE CITY OF
ARKANSAS CITY, KANSAS
JUNE 8, 2021**

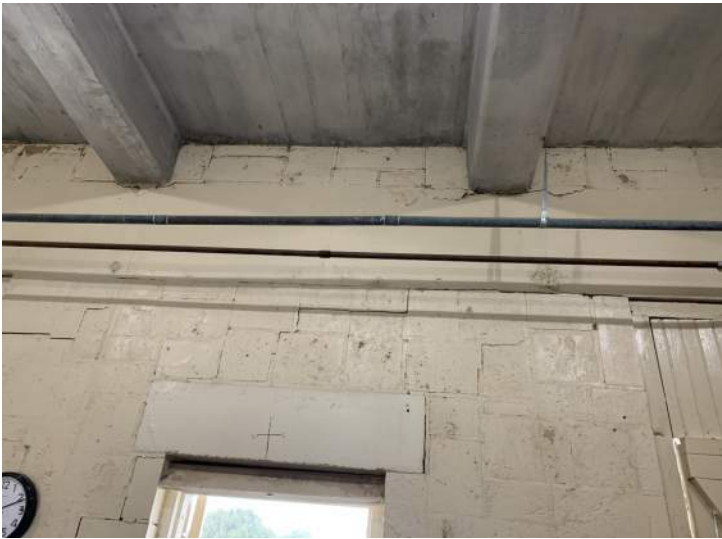
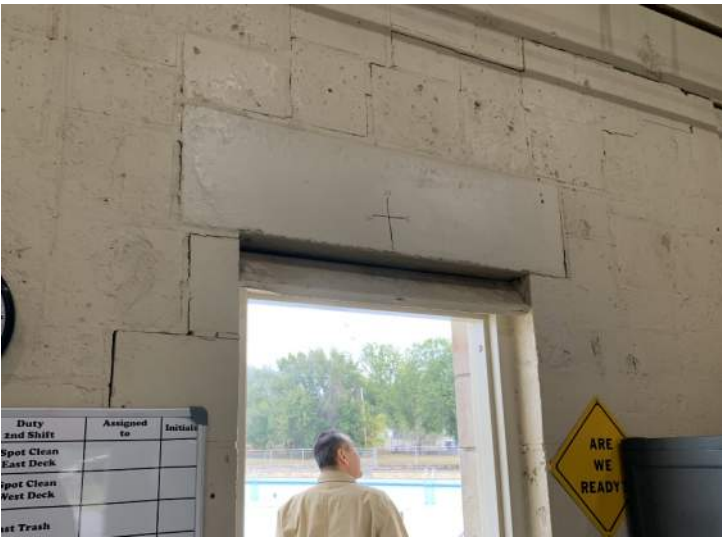
The bathhouse exhibits cracking in the masonry joints in numerous locations. The example to the left shows damage projecting from from the lintel at the doorway and damage around the connection points with the cast concrete roof structure. Note the displacement in the wall plane at the cracks. This damage reflects movement due to settlement. The damage may also have been exacerbated by past seismic activity or excessive wind damage. Water intrusion is also a factor as illustrated in photographs presented below.

This is a close-up of the lintel from the previous photo.

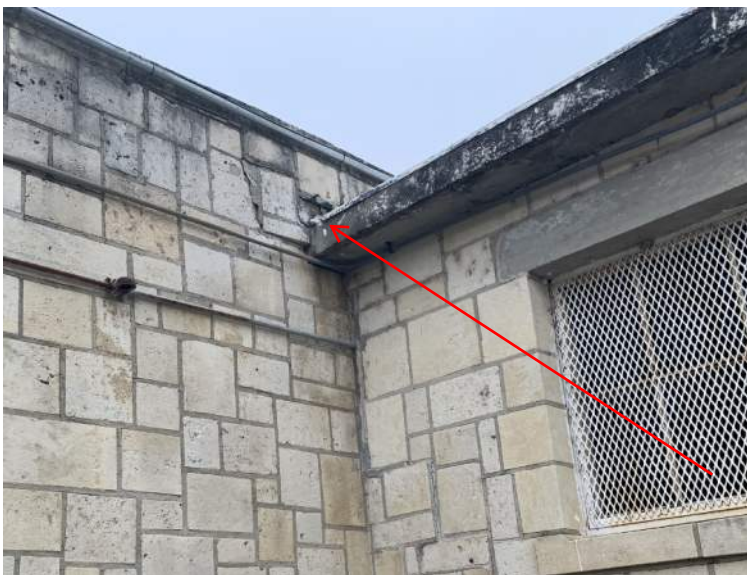
Another example of differential movement and rotation of the exterior wall, relative to the adjoining wall. This is in the southwest corner of men's changing area; wall on right is part of storage room on southwest corner.

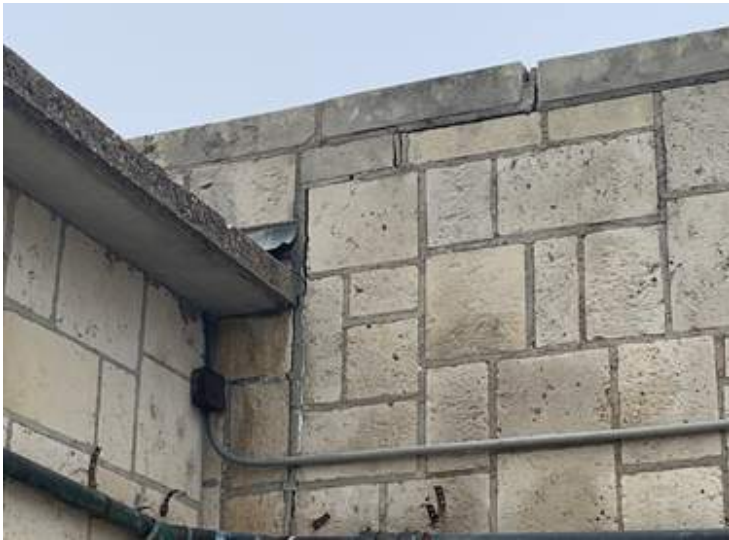
Damage due to settlement in the opposite (northeast) corner of the building from the previous photograph.

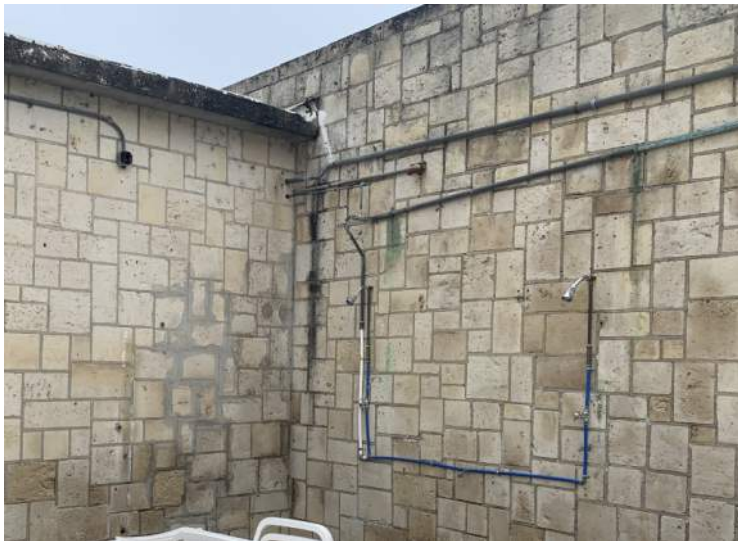
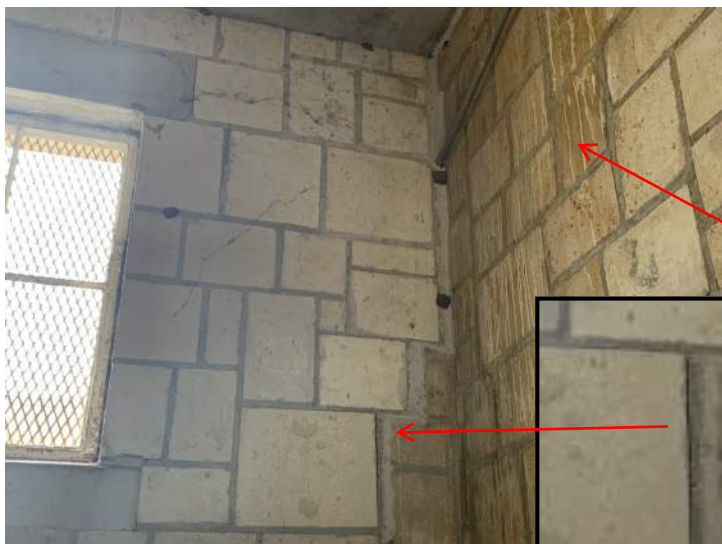
The next two photos show earlier tuck point repairs in the masonry joints to address cracking due to settlement.

Note a gap has opened up since the tuck point repair indicating continued movement in the structure. This is in the storage room on southwest corner of building.

Streaking from water leakage is also evident on this wall.

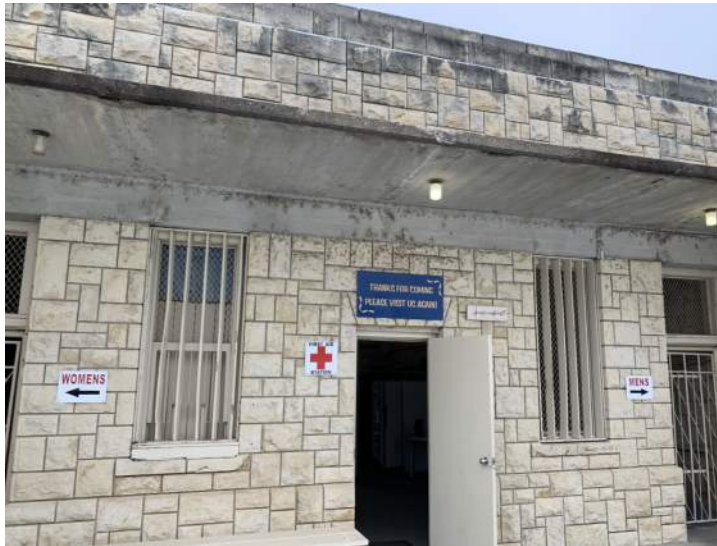
The concrete slab overhang shows cracking and distress most likely from water intrusion due to poor drainage. The dark patches along the the bottom side where the slab meets the wall may indicate mildew and potentially spalling of concrete. The slab exhibits lateral cracks extending through the width of the overhang.

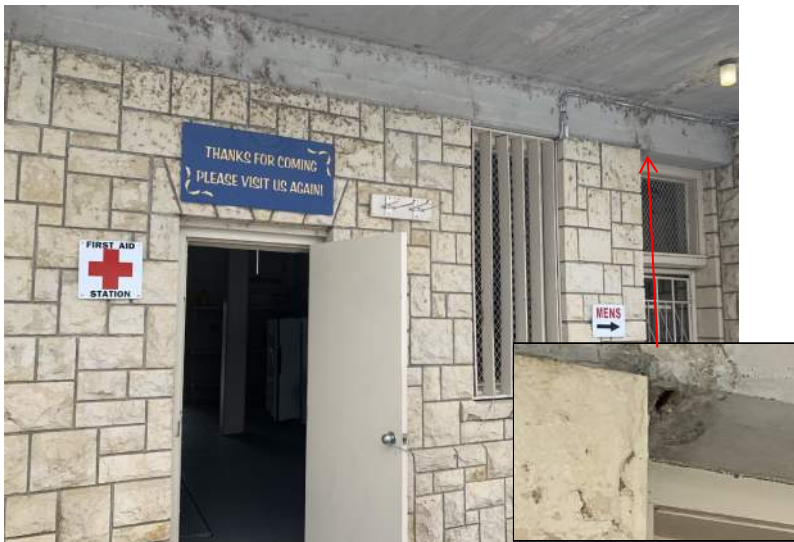
The most severe damage observed in this overhang is shown in the photo inset. Water intrusion has corroded the reinforcement causing the concrete to spall on the bottom of the member.

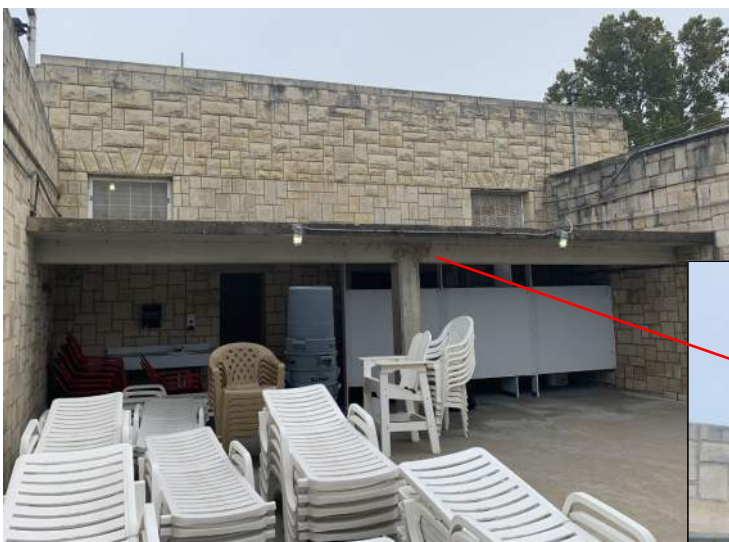
The roof overhang in the men's changing area show deterioration. Note the damage at the top of the center column and the cracking, spalling, and exposed reinforcement along the edge of slab.

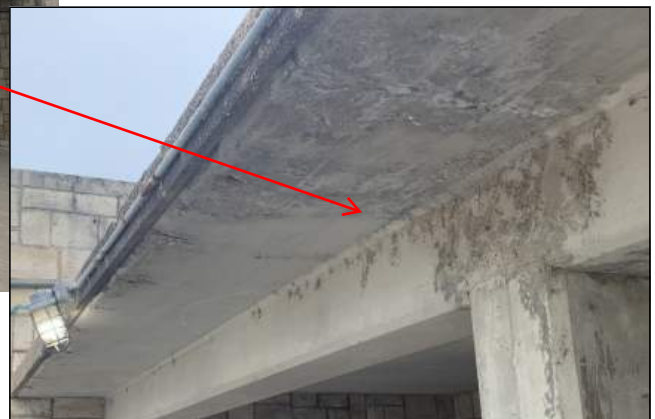
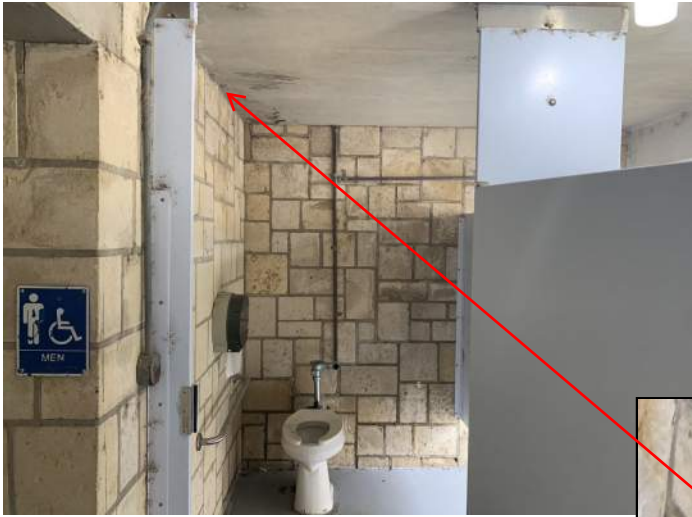
These photos were taken underneath the men's overhang where the roof meets wall. Note that water intrusion has caused delamination in the corner of the ceiling and in the lintel above the door. Cracking and efflorescence is also apparent in the bottom of slab. All of this damage is most likely contributable to poor drainage on the slab and lack of a sealing membrane layer on the top of concrete.

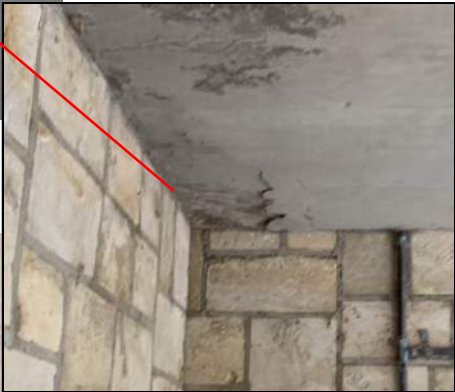
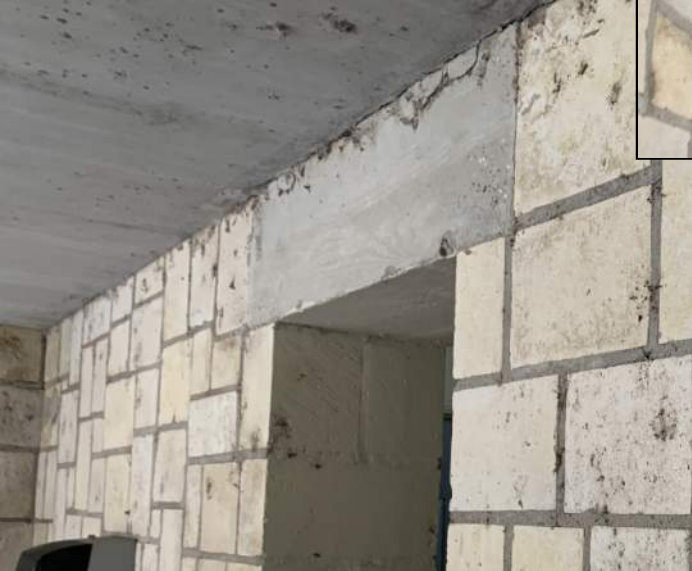
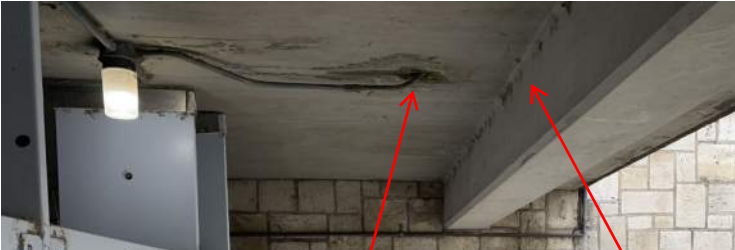
Also note the signs of water intrusion in the men's overhang. Note the efflorescence and mold around the electrical conduit penetration and the distress/discoloration in where the slab meets the beam.

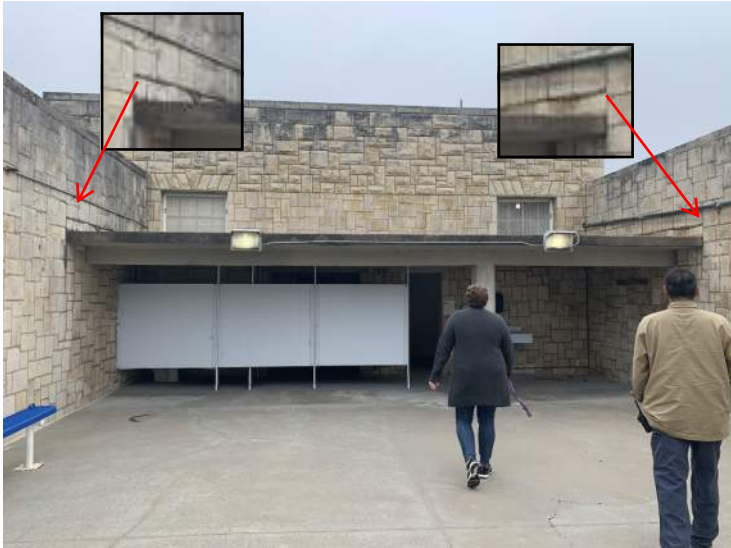
The women's side overhang does not exhibit the same water damage as the men's side. However, This photo reveals what appears to be remains of flashing in the mortar joint immediately above the overhang. It also appears there may be lateral displacement in the wall face at that joint. The flashing could have created a weak plane at the joint and make the course just below it susceptible to movement at the concrete slab joint. That movement could have resulted from wind against the wall, thermal expansion/contraction of the roof slab, and/or seismic movement.

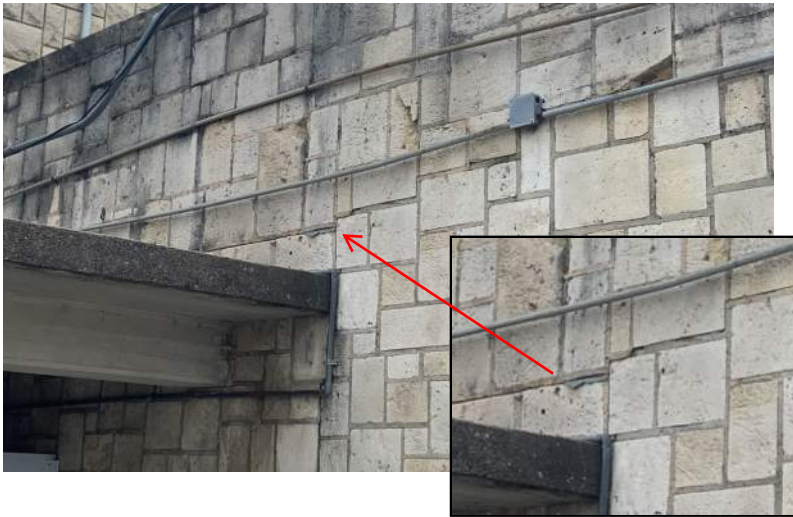
A remnant of what appears to be old flashing is also seen on the men's side. A crack extends in the mortar joint away from this line, indicating a point of weakness in the wall. It also suggests the original roof system was replaced by the current roof.

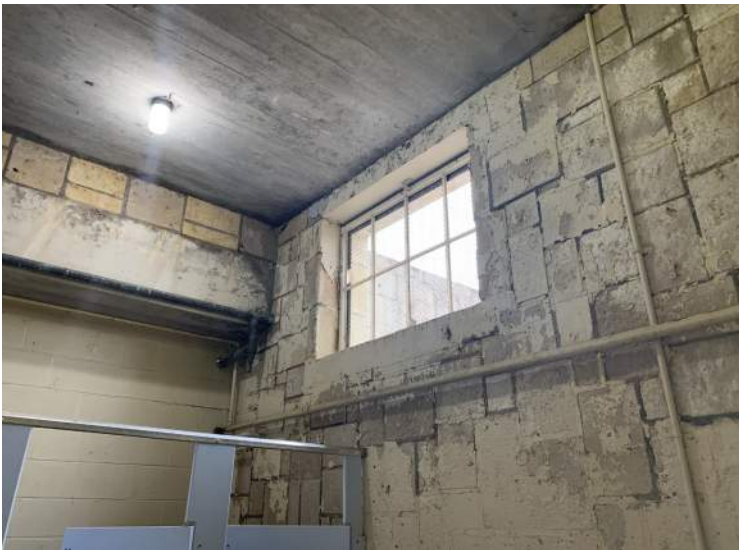
Deterioration from moisture intrusion is also evident in a number of locations. This is exhibited by the dark color of the mortar and the peeling paint.

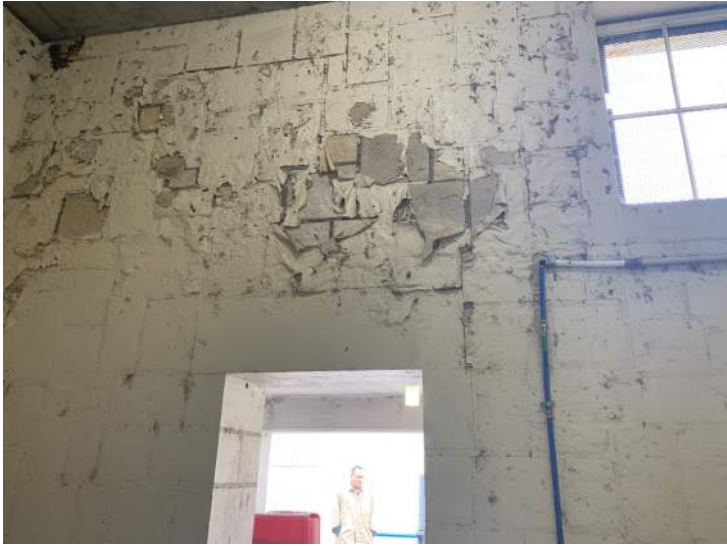
The type of paint applied has likely exacerbated the problem by trapping moisture in the block behind the paint. Again, the results of such intrusion are evident in peeling paint and discolored mortar.q

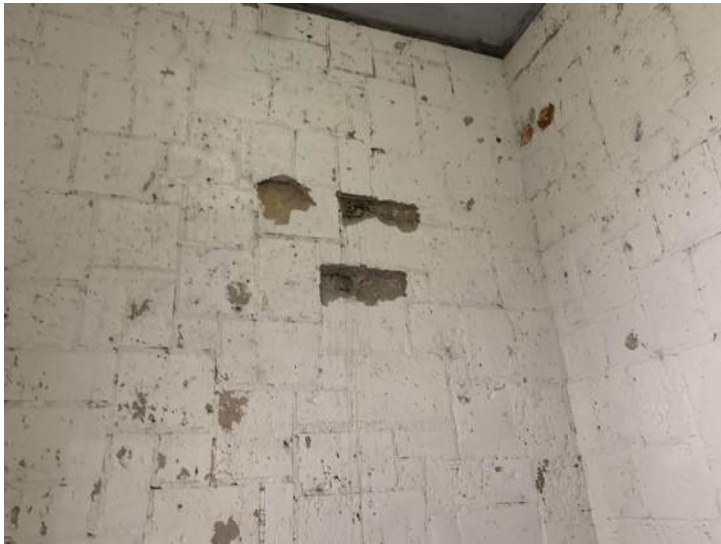
These conditions can also cause deterioration and delamination of the rock itself.wt

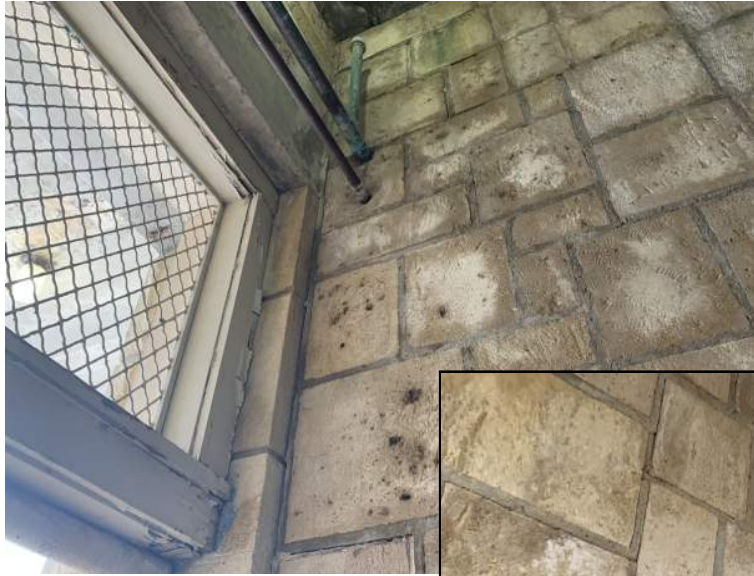
The casework around window openings and door frames needs attention. The age and environmental conditions have resulted in what appears to be some degree of wood rot.

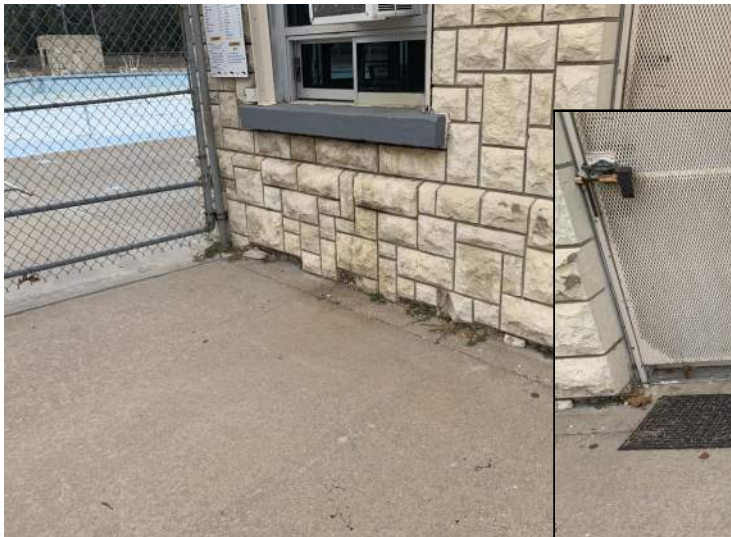
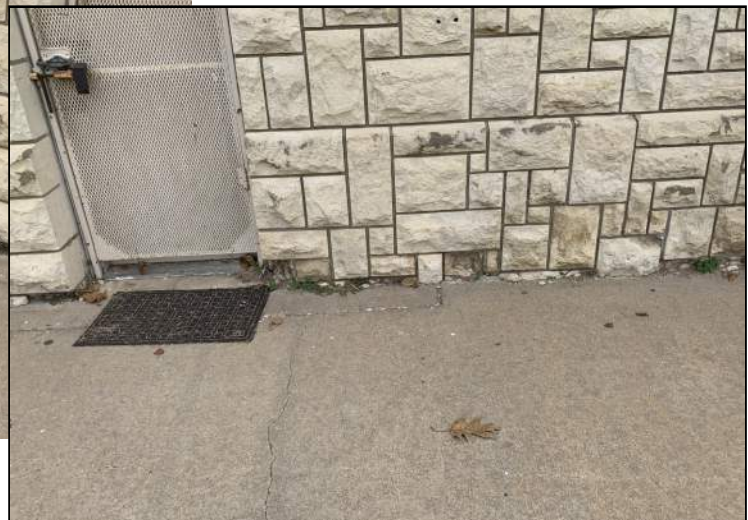
The bottom photos show deterioration in the bottom course of stone on the west end of the building. This condition is not observed elsewhere. This is attributed to poor drainage on the deck adjacent to the wall. The theory is water drains toward the wall, seeps into the stone, and--most likely due to freeze/thaw--has caused the rock to slowly disintegrate.

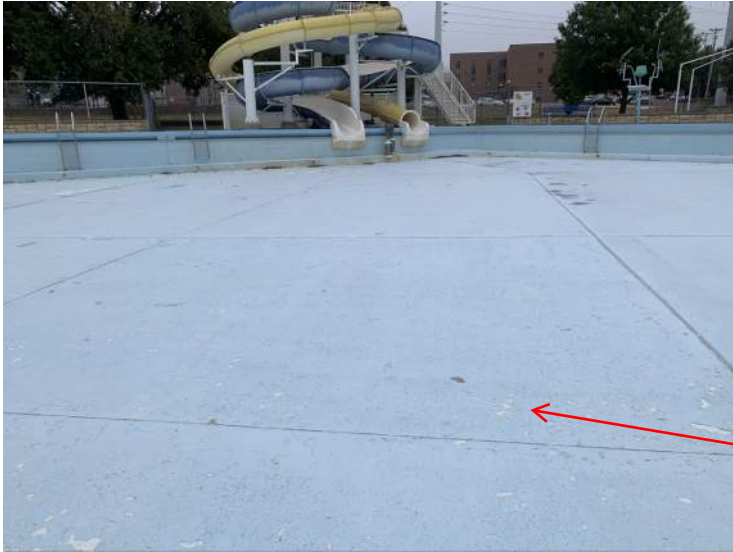
The floor built in 2002 is acceptable condition. No significant damage was observed around joints. A few cracks were observed in some of the slabs. The painted surface is in poor condition, exhibiting significant peeling.

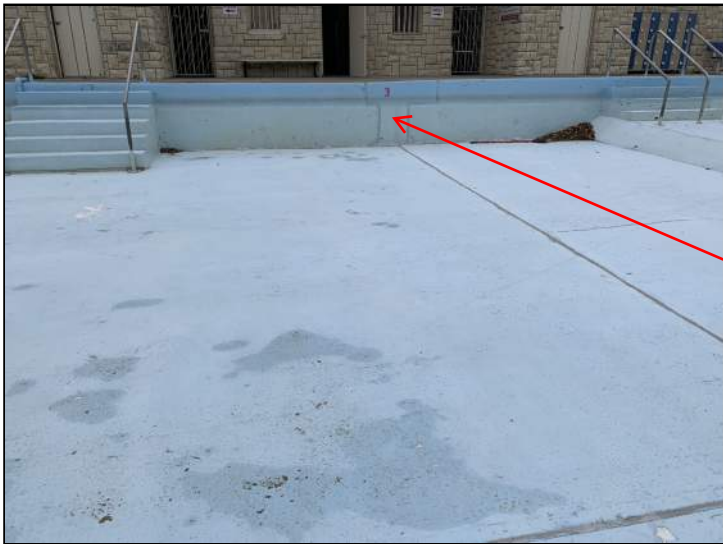
Note a patch made in the wall, presumably to replace piping.

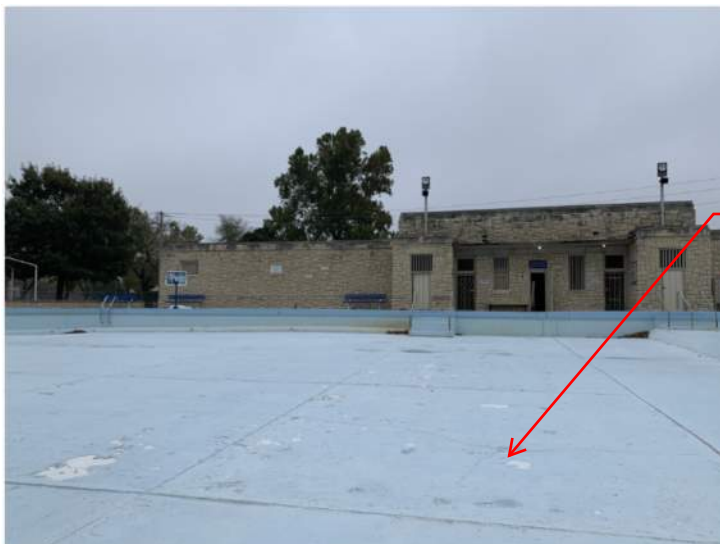
Note cracking in slab

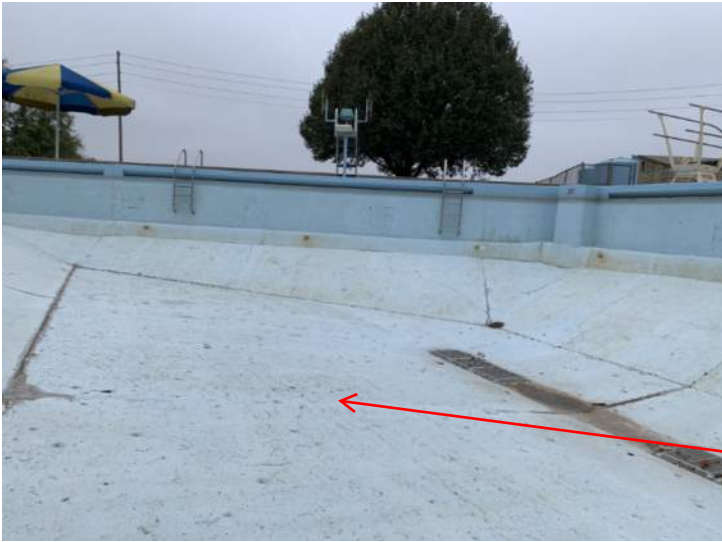
The dive well is in poor condition. The painted surface is deteriorated like the rest of the pool, but the paint may also be revealing deterioration cracking from the underneath concrete, as shown in the close-up below.

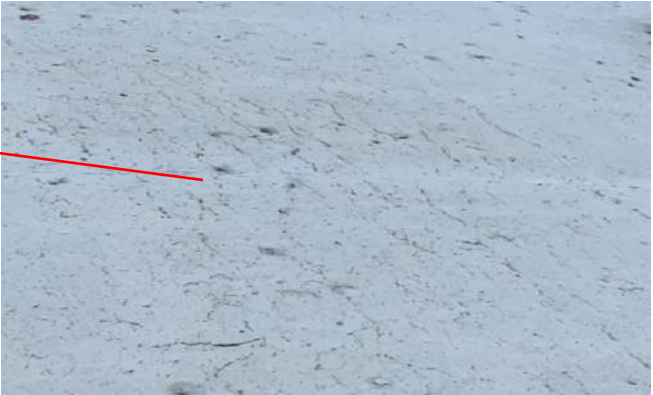
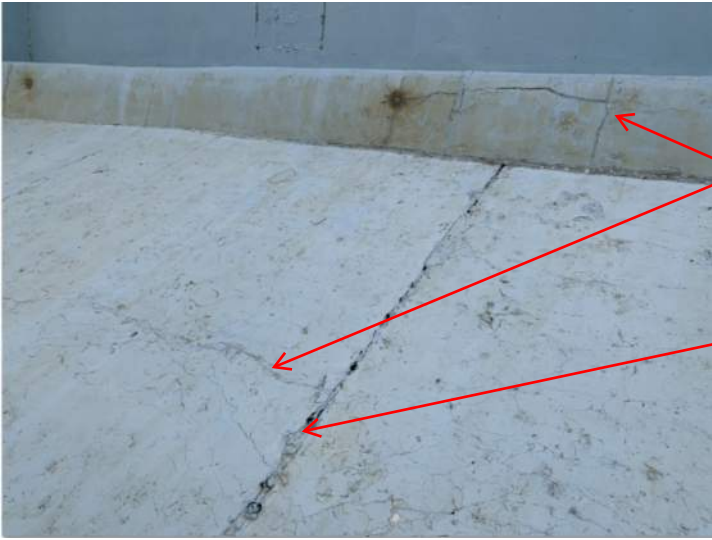
Extensive cracking

Damaged joints

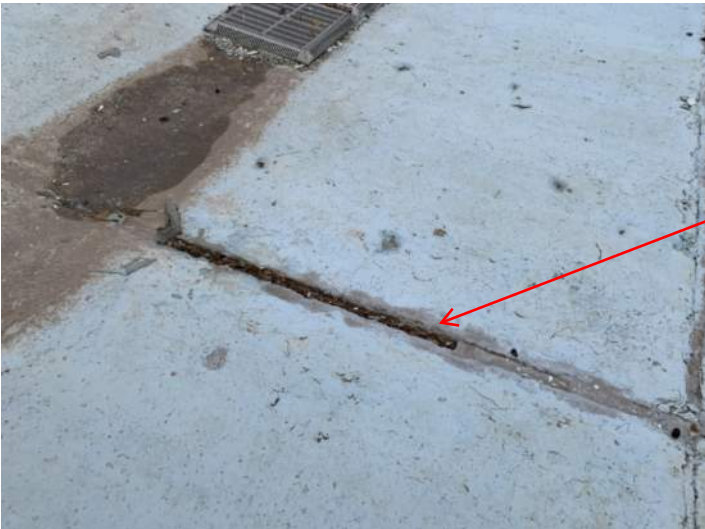
Damaged joint in dive well floor, representative of several locations. Note that the caulking has been removed. Reportedly, ground water intrudes at these joints during time of high groundwater when the pool is empty. This is a source of leakage when the pool is full.

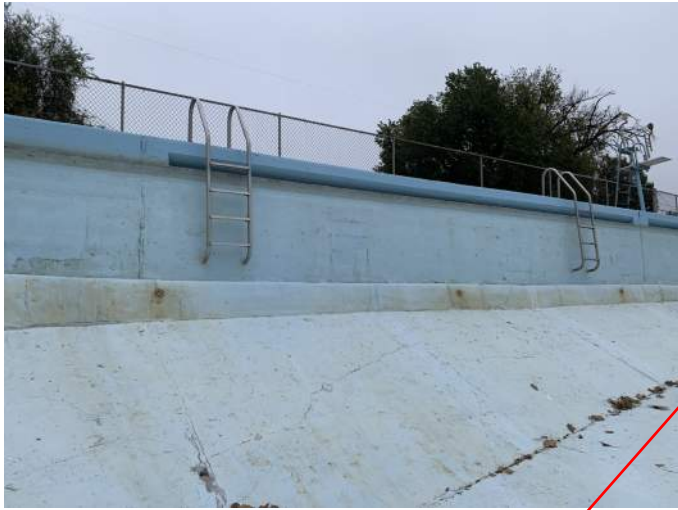
Pool walls and gutter appear in fair condition, given the age. There are numerous patches observed in the walls, presumably from filling in old light niches and wall returns. Note the supply piping encased in concrete at the base of wall. Typically, this is a re-model solution for replacing the return (supply) piping while minimizing impact to the existing pool

Missing diffuser will cause imbalance in return line and impact distribution of treated water in the pool.

Cracking in dive well wall suggests water penetration.

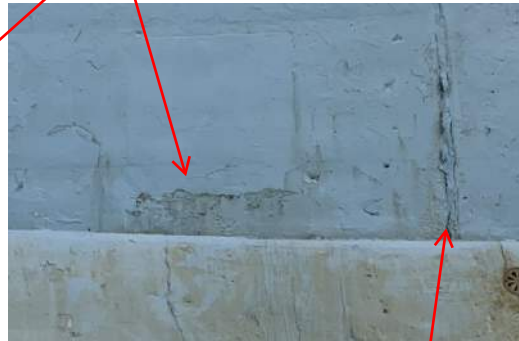
Appearance of joint suggests movement in the wall system.

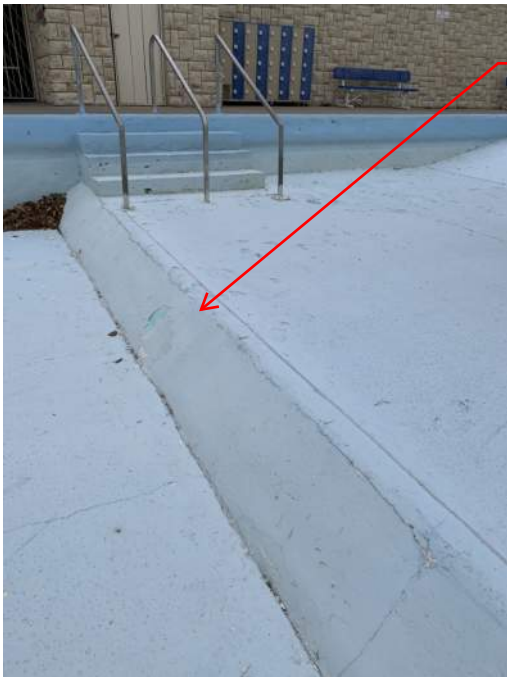
Severe drop-off is dangerous for non-swimmers. Modern code does not allow slopes greater than 8% (1:12) slopes in shallow (<5 feet) depth.

The first priority is addressing issues of life safety and liability. Two issues were noted. First, the dive well geometry does not appear to meet current code. Second, there is a significant drop off at the edge of the beach area. Before any action is taken on the dive well, a board should be installed and accurate measurements of the dive well envelope should be made to verify if this is a problem. Assuming the dive well is too shallow, then the dive boards should be taken out of service.

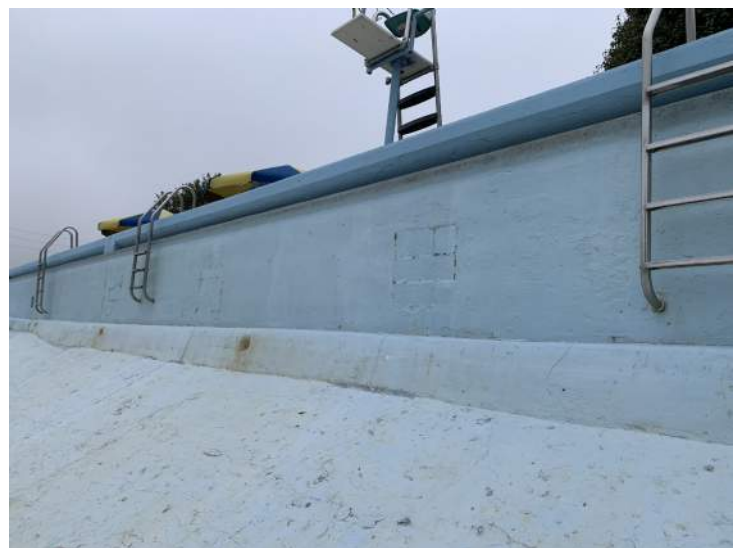
Slope appears to be about 12% (1:8) which is steeper than allowed by current codes. Code allows 8% (1:12) in water 5 feet or less deep.

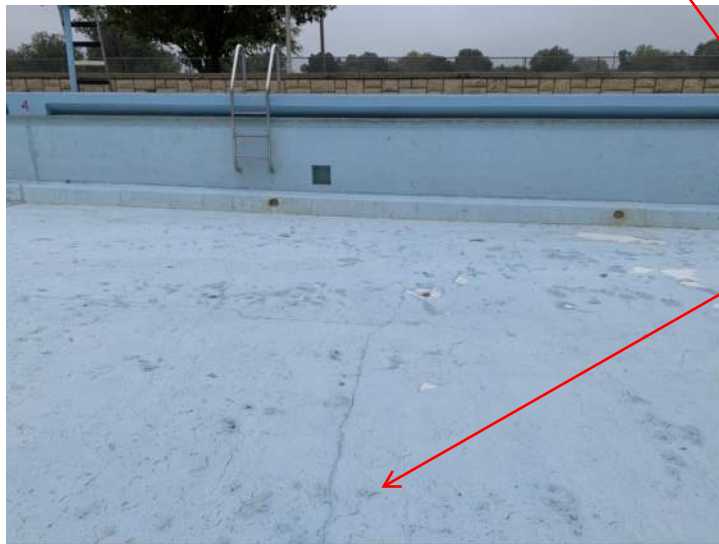
Note cracking in 18-year old deck

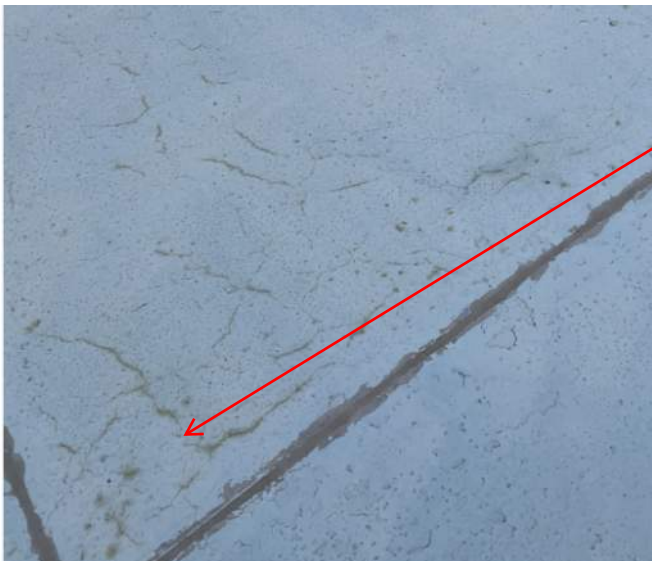
Deterioration cracking forming around joints. This indicates damage from freeze-thaw. Water penetrates joint and adjacent concrete in winter and cracking occurs when water freezes. This was observed in 18-year old floor slab.

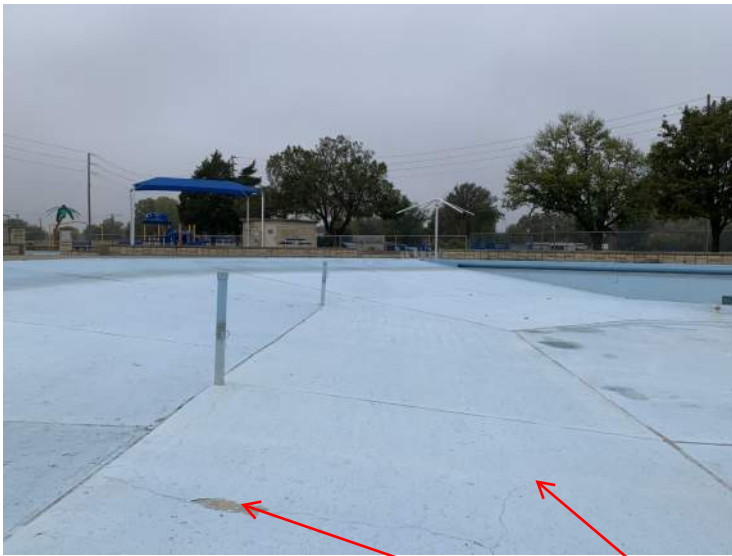
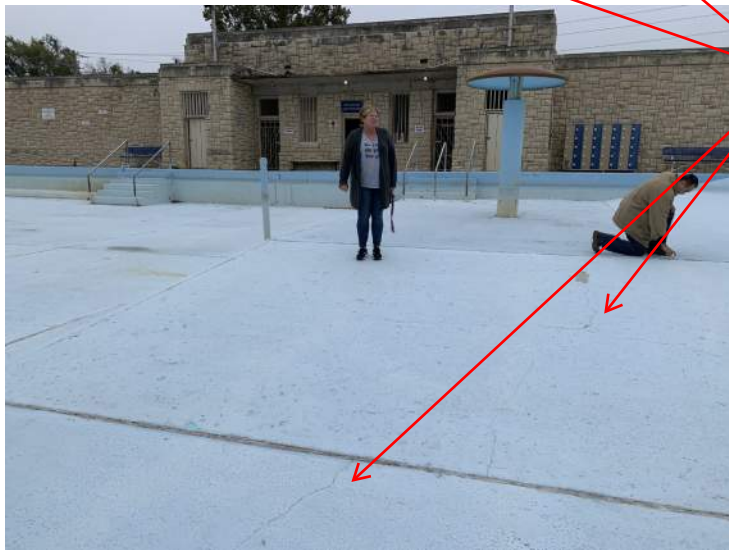
Note cracking and delamination in 36-year old beach slab.

Note cracking and delamination in 36-year old beach slab. Cracks likely formed at time of construction, but appear have gotten progressively wider with time.

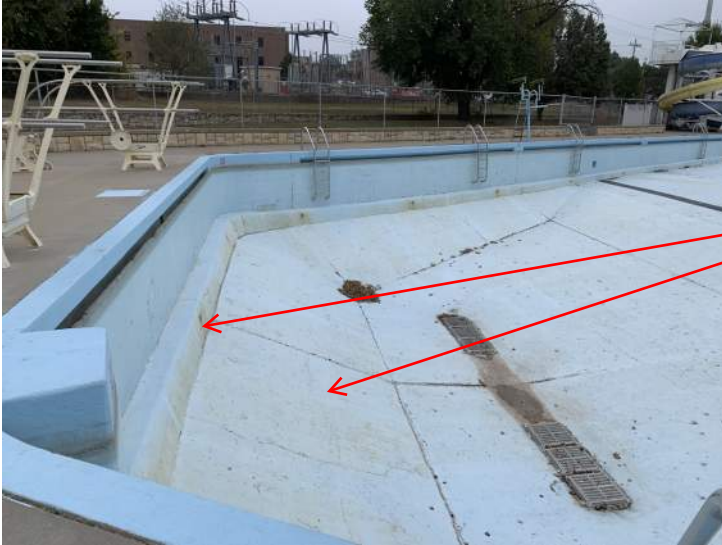
The dive well does not meet modern codes for dive envelope geometry. The depth at plummet (end of board) and the depth at backwall of dive well may not meet current code. This is a liability and life safety issue. Detailed measurements, with the dive board in place, are necessary to precisely assess this condition.

Depth at plummet (end of board) and depth at backwall of dive well may not meet current code. This is a liability and life safety issue.

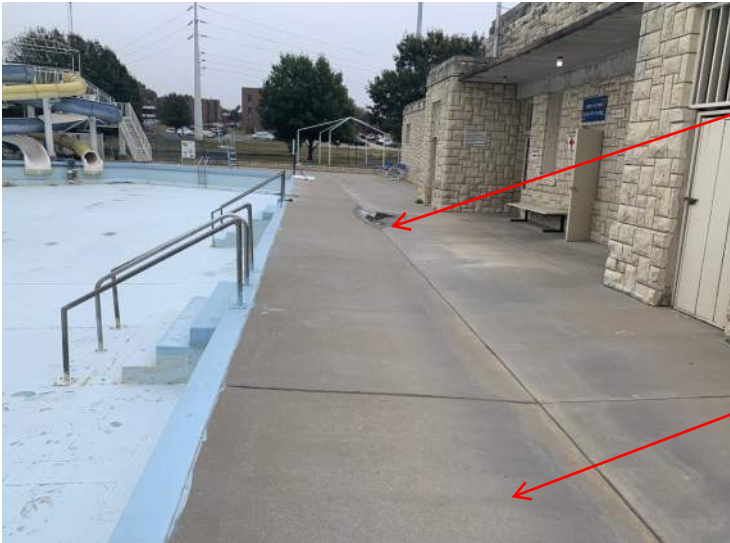
Ponding water is a concern when the facility is in operation.

Pool deck is in generally good condition.

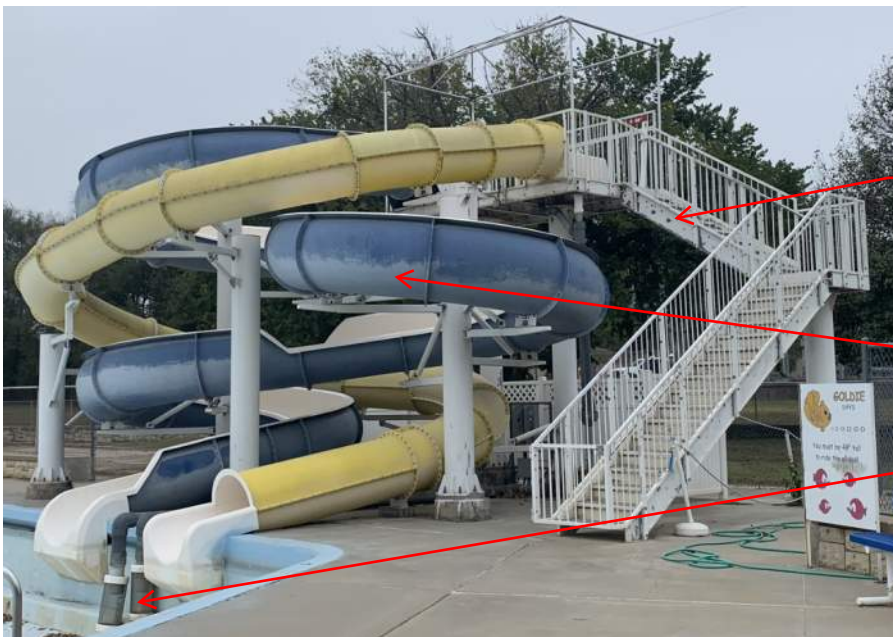
Water slide tower and stairs appear in acceptable condition. Some peeling paint is apparent. No significant rust was observed.

19-year old water slide is need of polishing, if not a new gel coat.

Intakes appear to be unblockable by VGB criteria

A close examination of the water slide was not conducted. But given the age (19 years) and overall appearance of the fiberglass and steel tower, some maintenance is warranted. As a minimum, the fiberglass should be polished. Any significant damage that poses a safety hazard, especially in the ride path, should be repaired. A fiberglass specialist should be consulted about whether a new gel coat is needed. Also, a closer examination of the steel structure to assess the presence of rust and sharp edges, especially on handrails and stair treads and platform, should be conducted. These measures are needed to extend the useful life of the water slides.

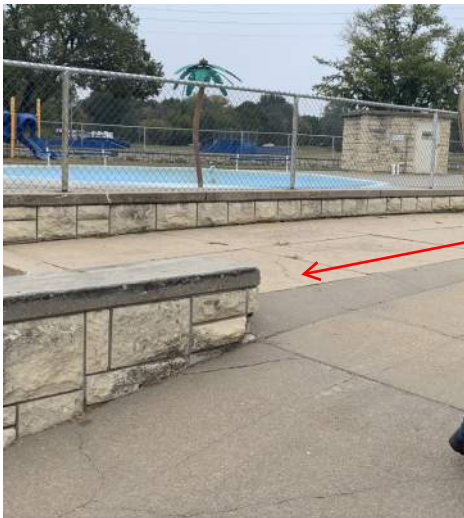
Some cracking was observed in parts of the deck, but there does not appear to be any significant vertical displacement

Perimeter fence is less than 6' tall.

Playground equipment appears to be newer and in good repair

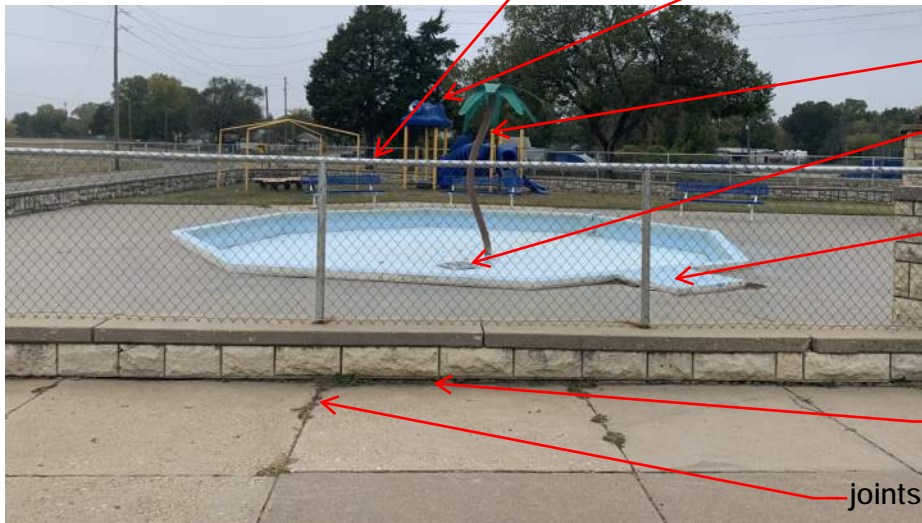
spray element installed in 2002

Single domed stainless steel grate.

appears to be poor drainage adjacent to wall.

joints need cleaning to remove weeds

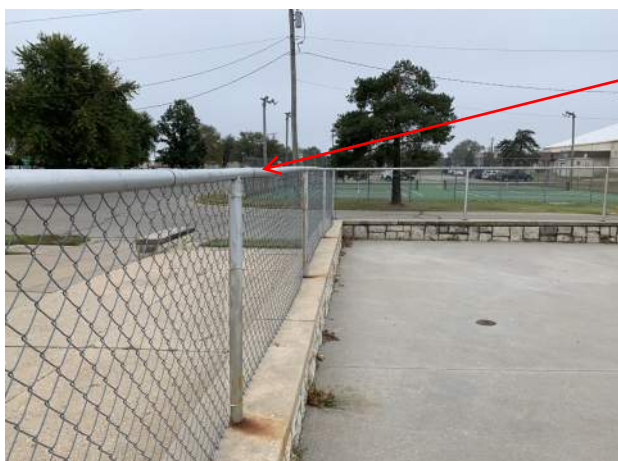
Fence enclosure is less than 6' near the concessions window and tot pool

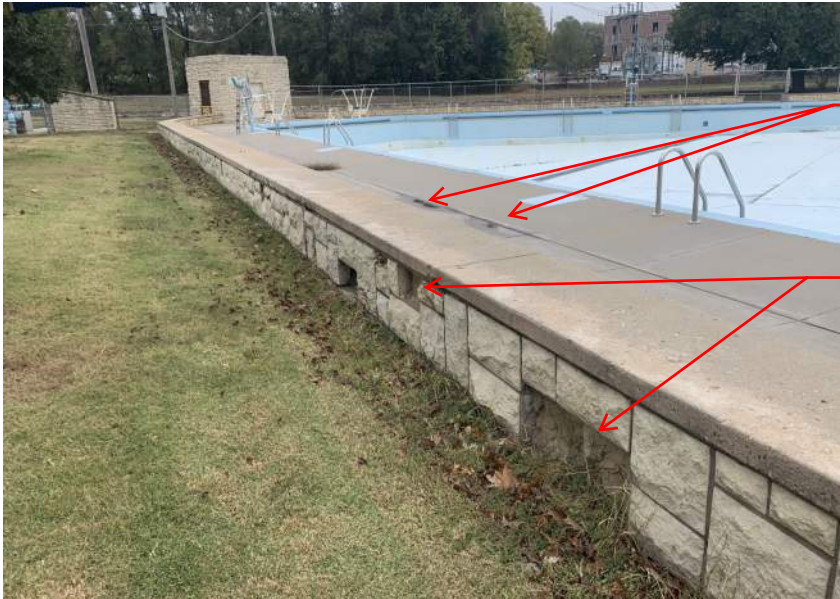
Standing water is a concern when the facility is in operation.

Deteriorated rock masonry due to water intrusion and subsequent freeze/thaw damage.

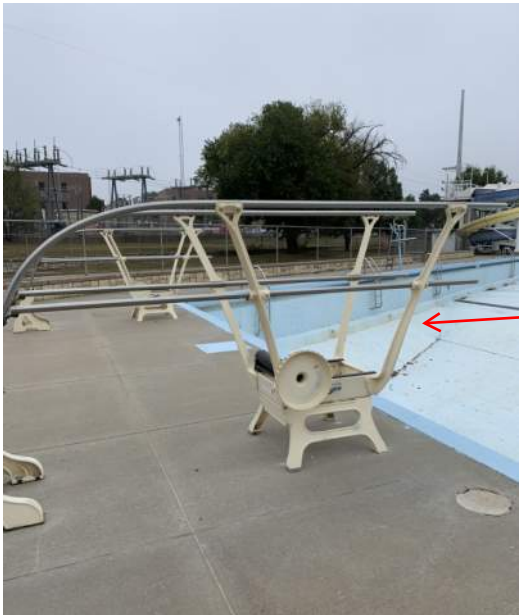
Dive stands appear in good condition

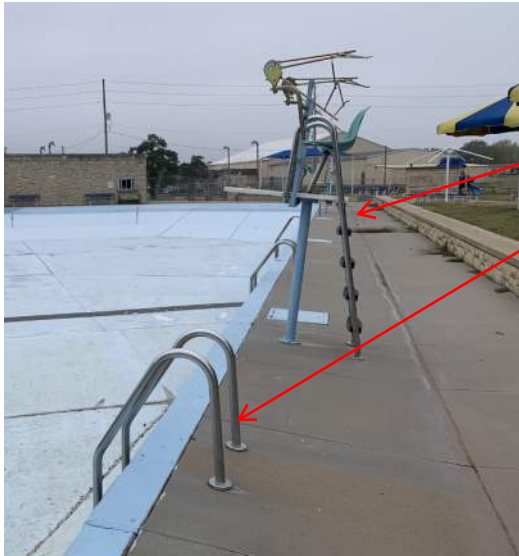
Life guard chairs and ladders appear in good condition
