WILSON PARK
 Summit St. & Birch St.
 Fall 2006

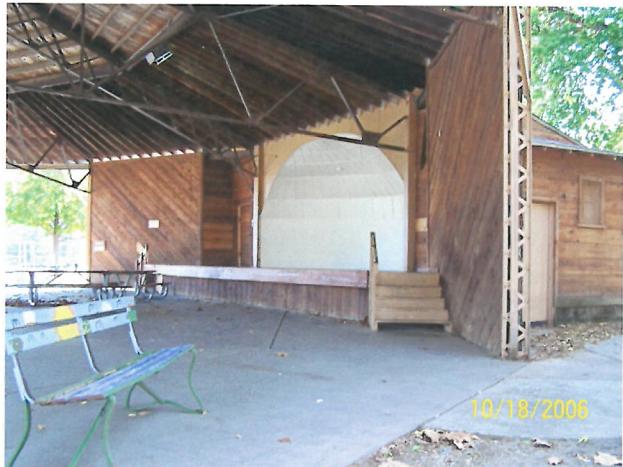
The shelter's amphitheater/stage is not accessible.

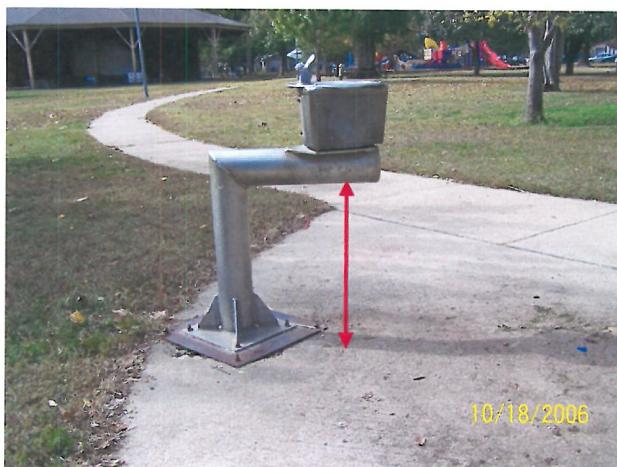
This drinking fountain does not have adequate knee clearance.

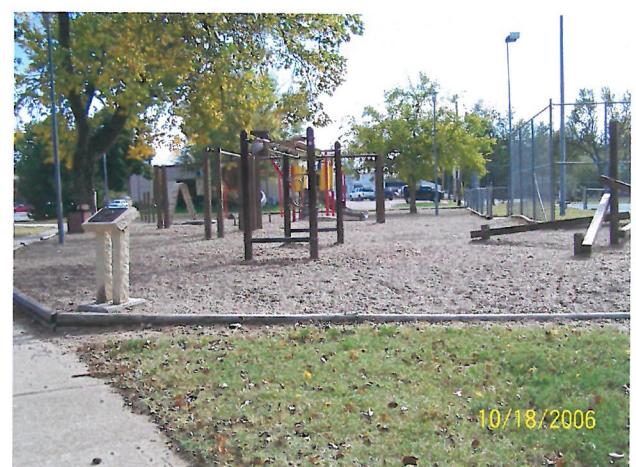
The playgrounds are not on an accessible route and lack accessible components.

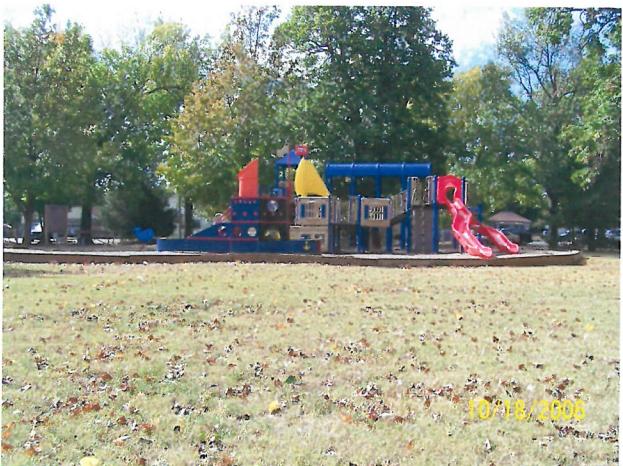
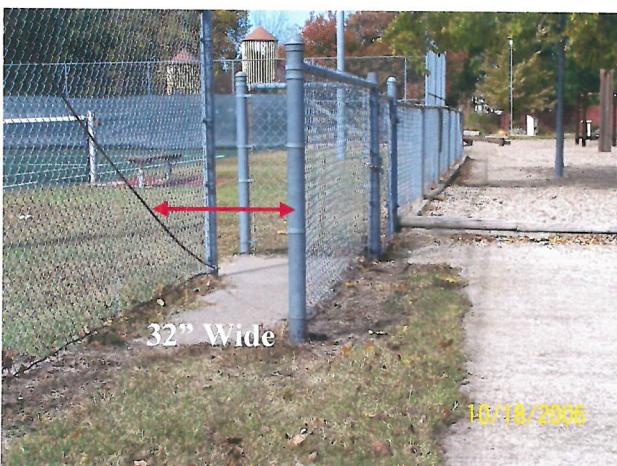
These routes to tennis court entrances are too narrow.

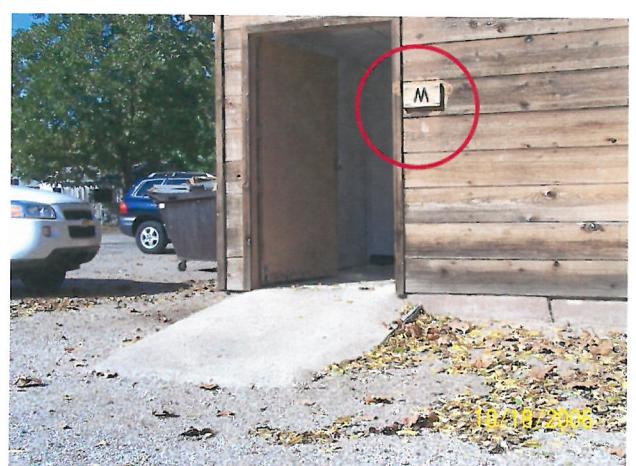
This ramp at the men's restroom is too steep, lacks edge protection, handrails and slopes to the doorway. The sign is mounted too high and is not in an accessible format.

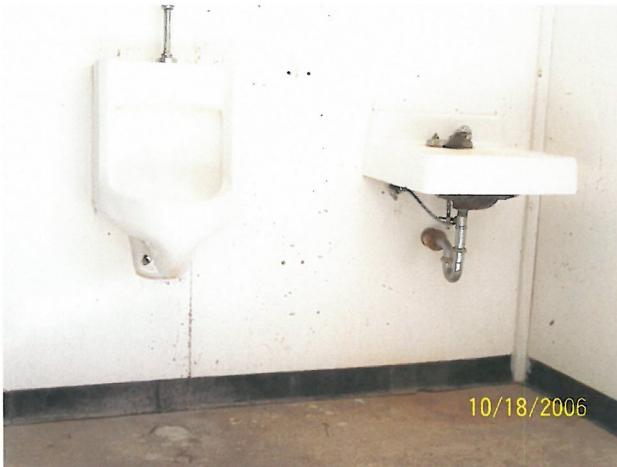
There is enough wall space in the men's restroom to widen the toilet stall. The urinal rim is too high and the lavatory has round faucet controls and exposed drain pipes.

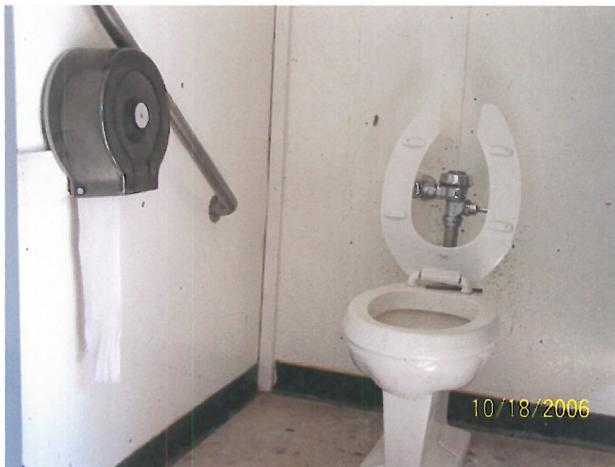
Toilet stalls are too narrow and have improper grab placements and lack bars on rear walls.

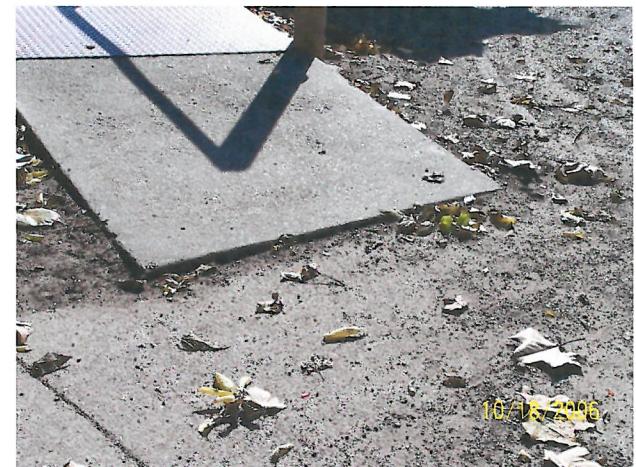
The women's restroom ramp has an excessive threshold.

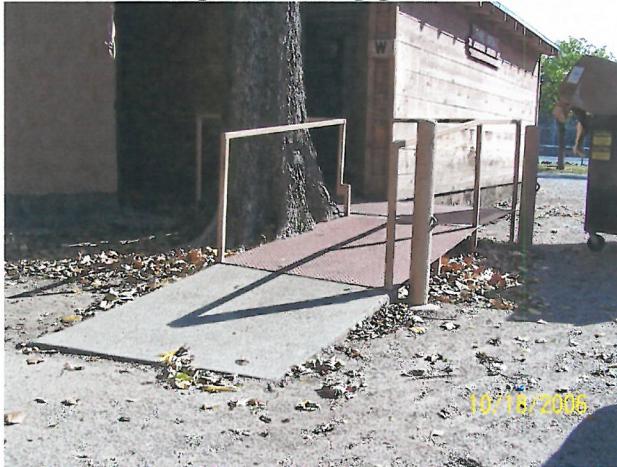
This ramp at the women's restroom is too steep, lacks adequate handrails and edge protection.

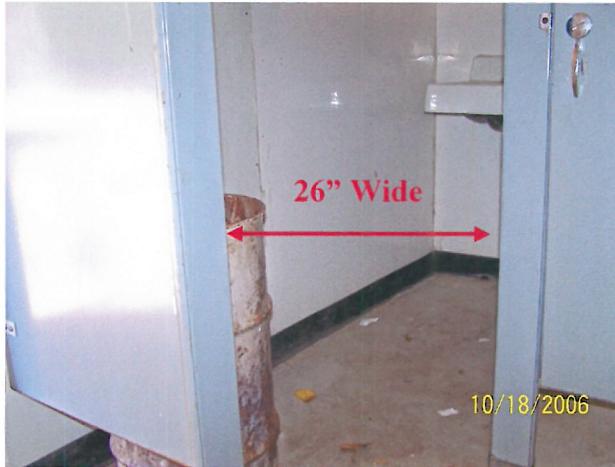
The route to the lavatory in the women's restroom is too narrow.
