SITE OBSERVATION REPORT

REPORT #: 001

DATE: 8/11/2023

PROJECT TITLE: Augusta Municipal Building Leak Investigation **JOB #:** PZL233

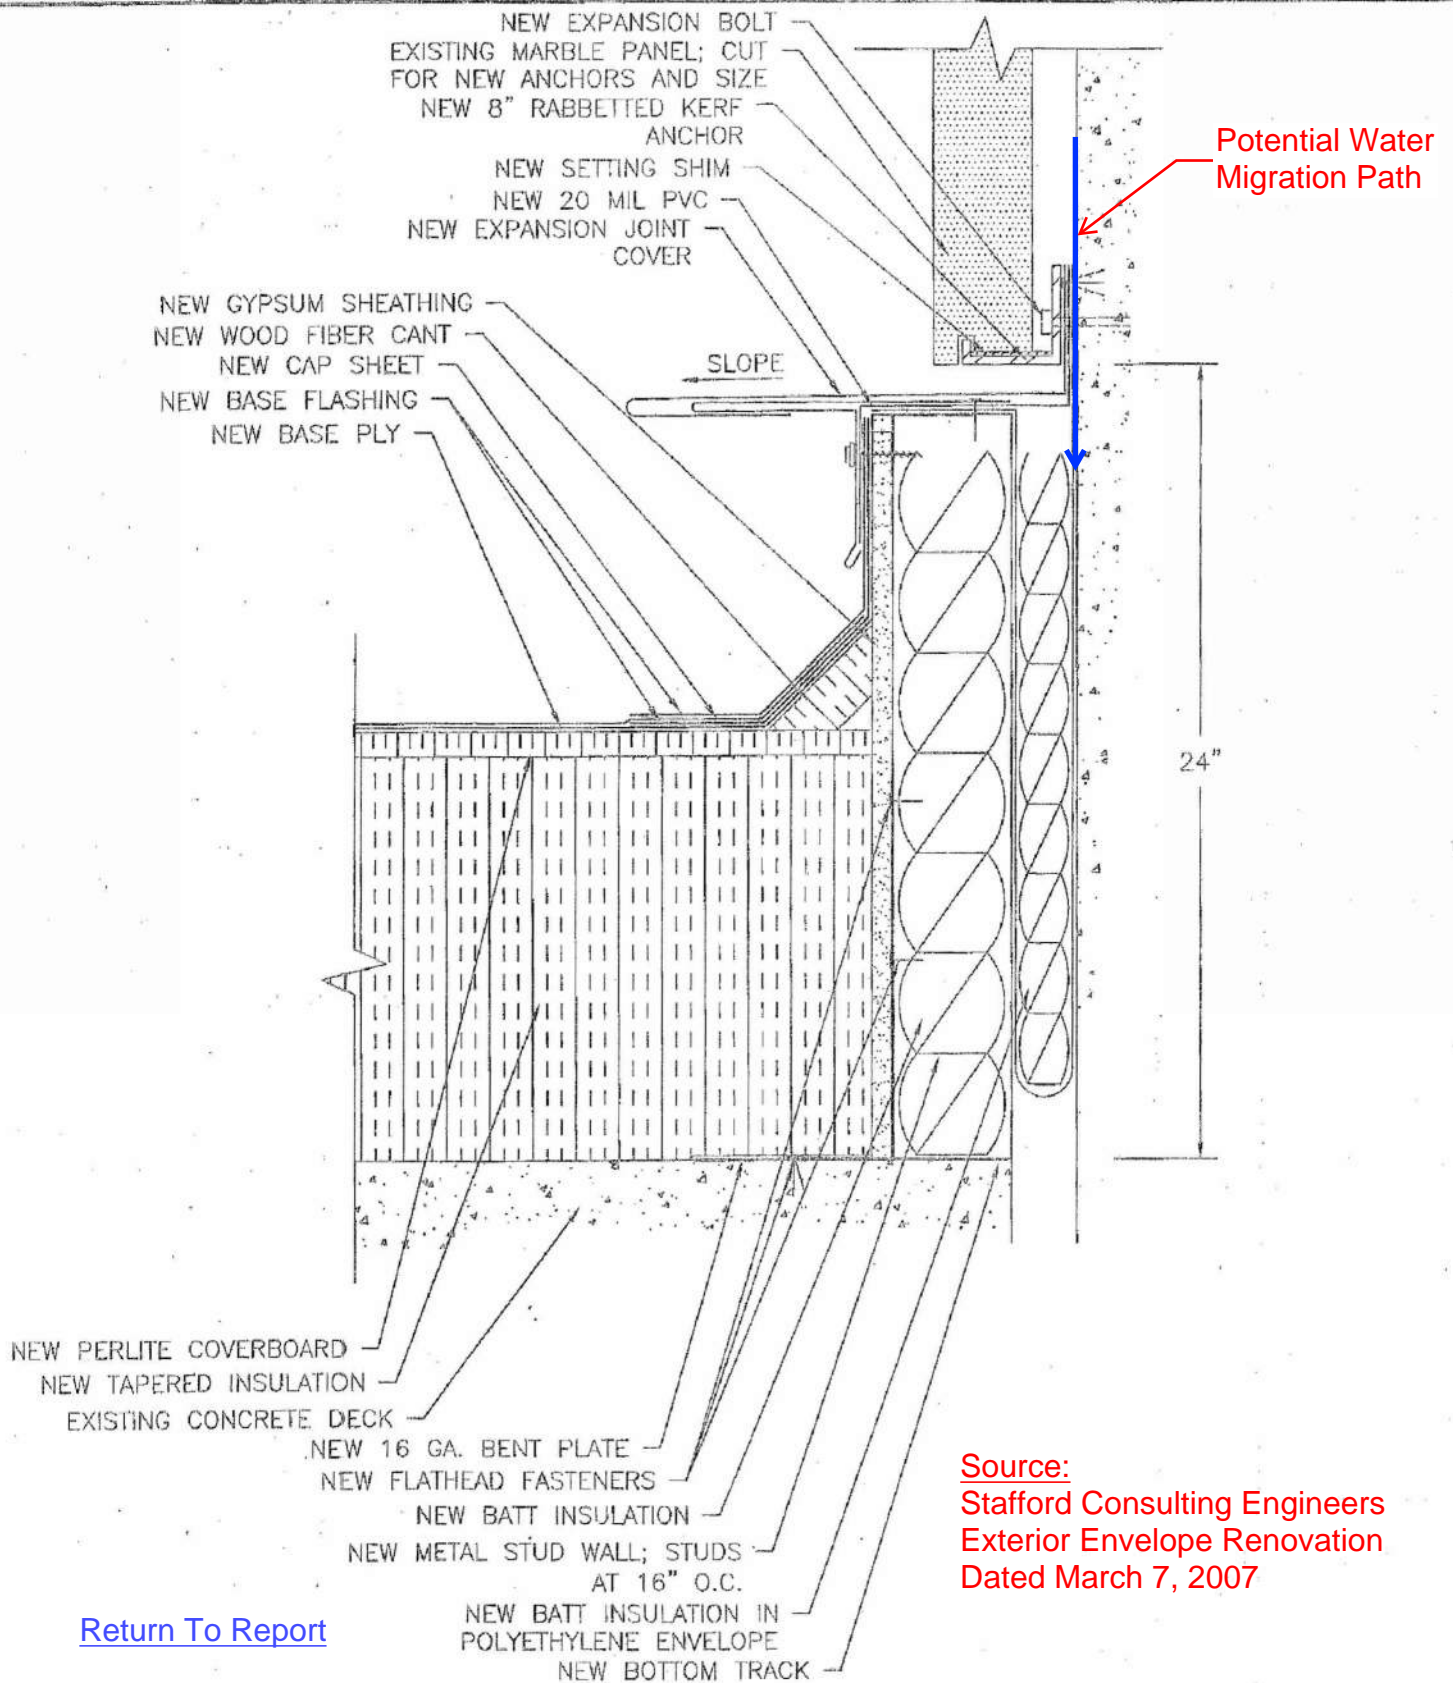
ATTACHMENT B

4. After the site visit, the City provided background drawings to JLA on August 3rd, 2023 that contained information on an Exterior Envelope Renovation project by Stafford Consulting Engineers, dated March 7, 2007. These background drawings contained a renovation detail that defined the building components at this expansion joint location that may indicate a potential leak path as noted ([Attachment B](#)).

Source:
 Stafford Consulting Engineers
 Exterior Envelope Renovation
 Dated March 7, 2007

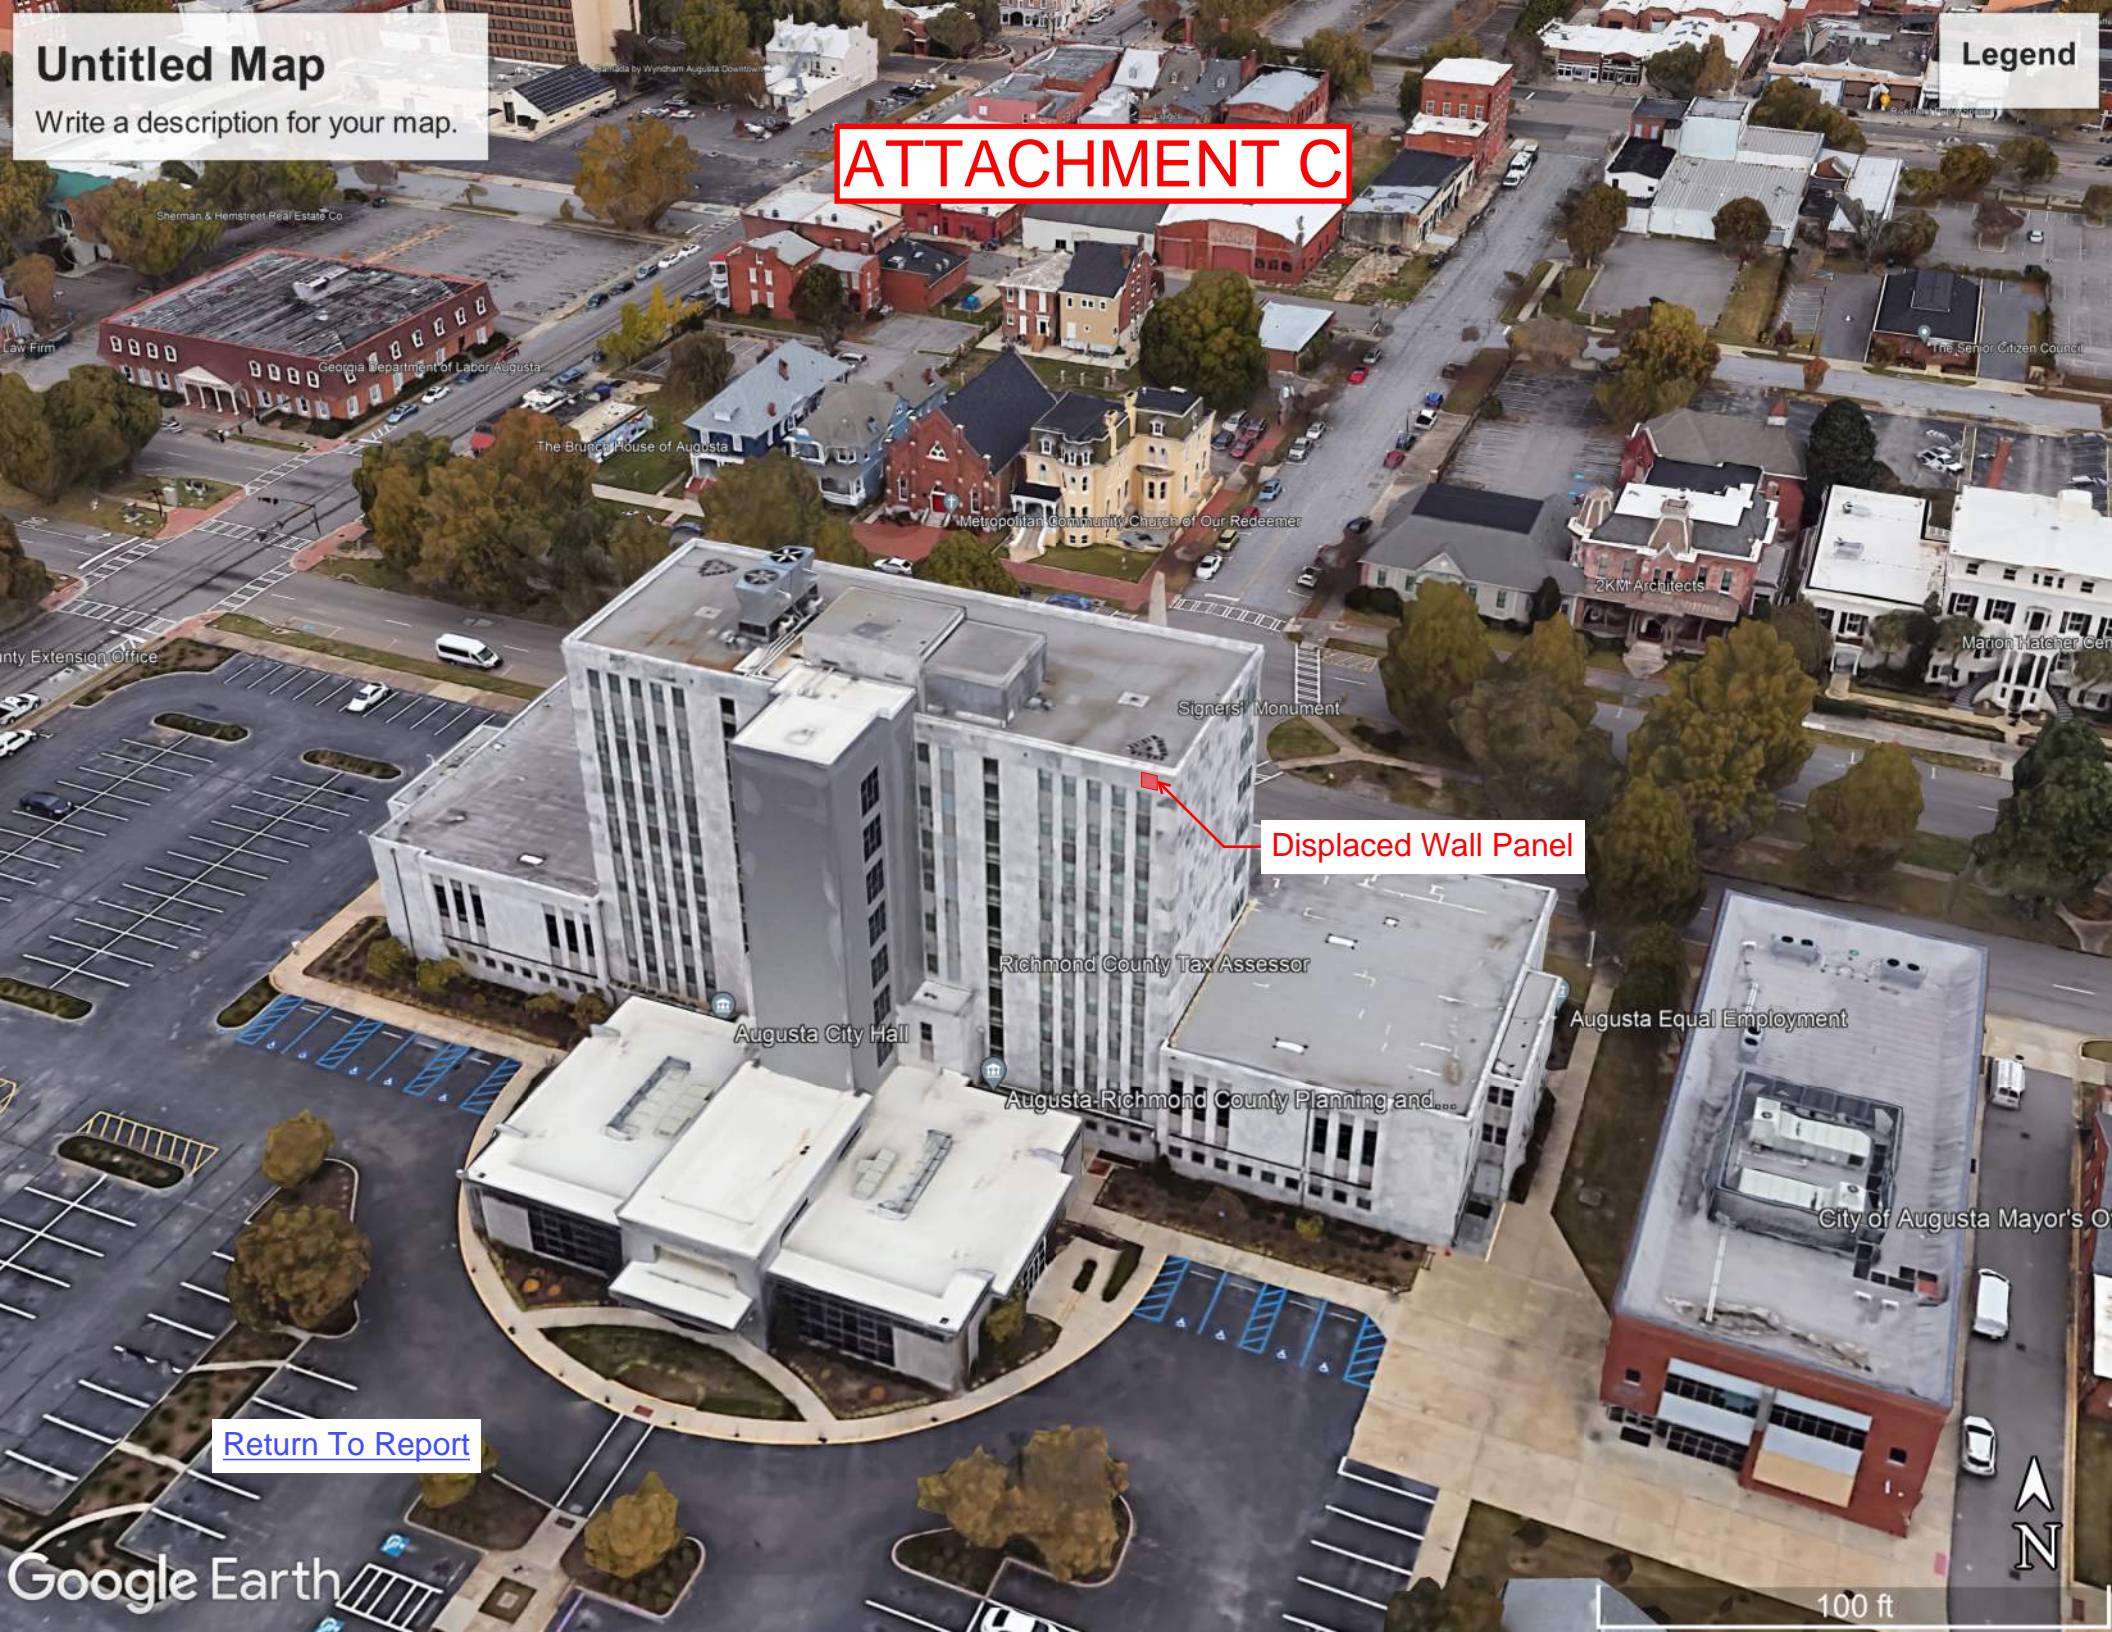
ATTACHMENT C

1. At the upper roof line, one of the marble wall panels was out of position and was not properly anchored ([Attachment C](#) and [Attachment D](#)).
2. As such, there is a possibility that the panel could fall and endanger people below. Consequently, the area below the loose panel needs to be immediately cordoned off and personnel and public kept out of this area ([Attachment E](#)).

Displaced Wall Panel

3. Subsequently, Lee Dorn met on-site with Ms. Maria Rivera-Rivera and a demolition contractor (Tyson Thompson) on August 11th, 2003 to further evaluate the wall cladding situation. It's reported that Thompson Wrecking was involved during the 2007 renovation and Mr. Thompson is going to talk with the superintendent who did that work to see if he remembers exactly how the wall cladding panels were attached. Mr. Thompson will also be developing a cost to remove two sections of the marble cap and the panel in question, to include temporary weatherproofing. Once JLA has an opportunity to review the connections and propose a solution, Thompson Wrecking will provide for the reinstallation

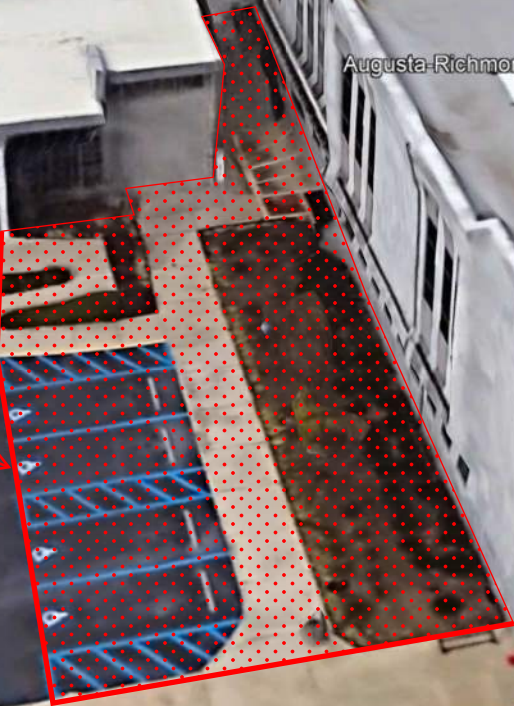
ATTACHMENT E

Area To Be Cordoned Off
