Baxter, Minnesota

Inspection Report:
400,000-Gallon Capacity
South Tower

May 2022

Project No.: 1320-22

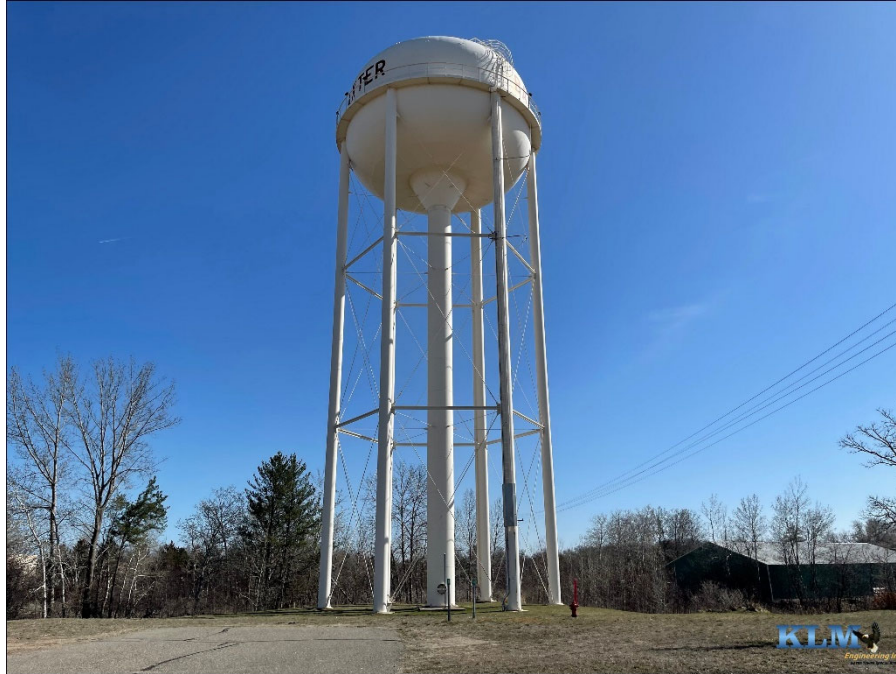
Photo No. 1
Overall view of the tower

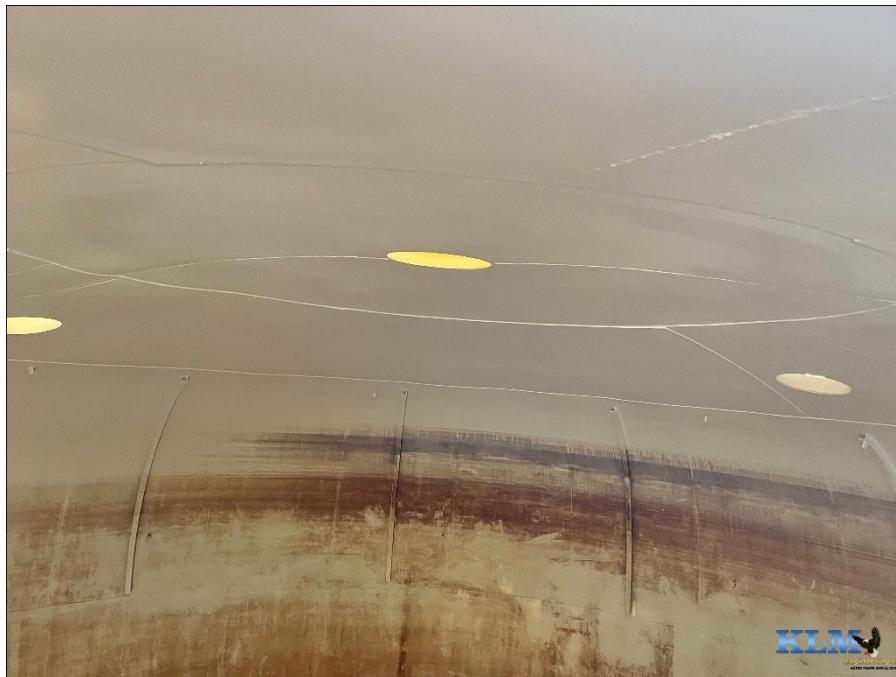
Photo No. 2
View of interior wet roof

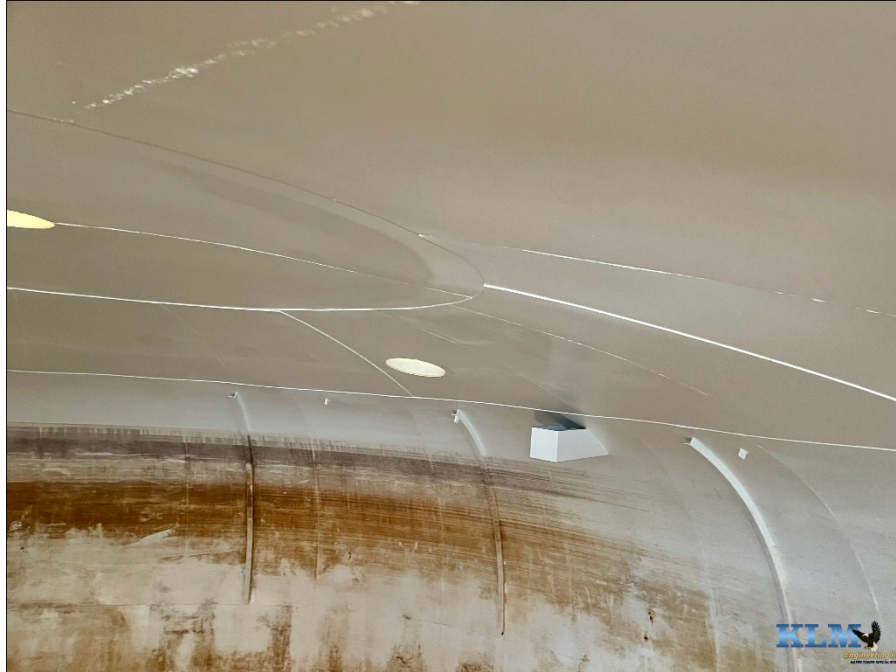
Photo No. 3
Condition of roof plate coatings
Overflow weir box visible

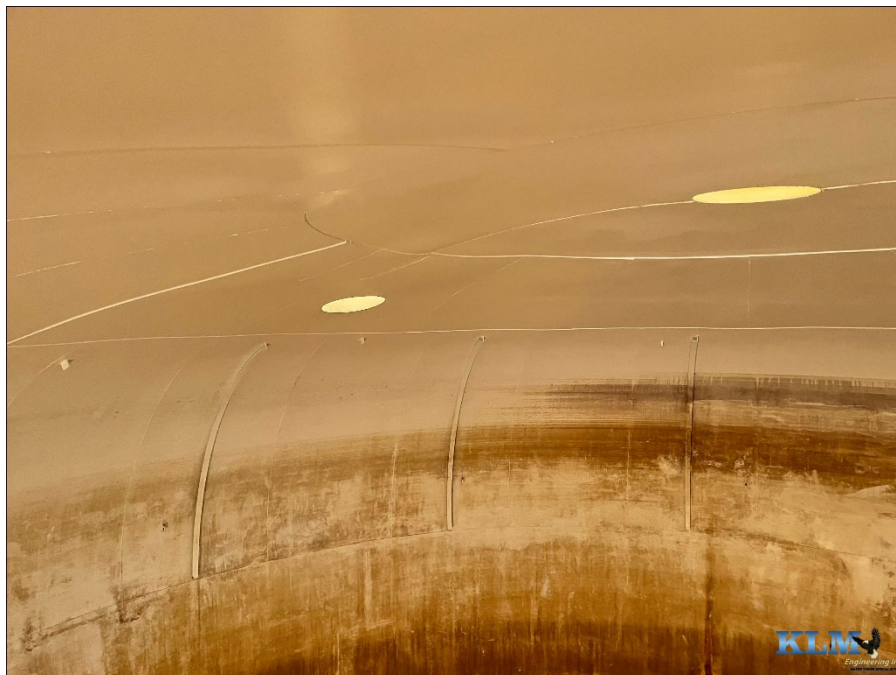
Photo No. 4
Condition of roof plate coatings

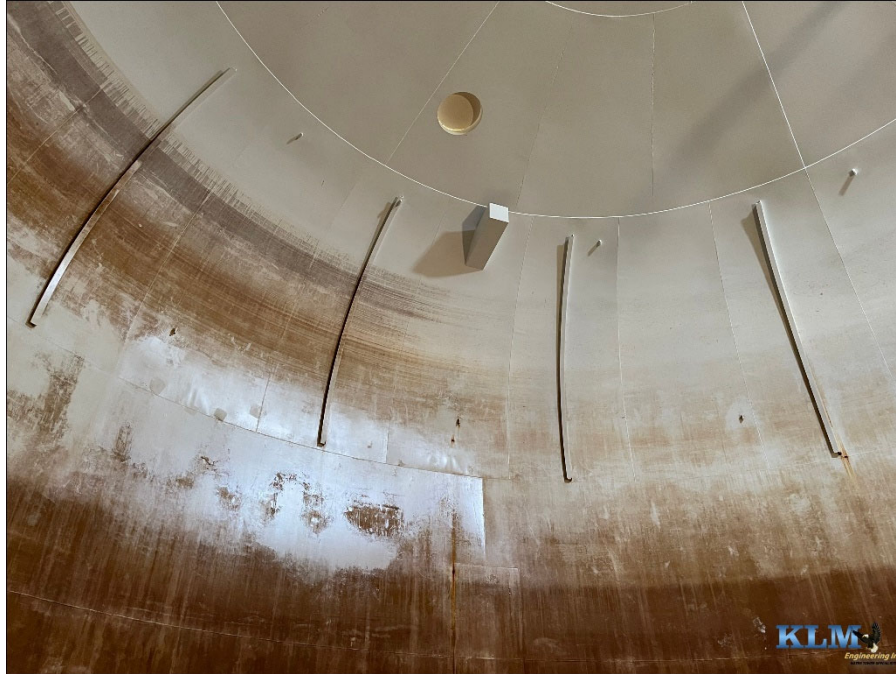
Photo No. 5
View of shell

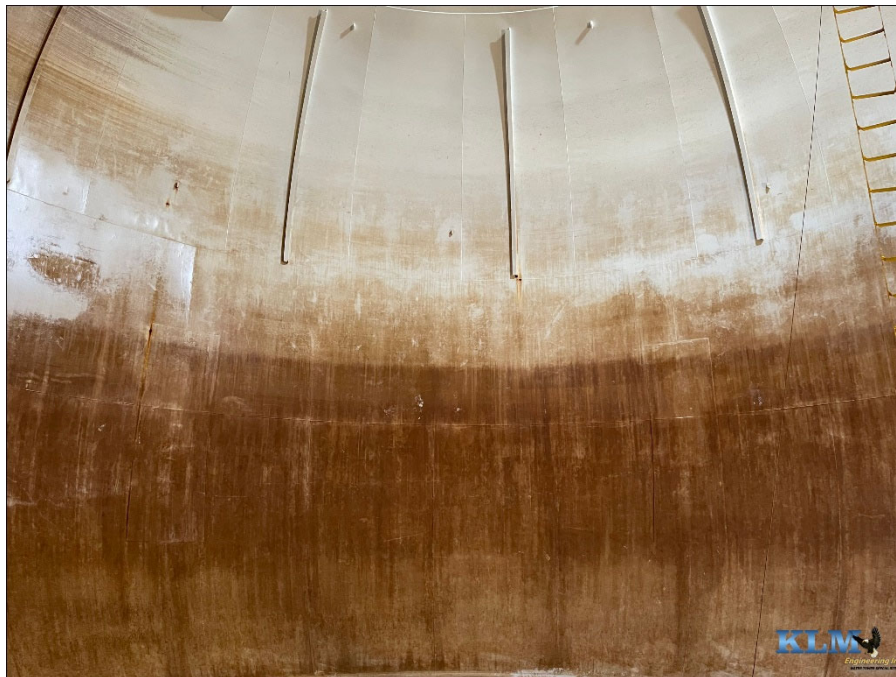
Photo No. 6
View of shell

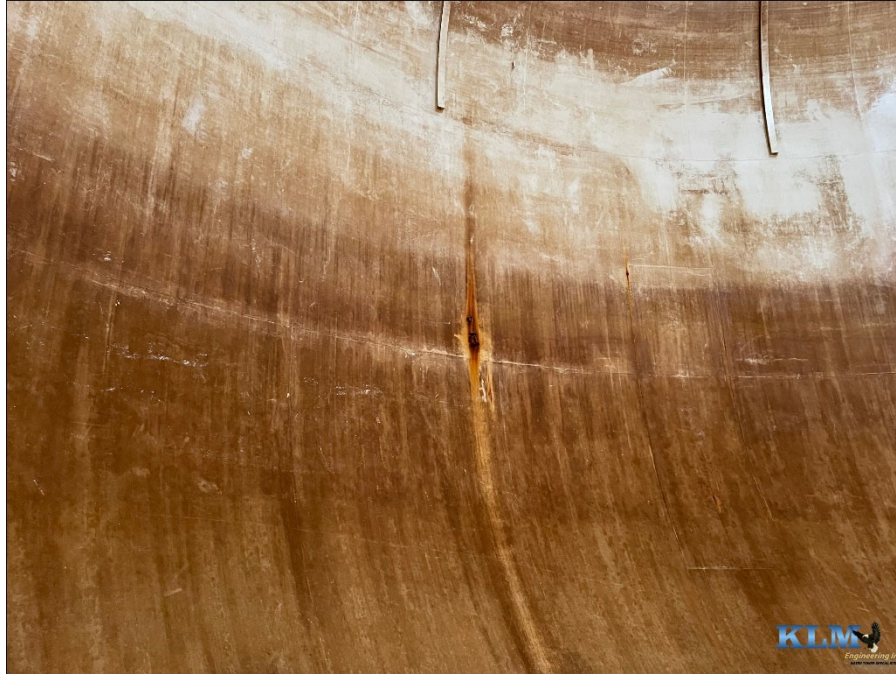
The interior wet coating is in overall good condition with less than two (2) percent visible coating failures. Failures consist of spot corrosion randomly located on the shell, pinole corrosion on the bowl, and surface corrosion on top of the fill pipe. While not affecting the integrity of the coating, brown staining is visible on the shell and bowl, likely due to the presence of iron and manganese in water. See attached photos.

Photo No. 7
Shell coating conditions
Large corrosion spot visible

Overall conditions were compared to the past KLM evaluation reports. The rate of corrosion occurring is minimal and virtually unchanged from the 2018 report. Based on the overall good condition of the coatings, the interior and exterior should be considered for spot repair within the next one to two years to prolong the need for full reconditioning and reduce corrosion associated damage. For budgetary purposes, if spot repairs were performed to the interior wet coating and the exterior was washed, the estimated current cost would be between \$55,000 and \$65,000. If the City wanted to improve the exterior appearance in addition to the wash, the tower is likely a candidate for a full overcoat of paint, which would increase the cost by approximately \$60,000 to \$70,000. These costs do include engineering and inspection services. Performing proper spot repairs and a possible overcoat now could greatly extend the service life of the coating system and appearance of the tower for as much as ten years, or more as determined by future inspections, for a fraction of the cost of full reconditioning. Not only would this extension provide plenty of time to prepare and budget for the next full

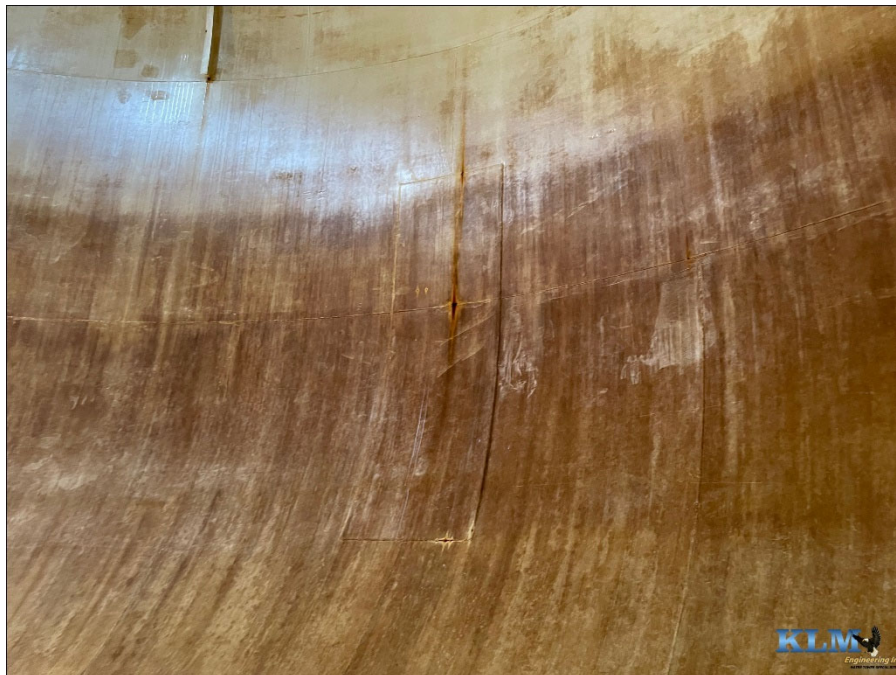
Photo No. 8
Shell coating conditions

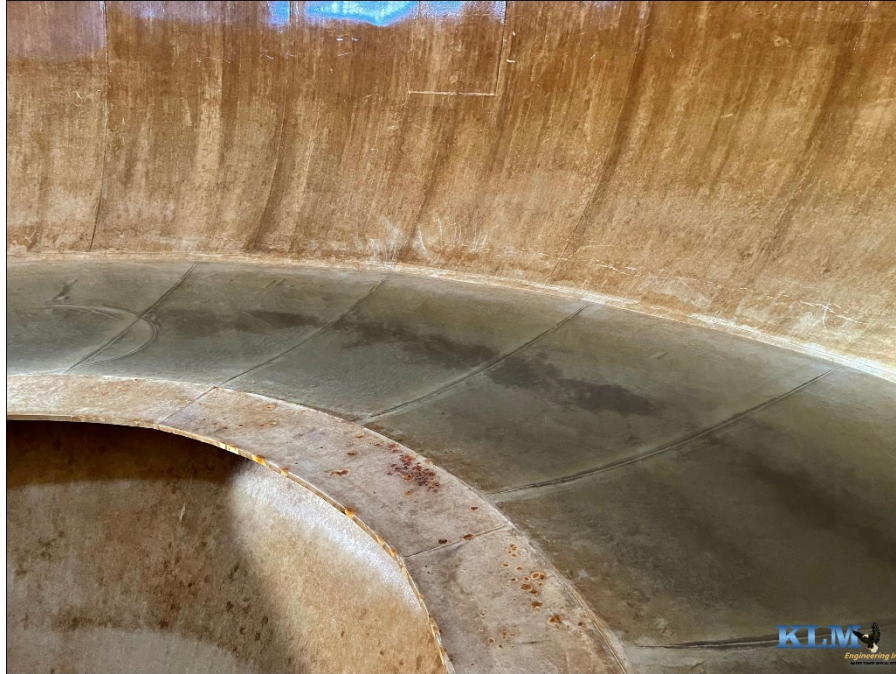
Photo No. 9
Bowl conditions
Corrosion on bowl visible

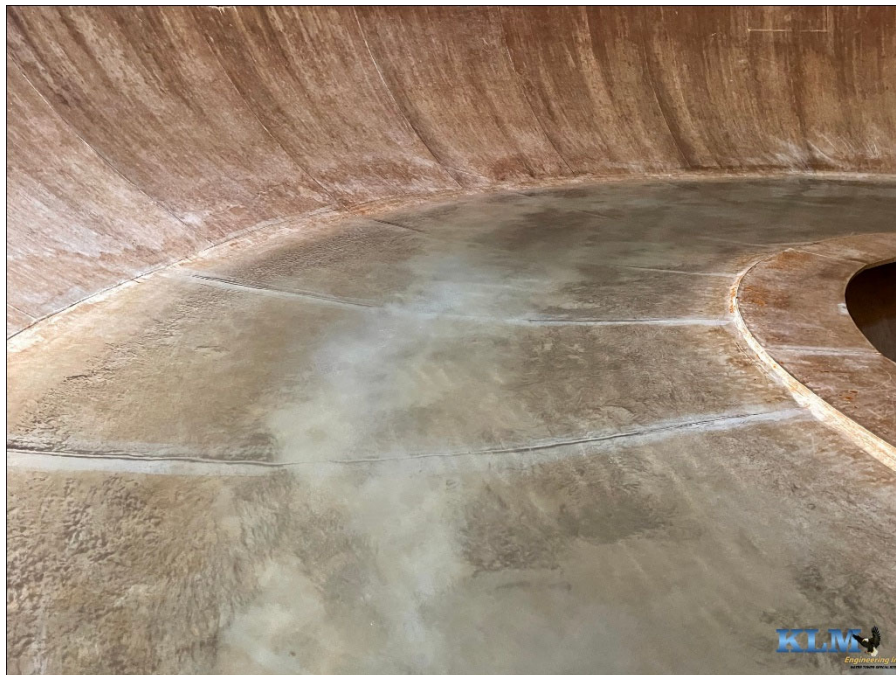
Photo No. 10
Bowl conditions

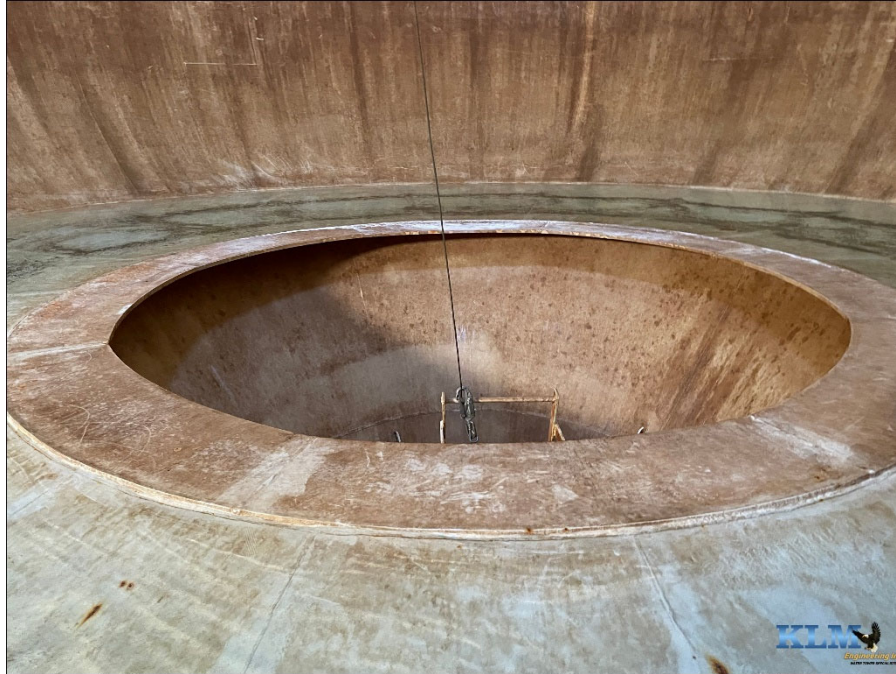
Photo No. 11
Top of cone

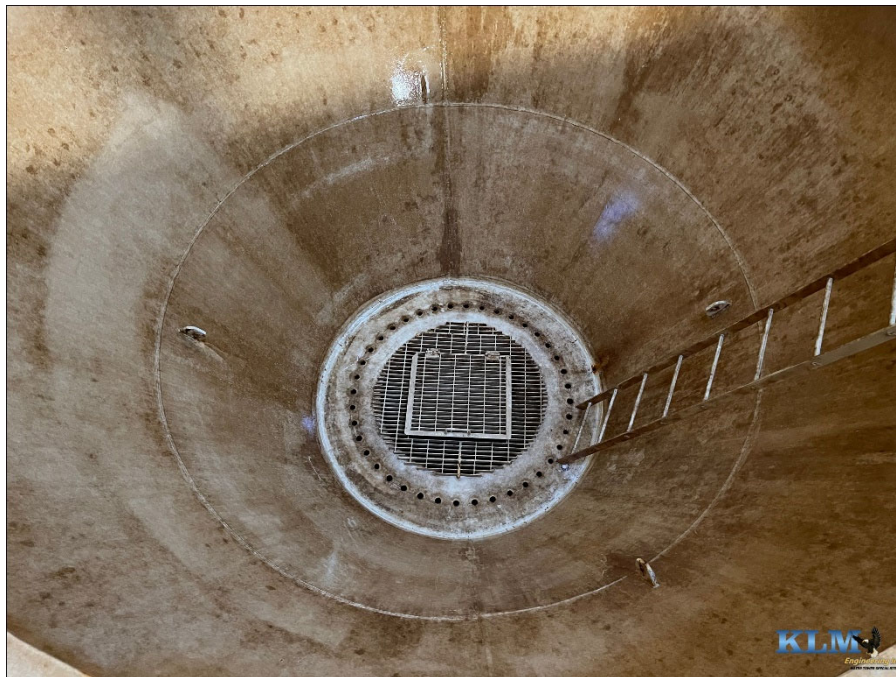
Photo No. 12
Cone conditions
Top of wet riser visible

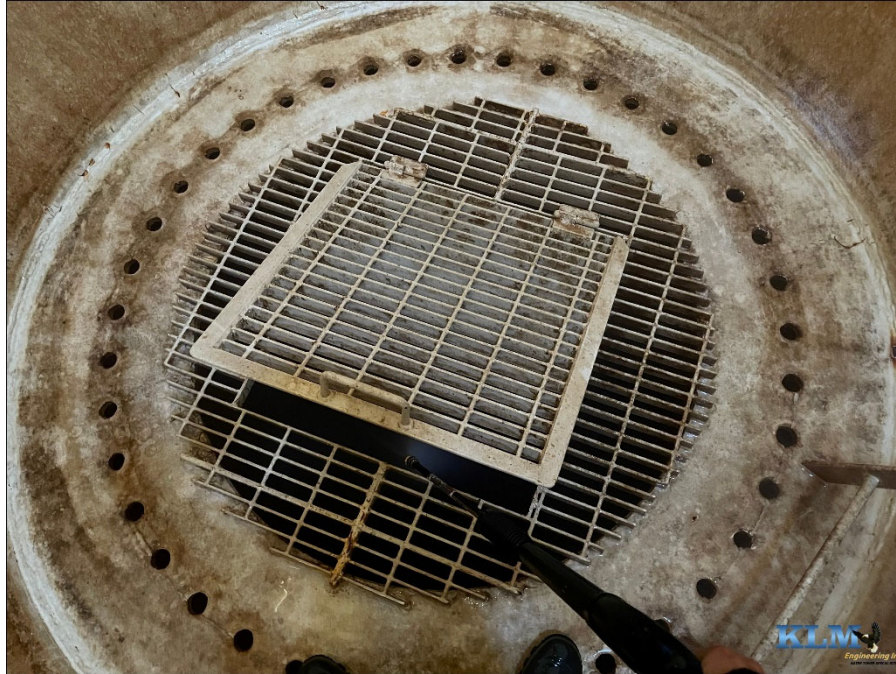
Photo No. 13
Condition of wet riser grating

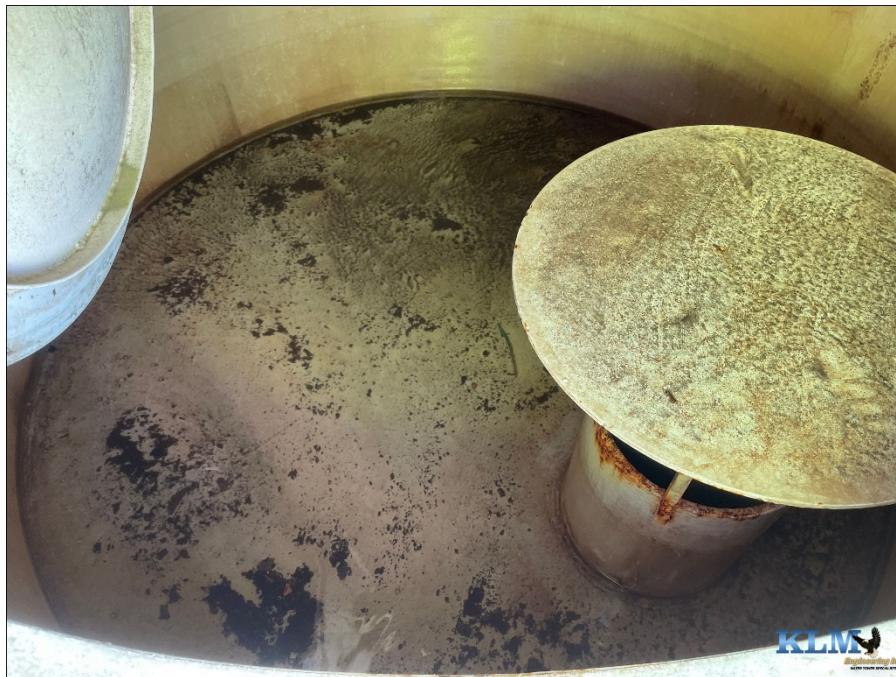
Photo No. 14
Bottom of wet riser

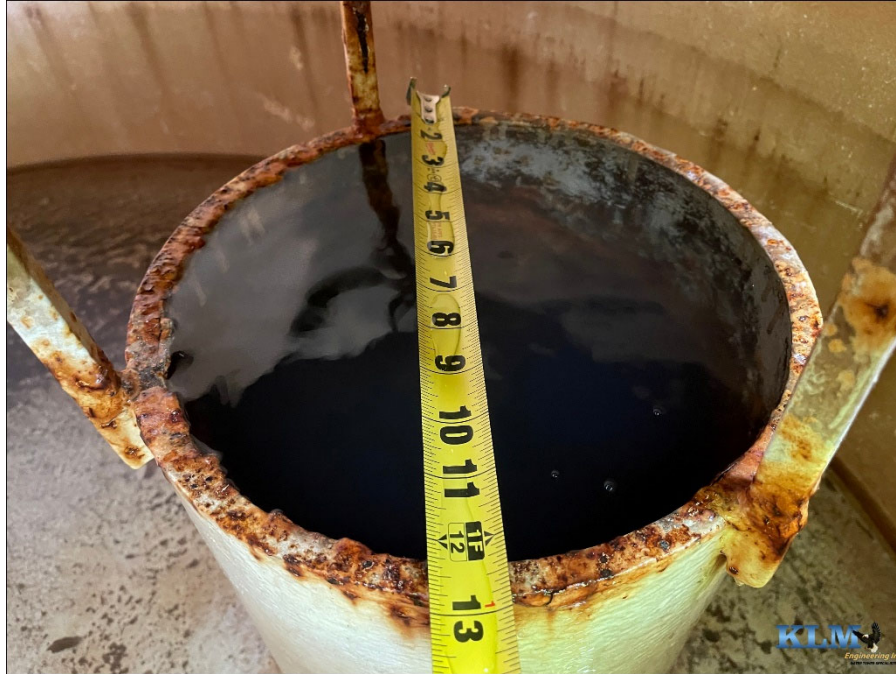
Photo No. 15
Condition of fill pipe

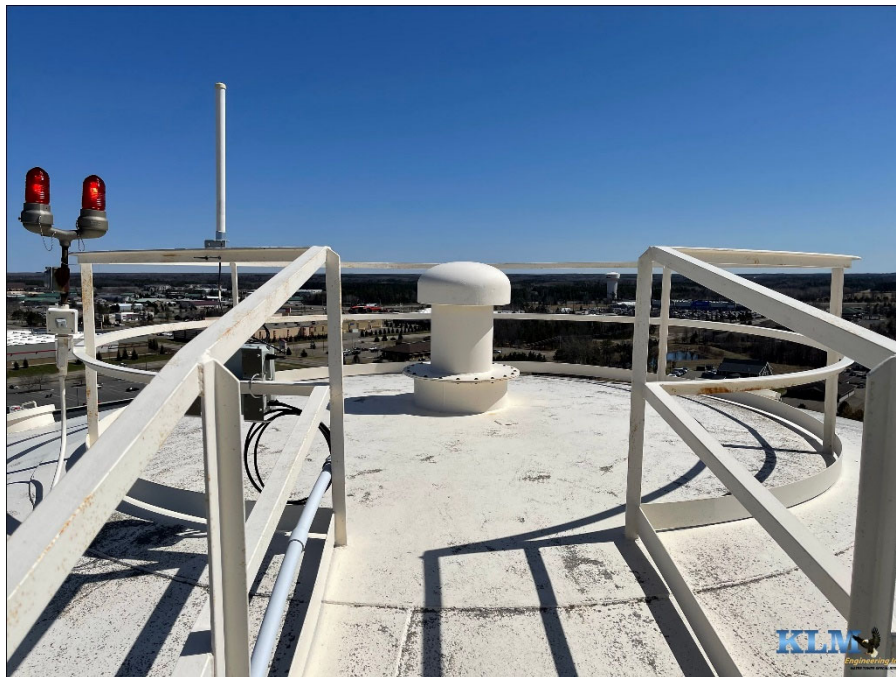
Photo No. 16
View of roof

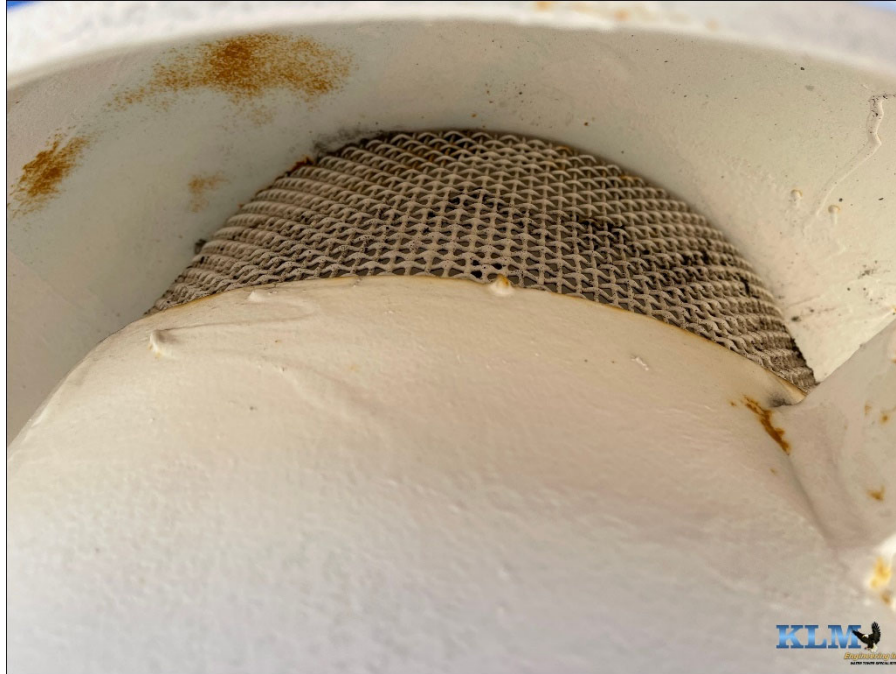
Photo No. 17
Condition of finial vent

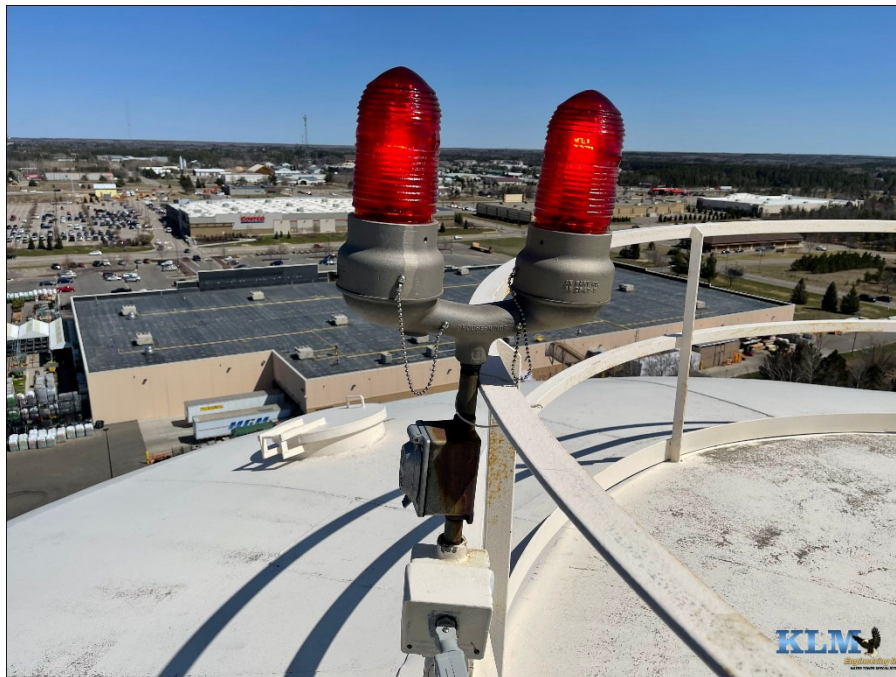
Photo No. 18
Aviation light

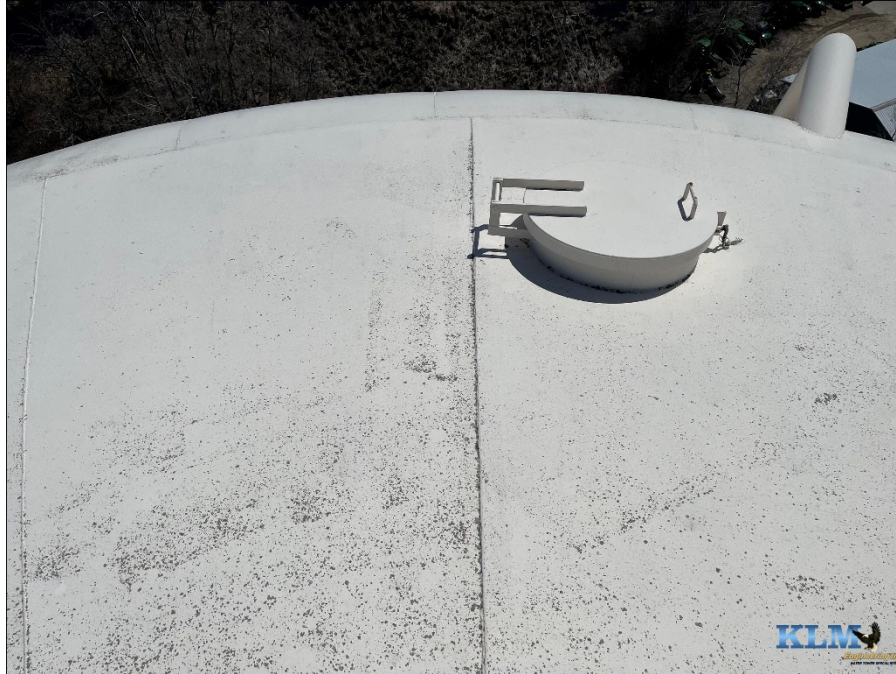
Photo No. 19
Roof plate coating conditions
Ventilation manway visible

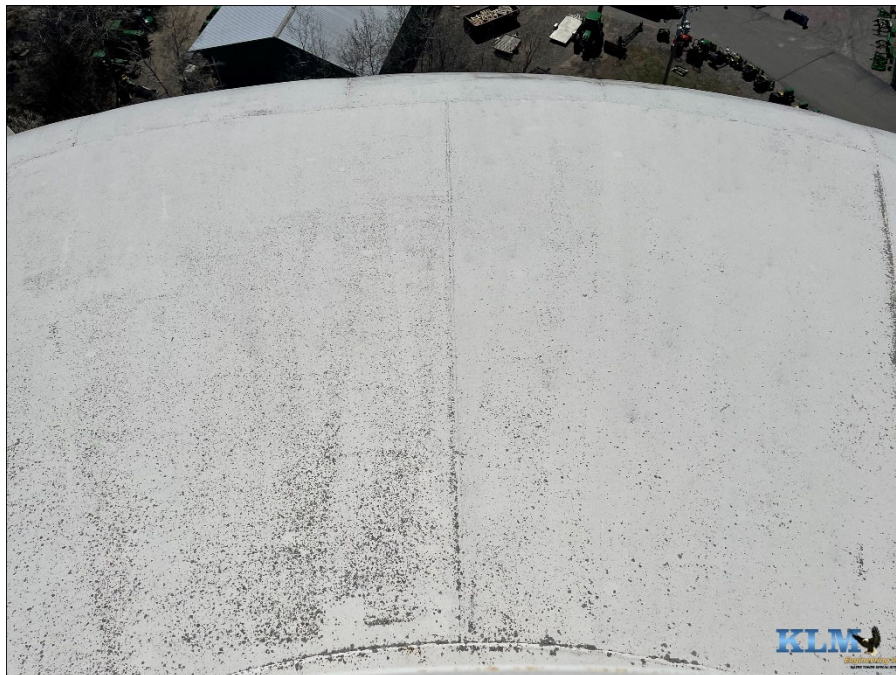
Photo No. 20
Roof plate coating conditions

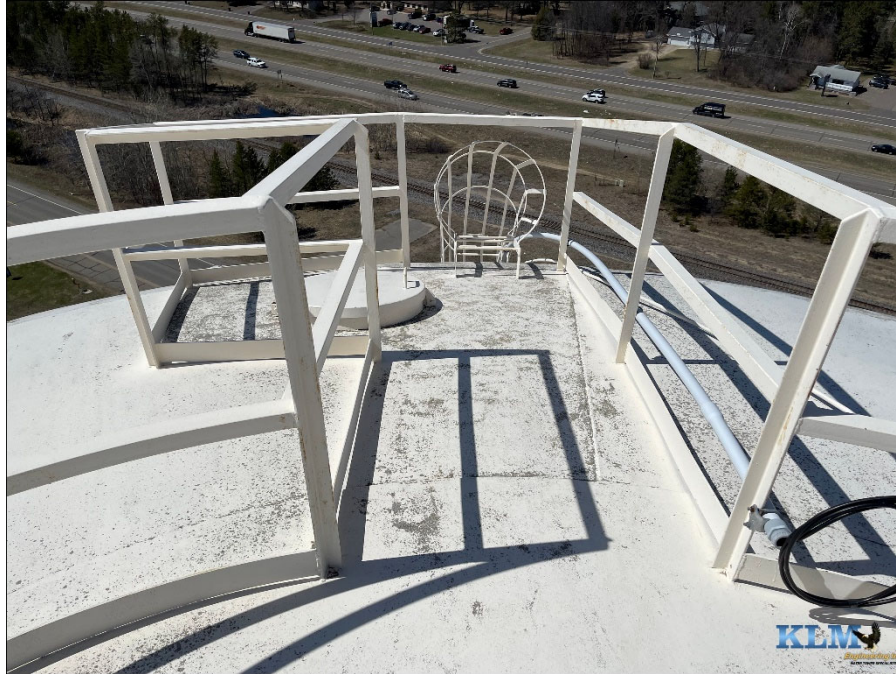
Photo No. 21
Roof handrail

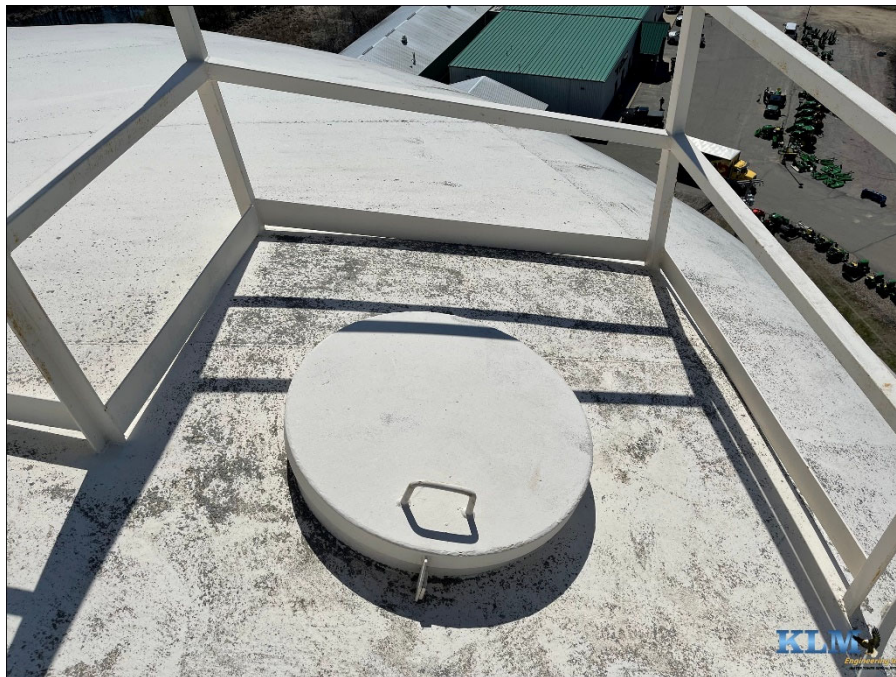
Photo No. 22
Wet access manway

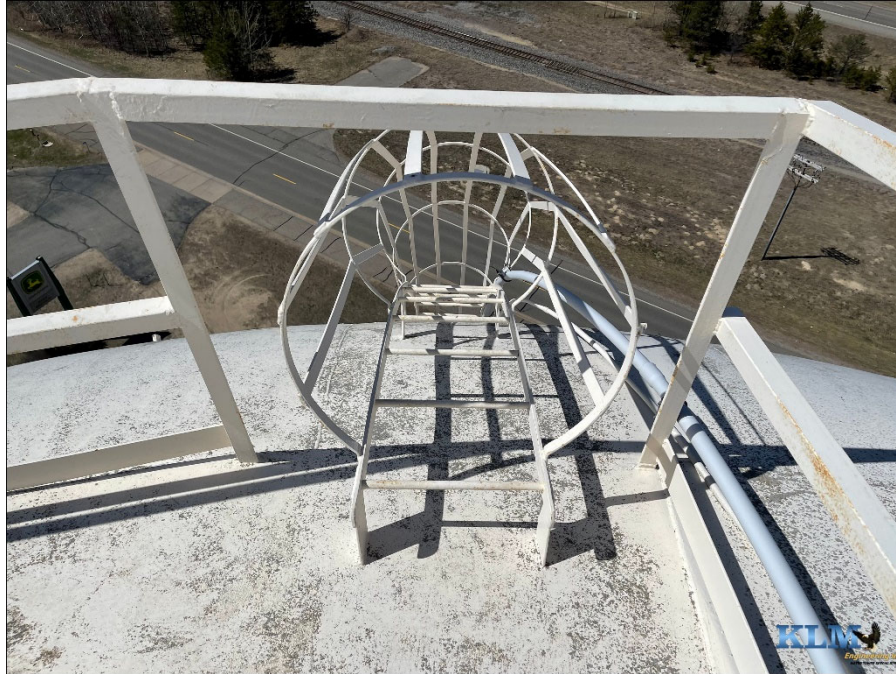
Photo No. 23
Roof access ladder

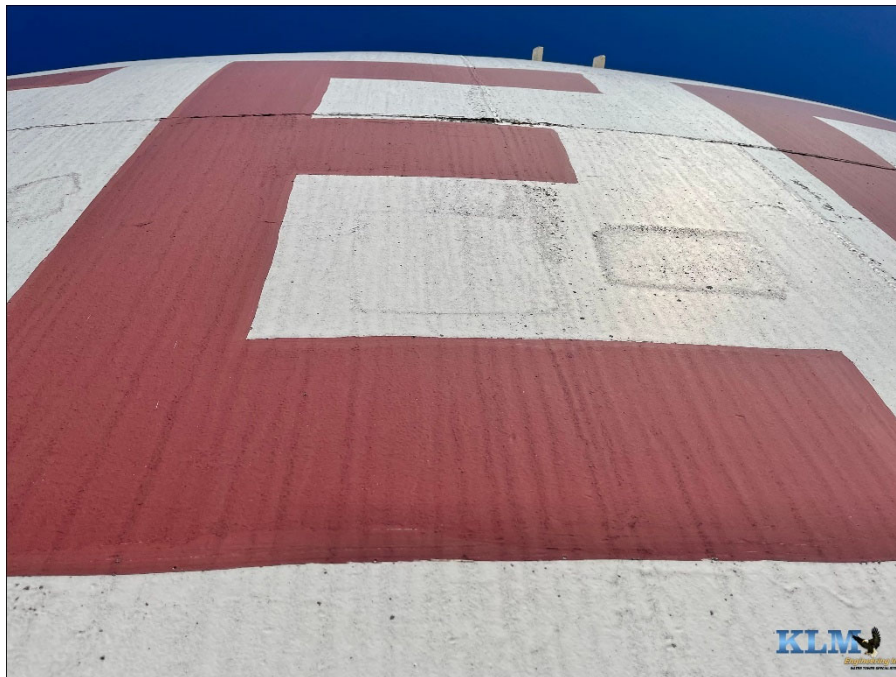
Photo No. 24
Shell coating conditions

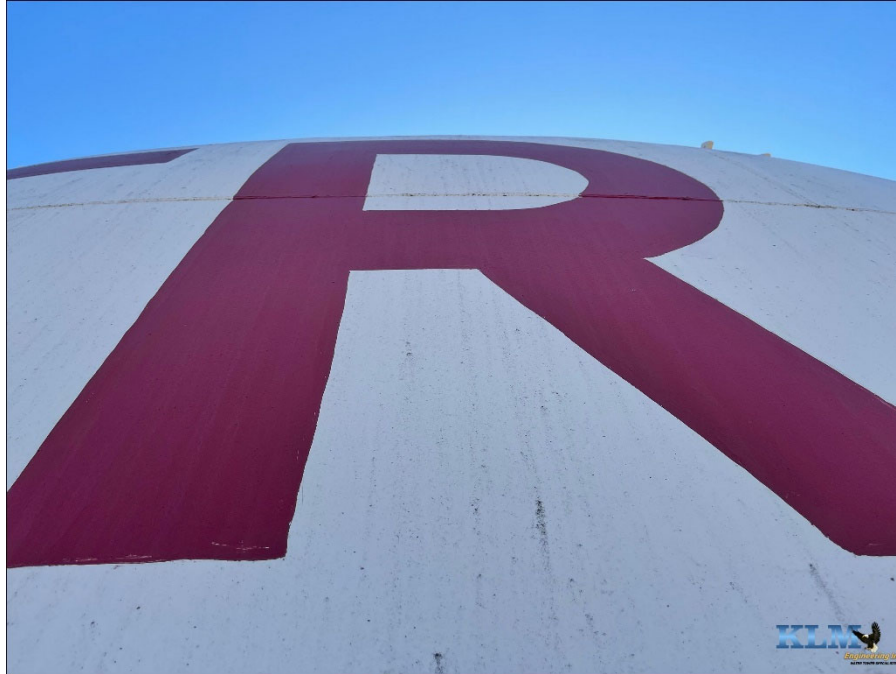
Photo No. 25
Shell coating conditions

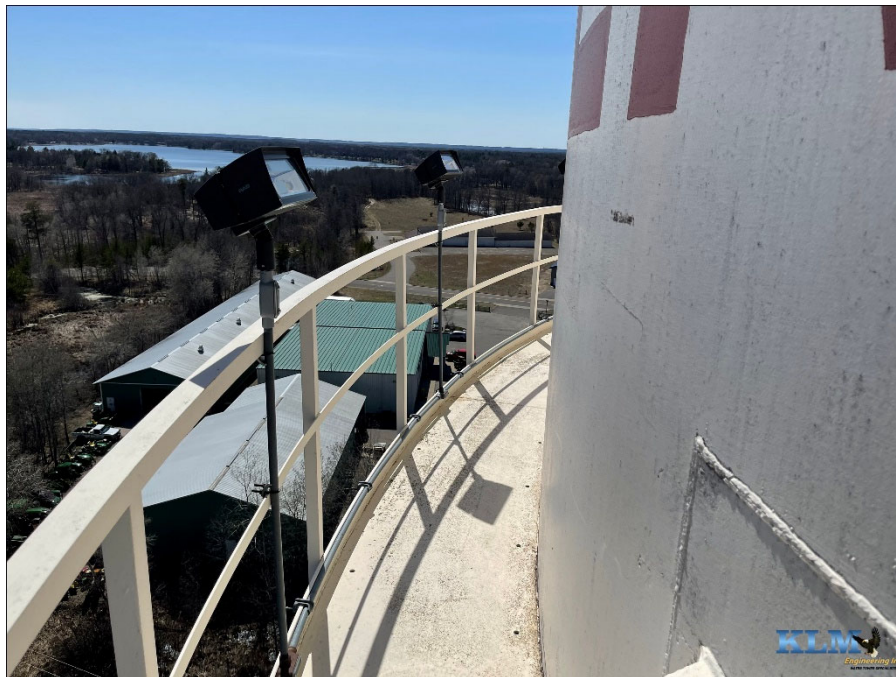
Photo No. 26
Balcony and handrail

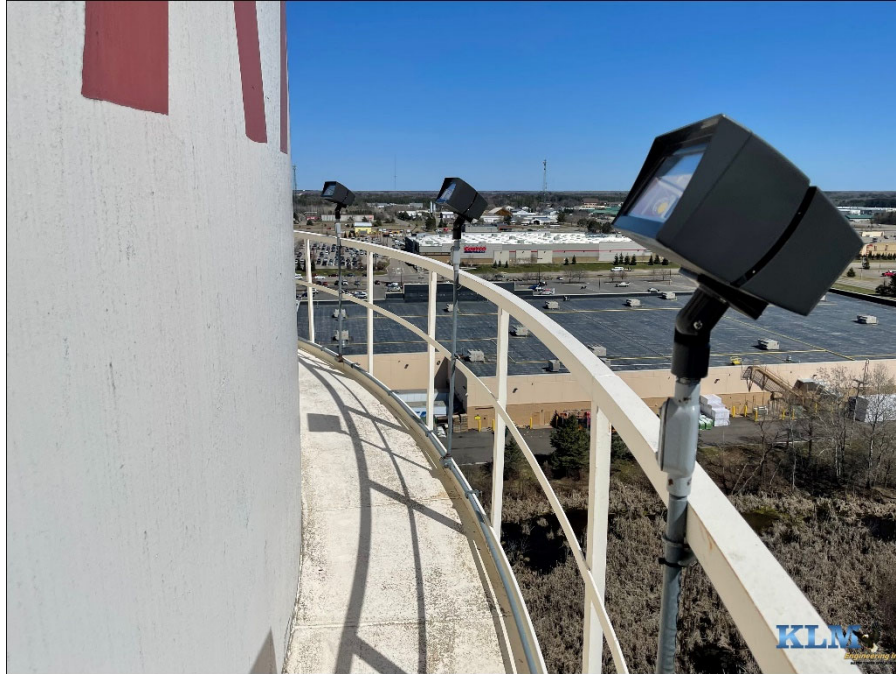
Photo No. 27
Balcony and handrail

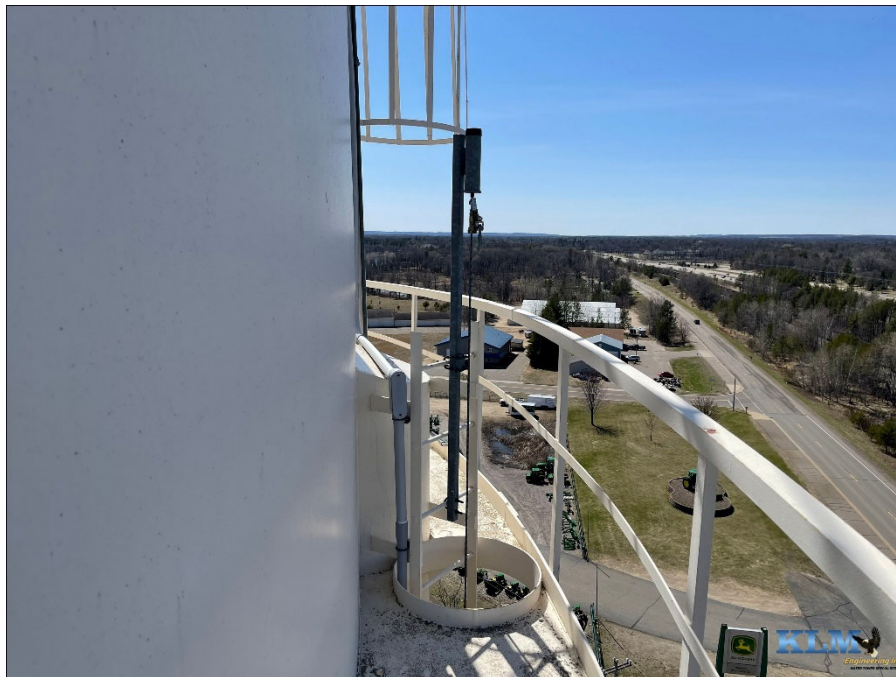
Photo No. 28
Balcony access

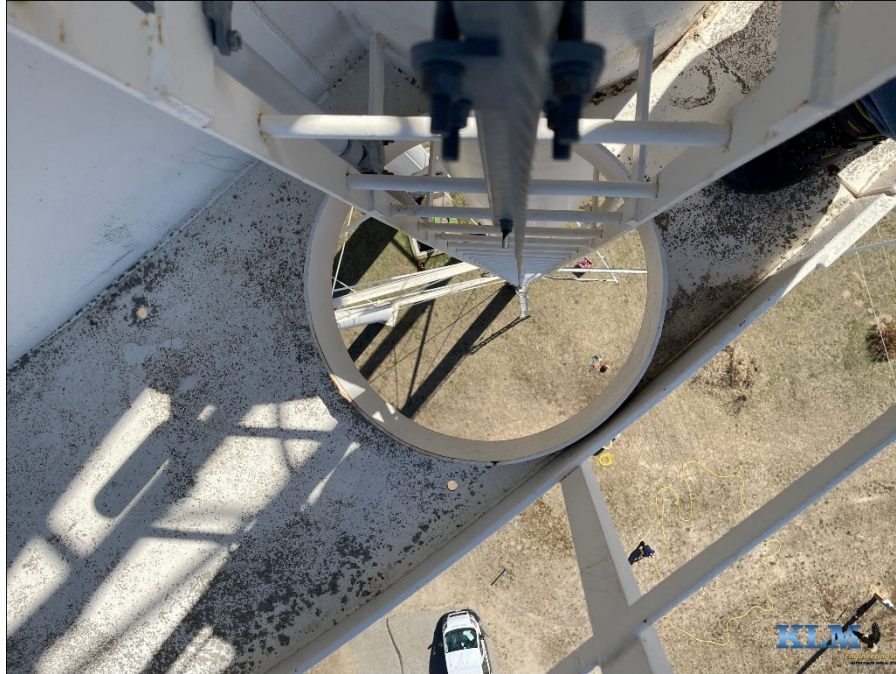
Photo No. 29
Column ladder

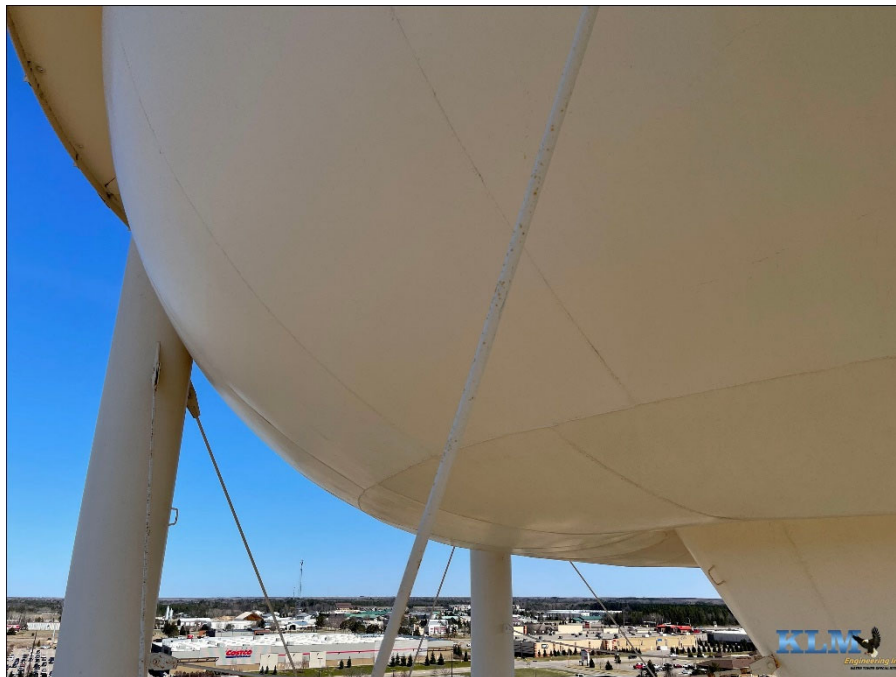
Photo No. 30
Bowl coating conditions

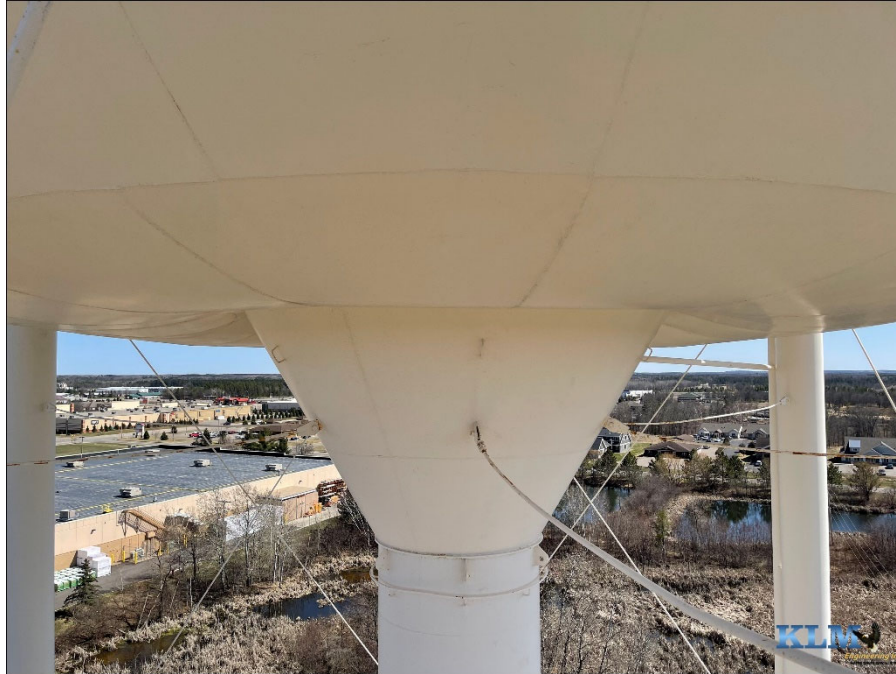
Photo No. 31
Bowl and cone coating conditions

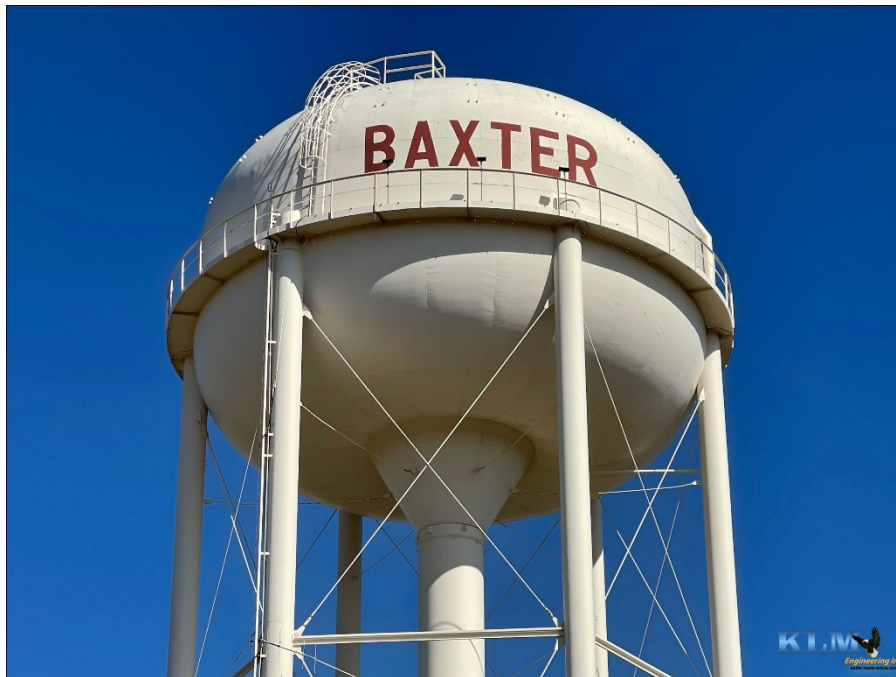
Photo No. 32
View of shell and bowl
Lettering visible

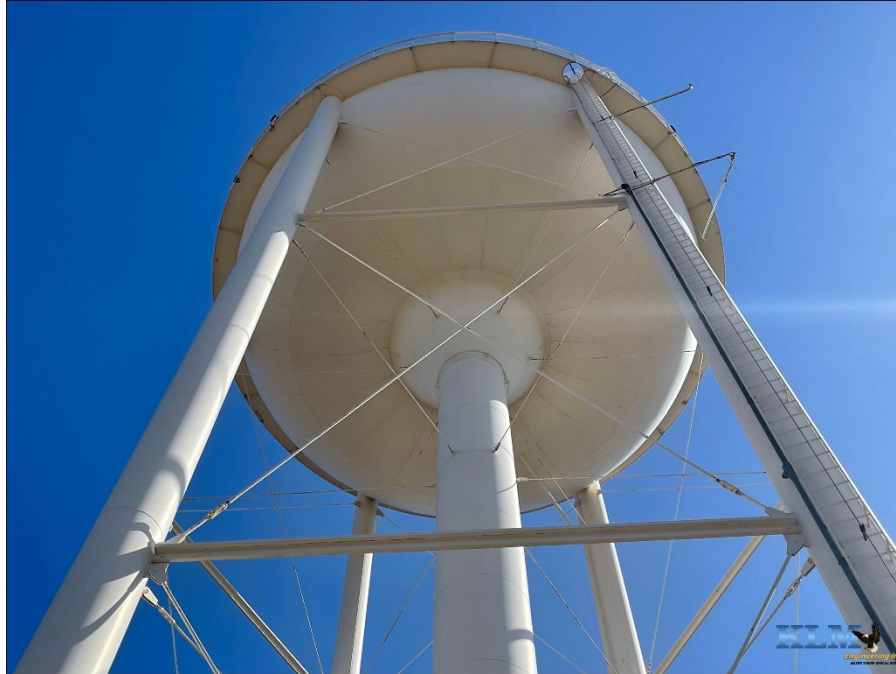
Photo No. 33
View of columns and wet riser

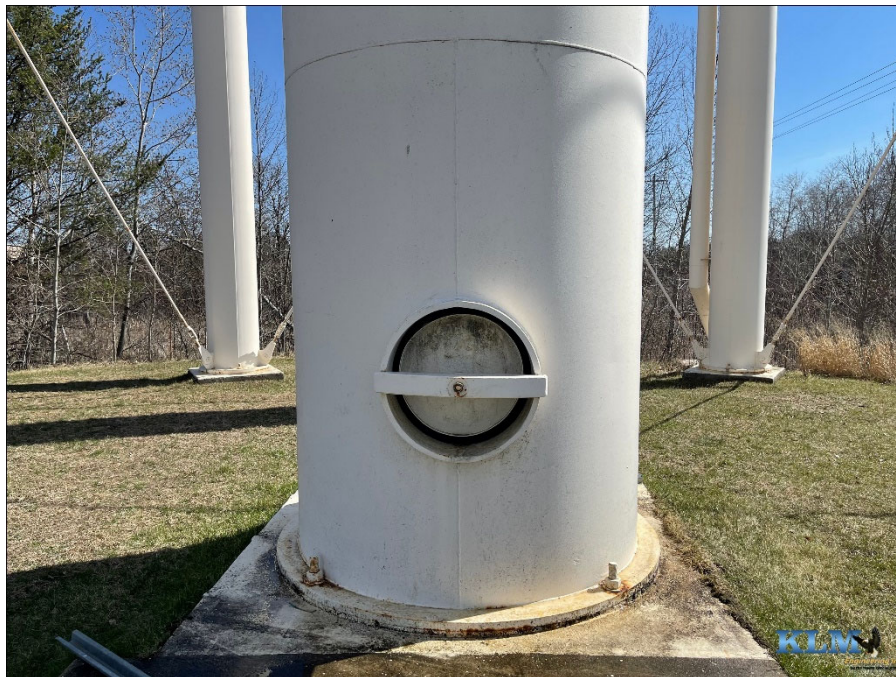
Photo No. 34
Base of wet riser

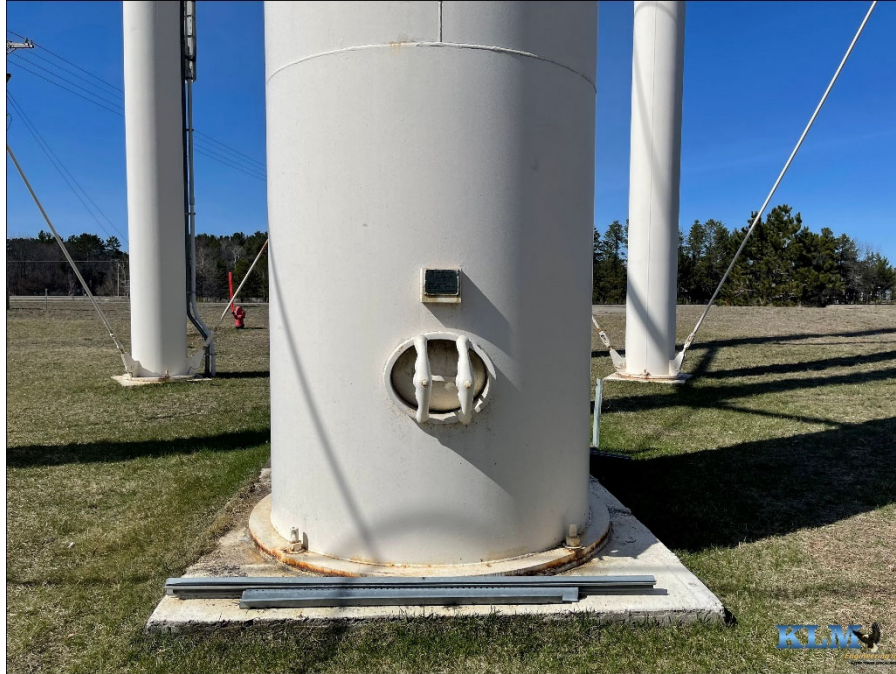
Photo No. 35
Base of wet riser

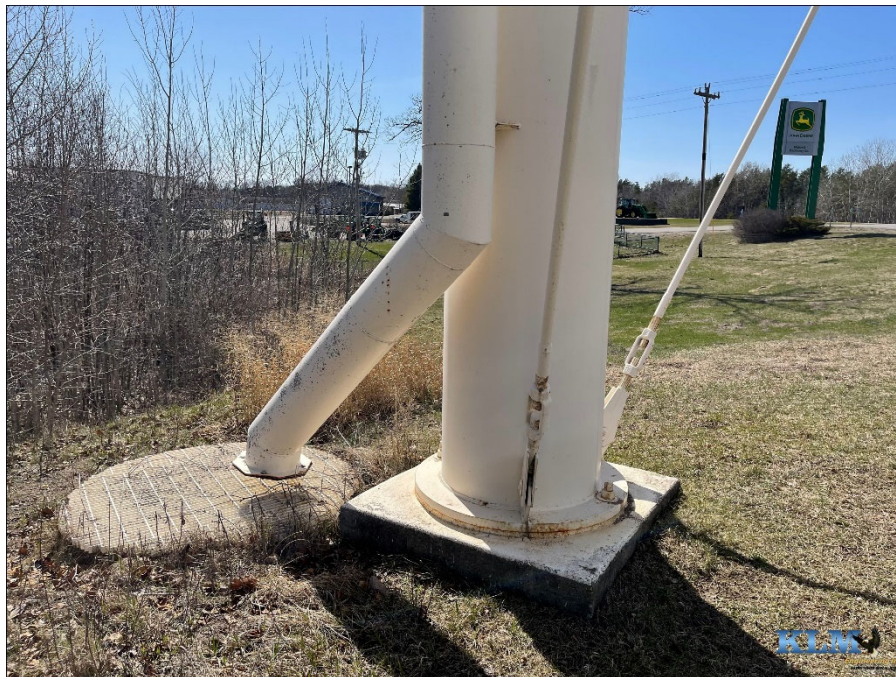
Photo No. 36
Overflow pipe and grating

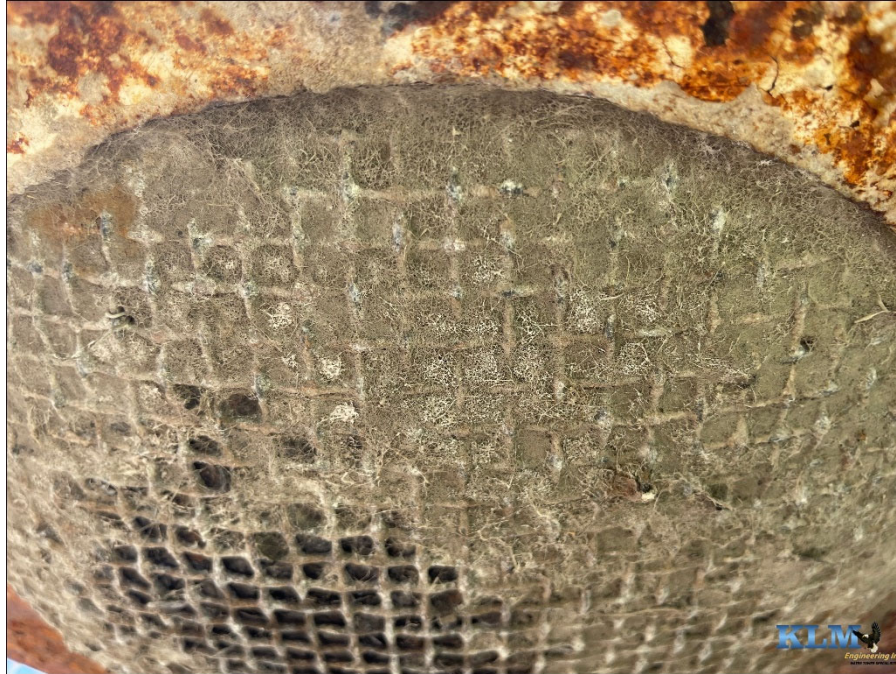
The exterior coating is in good condition with less than two (2) percent visible coating failures throughout the tower. Failures consist of UV deterioration, pinhole corrosion on typical wear areas such as the handrails, ladders, and manways, and surface corrosion on the overflow pipe screen retainer. See attached photos.

Photo No. 37
Condition of overflow pipe screen
