Baxter, Minnesota

Inspection Report:
400,000-Gallon Capacity
South Tower

May 2022

Project No.: 1320-22

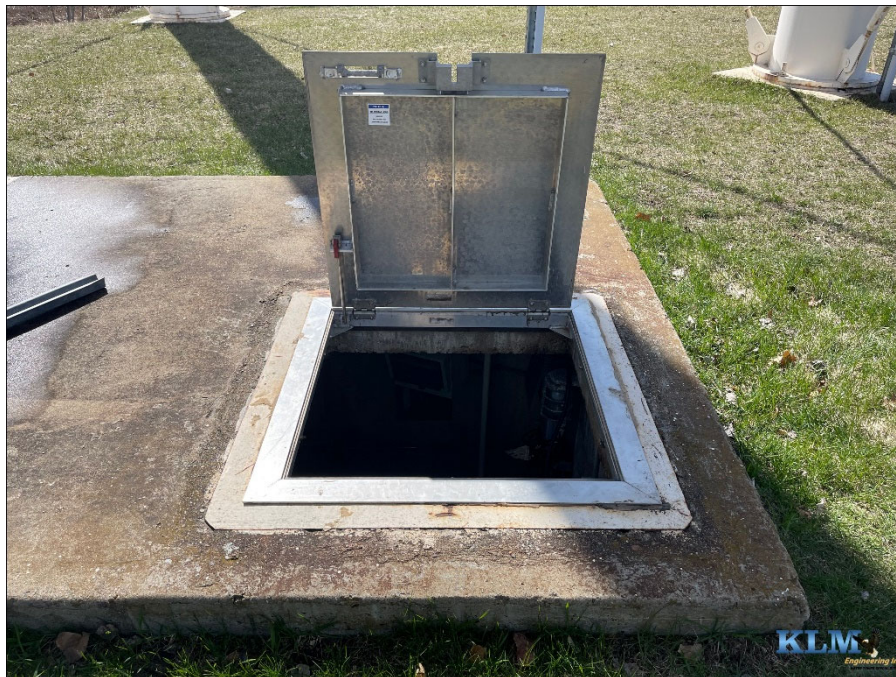
Photo No. 38
Valve pit manway

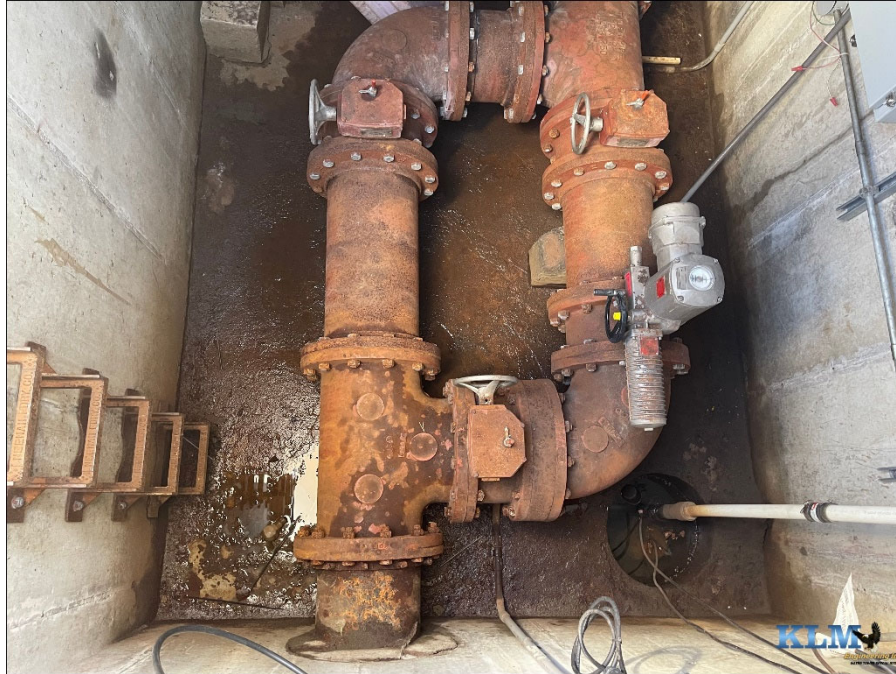
Photo No. 39
View of valve pit

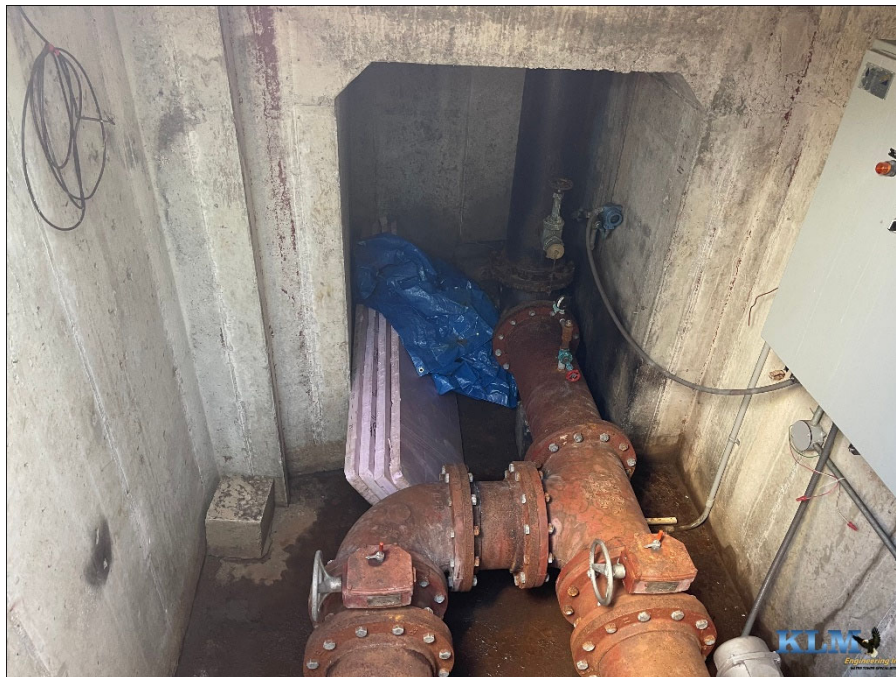
Photo No. 40
View of valve pit
