## **TECHNICAL MEMORANDUM**

**To:** Trevor Walter, PE, City of Baxter  
**From:** Alex Bitter, PE, Widseth  
**Subject:** Coring Memo for the 2026 Mill & Overlay Improvements Project  
**Date:** September 29, 2026  
**Project:** 2026 Mill & Overlay Improvements Project: 2024-10233

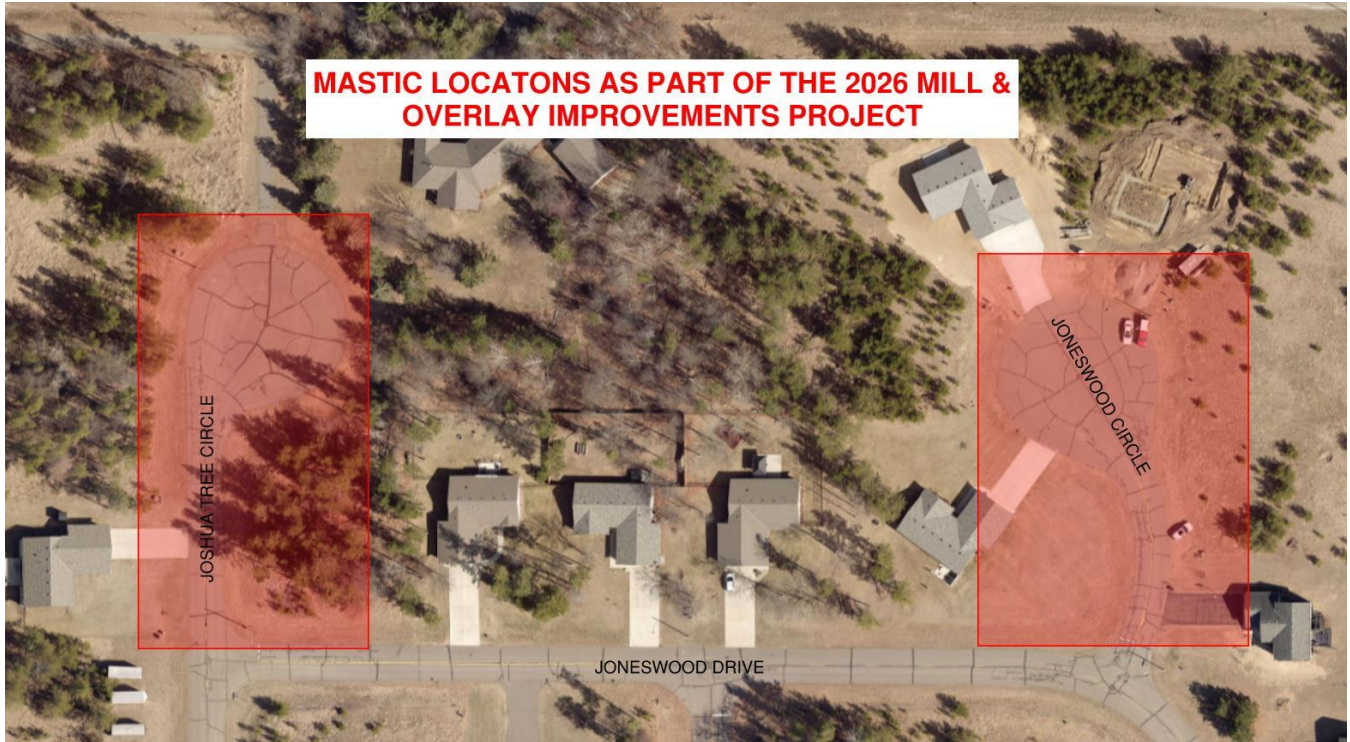
**Photo 1 - Mastic Locations**

Following the milling operations, the project team reviewed the options to repair the cul-de-sac and the City agreed this would be a good opportunity to Mastic the cracks as a test area. Mastic was applied to deep cracks that were less than 4 inches in width within the cul-de-sacs. Mastic operations were completed during the week of August 31, 2026, with the final applications occurring Thursday, September 3, 2026. The areas that Mastic was applied is shown in Photo 1.

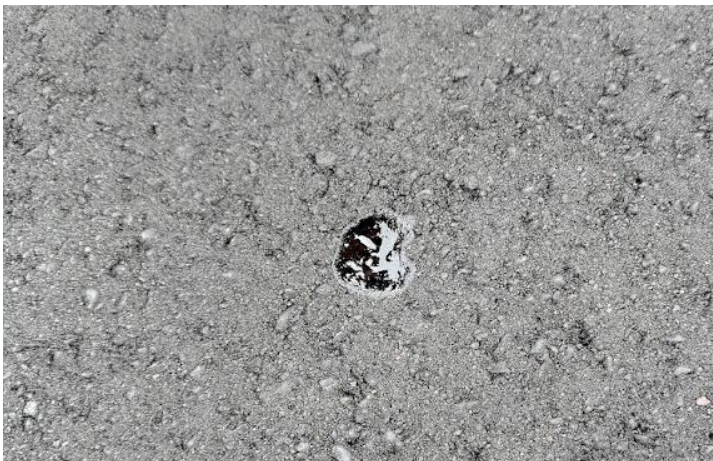
**Photo 2 - Visible Mastic on Surface**

The Mississippi Meadows streets were paved on Friday, September 4, 2026. During paving operations, Mastic was observed on the surface of the new pavement in several locations through both cul-de-sacs, with more areas observed on Joneswood Circle. Initial observations in the field suggested that the Mastic may have seeped through the new pavement layer. Photo 2 shows Mastic visible on the pavement surface, and Photo 3 shows one of the soft, pliable areas where Mastic was present.

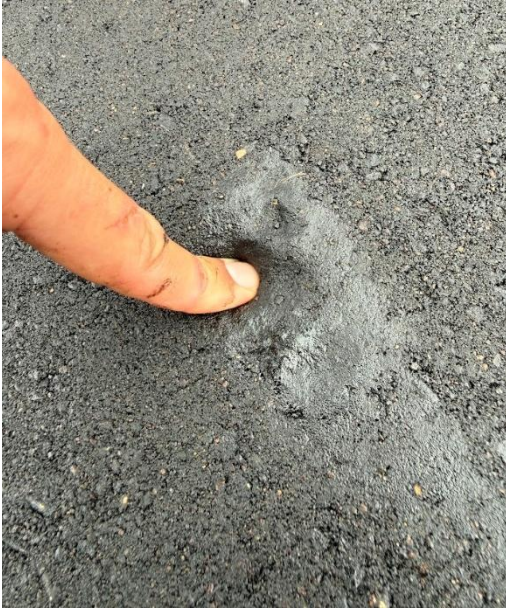
**Photo 3 - Pliable Area of Mastic**

The pavement was inspected again on Tuesday, September 8, 2026. At that time, the areas containing Mastic on the surface remained soft and pliable. During the project walkthrough on Friday, September 11, 2026, three locations were selected for coring to further evaluate the pavement section and determine the source of the Mastic on the surface. The three coring locations are shown in Photo 4.

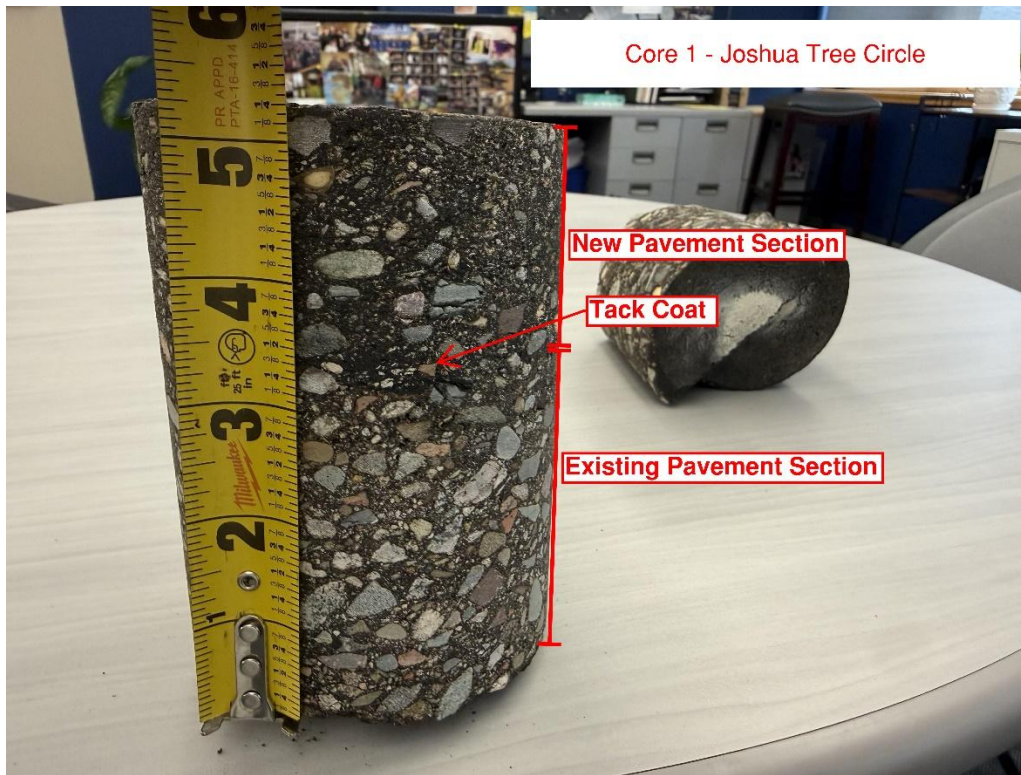
**Photo 5 - Section View of Core 1**

Core 1 was taken on Joshua Tree Circle near a manhole structure to verify pavement thickness. The pavement was flush with the casting which was set at 1.5" above the pavement surface. As shown in Photo 5, the core contained the existing pavement section (3.25-inches), tack coat, and the new overlay pavement section (2-inches). No abnormalities were found in the pavement section. Photo 6 shows the

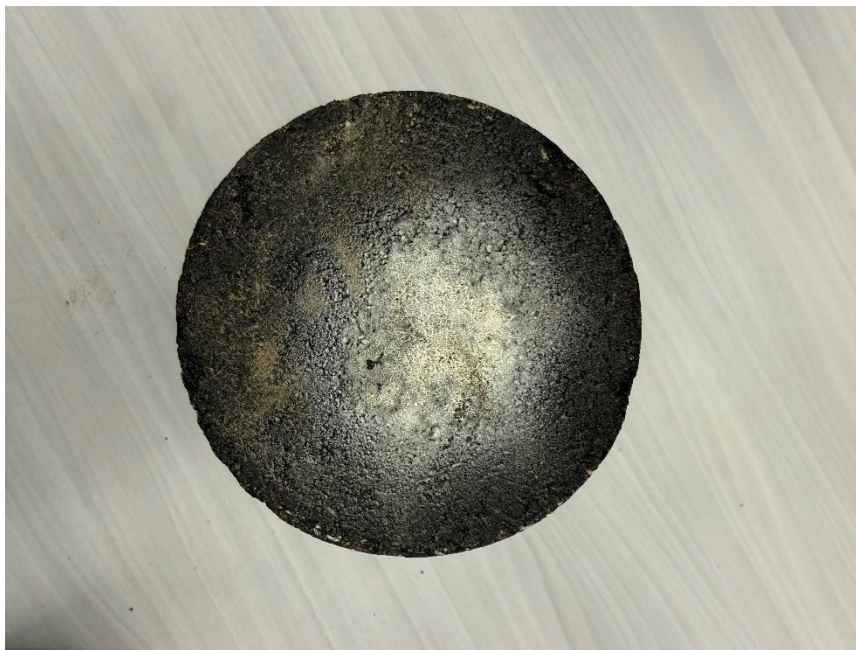
**Photo 6 - Top View of Core 1**

top view of the first core. It was found the bituminous patch around the casting was left approximately 0.5-inch low causing the casting to be flush. Mastic was placed around the flush casting.

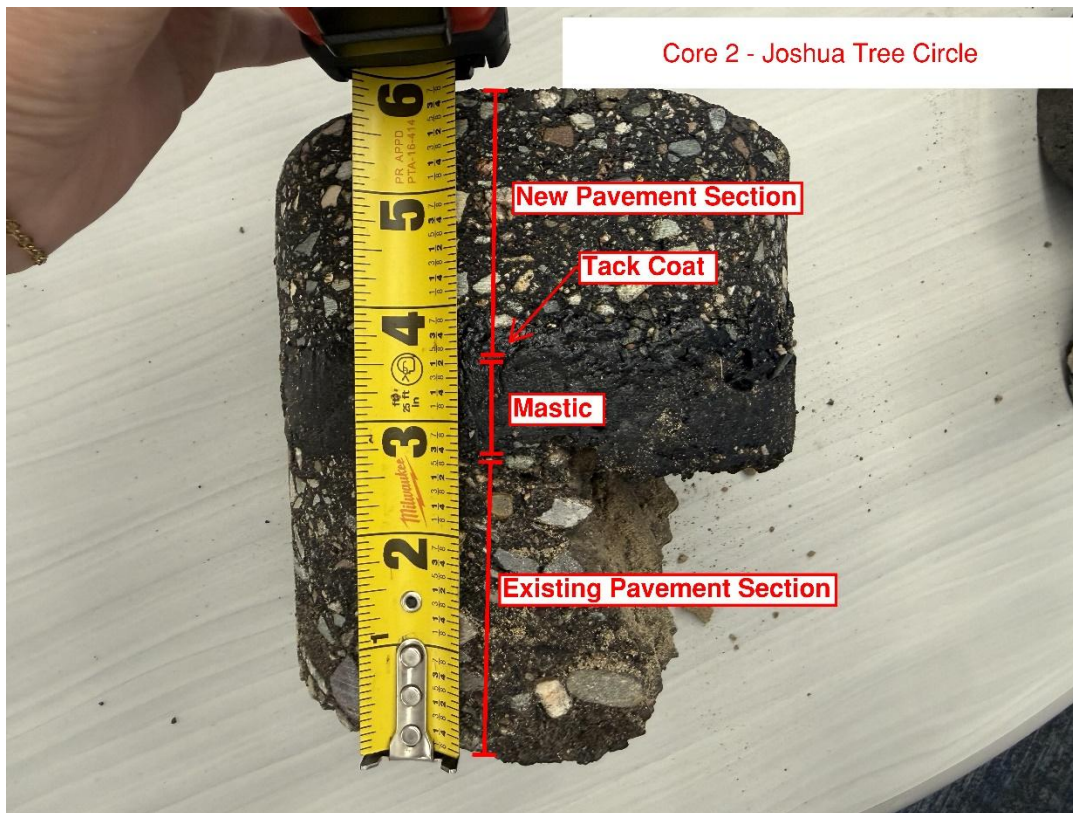
**Photo 7 - Section View of Core 2**

Core 2 was also taken on Joshua Tree Circle, this in an area where dirt was visible on the surface of the newly paved road. As shown in Photo 7, the pavement section consisted of the existing pavement (2.75-inches), a layer of Mastic placed over the crack (0.75-inches), an existing deep crack to the class 5 base

section, tack coat and the new overlay pavement (2.25-inches). The top of the core contained dirt as shown in Photo 8. This location was selected to verify adequate pavement thickness and the condition beneath the observed dirt. After observation of Core 2, the Mastic layer was visible between the existing and new pavement sections. The dirt on top of the core and mastic found in between the two pavement sections indicates that the dirt was likely due to turning movements of the trucks, paver, or roller during paving operations. It is not believed that mastic made its way through the new pavement section rather the mastic was mixed in as it was rolled.

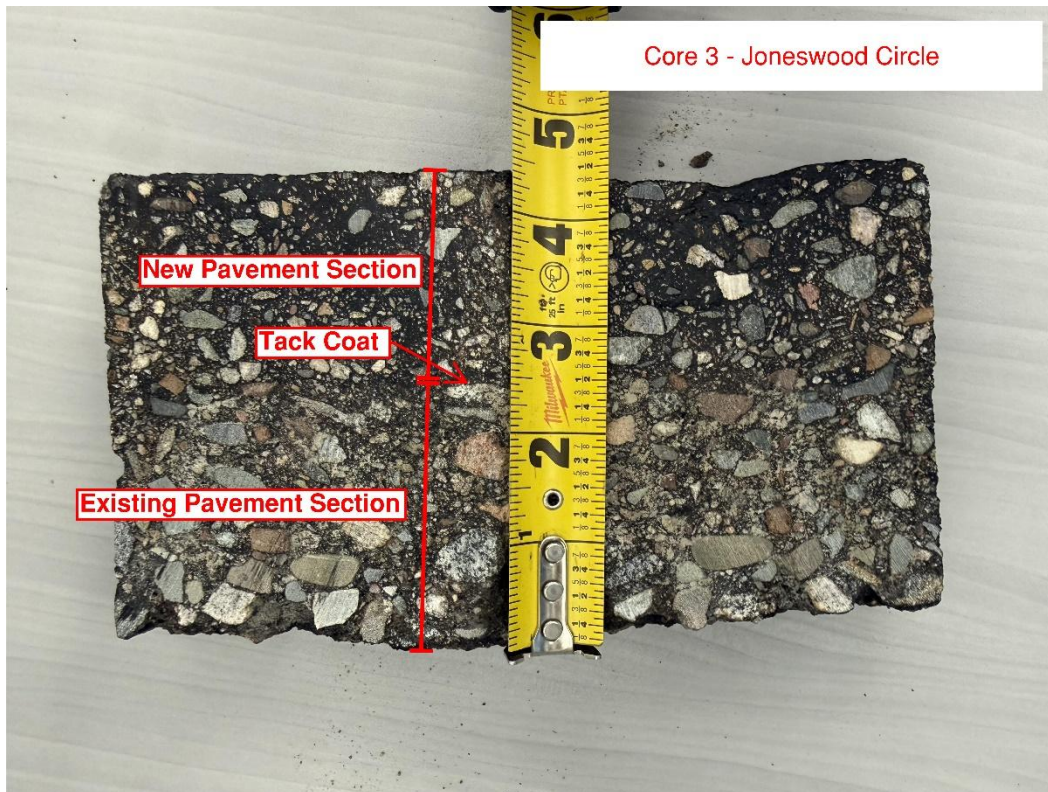
**Photo 9 - Section View of Core 3**

Core 3 was taken from Joneswood Circle at a location where Mastic had been observed on the pavement surface following the paving operations. The core, shown in Photo 9, was cut to determine whether Mastic had seeped through the newly placed pavement. Examination of the core did not show Mastic between the existing and new layer of pavement. Mastic was only observed in the surface of the core. The more probable explanation is that Mastic was picked up by construction traffic during the paving operations and rolled into the surface of the final lift. Photo 10 shows the top view of core 3.

As an initial best practice, when Mastic is used following milling operations, a minimum of a 2-week cure time should be provided to the Mastic prior to paving and attention should be made towards construction traffic over Mastic areas.
