RE: Whisky Creek Bridge
Structure Evaluation
2023-11678

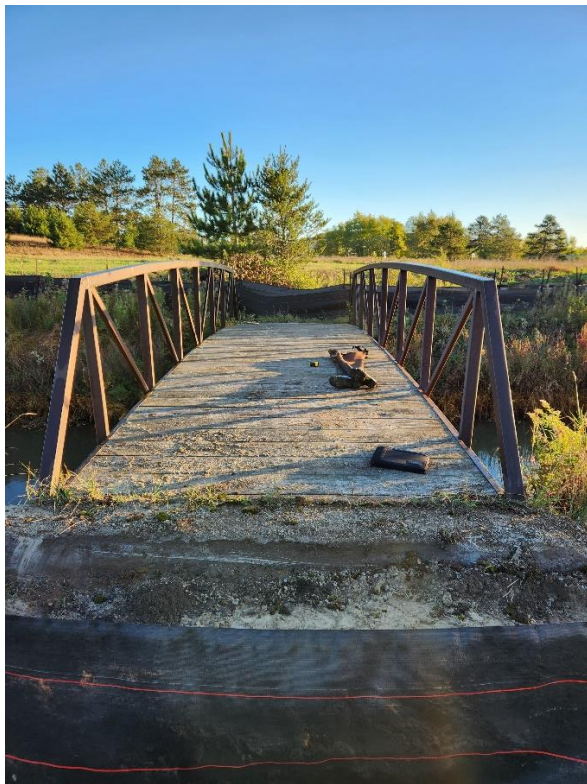
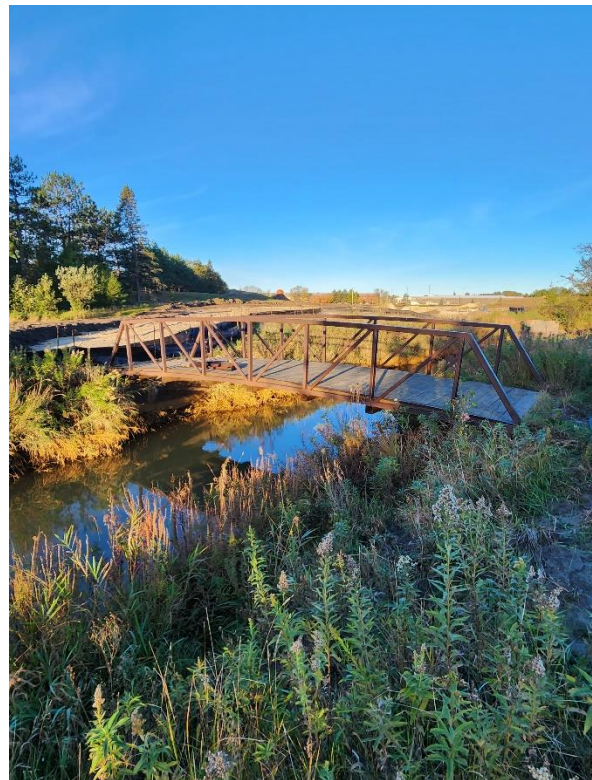
Per your request we completed a field inspection of the Whisky Creek Pedestrian Bridge to determine any immediate and long-term repair or maintenance items. The bridge is a steel truss style manufactured by Continental Bridge, the steel is corten and the deck is wood. Corten steel is used because it forms a dark brown oxidation over the metal that protects the steel from further corrosion and does not require painting. The steel truss is also a railing system that is 42" above the walk surface. The bridge is 30 feet long and 8 feet wide. Each end of the bridge is supported on a concrete abutment.

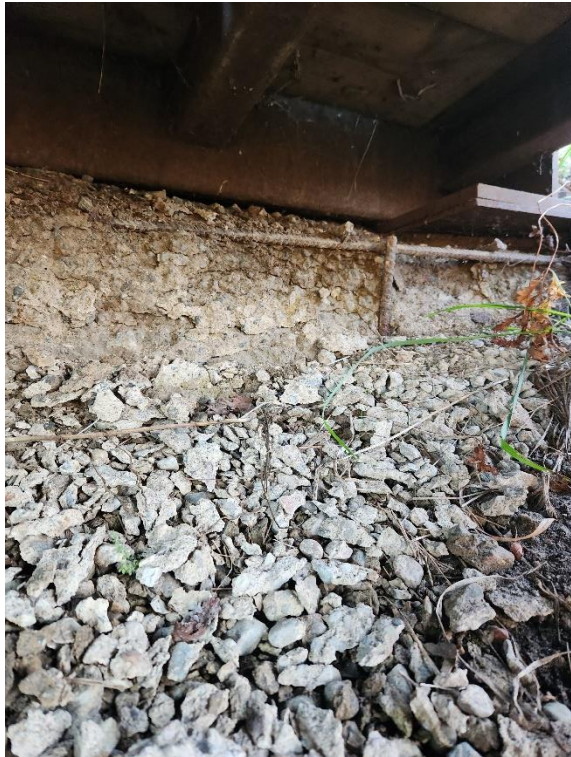
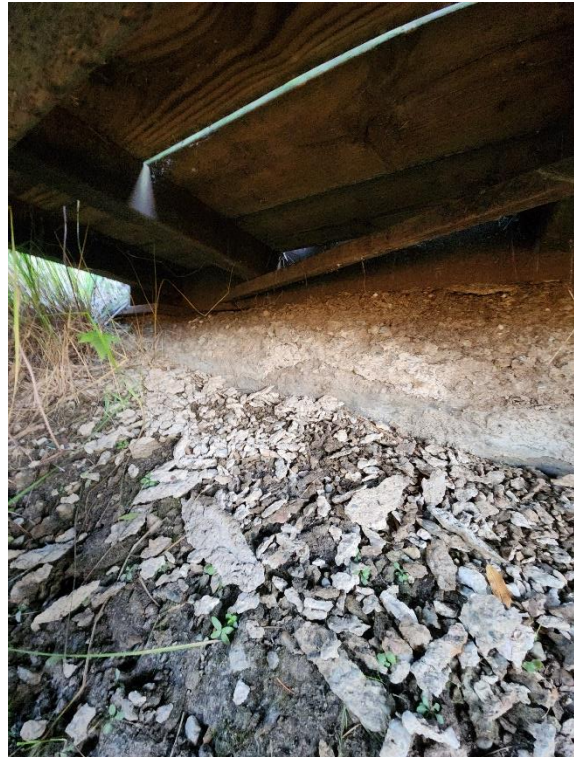
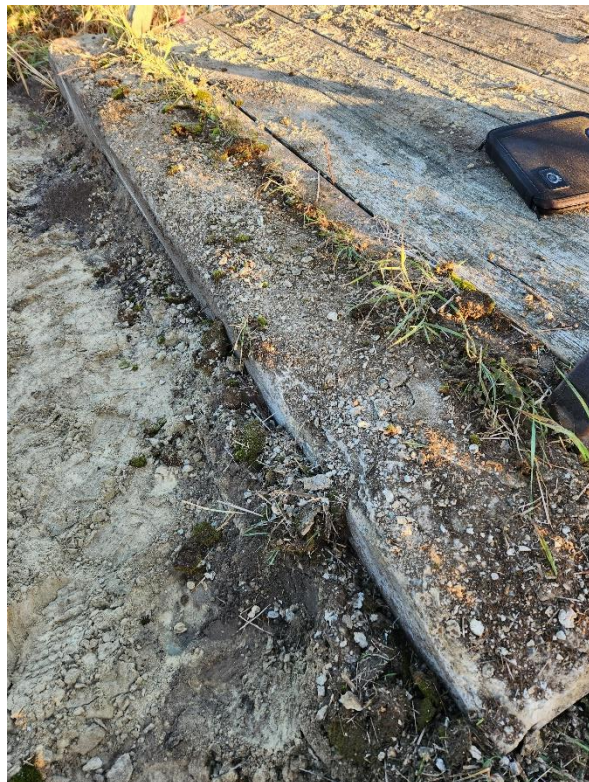
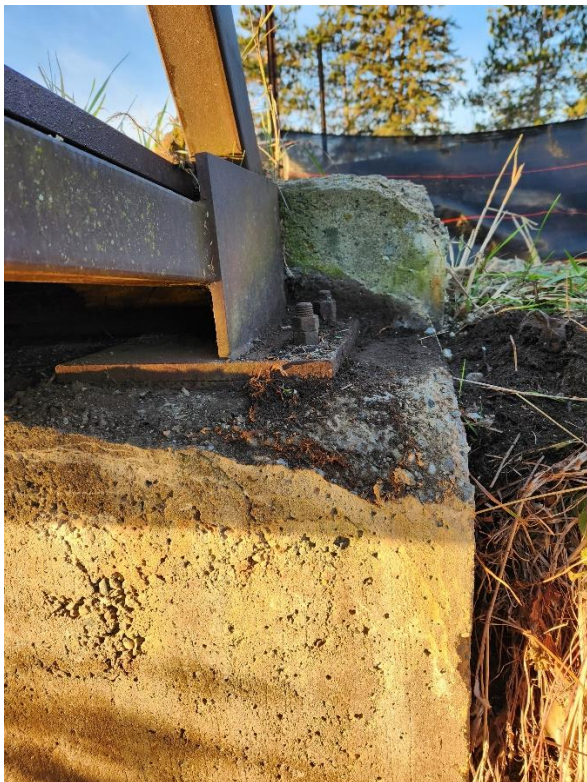
The bridge superstructure is in good condition with no noticeable defects in the steel portion. The timber plank are in fair to good condition with some minor deterioration starting. The concrete abutments are showing signs of severe deterioration along the top of the backwall and abutment seat,

the deteriorated concrete has extended under the northeast truss bearing seat. The deterioration extends about 50% under the seat. This is mostly occurring on the north abutment.

The condition of the abutments should be addressed in the next 12 – 24 months. It is anticipated the abutments can be repaired but will require the truss be lifted off, the deteriorated concrete at the top portions of the abutment be removed to sound concrete, new reinforcement installed and patch concrete placed. The bridge could also be relocated onto new abutments if there is a better location for the bridge. The wood decking appears like it will last another 4 – 5 years before it will need to be replaced. No repairs to the steel truss will be needed in the foreseeable future.

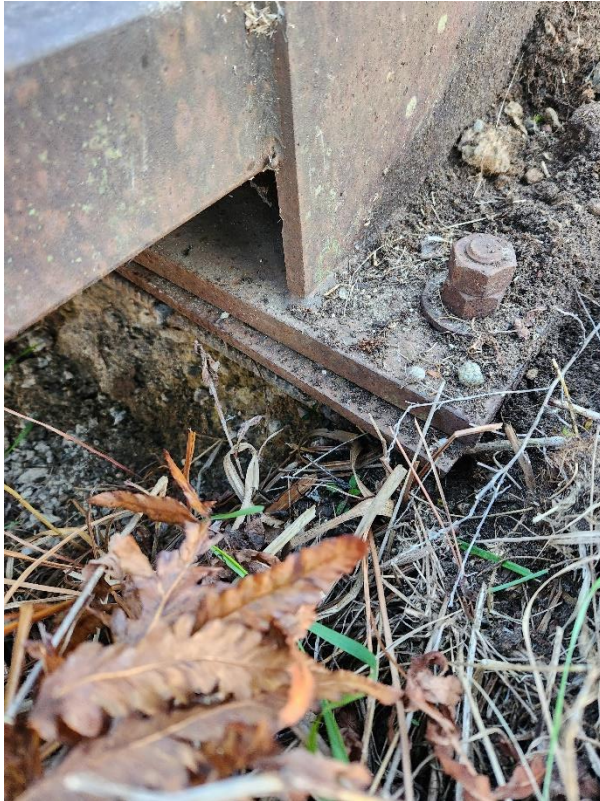
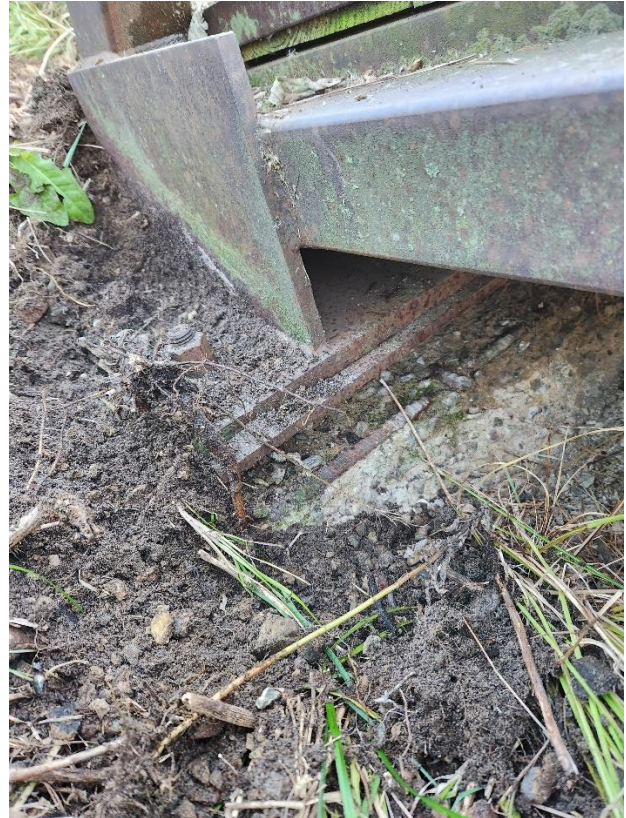
At the time of the inspection there was dirt and grass growing over some of the bearing plates, these bearing plates should be kept clean to prevent moisture and deterioration of the steel and anchor bolts.
