## FIELD REPORT

Project: Baxter WTP Backwash Trough Sealing Improvements

Field Report No.: 1  
Project No.: 189400

Date: 5-19-2026

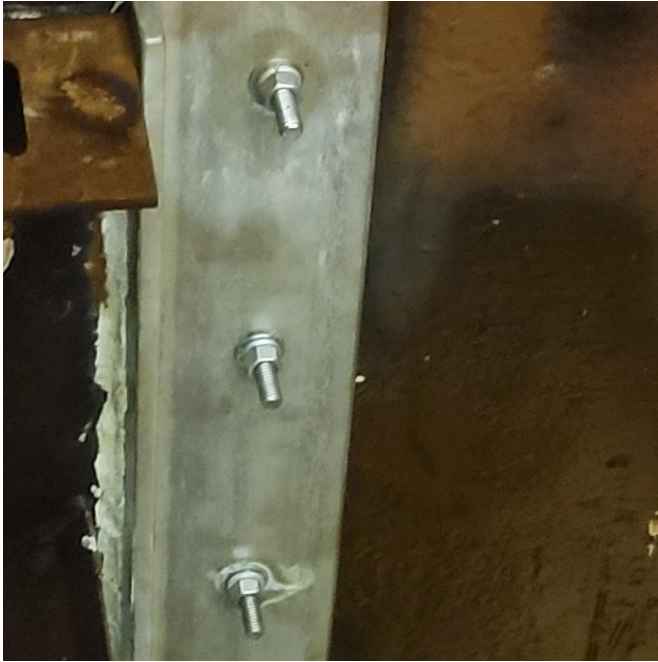
1. Example of angle bracket installation.

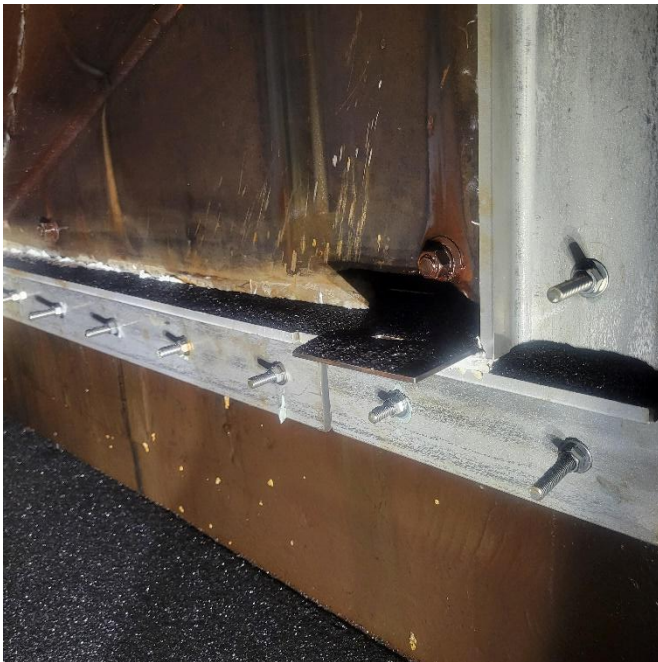
2. Example of angle bracket installation.

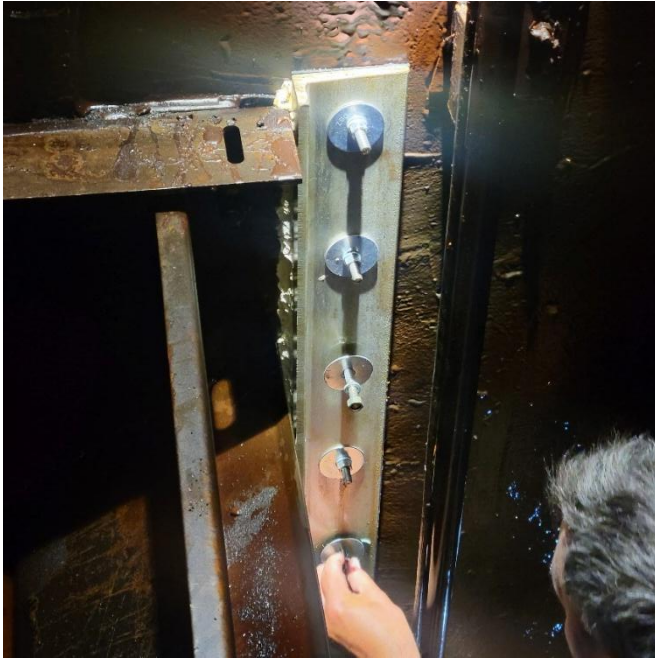
3. Reinstalling washers, lock washers, and nuts on studs.

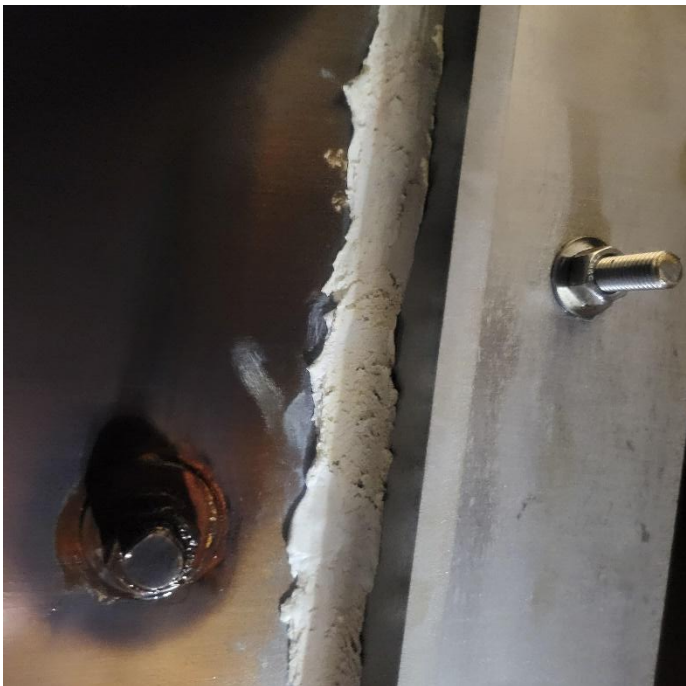
4. Example of Waterweld application.

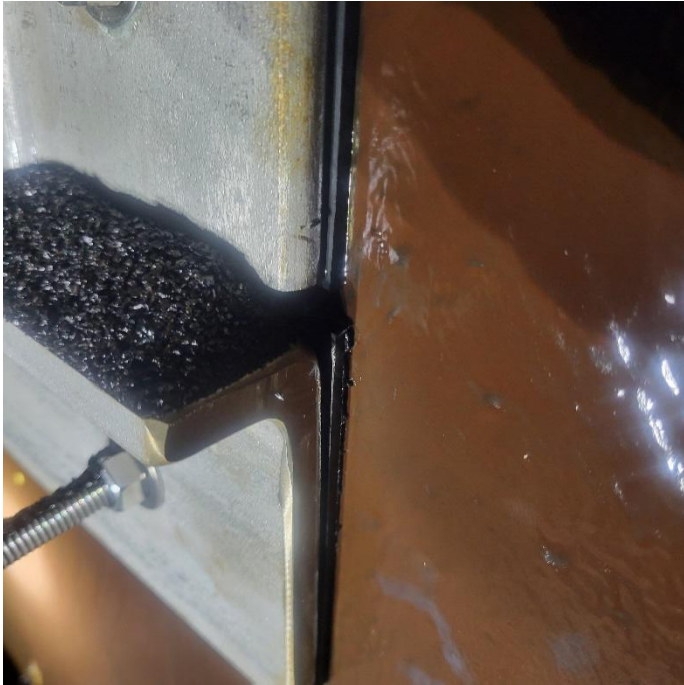
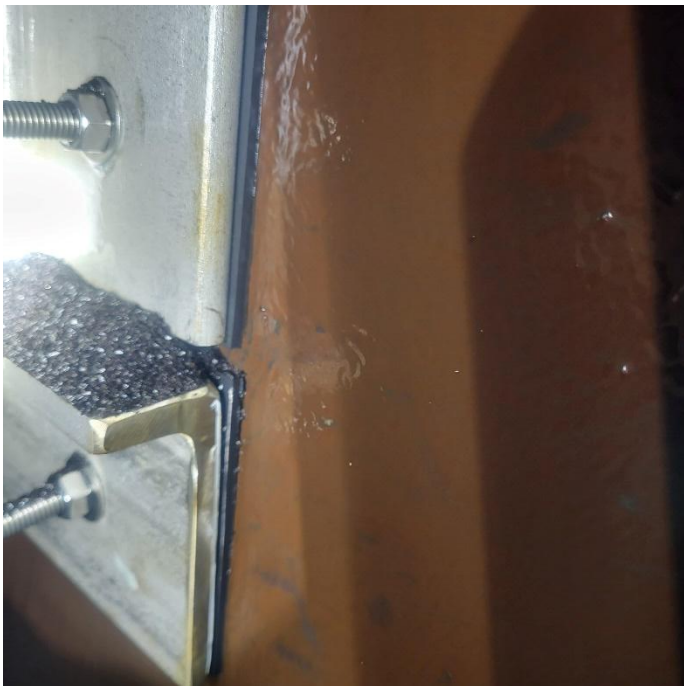
Filter #3 still has minor leak, but leakage is reduced by approximately 70%. Contributors to the continued leakage are the concave concrete wall at the bottom of the trough and a small gap where two gaskets butt up to each other. There is also a 1" crack in a weld on the lower lefthand side of the trough (looking towards the wall pipe). The cracked weld leaks water, but likely does not contribute to media loss. On 5/12/2026 City staff also observed media being lost through the gap between the stainless collar on the lower right side.

5. Gap in gasket at Filter 3.

6. Gap in gasket at Filter 3.
