# BUILDING ASSESSMENT AND PREDESIGN REPORT

## BAY CITY PUBLIC SAFETY HEADQUARTERS

### 4000 AVENUE F, BAY CITY, TEXAS

BUILDING ASSESMENT REPORT - 06/07/2021

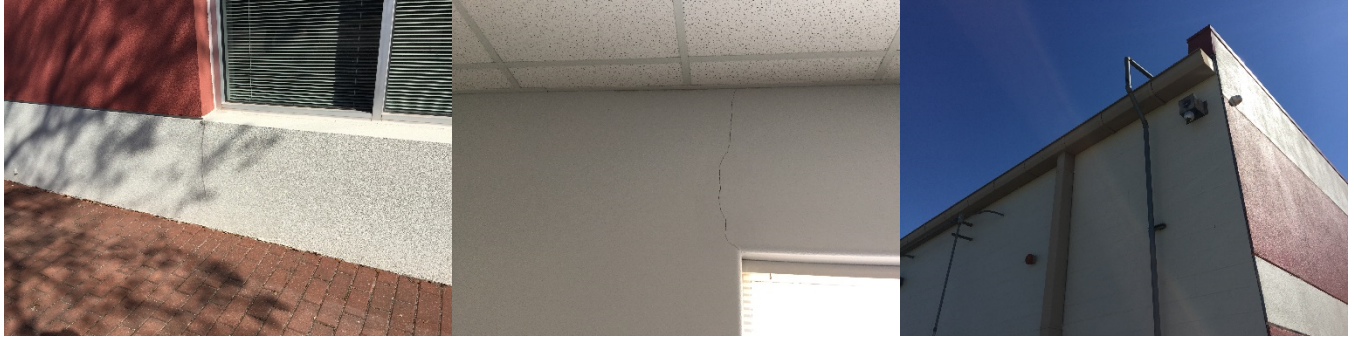
- The exterior bearing walls are 12" concrete block which have been covered by plaster on 3 sides. There is only one very minor sign of cracking on the south side.

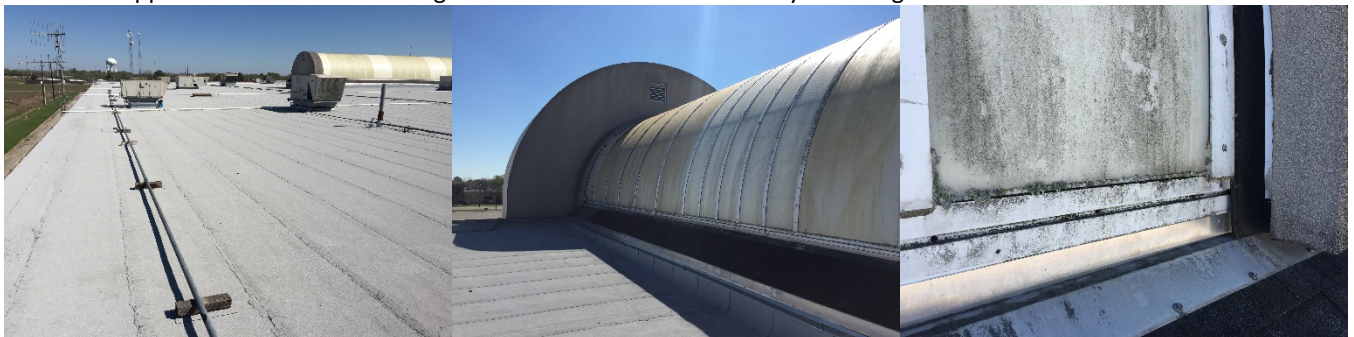
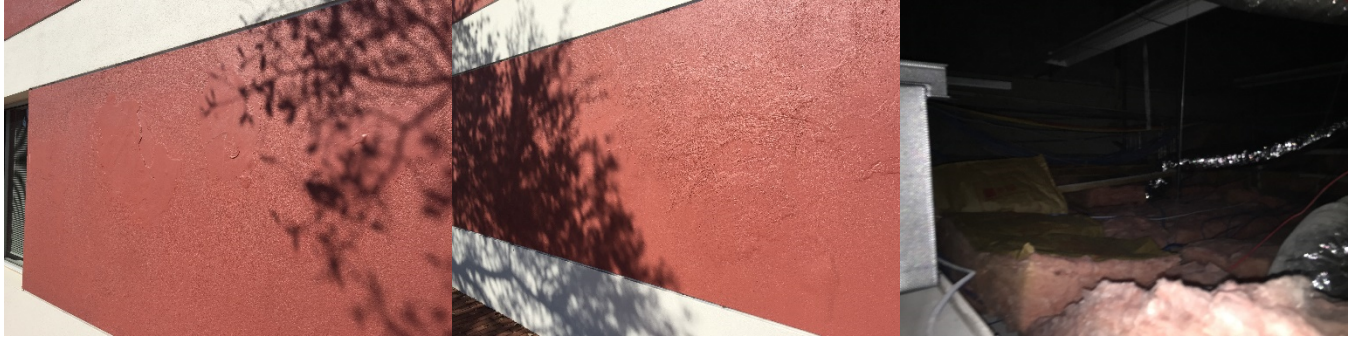
- The roof was replaced 1 year ago with a modified bitumen roof and granular coated cap sheet. It appears to be in excellent shape. The extent of roof insulation is unknown.

- The barrel skylight in the lobby is a translucent polycarbonate material. It is 15 years old with a life expectancy of 20+ years. There are no signs of damage from hail and only minor yellowing of the panels. There is mold build-up, so a power wash would be recommended. The replacement cost for new skylight panels and minimal structure would be about \$315,000.

- The exterior plaster installed over the concrete block shows signs of repair in many locations. The appearance of these repairs is noticeable due to a smooth finish compared to the sand finish of the plaster. The exterior is painted with elastomeric paint which is excellent at sealing against water but shows some signs of sagging.

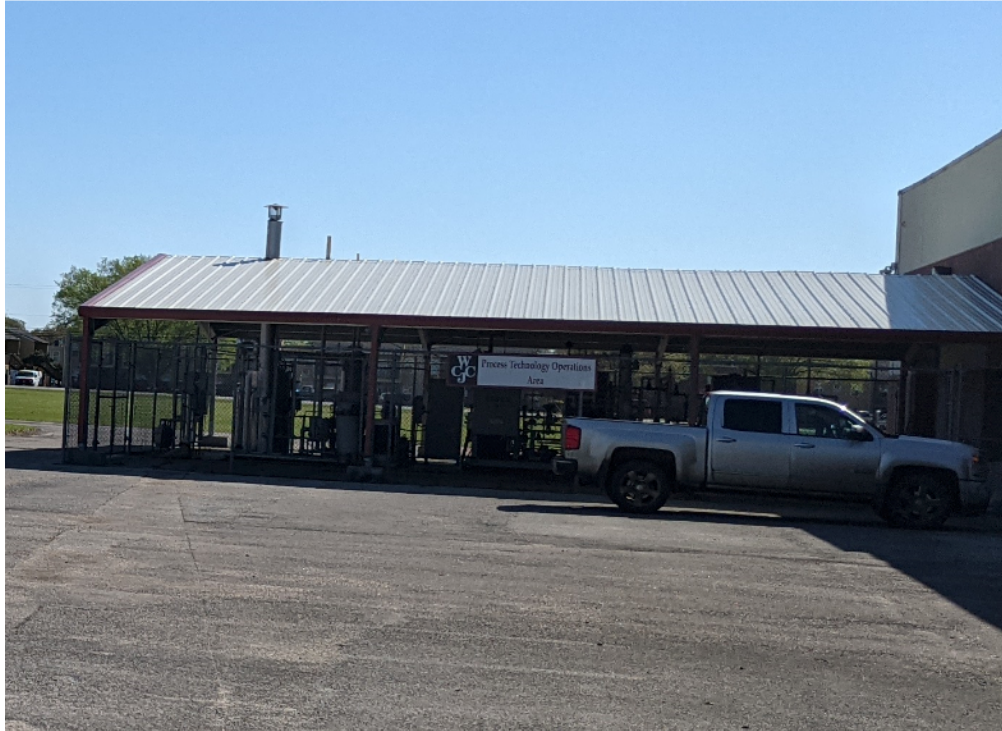
**Figure 3 – Steel-Framed Open Canopy Structure at North Side of Building**

There are also a few specialty equipment foundations on the north side of the building, including two antenna bases, a generator pad, and some additional equipment under the open steel-framed canopy structure.

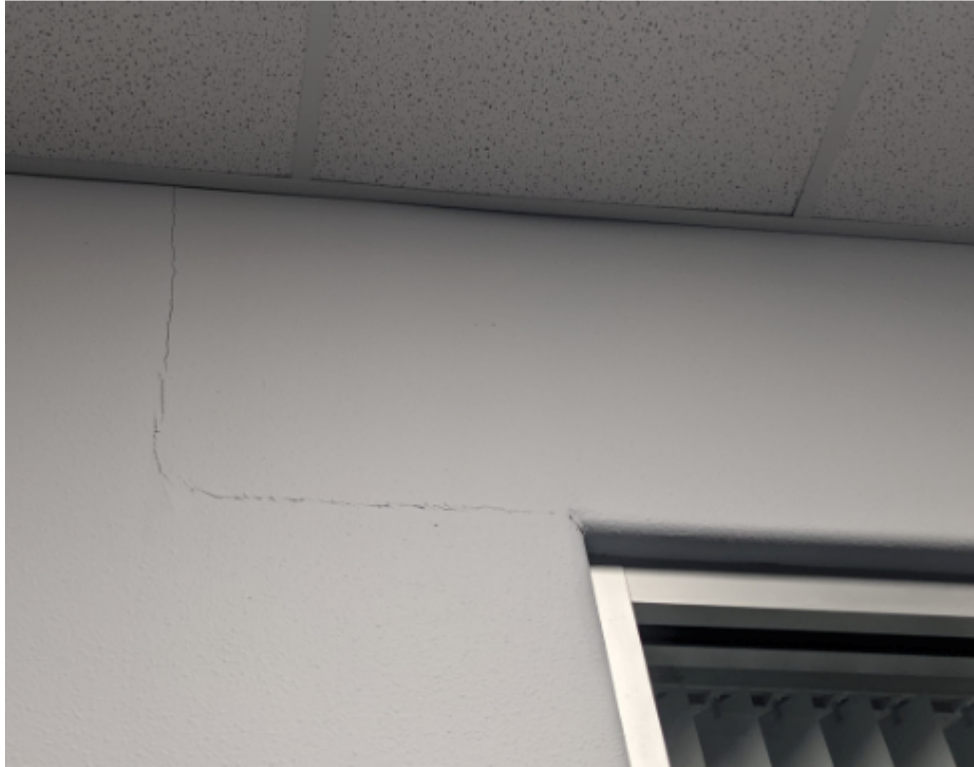
**Figure 5 – Gypsum Wall Crack at Interior Wall**

We walked much of the internal areas that were accessible to us on the day of our visit, and did not note any areas that had noticeable cracking at the flooring or change in slab slope. We noticed a couple of locations where the interior gypsum board walls showed cracking that could be associated with some movement of the slab (ref. Fig. 5).

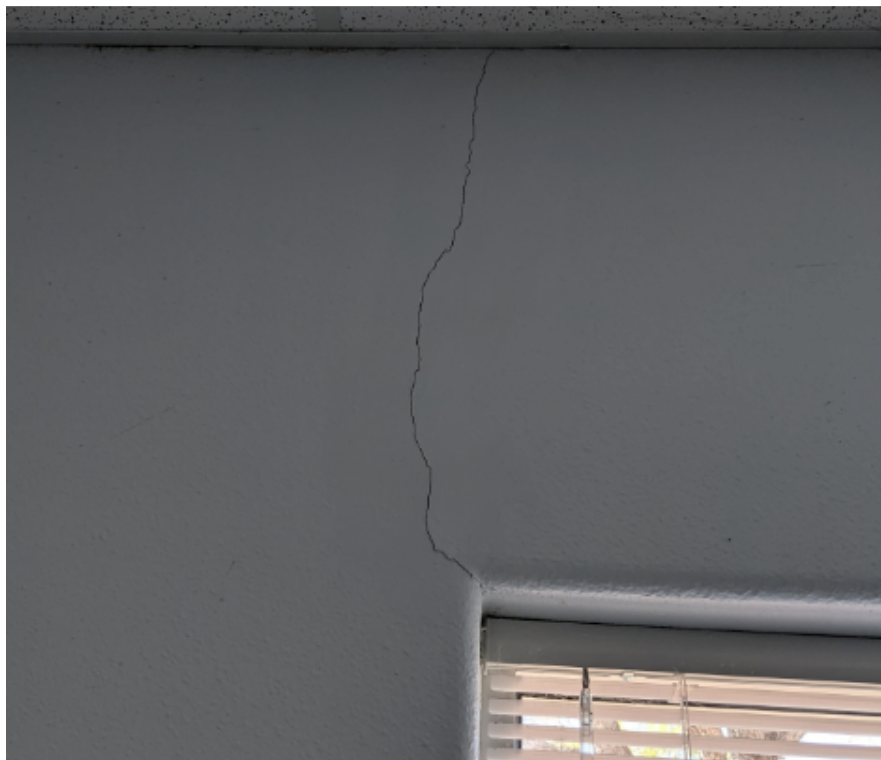
**Figure 6 – Gypsum Wall Crack at Exterior Wall (Near SE Corner of Building)**

We also walked the exterior perimeter of the building and typically did not note visible cracks in the building façade that would indicate potential ongoing differential settlement at the building footings. The exception was the bottom of a window on the south elevation of the building near the southeast corner (ref. Fig. 7), where we had also observed cracking at the interior finish from the top of the same window as well (ref. Fig. 6).

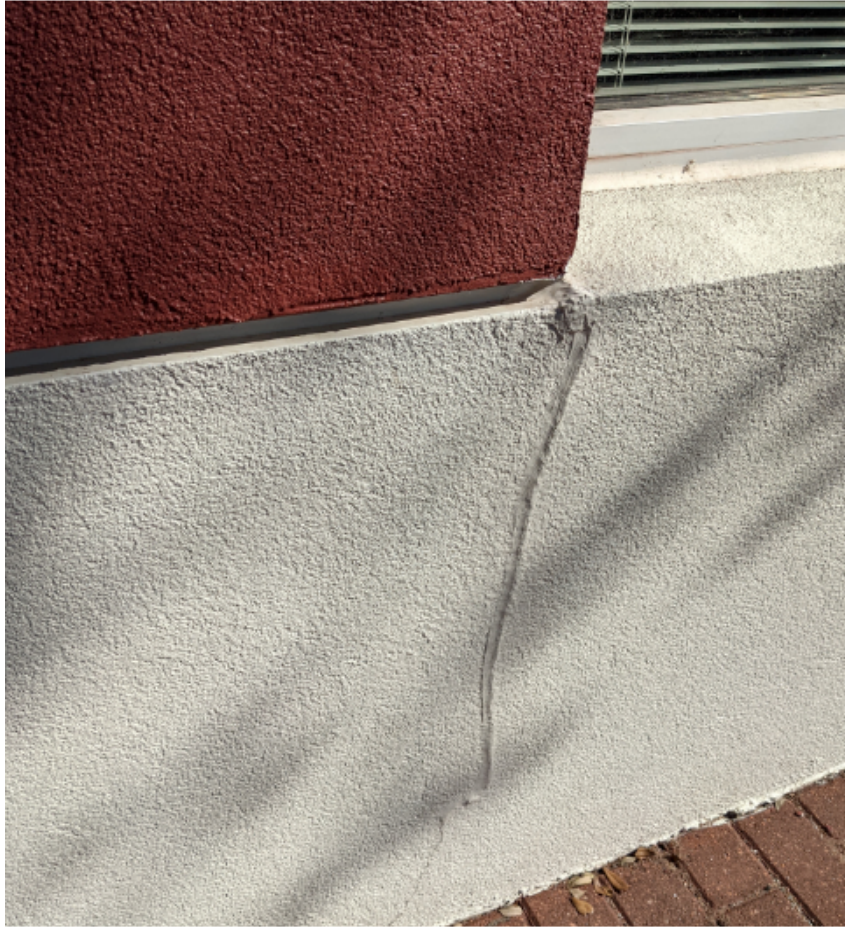
**Figure 7 – Facade Crack at Exterior Wall (Near SE Corner of Building)**

We noted that there are trees in planter areas that are very close to the building on the east and south sides, and the belled piers bear at a relatively shallow depth of 6 feet below grade, but it is unclear if the tree root systems may or may not have contributed to the foundation movement at the location of the cracked façade. We also noted from the as-built drawings that the original building construction included a small covered area in this same location at the southeast corner that had been removed at some point in the past.

It is worth noting that it appeared the entire exterior façade had recently been refinished and/or repainted, and the stucco expansion joints were filled with relatively new sealant. In some cases, upgrades to the façade can conceal cracks that have developed in the finishes, making it more difficult to identify any associated shifting at the foundations.
