Structural engineer report

Compass Floodplain Consultants, LLC
P.O. Box 3145
Bay St. Louis, Mississippi 39521
compass3@bellsouth.net
September 20, 2023

Structural inspection and analysis of property at 343 George Street, Bay St Louis

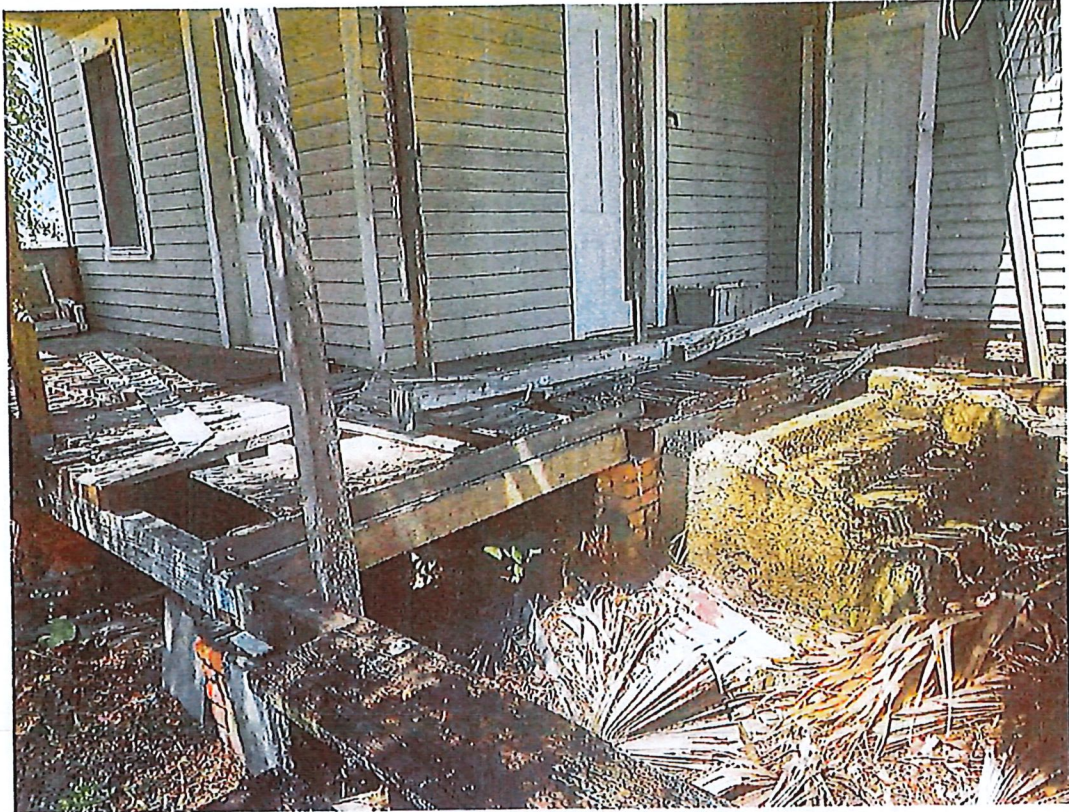
Photo 091223 deterioration of foundation elements

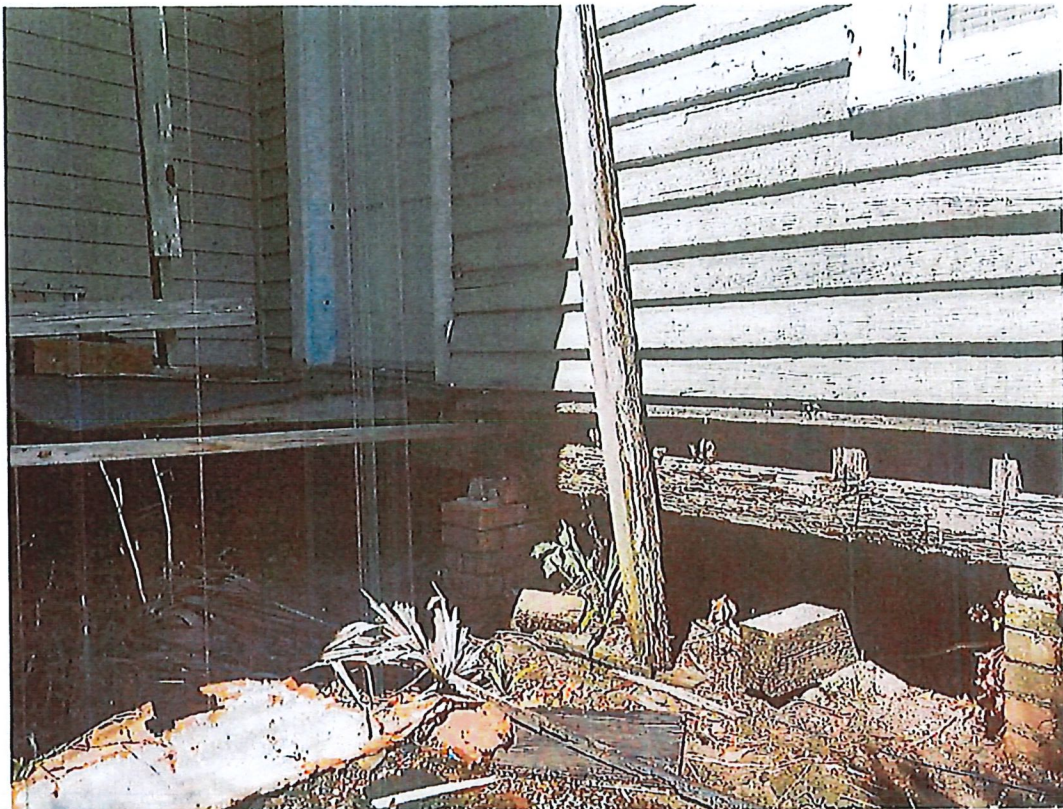
Photo 091223 deterioration from weathering and termites of horizontal support beam

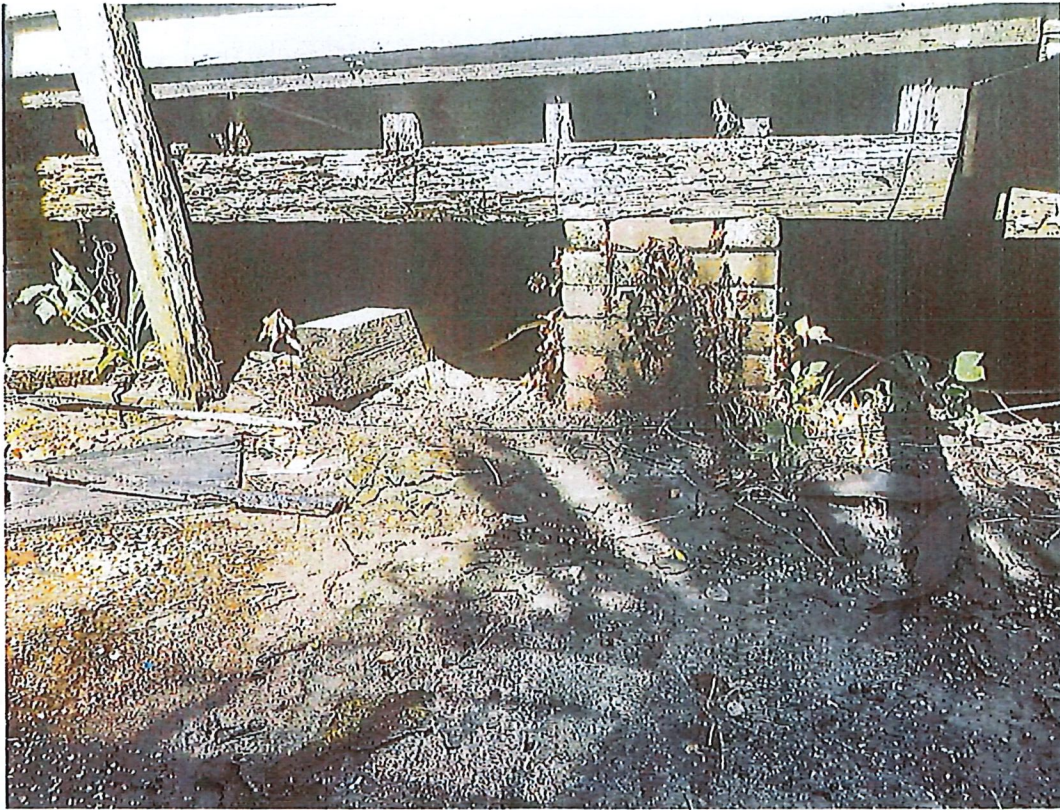
Photo 091223 deterioration from weathering and termites of horizontal support beam

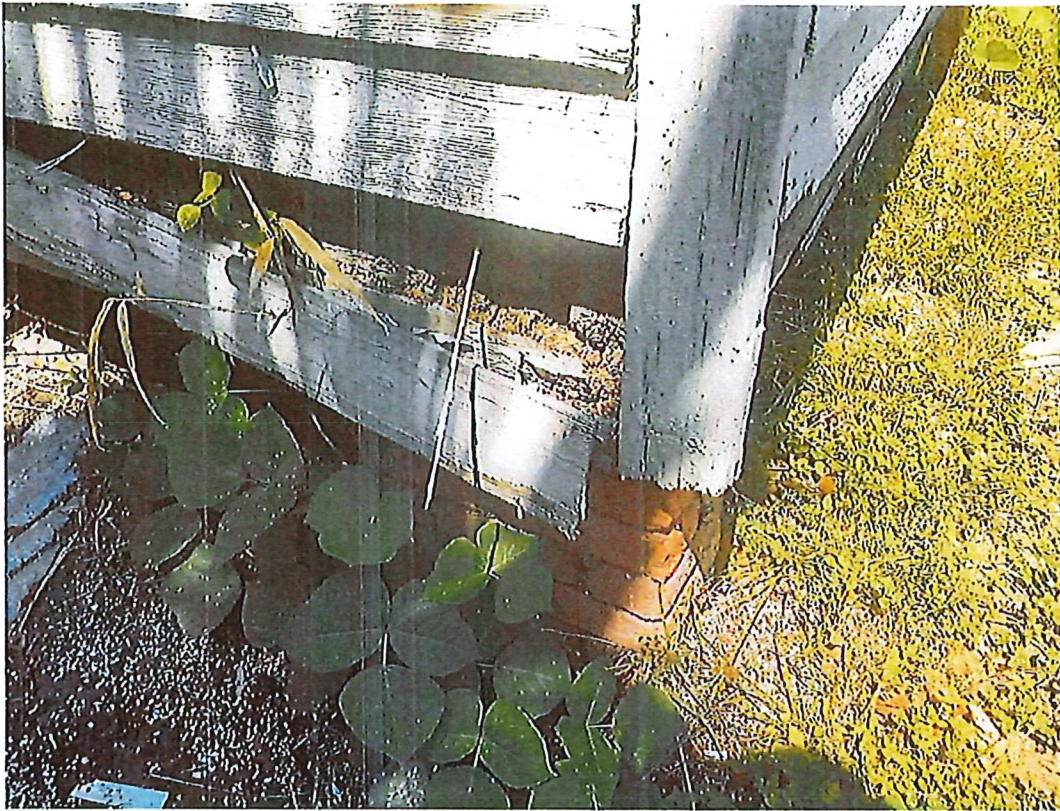
Photo 091223 exterior wall damage from weathering and termites.

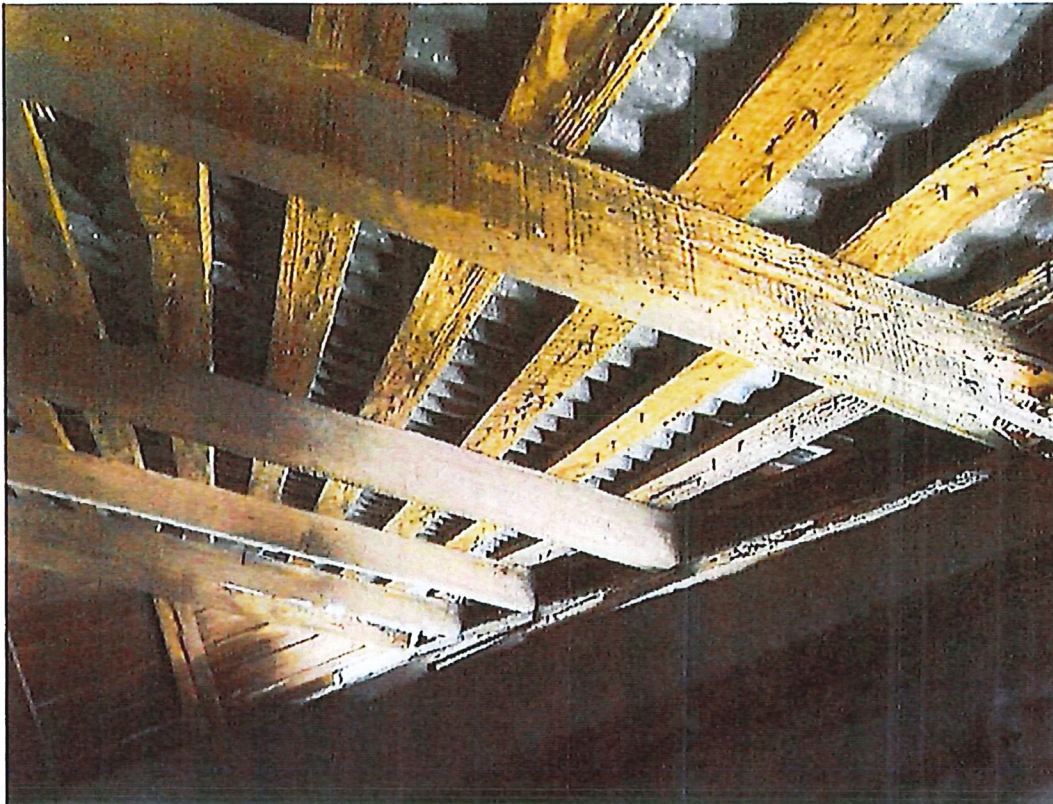
Photo 091223 rafter and purlin damage and a non-existent load path from the roof to the exterior walls

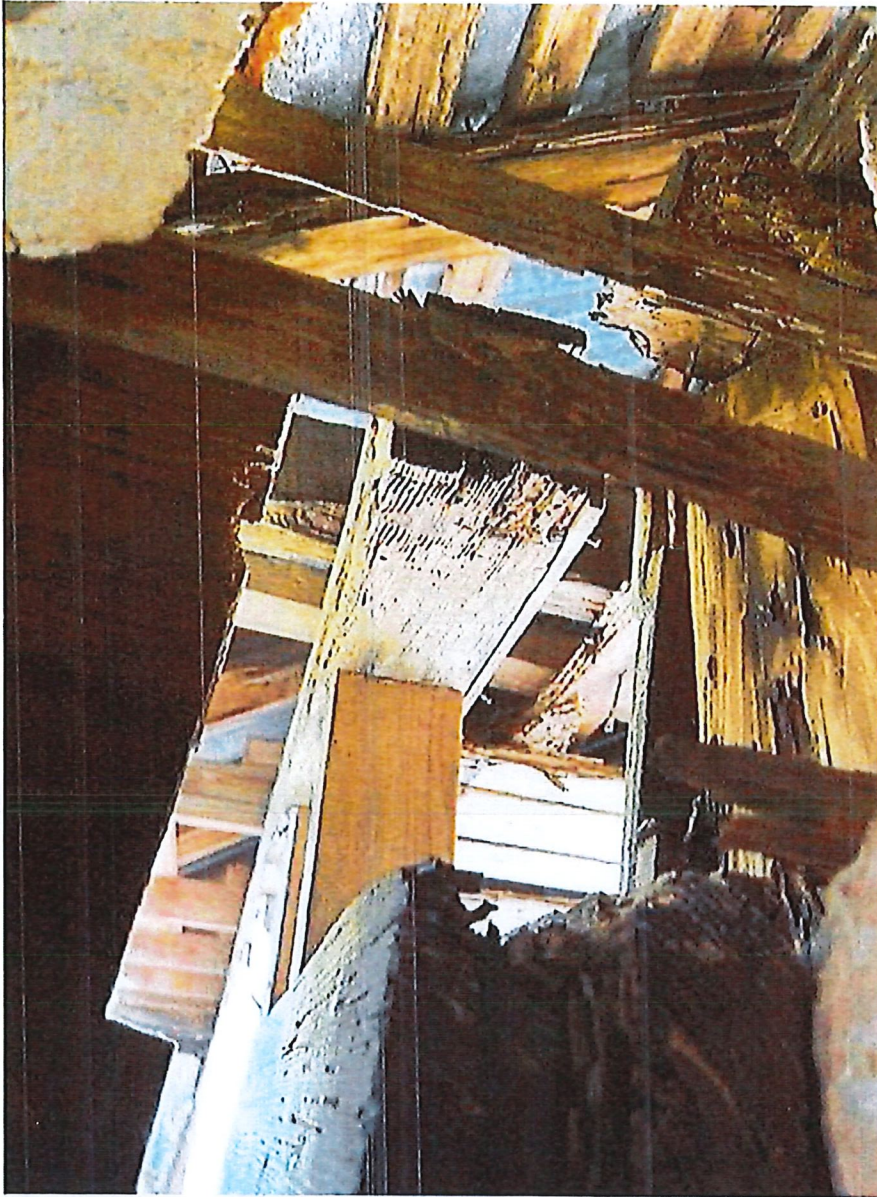
Photo 092023 roof deterioration from weathering and termites of rafters, cross bracing and purlins

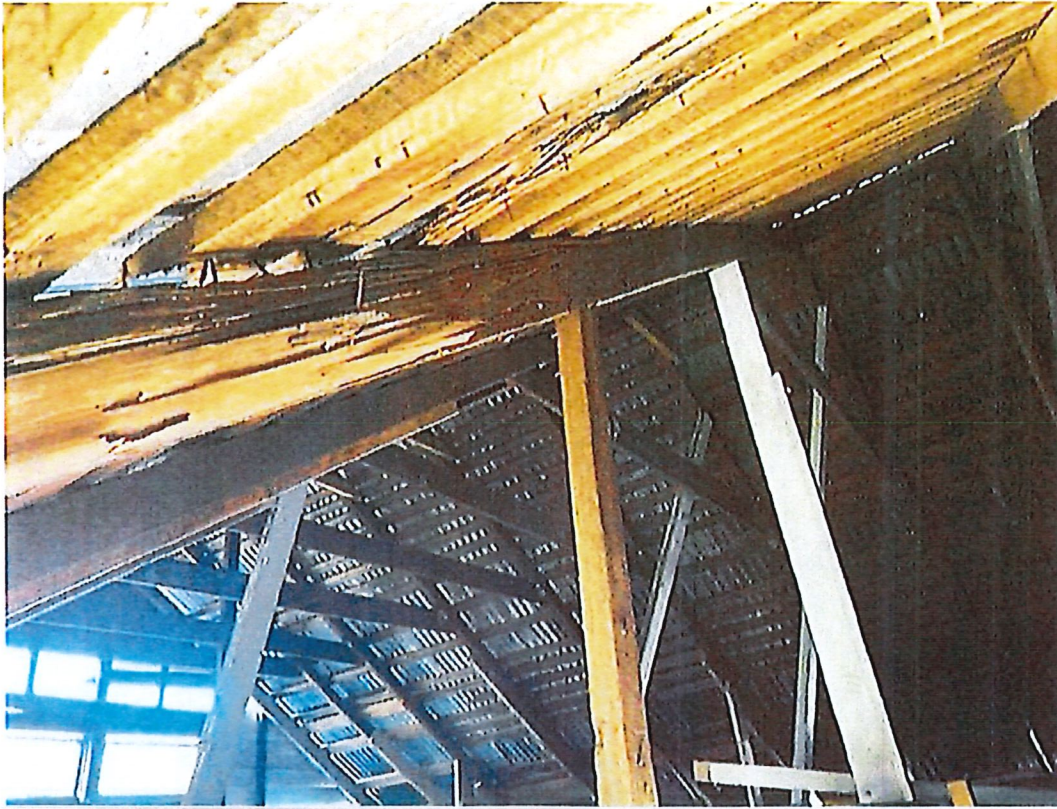
Photo 092023 roof deterioration of purlins, rafters, and cross bracing. In addition, no indication of a load path connecting rafters and plates to walls.

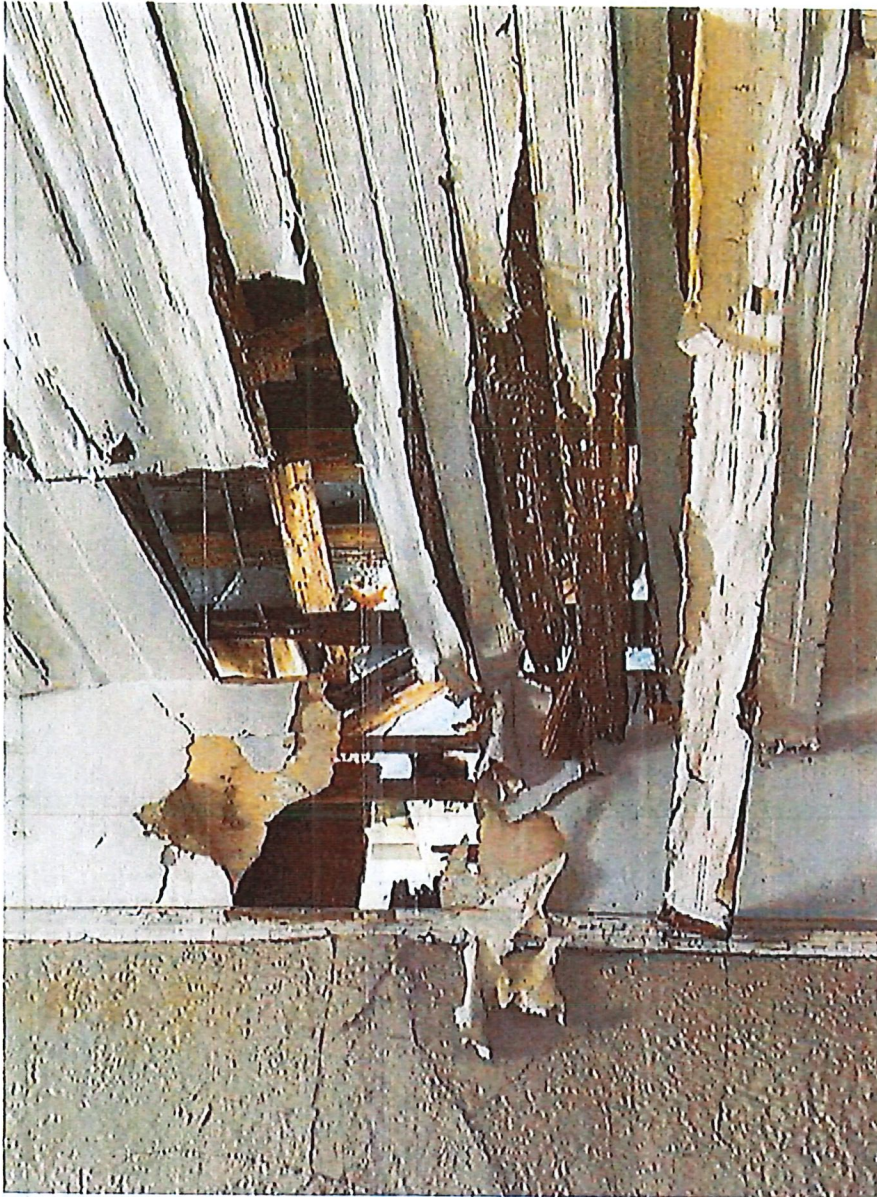
Photo 092023 interior ceiling damage from weathering and termites cross bracing and purlins can be seen in the background

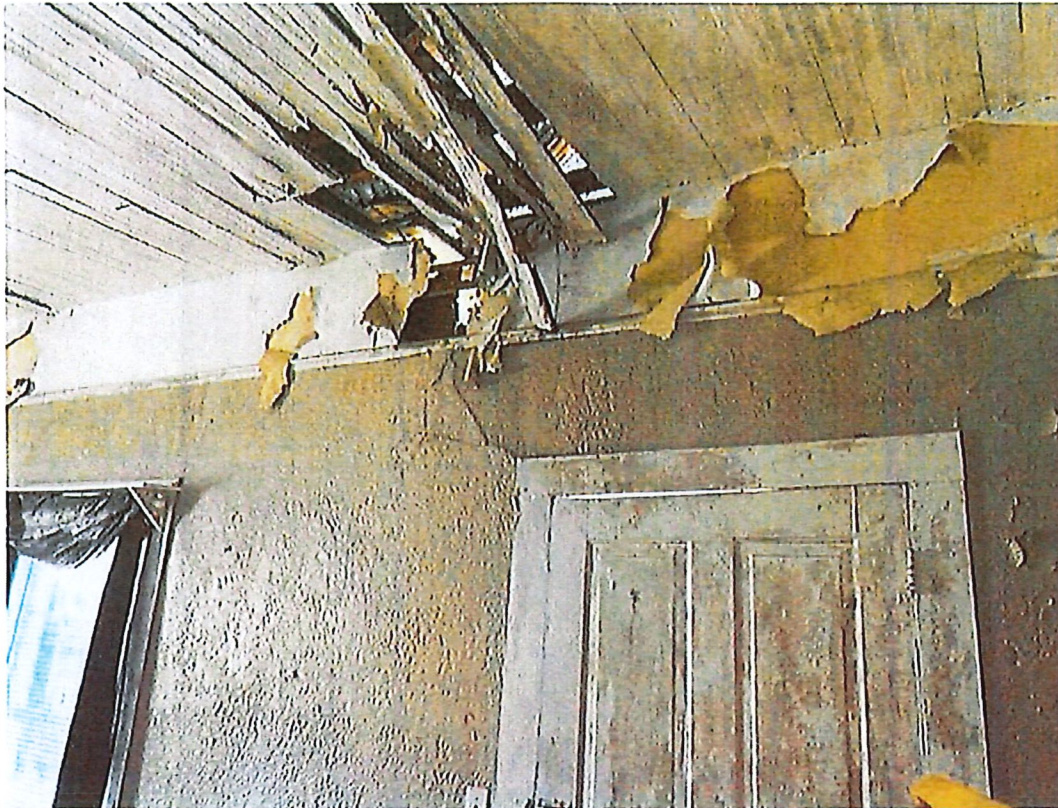
Photo 092023 interior mold and structural cracks above door indicating settlement.

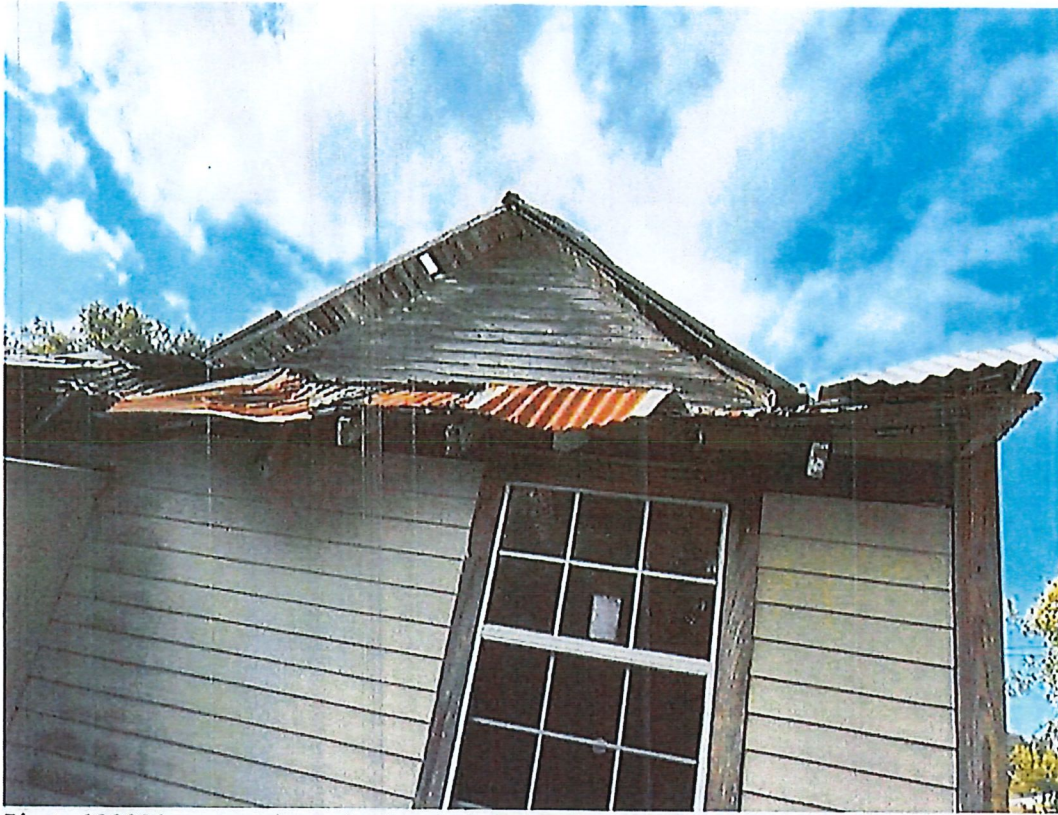
Photo 092023 a non existent load path from roof to exterior walls and indications of settlement.
Sincerely
