Property Assessment Report

232 Citizen Street
Bay Saint Louis, Mississippi 39520

Inspected by:
Home Inspection Building Specialist Inc.

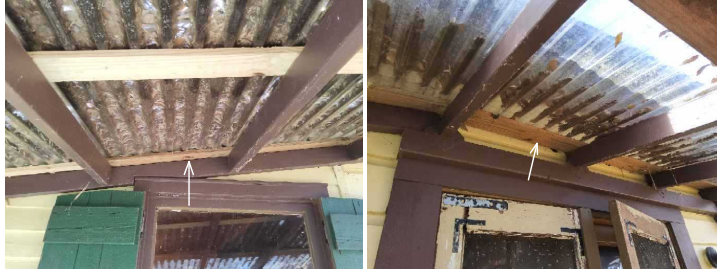
7. Major Concern Patio Cover: Wood - The left side patio cover is not properly attached / flashed to the home. Recommend a licensed contractor make the needed corrections.

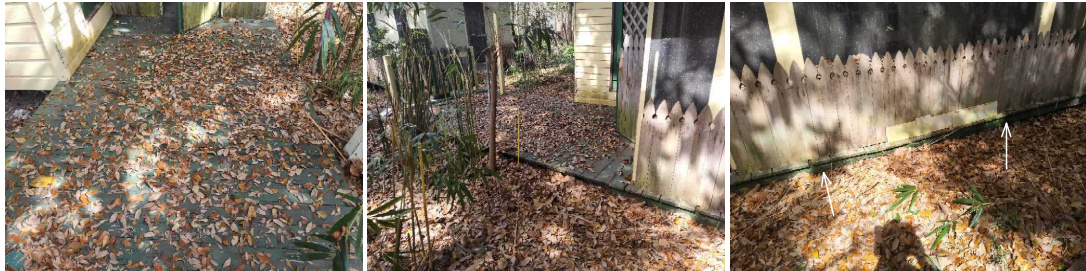
8. Major Concern Deck: Wood - Damaged wood was observed at the deck framing and portions of the deck appear to be constructed in direct contact with soil. Wood in soil contact is highly susceptible to accelerated deterioration and termite activity. Structural members showing deterioration should be replaced and the deck should be reconstructed so that structural framing is properly elevated above grade and protected from moisture exposure.

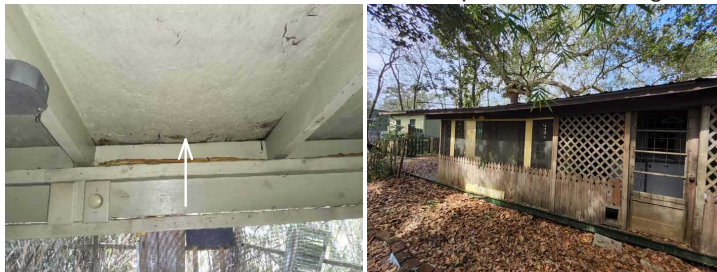
9. Major Concern Deck Cover: Wood - The deck cover has damaged wood and was observed sagging. Recommend a licensed contractor remove and replace all damaged wood.

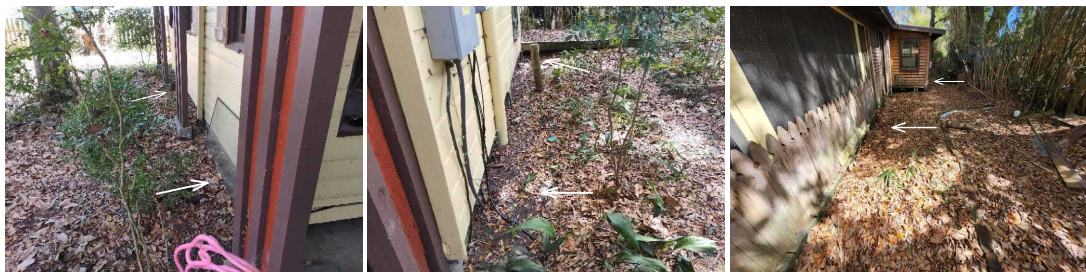
10. Major Concern Grading: Negative slope - The exterior grade slopes toward the structure allowing rainwater to collect beneath the crawlspace. Standing moisture was observed beneath the structure during the inspection despite no recent rainfall. Chronic moisture conditions in crawlspaces can accelerate wood deterioration and create conditions conducive to termite activity and fungal growth. Recommend correction of site grading and drainage to divert surface water away from the structure.

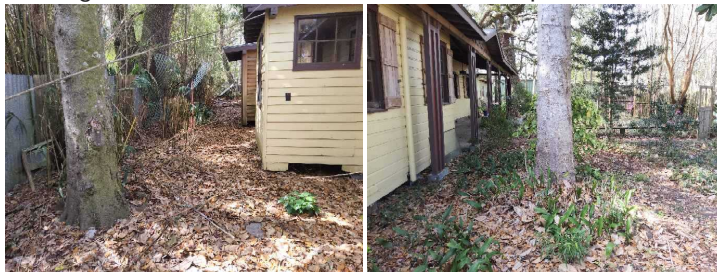
12. Attention Needed Vegetation: Trees, Shrubs/Weeds - Roots from a tree located near the foundation could cause foundation damage as the tree grows and the root system expands. Monitor this area of the foundation during the growing season (usually May through September) for signs of damage. If signs of damage appear (such as cracks) the tree may need to be removed. The potential for damage from tree roots varies with tree species. Consider evaluation by a qualified arborist.

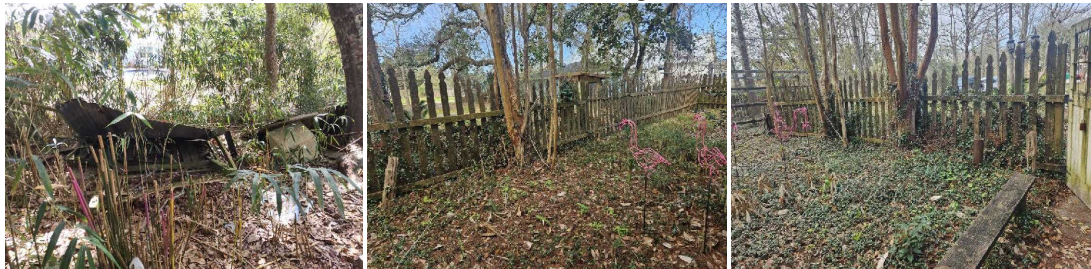
13. Not Inspected Fences: Wood - Inspection of fencing lies beyond the scope of the general home inspection. The fences were not inspected. *Note: Fence and / or gates are in need of repair.

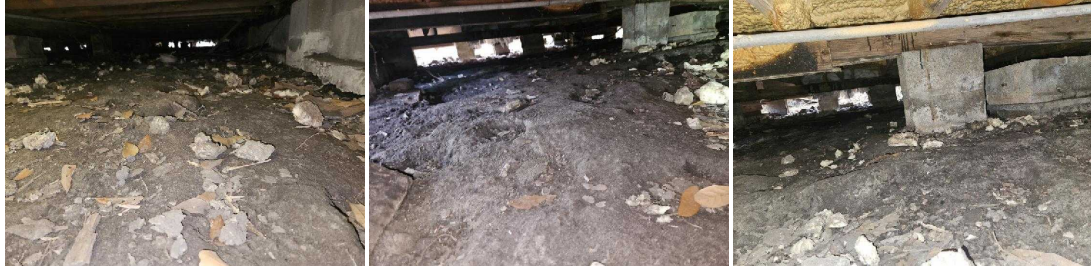
1. Major Concern Floor/Slab: Dirt - Wet soil conditions were observed beneath the structure during the inspection despite no recent rainfall. Persistent crawlspace moisture can accelerate wood deterioration and contribute to conditions favorable for termite activity and fungal growth. Recommend further evaluation and correction of moisture sources including grading, drainage, and ventilation improvements.

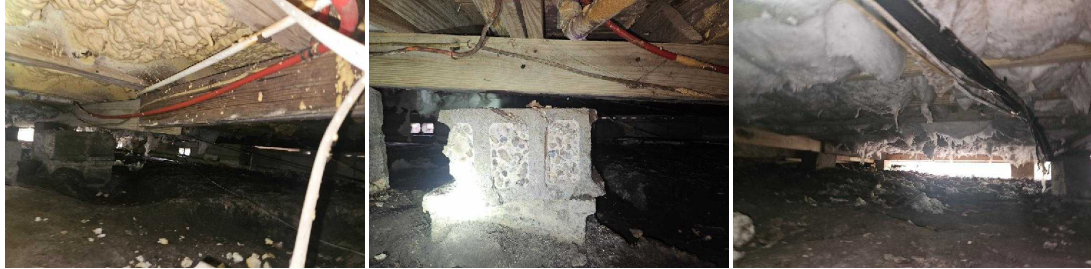
Beams: (continued)

2. Major Concern Foundation: Pier / Beam
3. Acceptable Structure Type: Wood frame
4. Major Concern Differential Movement: Sloping floors
5. Major Concern Beams: Wood - Structural beams supporting the floor framing were observed deteriorated, sagging, and in some locations broken or improperly spliced without adequate pier support. Several supporting piers also appear deteriorated from long-term moisture exposure and possible termite activity. These conditions indicate significant structural distress within the crawlspace framing system. Recommend a qualified contractor or structural professional further evaluate the structural support system and repair or replace all compromised beams and piers.

Due to the extent of deterioration observed, the structural integrity of the floor framing system is considered significantly compromised. The full extent of structural damage cannot be determined without removal of insulation and additional invasive evaluation.

Substantial structural repairs or reconstruction may be required to restore structural integrity.

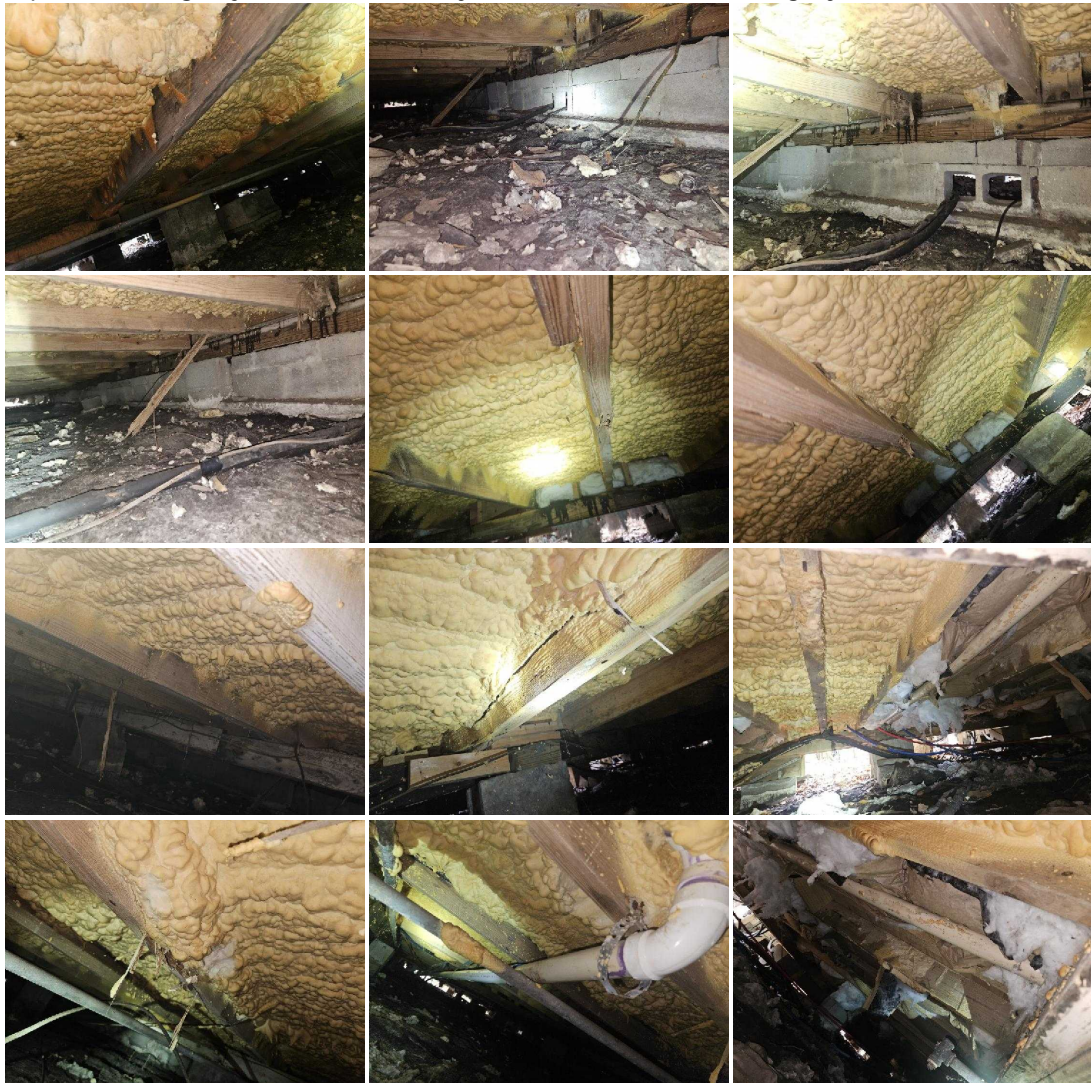
Joists/Trusses: Wood - Many floor joists were observed deteriorated and structurally compromised throughout the crawlspace. Several joists appear to have been previously repaired by scabbing additional lumber to damaged members; however, the existing joists and repair members show continued deterioration consistent with moisture exposure and termite damage. Significant sagging of the floor structure was observed in the rear right portion of the home. Recommend a qualified contractor or structural professional evaluate the framing system and replace damaged joists as necessary to restore structural integrity.

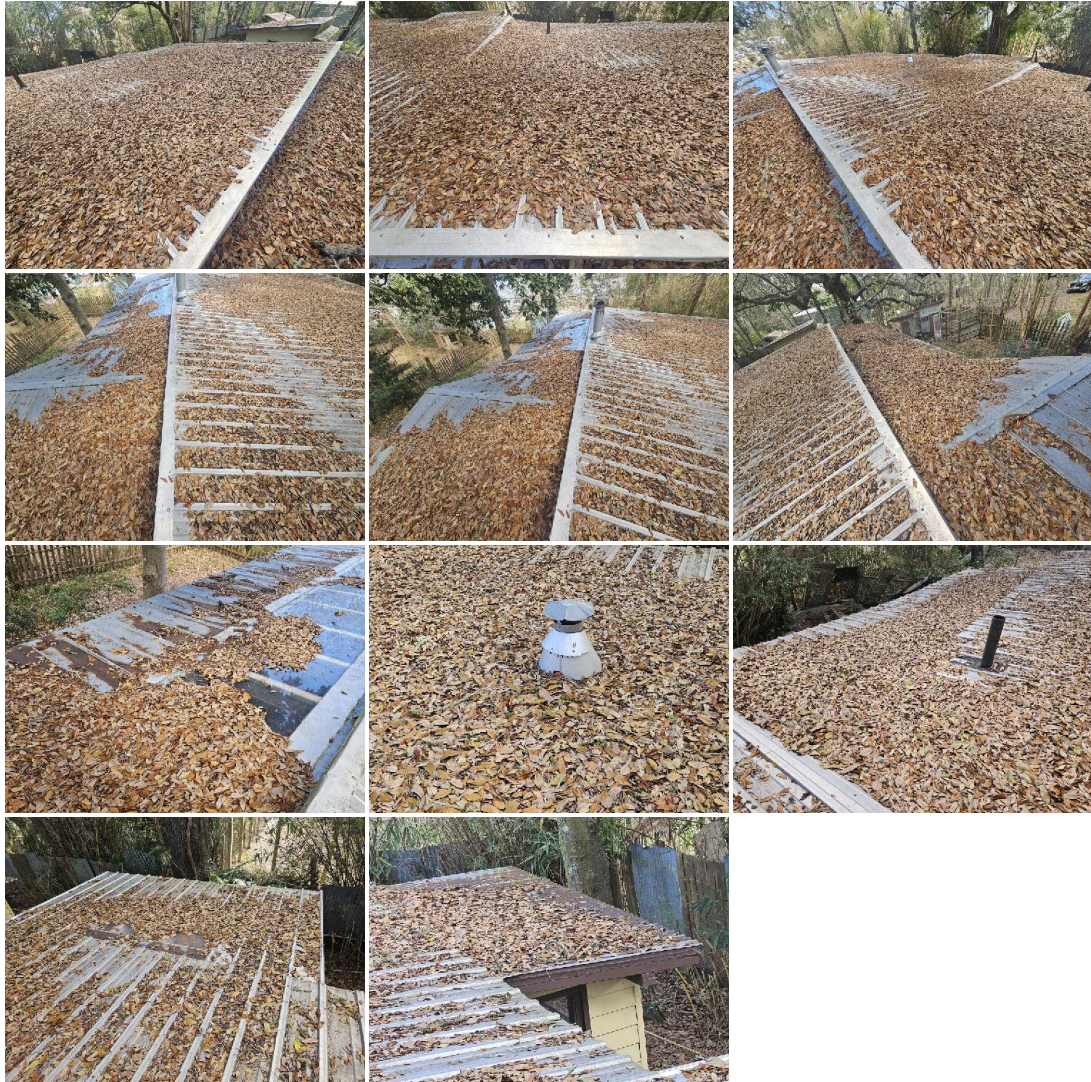
2. Major Concern Material: Metal - The roof covering consists of metal panels with areas of rust and debris accumulation. Significant debris buildup was observed across large portions of the roof surface. The rear right section of the roof exhibits visible sagging which may be related to structural framing issues beneath the roof. Heavy debris accumulation also adds weight to the roof structure when wet. Recommend removal of debris and further evaluation of the roof structure and covering by a qualified roofing contractor.

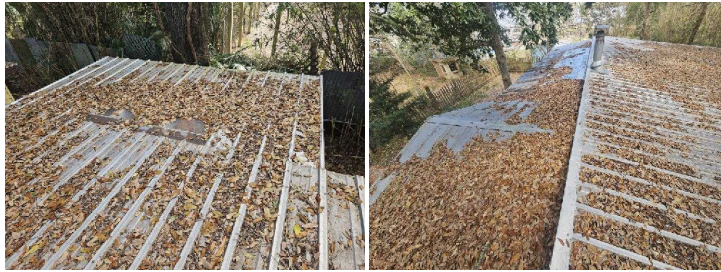
7. Major Concern Skylights: DIY, Non engineered/ manufactured - Glass panels were installed as makeshift skylights and do not appear to be part of a manufactured skylight system. These panels are not properly flashed and may allow water intrusion into the roof structure. Improvised installations can lead to roof leakage and structural deterioration over time. Recommend removal of these panels and installation of properly manufactured and flashed skylight assemblies or replacement of the roofing materials in these areas.

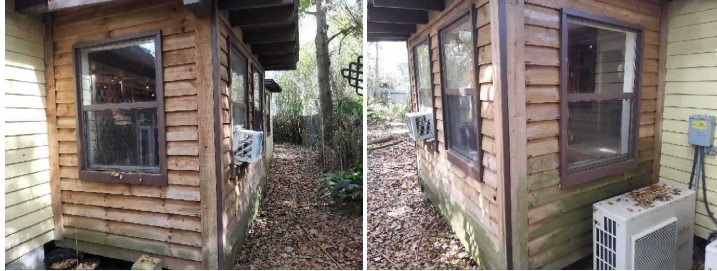
Type: (continued)

1. Attention Needed Type: Wood - Damaged wood was observed at the front of the home. Recommend a licensed contractor remove and replace all damaged wood.

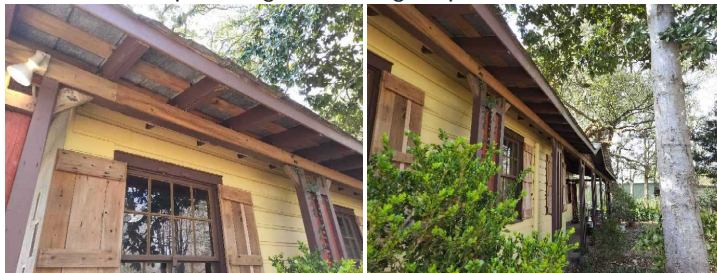
- 3. Acceptable Type: Cement Fiber
- 4. Attention Needed House Numbers Not installed - House numbers missing a number to identify address of home. Recommend correction.
- 5. Attention Needed Trim: Wood - Raw wood was observed in a number of areas around the exterior of the home. Recommend painting / staining to preserve the life of the materials.

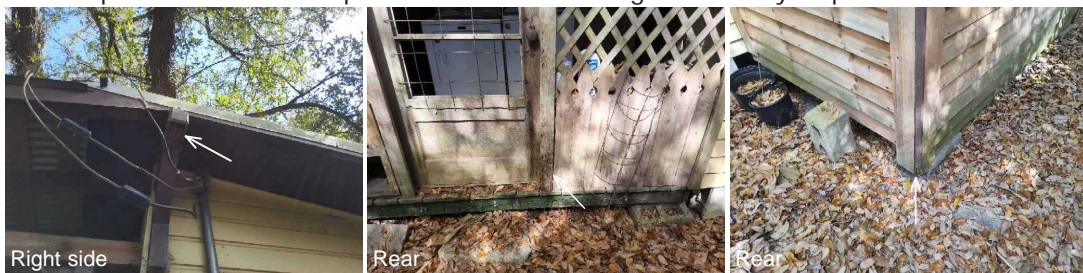
- 7. Major Concern Trim: Wood - Damaged wood consistent with wood destroying insect activity was observed at several areas of the exterior siding and trim. Wood components affected by insect damage may continue to deteriorate if infestation remains active. Recommend evaluation by a licensed pest control professional and replacement of all damaged wood by a qualified contractor.

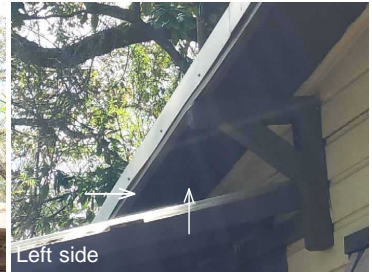
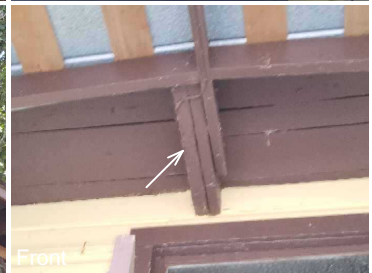
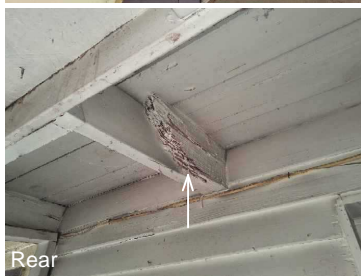
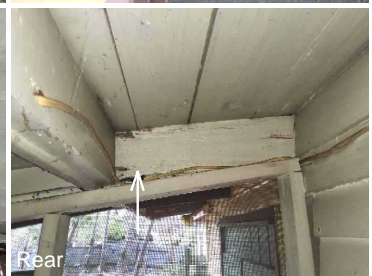
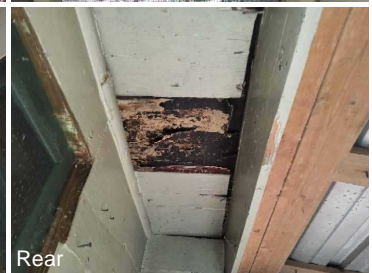
9. Major Concern Fascia / Soffit: Open (Exposed rafter tails), Wood - Fascia observed with wood damage at several locations. Recommend removing / replacing damaged wood. *The inspector was unable to determine if this was from moisture / wood destroying insect.

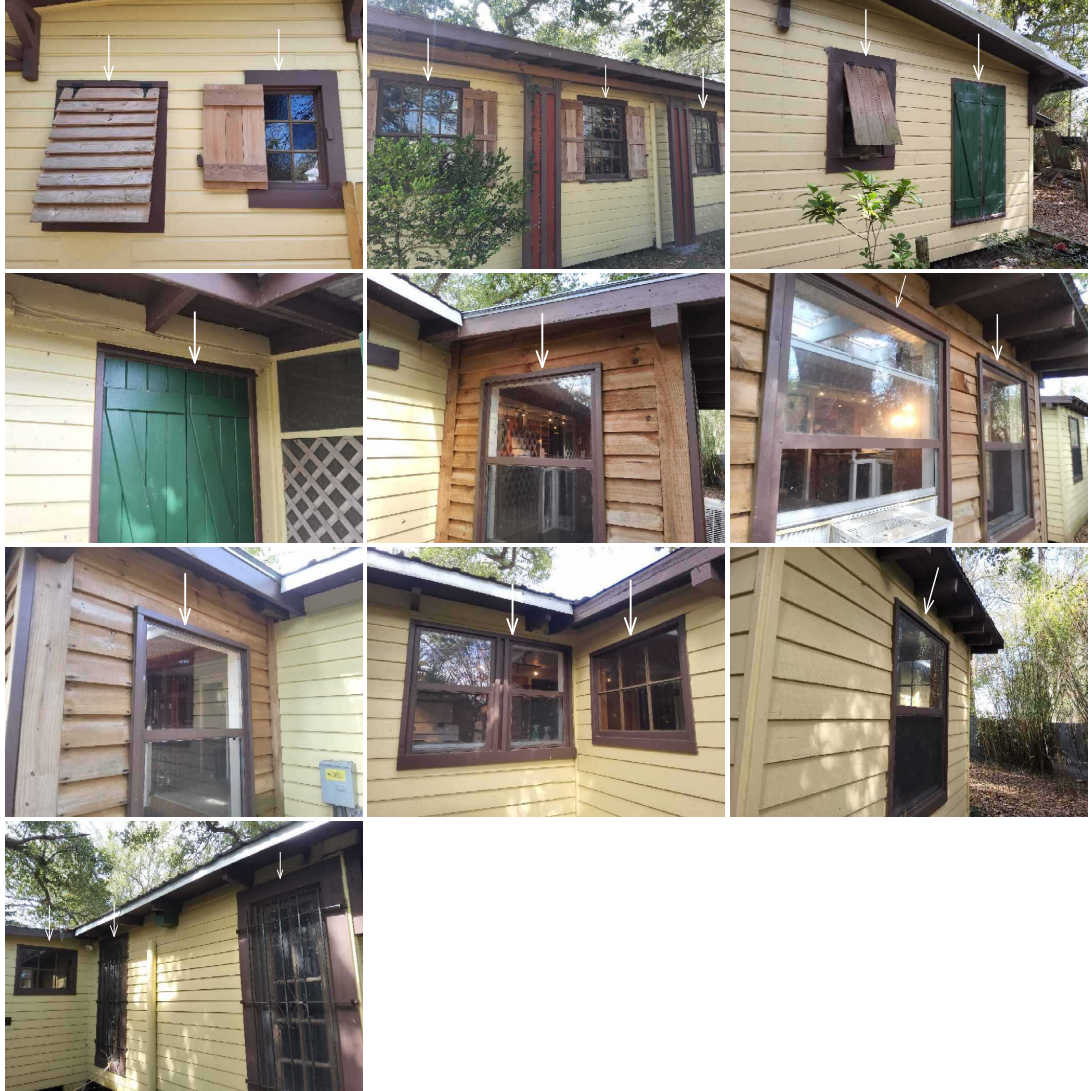
10. Attention Needed Windows: Wood, Metal - Windows appear to be installed without visible head flashing and appear dependent primarily on sealant to prevent water intrusion. Sealant is considered a maintenance component and deteriorates over time. Without proper flashing above the window openings, moisture intrusion into the wall assembly may occur leading to concealed deterioration. Recommend evaluation and correction by a qualified contractor.

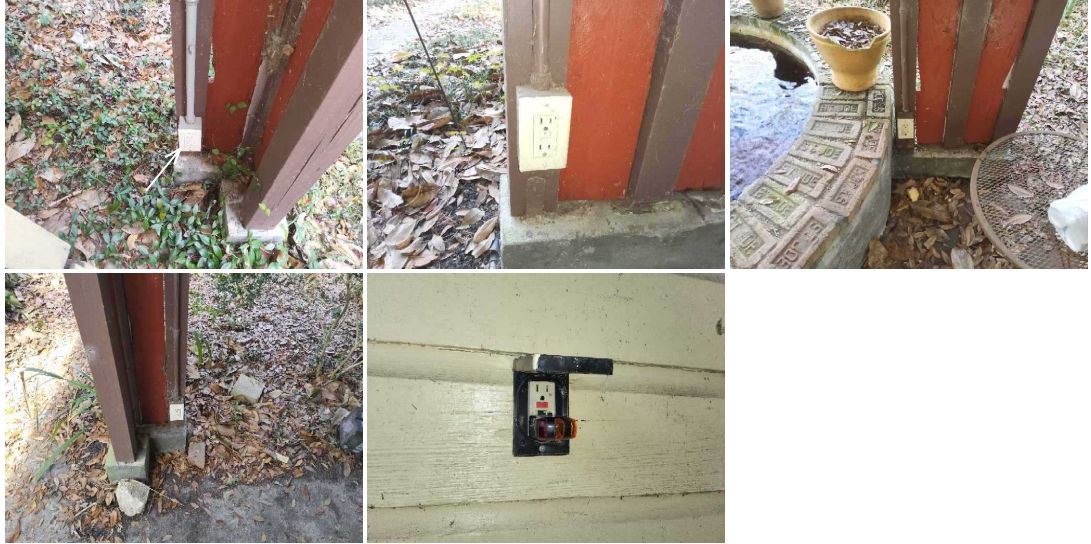
17. Major Concern Exterior Electric Outlets: 110 VAC GFCI - The GFCI outlet was tripped and will not reset. Recommend a licensed electrician make the needed corrections.

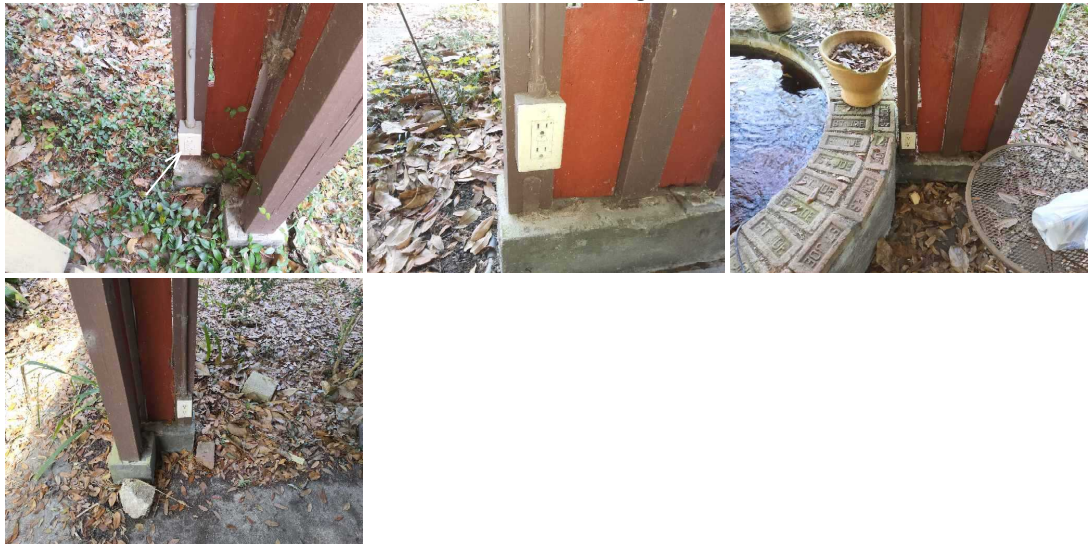
18. Safety Hazards Exterior Electric Outlets: 110 VAC GFCI - Exterior outlets are missing weathertight covers. Recommend a licensed electrician replace missing covers.

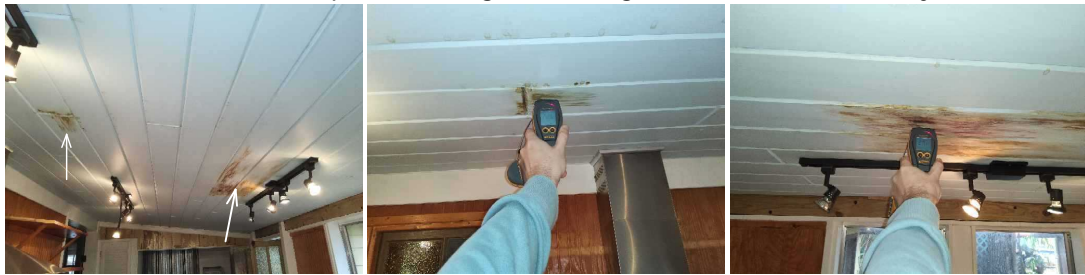
2. Acceptable Ventilator: Manufacturer unknown
3. Acceptable Disposal: In-Sinkerator
4. Acceptable Dishwasher: Samsung
5. Not Present Refrigerator: None
6. Acceptable Sink: Porcelain Coated
7. Acceptable Plumbing/Fixtures: Double Valve Split Fixture
8. Acceptable Cabinets: Wood
9. Acceptable Counter Tops: Porcelain, Other
10. Acceptable Pantry: Single Door
11. Acceptable Floor: Wood
12. Acceptable Walls: Paneling
13. Major Concern Ceiling: Wood - Moisture staining was observed on the kitchen ceiling and elevated moisture readings were detected during the inspection. Elevated moisture levels indicate an active or recent moisture intrusion source. Continued exposure to moisture may lead to structural deterioration and microbial growth. Recommend a qualified contractor locate and repair the source of moisture and replace damaged building materials as necessary.

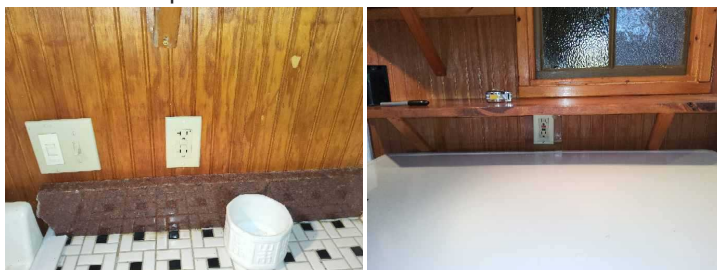
14. Acceptable Doors: Wood
15. Acceptable Windows: Metal
16. Major Concern Electrical: 110 VAC GFCI - GFCI outlets were tripped and will not reset. Recommend a licensed electrician replace the outlets.

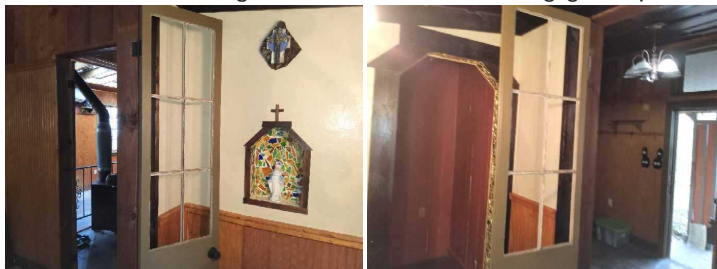
4. Acceptable Ceiling: Metal
5. Attention Needed Doors: Wood with glass - Doors are missing glass panes. Recommend replace.

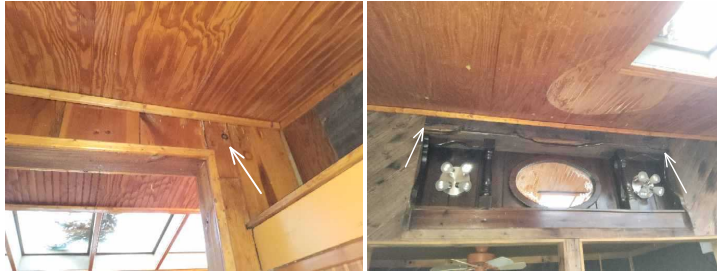
9. Acceptable Ceiling: Paneling
10. Major Concern Walls: Paneling - Dirt tubes and wood destroying insect damage were observed above the beam. Recommend having the home further evaluated by a qualified pest control company as well as a licensed contractor remove and replace all damaged wood.

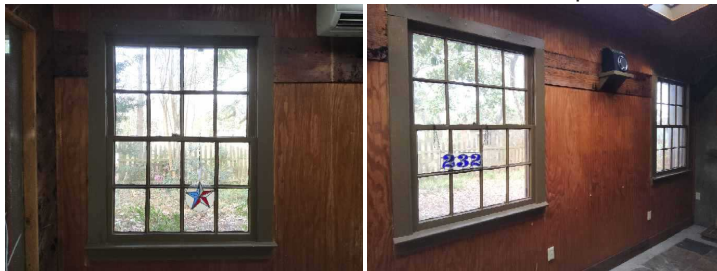
13. Attention Needed Windows: Wood - Windows were stuck shut at the time of the inspection. Recommend maintenance needed to make the windows operable.

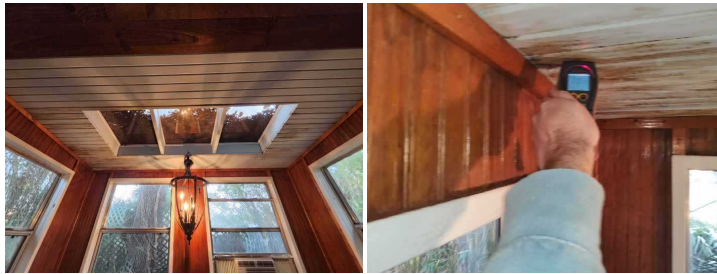
- 25. Major Concern Ceiling: Wood - Moisture stains observed on the ceiling. Upon moisture survey this area tested elevated for moisture. Recommend a licensed contractor remove and replace all damaged wood.

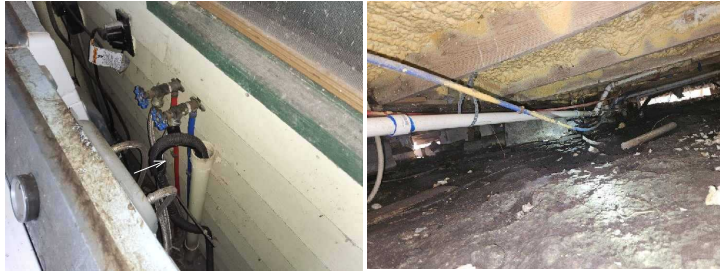
3. Attention Needed Water Lines: Plastic, Pex - Exposed water supply lines were observed at the exterior of the home without proper insulation. Uninsulated pipes are susceptible to freezing and potential damage during cold weather. It is recommended to insulate all exposed exterior water lines to prevent freezing and maintain system integrity. *Note: Pipes are hanging under the house without proper support.

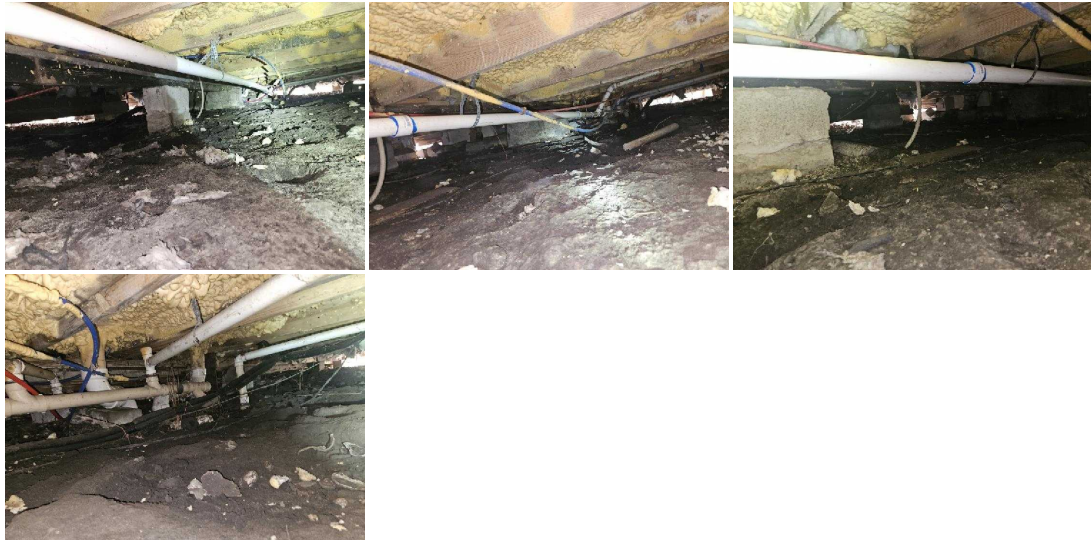
Drain piping: PVC - Drain piping beneath the structure appears improperly installed in areas. Portions of the piping run up and over structural framing members rather than maintaining a continuous downward slope toward the discharge point. Improper slope can restrict drainage and allow waste accumulation within the piping. Some sections also appear inadequately supported. Recommend a qualified plumbing contractor evaluate and correct the drain piping installation.

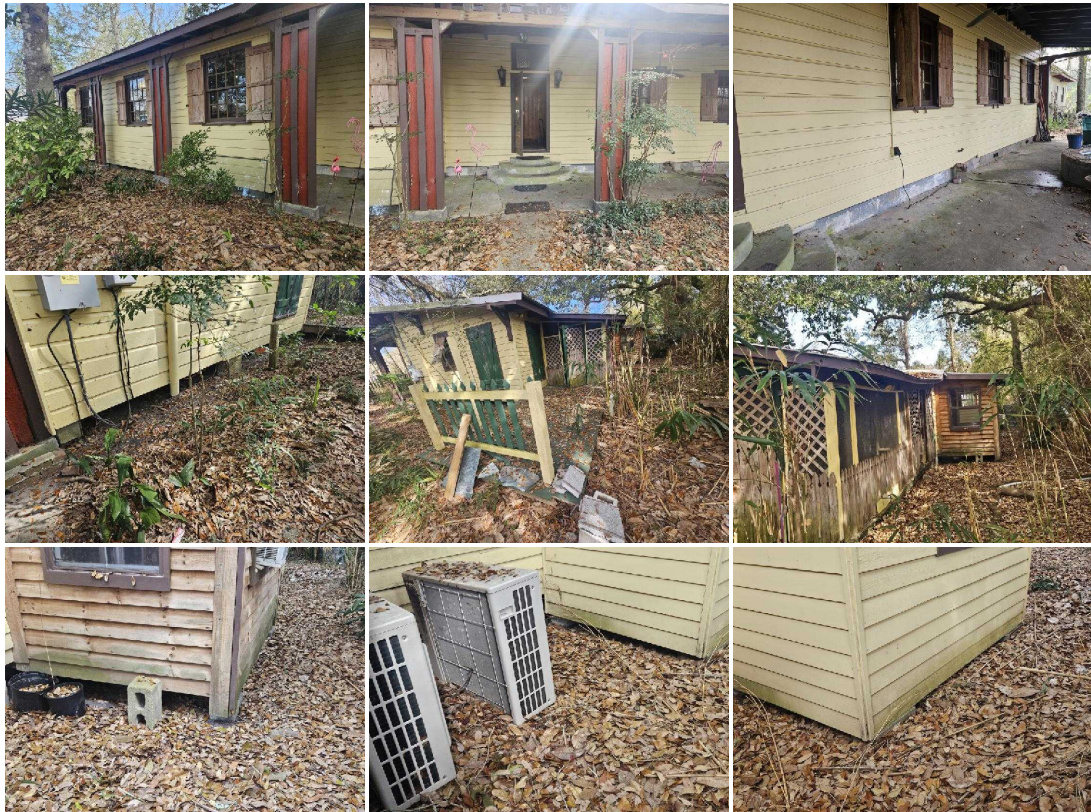
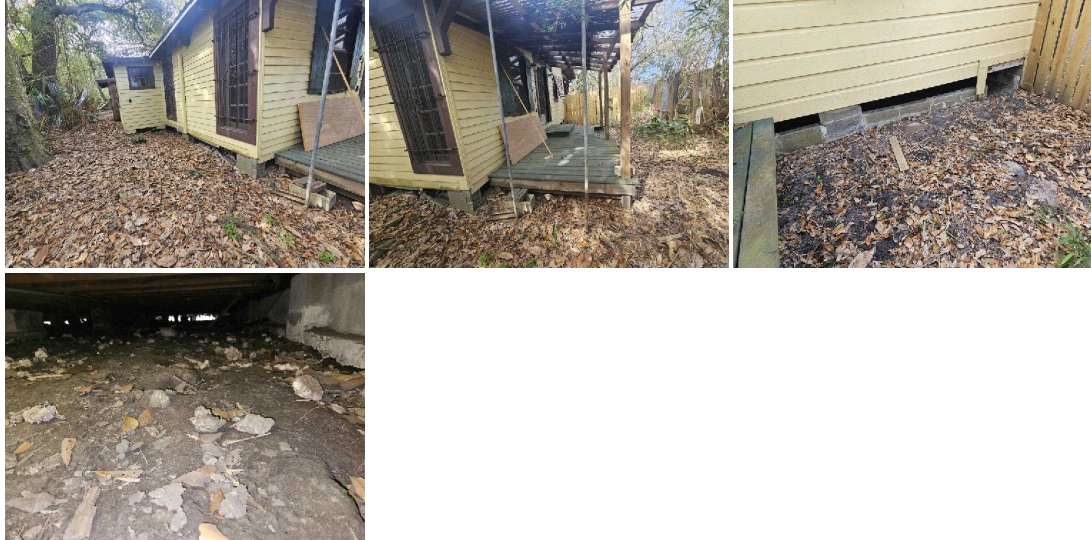
5. Moisture Location: Grading
6. Major Concern Ventilation: Open at perimeter (3 Sides) - Crawlspace ventilation was observed to be open along much of the perimeter, with limited venting present only at portions of the front and rear right corner of the structure. Soil conditions beneath the home were wet at the time of the inspection despite no recent rain events, which suggests moisture may be accumulating beneath the structure. Excessive crawlspace moisture can contribute to wood deterioration, elevated humidity levels within the home, and conditions conducive to fungal growth or wood-destroying organisms. Recommend a qualified contractor further evaluate the crawlspace moisture conditions and improve drainage and/or ventilation as needed to reduce moisture accumulation beneath the structure.

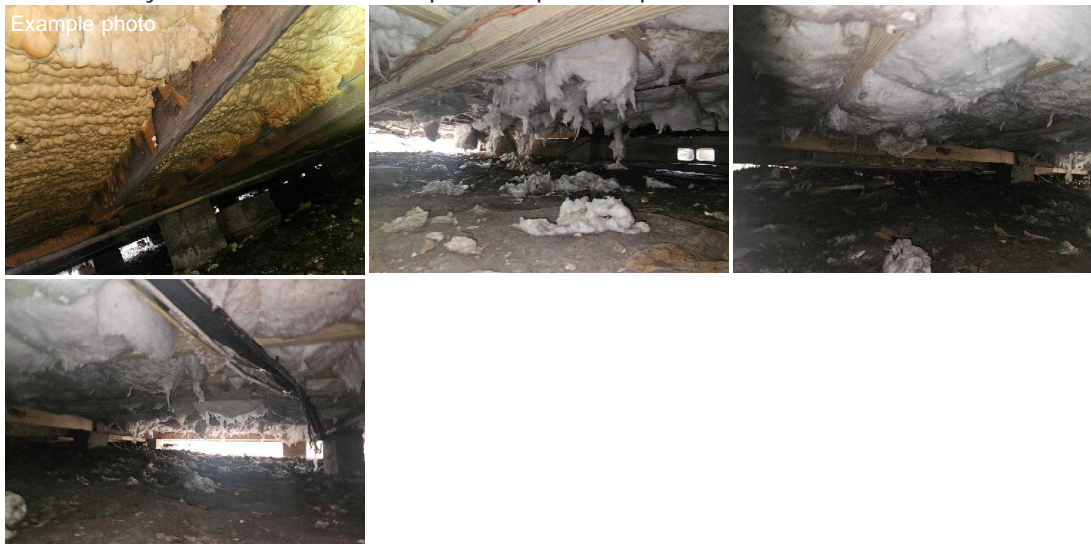
The spray foam and fiberglass insulation conceal large portions of the framing system, preventing determination of the full extent of termite damage and structural deterioration. In the inspector's professional opinion, removal of insulation and comprehensive structural evaluation is necessary to determine the scope of required repairs.
