**129 Railroad Ave.**

**Bay Saint Louis**

**Historical Preservation Report**

**Sept 9, 2024**

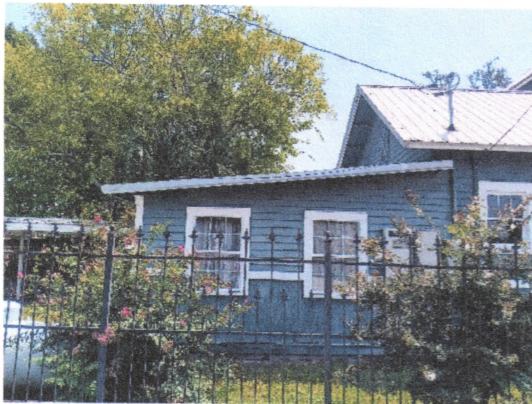
**Rear Extension**

The additions to the rear (north) and side (east) of the house (circa. 1980) are of no historical or architectural significance and have extensive damage from insect infestation and weathering. They will both be removed.

The rear of the original house will be returned to the original wall/design and a porch/deck will be installed replacing the existing "extension".

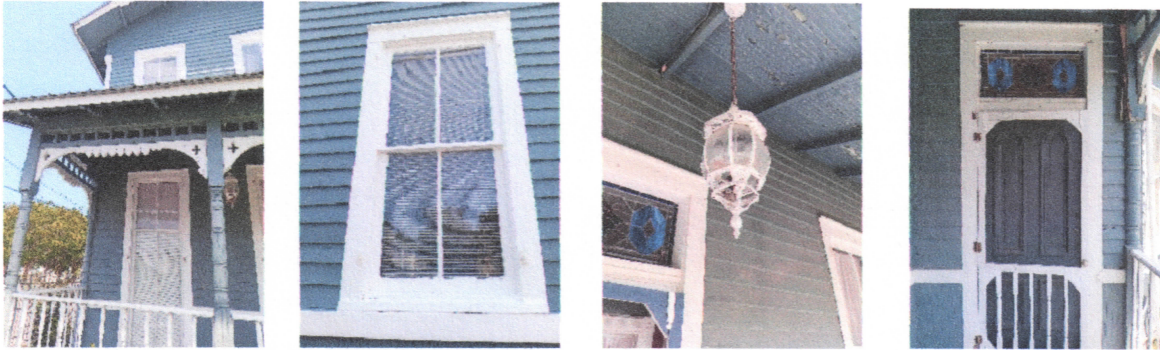
The house has significant architectural characteristics which will be retained and repaired where necessary. These include the front porch, gables, lamps, metal roof, windows/stained glass, doorways/doors and siding.

Areas where weather and insect damage have been identified will be repaired as per the original design. The entire house will be painted once all repairs have been completed.

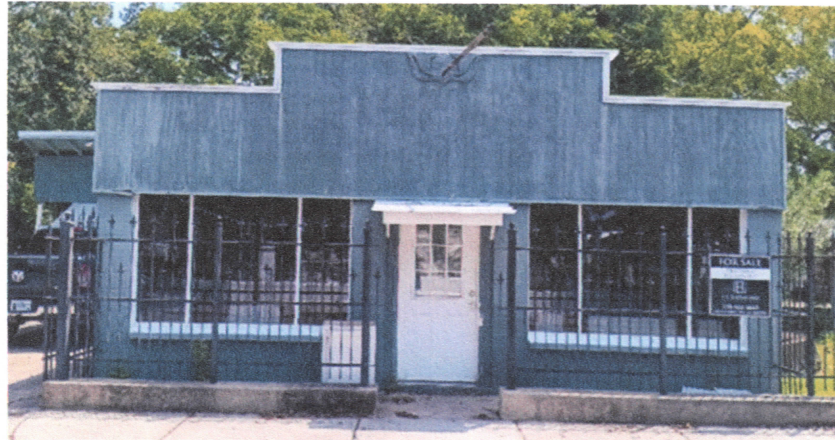
The existing Commercial Building is of unknown historical value and probably dates to the 1960s. It is made from cinder blocks with wooden signage (in need of repair) facing towards 2<sup>nd</sup> street. The building itself is structurally sound.

The intent is to clean up and modernize this building (new restroom, new A/C) and utilize it as a commercial salesroom for Harvest Bay Bakery and Bistro.

The existing exterior signage will be repaired and utilized As-Is.

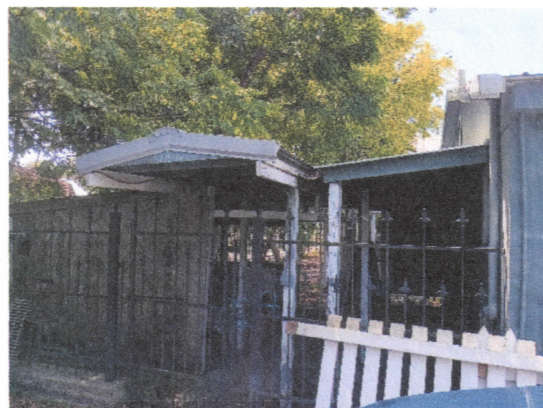
The storage shed behind the Commercial Building is rotten/beyond repair and will be removed. The long-term intent is to extend the commercial building into this location to facilitate the location of the Bakery/Bistro Kitchen and Equipment.

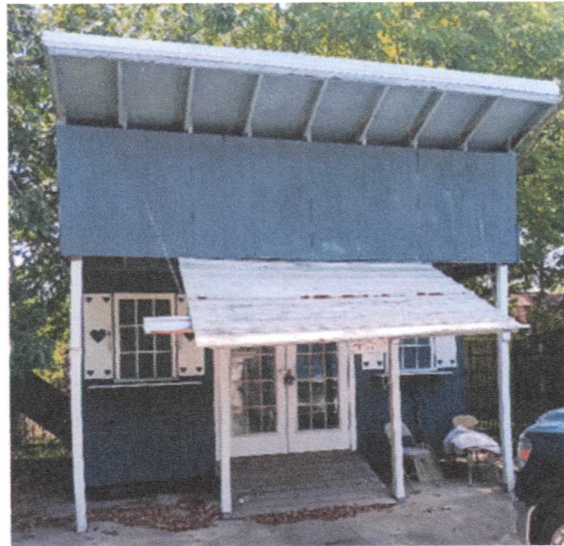
The storage shed to the rear of the main property is rotten/beyond repair and will be removed.

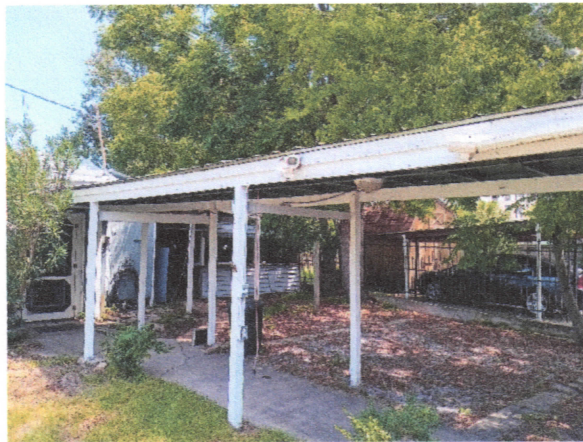
The covered walkway from the Commercial Property to the rear of the main house is in poor condition, serves no functional purpose and will be removed.
