City of Beaumont, California

Beaumont Plunge Pool Study

January 2021

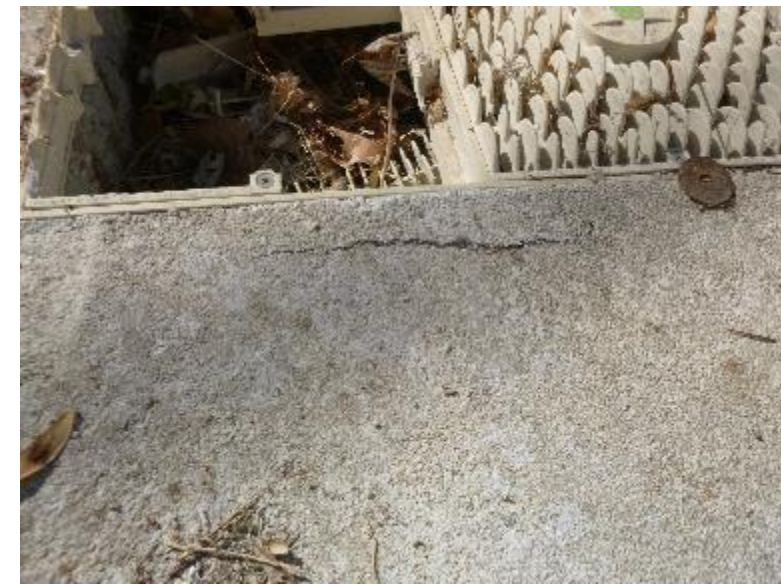
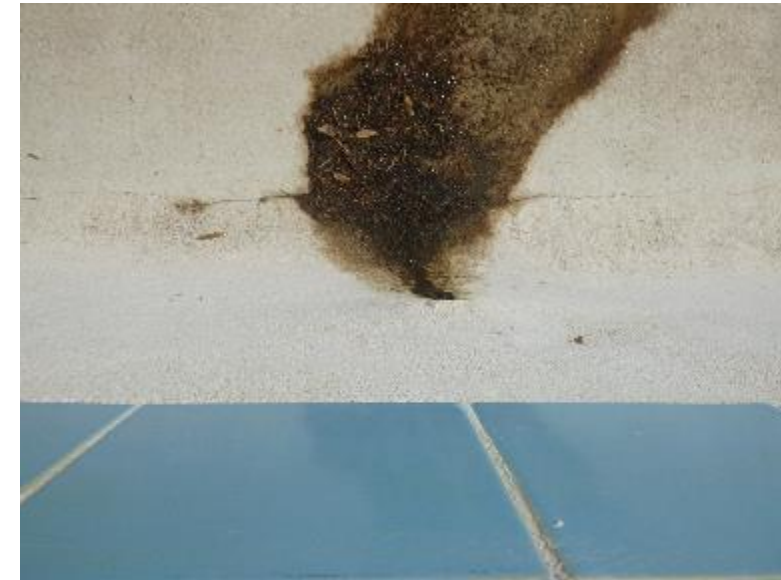
The swimming pool is a concrete structure with a pebble-tec/sheen finish that was installed in 2014 and a tile perimeter band. Cracking was prevalent in the pool's surface near the main drain covers, and in both the shallow and deep ends on the slope where the pool wall and floor meet.

When structural cracking in a pool occurs, it can be created by many factors including shifting soils around the perimeter of the pool. Structural failure will continue until the issue is addressed. Furthermore, structural cracking allows water (pool or hydrostatic ground water) to penetrate the concrete and reach the embedded rebar. The result is corroded and eventual failed rebar, further weakening the pool structure.

Industry experience has shown that Pebbletec pools, if maintained in a wet or moist condition, will typically have a lifespan of 7 to 10 years. In most cases achieving a 10-year life on a Pebbletec surface is expected.

Staff report they started finding black mold on the pool's surface and have received a quote from a contractor to acid wash the affected areas.

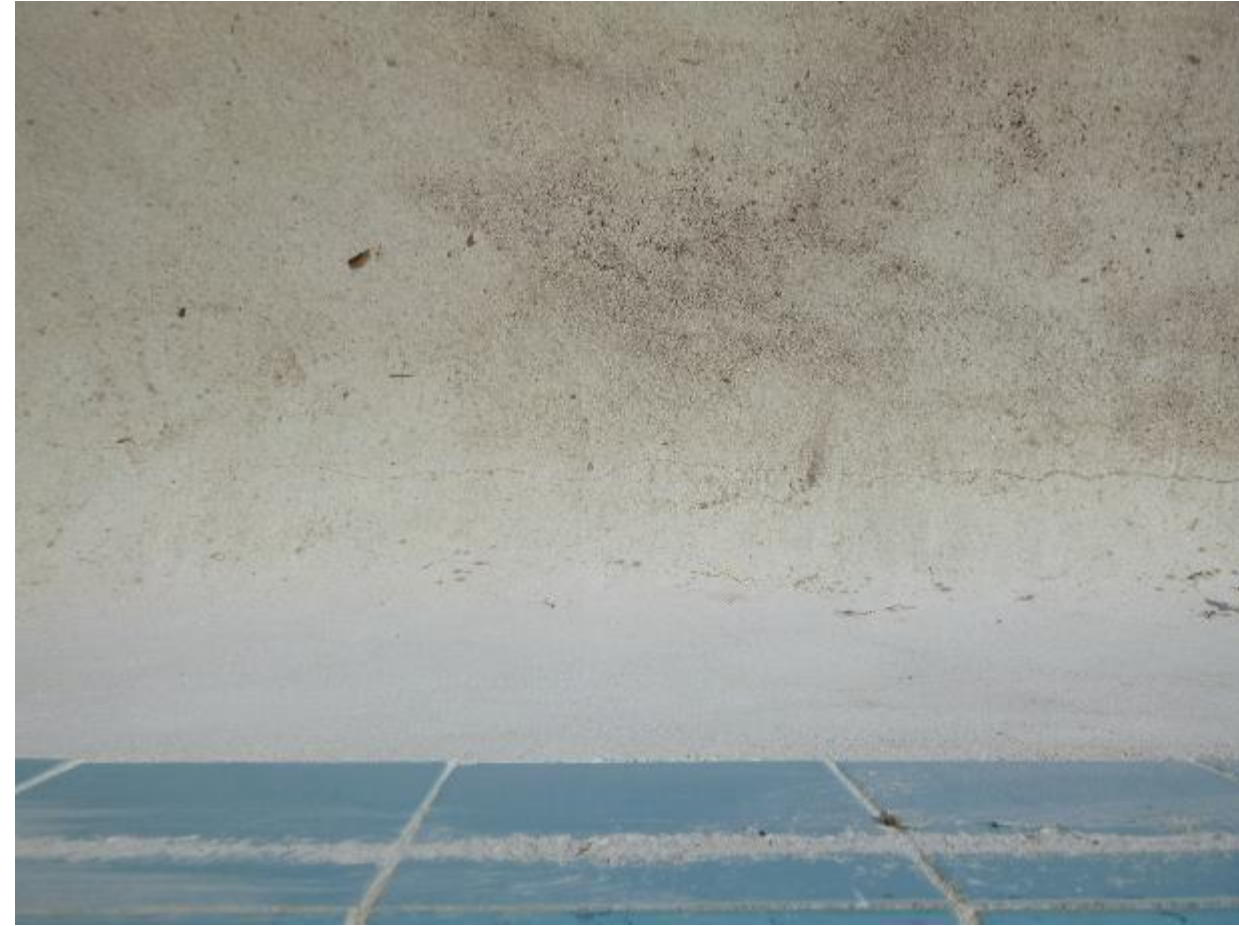
Staff report the 48-hour water loss with the pumps running goes from the middle of the blue tile to below the first step on stair entry. Since the pool did not lose as much water without the pumps running, there is a leak within the pool's recirculation system.

Staff have not observed the pool water leaking into the adjacent park, which likely means the leaking pool water is draining below the pool, which could be destabilizing the soil surrounding the pool structure. There are limited solutions to soil stabilization after the pool structures are in place.

Because of these cracks, coupled with the water loss and shifting deck, it is recommended that the pool shell not be reused if the facility undergoes a substantial renovation. It is possible to add a vinyl or fiberglass pool liner to the facility, purely as a band-aid approach, in order to get the facility 5 more years of operation.

And, while it is impossible to repair significant cracking in the pool and pool deck, they can be filled with an epoxy injection. However, with this type of movement, the cracking will reoccur.

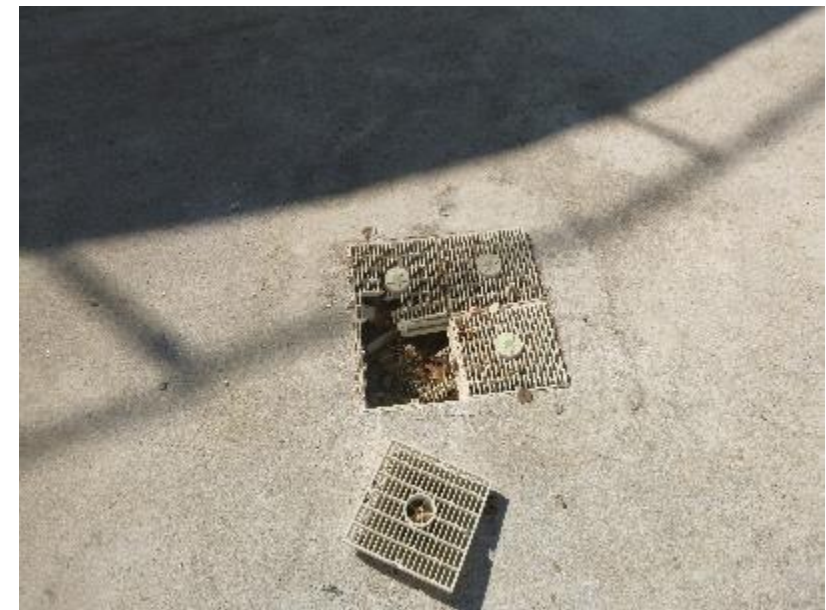
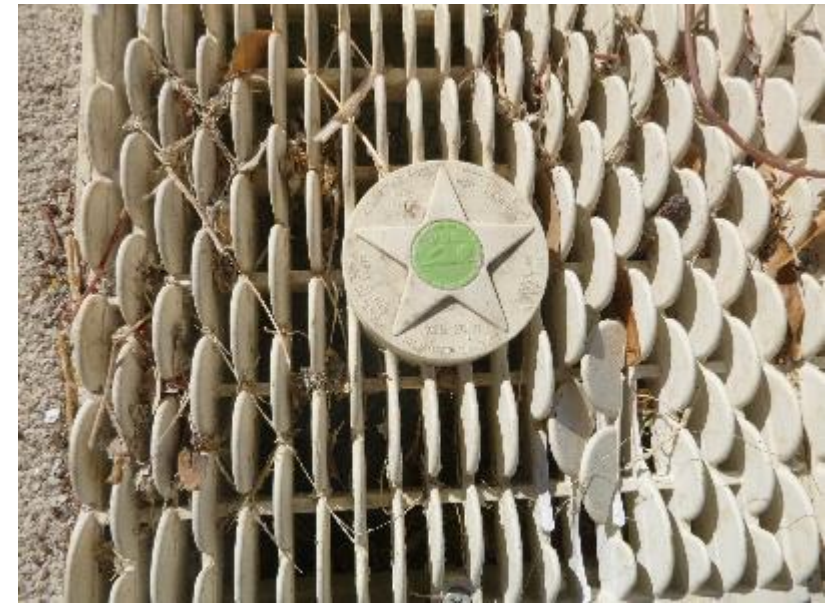
There are two (2) 24" x 24" square, fiberglass main drain covers located in the deep end of the main pool. The main drain grates were broken and unsecured at the time of the site visit. The grates are suction and hair entrapment certified as required by the Virginia Graeme Baker Pool and Spa Safety Act (VGB), ASME/ANSI A112.19.81. All main drains with dimensions 18" x 23" or smaller are classified as "blockable" and must have a VGB stamped and certified "unblockable" grate cover with tamper proof screws.

The federal regulations of VGB were passed by Congress in 2008 and are designed to reduce the potential for suction and hair entrapment in commercial swimming pools at all suction outlets (e.g. main drains, skimmer equalizer lines, etc.). The Consumer Product Safety Commission (CPSC) is tasked with Federally enforcing all VGB regulations, but due to the vast number of commercial swimming pools in the United States, enforcement most commonly is the responsibility of the local governing agencies (e.g. public health departments, building departments, etc.).

Staff should confirm when the grates were last replaced to ensure it is still within the stipulated time frame. New grates will be necessary if the pool is brought back into operation.

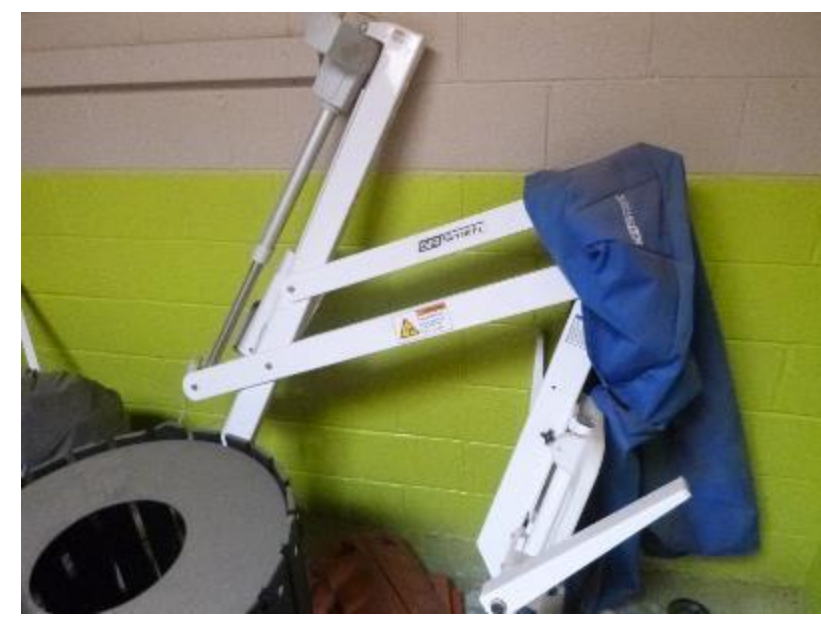
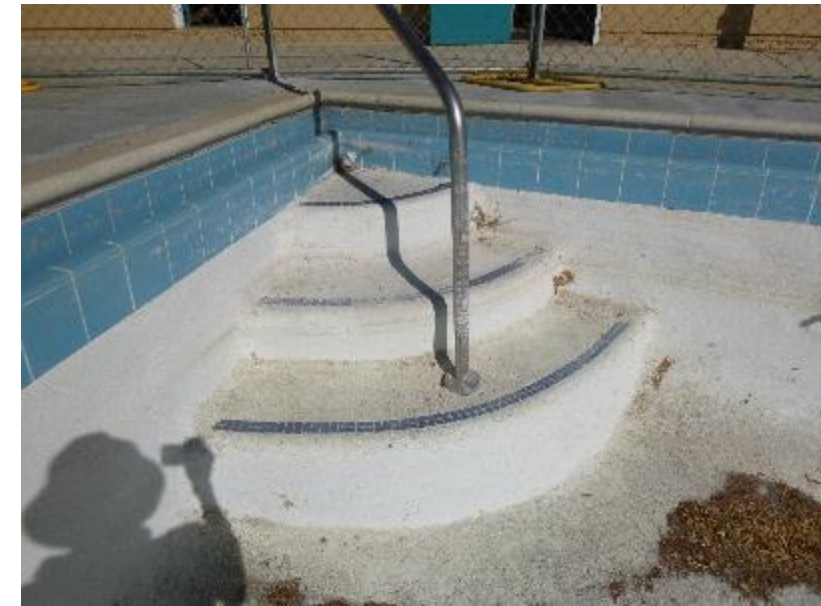
The ADA Act requires that a swimming pool with a perimeter that is less than 300' to have at least one accessible means of entry, provided that the primary accessible means of entry is an ADA compliant swimming pool lift or ADA compliant swimming pool ramp with handrails. The secondary means of access can be either a ramp, lift or compliant stair entry. The main pool's size necessitates one means of entry which is met with the ADA lift that is on-site. The lift will need to be installed adjacent to the pool if the pool is brought back into operation.

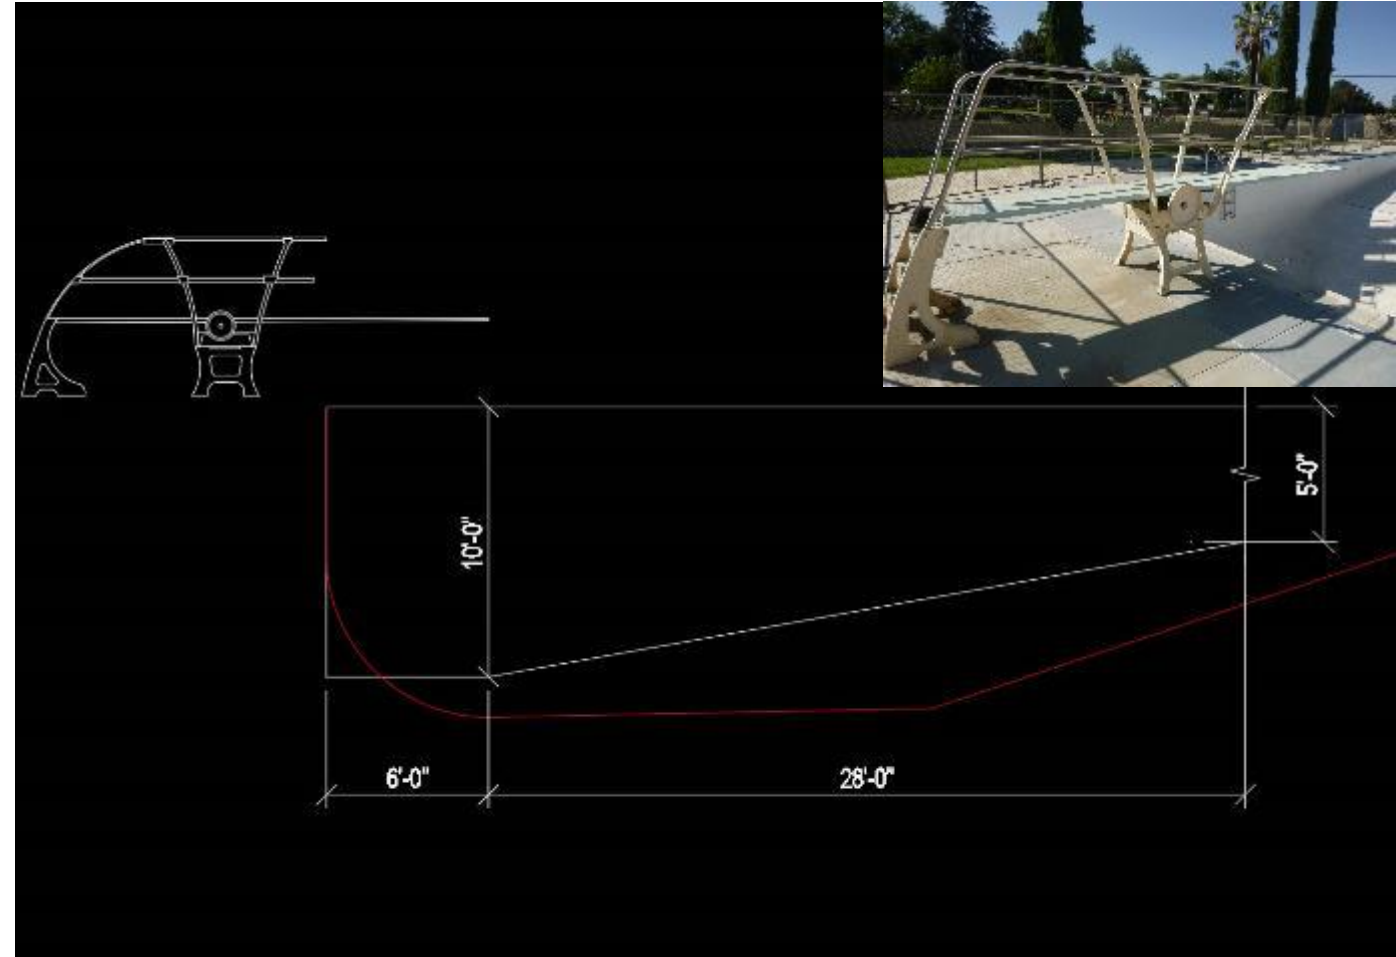
Through Counsilman-Hunsaker's analysis of the existing deep end of the Beaumont Plunge Swimming Pool, the following has been determined:

- The depth of the diving well does not meet the minimum standards stipulated by the State Code. With a depth of 10 feet, the depth fails the standards by 18 inches.
- The existing slope of the pool floor does not meet the standards stipulated by the State Code. As shown in the picture to the right, the white line denotes the existing pool floor and slope while the red line represents the depth and slope required by the State Code. The pool does not meet the slope or the depth requirement.

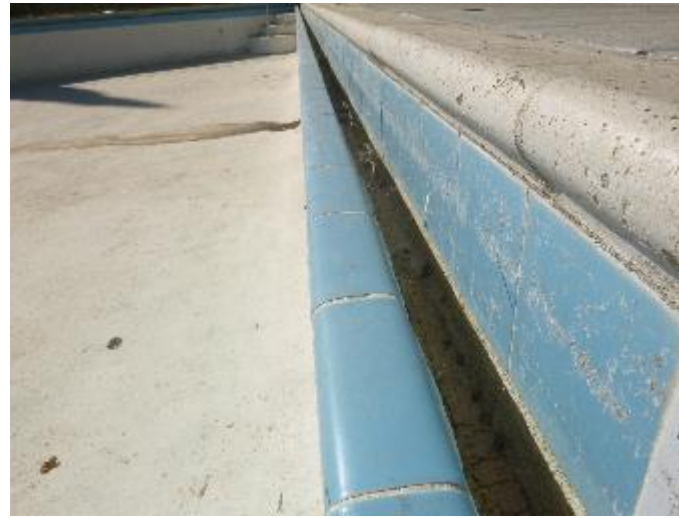
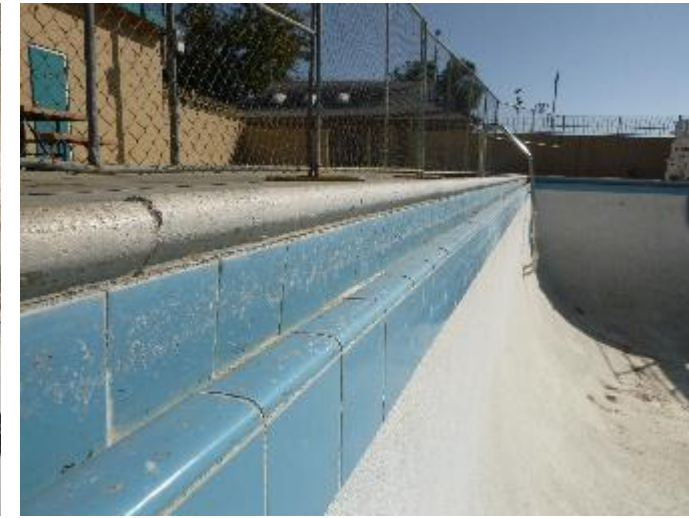
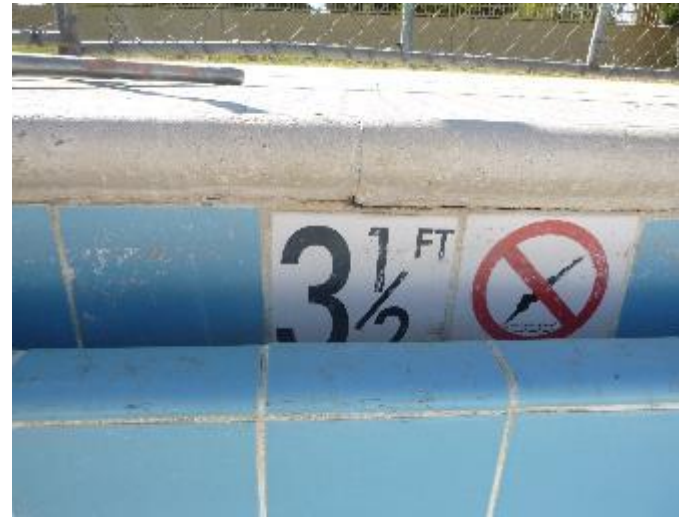
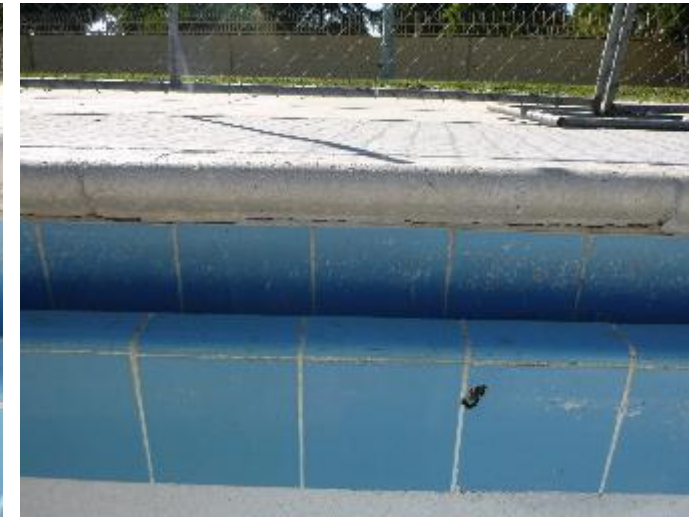
The pool has a tiled, concrete gutter overflow system that allows for continuous surface skimming around the perimeter of the pool. The gutter system is in poor condition with noticeable cracks in the concrete and in the connecting coping stone.

The State Code and current industry standards stipulate that overflow gutters shall be capable of continuously removing no less than 100% of the recirculated water, which is not met with the current flow rate and gutter capacity.

Based on the location of the scum line in the pictures to the right, it appears the gutters might not have been properly draining when the pool was last in operation. If the water level in the gutters is above the tile lip, then the gutters are not functioning properly.

A new perimeter overflow system would require a surge tank to be constructed equal to at least 1 gallon per square foot of pool surface area. Solutions exist to install a stainless-steel gutter system on this type of pool by cutting the top off the pool's perimeter and installing the gutter system. The installation of this gutter system would bring the pool's perimeter overflow system up to code.

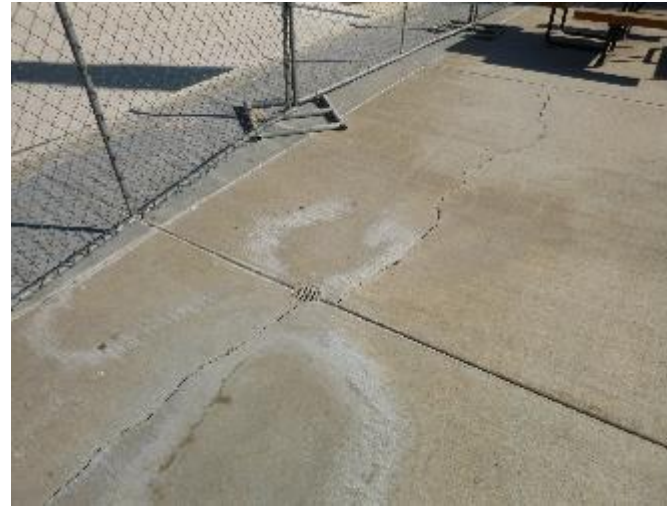
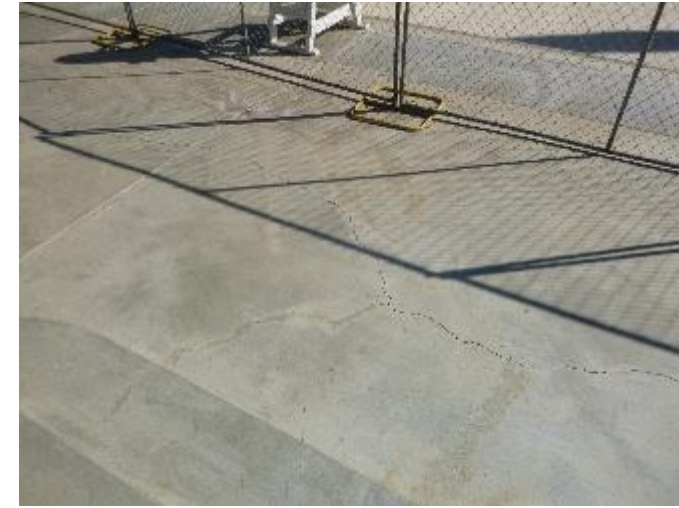
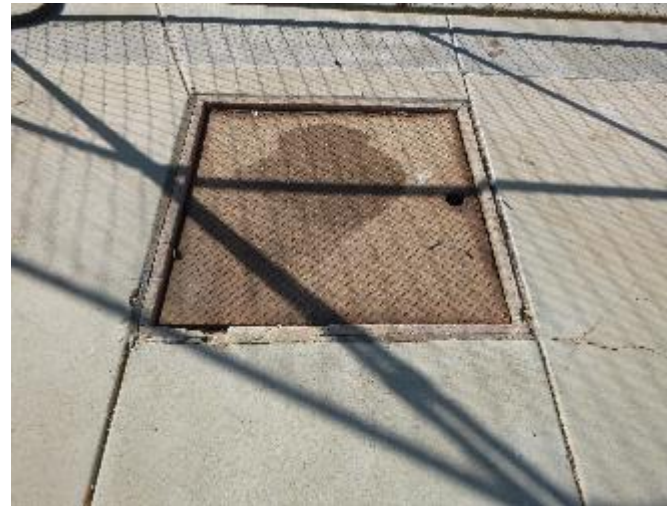
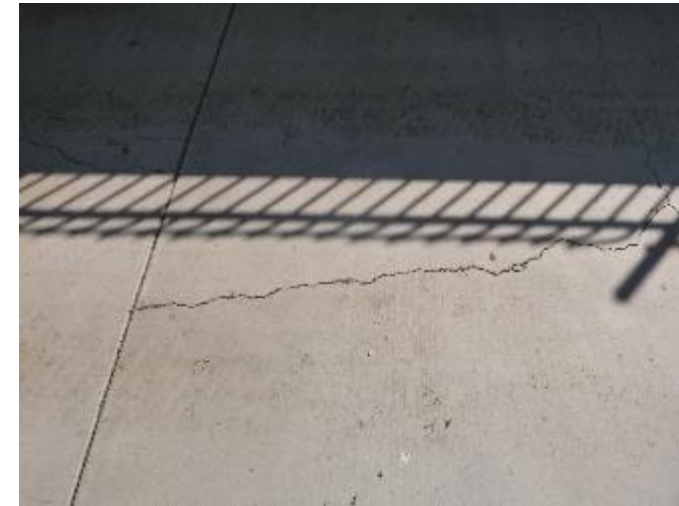
Cracking is evident in the pool deck around the entire perimeter of the pool. Some of the cracks span 10 feet or longer. Staff reported that they have observed water bubbling under the cracks in the deck and when the pool is filled, there is often standing water behind the diving board.

While the facility does meet the California Building Code requirement of maintaining a minimum deck width of four (4) feet around the pool perimeter, due to the condition of the deck, a full replacement is recommended during a future renovation.

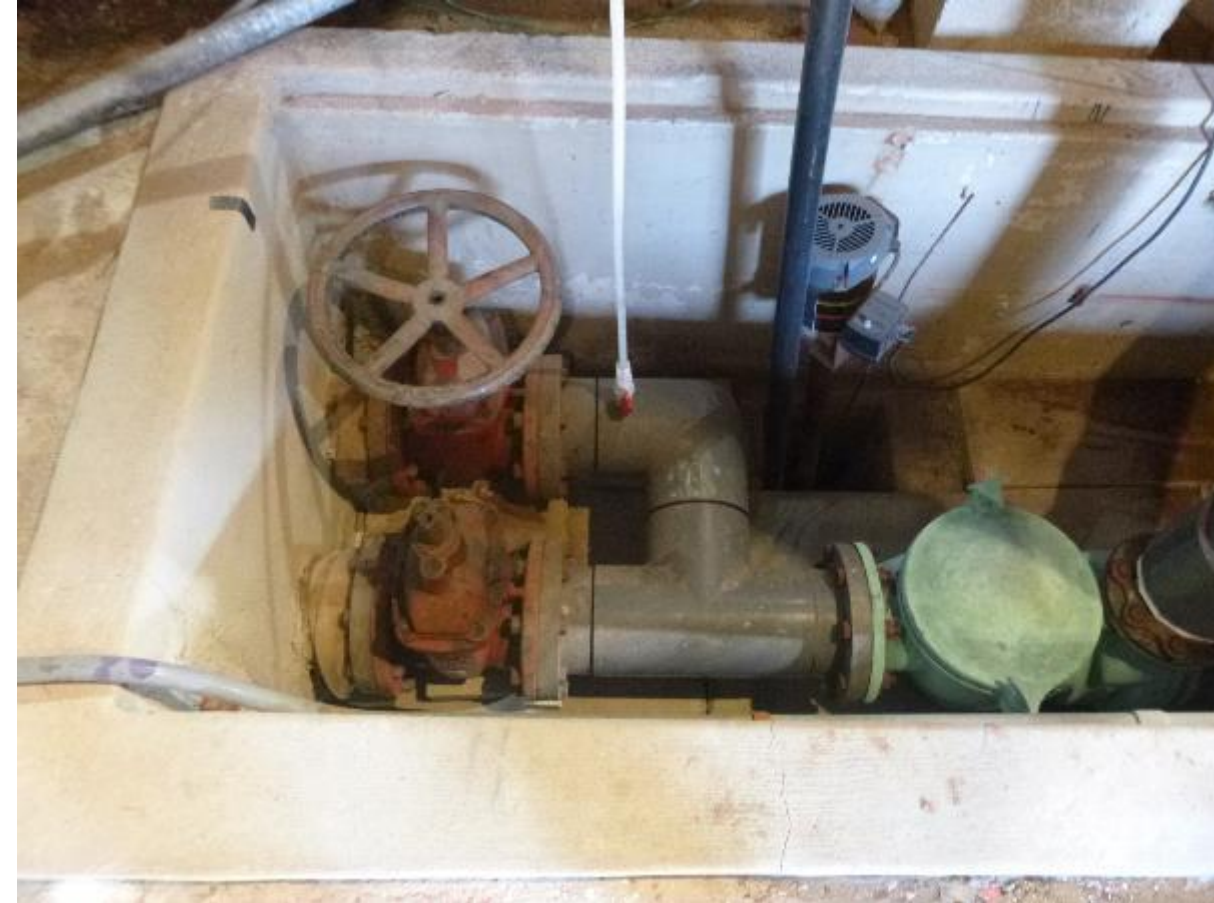
A single 10-horsepower Marathon pump is provided on the recirculation system that is under direct suction from the main drains. The pump and motor both display significant signs of corrosion. The GPM rating for the pump and the horsepower for the motor were not verified by nameplate during the site visit. A strainer is provided for the pump as required by the State Code.

The main drain and skimmer combine to a 6-inch PVC schedule 80 pipe in the mechanical room that is routed through the required skimmer basket (3125B.4) and to the high-rate sand filters. The filtered water is routed back to the pool via a single, 6-inch pipe (pressure). A flow meter was observed as required by 3125B.3.

The California Building Code, Chapter 3124B requires that public pools be turned over at a minimum rate of six hours. The pool was empty during the site visit, so the mechanical system was not observed as operational. Based on the size of the pool's suction piping at the current flow rate of 350GPM, the 160,000-gallon pool is turned over every 7.9 hours, which exceeds the current code requirement. The minimum flow rate for the swimming pool to achieve the required 6-hour turnover is 461 GPM.

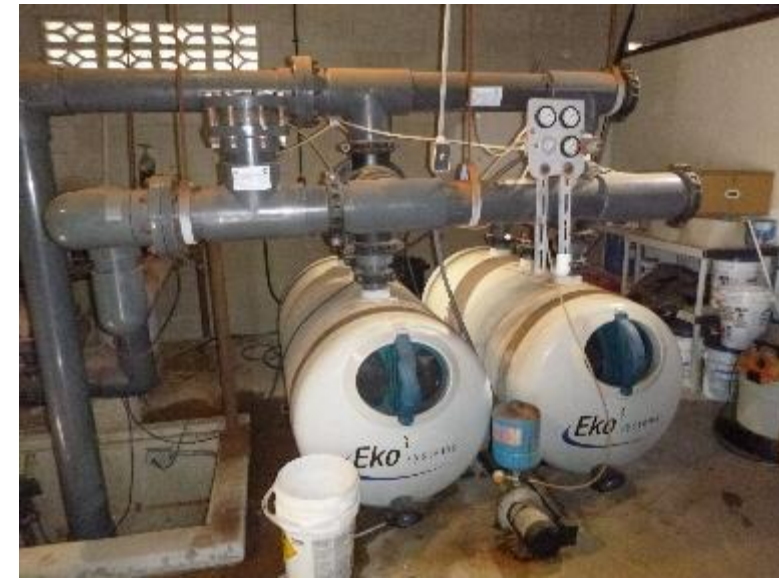
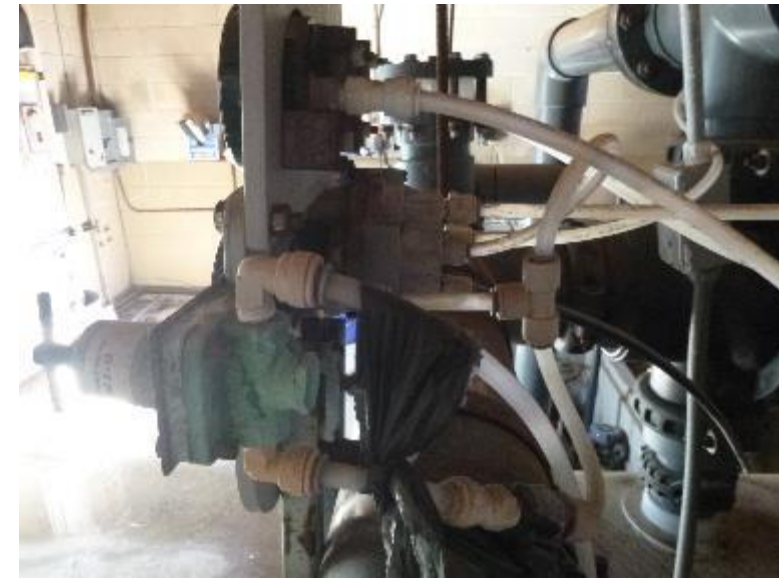
The horizontal filter tanks did not have any noticeable defects and staff reported they were functional during the 2019 summer season when the pool was last opened. Staff reported the gaskets and connectors behind the filter gauges are constantly leaking.

CH typically assigns a lifespan of 15-20 years to pool filters and related mechanical equipment. Since the pool filters are only 6 years old, CH would expect them to last another 10+ years for the operation of the pool.

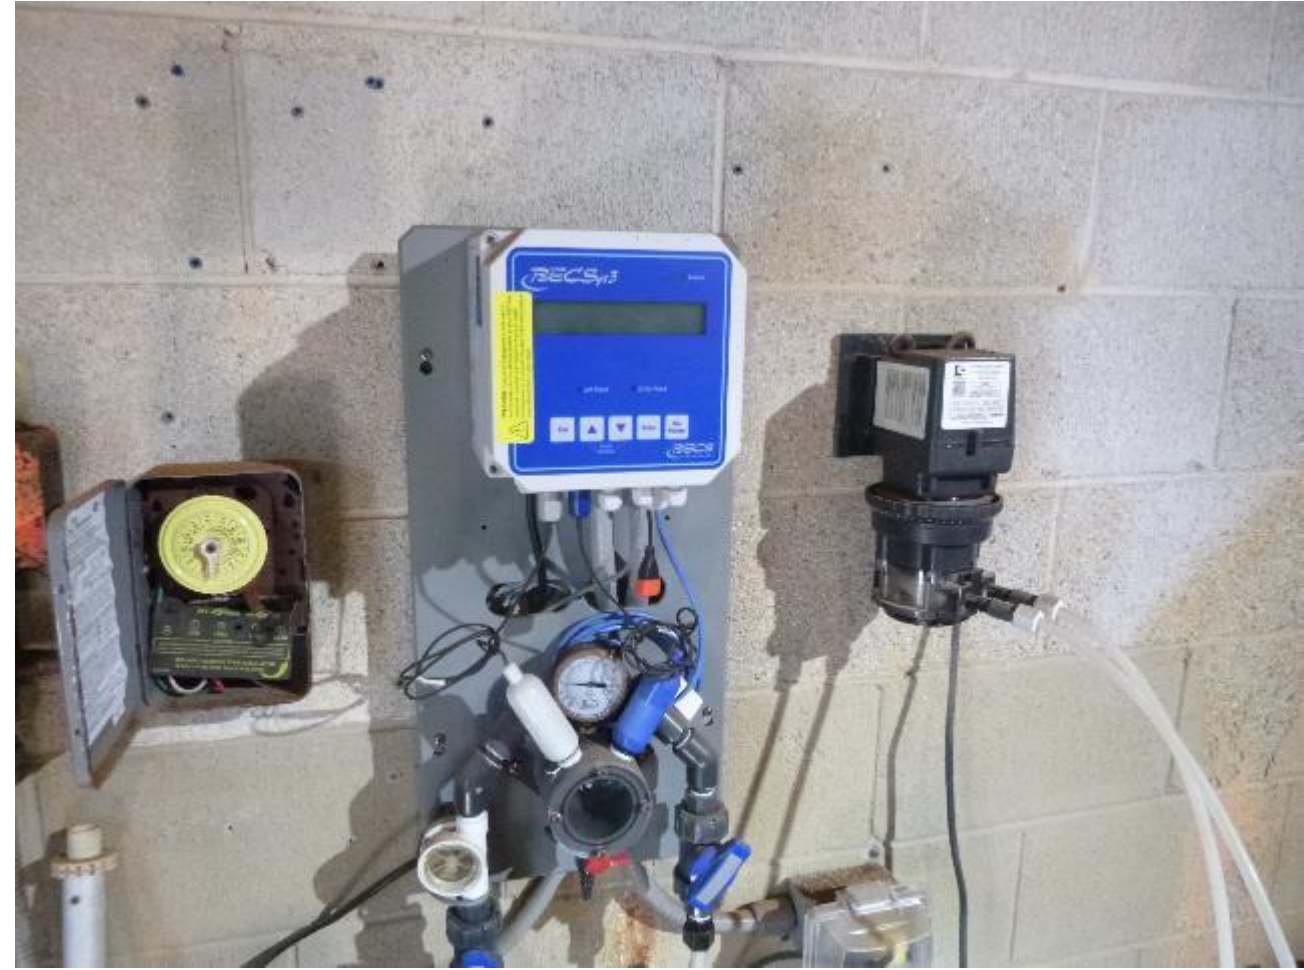
The pool is controlled by an BECSys 3 chemical controller. The chemical controller automatically adds sanitizer from the Pulsar 4 system, or muriatic acid as the pH buffer, as necessary to minimize the peaks and valleys common when the chemical feed is controlled manually. The controller was installed within the past few years and is in good working condition. It is appropriate for this type of usage and could be reused in a future renovation.

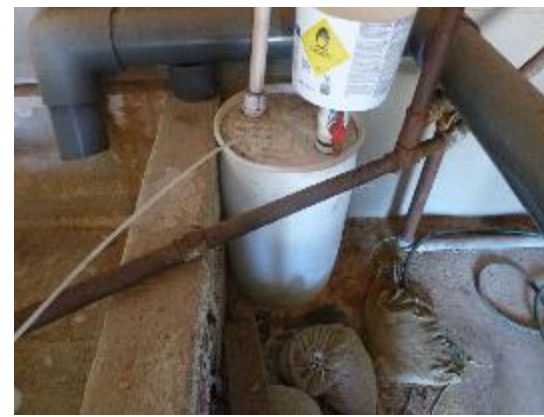
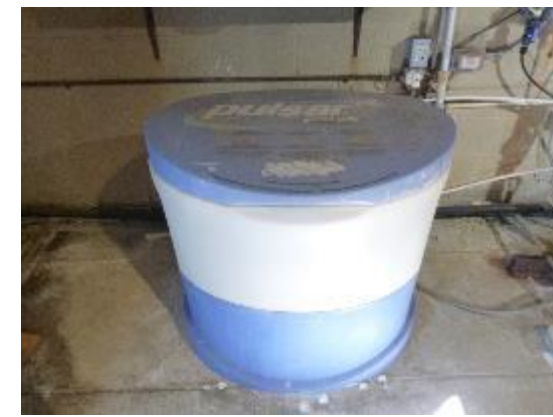
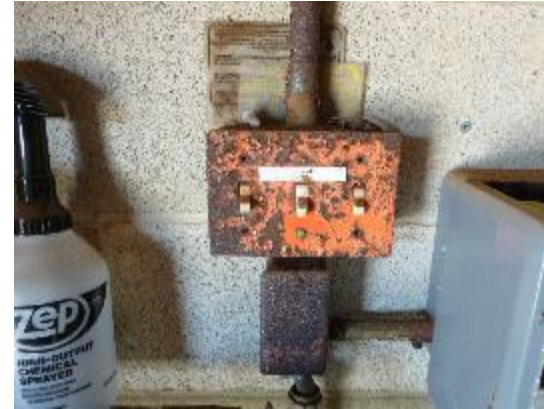
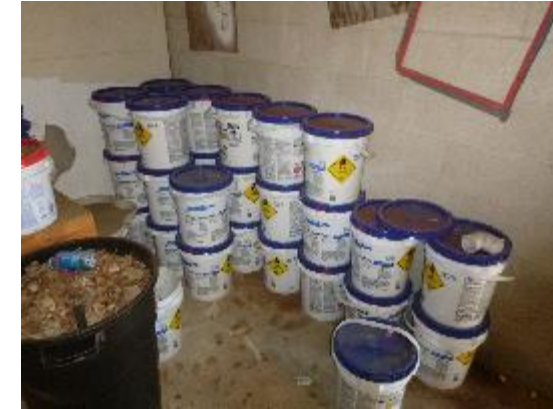
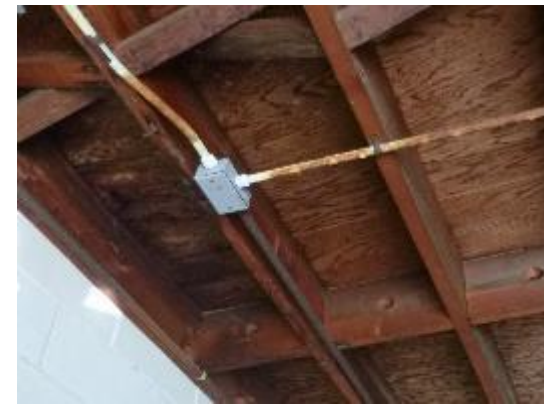
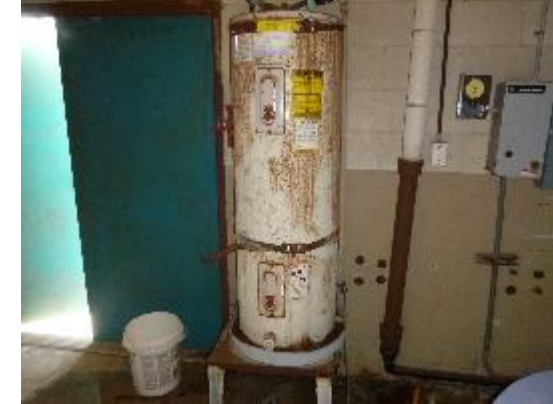
Corrosion was evident on several items within the mechanical space, including the following:

- Electrical panel
- Water heater
- Electrical conduit
- Electrical box for the Pulsar switch

This is most likely due to the presence of the muriatic acid feeder that is located within the mechanical room. A separate, dedicated and ventilated chemical storage room for both the sanitizer and pH buffer is recommended and is the current industry standard. During a future renovation, these separate mechanical rooms could be included. In an ideal setting these two would be in their own separate, ventilated spaces.

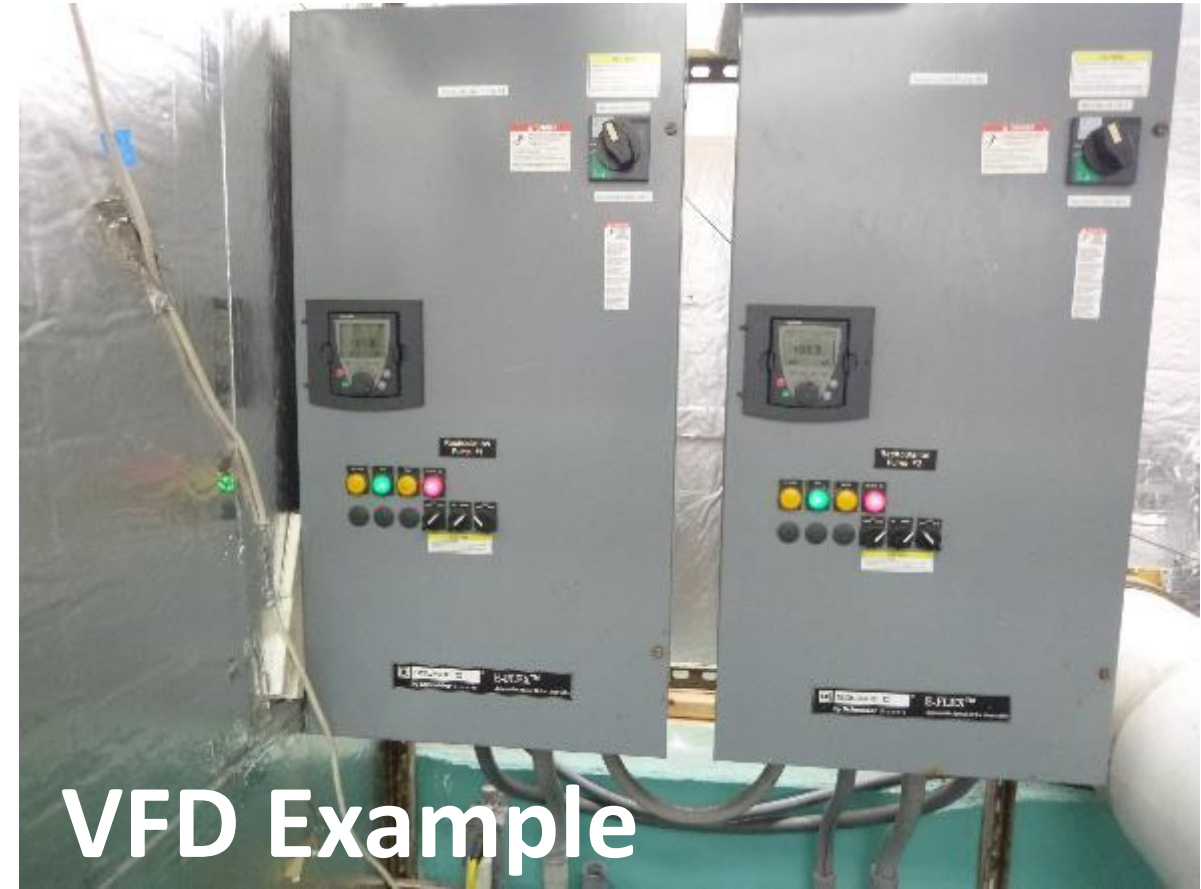
A variable frequency drive is not installed on the circulation system. A variable-frequency drive (VFD) is a system for controlling the rotational speed of an alternating current (AC) electric motor by controlling the frequency of the electrical power supplied to the motor. VFDs should be considered on any future mechanical system upgrades.

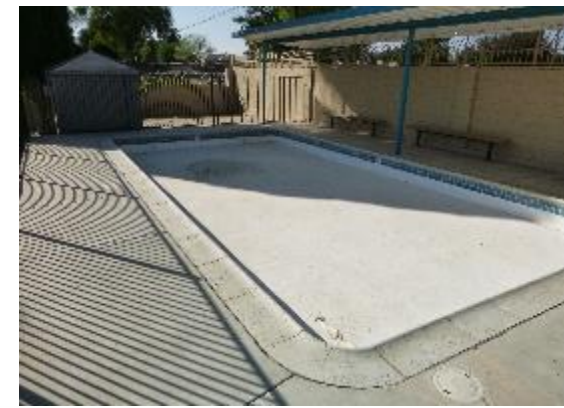
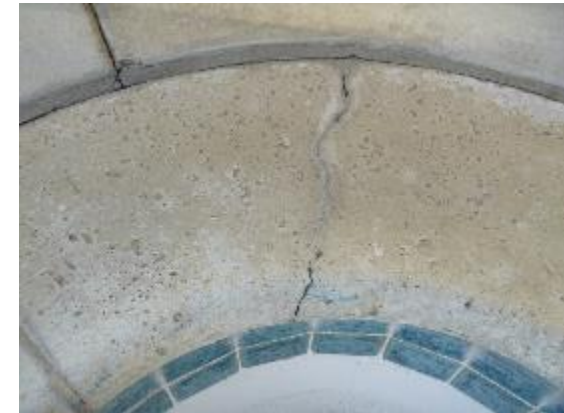
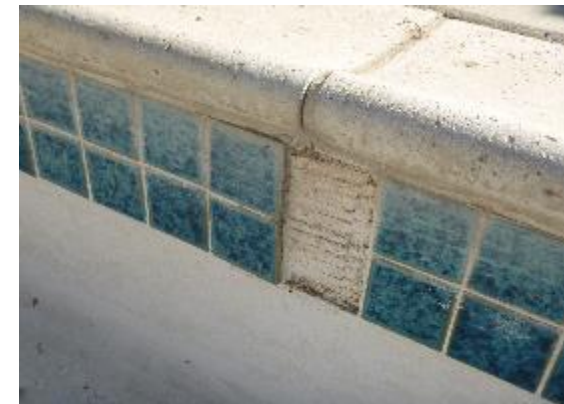
- The children's pool is in fair condition overall but does not meet the current expectations for a children's area at an outdoor aquatic facility. The pool holds approximately 5,600 gallons which would necessitate a flow rate of 85 gallons per minute to reach a one-hour turnover rate as required by the State Code.

- Noticeable cracking is evident in the pool's coping stone and there are areas that do not contain any grout along the expansion joints. Missing tiles from the perimeter tile band were also observed.

- The pool is not compliant with the current ADA Standards for swimming pools (2010) and would need to add an entry ramp with compliant handrails in order to meet the current ADA requirements.

- The main drain grate is compliant with the Virginia Graeme Baker Pool and Spa Safety Act (VGB) but has a lifespan that is noted at 5 years. Staff should confirm when the grate was last replaced to ensure it is still within the stipulated time frame. Since the pool contains only one main drain, a Safety Vacuum Release System (SVRS) system is necessary to protect users against suction entrapment.

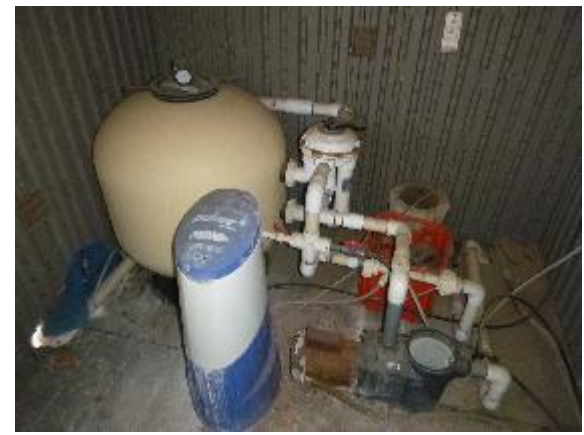
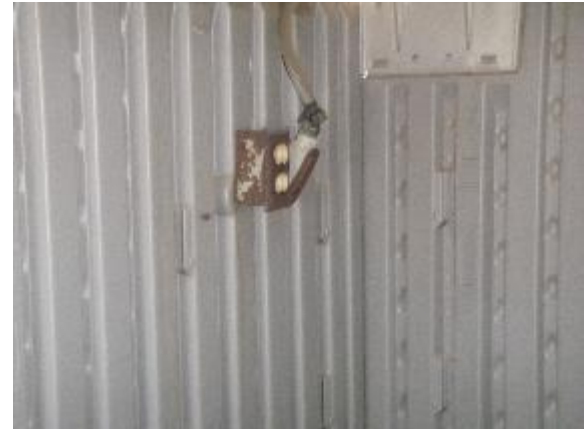
- The pool's mechanical system contains a Triton Sand Filter, BecSys 2 chemical controller and a Pulsar 1 unit for the calcium hypochlorite sanitizer. The muriatic acid and calcium hypochlorite feeders are both located in the mechanical shed and have caused corrosion on some of the surrounding equipment. This is especially noticeable on the pool pump motor and electrical outlet.

- The children's pool does not have a mechanical system that meets industry design standards since it does not contain an Ultraviolet Treatment (UV) System on the pool (picture – bottom right) to provide secondary sanitation. UV has been shown to be highly effective against chlorine resistant pathogens like Cryptosporidium and Giardia; as well as the vast majority of bacteria, viruses, yeast, and mold.

- According to the Model Aquatic Health Code, "Due to the risk of outbreaks of RWIs associated with the DISINFECTANT tolerant parasite Cryptosporidium, it is strongly recommended that all AQUATIC FACILITIES include SECONDARY DISINFECTION SYSTEMS to minimize the risk to the public associated with these outbreaks."

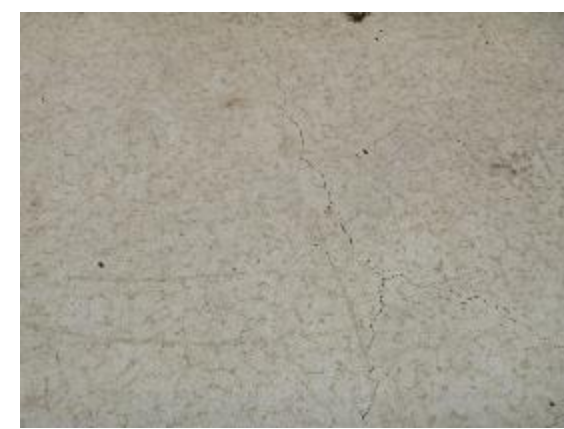
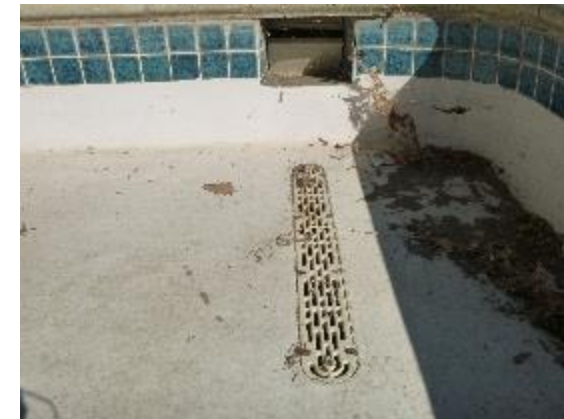
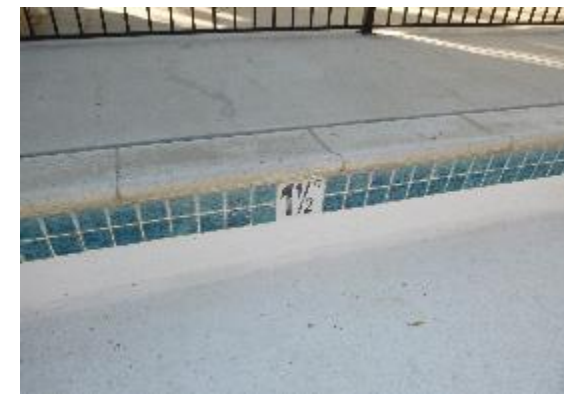
- The pool contains a single main drain with two (2) return inlets on the west side of the pool and a single skimmer box on the east side of the pool. With 2-inch schedule 40 pressure piping that is rated for 105 GPM at 10 feet per second, the piping can handle the flow rate necessary to meet the required one-hour turnover rate.
- The single skimmer suction piping cannot handle the full recirculation flow rate for the children's pool. Assuming the maximum flow rate of 63 GPM the pool would need a 3-inch pipe to handle this flow.
- The tot pool does not meet the modern definition of a children's pool because it lacks a zero-beach entry, children's play features, tot slides, etc. If the facility undergoes a future renovation, it is recommended that this area be replaced with a modern tot pool or interactive spraypad.
