Harris Civil Engineers, LLC

Date Issued: 07/15/2020

Sol Avenue Roadway and Drainage

07/09-10/2020- Field Report

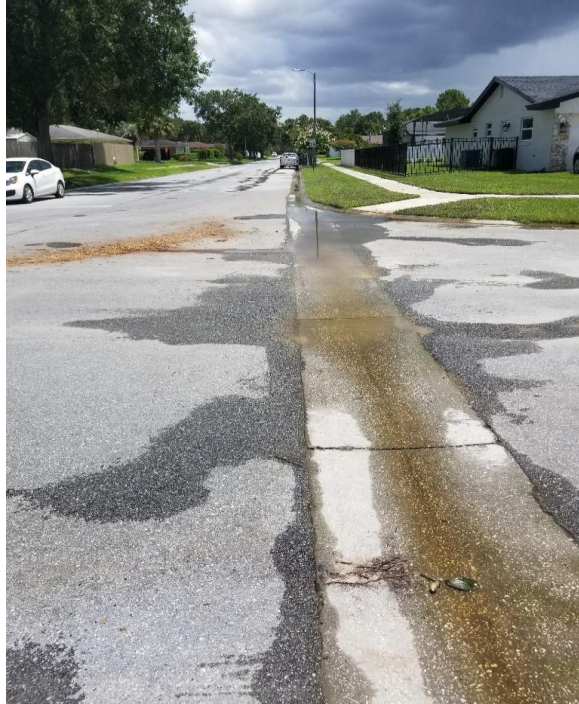
Photo 1 ~

Standing on Cove Drive; view looking south down Sol Avenue.

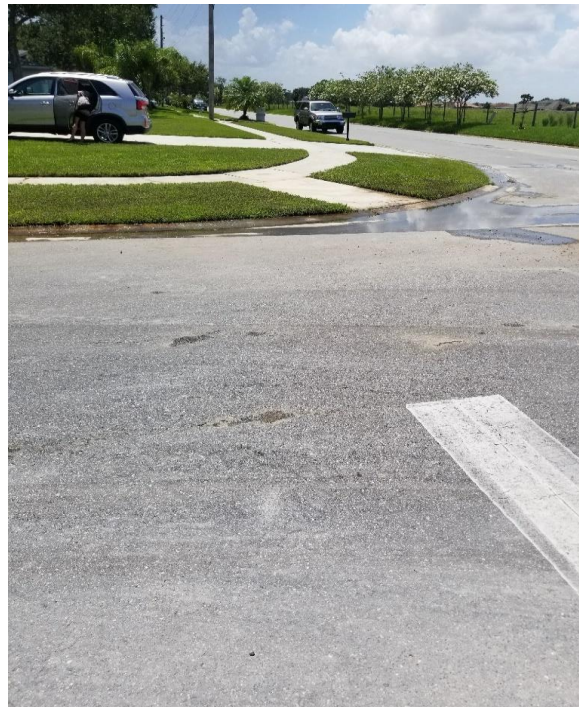
Photo 2 ~

Low spot pictured at intersection of Cove and Sol; view looking west at Cove intersection.

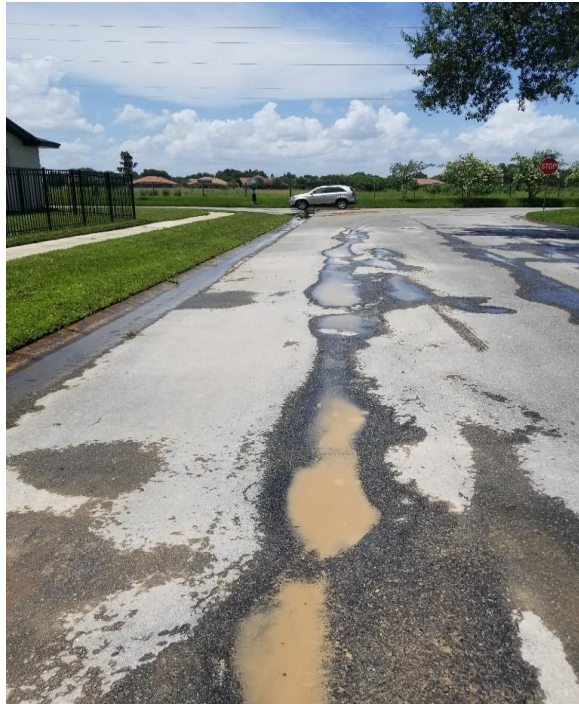
Photo 3 ~

Standing on Sol Avenue; view looking north at Cove intersection.

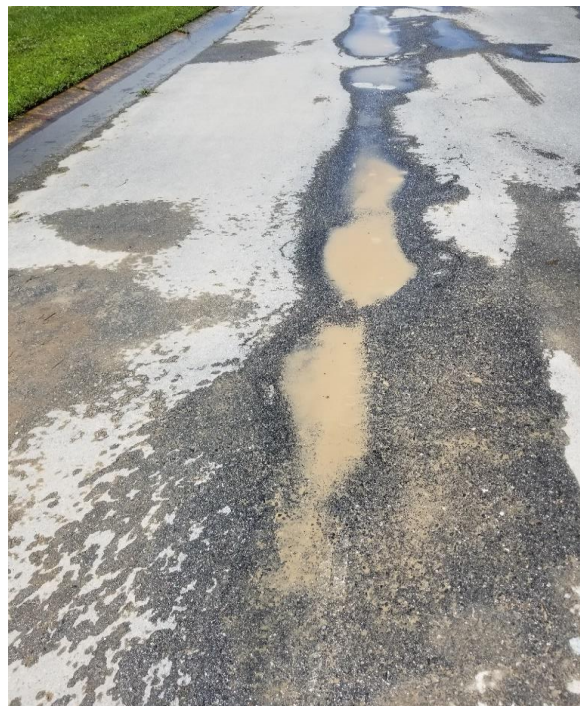
Photos 4 ~

HCE suspects that water has infiltrated the asphalt and is traveling horizontally between the base course and top asphalt layer. Where it can, water is making its way up through cracks or joints in the asphalt (bringing the road base with it) and is ponding in the ruts/depressions seen. Sol Avenue appears to have minimal slopes and runoff moves slowly in the curbing to reach the existing drainage basins. The portion of Sol roadway, between Cove and Playa, does not currently have underground drainage and relies on curbing to convey water away from the road.					
ACTION ITEMS					
1 Engage the services of a Geotech to perform borings, a subgrade analysis and render an opinion of the source of the problem.					
2 Request a topography survey be performed on Sol Ave, from Cove to Kandra.					
3 Place project on next budget's year for roadway and drainage remediation.					
CONTRACTOR	HE JOB NO.	DATE	DAY Of WEEK

Picture of ruts/depressions formed in asphalt; water ponding mixed with base material seen.

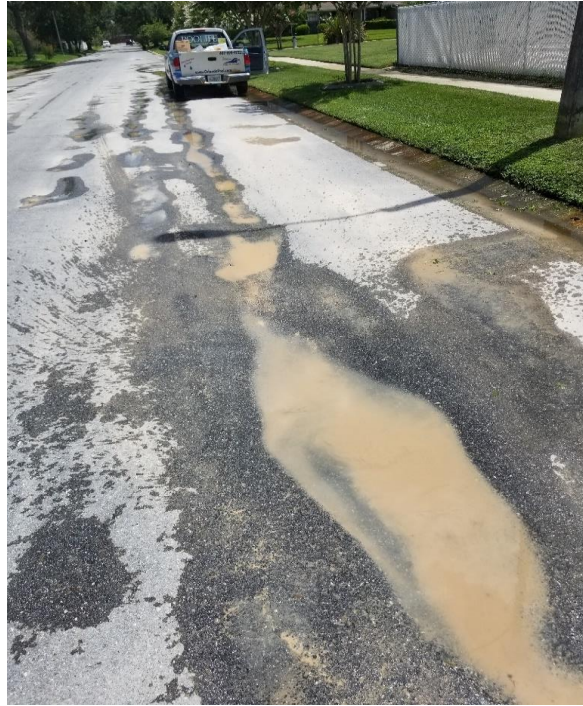
Photo 5 ~

Standing on Sol Avenue; view looking south down Sol.

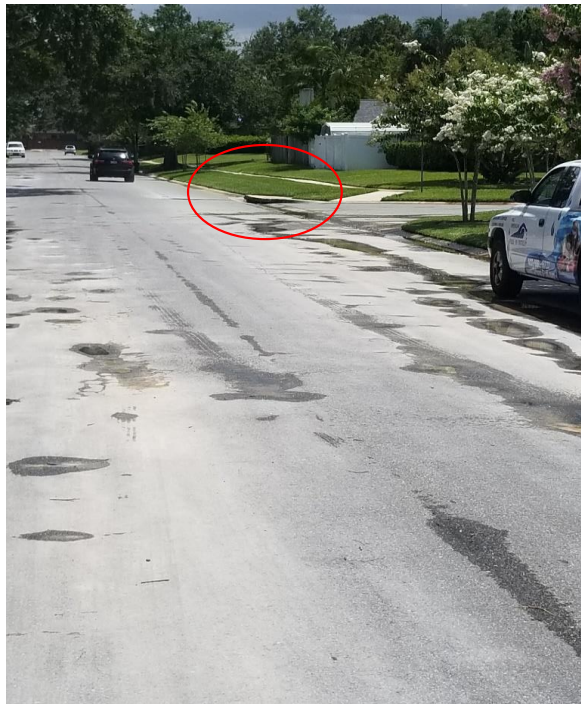
Photo 6 ~

Sol Avenue and intersection with Playa pictured; view looking south. Nearest drainage basin circled in red.

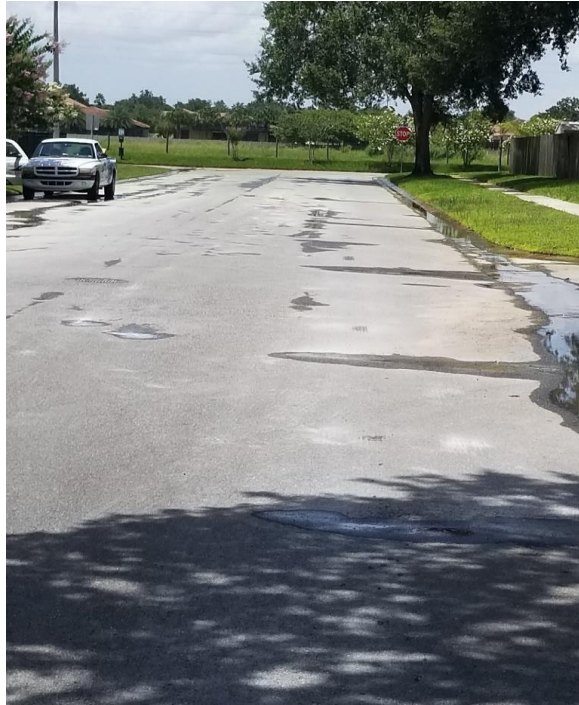
Photo 7 ~

View looking north at Sol and Playa intersection. Water ponding seen in curbing.

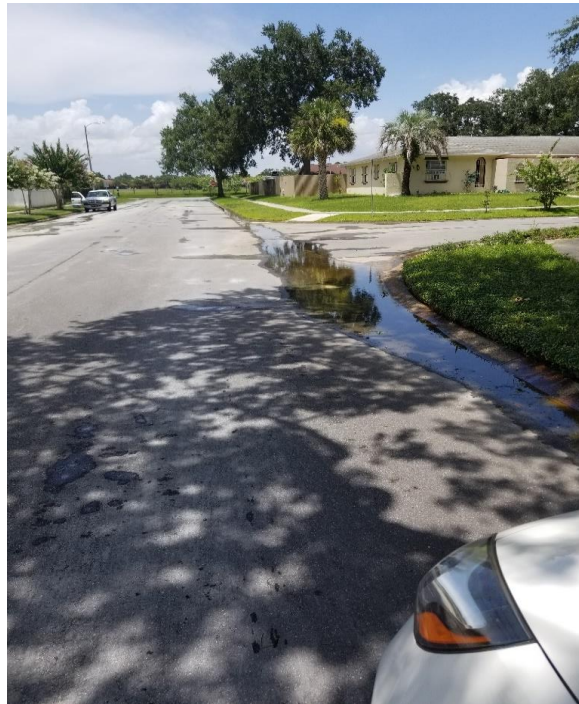
Photo 8 ~

Low spot in curbing/road at Sol intersection with Playa (east side). Existing drainage basin on opposite side of Sol.

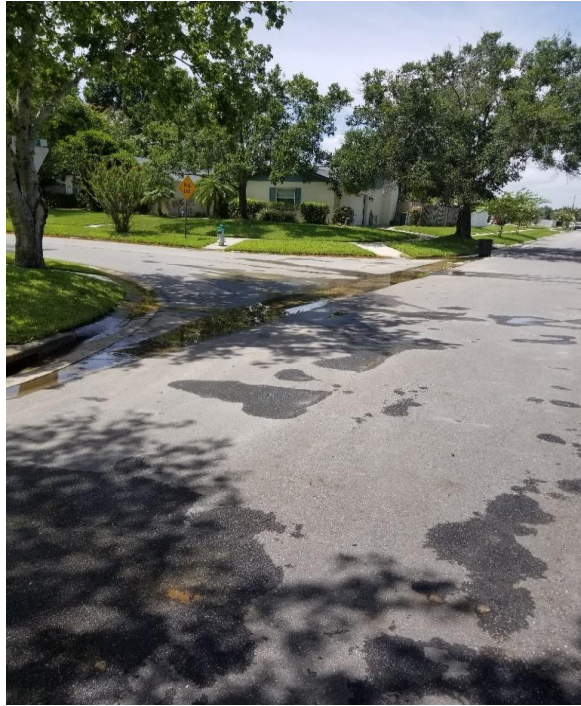
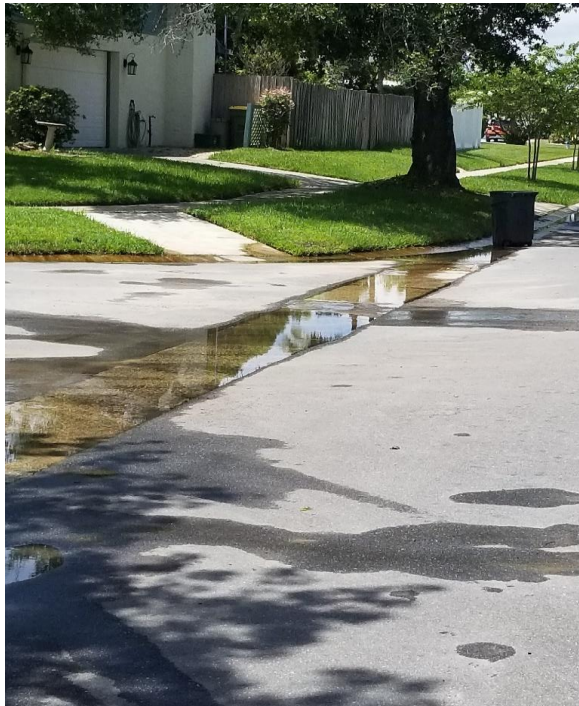
Photo 9 & 10 ~

Water ponding in curbing on west side of Sol / Kandra intersection; view looking northwest.

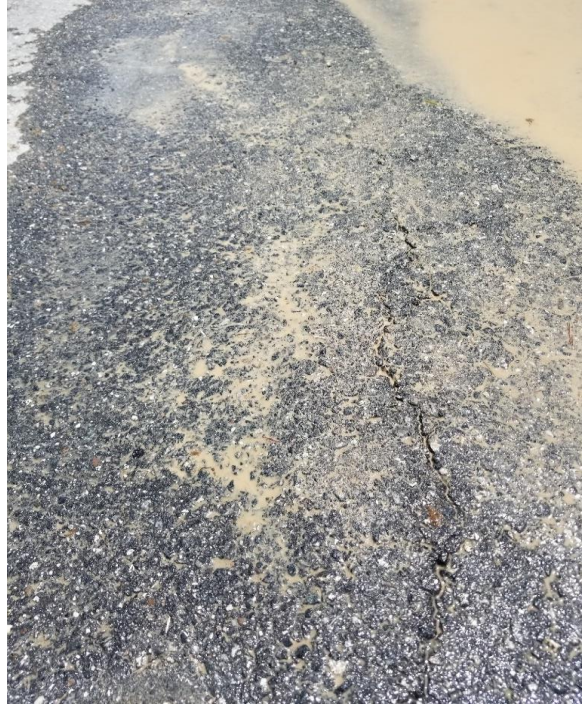
Photo 11 ~

Roadway cracks noted; appears formed from upheaving or uplifting of asphalt.
