# INSPECTION REPORT

5003 RANDOLPH STREET

BELLE ISLE, FL

Inspector: Ed Pierzynski, State Certified Home Inspector# HI 4076

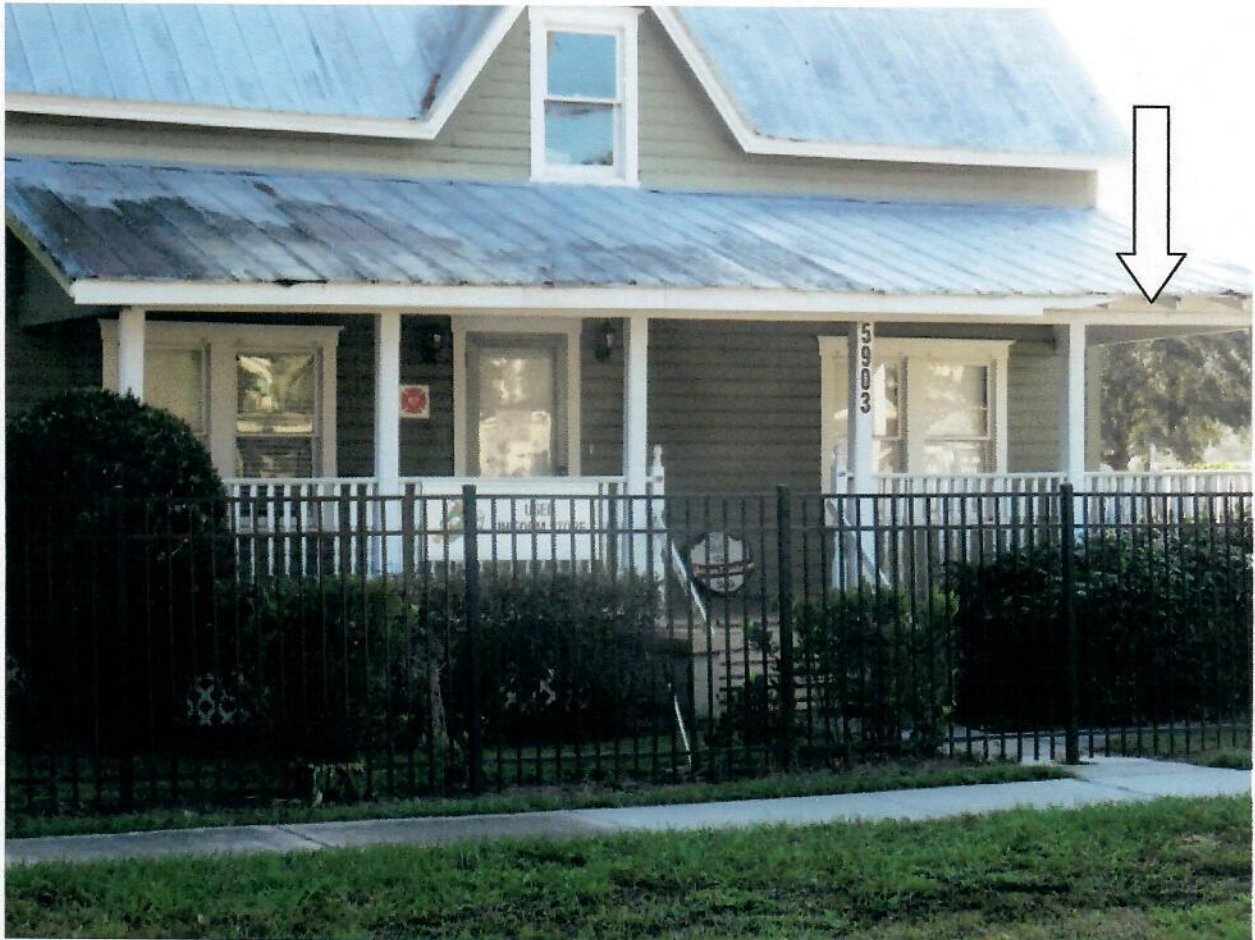
**FRONT FACING WEST** some fascia and roof damage as shown by arrow. Front porch has had the railing replaced but is not a permanent or adequate railing going forward. (Should be replaced with a permanently anchored handicap railing meeting Florida building code.). The concrete steps to the front porch are concrete but pitched the wrong way (toward the house) this needs to be repaired to avoid rot damage to the porch and slip threat.

Some of the supporting columns have rot on the bottom where they attach to the deck. Repair or replacement needed.

The damage on the front porch roof was caused by a previous storm. The roof sheathing was broken off due to the wood being decayed beyond its ability to have the roof fastened properly to it.

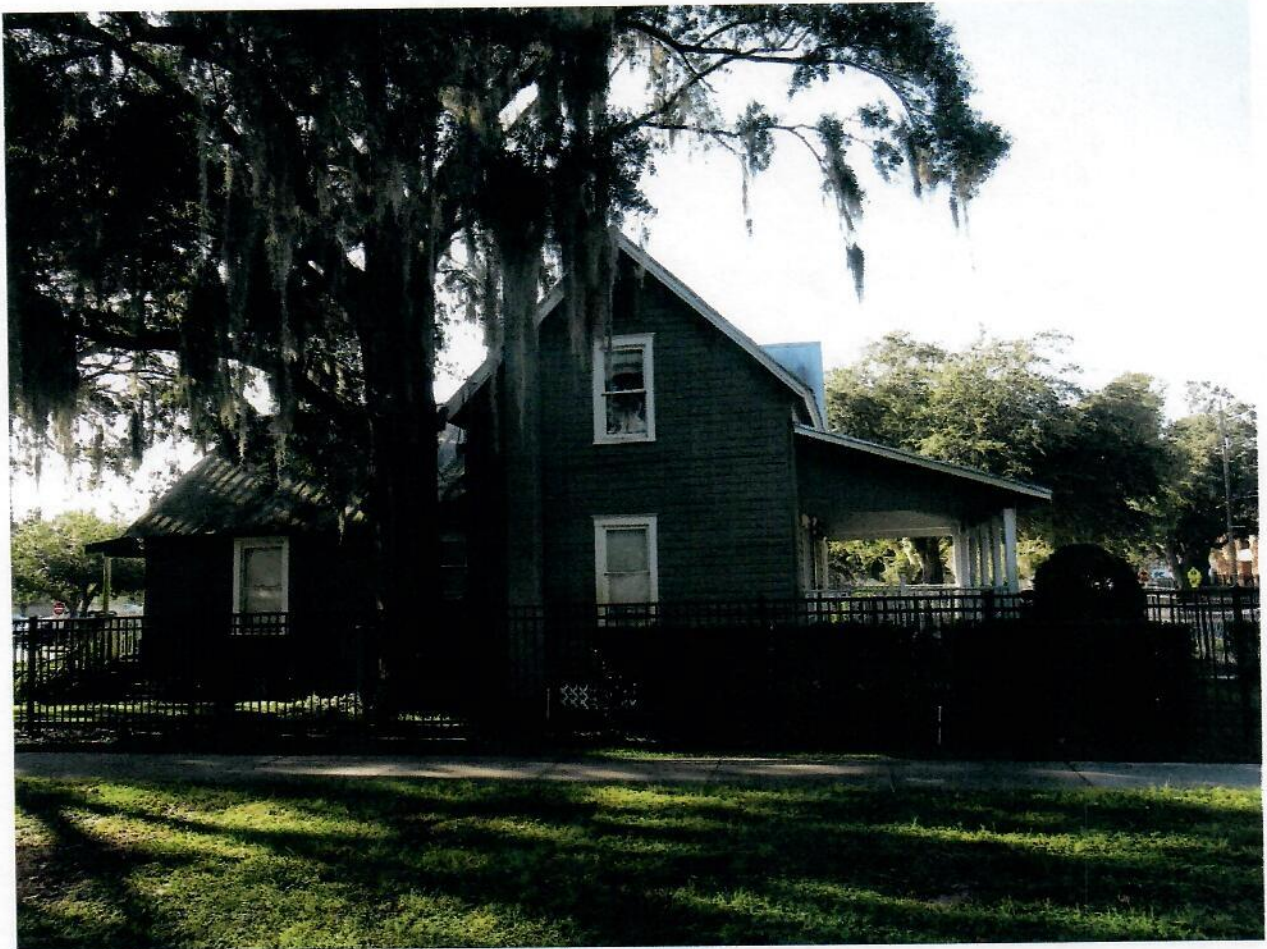
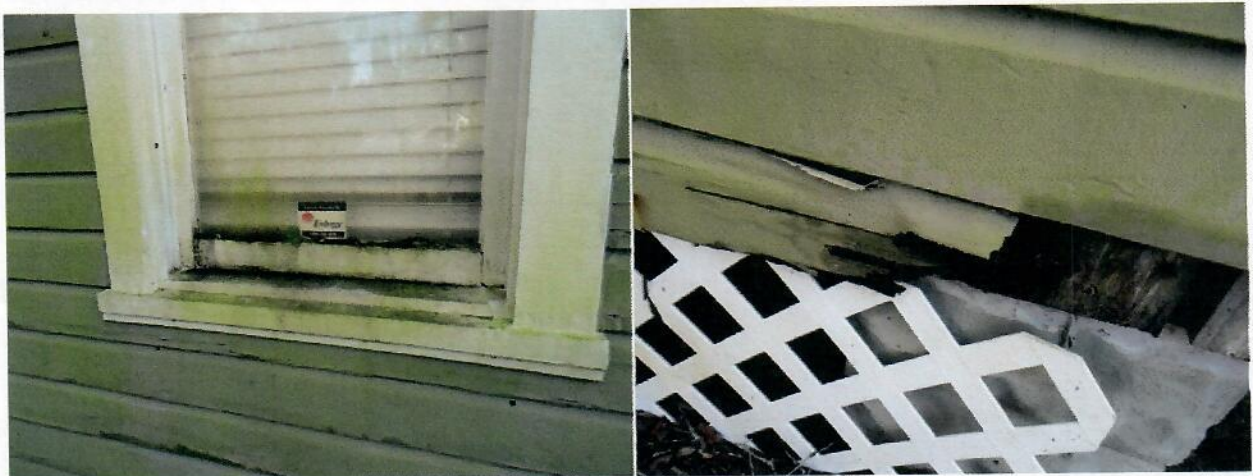
**NORTH SIDE**

North side bathroom window has considerable mold on the window and siding. There is some rot in the window sashes as well. I did not attempt to open the window for fear I would never get it closed or it would fall apart

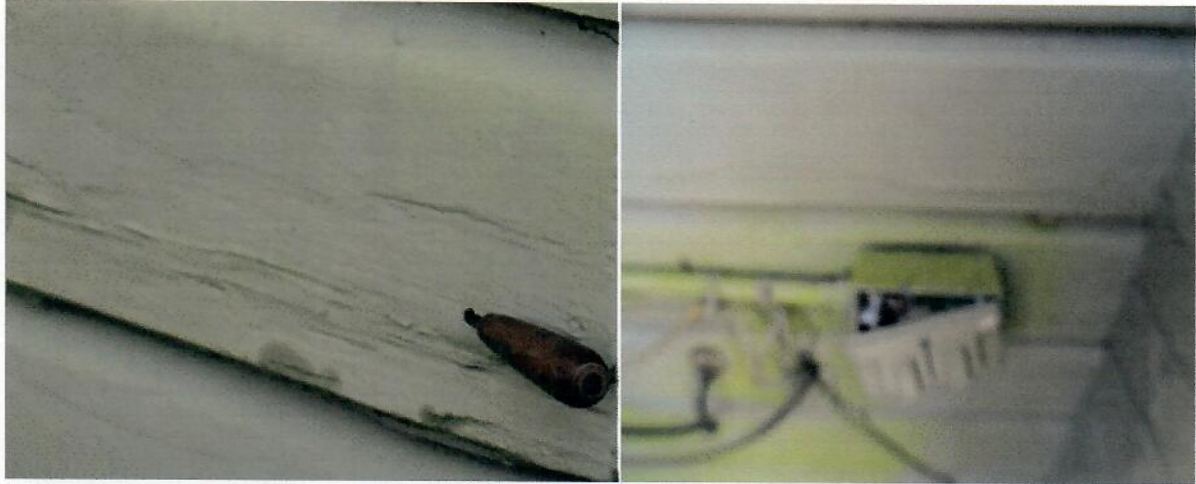
**NORTH SIDE REAR** severe rot on siding, (inserted 4" probe as seen). Also an open live electrical receptacle. Needs prompt attention. Paint is peeling in many places to bare wood allowing weather elements to penetrate the siding.

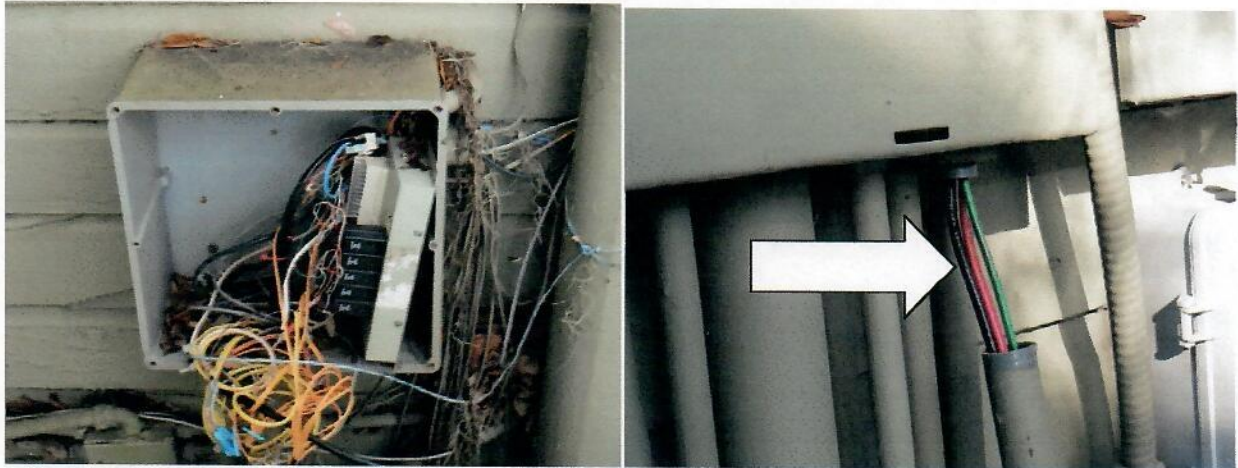
The communication box has no cover so it is open to the weather, insects and rodents. The "sealtite" weather proof covering for the power line to the Air conditioners compressor has come off exposing the (220volt) electric lines to the elements. There is a substantial amount of debris on the ground in this area causing difficulty to service the compressor unit and the electrical components. Trees and bushes within three feet of the structure should be removed if possible because they promote access of insects and rodents as well as branches falling on the structure. The overhang of the roof has extensive rot on this side of the building. If not repaired the roof covering will first become detached, then collapse. This situation is evident in many areas around the building.

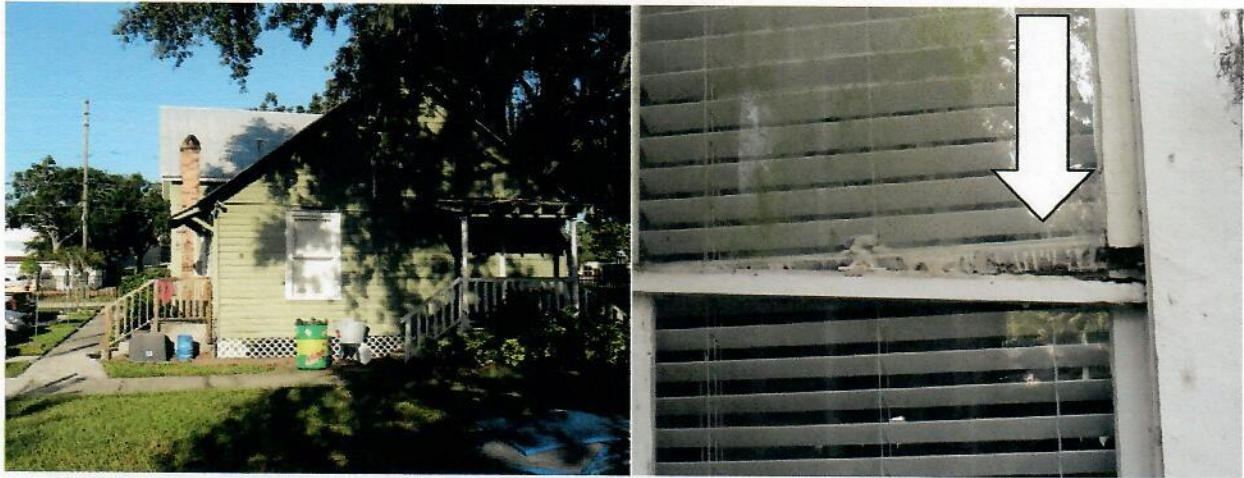
**EAST SIDE**

Siding on this side was peeling but not much rot was found. The door was not accessible but the porch was walkable. The attic access door to the outside was screwed shut due to past storm damage. Did not try to open the window on the left, and did not attempt the one on the right.

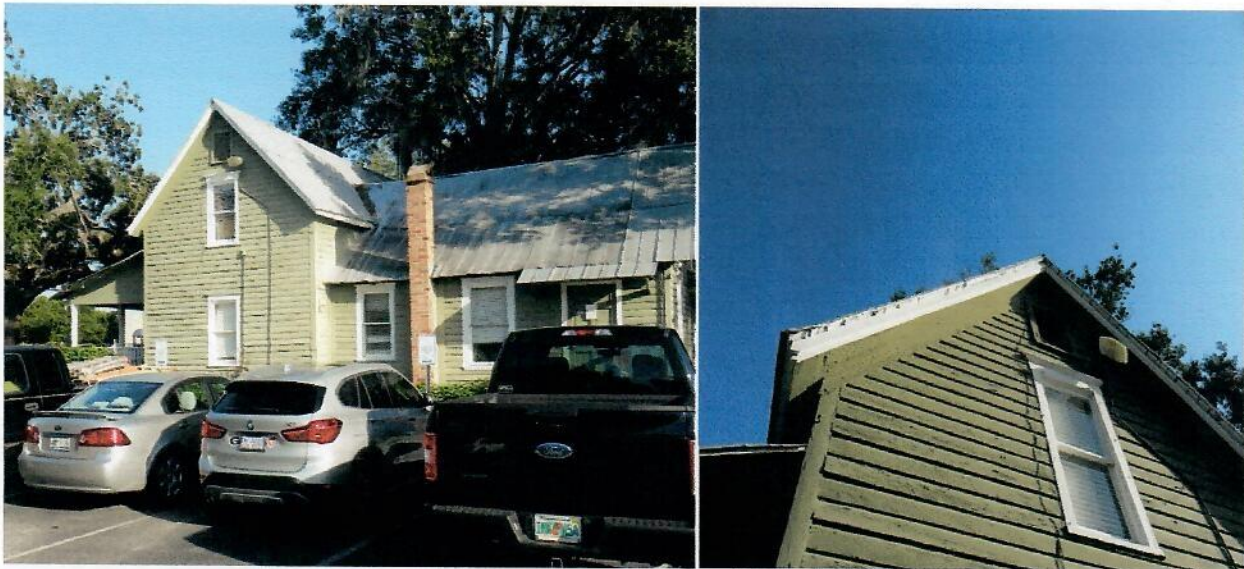
**SOUTH SIDE**

South side of the structure has a lot of wood decay. The probe with the wooden handle shown is 5" long.

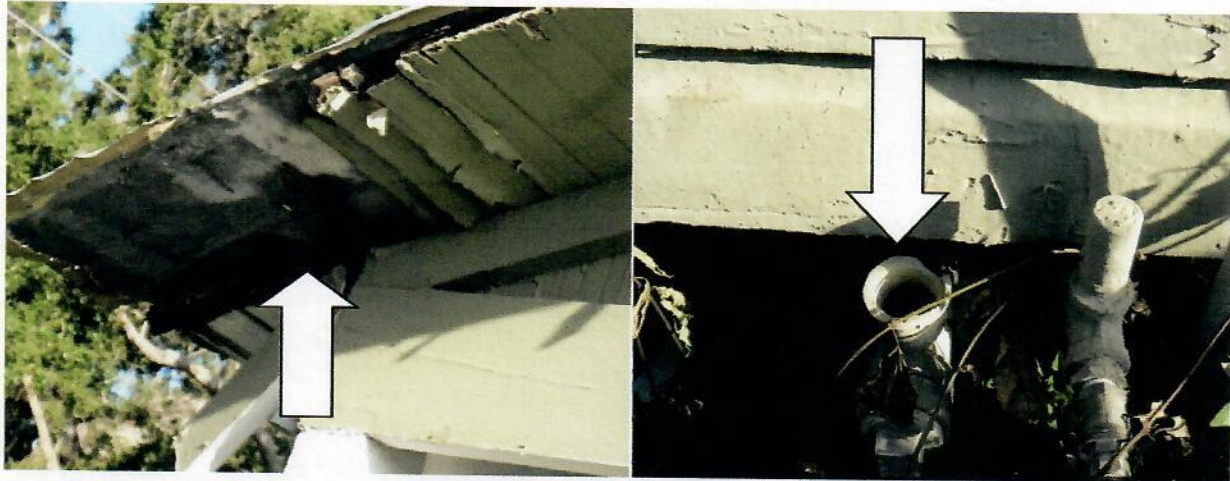
**Open sewer line**

The open sewer line shown goes under the building to the main drain. Its purpose is unknown and should be capped to prevent debris from entering it. The main drain goes to sewer service.

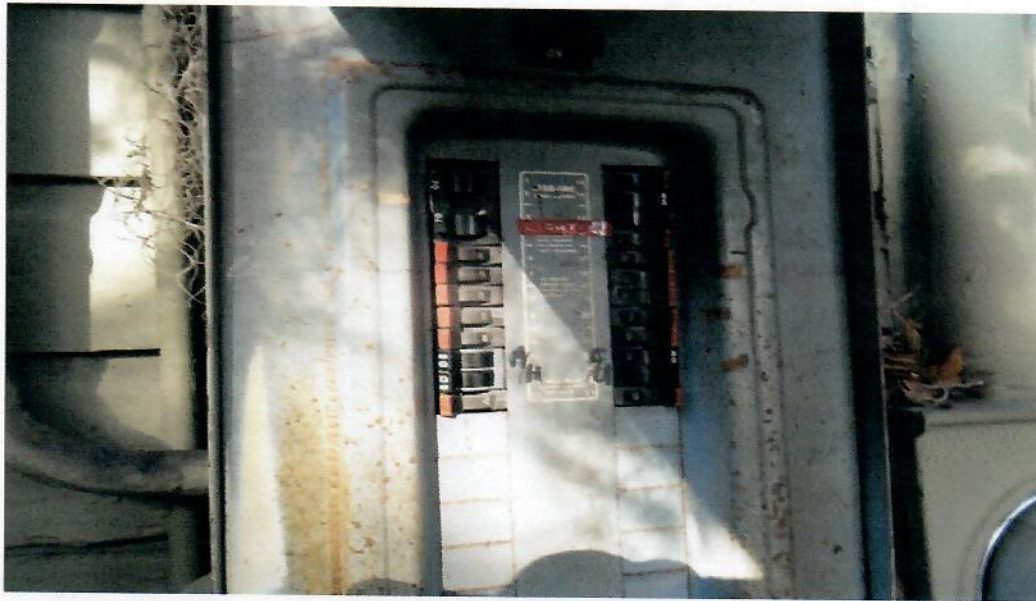
The main service is 100 amps. The circuit breakers in this panel are FEDERAL PACIFIC. These breakers are known not to trip when there is a short circuit of some kind. Thus causing a fire. Many insurance companies will not insure buildings with this type of circuit breakers due to the hazards. I highly recommend replacement of this electric service.

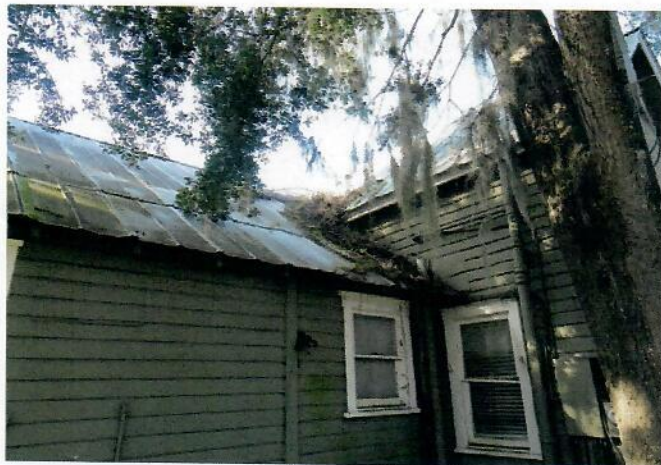
Recommend to clean the debris off the roof especially in the north valley where there is a large amount of leaves and branches which will cause problems in the future if not removed.

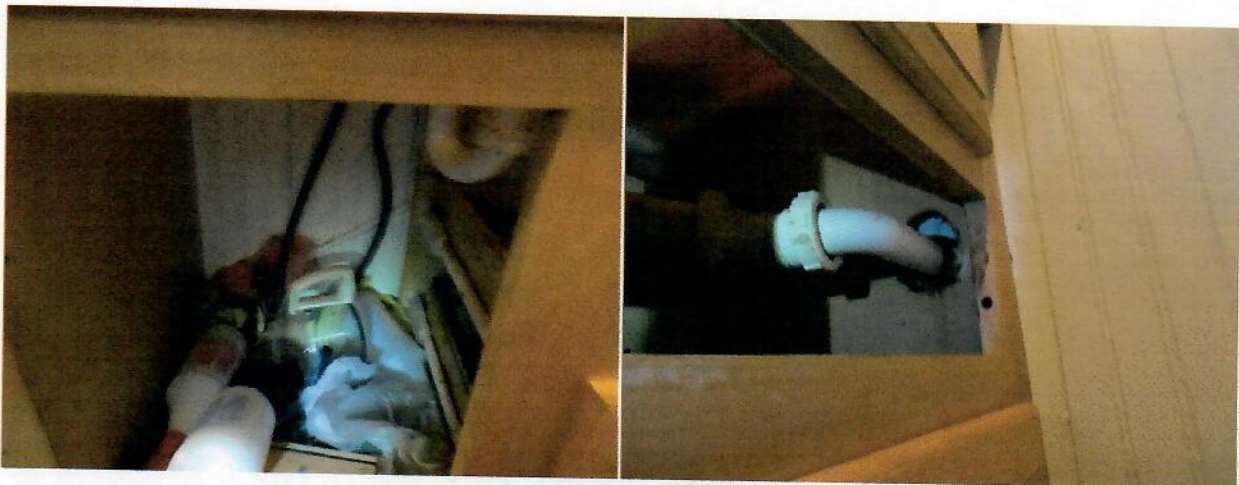
Downstairs bathroom vanity was operated, drained well and showed no leaks. Supply lines are copper to the valves, then flexible supply lines to the fixture. One of the fronts was missing from the vanity. There is no GFCI ground fault protection in the bathroom or any found on the first floor.

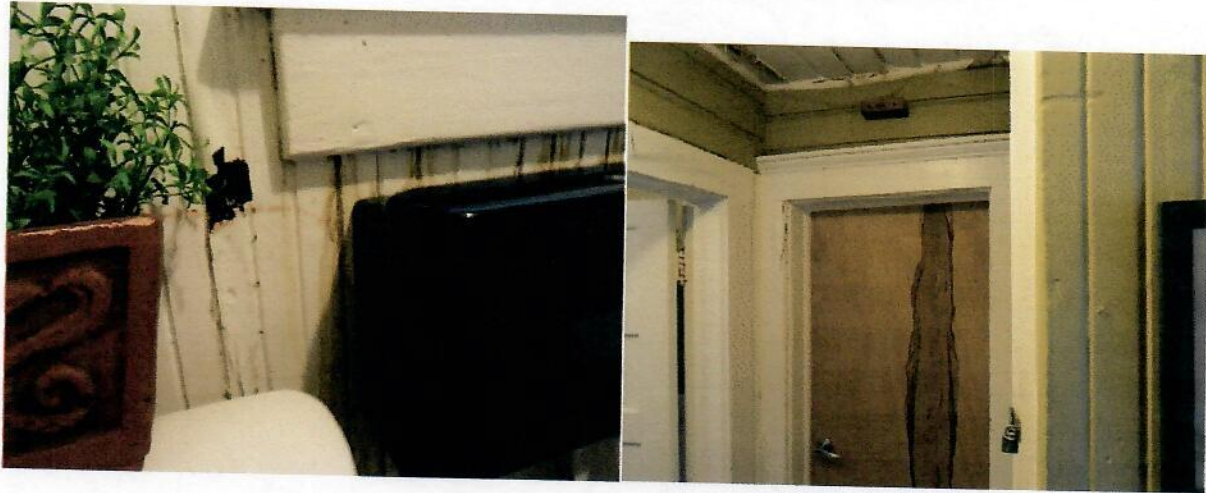
There are water stains on the bathroom door and the ceiling of the bathroom. This is from the Air Conditioning pan above the hall.

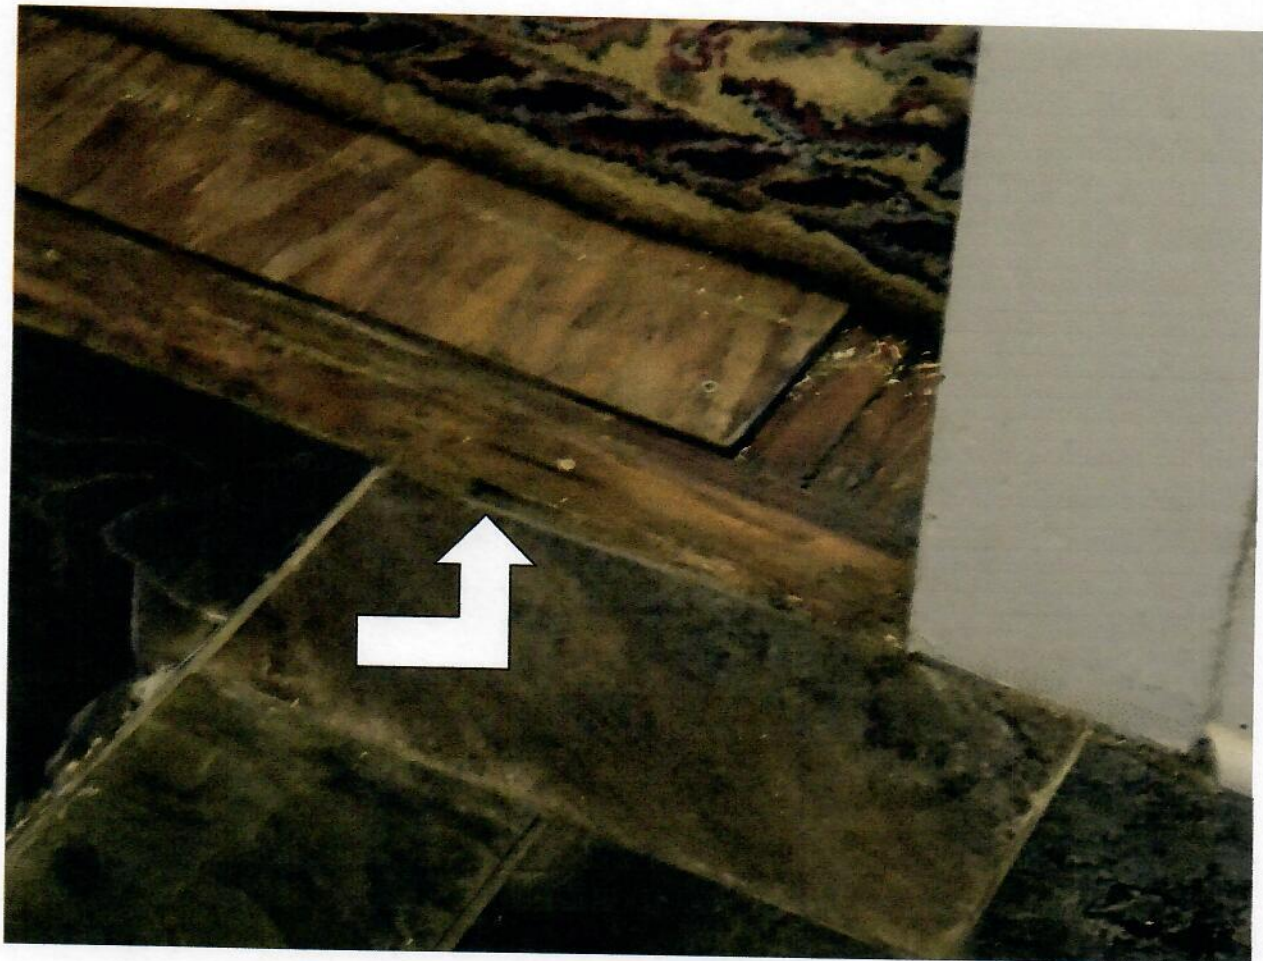
Termite damage in the floor outside the bathroom. I suspect the plywood was placed there because of previous termite damage. I saw no evidence of active termites.

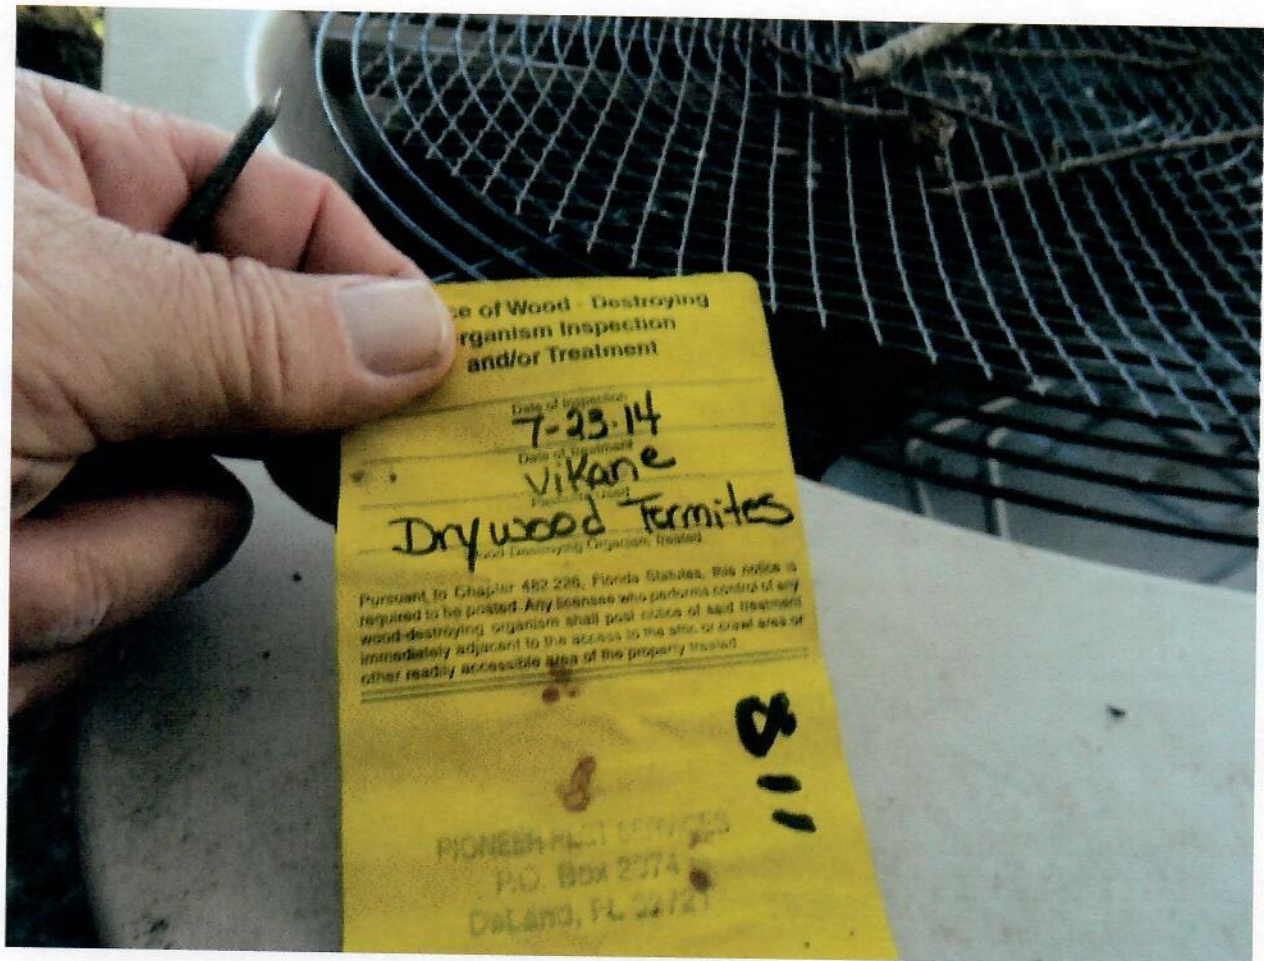
Most flooring is hardwood pine and is solid. There are some areas of unevenness but to be expected for an older building on concrete piers. This sticker was in the panel box outside indicating termites in 2014. Dry wood termites are difficult to treat without texting the building. Suggest another inspection or treatment from a termite technician

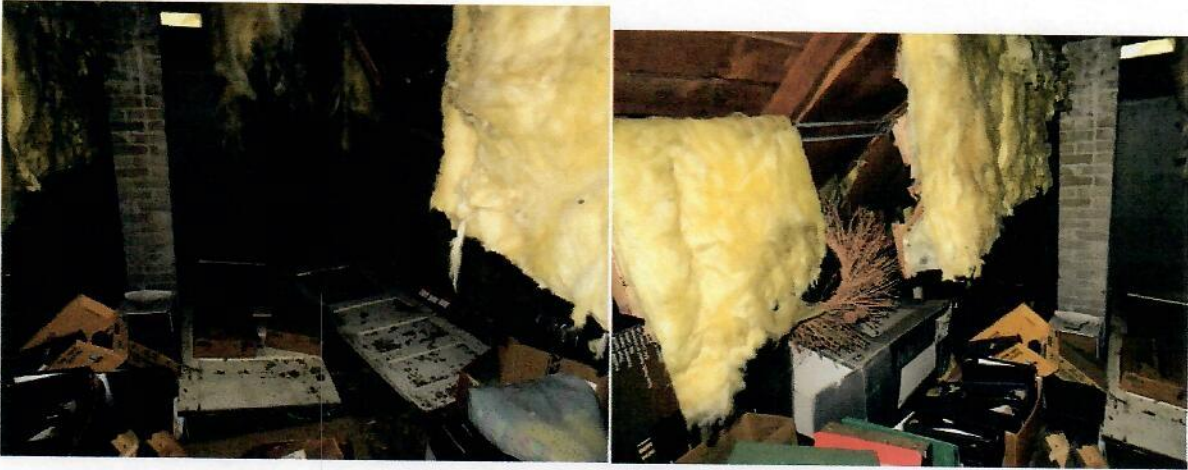
Second floor attic storage has insulation in disarray with evidence of rodents.

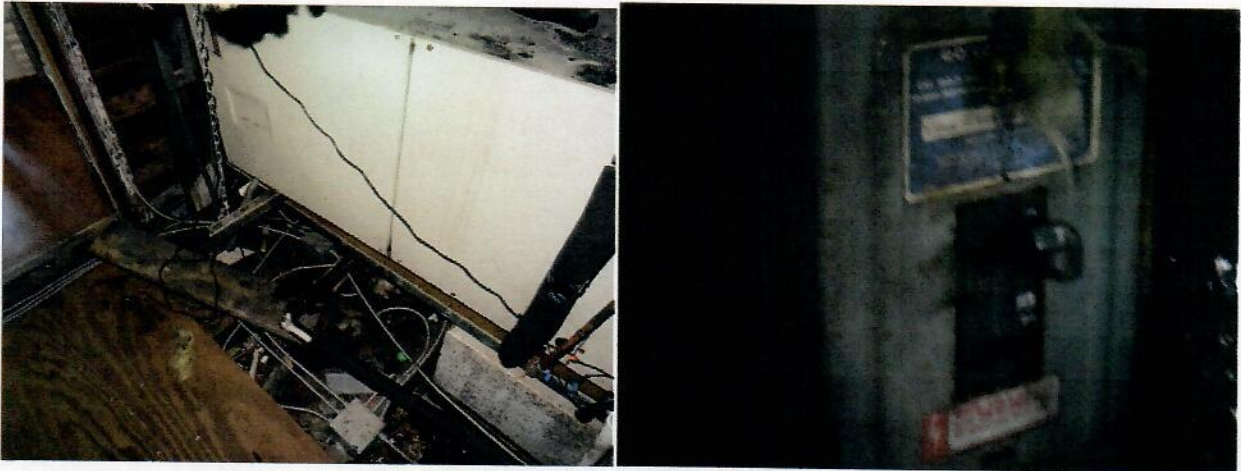
Although there is a pan under the air conditioning unit it is pitched away from the float switch. so it would overflow before the float (pump) would engage, this is why there is water on the downstairs bathroom door and hall ceiling below.

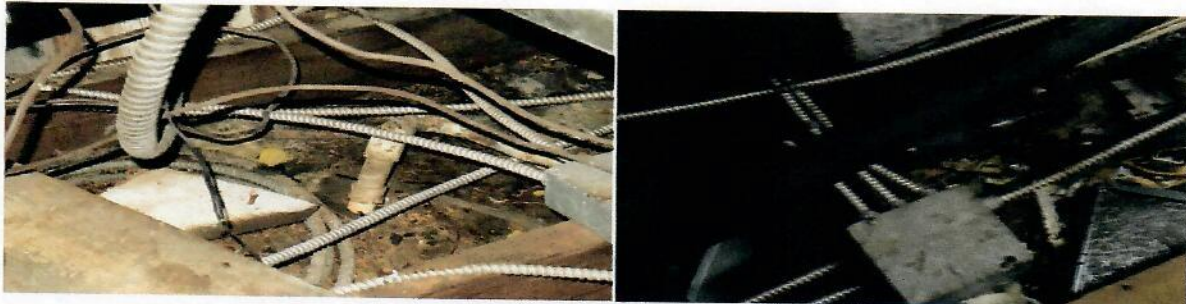
Lots of debris in the attic. Wiring is below the overflow pan. Potential electrical short if pan overflows. Insulation is torn off almost everywhere.

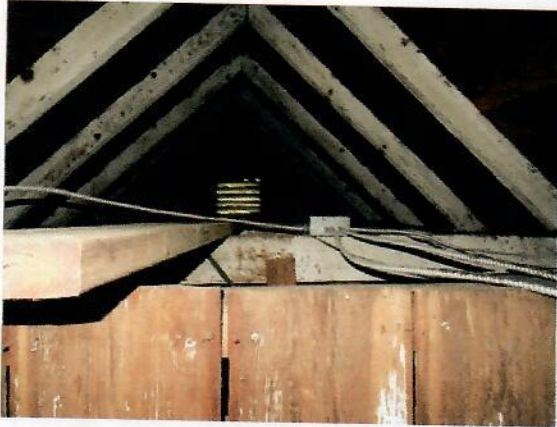
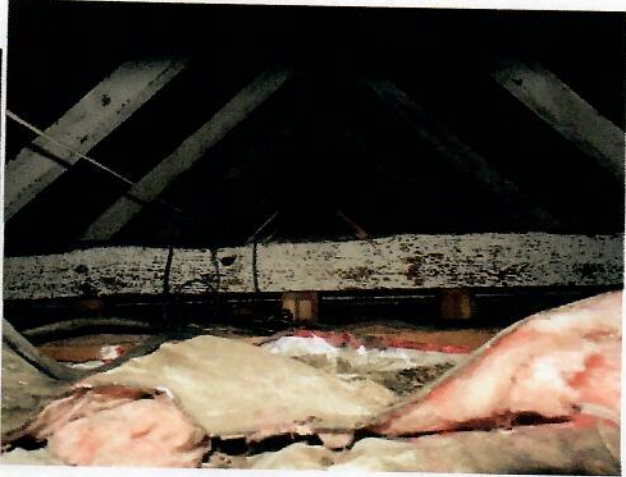
Upper attic accessed though hallway hatch. Some insulation has been laid on the ceiling, but the vapor barrier is upside down. It would have been better to have taken the vapor barrier off.

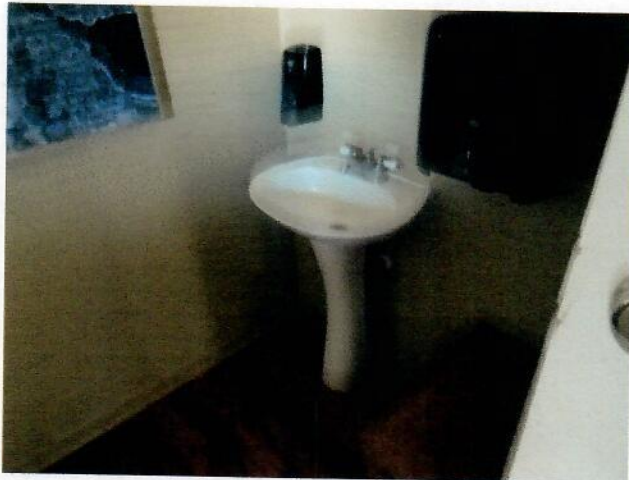
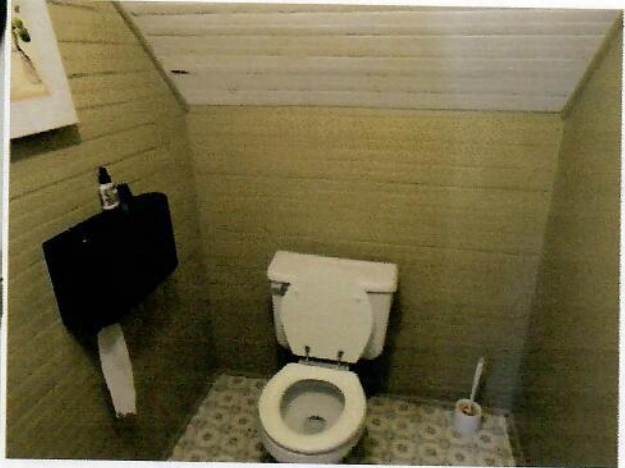
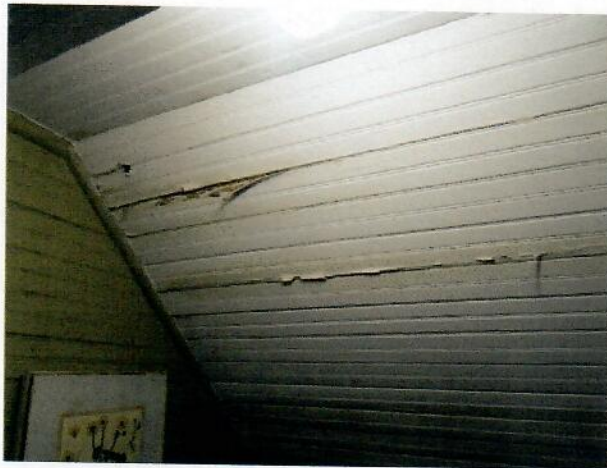
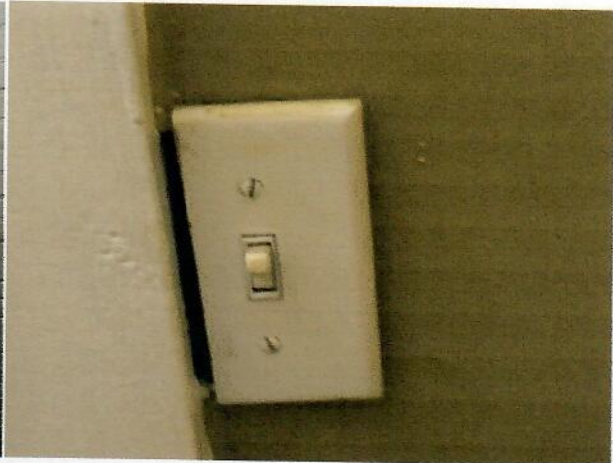
#### UPSTAIRS BATHROOM

The upstairs bathroom is operational with shut-off valves on both the sink and the toilet. There is no ventilation in this room and needs an exhaust fan installed. The light switch has more than ¼" gap to the trim, replace cover plate.

The ceiling has the paint peeling off and although the moisture reading was low there may be a condensation problem from the lack of insulation.

The door has no knob and can only be locked with a "hook and eye" needs repair.

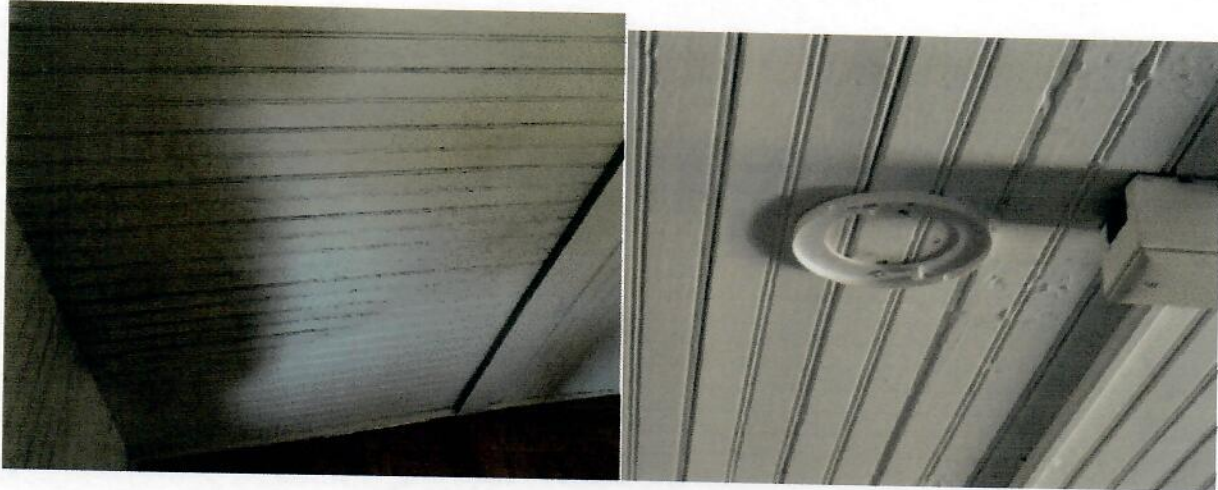
Mold on the wall from the hallway to the attic. The smoke detector was removed from the upstairs hall and needs to be replaced as soon as possible.
