Subject: Beacon House (Green House at 5003 Randolph)

INSPECTION REPORT

5003 RANDOLPH STREET

BELLE ISLE, FL

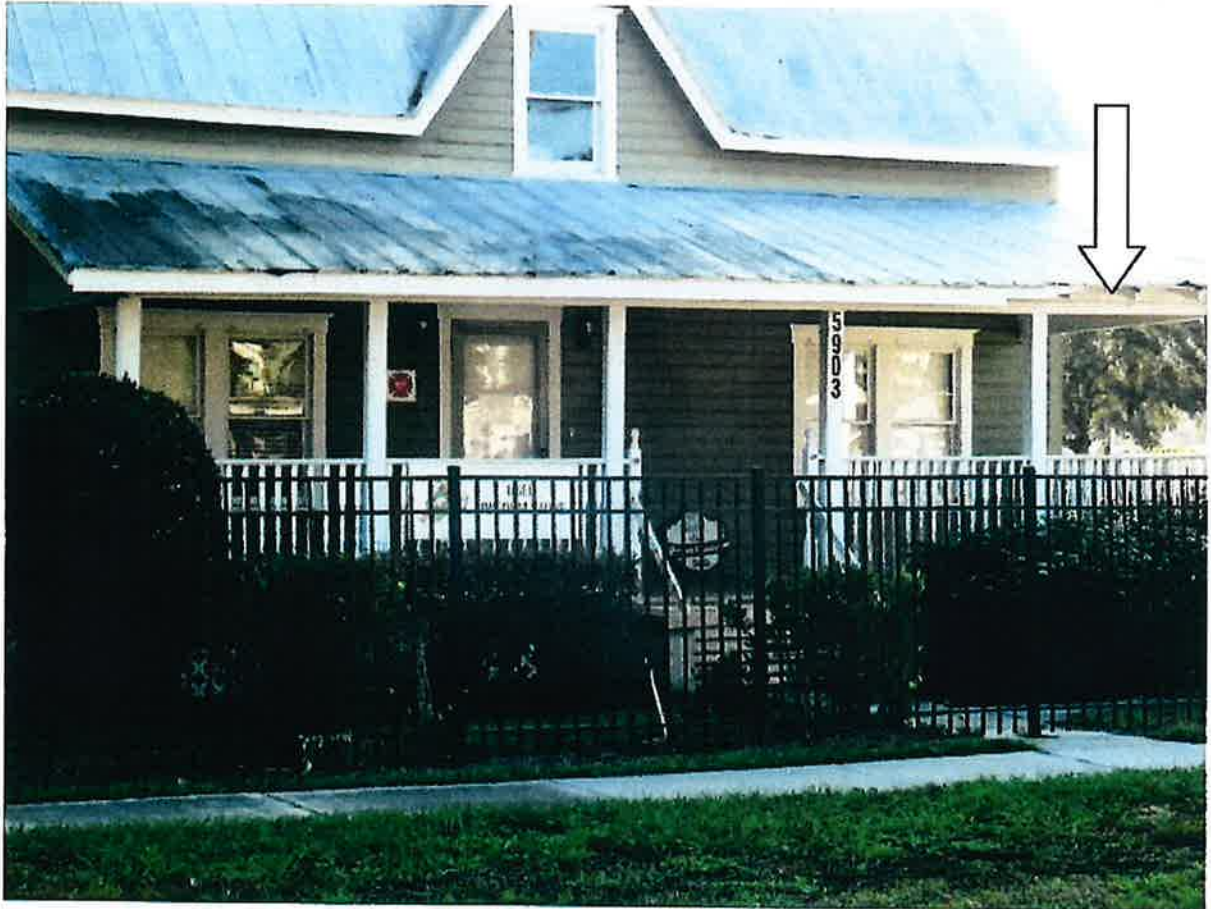
FRONT FACING WEST some fascia and roof damage as shown by arrow. Front porch has had the railing replaced but is not a permanent or adequate railing going forward. (Should be replaced with a permanently anchored handicap railing meeting Florida building code.). The concrete steps to the front porch are concrete but pitched the wrong way (toward the house) this needs to be repaired to avoid rot damage to the porch and slip threat.

Some of the supporting columns have rot on the bottom where they attach to the deck. Repair or replacement needed.

The damage on the front porch roof was caused by a previous storm. The roof sheathing was broken off due to the wood being decayed beyond its ability to have the roof fastened properly to it.

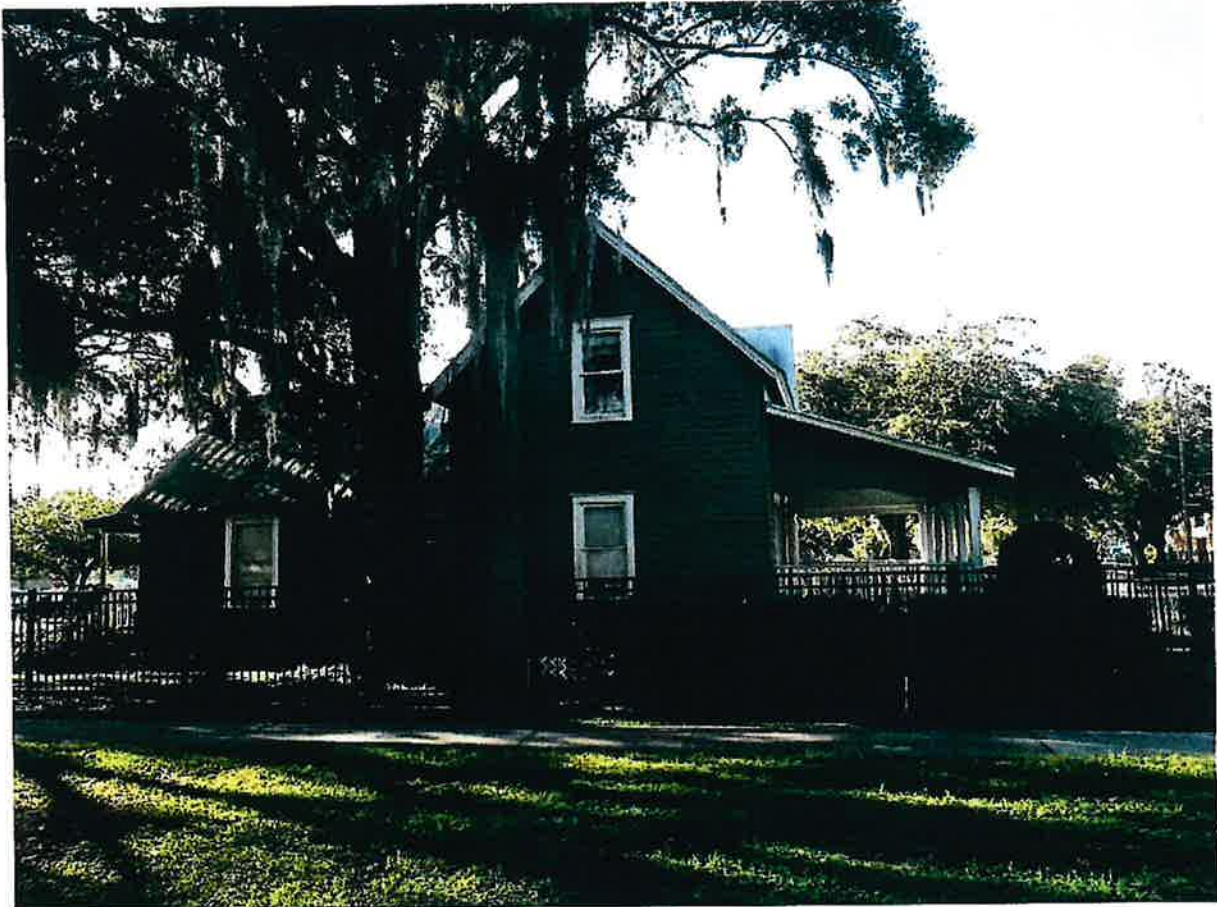
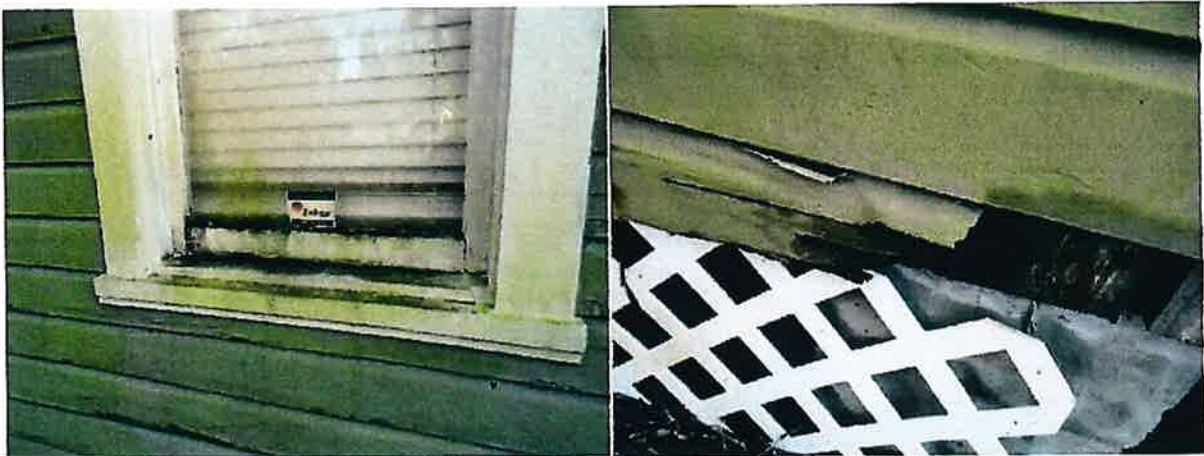
NORTH SIDE

North side bathroom window has considerable mold on the window and siding. There is some rot in the window sashes as well. I did not attempt to open the window for fear I would never get it closed or it would fall apart

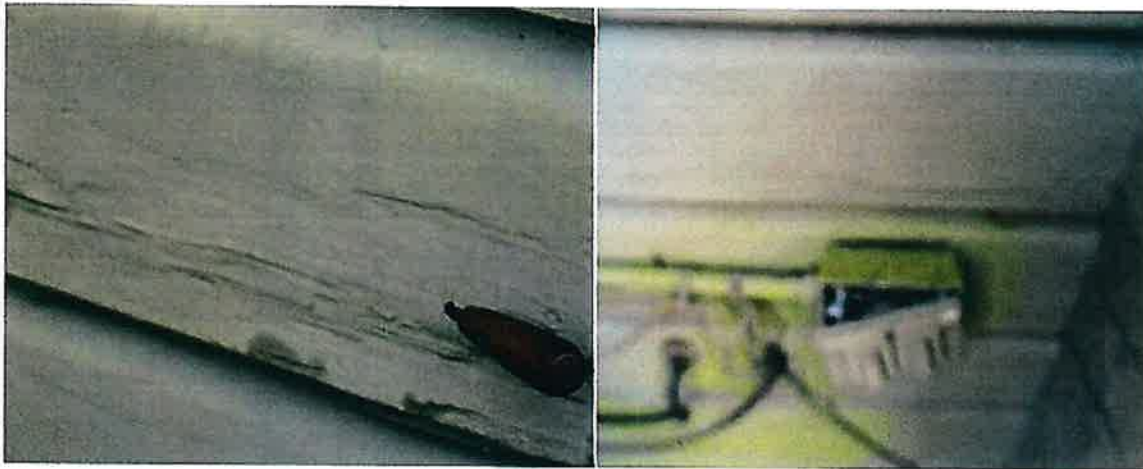
NORTH SIDE REAR severe rot on siding, (inserted 4" probe as seen). Also an open live electrical receptacle. Needs prompt attention. Paint is peeling in many places to bare wood allowing weather elements to penetrate the siding.

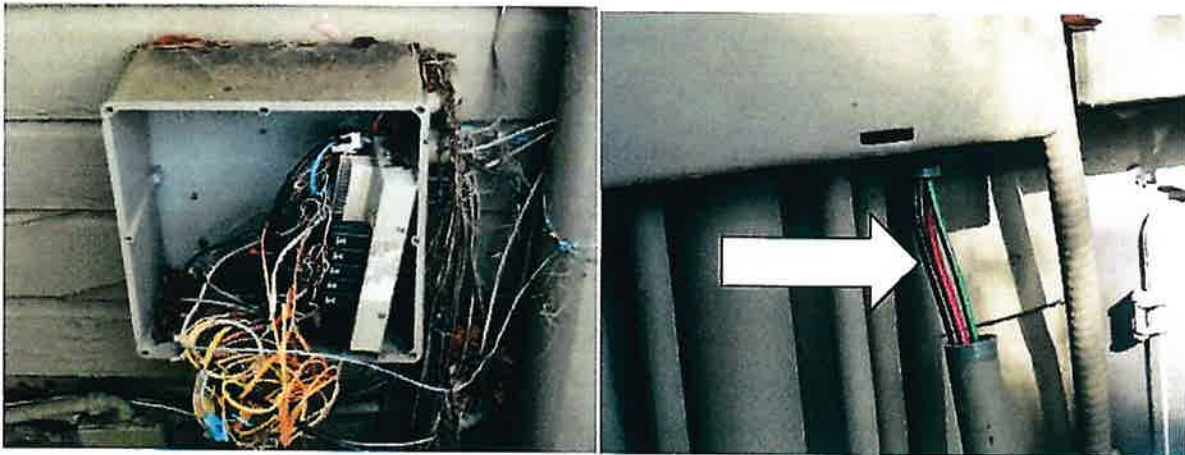
The communication box has no cover so it is open to the weather, insects and rodents. The "sealtite" weather proof covering for the power line to the Air conditioners compressor has come off exposing the (220volt) electric lines to the elements. There is a substantial amount of debris on the ground in this area causing difficulty to service the compressor unit and the electrical components. Trees and bushes within three feet of the structure should be removed if possible because they promote access of insects and rodents as well as branches falling on the structure. The overhang of the roof has extensive rot on this side of the building. If not repaired the roof covering will first become detached, then collapse. This situation is evident in many areas around the building.

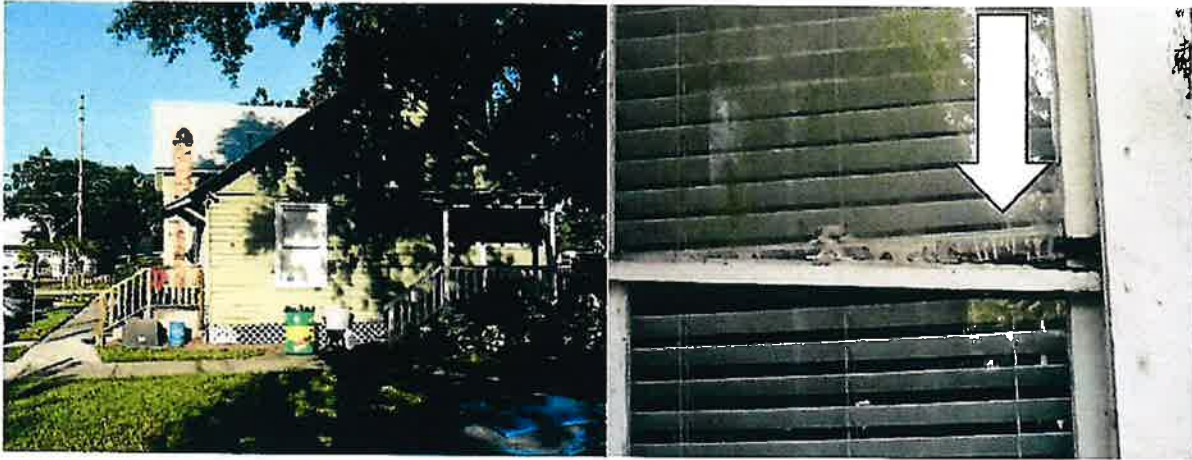
EAST SIDE

Siding on this side was peeling but not much rot was found. The door was not accessible but the porch was walkable. The attic access door to the outside was screwed shut due to past storm damage. Did not try to open the window on the left, and did not attempt the one on the right.

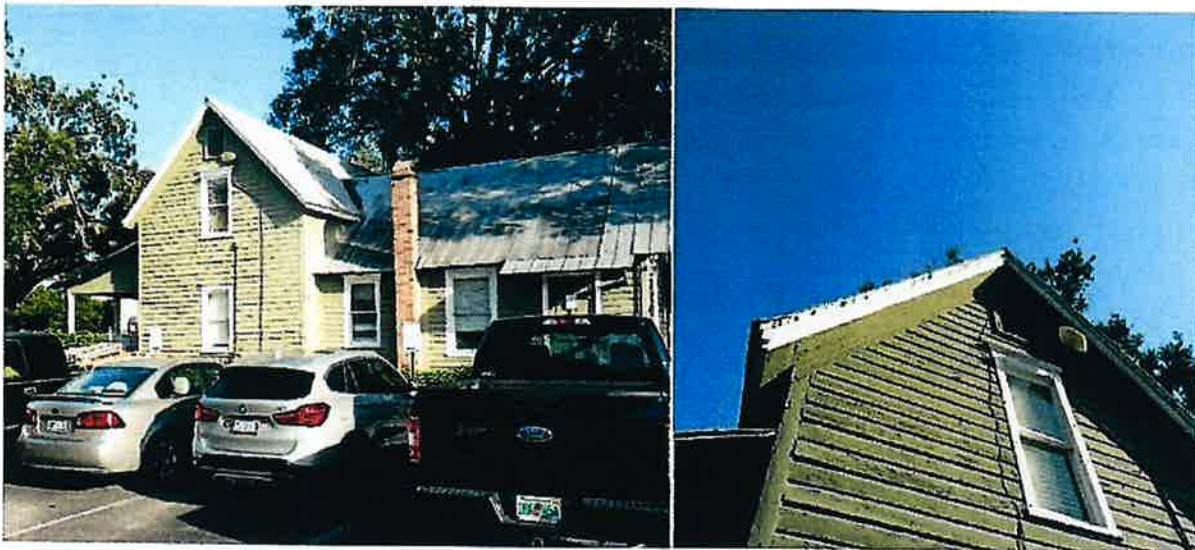
South side of the structure has a lot of wood decay. The probe with the wooden handle shown is 5" long.

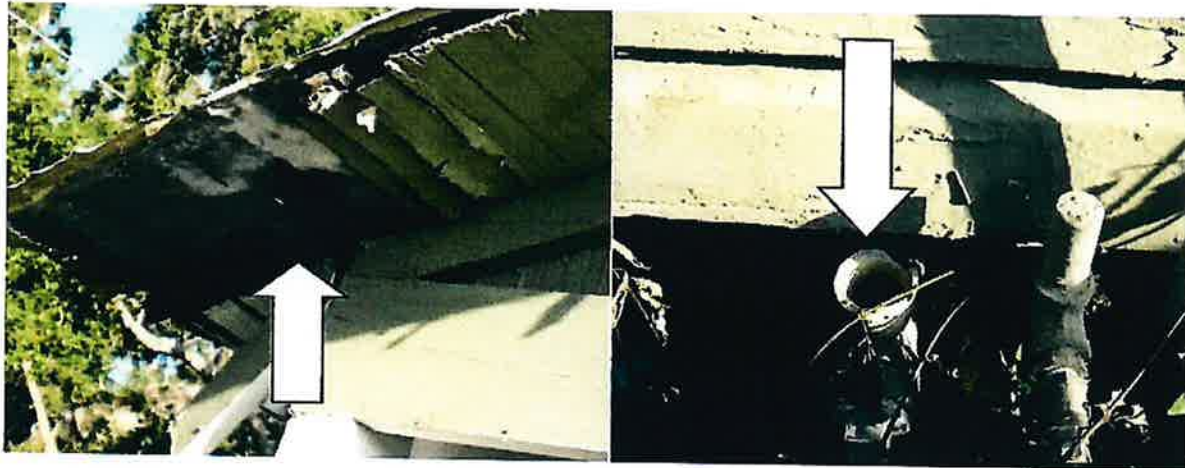
Open sewer line

The open sewer line shown goes under the building to the main drain. Its purpose is unknown and should be capped to prevent debris from entering it. The main drain goes to sewer service.

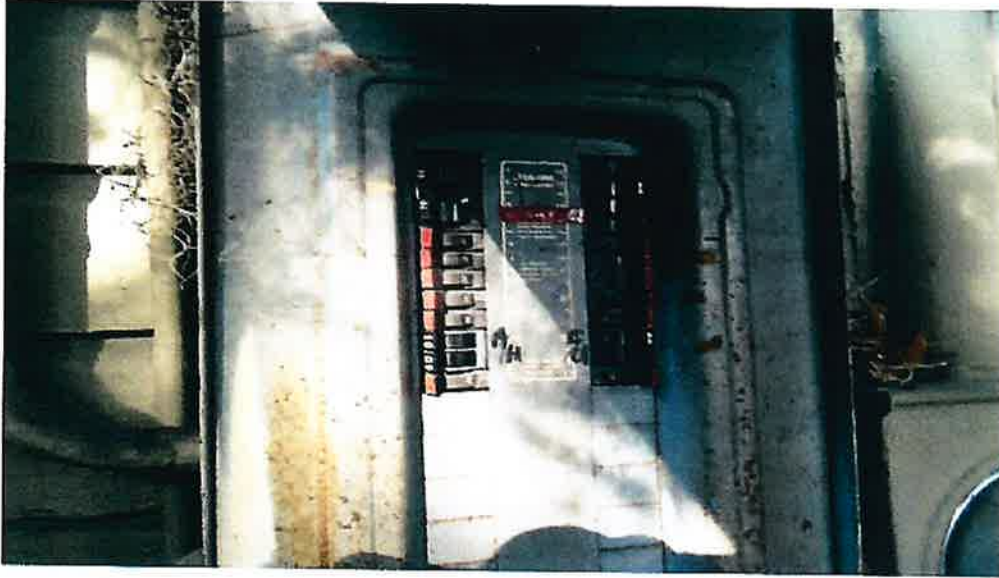
ELECTRIC

the main service is 100 amps. The circuit breakers in this panel are FEDERAL PACIFIC. These breakers are known not to trip when there is a short circuit of some kind. Thus causing a fire. Many insurance companies will not insure buildings with this type of circuit breakers due to the hazards. I highly recommend replacement of this electric service.

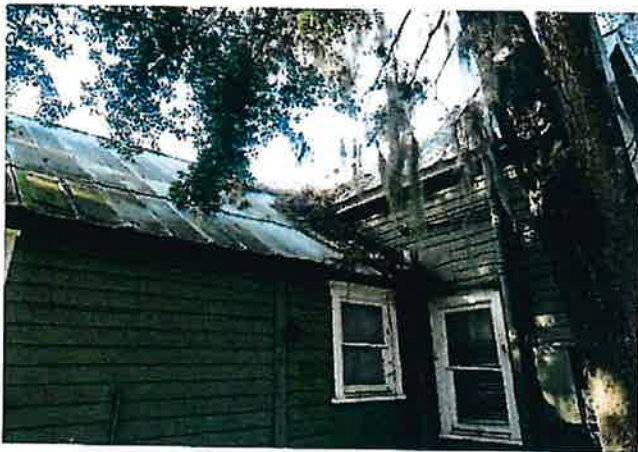
The roof was not walked on. Access from the attics showed no evidence of leaks at present time.

Recommend to clean the debris off the roof especially in the north valley where there is a large amount of leaves and branches which will cause problems in the future if not removed.

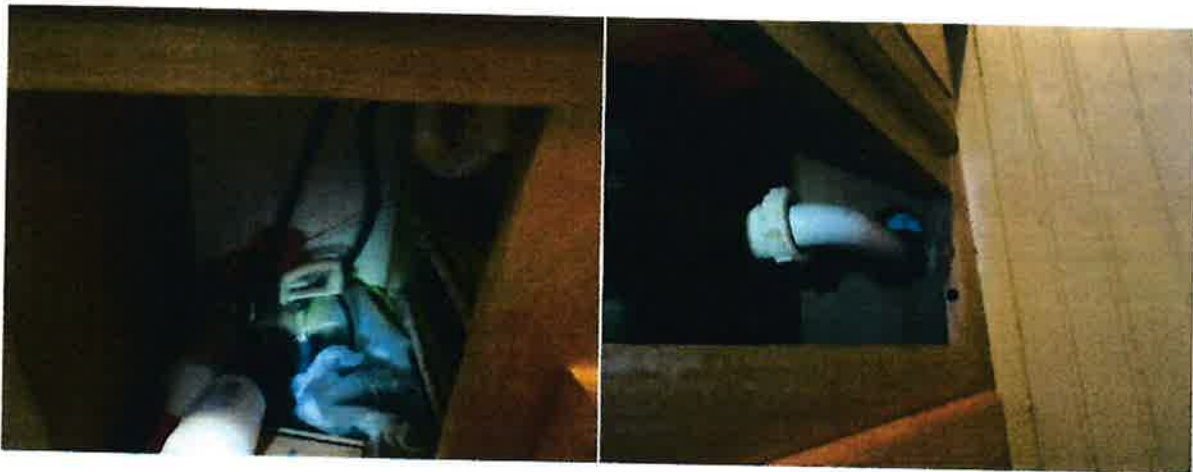
A hole in the wall provided access to prove no insulation in the exterior walls. Hole should be repaired as soon as possible.

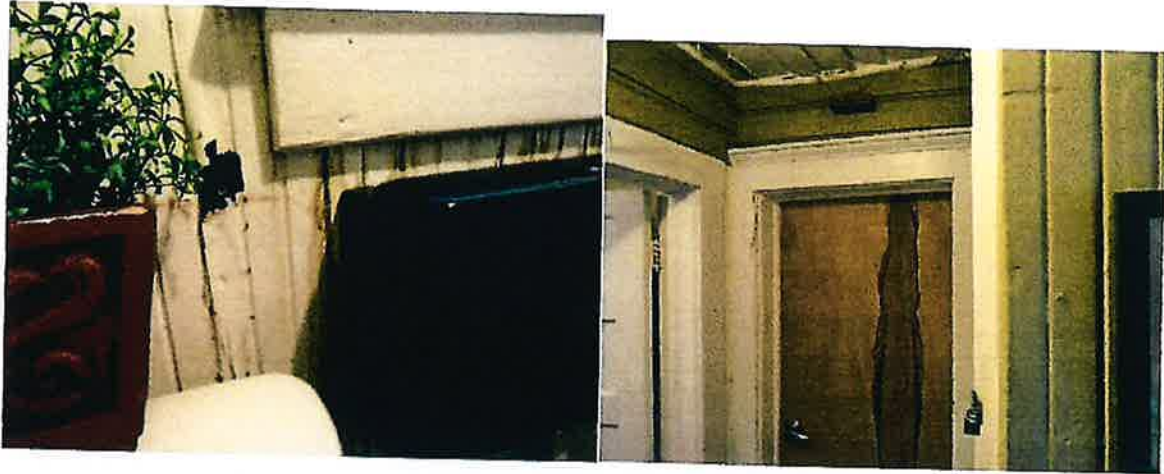
The wainscoting under the window is stained with water run-off on the wall. Mold is evident.

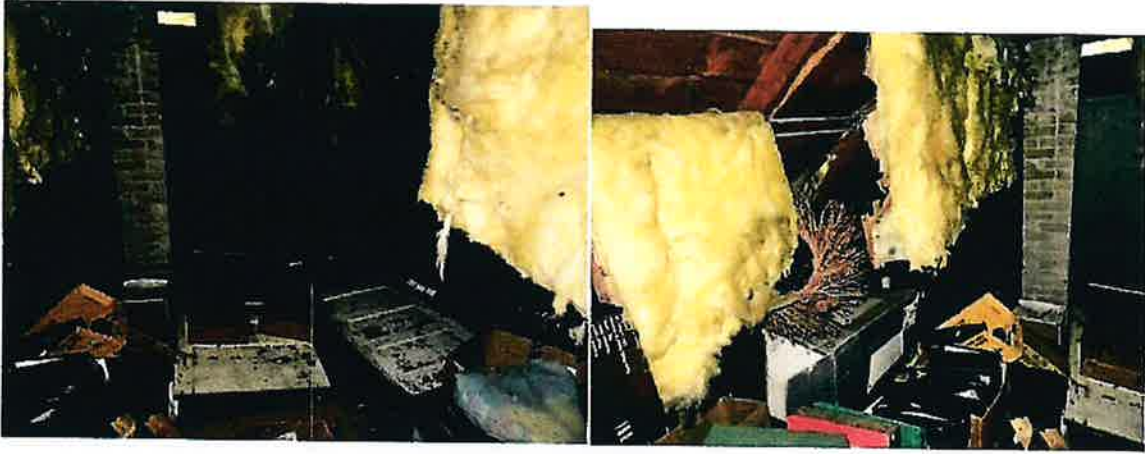
Second floor attic storage has insulation in disarray with evidence of rodents.

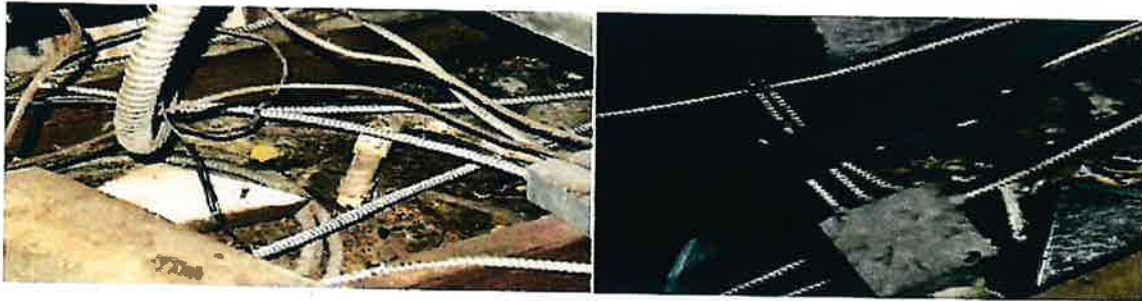
Lots of debris in the attic. Wiring is below the overflow pan. Potential electrical short if pan overflows. Insulation is torn off almost everywhere.

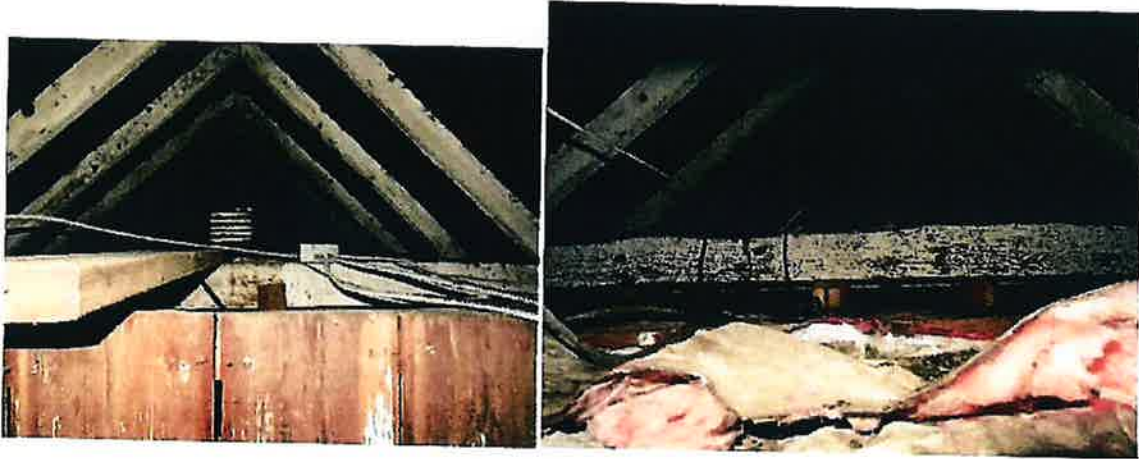
Upper attic accessed through hallway hatch. Some insulation has been laid on the ceiling, but the vapor barrier is upside down. It would have been better to have taken the vapor barrier off.

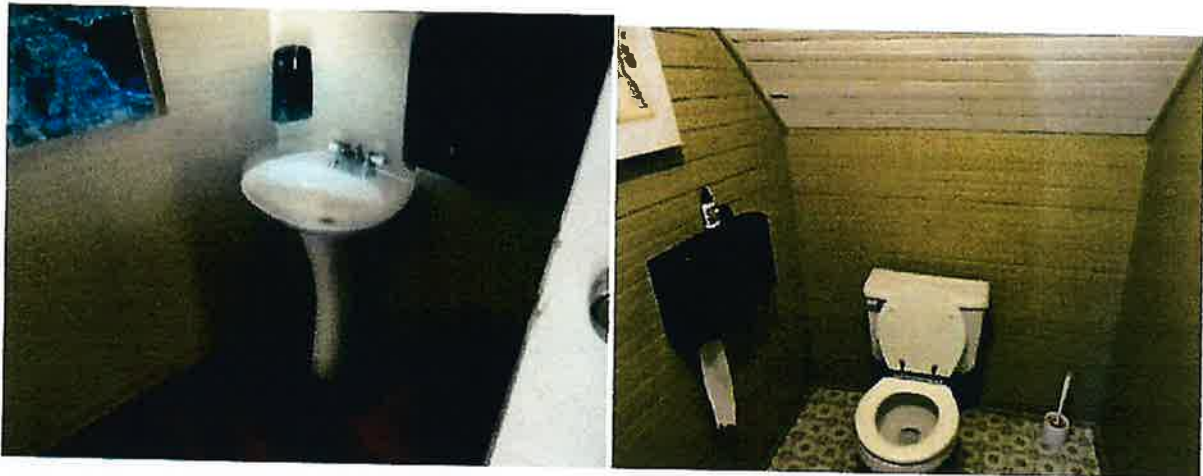
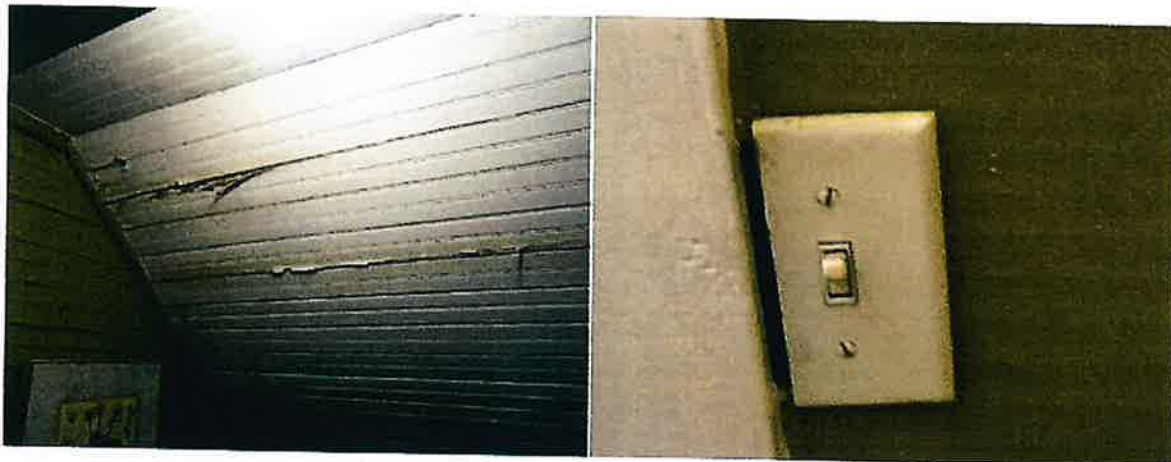
UPSTAIRS BATHROOM

The upstairs bathroom is operational with shut-off valves on both the sink and the toilet. There is no ventilation in this room and needs an exhaust fan installed. The light switch has more than $\frac{1}{8}$ " gap to the trim, replace cover plate.

The ceiling has the paint peeling off and although the moisture reading was low there may be a condensation problem from the lack of insulation.

The door has no knob and can only be locked with a "hook and eye" needs repair.

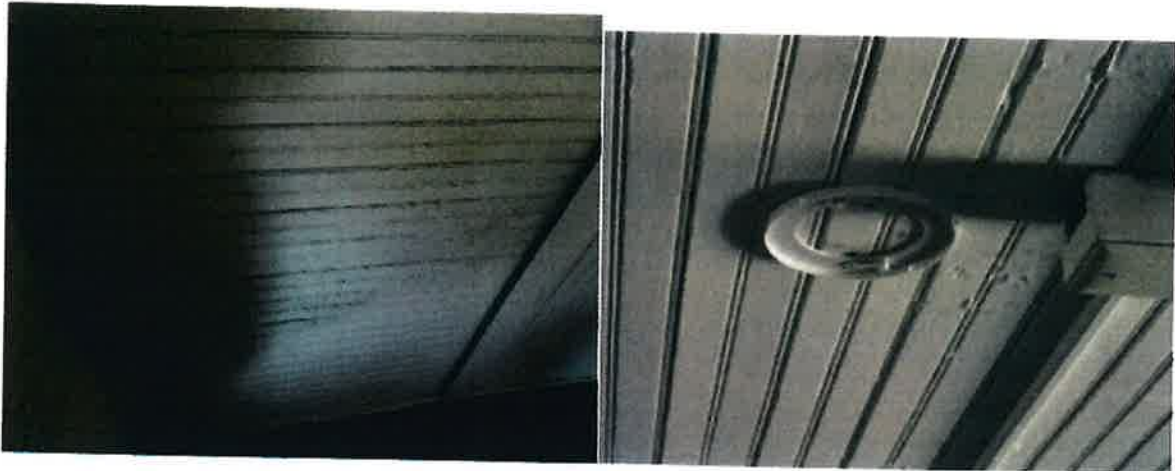
Mold on the wall from the hallway to the attic. The smoke detector was removed from the upstairs hall and needs to be replaced as soon as possible.
