Subject: Limited Asbestos Bulk Sampling Report
Residence located at 34 Thomas Heyward
Bluffton, South Carolina 29910
Project #:VC25-23

Limited Asbestos Bulk Sampling Report

Project #:VC25-23

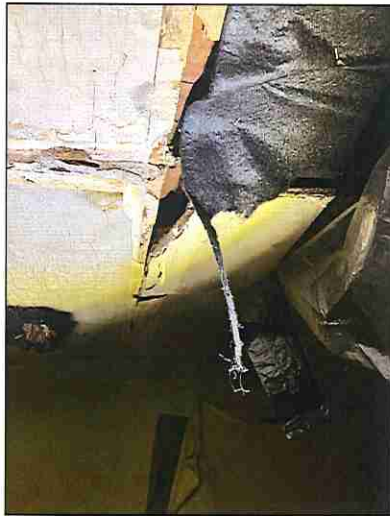
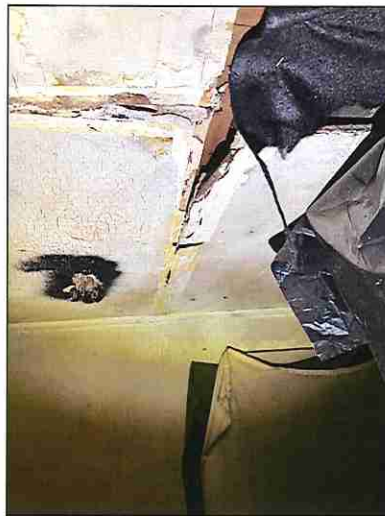
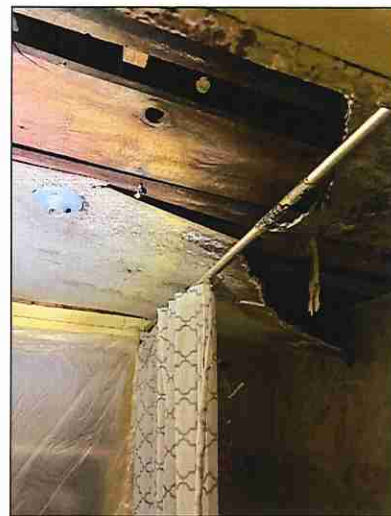
- Back Bedroom Joint Compound-**2 percent**, approximately 200 sqft;
- Living Room Closet VFC/Backing-**15 percent**, approximately 15 sqft;
- Bathroom VFC/Backing-**80 percent**, approximately 60 sqft;
- Kitchen Middle Layer VFC/Backing-**20 percent**, 150 sqft;
- Kitchen Bottom Layer VFT/Backing-**10 percent**, approximately 150 sqft.

View back bedroom wallboard and joint compound and bathroom wallboard

Based on our asbestos survey, the asbestos containing materials (ACMs) wallboard/joint compound would **constitute a hazardous and unsafe condition due to the heavy fungal growth and partial collapse of back bedroom and bathroom ceiling/roofing components**. In addition, **due to the kitchen sagging floor system** the removal of the various ACM flooring materials would be considered an **unsafe condition**.

Therefore, based on the interior mold hazards and overall structural integrity of the residential home, we would recommend this home be categorize as a **"razed structure"** or an **"emergency demolition"**, in which the residential structure is considered an **Environmental "Hazardous" Condition that also contains compromised asbestos containing materials**.

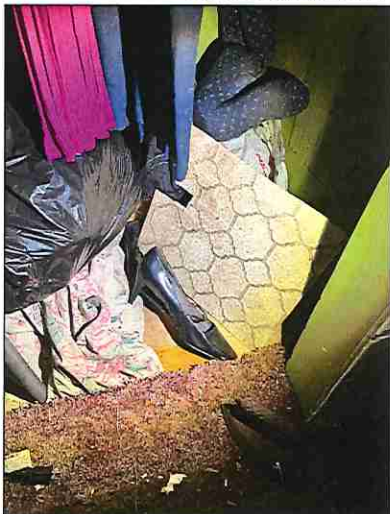
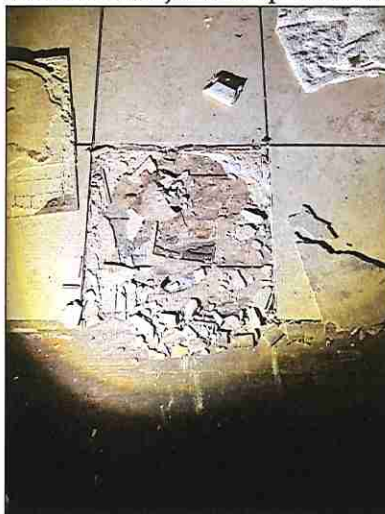
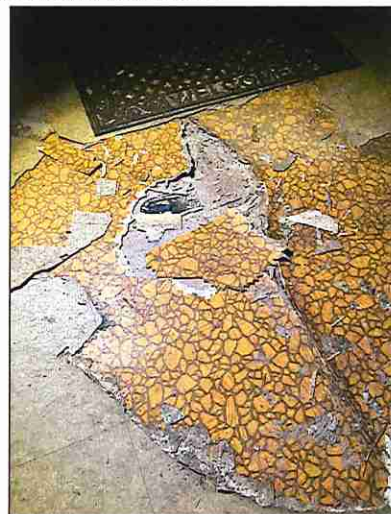
View of living room, bathroom, and kitchen ACM floor covering

Due to the **compromised (poor) condition** of these regulated asbestos building materials, we would categorize these ACMs as a "friable condition". We have estimated the total quantities of ACM listed above to be **approximately 575 sqft**.

In accordance with state and federal regulations, ACM **above 1%** would require proper removal and disposal prior to any physical renovations or demolition activities.
