34 Thomas Heyward Street 2025 Assessment Report

**Meadors, Inc.
PO Box 21758
Charleston, SC 29413**

Date: 08.20.2025

Introduction

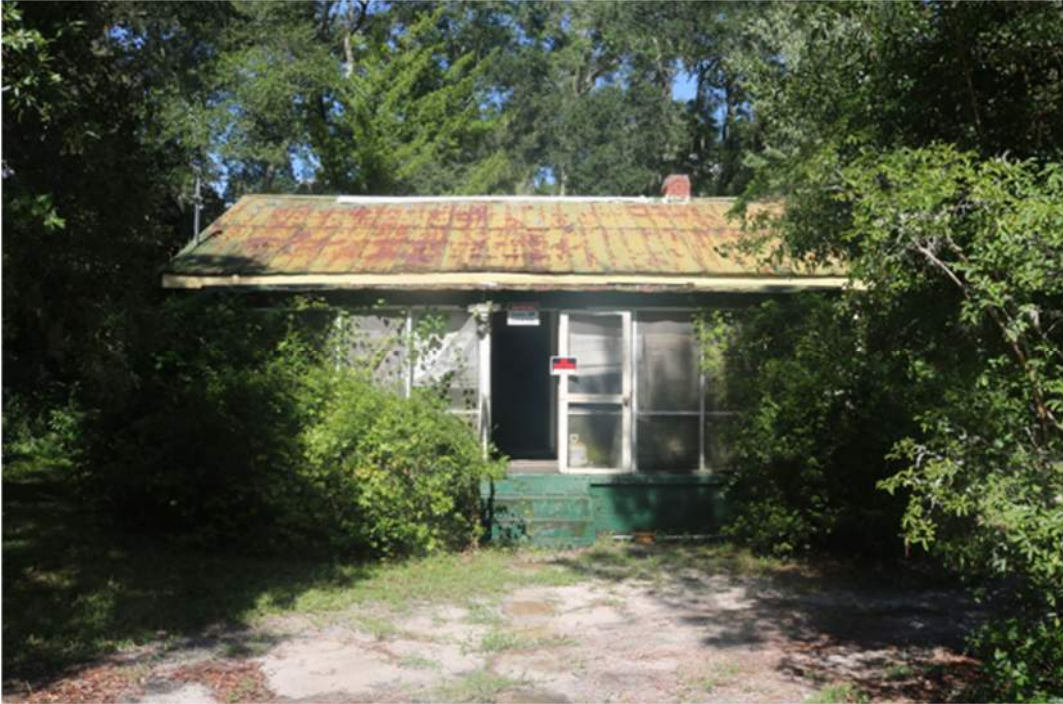
Figure 1: East elevation. Cottage at 34 Thomas Heyward Street as viewed from the street.

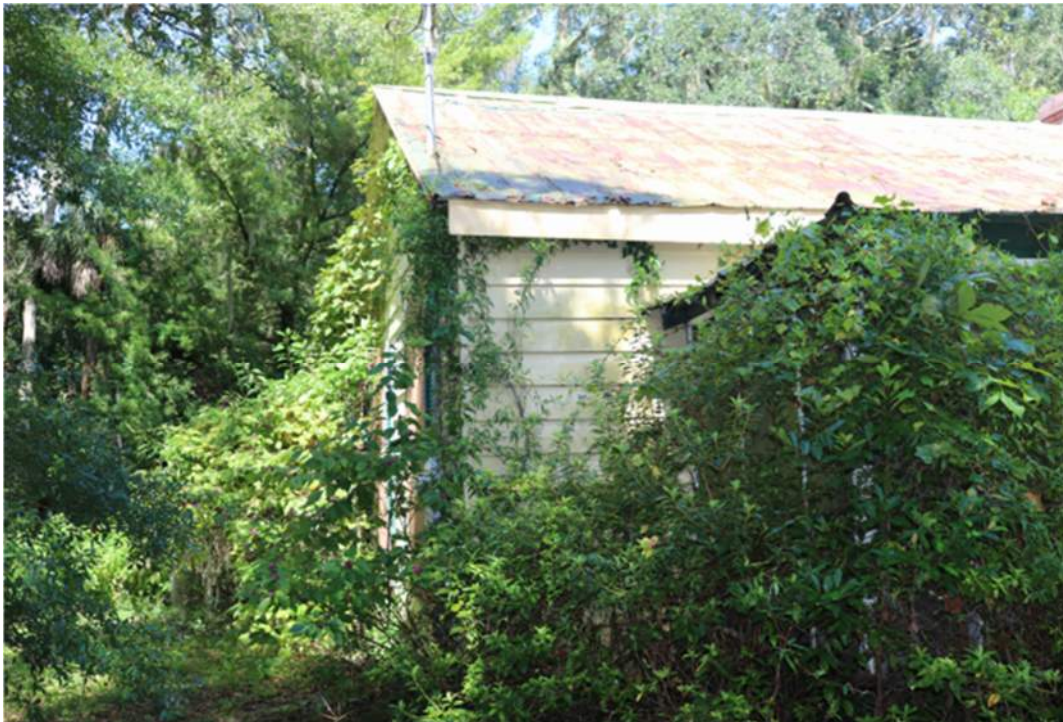
Figure 2: Southeast corner. The exterior of the structure is overgrown with vegetation, but the exterior was generally accessible for inspection.

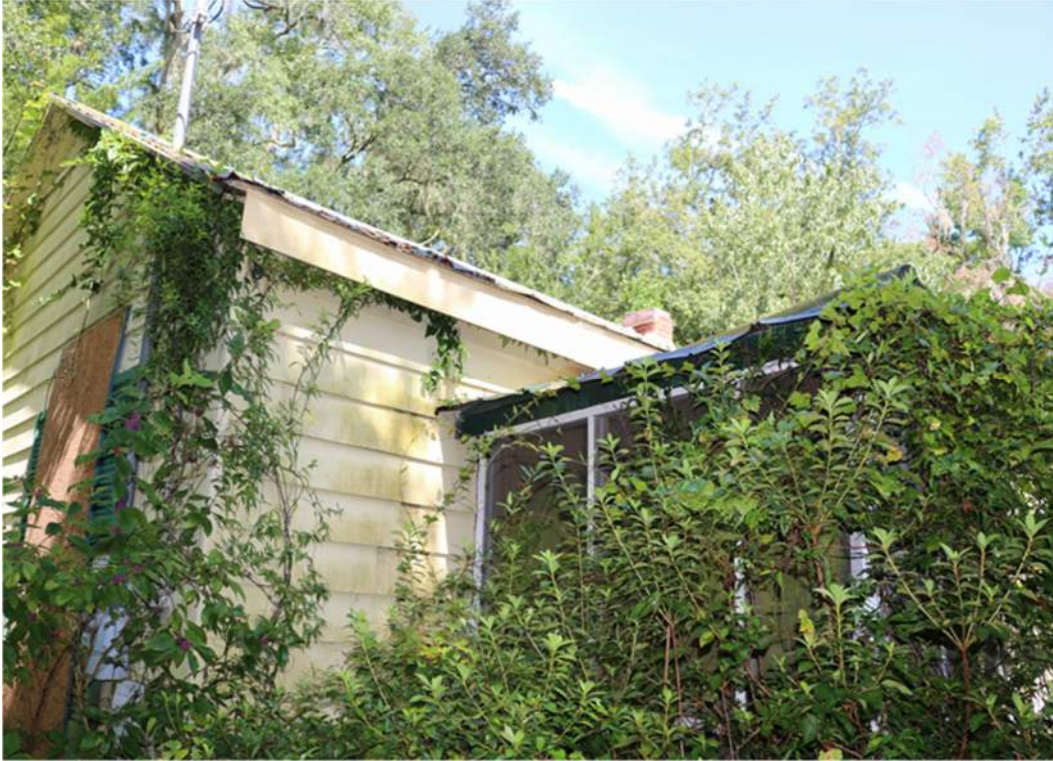
Figure 3: Southeast corner. The exterior of the structure is overgrown with vegetation, but the exterior was generally accessible for inspection.

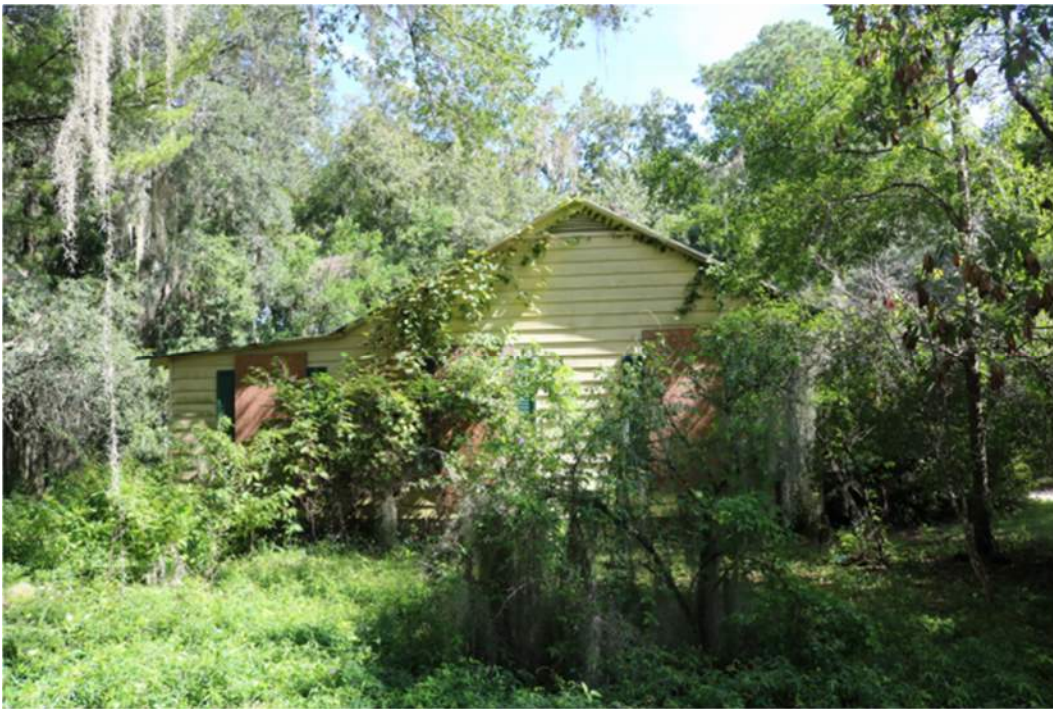
Figure 4: South elevation. The exterior of the structure is overgrown with vegetation, but the exterior was generally accessible for inspection.

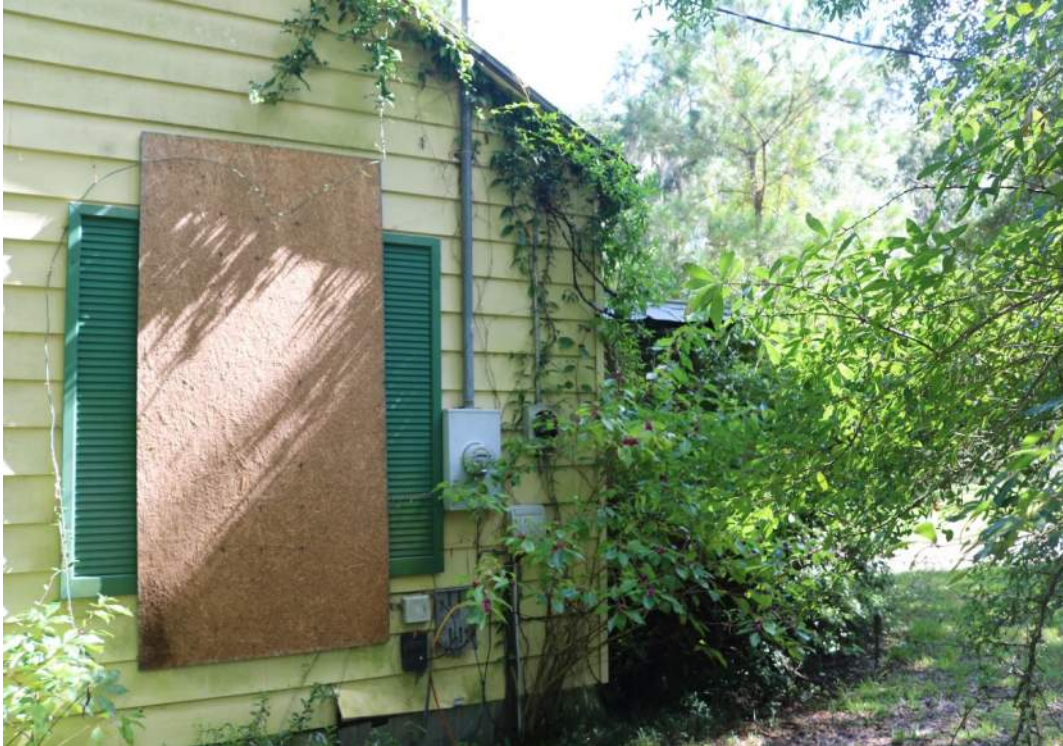
Figure 5: South elevation. All the windows and doors except the front entrance have been boarded up on the exterior.

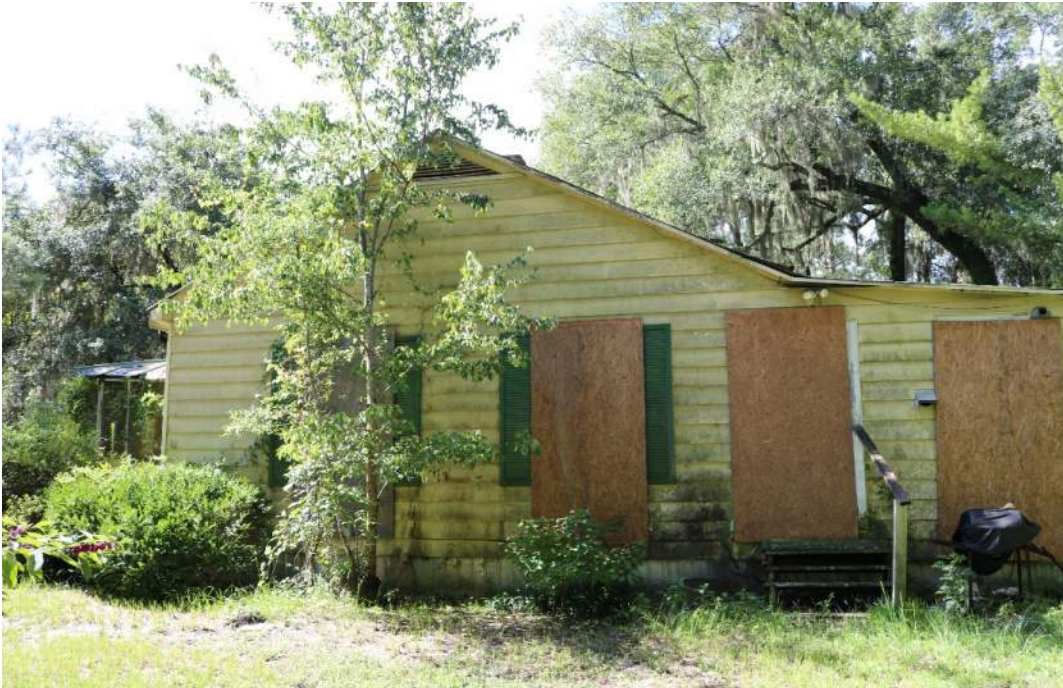
Figure 6: North elevation. All the windows and doors except the front entrance have been boarded up on the exterior.

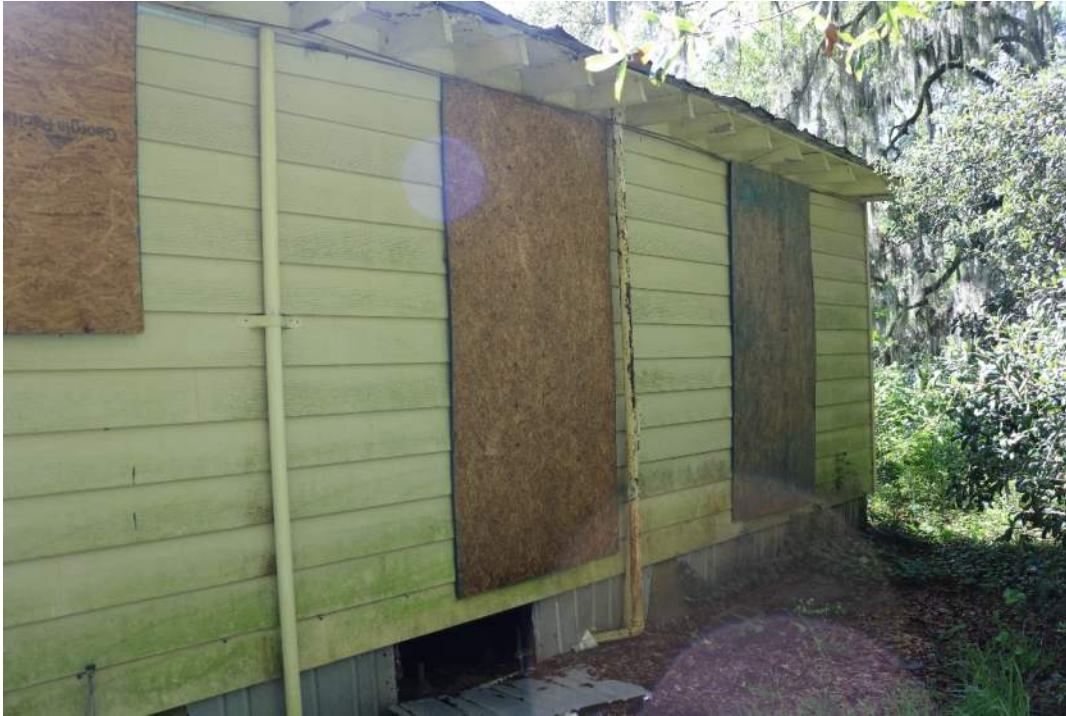
Figure 7: West Elevation. All the windows and doors except the front entrance have been boarded up on the exterior.

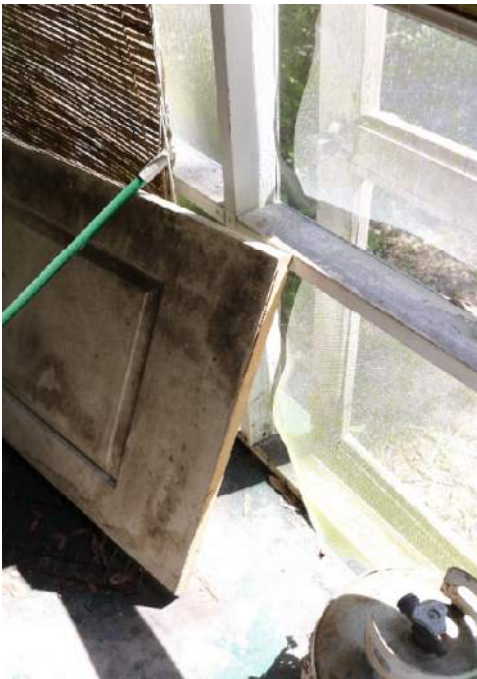
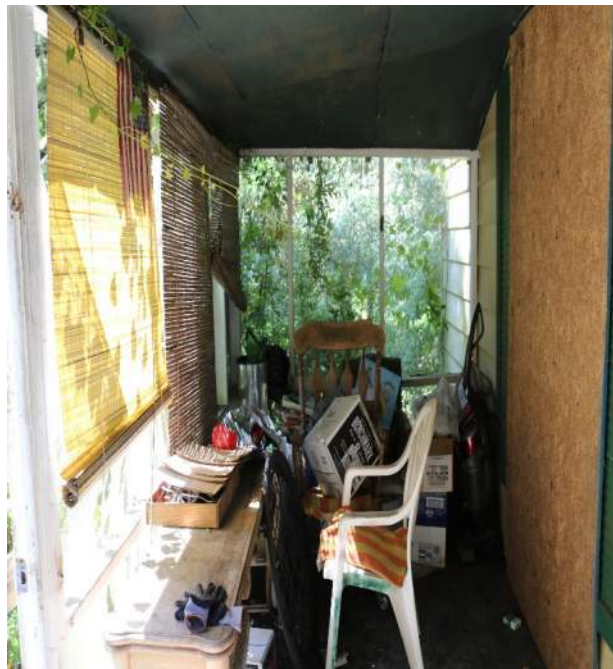
The front porch framing, ceiling, and screening are modern material and not original to the house. The porch deck is a raised concrete slab accessed by concrete stairs. The age of the deck and stairs was not determined. They could be original to the construction of the house or a later addition, as is the screened front porch.

Figure 8: Interior view of the front porch. The framing material of the porch was inspected and determined to be modern and not original to the structure. The porch and the entire interior of the house were filled with abandoned furniture and personal effects. This made the assessment somewhat limited, but did not compromise the final conclusions.

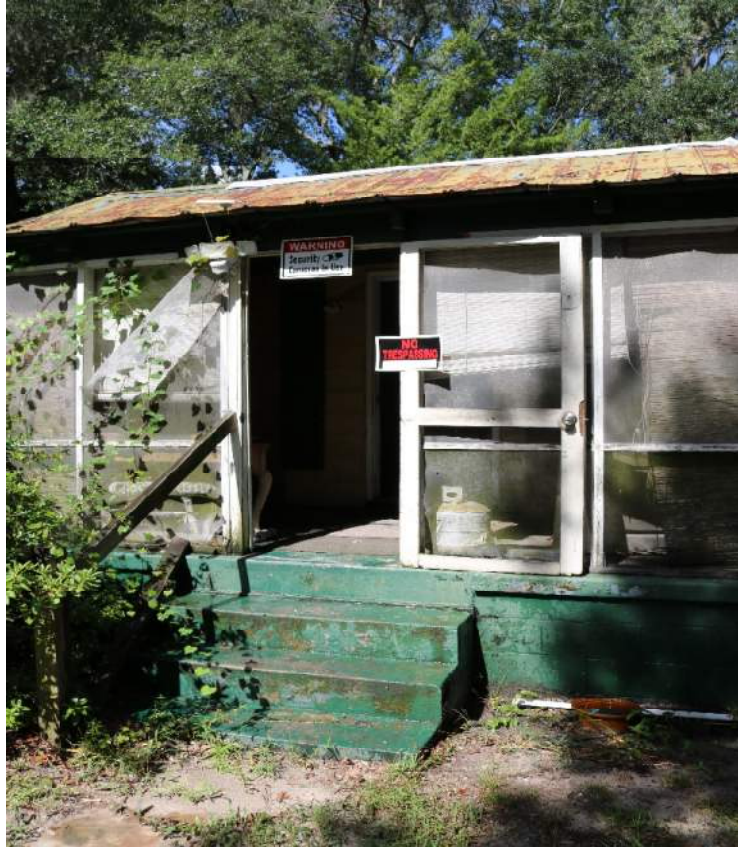
Figure 9: The age of the front porch steps and concrete deck was not determined.
The front steps could be original to the structure or a later addition.

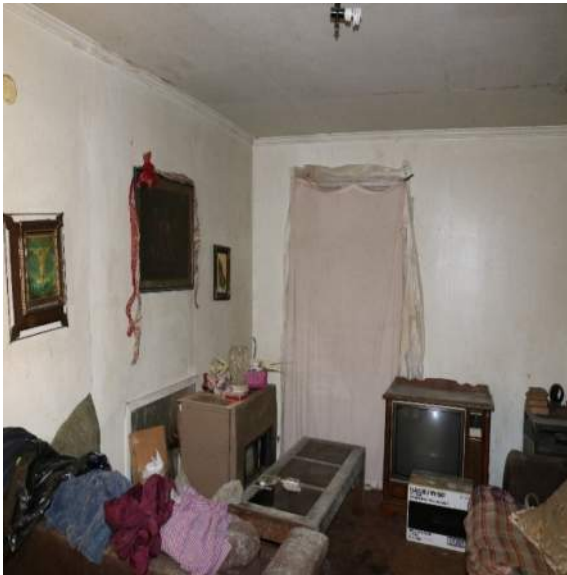
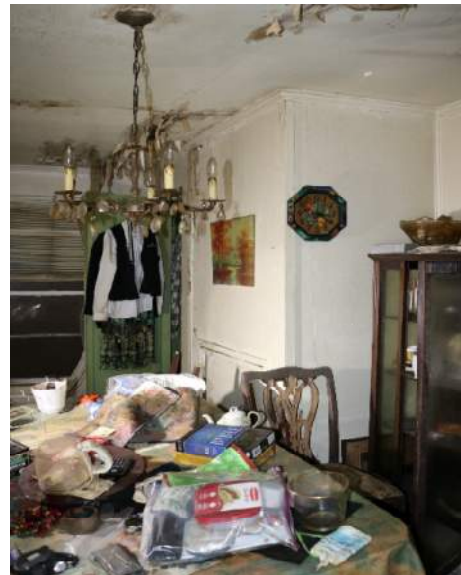
Figure 10: The entire interior of the house was filled with abandoned furniture and personal effects.
This made the assessment somewhat limited, but did not compromise the final conclusions.
Note the mold apparent on the walls and furnishing.

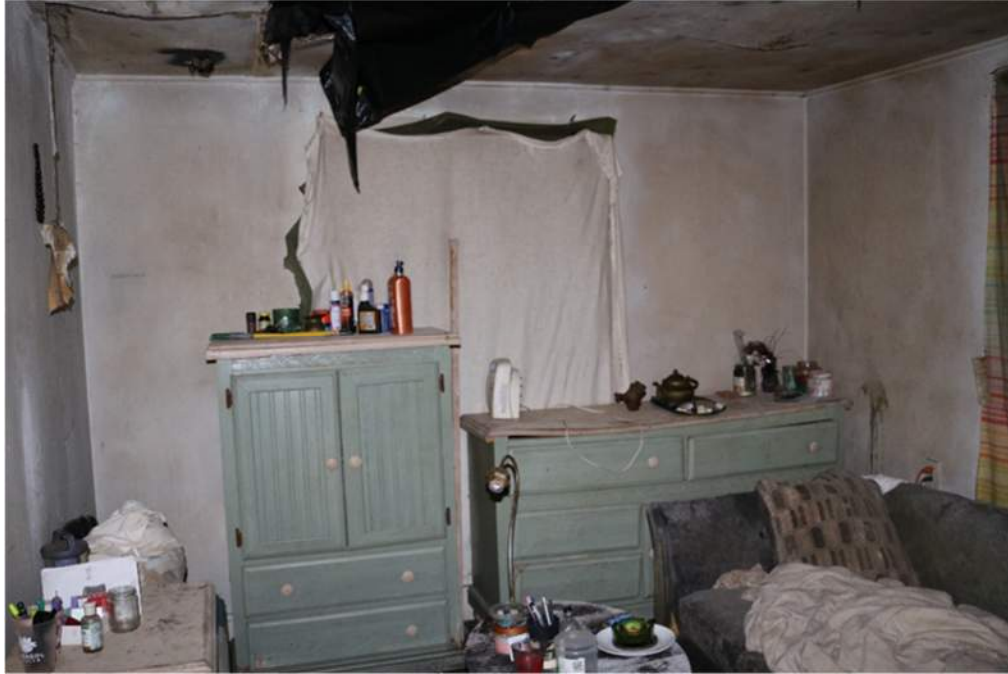
The wall and ceiling covering is a combination of plywood sheets and gypsum drywall. Several areas of the ceiling covering have failed due to water intrusion through the roof. All the walls and ceilings are covered with visible mold.

Figure 11: Note the mold covering the walls. The wall and ceiling covering throughout house is a combination of 4 x 8 sheets of plywood with some gypsum drywall. Note the damage to the ceiling. The roof has been leaking for some time, and there is likely damage to the roof framing due to water intrusion.

- Reframing of the floor system.
- Removal of the roof closure system, removal of the deteriorated roof sheathing and repair of the roof framing.
- Repair of deteriorated ceiling framing.

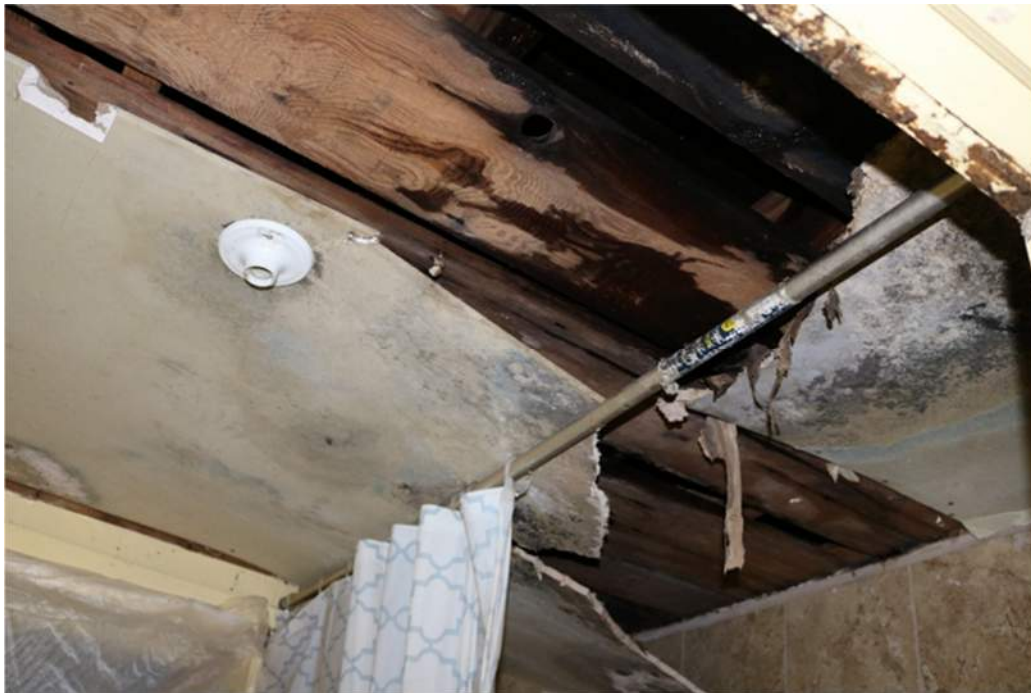
The roof covering system is in a deteriorated condition and has been allowing water intrusion into the structure for some time. This has caused substantial damage to the roof framing, the interior ceiling framing, and the interior floors. At the time of inspection, the interior carpet was wet from water intrusion in the roof.

Figure 12: Interior of the house: Note the severely damaged ceiling. The roof has been leaking for some time, and there is likely damage to the roof framing due to water intrusion.

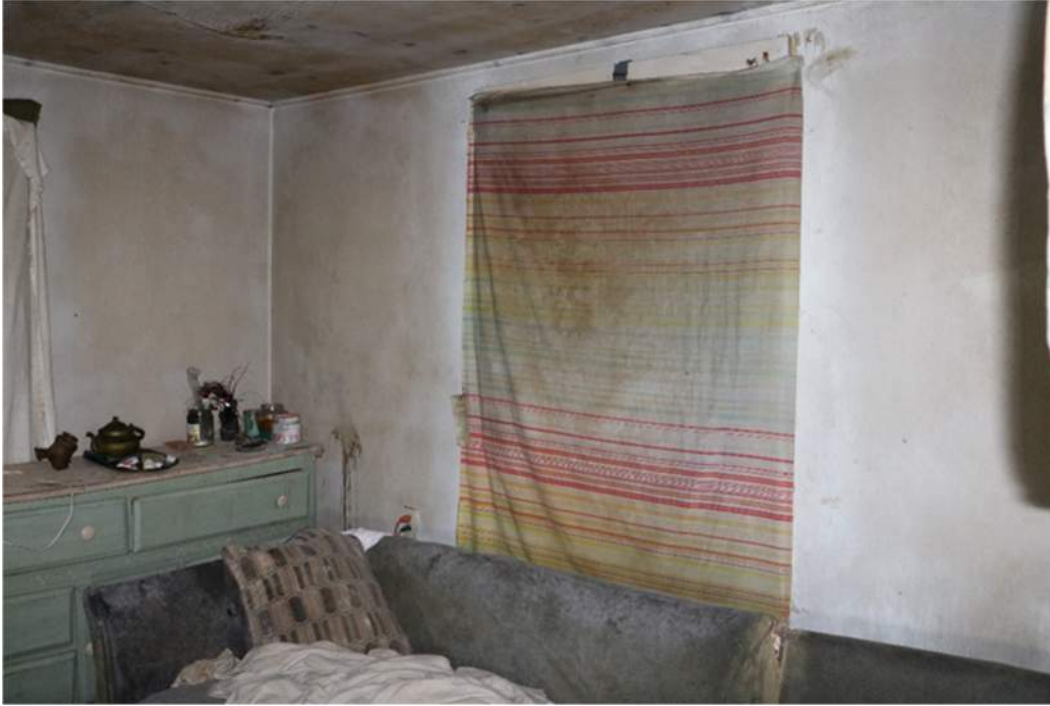
Figure 13: Note the mold covering the walls.

- Abatement of the asbestos material.
- Removal of all interior finishes including, trim, wall covering, ceiling covering, floor covering, and flooring material.

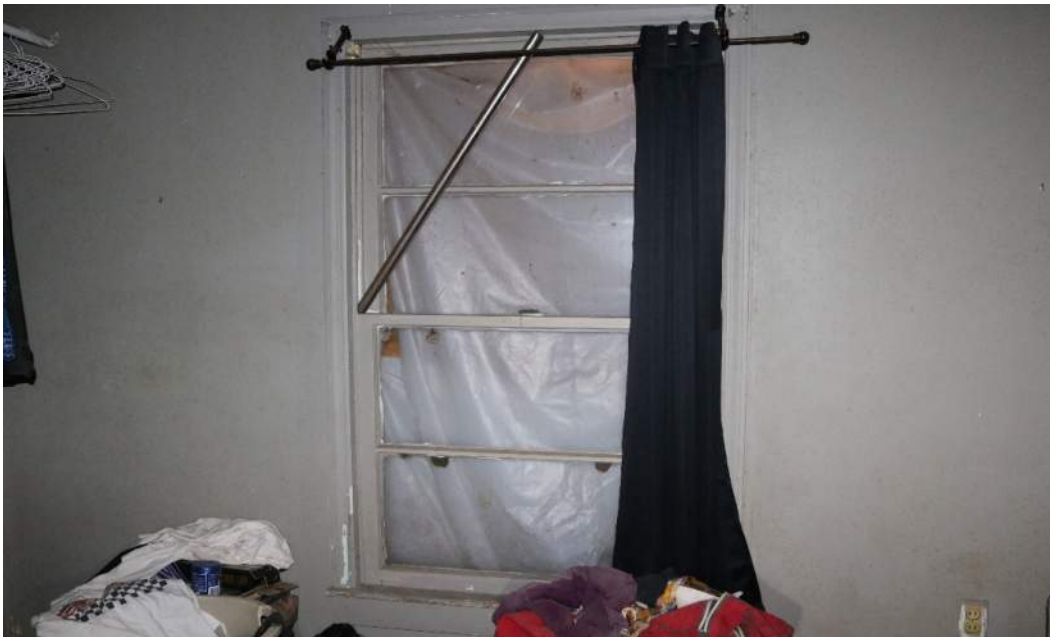
As noted above, the exterior of the windows and doors is covered with OSB for security reasons and unavailable for inspection. Interior inspection of the windows revealed that there are two generations of windows. The two windows on the rear elevation in the kitchen appear to be original and earlier than the remainder of the windows in the house. These two windows are unbalanced and do not have jamb liners. The remainder of the windows in the house have aluminum jamb liners with spring balances which are common in windows manufactured after this building's date of construction. It is likely that all but two of the windows in the house have been replaced. The general condition of the windows, as observed from the interior, is poor. The windows have non-operable vinyl shutters applied to the exterior walls adjacent to the windows. The vinyl shutters are modern.

Figure 14: Interior of the house: The window is a later two over two which does not match the light configuration of the windows in the back wall of the shed-roofed rear portion of the structure. The window has aluminum jamb liners and spring balances, which are likely dated to post 1940s. All the windows in the side and front elevations of the structure have aluminum jamb liners with spring balances and are later than the construction date of the house. The two windows in the rear wall of the structure are not balanced and have no jamb liners. These are likely the earliest extant windows.

- Repair of original windows. (Only two windows are thought to be original)
- Replacing non-original deteriorated fenestration.
- Repair of original fenestration.

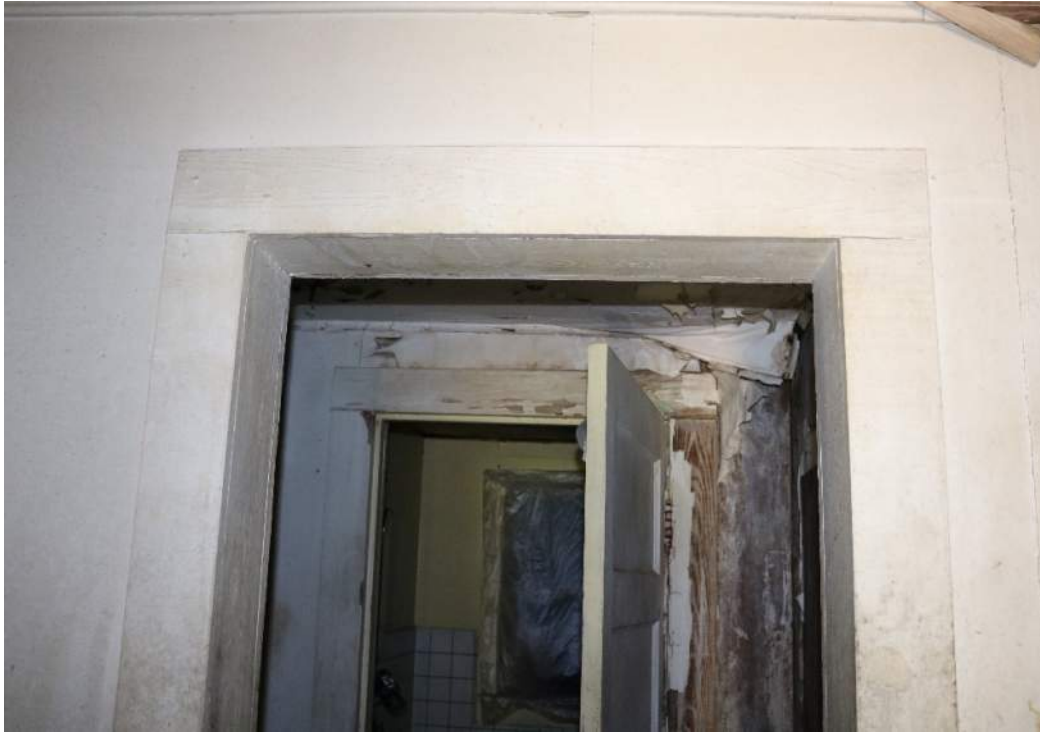
The interior trim at the doors and windows is a simple 1 x 6 F4S flat board. The trim, wall and ceiling materials are consistent throughout the interior of the house. All the trim material is covered with visible mold. The flat trim has been replaced with a more ornate profile on a few windows. There is a simple crown molding in all of the rooms.

Figure 15: Door trim at the interior of the house. All the door and window trim on the interior of the house is consistent, being S4F 1x6 flat board. The shed-roofed rear portion of the structure maintains this pattern.

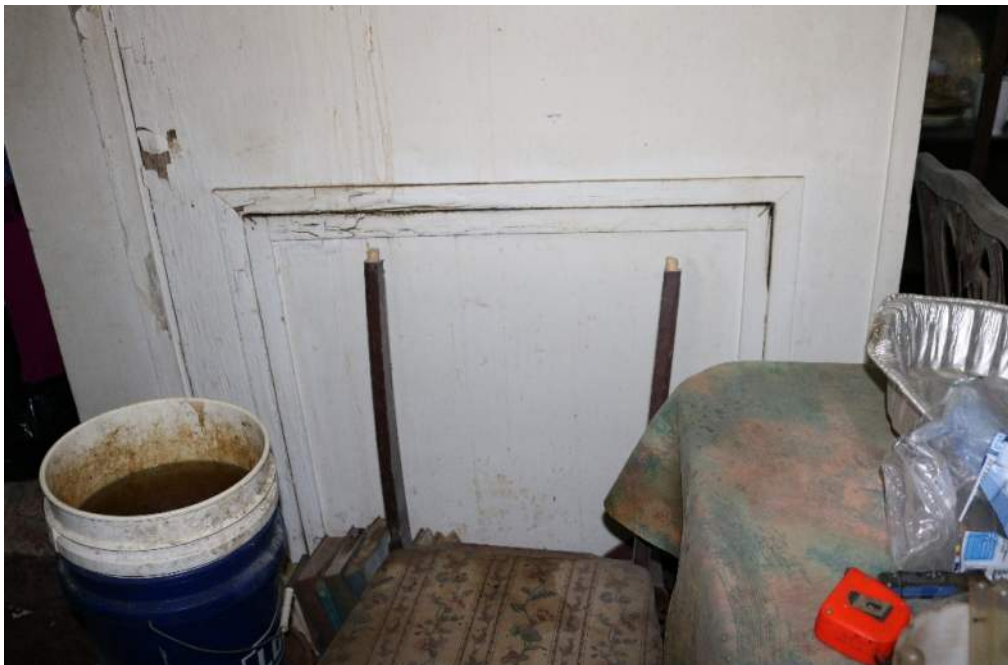
In the dining room, there is a boxed-in area against the front wall. The chimney is in this area, and the boxed structure likely conceals the area where a fireplace or heating stove existed.

Figure 16: A boxed-out area in the dining room at the location of the chimney. This may cover the location of a removed or infilled fireplace or heat stove.

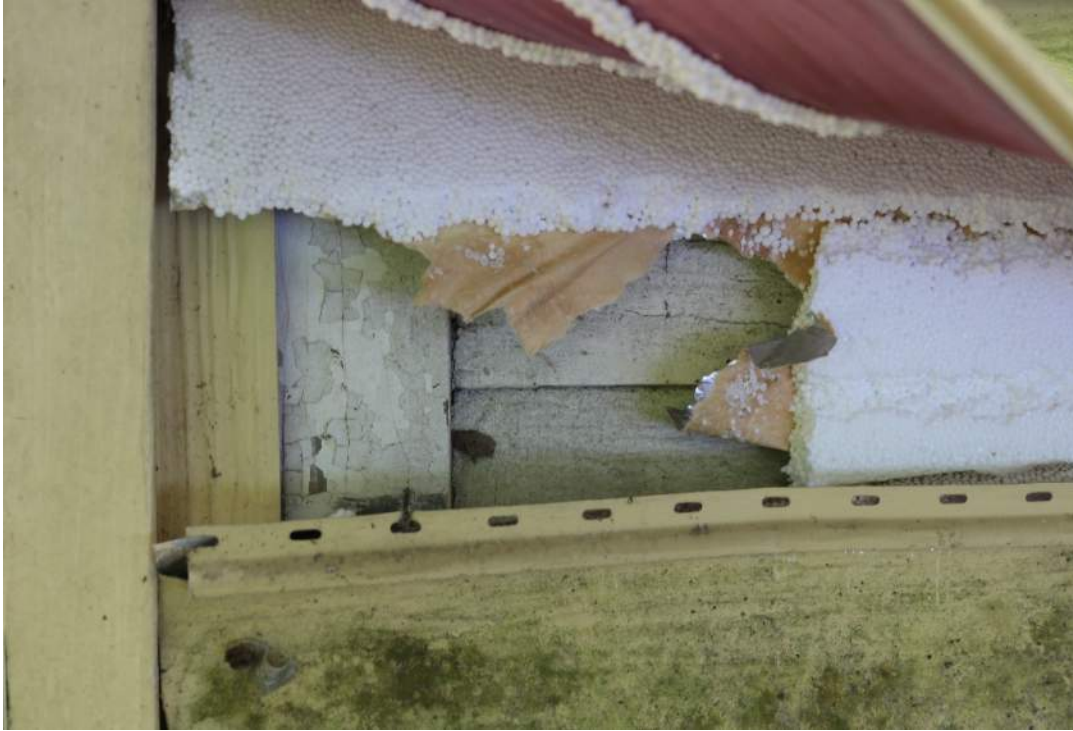
The exterior siding was originally wood lapped siding. The siding thickness appears to be very thin. The extant wood siding has been covered with a vinyl lap siding system. The original corner boards and most

Figure 17: The original siding is in place under the later vinyl siding. The original siding is wood and its condition likely varies from salvageable to completely deteriorated.

- Repair or removal of vinyl siding and trim.
- Repair/replacement of exterior trim.
- Repair /replacement of original wood siding if vinyl siding is removed.

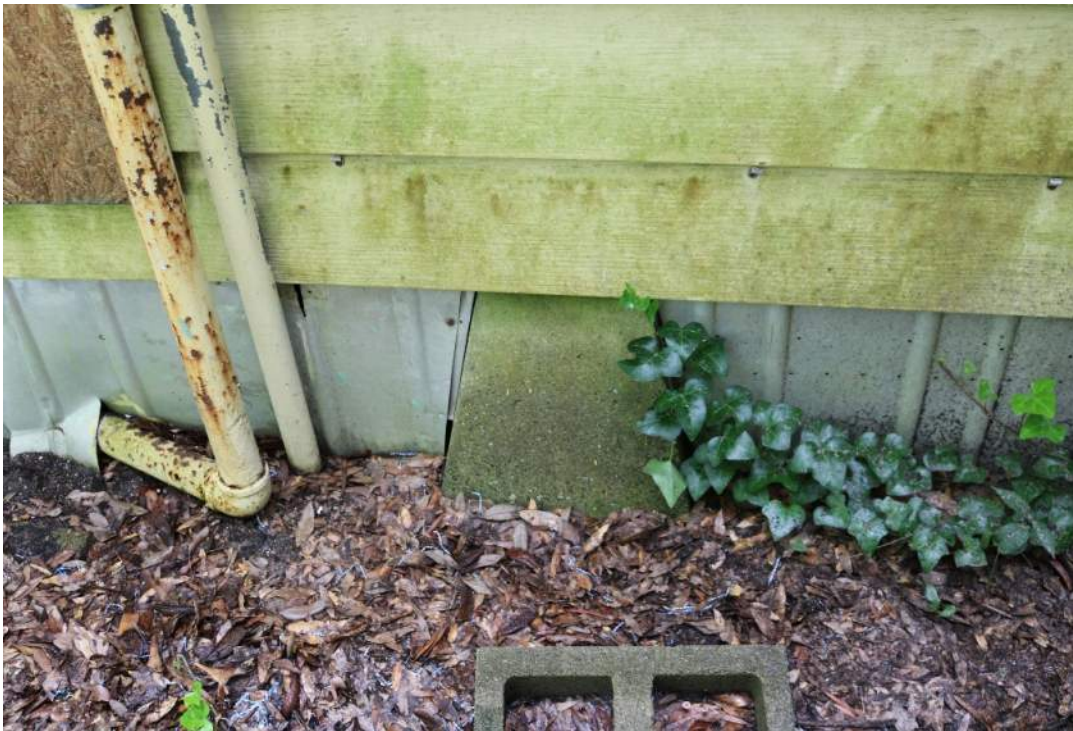
The foundation consists of precast concrete piers spaced at regular intervals around the exterior framed walls of the structure. The structural engineer's report indicated that there was no appropriate footing supporting the piers. The areas between the concrete piers are infilled with metal panels, so access into the crawlspace was extremely limited. Additionally, the height of the crawlspace makes access difficult.

Figure 18: The foundation consists of precast concrete piers. The condition of the footings was not observed, but the Engineer's Report indicated that no adequate footing existed.

- Repair of any wall framing found to be deteriorated.
- Lifting of the structure to install a proper footing and pier system.
- Replacing the structure on the new foundation.

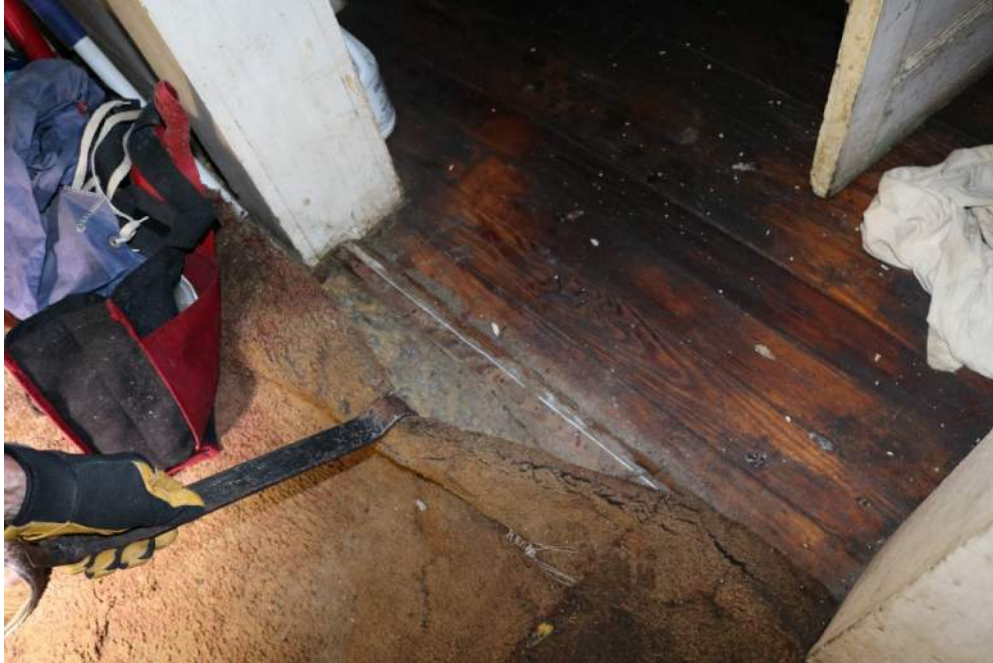
The rear appendage may be a later addition, but there is evidence that, if added after initial construction, it was soon after. The earliest extant windows are in the addition. The original wood siding is the same on the main body of the house and the rear appendage. There is a slight floor height differential (1/2 to 3/4 inch) at the doorway between the main house and the rear appendage. The evidence of when the rear appendage was built is inconclusive.

Figure 19: The floor level at the shed-roofed rear portion of the structure, is approximately $\frac{1}{2}$ to $\frac{3}{4}$ of an inch lower than the main floor of the house. This difference could indicate that the rear of the house is later. However, the trim details, the wall covering, and the flooring are the same as the main part of the house. Also, the earliest extant windows are in the rear part of the house. If the rear portion of the house is a latter addition, it appears to have been constructed early in the life of the structure.
