Re: 9 Bruin Road
Bluffton, SC 29910

Re: Evaluation of Building Structures
9 Bluffton Road
Bluffton, SC

This is to follow-up the two site visits made on April 23 & 26, 2019. During the first visit, I met with Taiwan Scott who provided a brief, verbal history of the house that I inspected. The second visit was to evaluate the barbeque shed situated close to the sidewalk on Bluffton Road (S.R. 46). At the end of the written portion of this report are several photos referenced in the text.

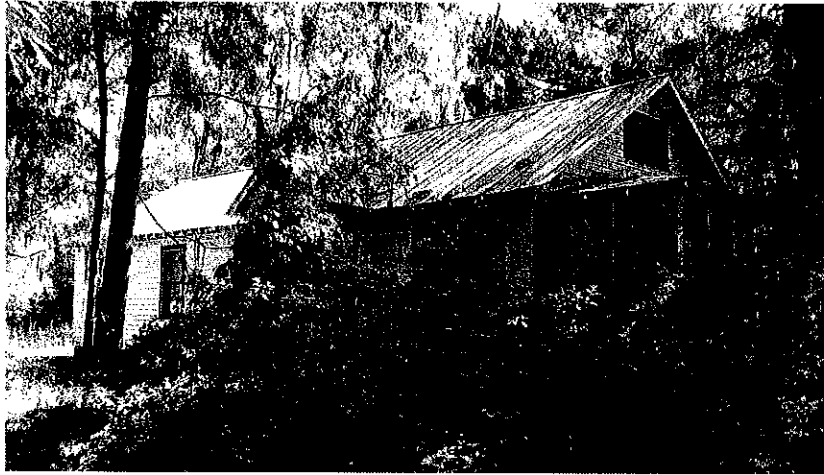
1. West Side (facing Bluffton Road) – left: circa 1990s; right: circa 1940s

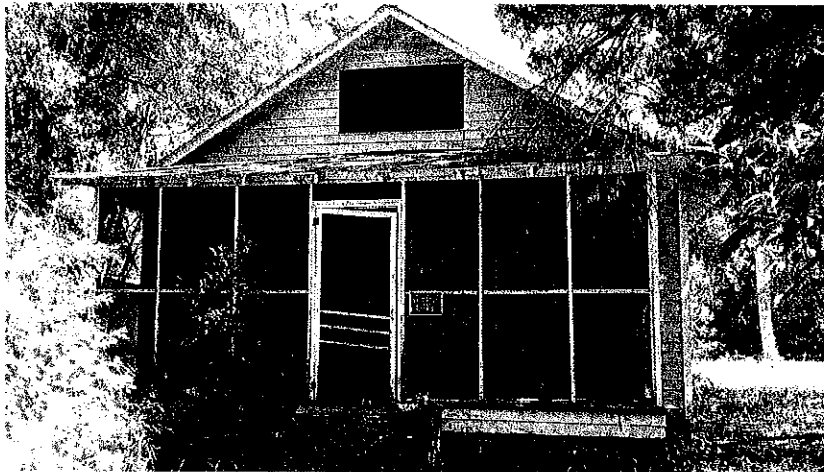
2. South Side (facing Bruin Road) – 1940s

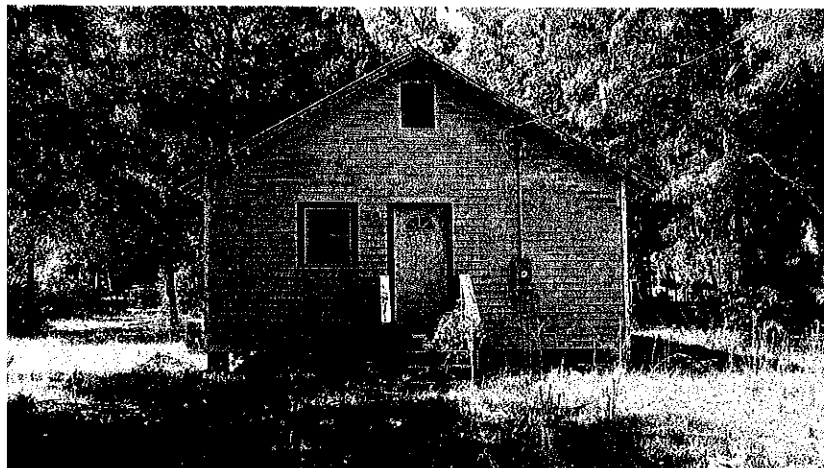
3. North Side – 1990s

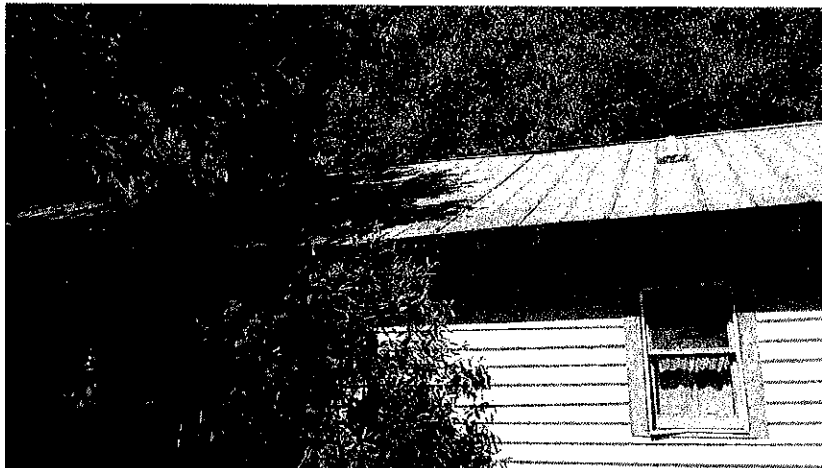
5. East Side – old section on left; rebuilt on right;

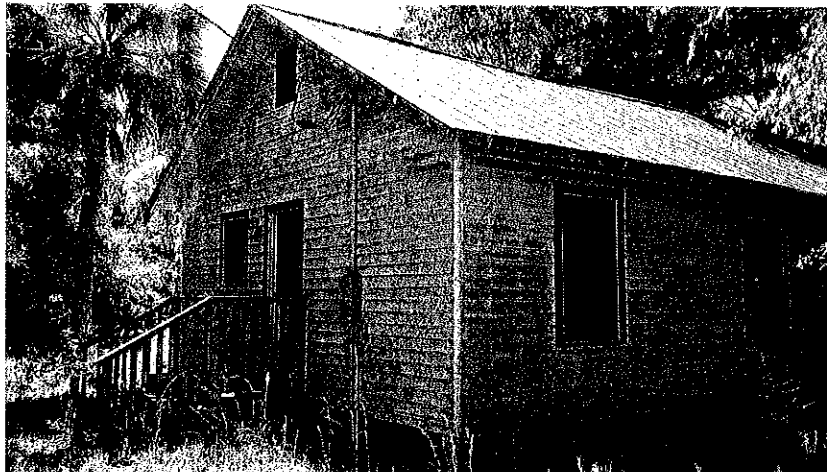
6. Northwest corner – Rebuilt section

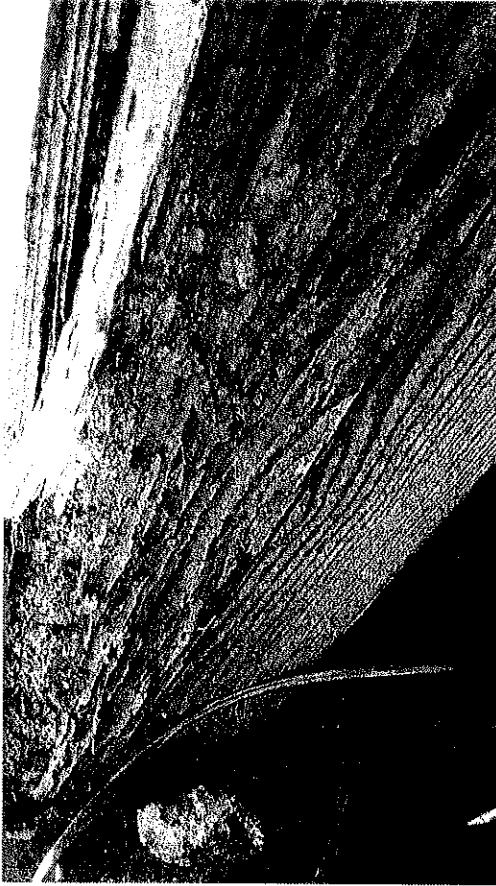
Reputedly, the other, more deteriorated half of the house was built as an add-on to the original structure in the late 1940s. It is structurally unsound and unfit for occupancy, which thereby deems the entire building unfit for occupancy. The floor is very weak in certain areas of the hallway (photo 11) and living room (photo 13) due to deteriorated sheathing and joists. The roof framing appears inadequate (photo 14). I found a decayed perimeter beam (photo 10) and a displaced support beam (photo 8).

10. Decayed perimeter support beam

Based upon the overall structural condition of the building and the fact that, in my opinion, there is no inherent extraordinary or significant features; and that it would not be cost-effective to rehabilitate, I recommend that the building be demolished, thereby providing an opportunity to improve this area of "Old Town Bluffton."

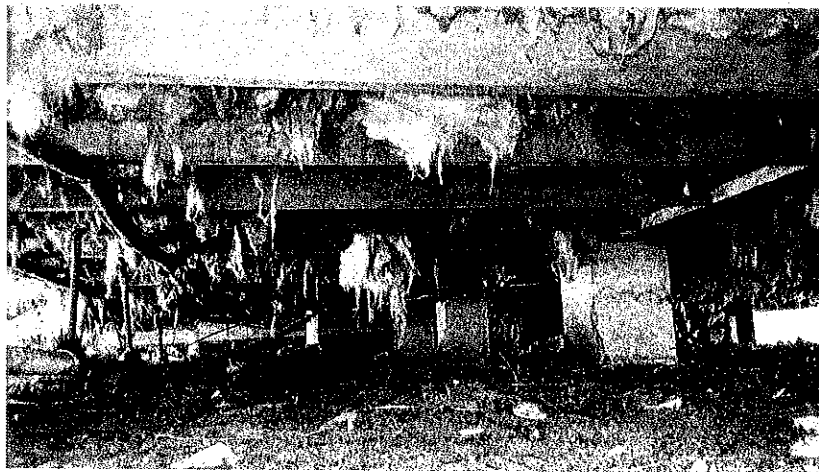
12. Crawlspace of new section

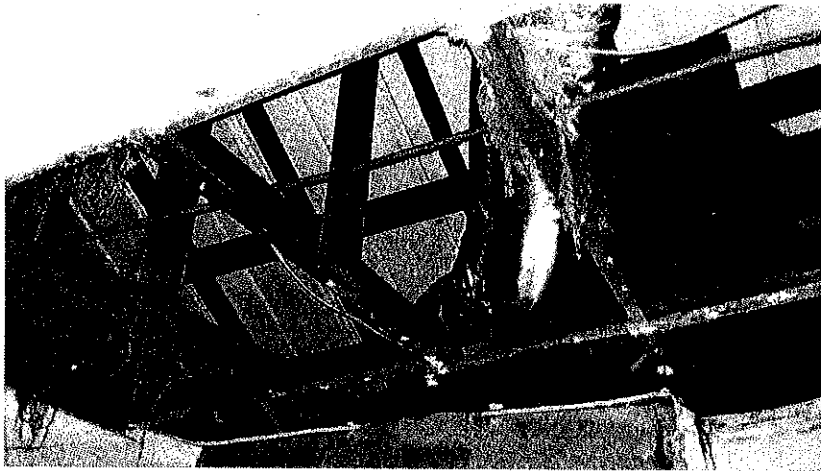
14. Ceiling collapse – old section. “Skeletal” roof structure.

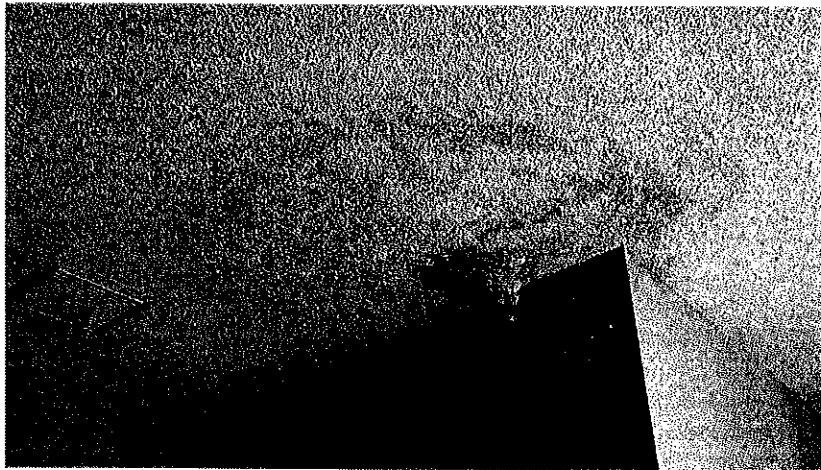
Apparently, the house has a history of a few modifications over the years since the owner used to live in the original part of the house (the northern half) which suffered a fire and was reputedly rebuilt in the mid to late 1990s. It is the portion of the house that, while run down, has a roof leak (photo 15) and shows some signs of structural fatigue, is in fair condition. It is certainly not "historic" in the sense that it is not "architecturally significant." It is comprised of common construction materials. I found that some areas of the floor had deflected, especially near the utility closet wall where the depression measured in the floor is about $\frac{3}{4}$ " in two feet (photo 16). The condition of the wood floor system seen in the crawlspace (photo 12) is in fair condition. However, it is founded on individual concrete block piers, which tend to be unstable if not tied together with grade beams. Also, it is noted that the wood floor structure is not physically tied down to these piers with metal straps.

15. Roof leak – new section

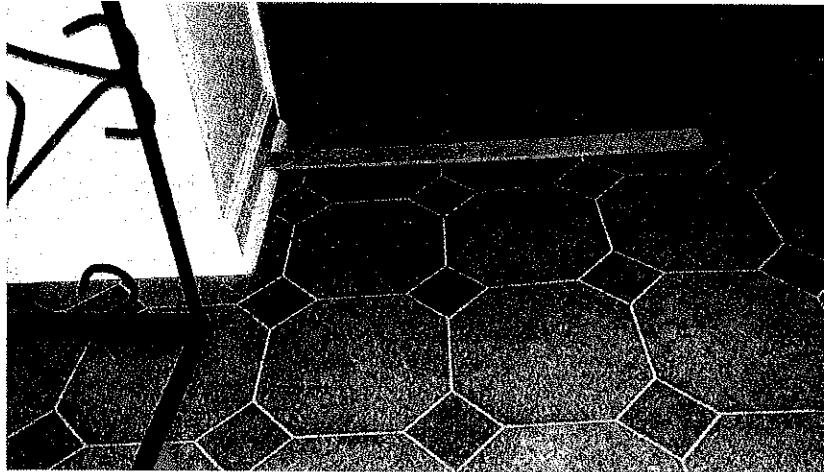
16. Floor deflection – new section

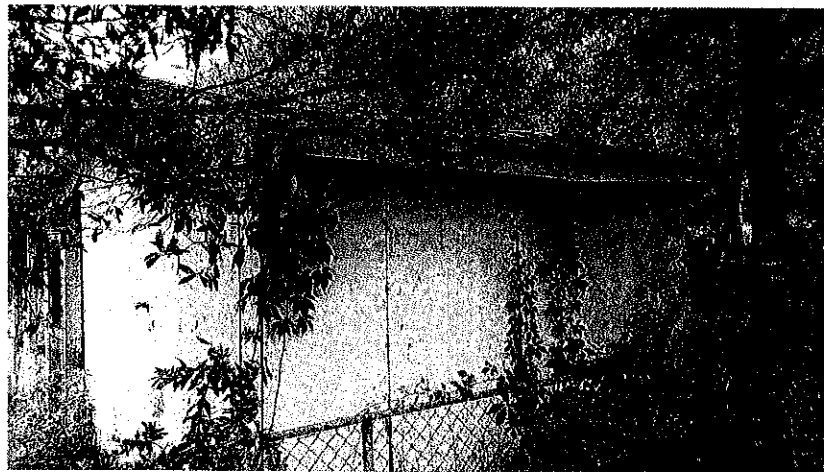
I have no historic information on this structure, but after inspecting it, it can be classified as a derelict building and potential public nuisance. As can be seen in photos 17 through 24, the building is in a state of neglect and suffers severe deterioration of its roof, floor, siding and foundation. It is unsafe to enter this structure. It appears to have harbored animals and perhaps homeless individuals.

17. West side (front) of BBQ shed, facing Bluffton road; roof deteriorated

Therefore, it is my opinion, that this shed also be scheduled for demolition.

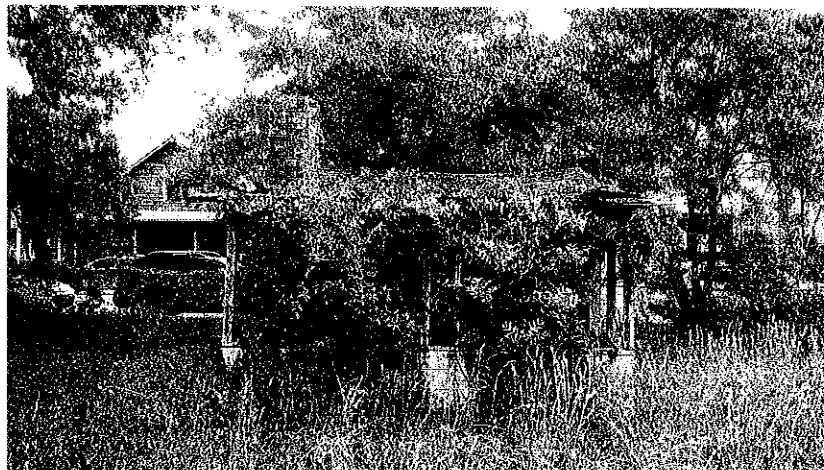
18. East side (rear) of BBQ shed; severe deterioration

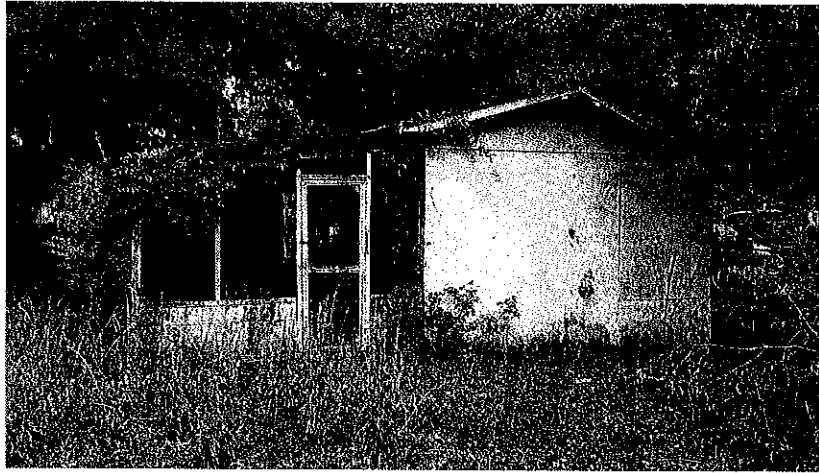
19. North side of BBQ shed

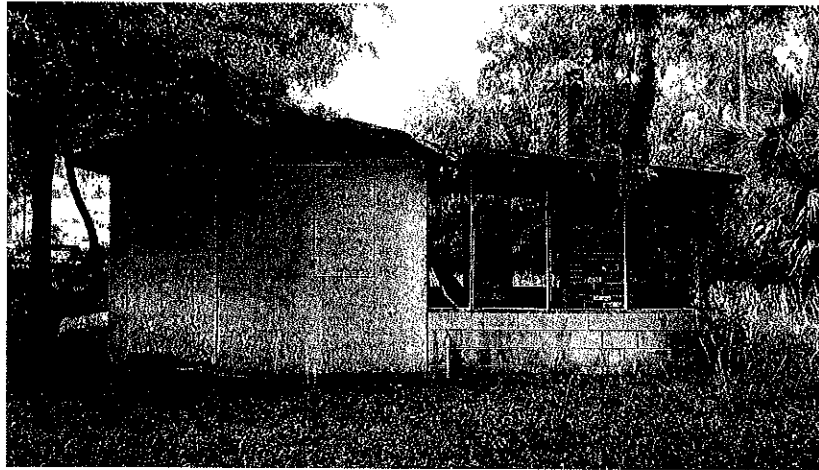
20. South side of BBQ shed

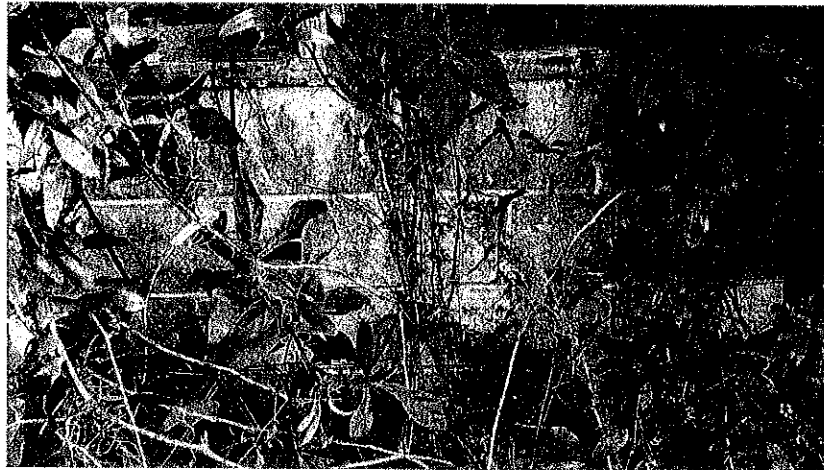
23. Foundation damage at BBQ shed
