ATTACHMENT 7

Re: 9 Bruin Road
Bluffton, SC

CPW
ENGINEERING, LLC

Re: Evaluation of Building Structures
9 Bluffton Road
Bluffton, SC

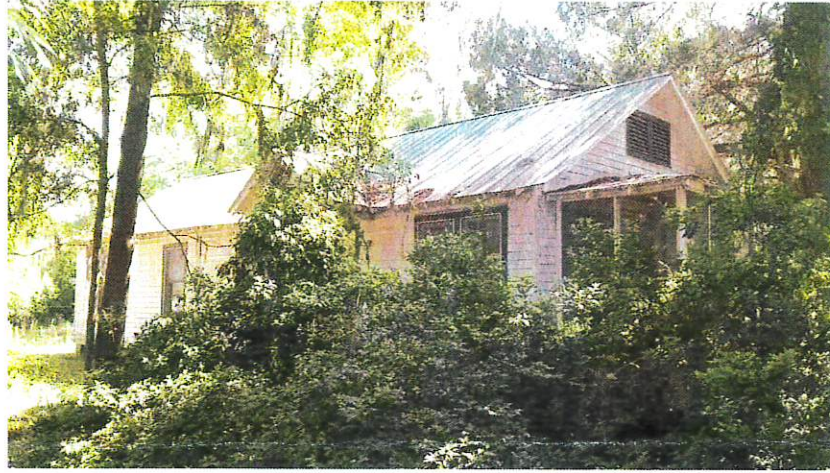
1. West Side (facing Bluffton Road) – left: circa 1990s; right: circa 1940s

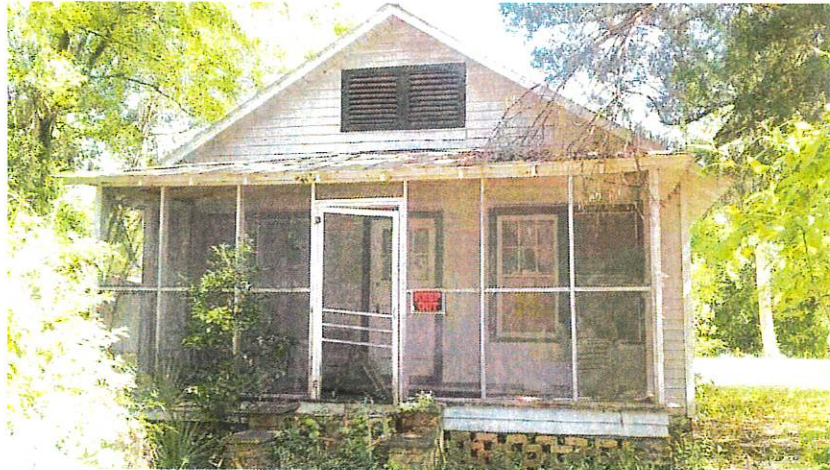
2. South Side (facing Bruin Road) – 1940s

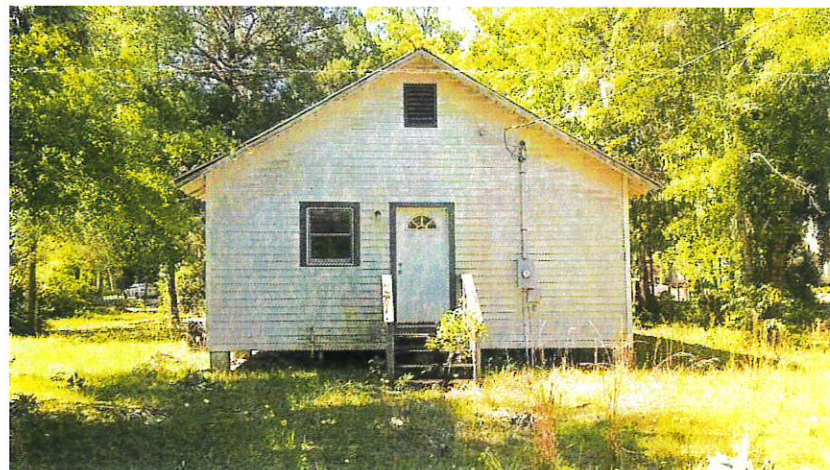
3. North Side – 1990s

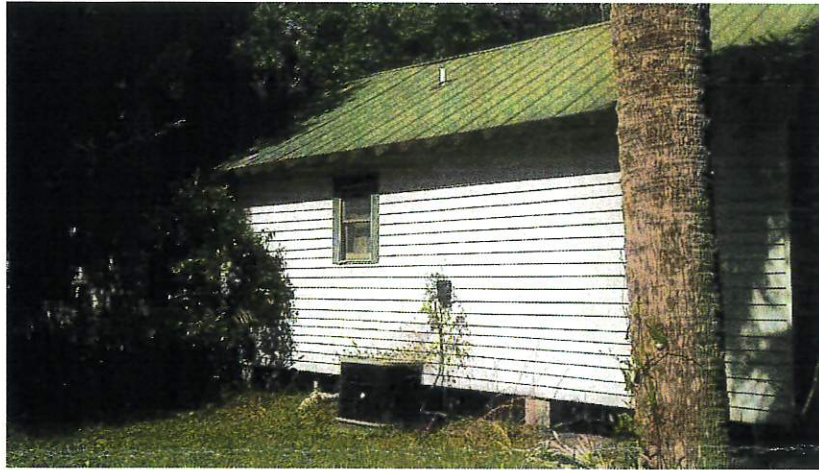
4. East Side

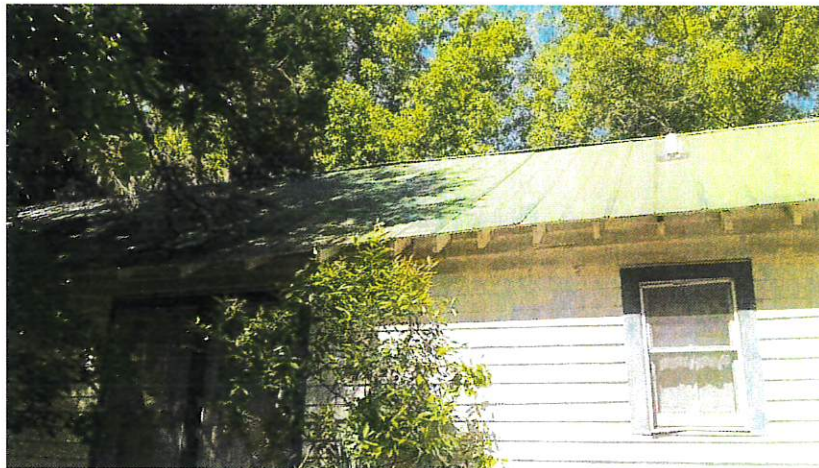
5. East Side – old section on left; rebuilt on right;

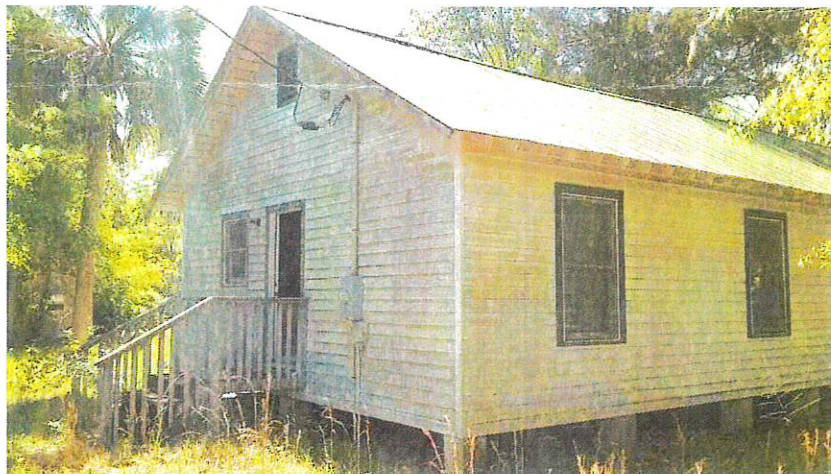
6. Northwest corner – Rebuilt section

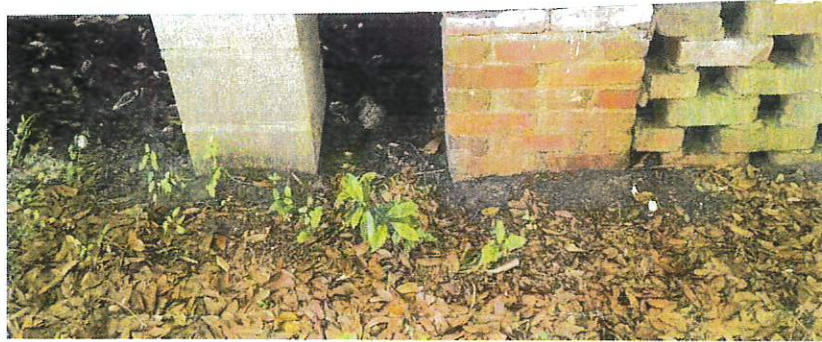
7. Foundation – Rebuilt on left; old on right

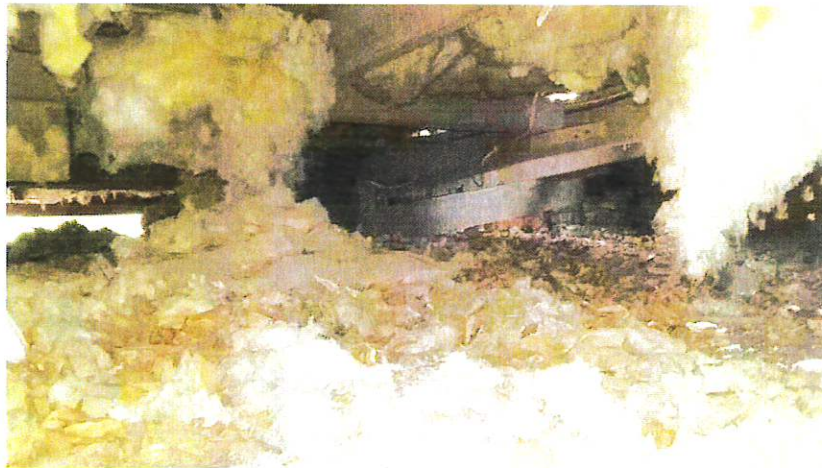
Reputedly, the other, more deteriorated half of the house was built as an add-on to the original structure in the late 1940s. It is structurally unsound and unfit for occupancy, which thereby deems the entire building unfit for occupancy. The floor is very weak in certain areas of the hallway (photo 11) and living room (photo 13) due to deteriorated sheathing and joists. The roof framing appears inadequate (photo 14). I found a decayed perimeter beam (photo 10) and a displaced support beam (photo 8).

8. Crawlspace of old section (note deflected support beam)

Based upon the overall structural condition of the building and the fact that, in my opinion, there is no inherent extraordinary or significant features; and that it would not be cost-effective to rehabilitate, I recommend that the building be demolished, thereby providing an opportunity to improve this area of "Old Town Bluffton."

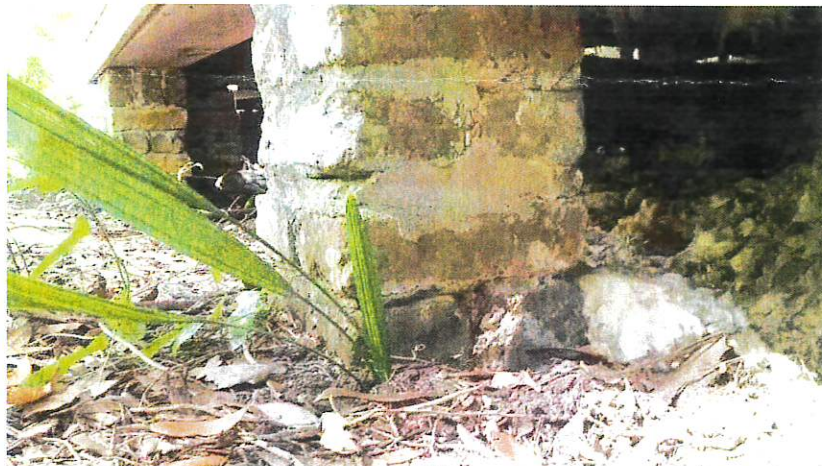
9. Brick pier of old section (mortar joint failure at base)

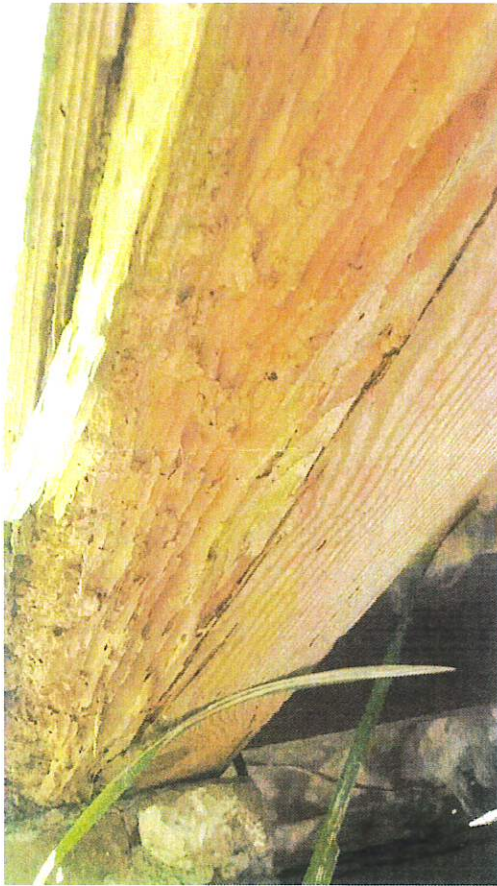
10. Decayed perimeter support beam

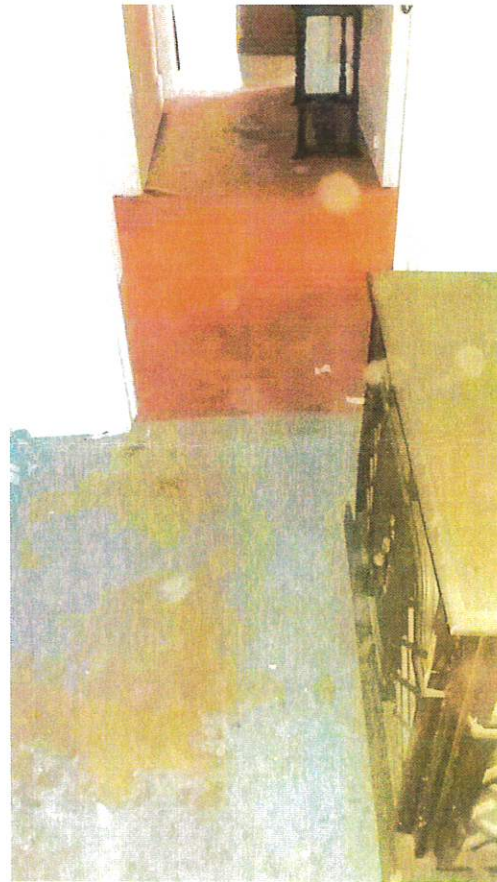
11. Weak/hazardous floor area (old section)

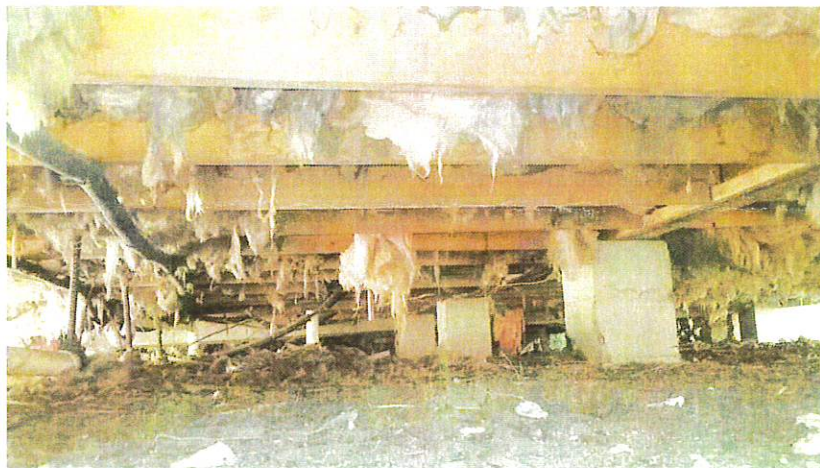
12. Crawlspace of new section

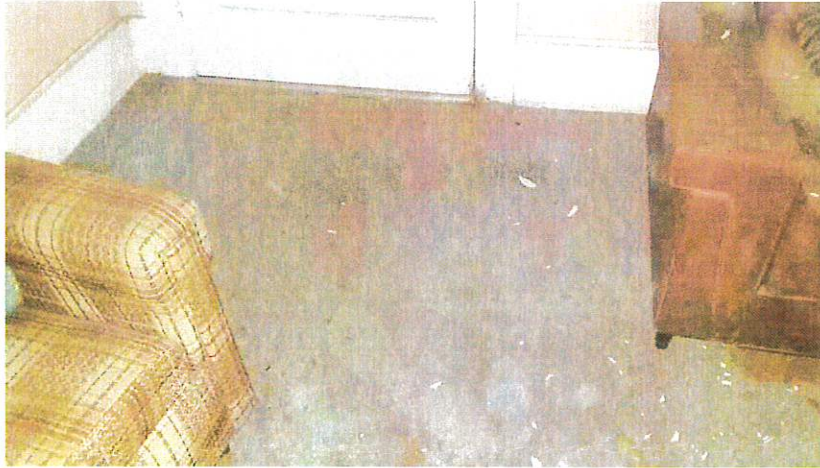
13. Weak floor near south entrance – hazardous

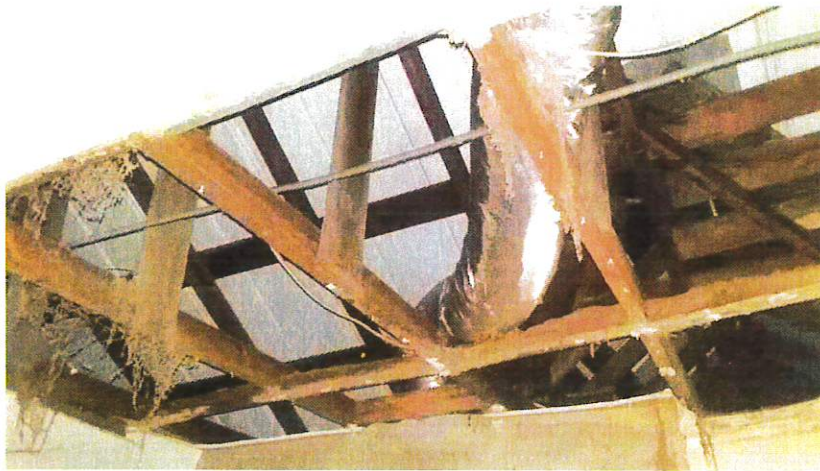
14. Ceiling collapse – old section. “Skeletal” roof structure.

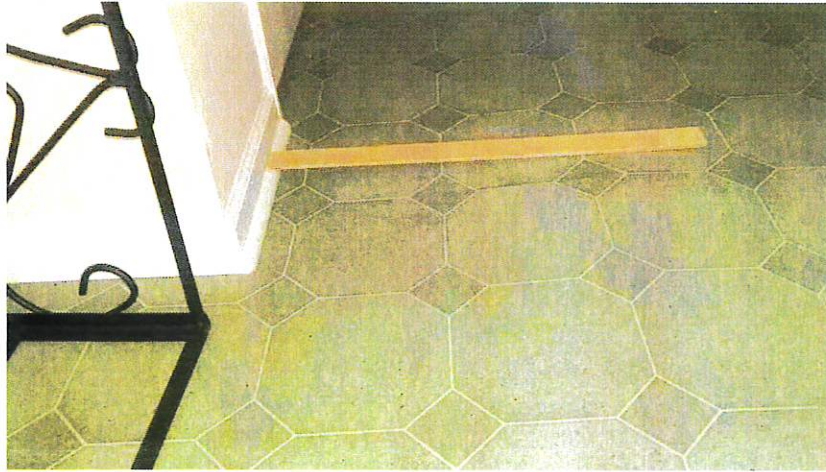
16. Floor deflection – new section

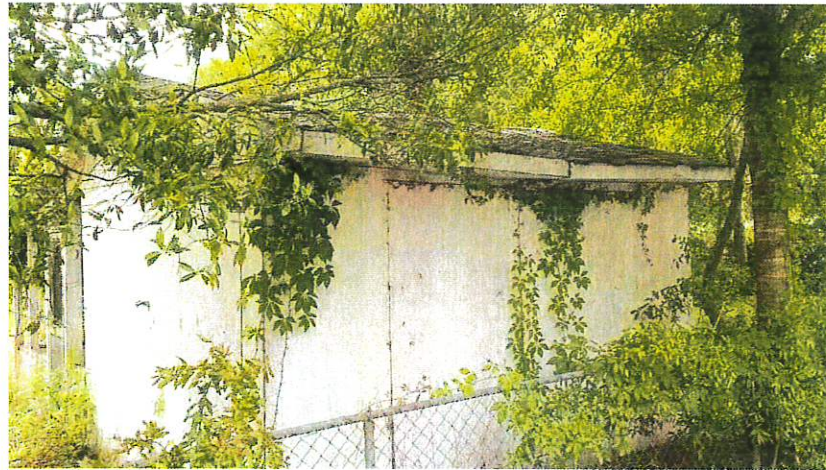
I have no historic information on this structure, but after inspecting it, it can be classified as a derelict building and potential public nuisance. As can be seen in photos 17 through 24, the building is in a state of neglect and suffers severe deterioration of its roof, floor, siding and foundation. It is unsafe to enter this structure. It appears to have harbored animals and perhaps homeless individuals.

17. West side (front) of BBQ shed, facing Bluffton road; roof deteriorated

Therefore, it is my opinion, that this shed also be scheduled for demolition.

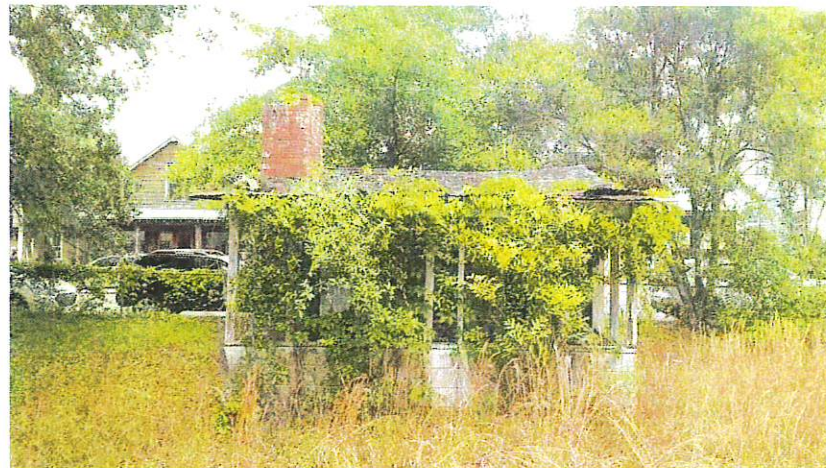
18. East side (rear) of BBQ shed; severe deterioration

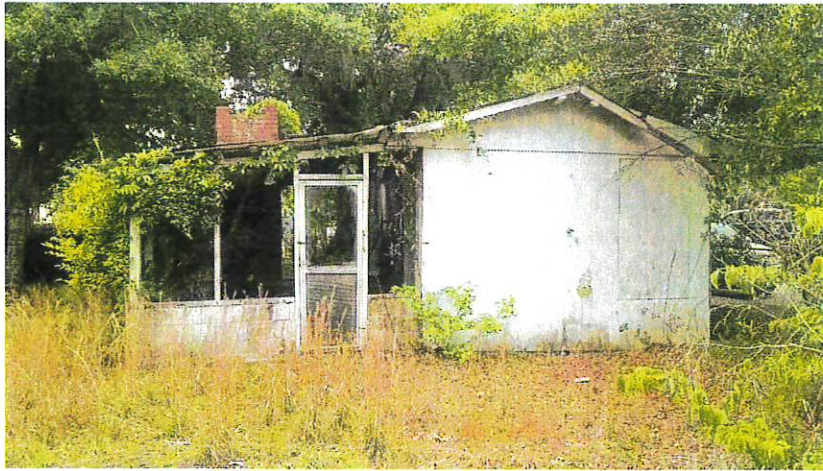
19. North side of BBQ shed

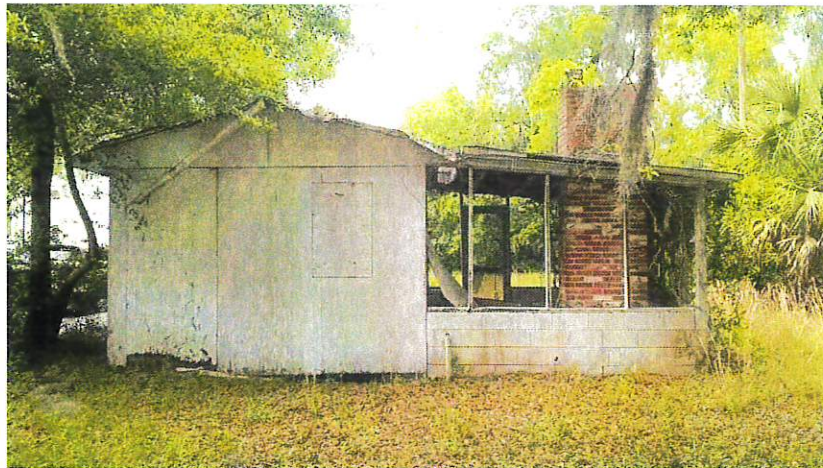
20. South side of BBQ shed

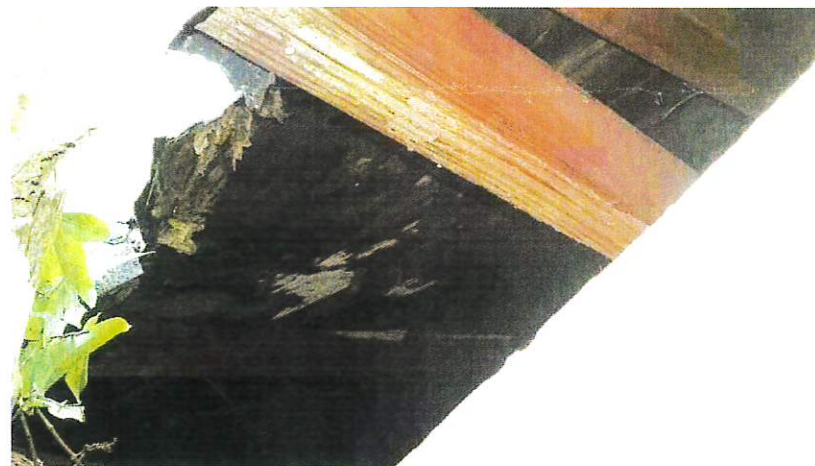
21. Deteriorated roof of BBQ shed

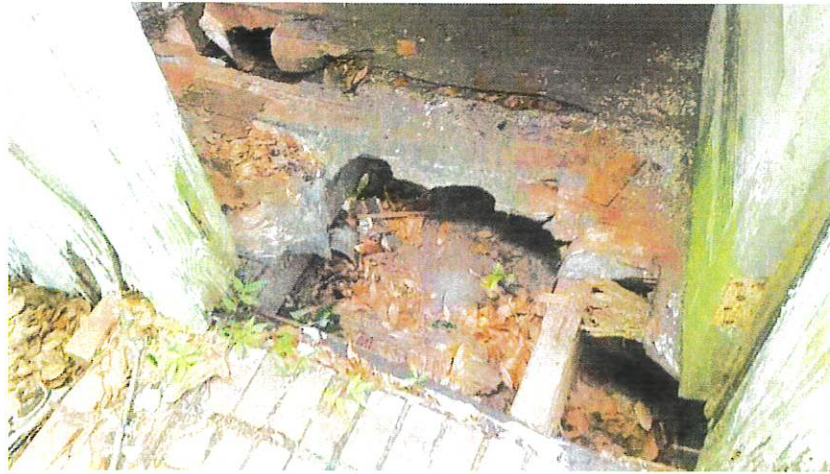
22. Deteriorated floor of BBQ shed

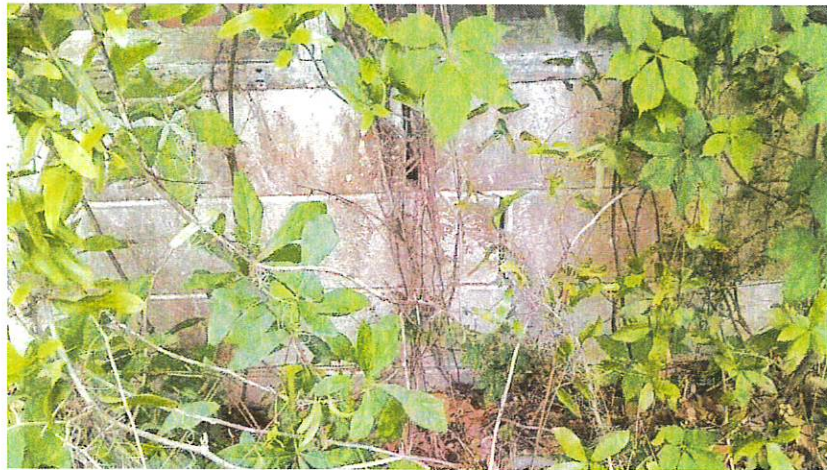
23. Foundation damage at BBQ shed

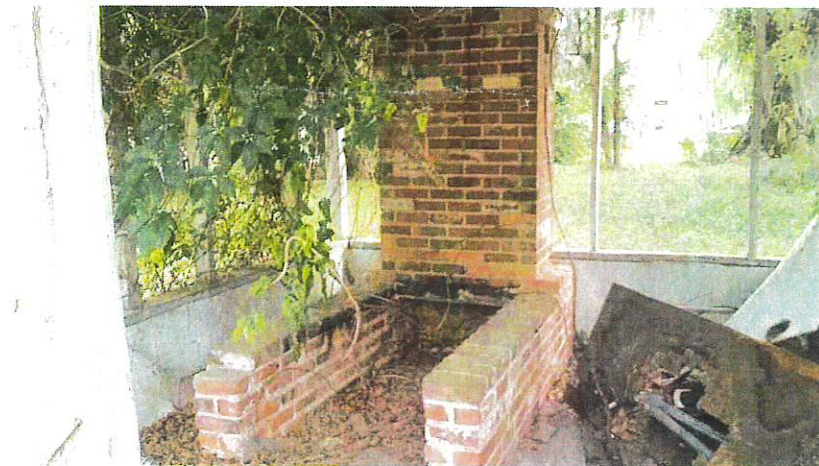
24. The barbeque pit
