Project: 22-002.11 3 Wharf Street  
3 Wharf Street, Bluffton, SC

RE: Building Remodel Recommendations  
Construction Site Visit (CSV) #01

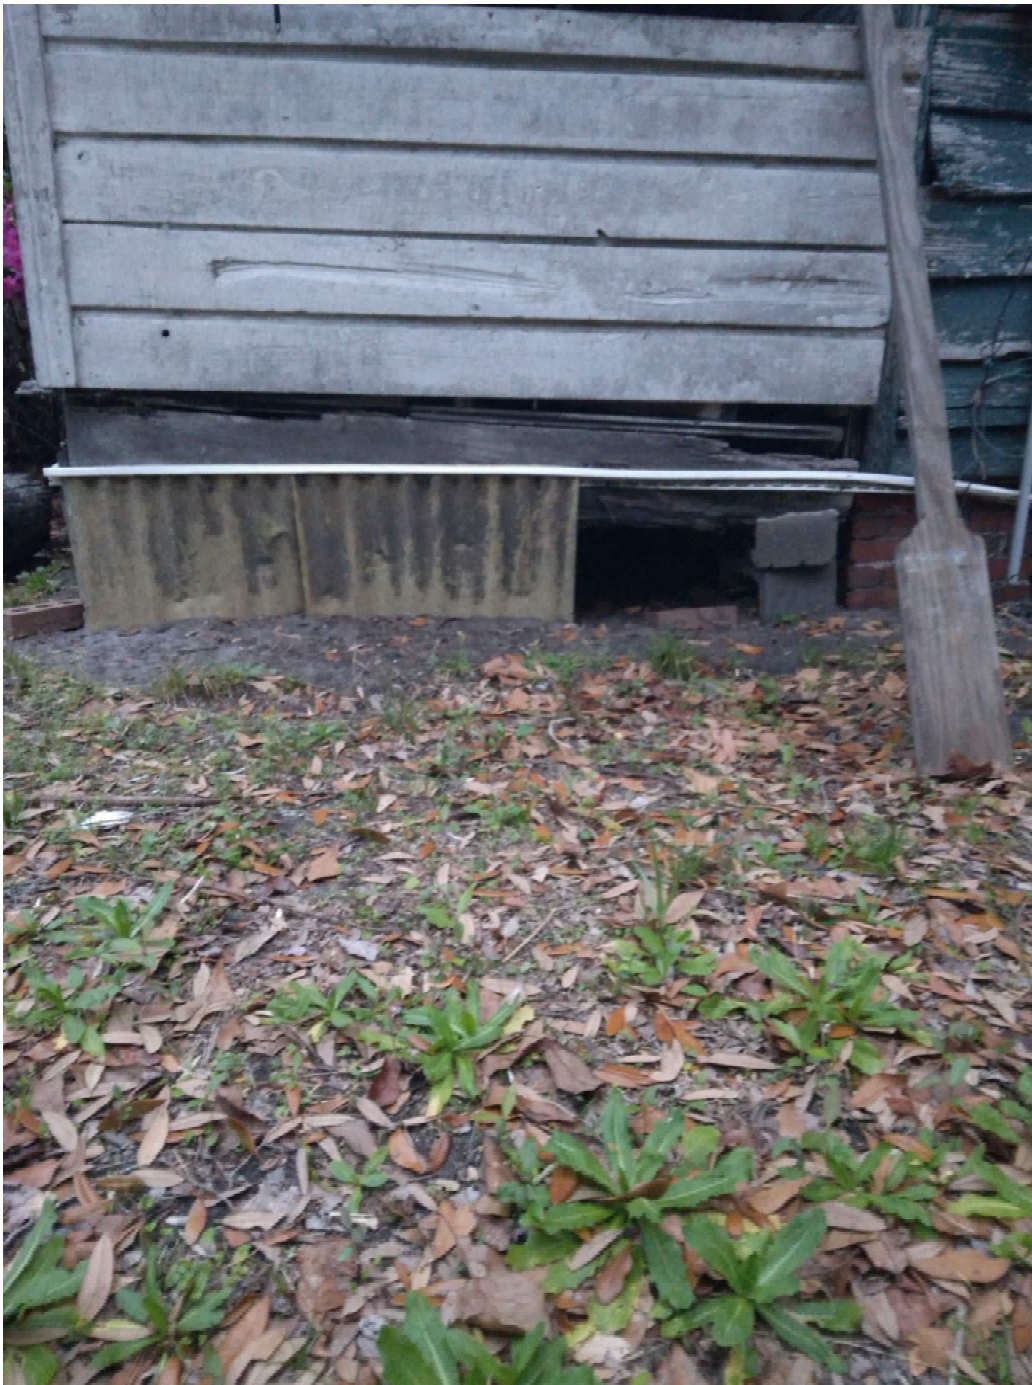
South West Porch Supports  
Broken CMU Block due to incorrect orientation

- i. Foundation: Footings, piers, supports – it is noted here that no investigation to the midspan piers was performed due to the uncertainty of the structure's integrity

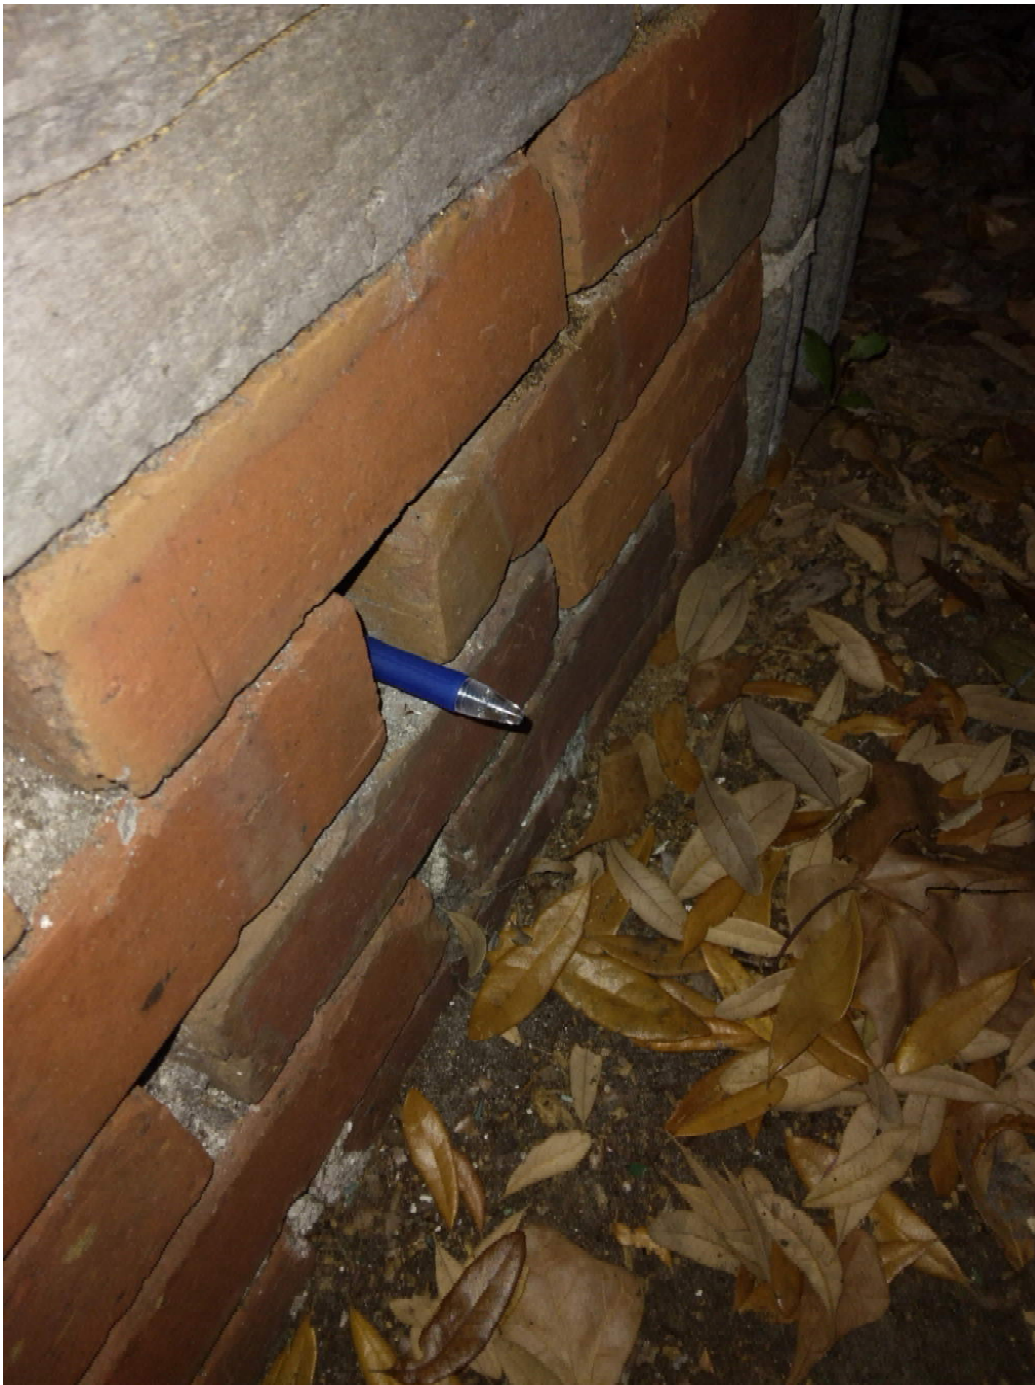
North-West Corner Pier  
Notice Ball Point Pen in brick joint

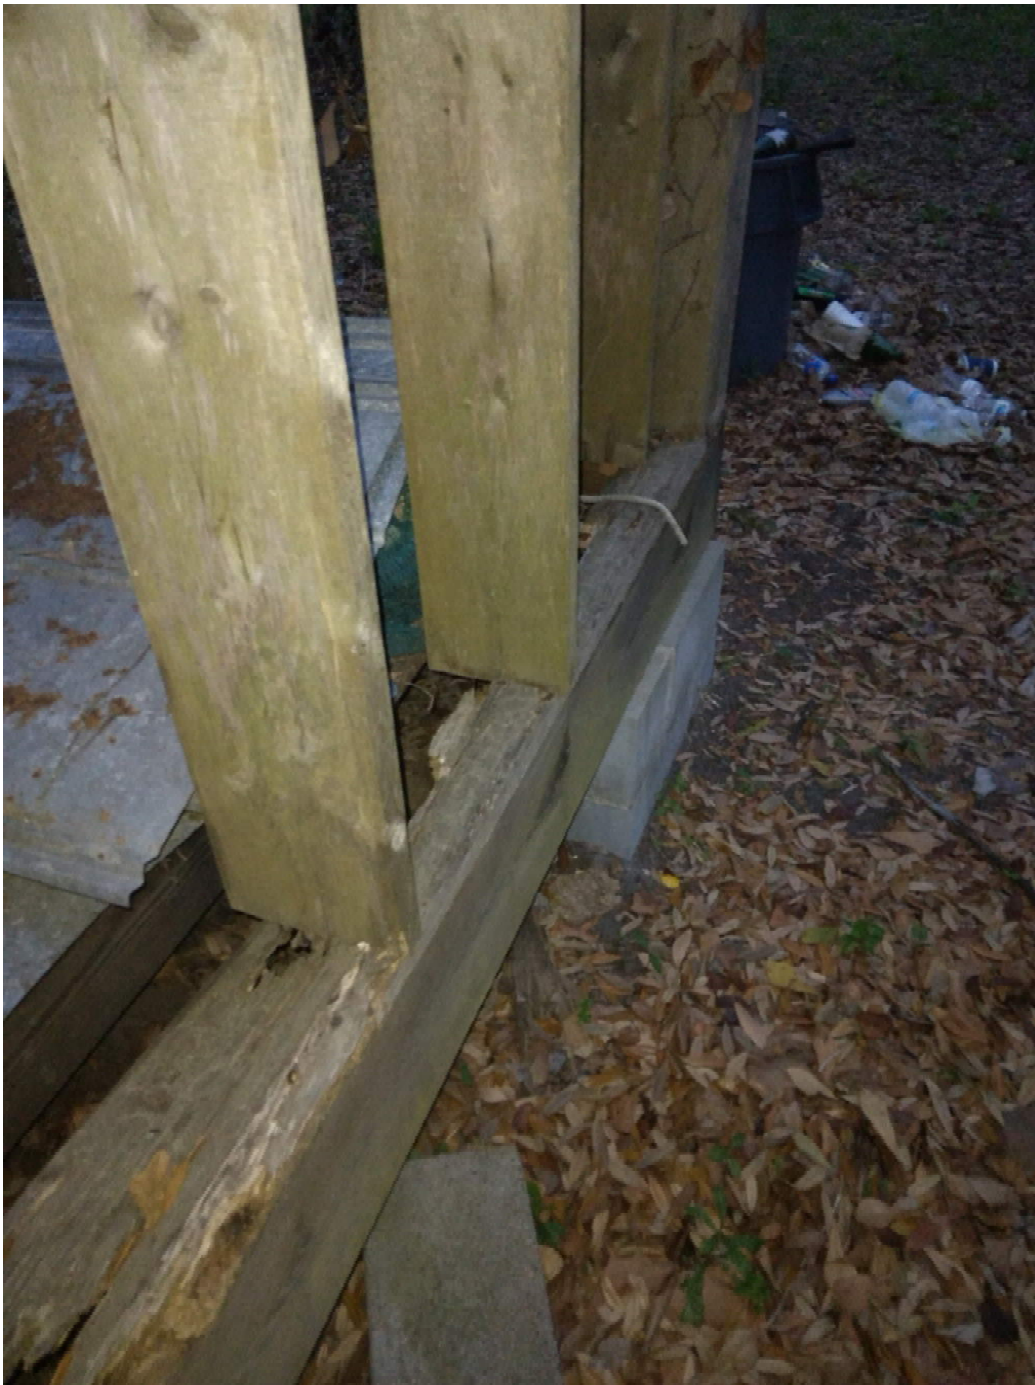
Back Room with rotten shoe plate and studs

- ii. Floor Joist and Sheathing: Porch and connections to structure, sagging floor joist and sheathing
    - iii. Walls: rotten studs, shoe plates, top plates – interior and exterior

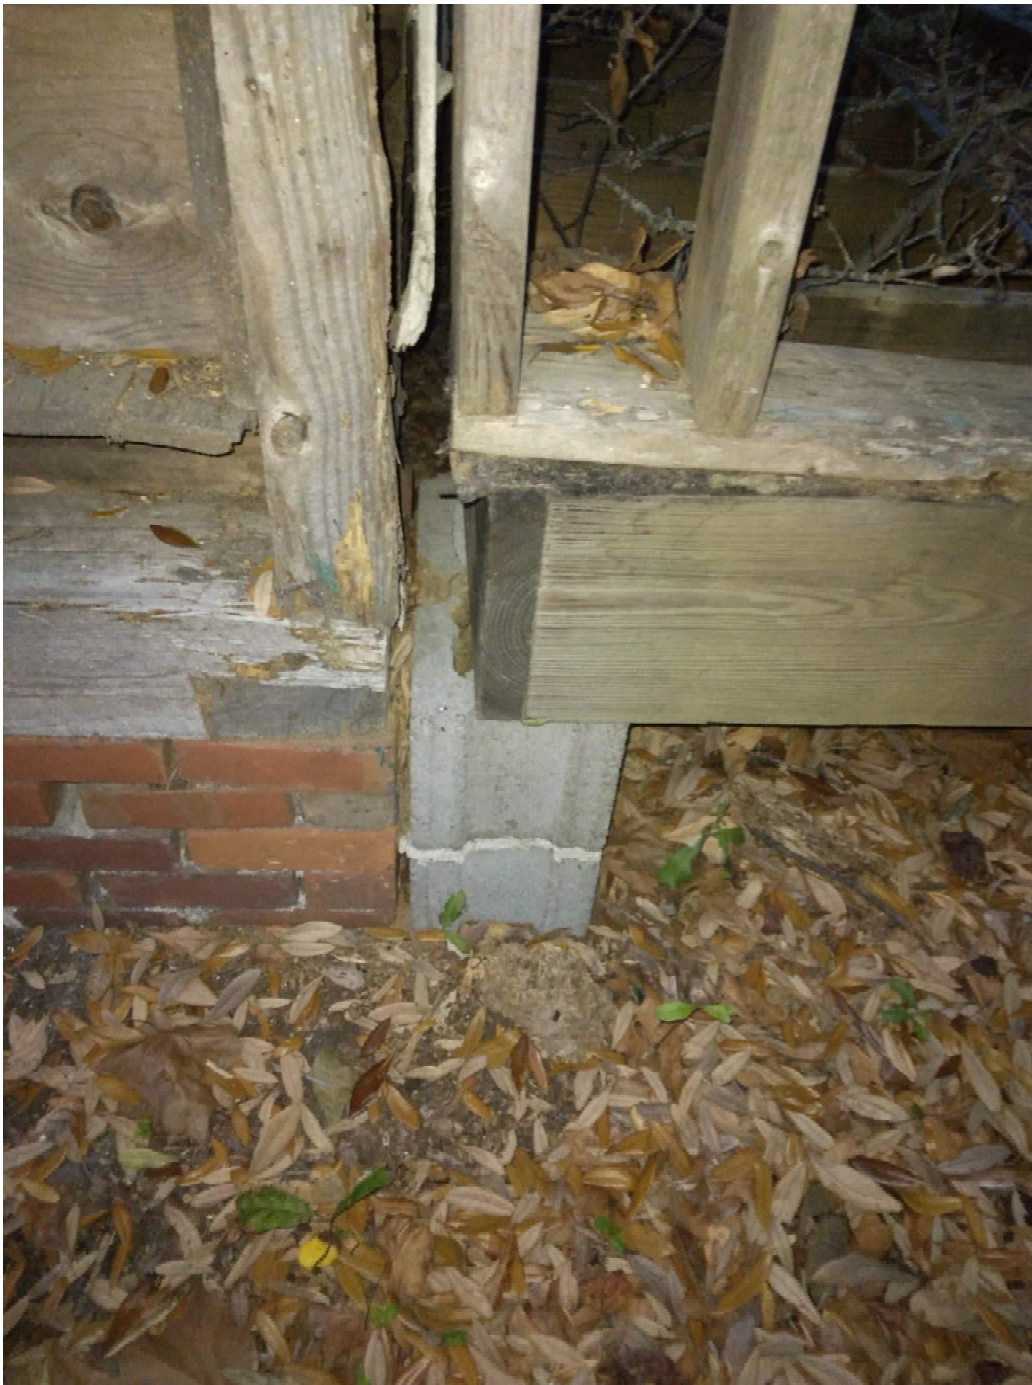
Back Room and North-West Corner connection – No apparent connection of two structures

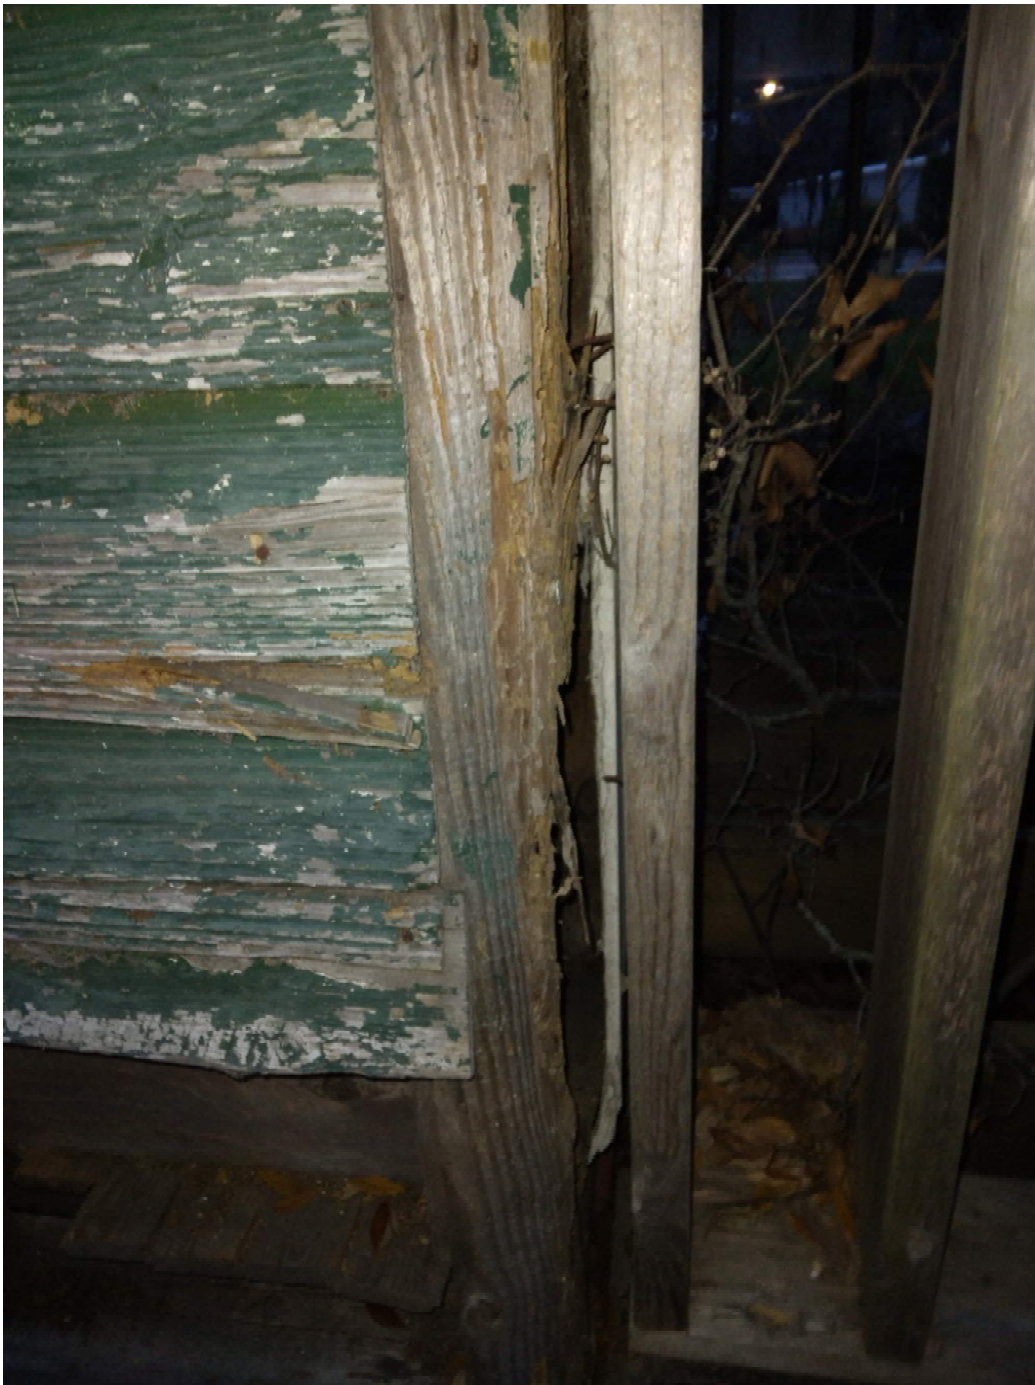
North West Corner finish rotten

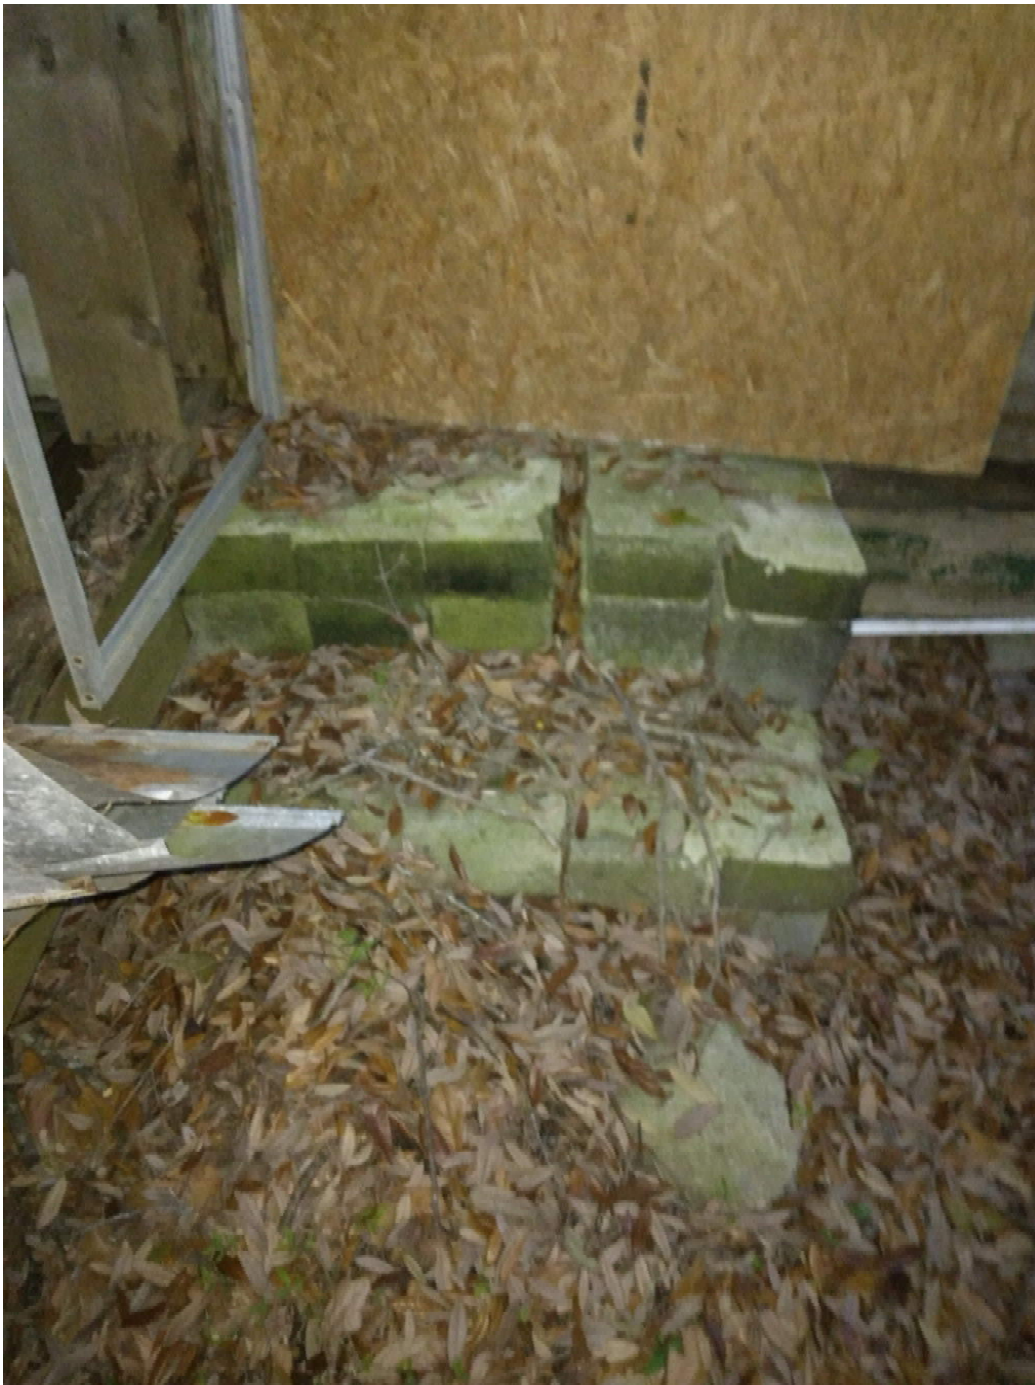
Back Entrance Stair construction is not to code

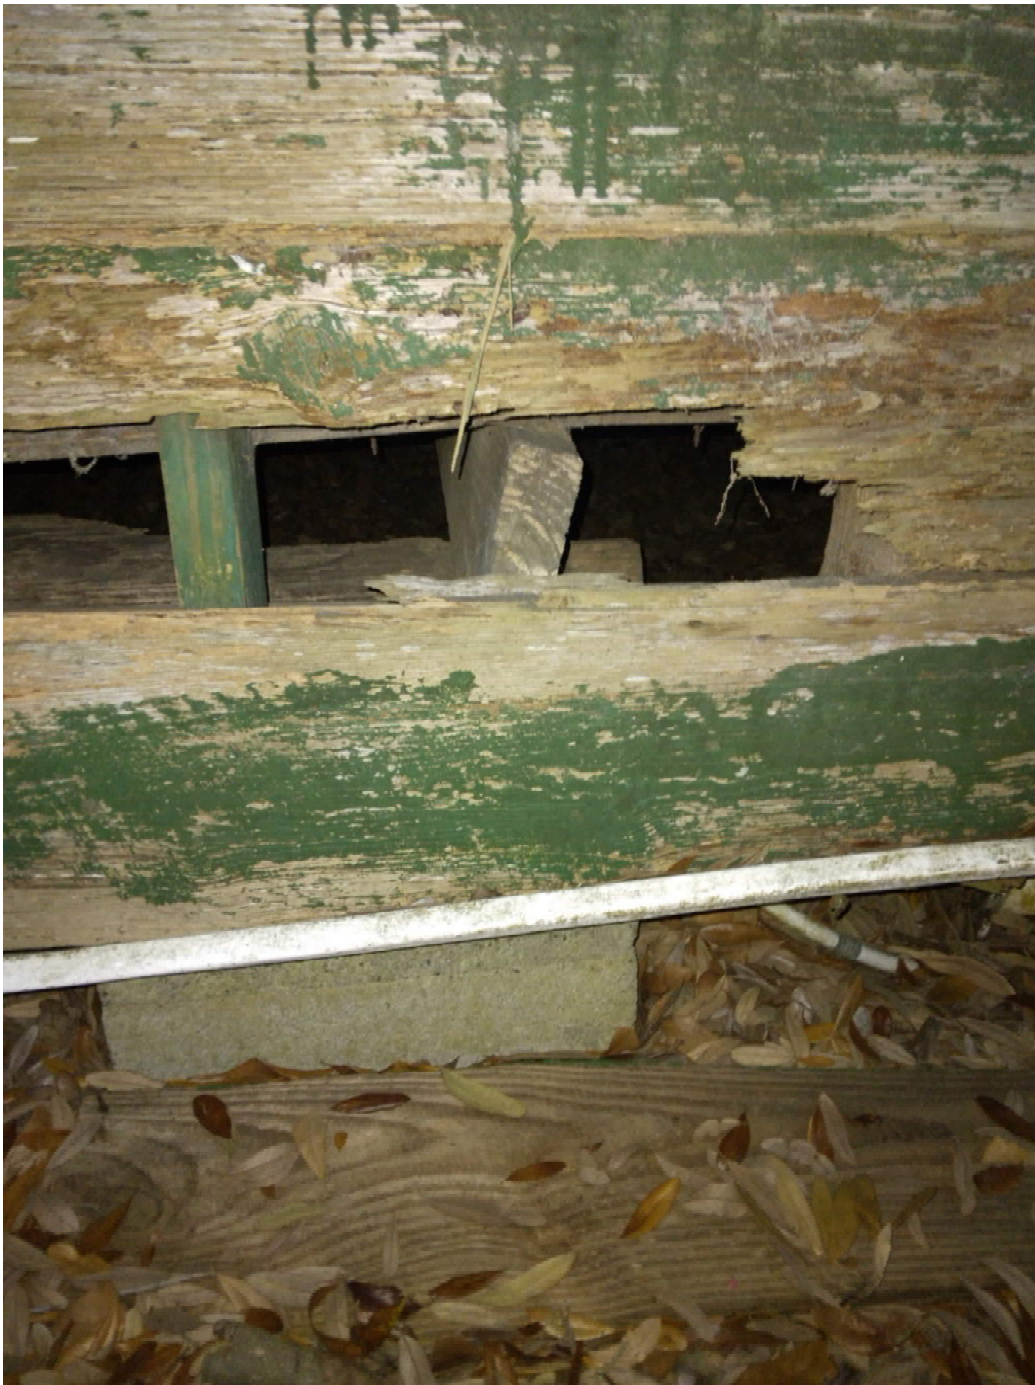
Rotating Floor Joist due to missing band board connection and rotten siding

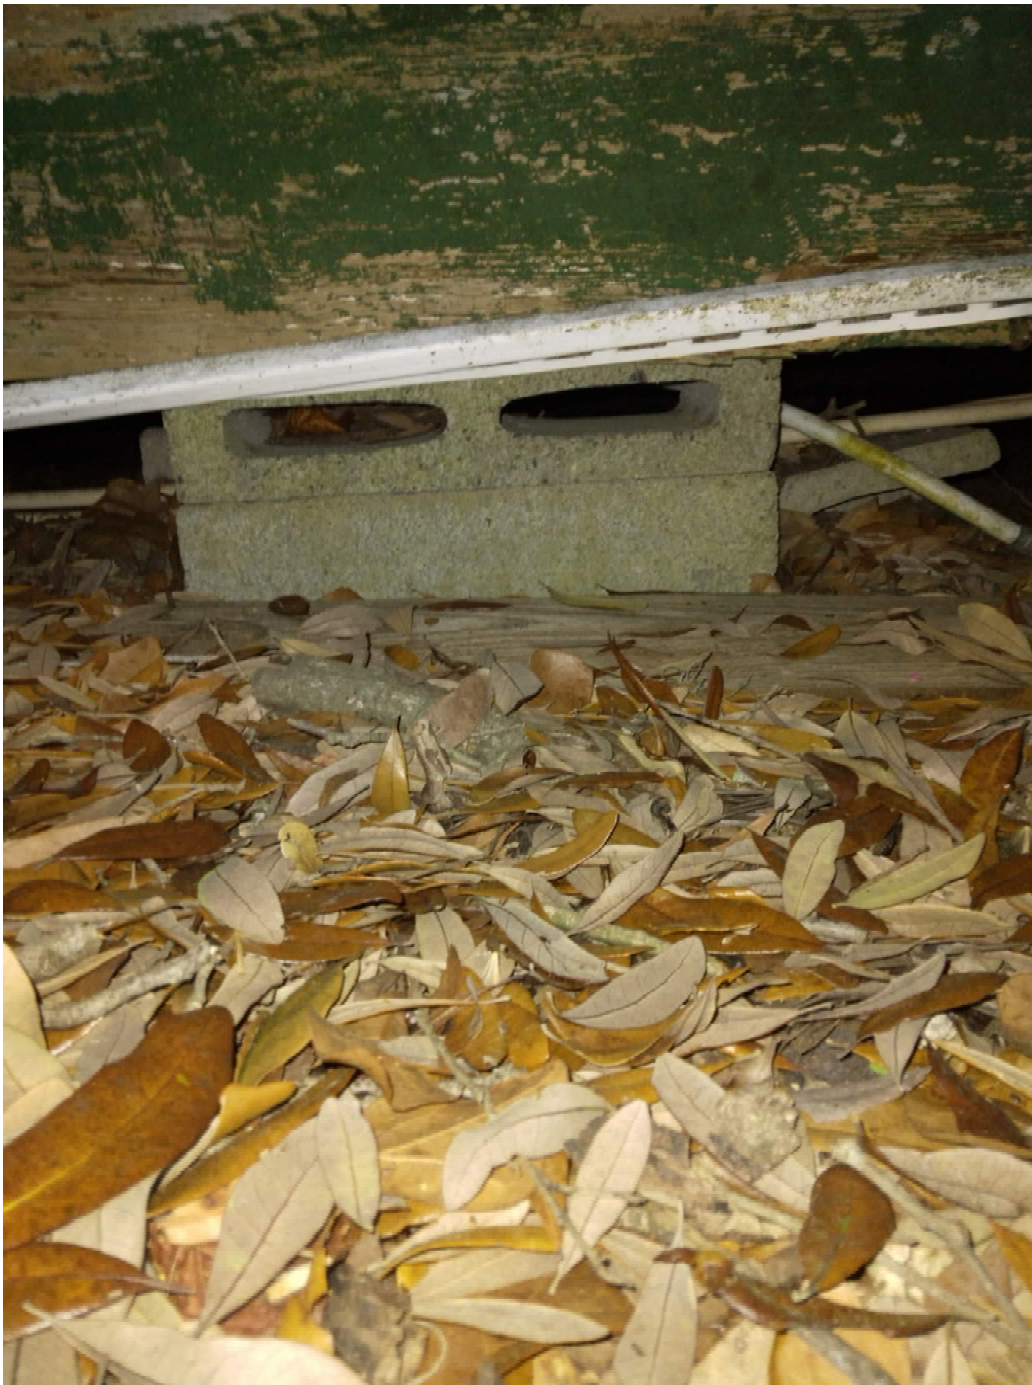
Incorrect loading of 4" CMU block

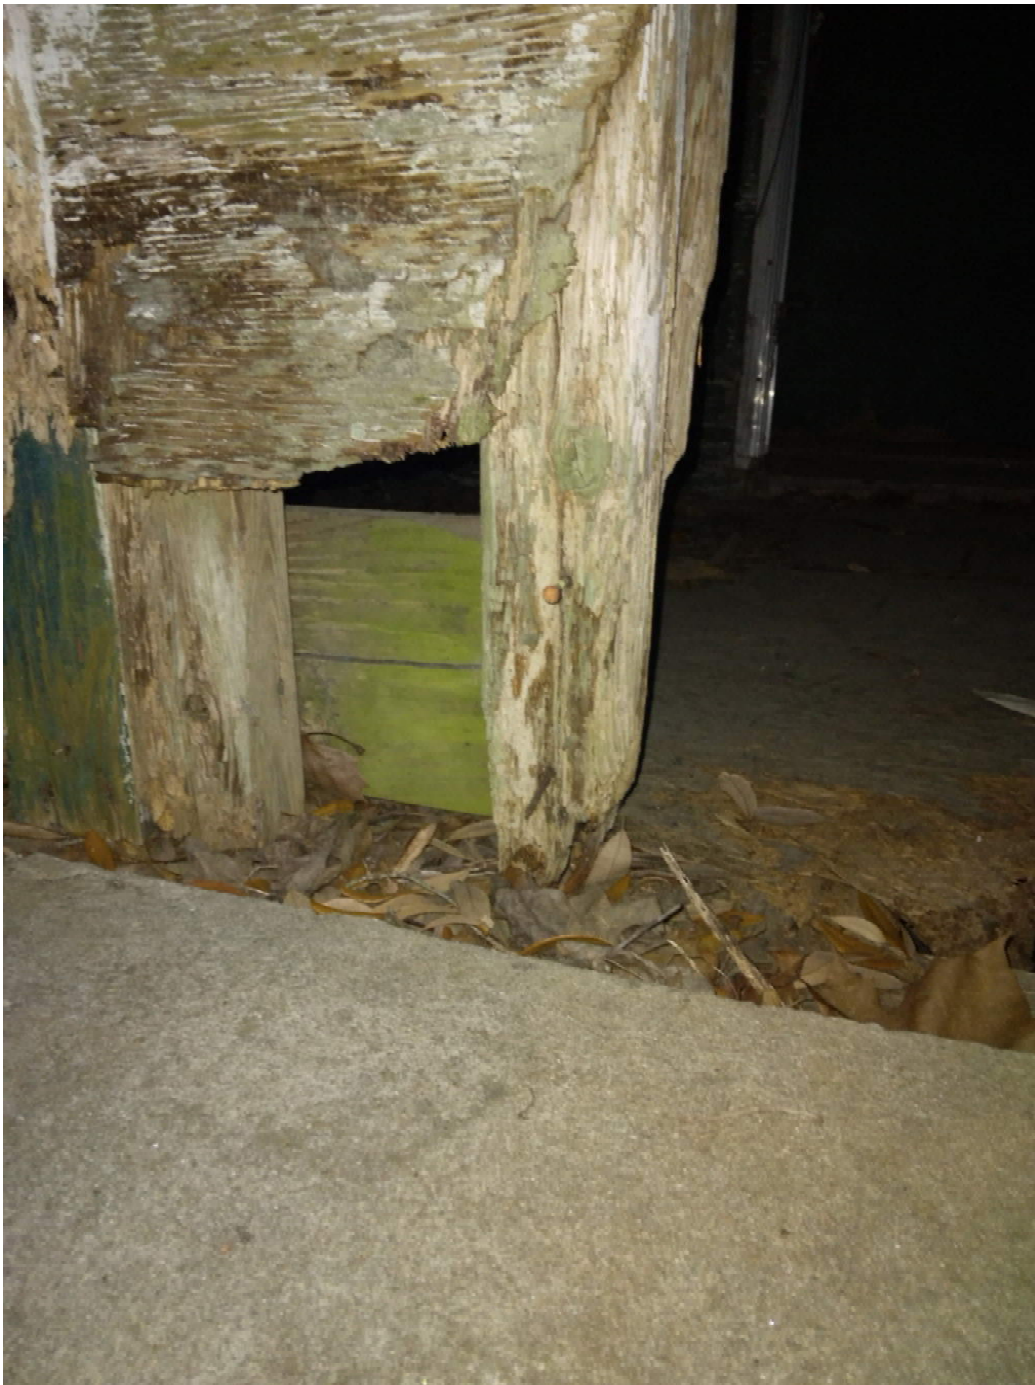
Rotten Jack and King post at Porch door

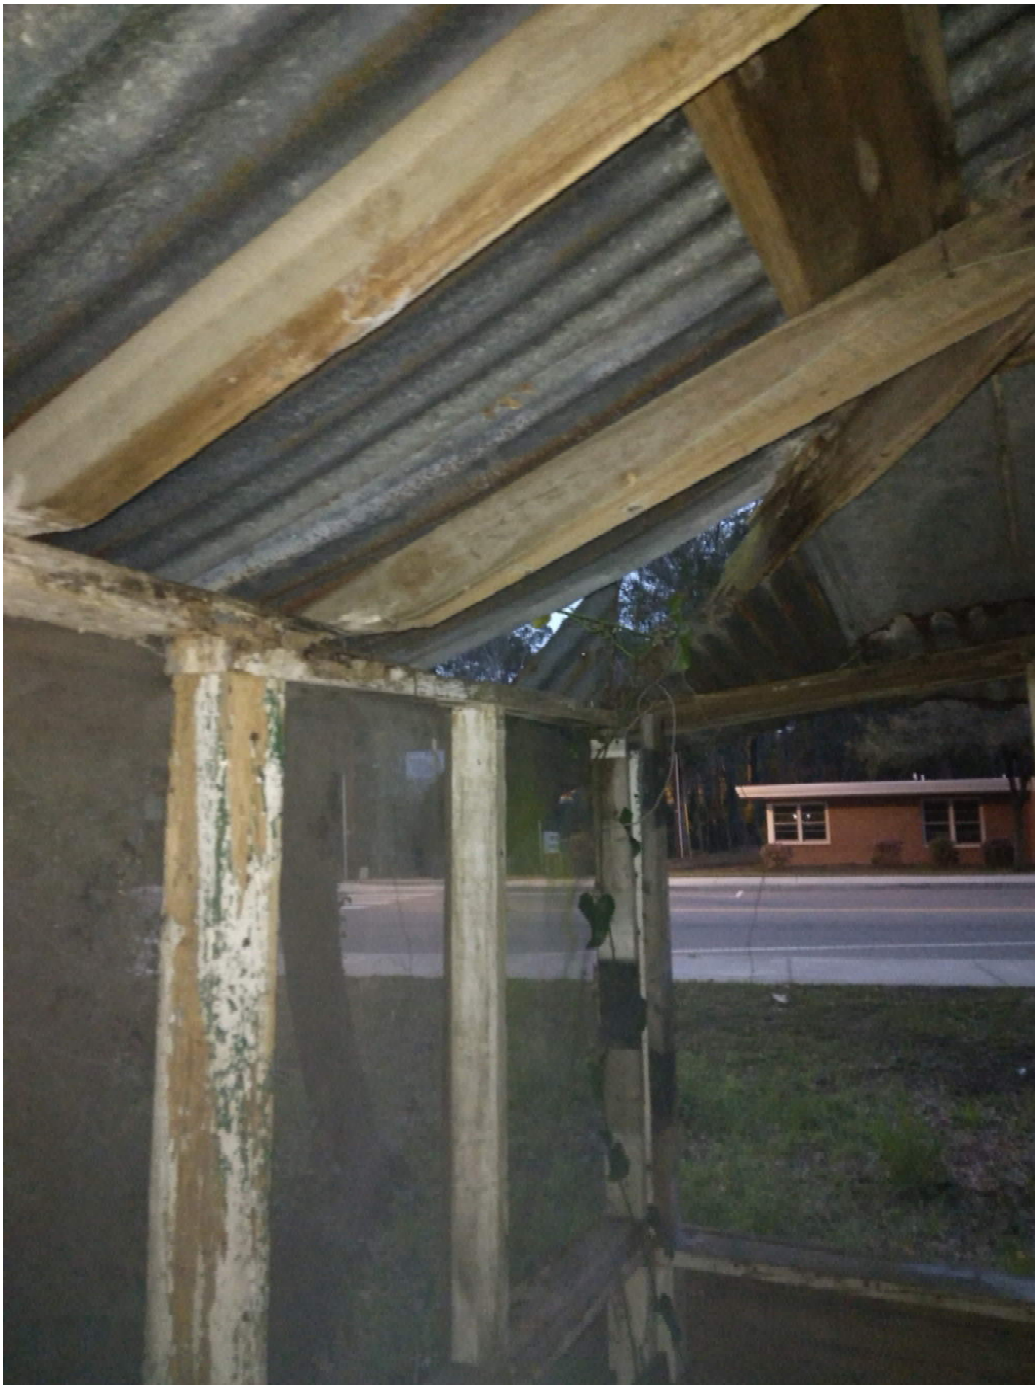
Porch Rotten Top Plate and Roof Rafters

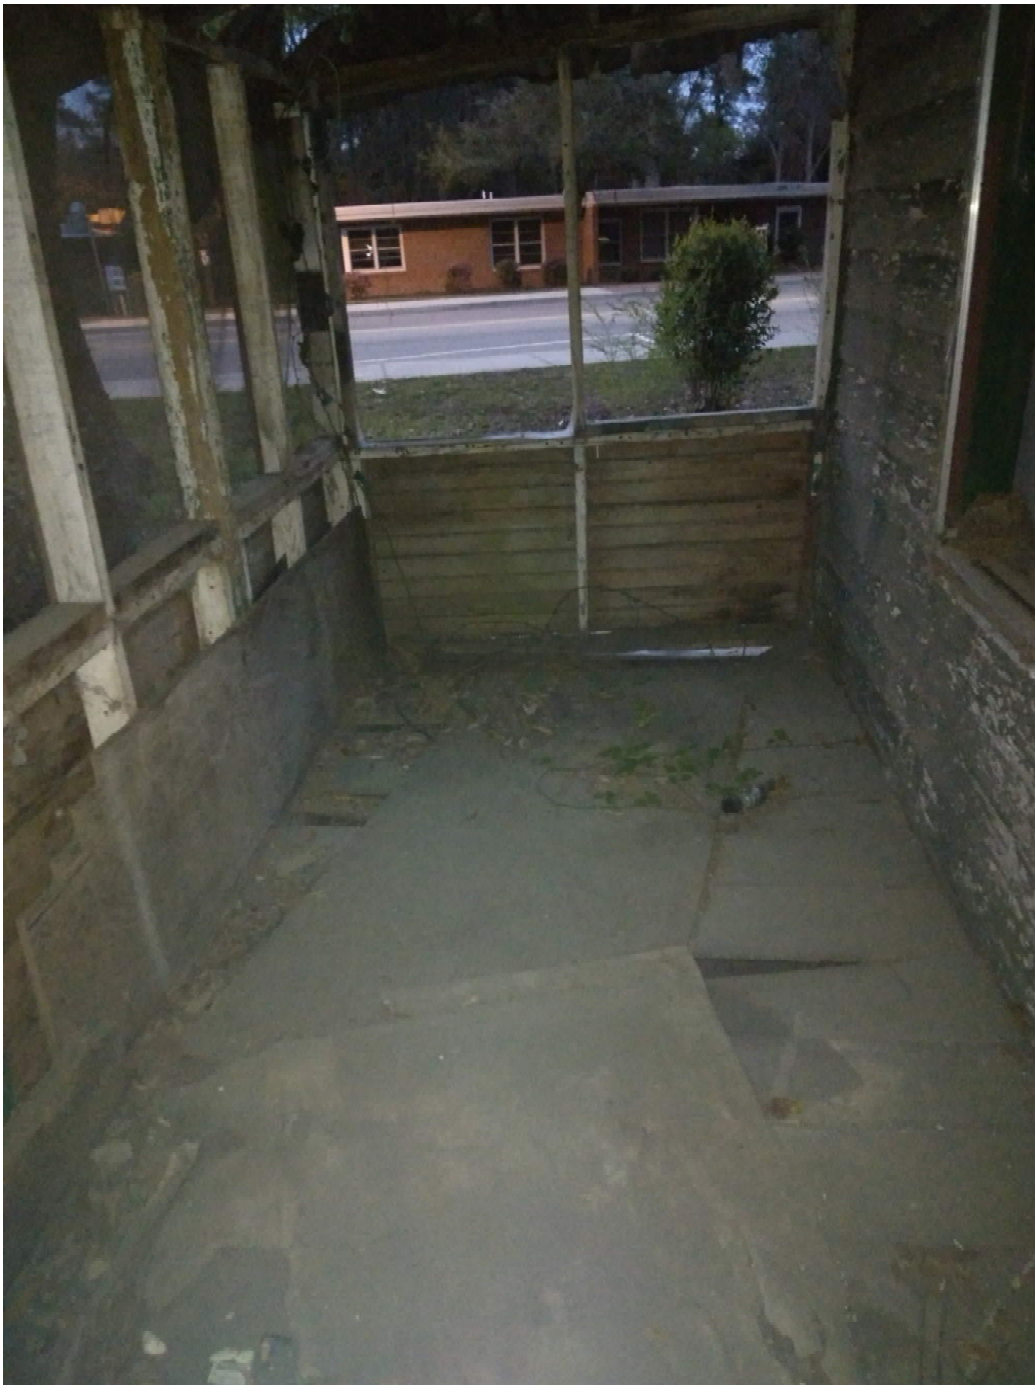
Porch Deck sheathing is rotten and gap between wall and deck

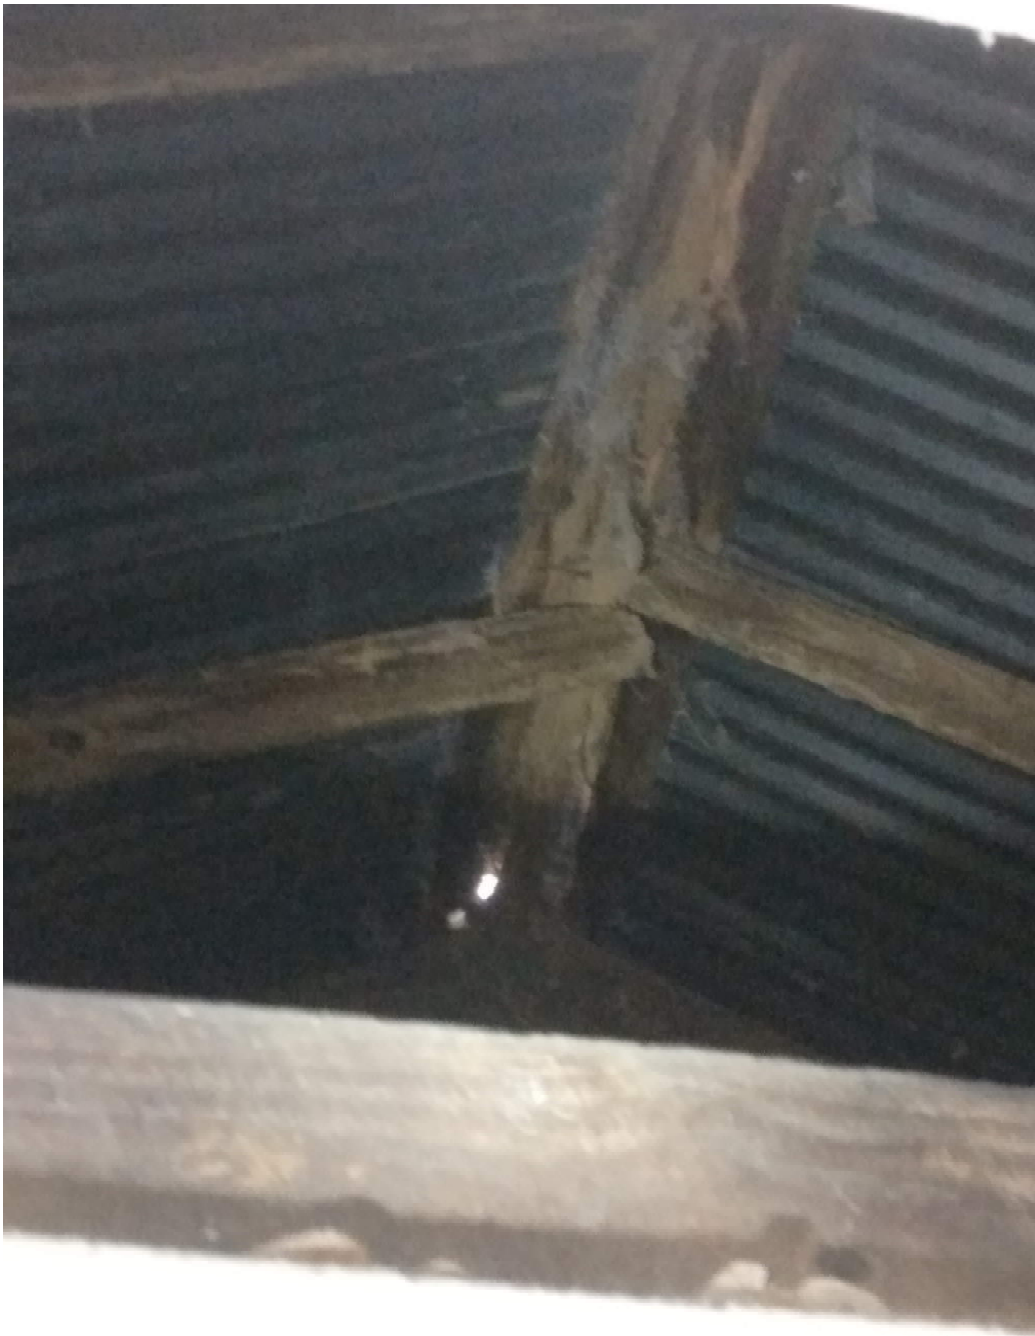
- v. Roof Rafters and Covering: Rafter are not connected at the peak; tin roof sheets are dislodged exposing the interior to the elements
    - vi. Exterior siding: many pieces of siding are missing, soft or rotten due to exposure and no protection from elements (paint)

Roof Rafters not connected to ridge board

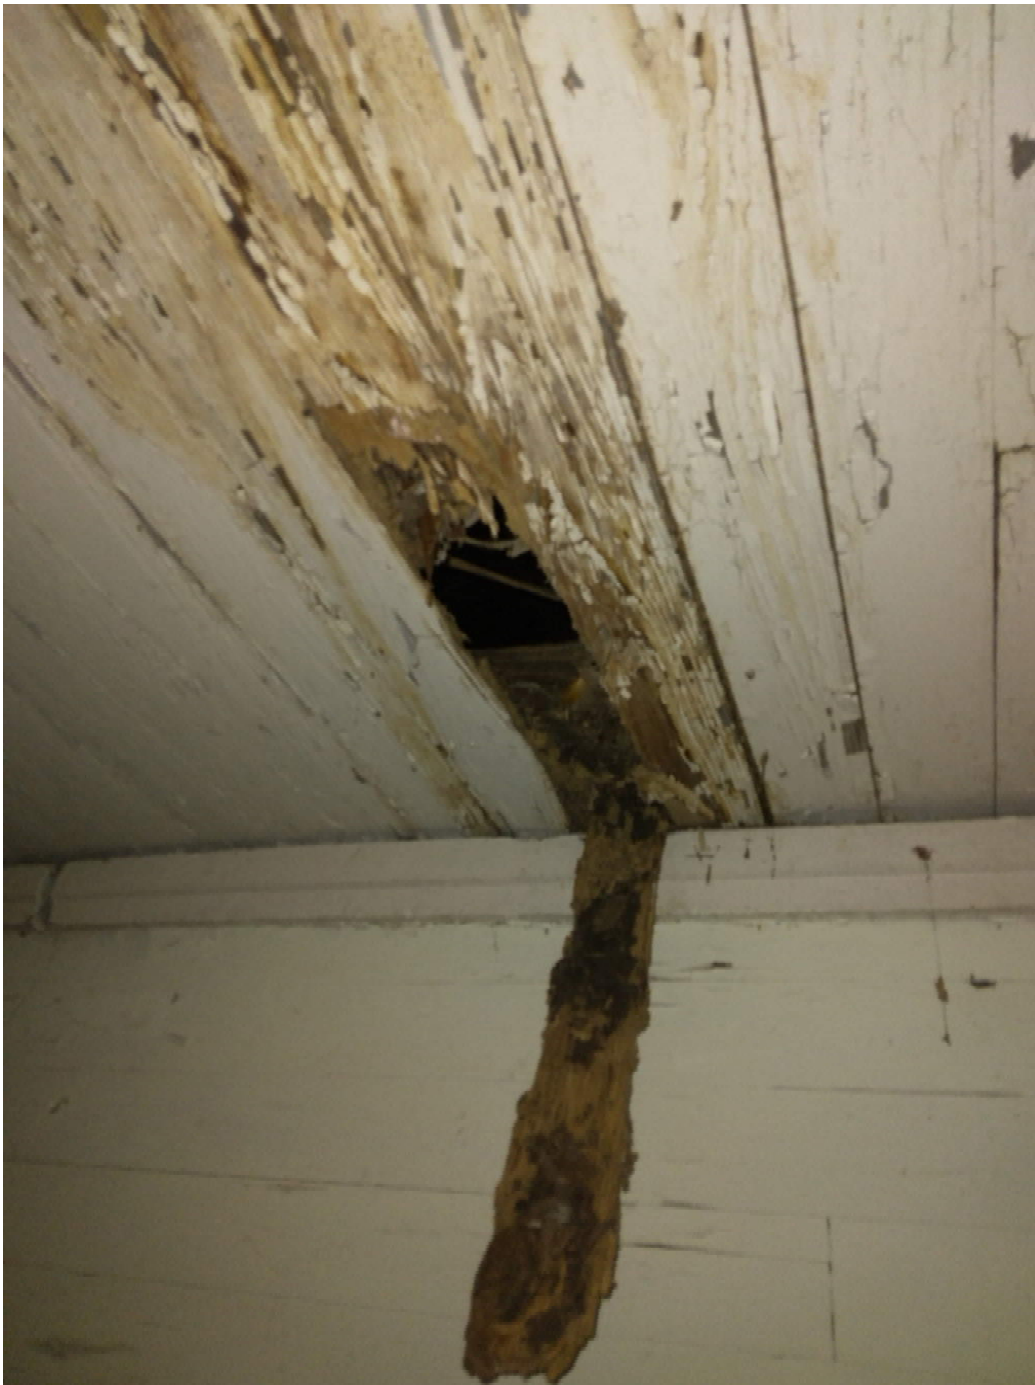
- iv. Ceiling Joists and finishes: areas where plank ceiling is rotten, joist most likely are soft in these areas due to being in contact with water for extended time frames

Rotten Ceiling finish

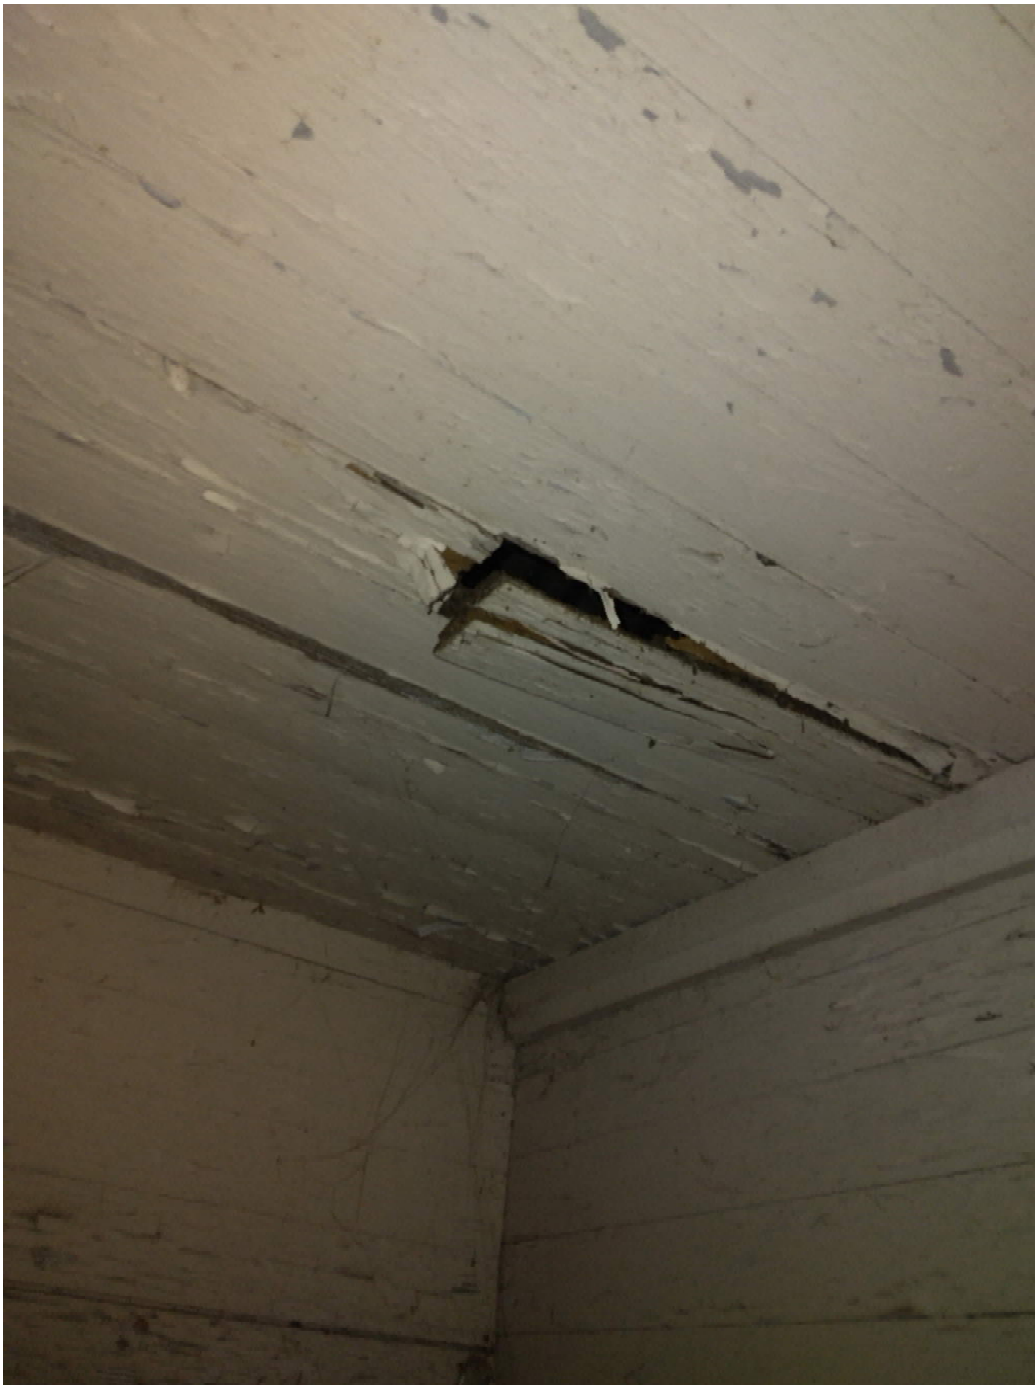
Rotten Ceiling Finish
