HISTORIC TISON-DERST COTTAGE

113 Bridge Street, Bluffton, SC 29910

Structural Conditions Assessment and Code Study

Prepared May 2024

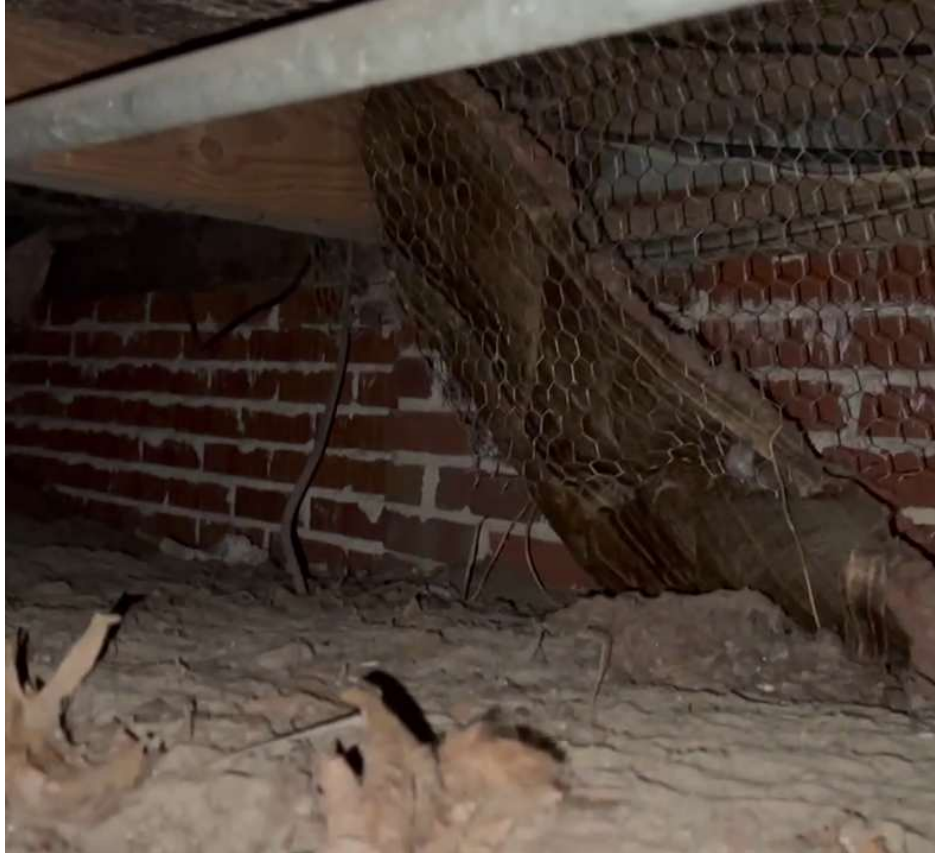
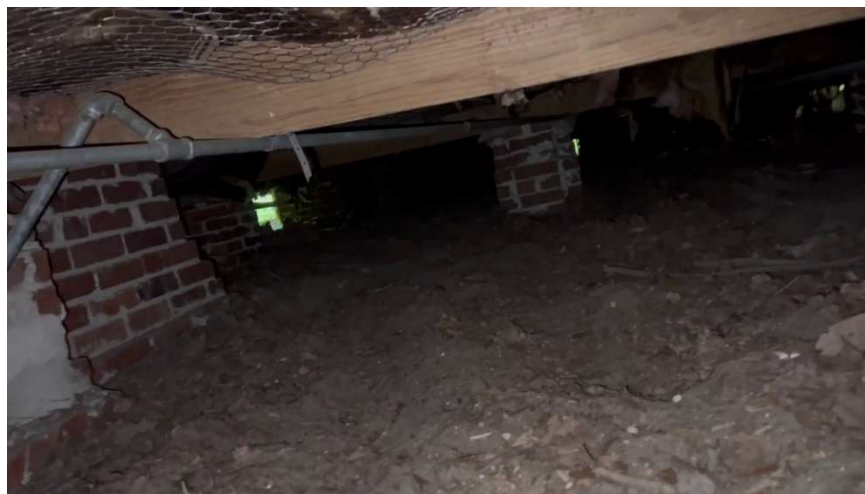
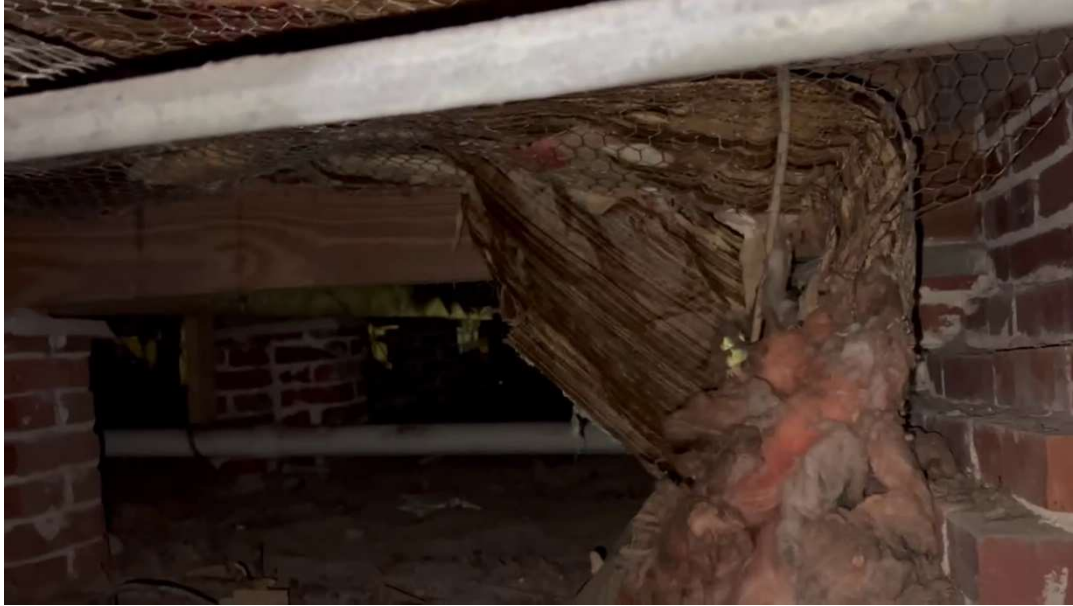
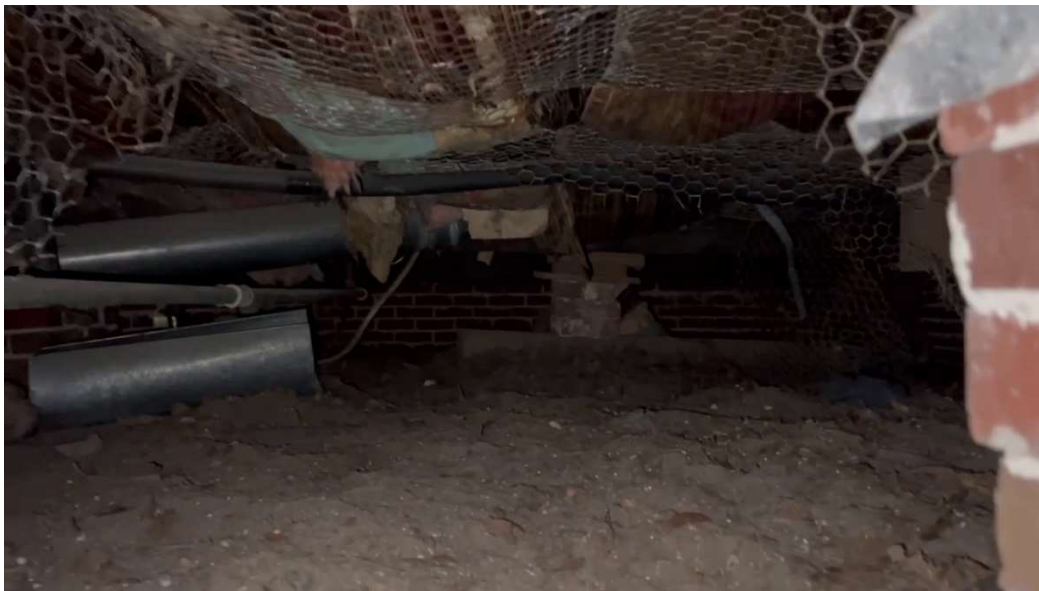
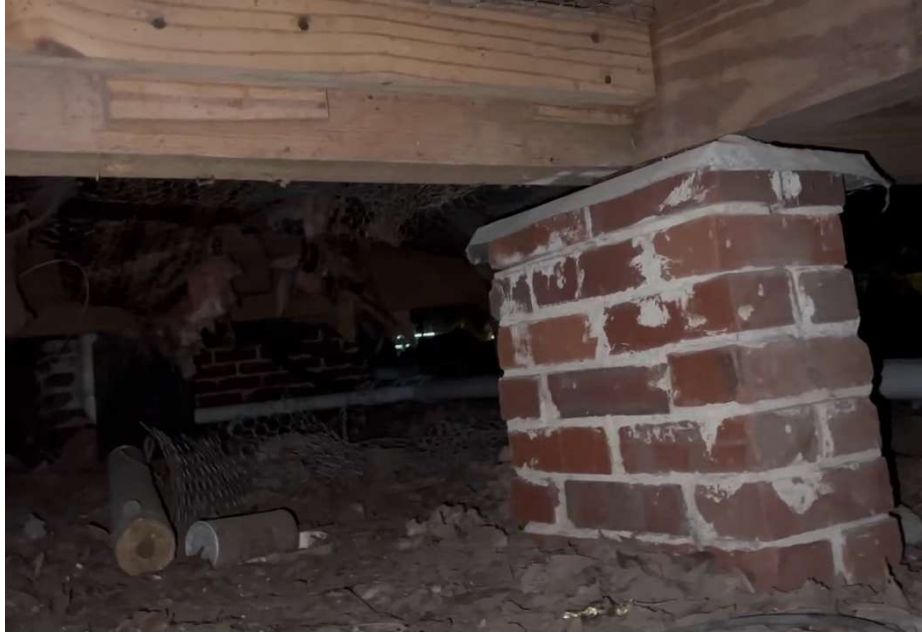
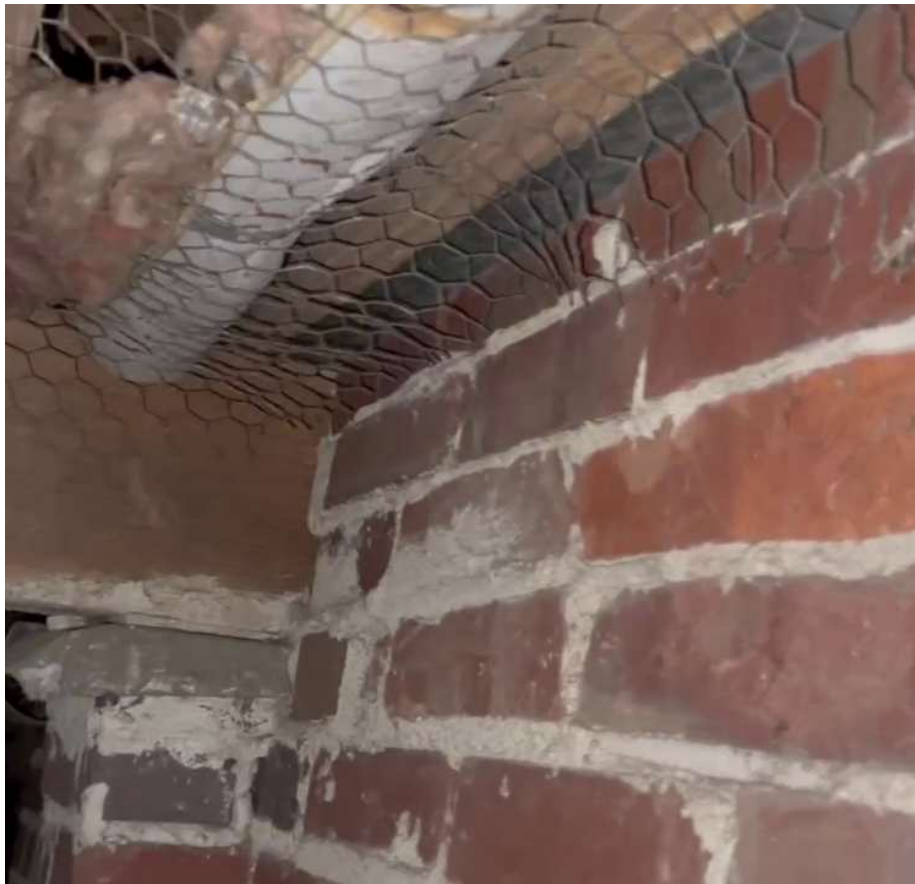
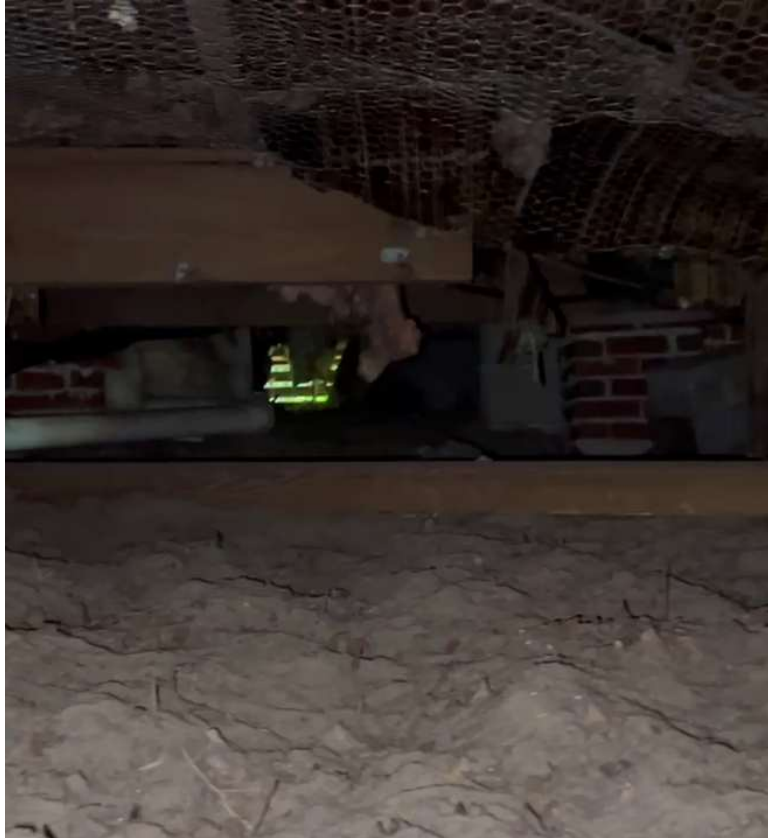
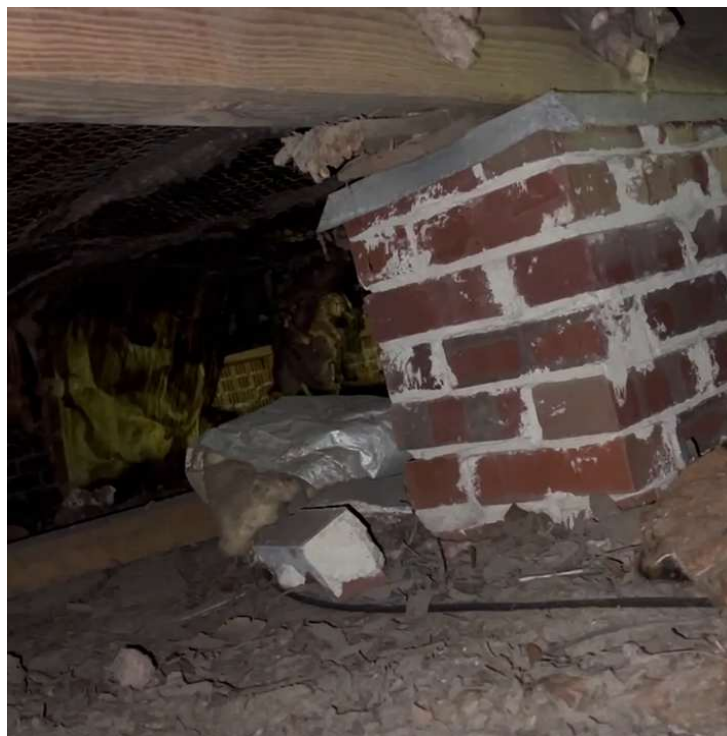
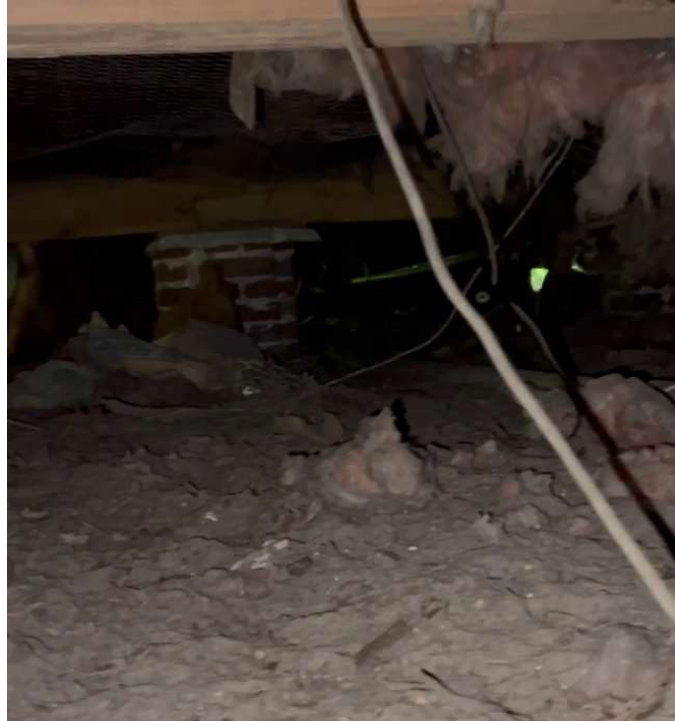
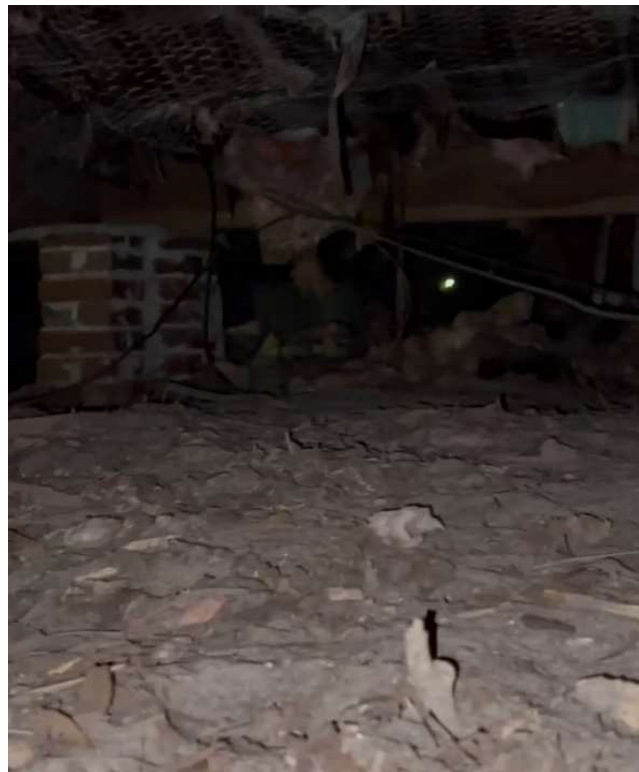
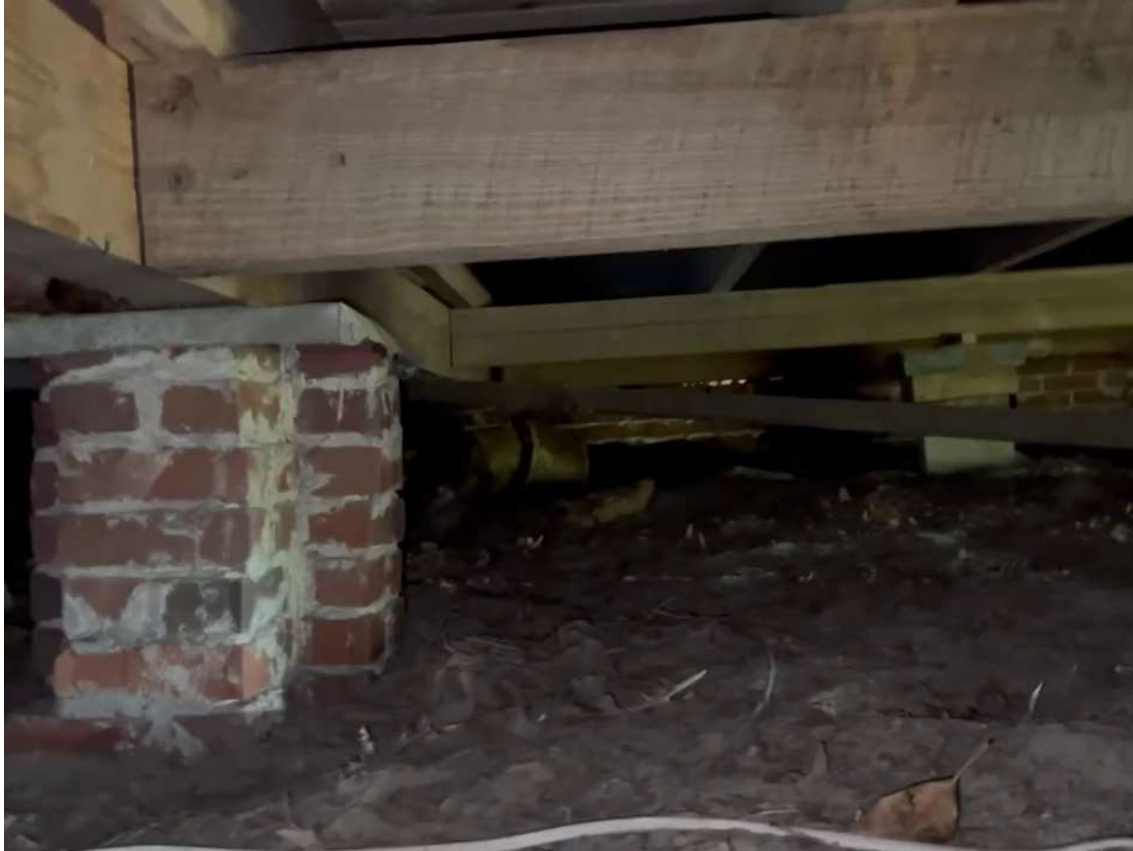
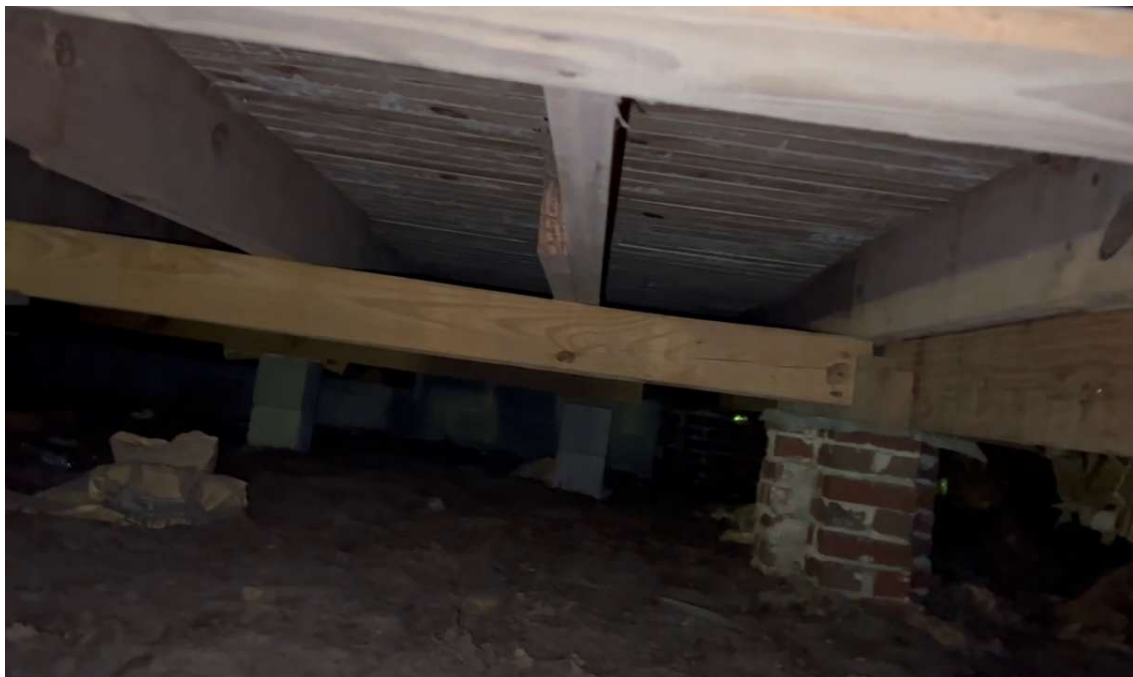
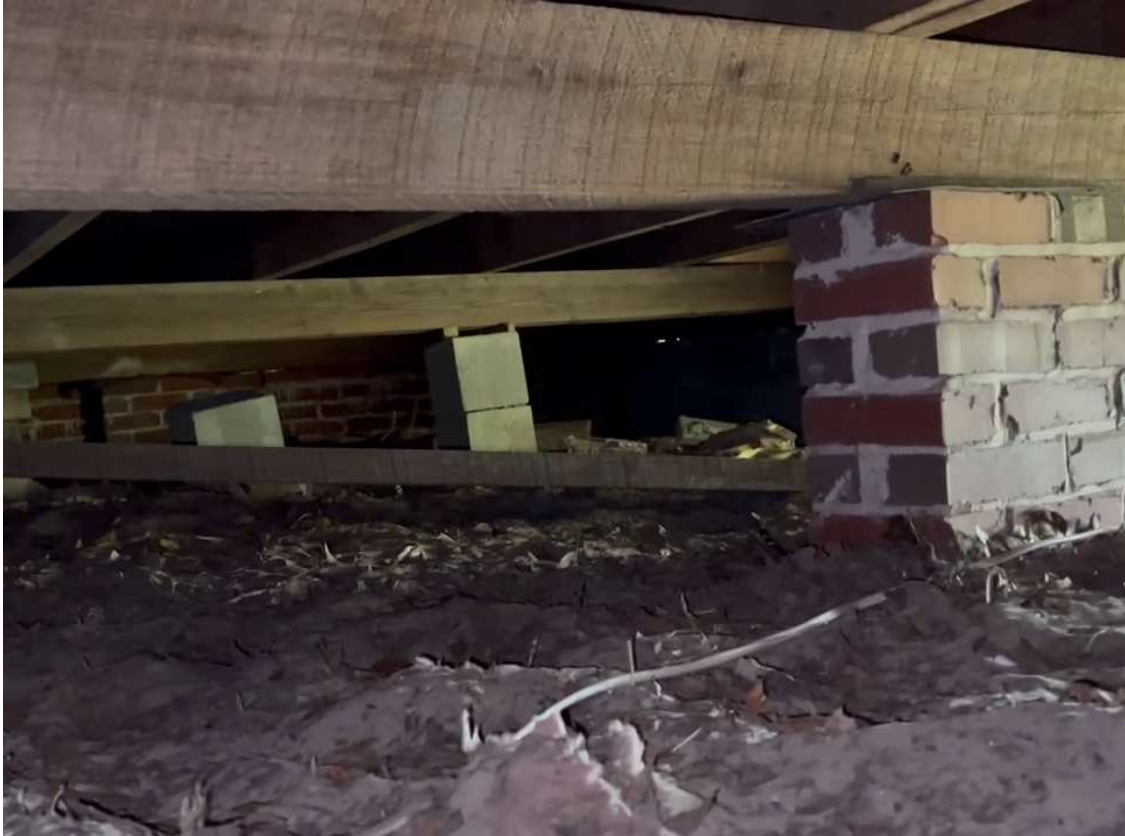
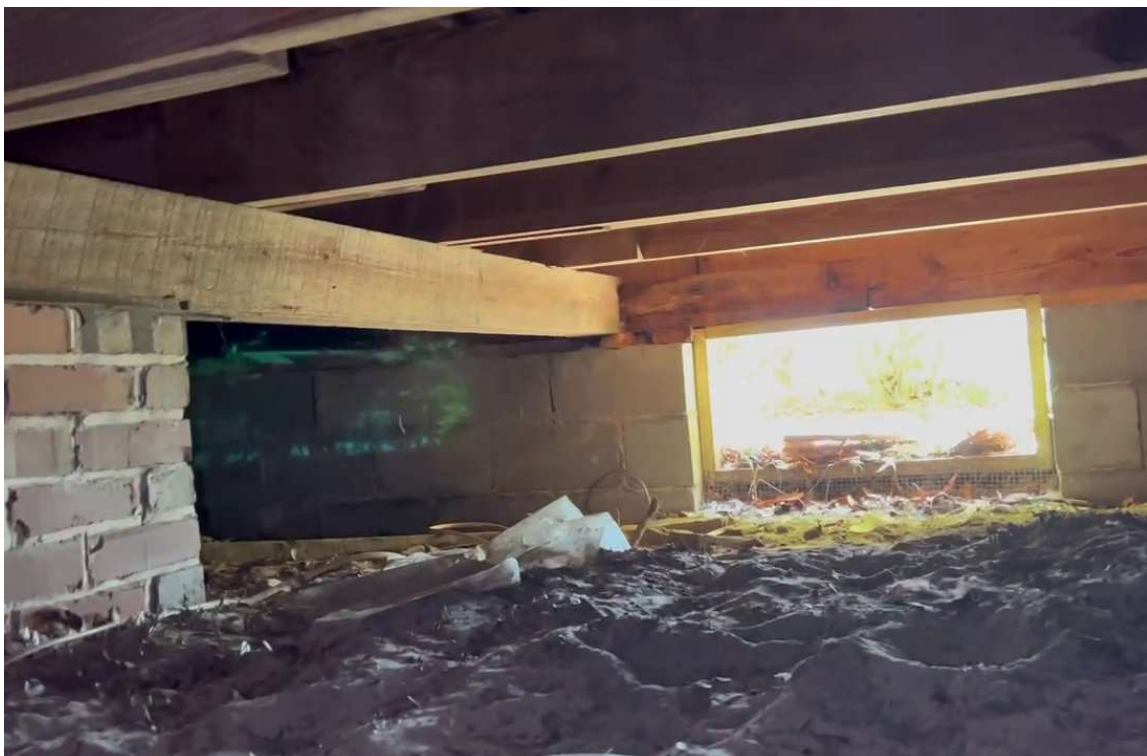
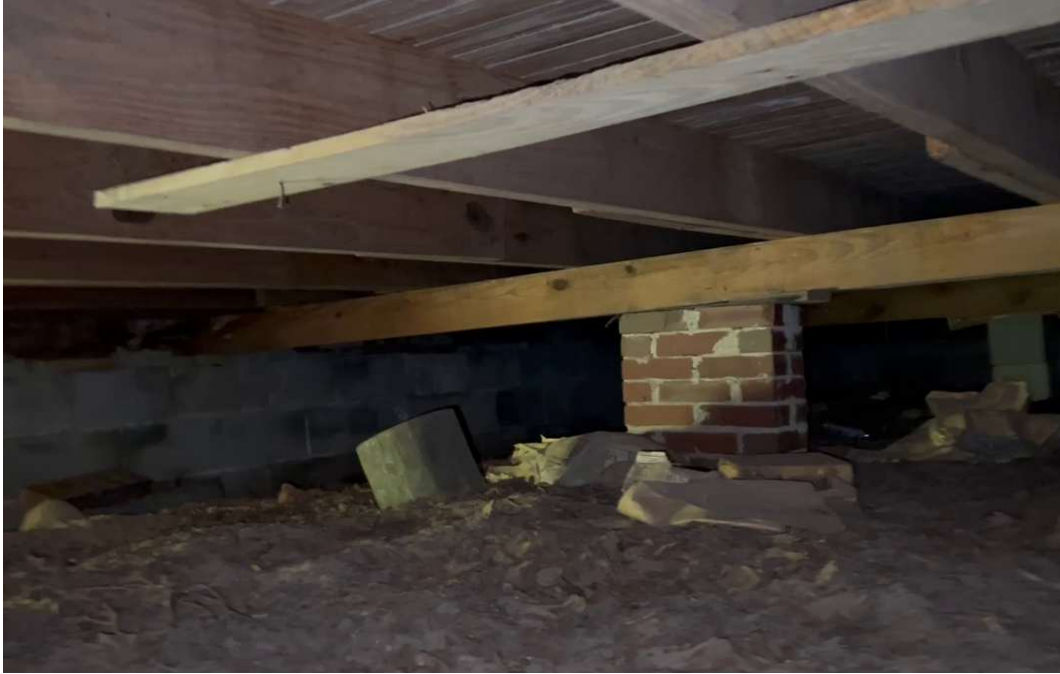
Figure 5: View of Existing Crawlspace Condition
