February 28, 2022

RE: 67 Boundary Street, Lot 1A Arborist Report

RE: 67 Boundary Street, Lot 1B Arborist Report

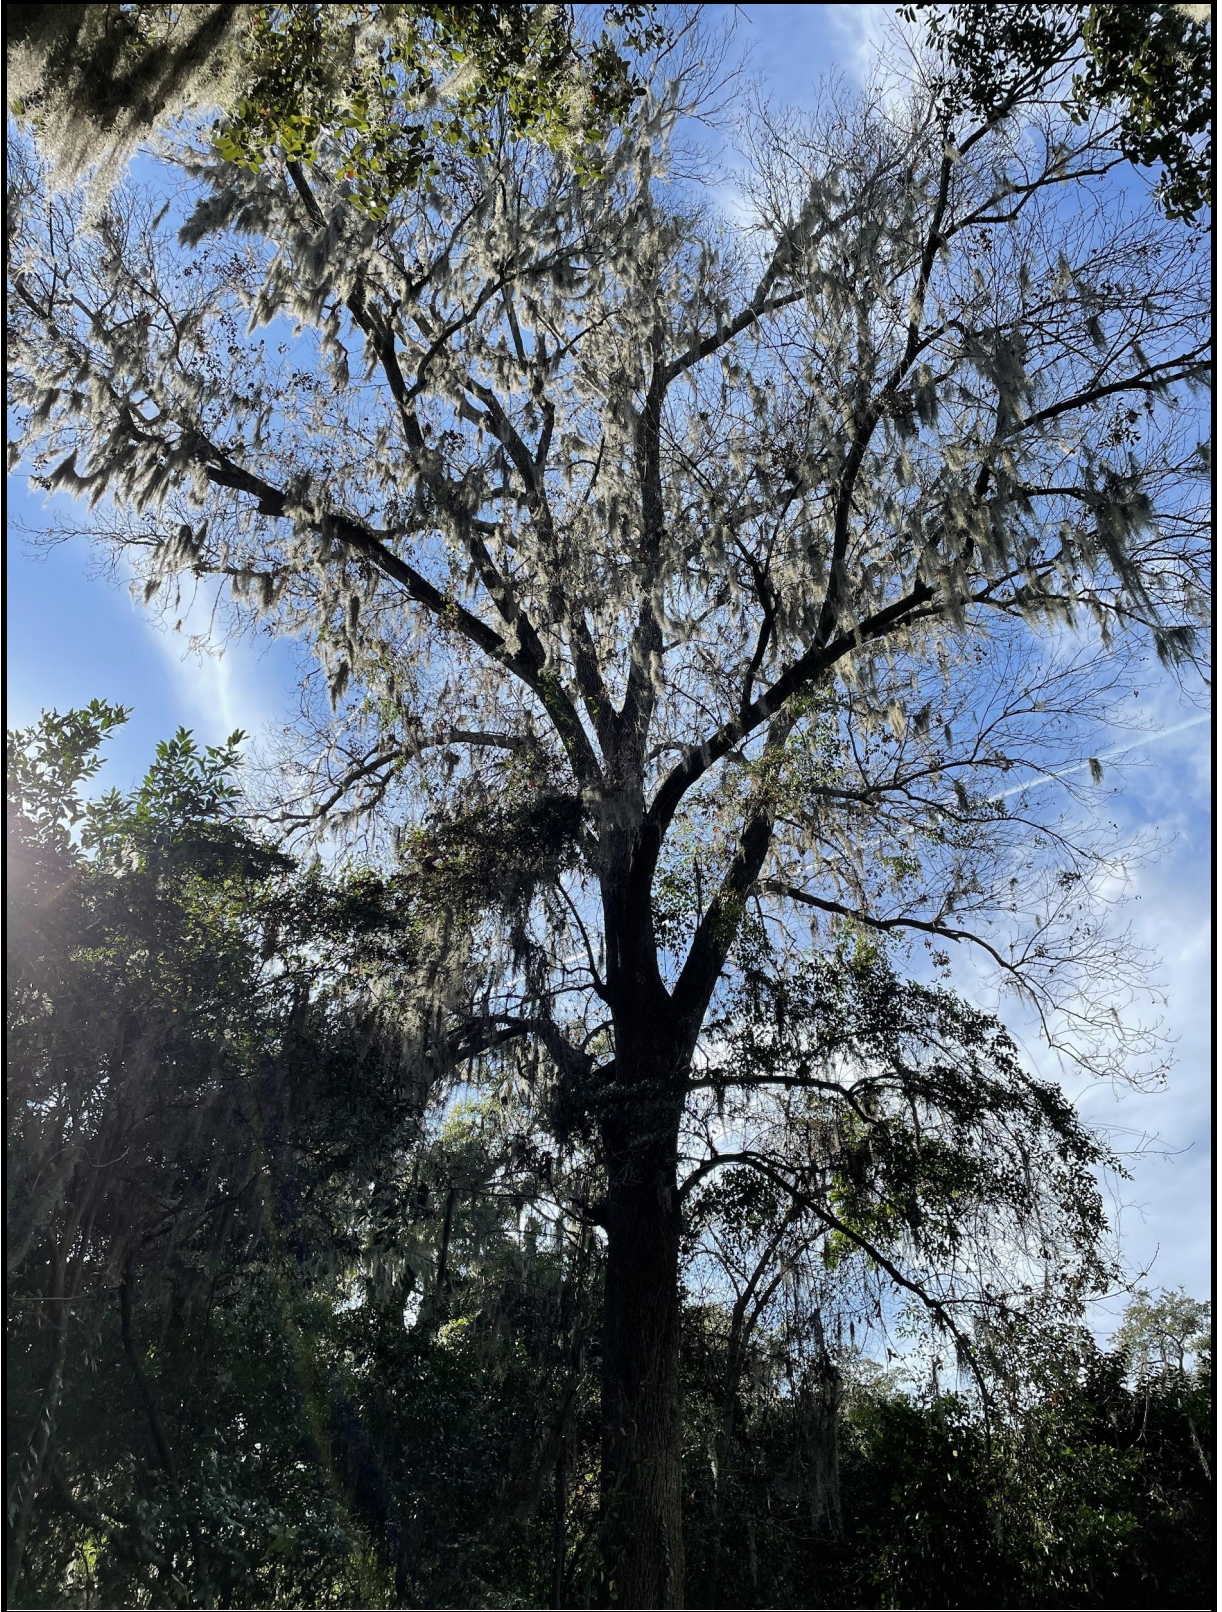
Photo 1

The Hickory (*Carya spp.*) measured 29.2-inches in diameter at breast height (dbh) and is located at the right of the unpaved road labeled "Hickory Trace" near the end of the property (Photo 1).

The tree trunk is structurally sound and did not appear to have any significant cavities or defects of concern. Additionally, the branching structure is normal for the species with no notable large dead limbs. The general health appeared to be good however the tree was observed during the leaf-off season and assessments of tree vitality during this time of the year are limited to observations of the tree structure and live observable buds.

Under the Town of Bluffton Unified Development Ordinance (UDO) this tree would be considered a significant tree due to its size and condition and is therefore protected under the code. This tree is marked as tree #1 on the site plan below. Due to its location on the lot, the building design can likely be adapted to preserve the tree.

Preservation guidelines should follow the UDO 5.3.3.D Parts 1 (Tree Protection Zone), 2 (Tree Protection Fencing), and part 3 (Damage during construction). Additionally, it is advisable that a thorough **Tree Preservation Plan** be developed by a qualified, Certified Arborist and implemented for this tree to best preserve it before and after construction.

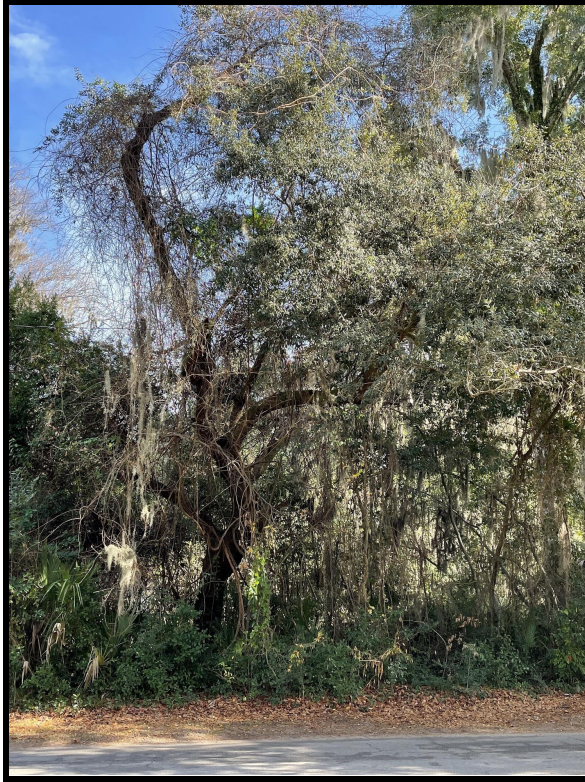
Photo 1

Tree #1 is a Live Oak measuring 26.2-inches in diameter at breast height (dbh) and is located near Boundary street. As shown in **photo 1**, the tree overhangs the power lines, is covered in vines, and is significantly leaning towards the road. It appears to be in poor condition. Structurally the tree seems to be sound at this time. This tree could be retained with proper pruning and removal of the vines however will likely never become a feature tree on the property due to its lean.

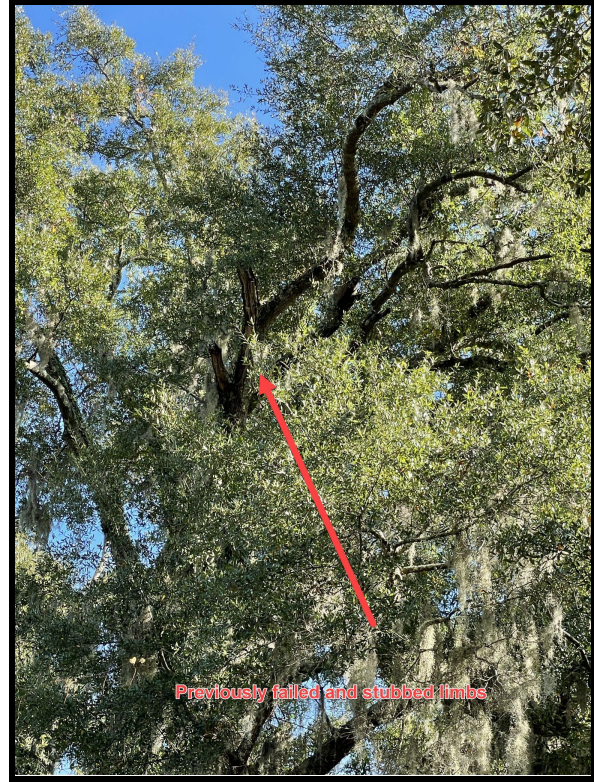
Photo 2

Tree # 2 is a 28.7 dbh Laurel Oak and is leaning significantly towards the road due to its proximity to the neighboring Laurel Oak. The tree appears to be healthy, and aside from some large limbs which are broken and stubbed (**Photo 2**) does not appear to have significant deadwood. The concern this may pose is when the adjacent potentially high-risk Laurel Oak is removed, this tree will be exposed to wind and rain that it is not acclimated to and become a possible moderate risk tree. Additionally, its location on the lot may limit the ability to develop it properly. The tree should be considered for mitigation rather than retention due to its uneven growth habit and potential for future failure.

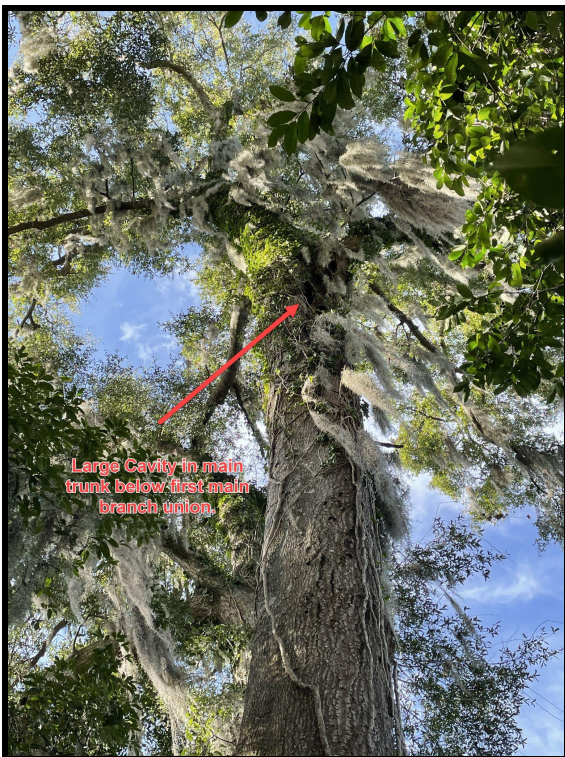
Photo 3

The third (**Tree #3**), Laurel Oak, measured 30.6 inches in diameter. While the upper canopy appears to be full and vigorous, a significant cavity was observed (**Photo 3**), causing this tree to be a high-risk tree if retained during construction. This tree should be considered for removal due to its potential high-risk nature.

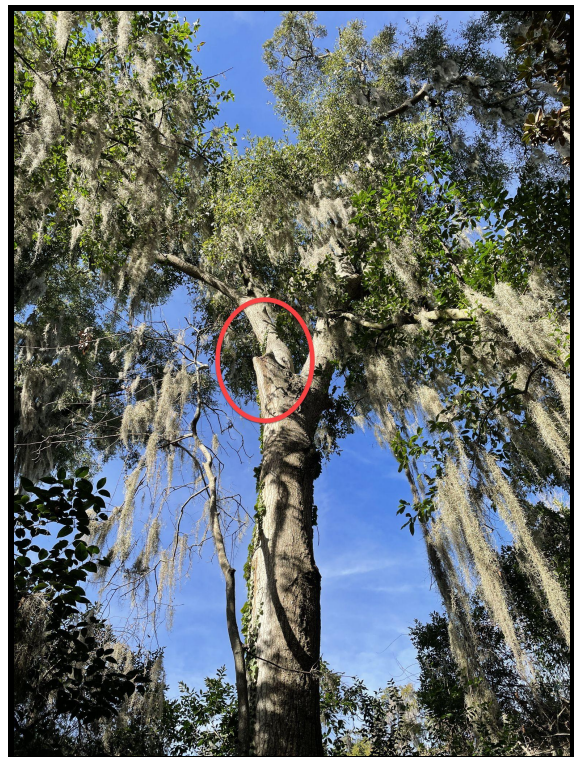
Photo 4

Tree #4 is a Laurel Oak located roughly in the center of the lot and measured 29.0 inches in diameter. The tree trunk appeared free from wounds or indications of internal decay. The tree seems to be healthy and has two major stems. Below the stems is an area where a large limb has been previously lost (**Photo 4**). Due to the height where the limb was lost, it is difficult to determine if this has resulted in internal decay of the main stem and should be inspected further with aerial equipment. If it is determined that the tree does not have internal, it would be a candidate for incorporation into the site plan and preservation.

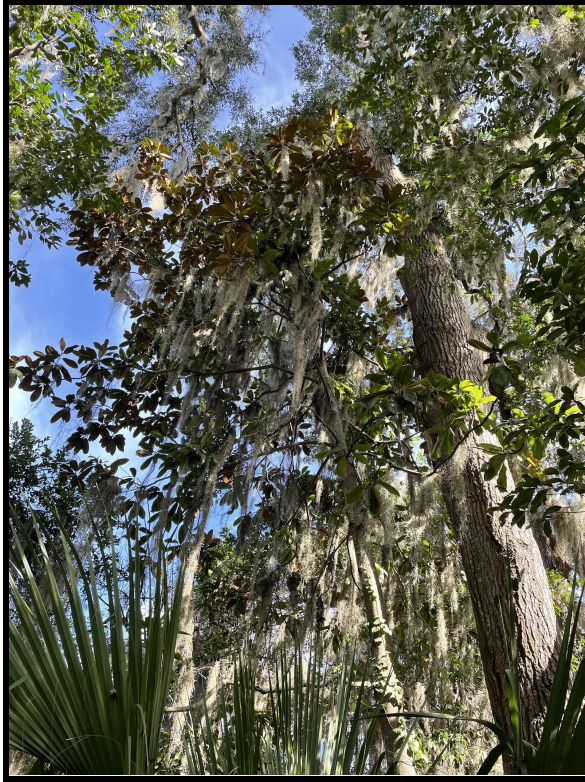
Photo 5

Tree #5 is a 6.6-inch diameter Magnolia tree growing at the base of the large 25.3-inch diameter Laurel Oak (Tree #6). The tree is slightly leaning due to its proximity to the Oak; however, it appears healthy and free from defects (**Photo 5**). However, this tree will likely need to be removed since the Laurel Oak has significant internal decay at the base and should be removed. Planning for mitigation of the loss of this tree should be accounted for.

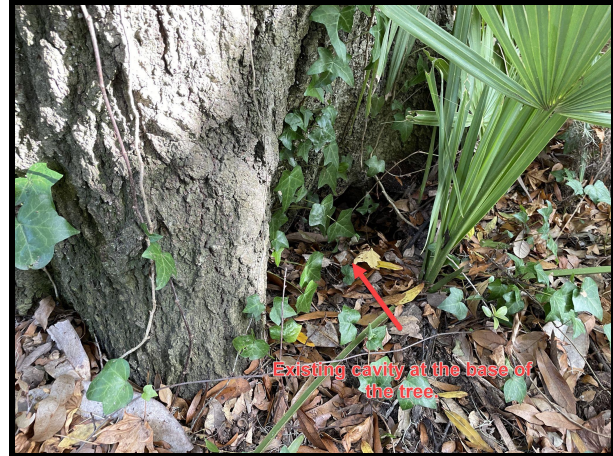
Photo 6

Tree #6 is healthy however is structurally compromised at the tree's base. The exposed cavity (**Photo 6**) indicates the lower tree trunk likely has significant internal decay and possibly root decay. It is recommended that this tree be removed rather than retained since it will likely become moderate to a high-risk tree if preserved.

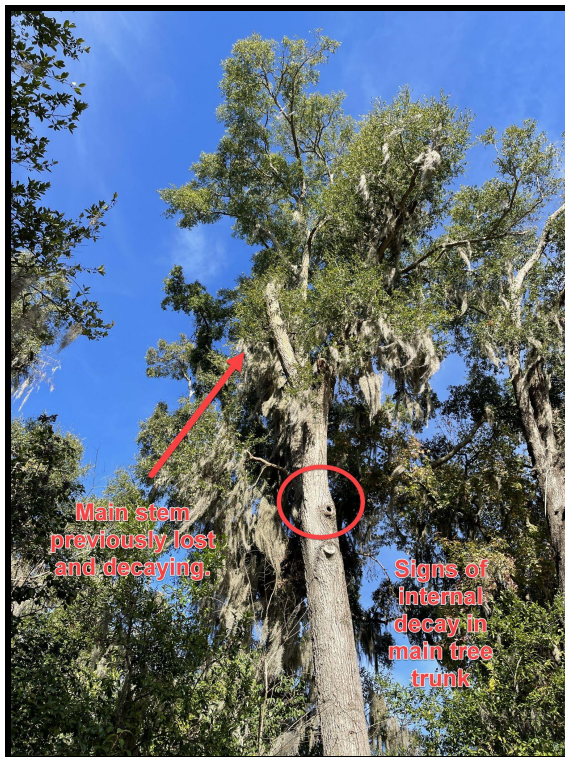
Photo 7

At the south side of the lot, 1B, are two large Laurel Oaks. The first is labeled **tree #7** on the site plan, measured 37.5-inches in diameter. At the time of inspection, this tree poses a moderate risk for failure. It has lost a large main stem and has areas of decay throughout the main trunk (**Photo 7**). Soundings of the trunk indicated the presence of internal decay on the backside of the tree facing away from the road.

The tree has a lean towards the existing home across the dirt road. It is recommended that this tree be removed before development.

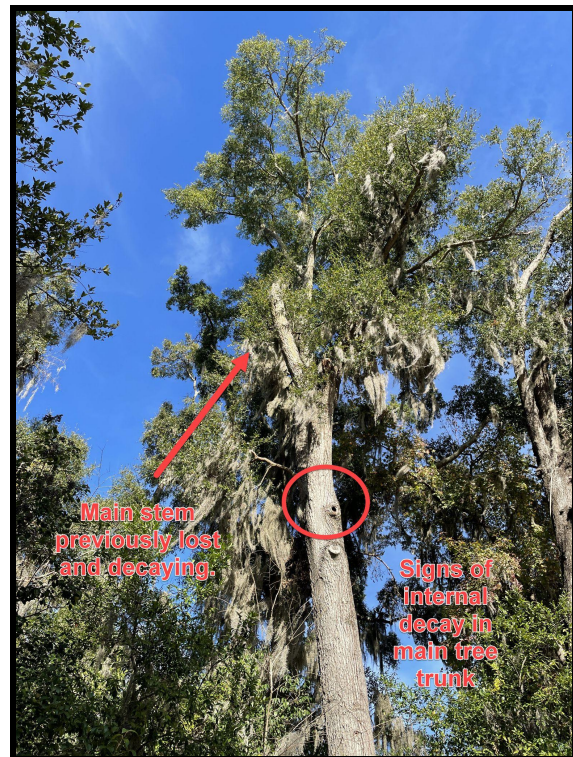
Photo 8

Tree #8 is a 28.3-inch diameter Laurel Oak. This tree is in fair health and has lost more than 50% of its overall canopy. Two large lower limbs appear to have broken off and are decaying (**Photo 8**). Additionally, this tree has a cavity at the base that an animal has used as a burrow at the tree's base (**Photo 9**). This tree currently poses a moderate risk of failure and should be considered for removal before development.
