November 21<sup>st</sup>, 2022,

# 2022 PAVEMENT CONDITION REPORT

Breezy Point, MN

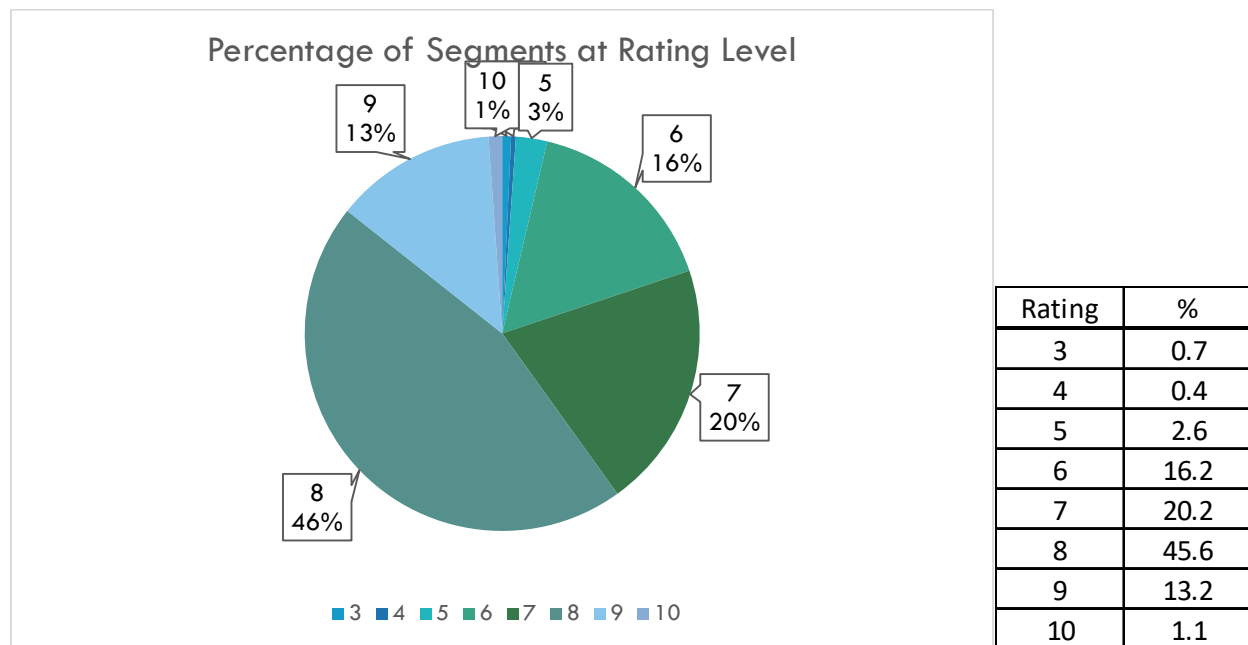
- Approximately 43 miles of paved City streets were evaluated in Breezy Point.
- The current weighted average Pavement Condition Index (PCI) for bituminous roads in Breezy Point is 7.4. PCI is based on a 0 to 10 scale, with higher PCI values corresponding to better road conditions. This weighted average is calculated from the PCI values generated on each segment of roadway. A road's PCI is based on the quantity and severity of pavement distresses identified in the field.

**Figure I.1.** Percent of System in Each Pavement Condition Category.
