Brisbane Mural Environmental Monitoring

3/18/25-10/15/25

Site & Studio Conservation
Samantha Emmanuel and Kiernan Graves

Scope of Work (6 month overview)

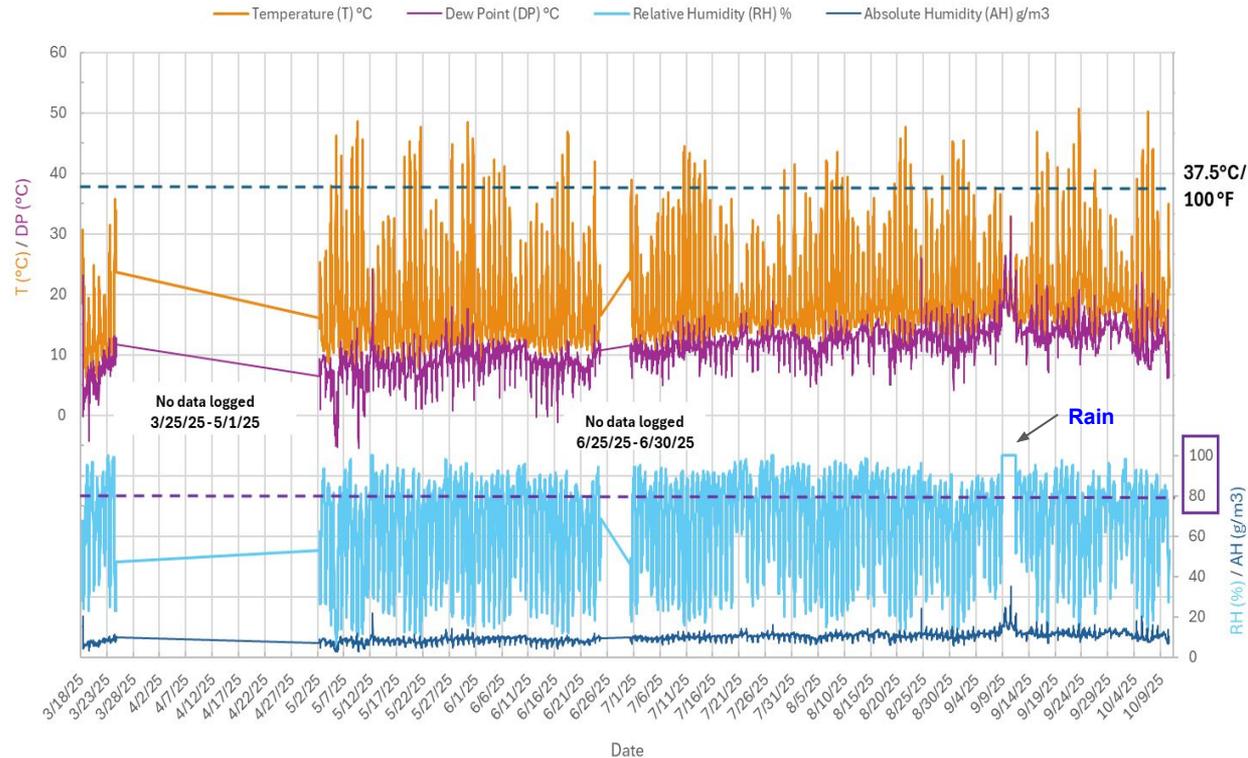
Brisbane EnvMon 3/18/25 - 10/10/25

Data from Environmental Monitor with sensor to measure: Ambient Temperature, Relative Humidity, Dew Point & Heat Index

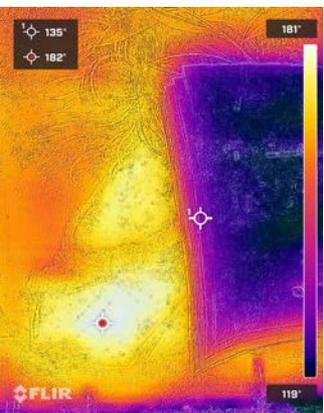
3/24/25 4:49pm;

Surface Temp High of 181°F
(Air Temp High of 96.4°F at
1:50pm)

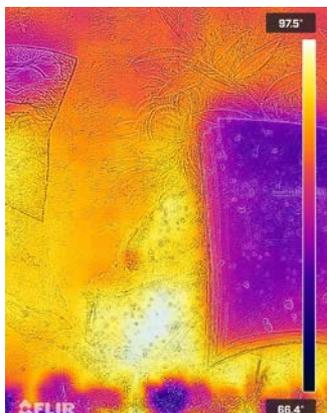
6/24/25 6:09pm

Surface Temp High of 97.5°F
(Air Temp High of 76.6°F at
2:10pm)

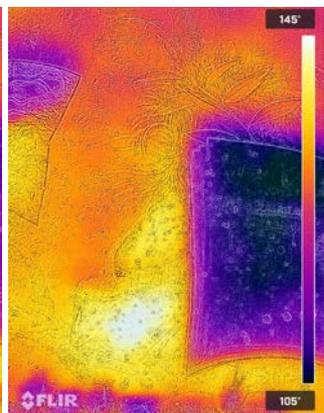
8/22/25 5:30pm

Surface Temp High of 145°F
(Air Temp High of 106.7°F at
3:30pm)

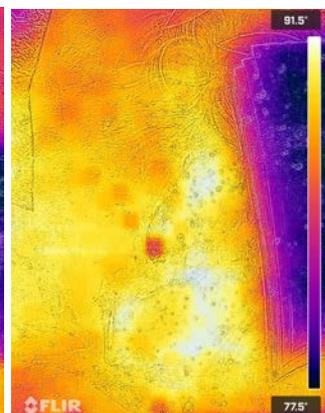
9/12/25 6:28pm

Surface Temp High of 91.5°F
(Air Temp High of 78.1°F at
2:40pm)
(Mural completely in shade at
time of imaging)

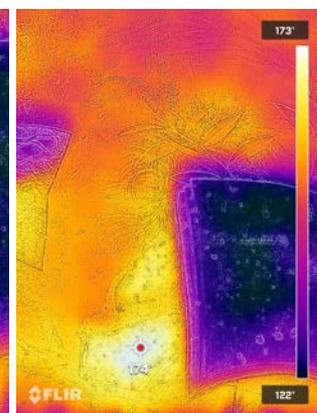
9/23/25 4:47pm

Surface Temp High of
173°F
(Air Temp High of 123.3°F
at 1:30pm)

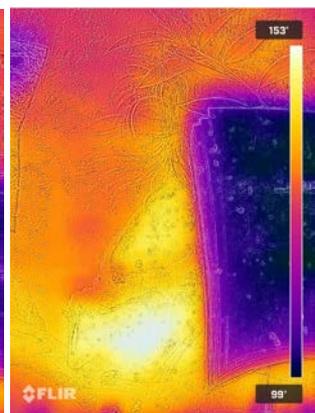
10/10/25 4:08pm

Surface Temp High of
153°F
(Air Temp High of 90.7°F
at 12:40pm)

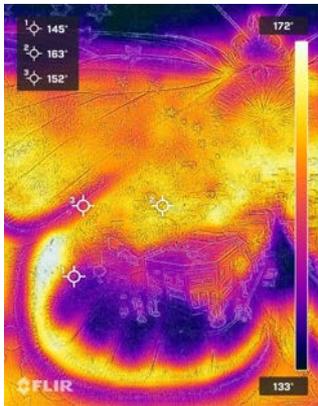
3/24/25 4:51pm

Surface Temp High 172°F
(Air Temp High of 96.4°F at 1:50pm)

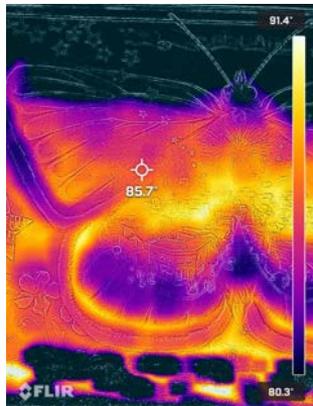
6/24/25 6:04pm

Surface Temp High 91.4°F
(Air Temp High of 76.6°F at 2:10pm)

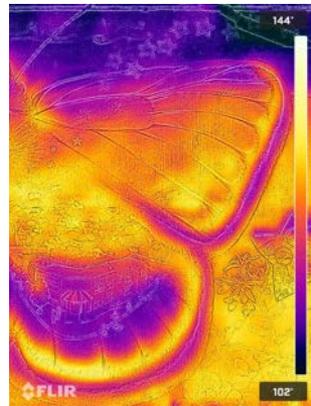
8/22/25 5:26pm

Surface Temp High 144°F
(Air Temp High of 106.7°F at 3:30pm)

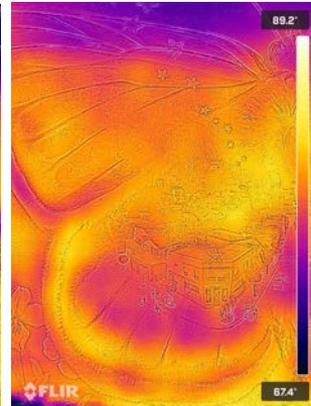
9/12/25 6:29pm

Surface Temp High 89.2°F
(Air Temp High of 78.1°F at 2:40pm)

(Mural completely in shade at time of imaging)

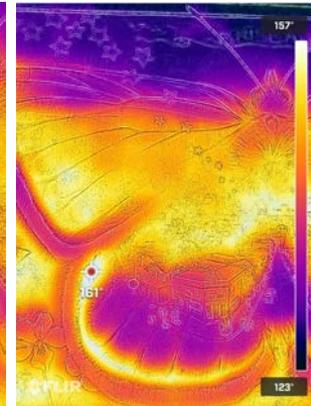
9/23/25 4:47pm

Surface Temp High of 157°F
(Air Temp High of 123.3°F at 1:30pm)

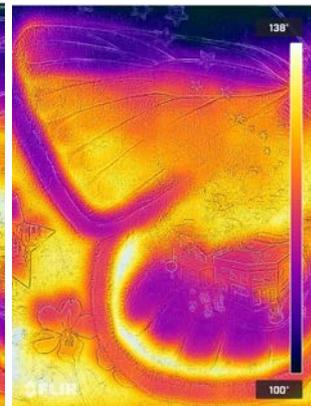
10/10/25 4:07pm

Surface Temp High of 143°F
(Air Temp High of 90.7°F at 12:40pm)

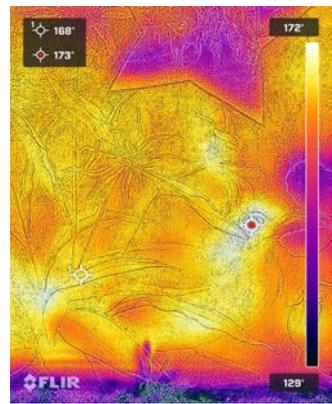
3/24/25 4:50pm

Surface Temp High 172°F
(Air Temp High of 96.4°F
at 1:50pm)

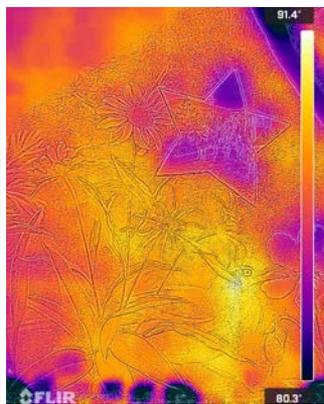
6/24/25 6:09pm

Surface Temp High 91.4°F
(Air Temp High of 76.6°F at
2:10pm)

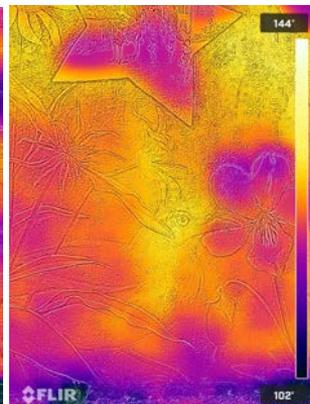
8/22/25 5:30pm

Surface Temp High 144°F
(Air Temp High of 106.7°F
at 3:30pm)

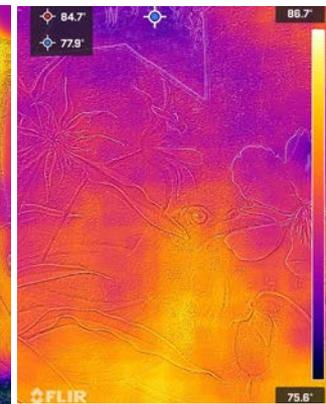
9/12/25 6:30 pm

Surface Temp High 86.7°F
(Air Temp High of 78.1°F at
2:40pm)

(Mural completely in shade at
time of imaging)

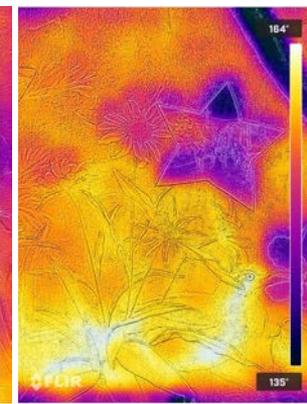
9/23/25 4:44pm

Surface Temp High of 164°F
(Air Temp High of 123.3°F at
1:30pm)

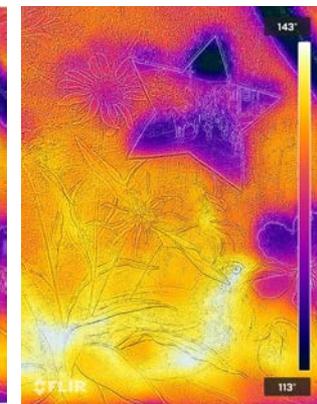
10/10/25 4:07pm

Surface Temp High of
143°F
(Air Temp High of 90.7°F at
12:40pm)

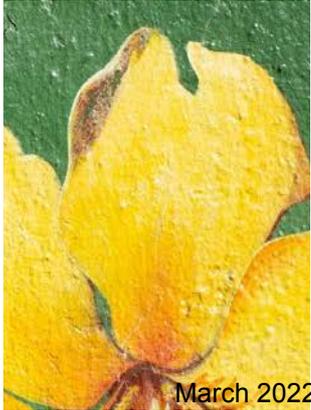
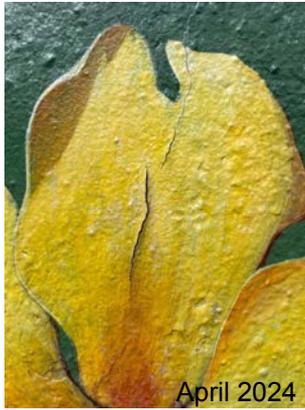
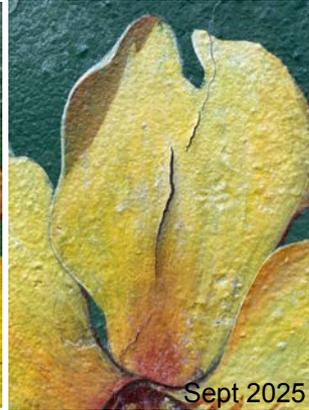
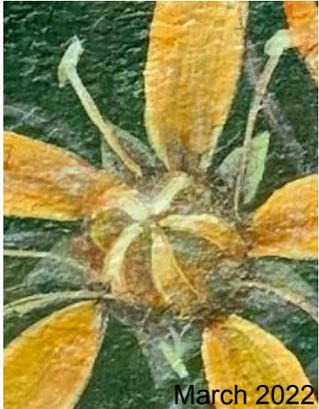
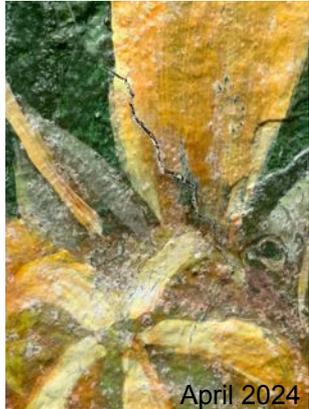
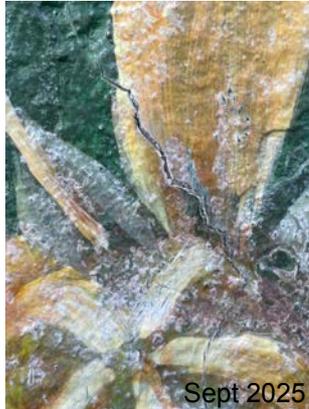
Other Condition Issues 2024-2025

Few examples of flaking paint lifting away from the substrate

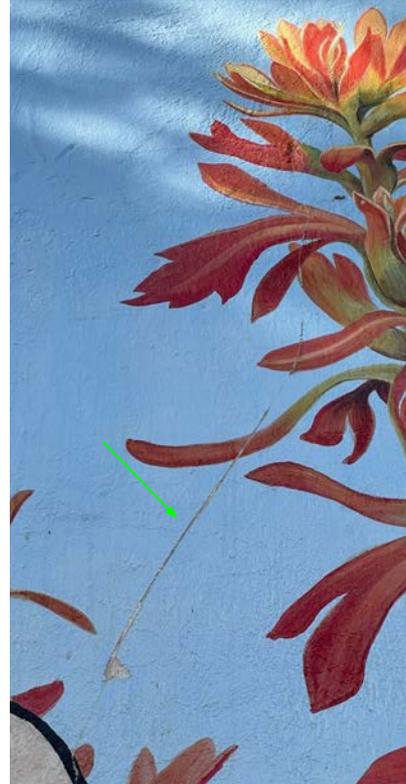
Large gash in paint layer noted in August 2025

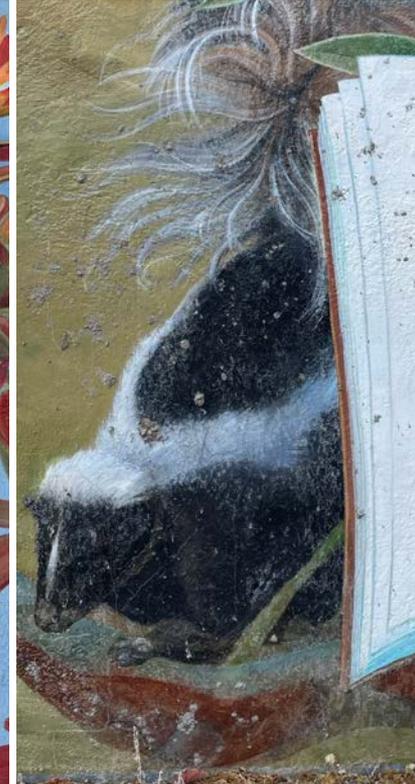
Splashes of sandy dirt/mud (cement?) on surface.
