GEOTECHNICAL INVESTIGATION

*Proposed Addition to Residence
338 Kings Road
Brisbane, California*

February 27, 2018

February 27, 2018
Job No. 18-4751

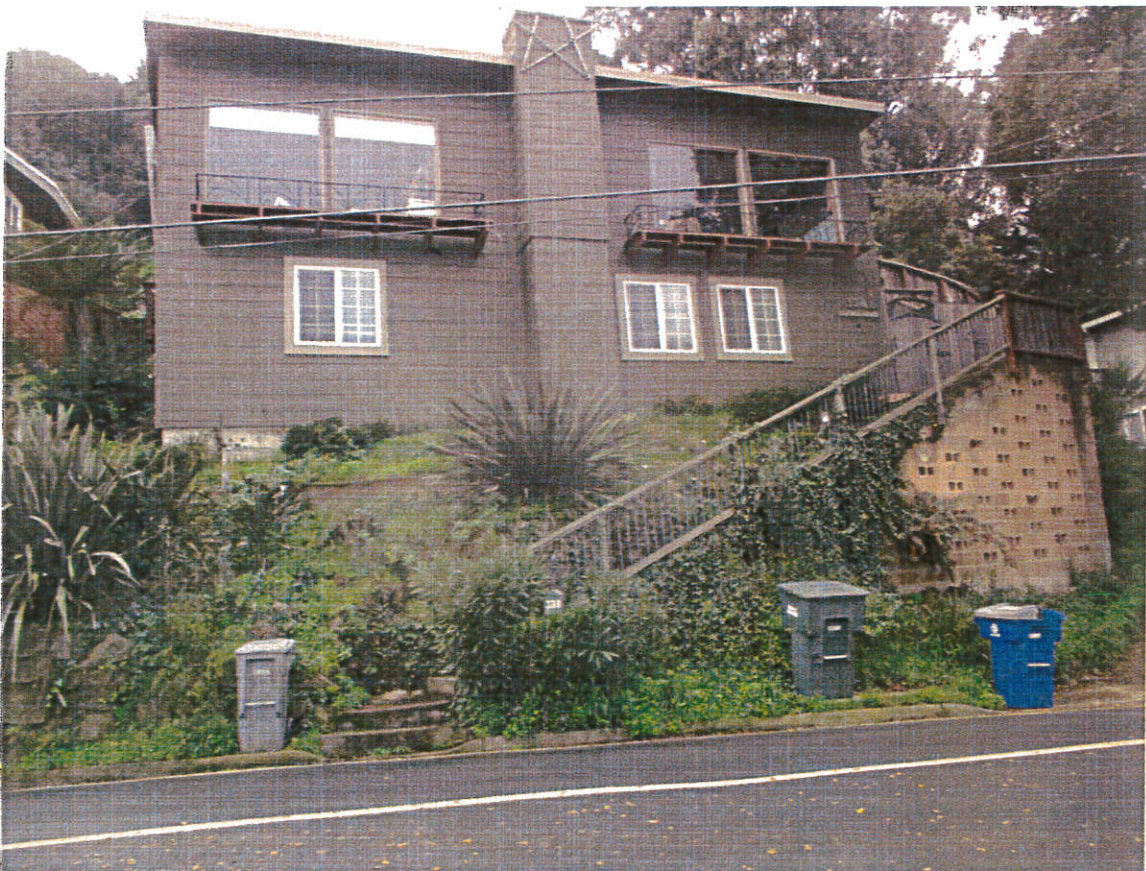
Photo 1: View of the front of the residence from Kings Road. The garage addition is planned on the right side of the residence (on the right side of the photo).

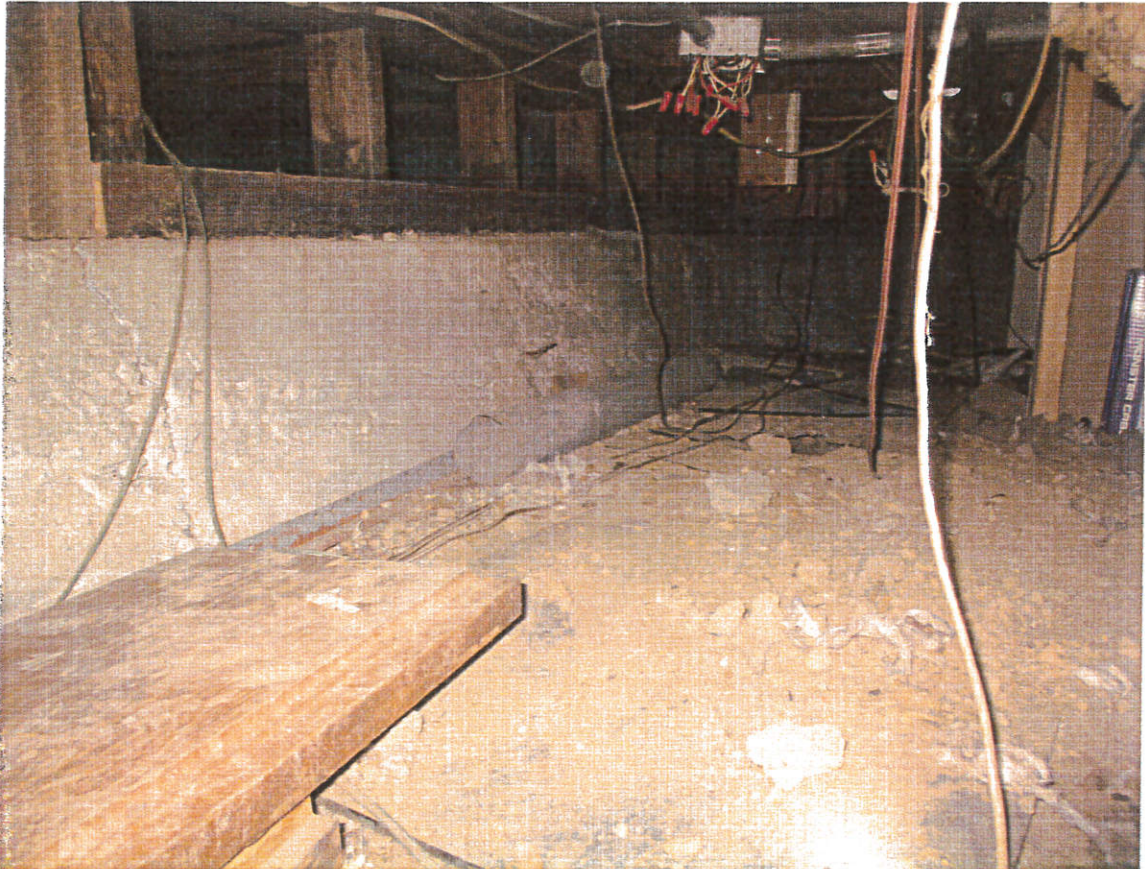
In order to help evaluate the performance of the existing foundation and the compatibility with a new foundation, we conducted a relative floor elevation survey on the floors of the main entry level using a water-filled manometer. The results of the survey, which are included on the attached Figure 7, indicate that the existing residence is on the order of 4.0 inches out-of-level. This suggests that greater than normal foundation settlement has occurred.

We also inspected the accessible portions of the foundation crawl space as part of our study. In general, the foundation appeared to be in serviceable condition from a geotechnical viewpoint. We did observe a 1/16 to ¼ inch wide diagonal crack in a continuous interior footing that extended just upslope of the lower level of the residence, but for the most part the foundation looked good. The crack is visible from the crawl space entry just beyond the hot water heater and the furnace and the associated small diameter copper piping. Our observations suggest that the continuous interior footing where the crack was observed may have been the original front footing for the house before an addition was done along the front of the residence after the original construction was completed. The crack in the foundation is visible in the following photo.

Photo 2: View within the foundation crawl space. Note the diagonal crack in the continuous interior footing near the left side of the photo.

Based upon our study, it is our opinion that the project can be developed as planned, provided that the recommendations contained within this report are followed. The primary geotechnical consideration will involve embedding the new addition foundation into the dense sandstone bedrock that was encountered in our test borings. Since the existing foundation has been affected by excessive settlement, portions (or all of the residence) should be underpinned or replaced and also supported in bedrock.

In our opinion, underpinning the settled portions of the existing residence is feasible from a geotechnical viewpoint. The underpinning should consist of either drilled or hand excavated reinforced concrete piers that are designed to resist both vertical as well as lateral loading (that could be imposed by creeping soil). The structural engineer should utilize the relative floor elevation surveys that we provided as well as their own observations of the foundation elements to determine underpinning locations.
