# Bristol Historic District Commission

## Application for Review of Proposed Work - Printable Application

| We would like to demo the existing house and garage and build something new that meets Flood and Velocity codes. |

125 HOPE STREET, BRISTOL, RHODE ISLAND  
STRUCTURAL INSPECTION, JANUARY 16, 2025

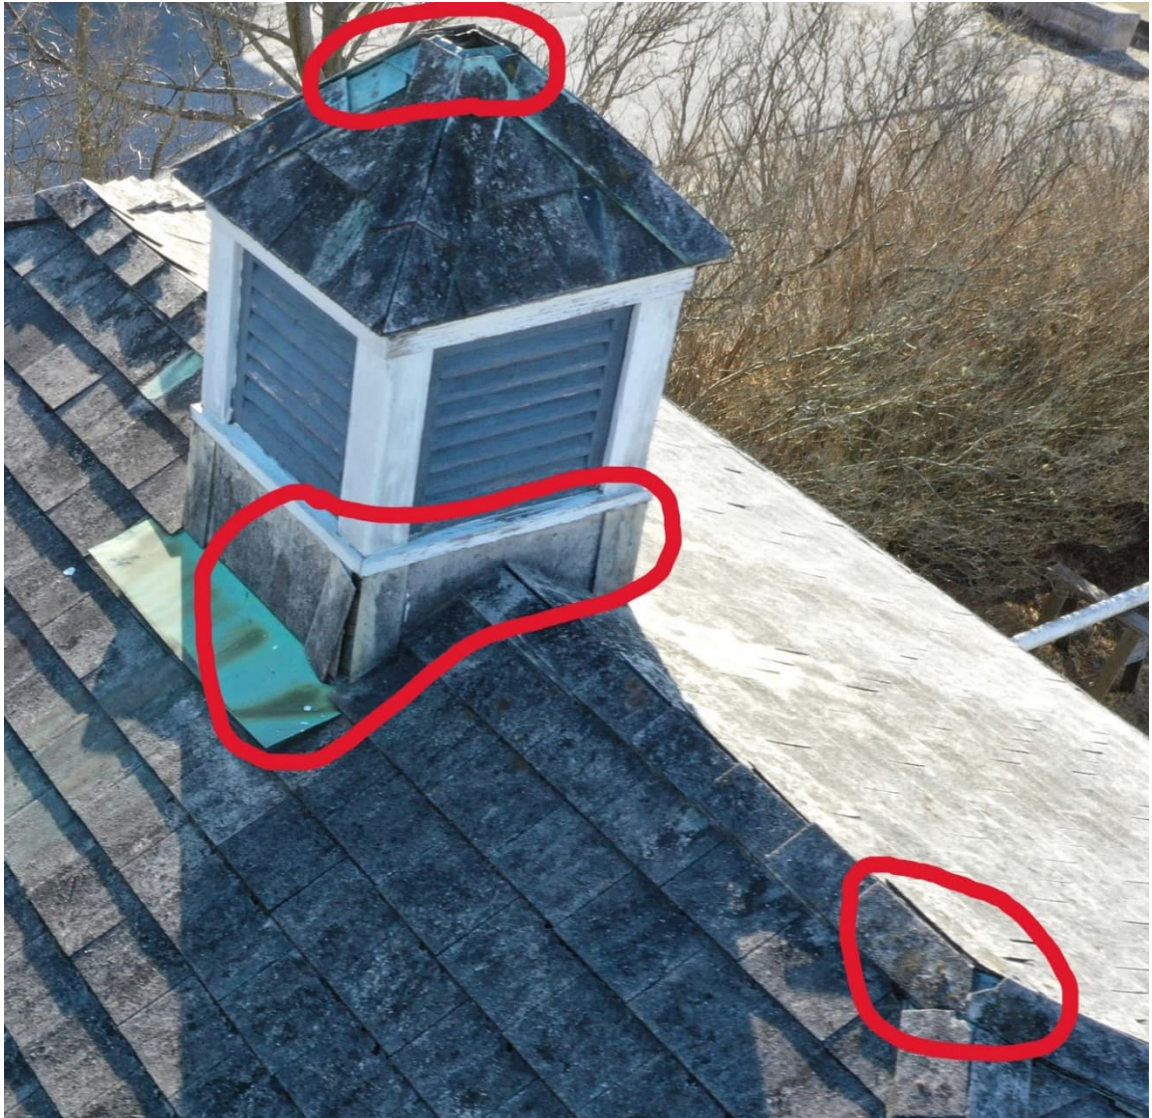
1. Openings in east addition roof.
  - o Comments and recommendations: The east addition roof has gaps and/or missing components which may allow weather to infiltrate the building envelope which may cause deterioration to the structural system and/or interior finishes. It is recommended that the deficiencies be repaired by a qualified contractor to ensure weather-tightness of the building envelope and structural integrity of the building.

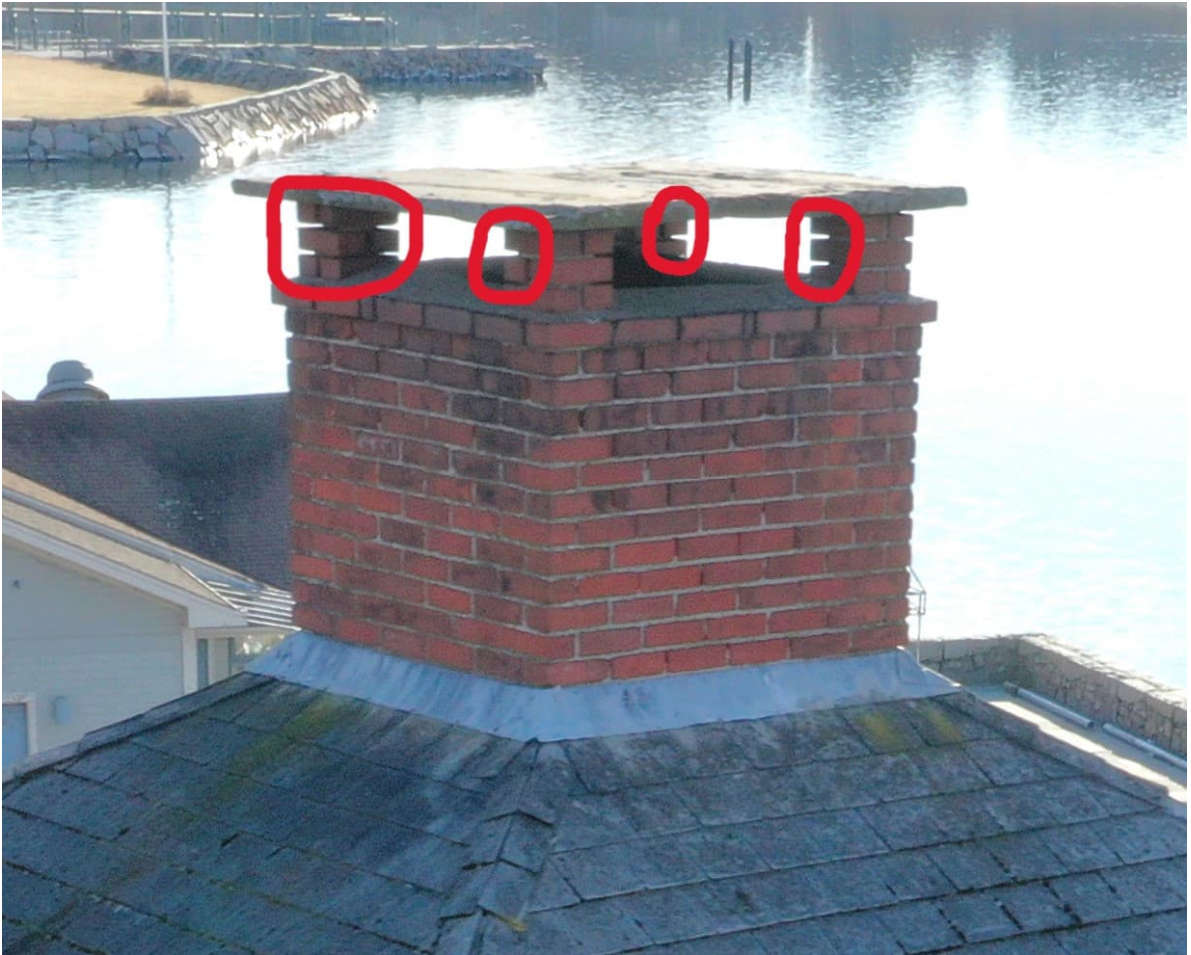
5. Mortar gaps at house chimney.
  - o Comments and recommendations: The mortar joints of the brick columns which support the house chimney cap have significant deterioration. If the brick columns were to fail, the chimney cap could fall and possibly damage property or injure people. It is recommended that the mortar joints be repaired by a qualified mason.

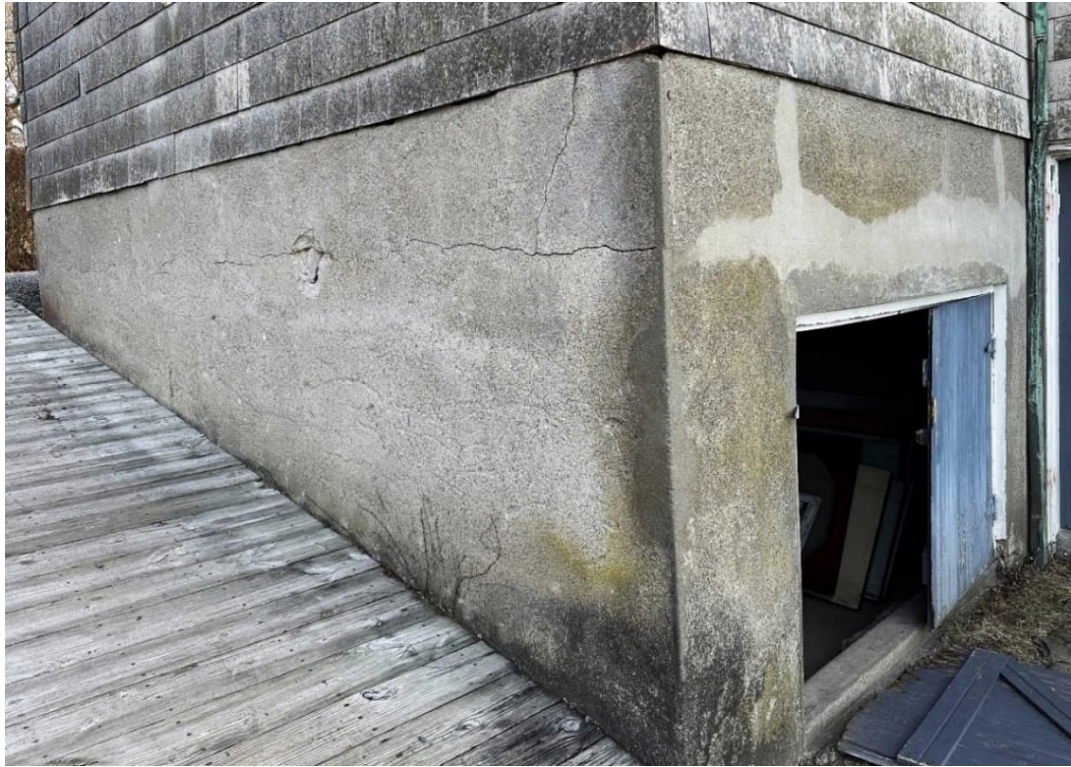
8. Foundation wall cracks with exposed rusting reinforcement.
- o Comments and recommendations: The foundation walls below the northwest corner of the house bump-out (former garage, current laundry room) has large horizontal cracks and exposed rusting reinforcement. There also appears to have been previous repairs performed at the wall corner and over the crawlspace doorway opening. The cracks may be due to lateral forces, settlement, and/or building expansion/contraction from changes in temperature and humidity. The cracks may allow weather to infiltrate the wall and cause further damage. The exposed rusting reinforcement will expand and cause further cracking of the wall, thus, exposing more reinforcement and continuing the cycle. It is recommended that the cracks and exposed rusting reinforcement be repaired by qualified personnel using high-performance repair materials.

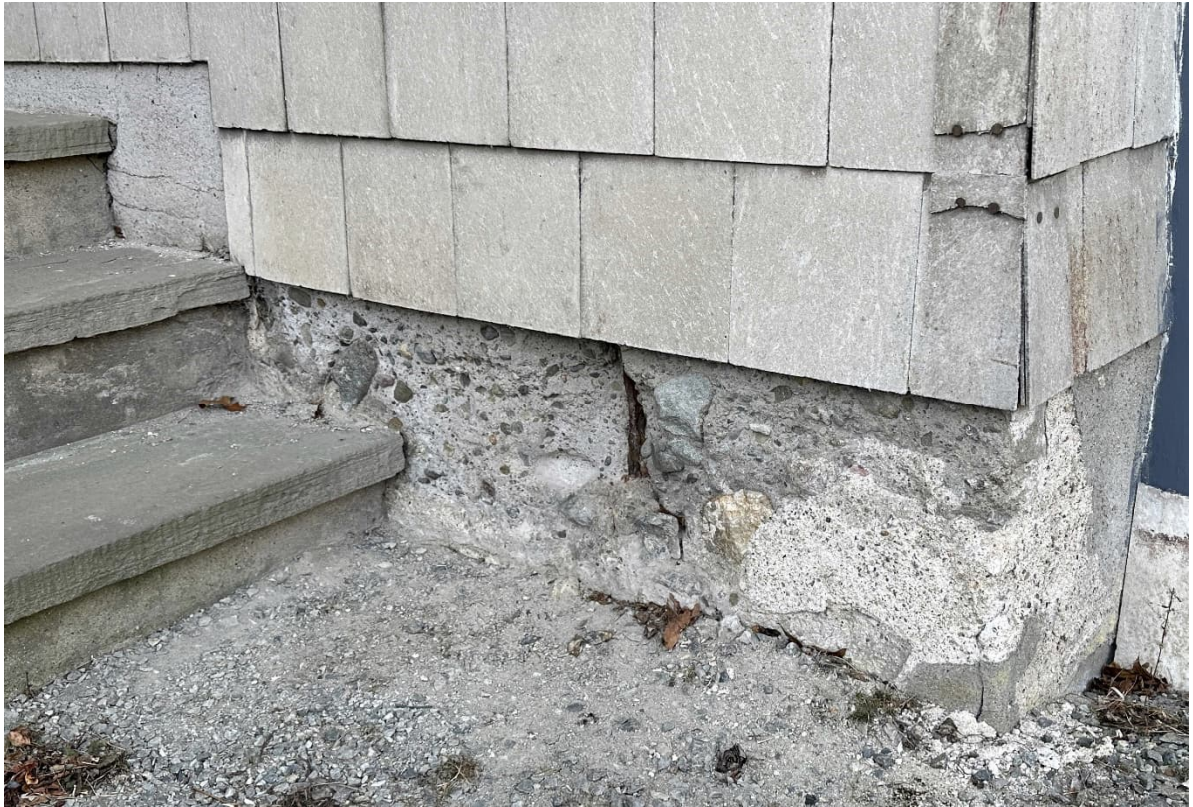
10. Spalled foundation wall, exposed rusting reinforcement.

- o Comments and recommendations: The foundation wall adjacent to the main entrance stairs has large areas of spalling, some cracks and exposed rusting reinforcement. The spalling may be due to previous cracks that allowed weather to infiltrate the wall causing expansion of the concrete. The current cracks may allow weather to infiltrate the wall and cause further damage. The exposed rusting reinforcement will expand and cause further cracking of the wall, thus, exposing more reinforcement and continuing the cycle. It is recommended that the cracks and exposed rusting reinforcement be repaired by qualified personnel using high-performance repair materials.

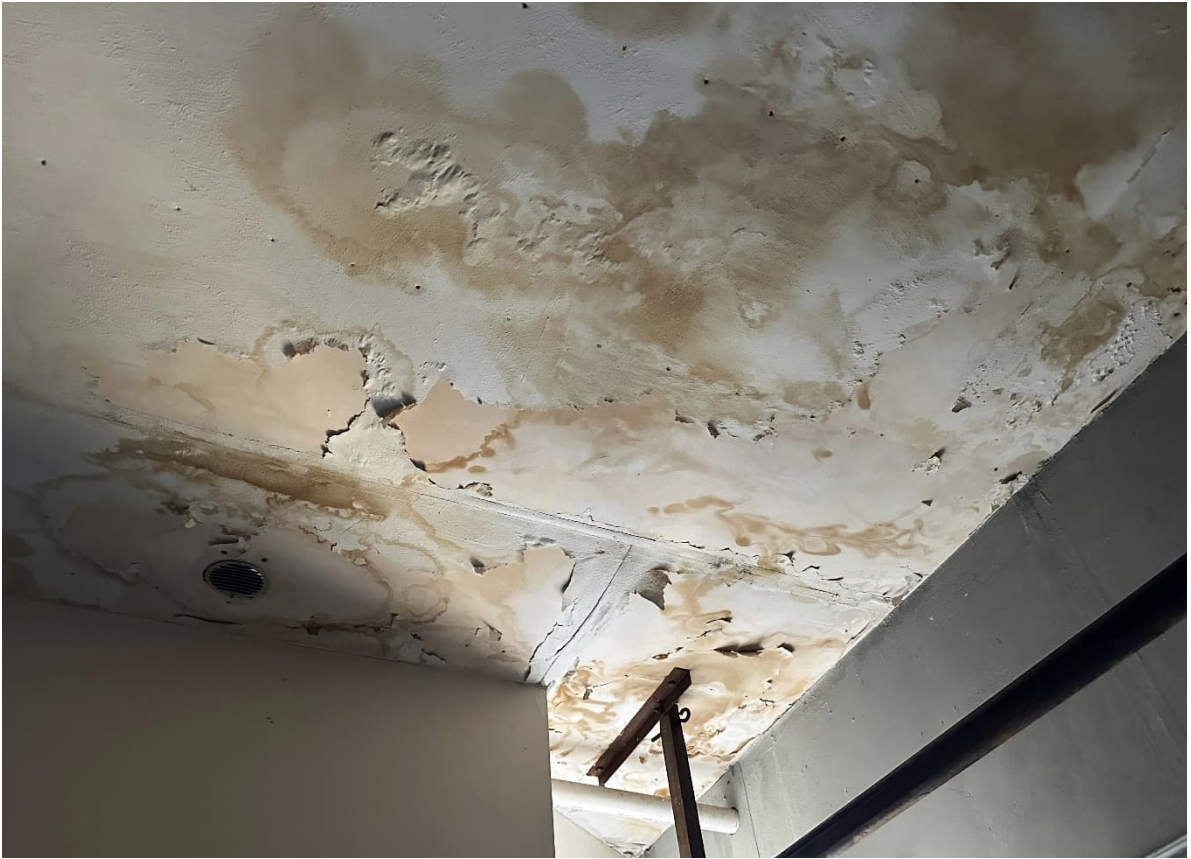
17. Staining on laundry room ceiling.

- o Comments and recommendations: There are stains on the laundry room ceiling which indicate the infiltration of water. Prolonged water infiltration may cause deterioration to the roof elements, structural system, and interior finishes. Further investigation is required to determine the cause of the water infiltration and if there is damage to the structure.

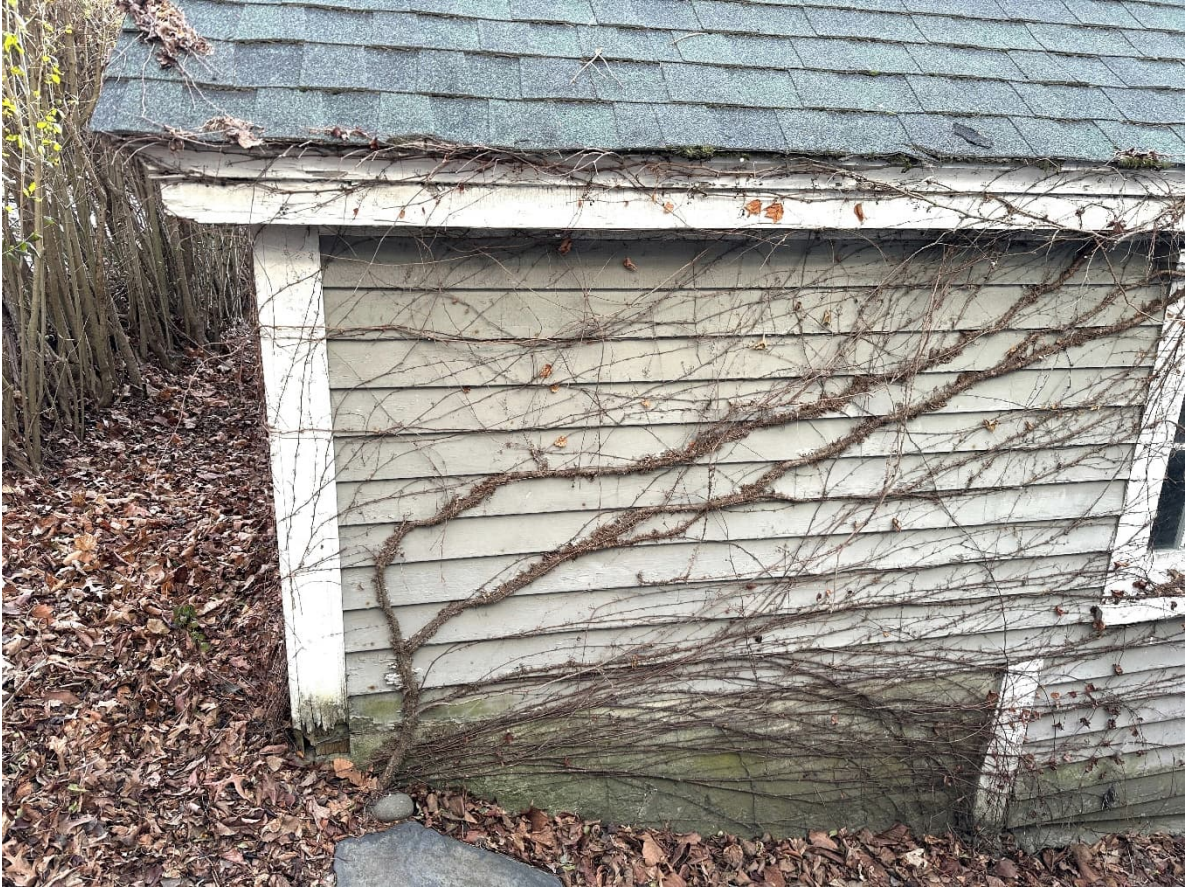
19. Deterioration and vegetation at shed exterior.

- o Comments and recommendations: Deterioration of the exterior wood and attached vegetation on the shed was observed at various locations. It is recommended that the deteriorated parts be replaced in-kind and the vegetation be removed as it can create openings in the building envelope which may allow water and air infiltration that could cause damage to the structure and/or exterior of the shed.

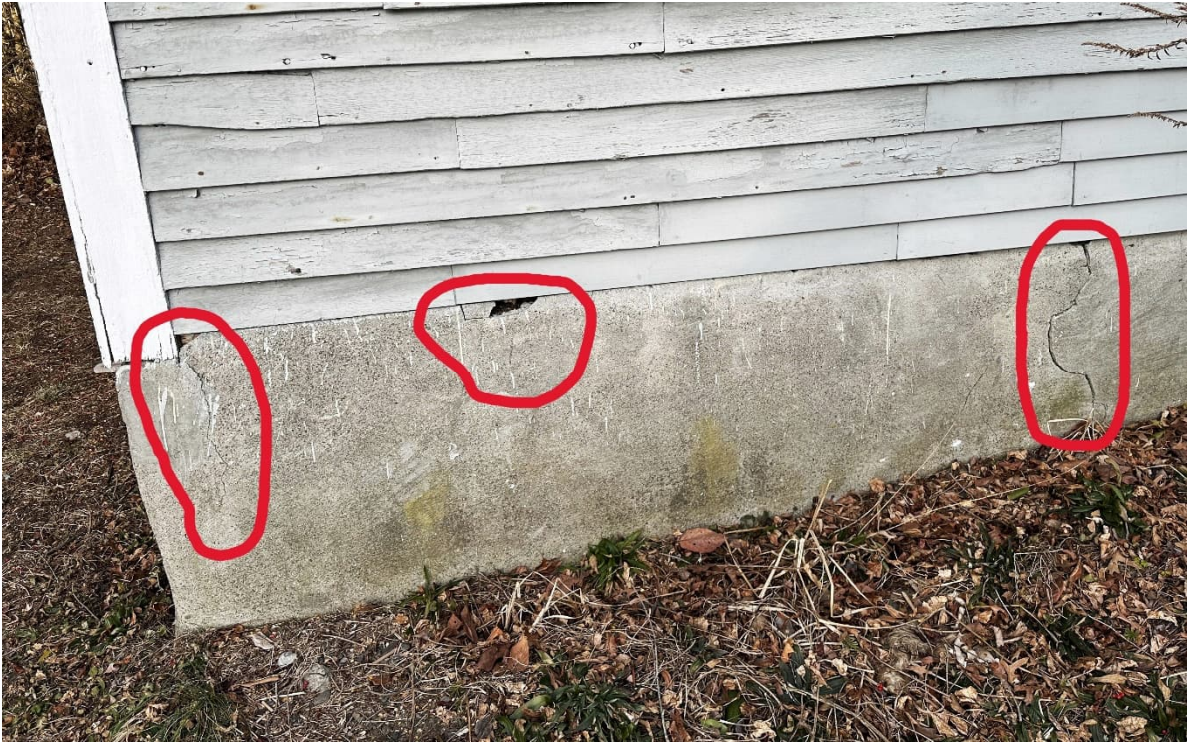
20. Shed foundation wall cracks.

- o Comments and recommendations: The shed foundation wall has cracks at various locations. The cracks may be due to lateral forces, settlement, and/or building expansion/contraction from changes in temperature and humidity. The cracks may allow weather to infiltrate the wall and cause further damage. It is recommended that the cracks be repaired by qualified personnel using high-performance repair materials.

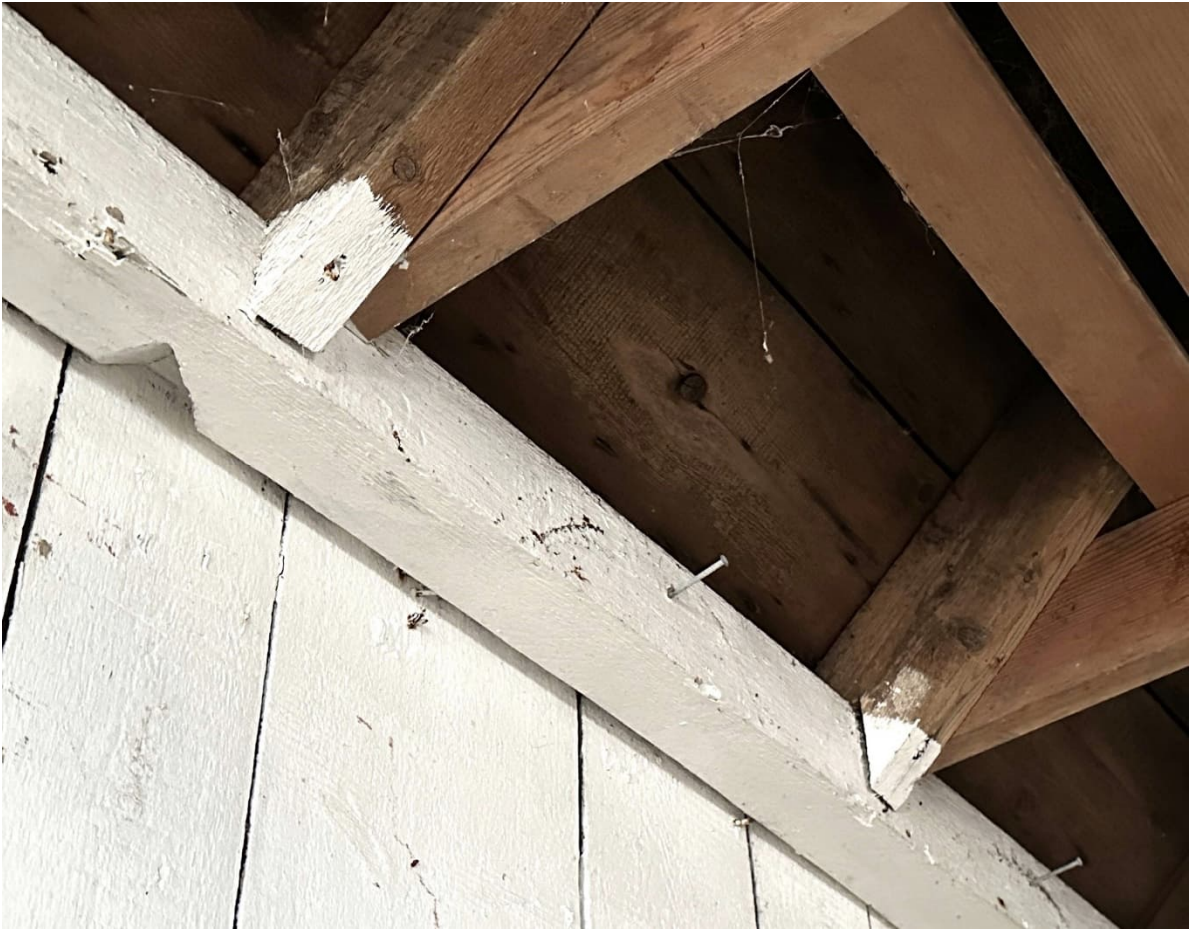
21. Shed roof framing connections potentially insufficient for uplift.

- o Comments and recommendations: The shed roof framing appears to be connected to the perimeter beam by a single nail which is potentially insufficient to resist design wind uplift forces. It is recommended that joist hurricane straps be installed to connect the joist to the perimeter beam.
