Application for Review of Proposed Work - Printable Application

HDC-25-12	Contributing	February 11, 2025
-----------	--------------	-------------------

Project Address	Assessor's Plat	Assessor's Lot
125 Hope Street	16	51

125 HOPE STREET, BRISTOL, RHODE ISLAND
STRUCTURAL INSPECTION, JANUARY 16, 2025

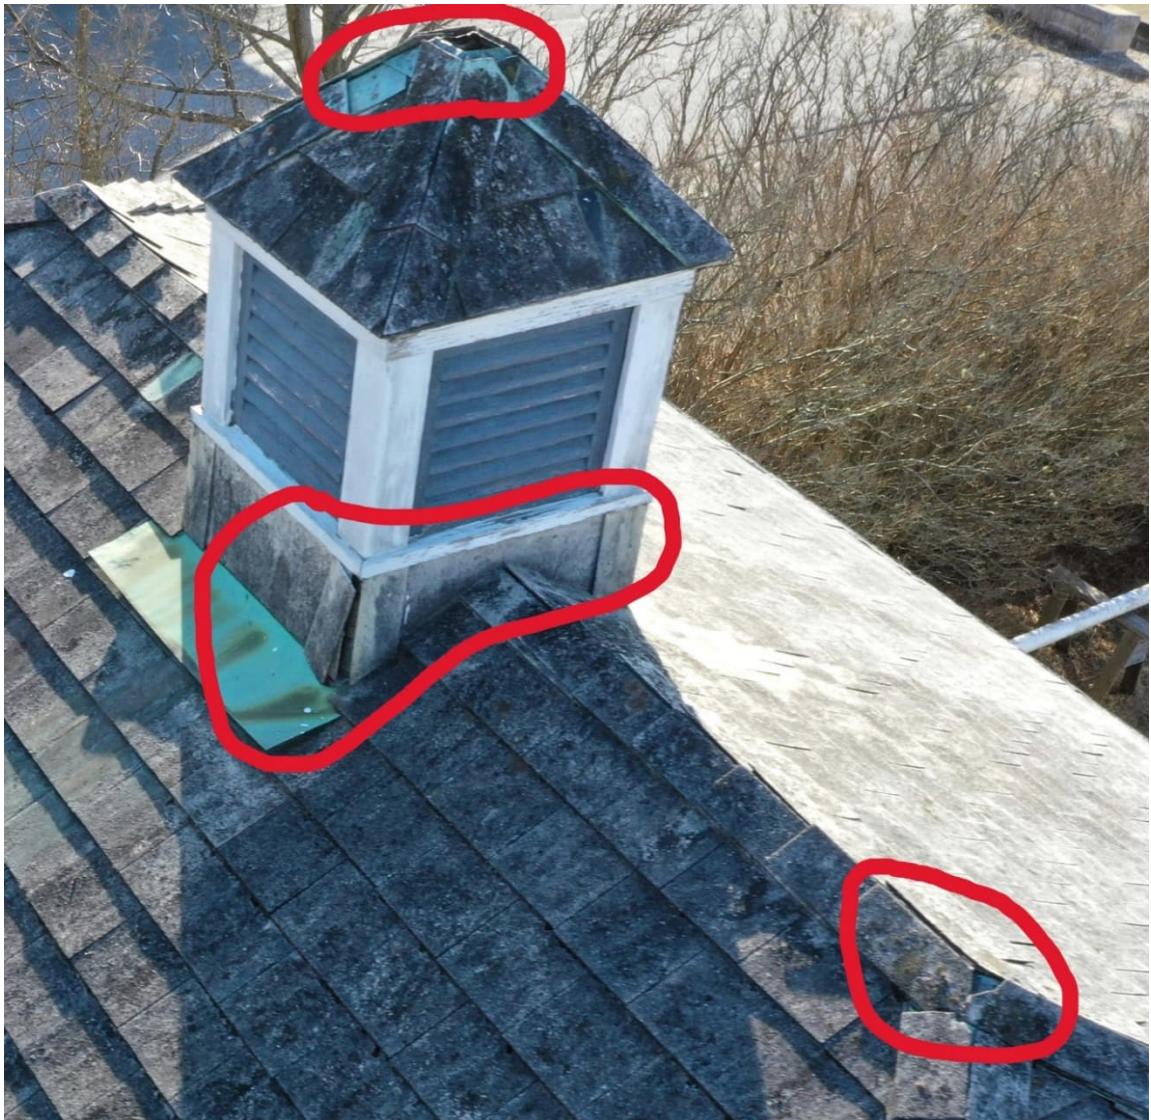
1. Openings in east addition roof.
 - Comments and recommendations: The east addition roof has gaps and/or missing components which may allow weather to infiltrate the building envelope which may cause deterioration to the structural system and/or interior finishes. It is recommended that the deficiencies be repaired by a qualified contractor to ensure weather-tightness of the building envelope and structural integrity of the building.

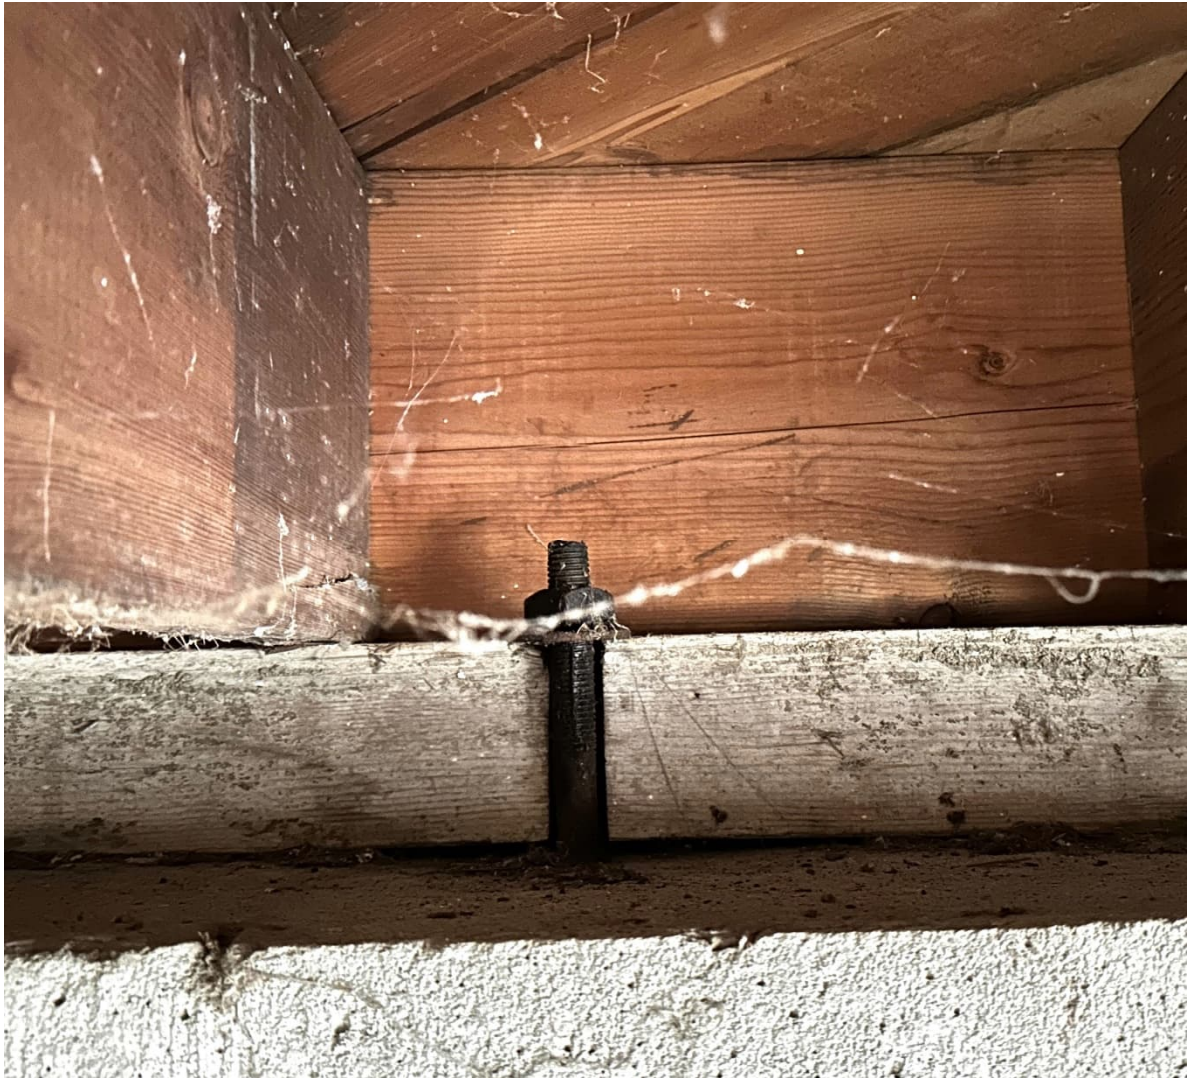
3. Insufficient anchorage of east addition wall.
 - Comments and recommendations: The east addition wall sill plate which supports the floor joists and exterior walls above is not properly anchored to the concrete foundation wall. The anchor appears to be partially contacting the sill plate at the edge, rather than being centered upon the sill plate. The purpose of the anchors is to prevent uplift of the building walls, such as when experiencing lateral loads (wind and/or seismic) or buoyancy due to flooding. This is a structural hazard and it is recommended that appropriate anchorage be designed by a Structural Engineer and installed by a qualified contractor.

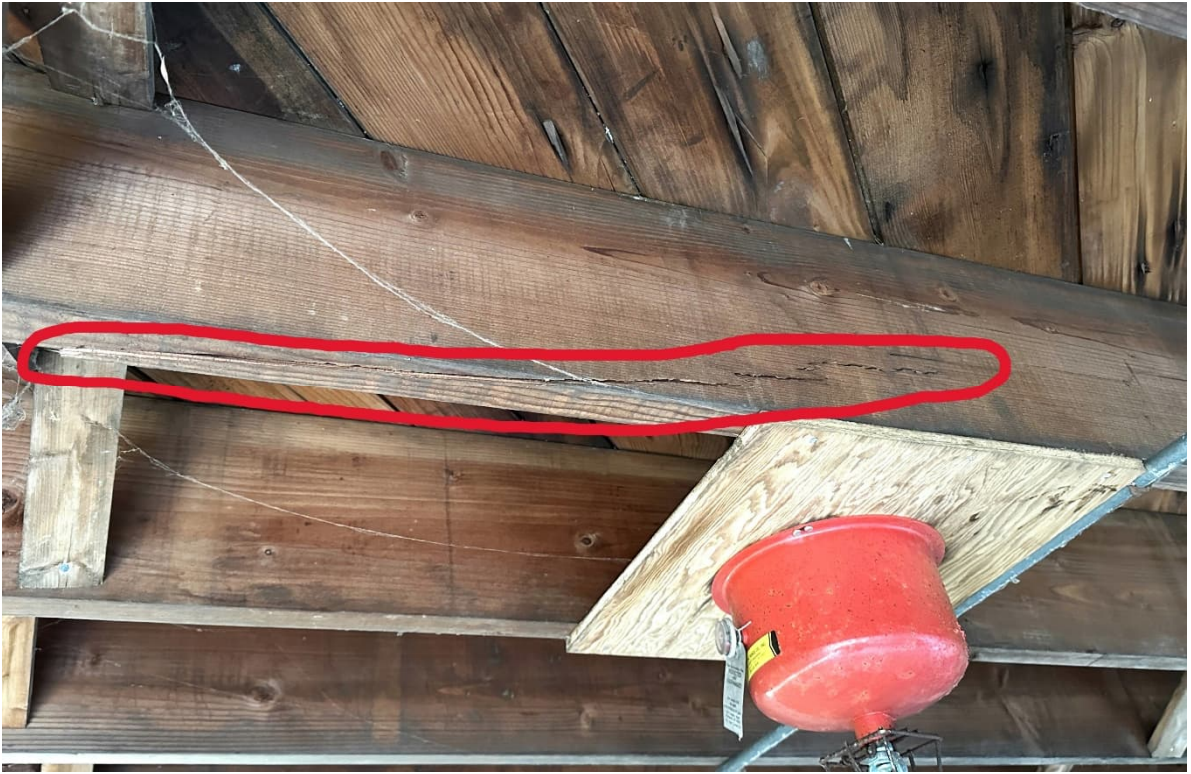
4. Floor joist in east addition has split.
 - Comments and recommendations: A floor joist in the east addition has split from its bottom edge to approximately halfway up its depth. This is a structural hazard as the load carrying capacity of the joist has been greatly reduced which can cause load to be redistributed to the adjacent joists which may overstress them. It is recommended that a repair be designed by a Structural Engineer and installed by a qualified contractor.

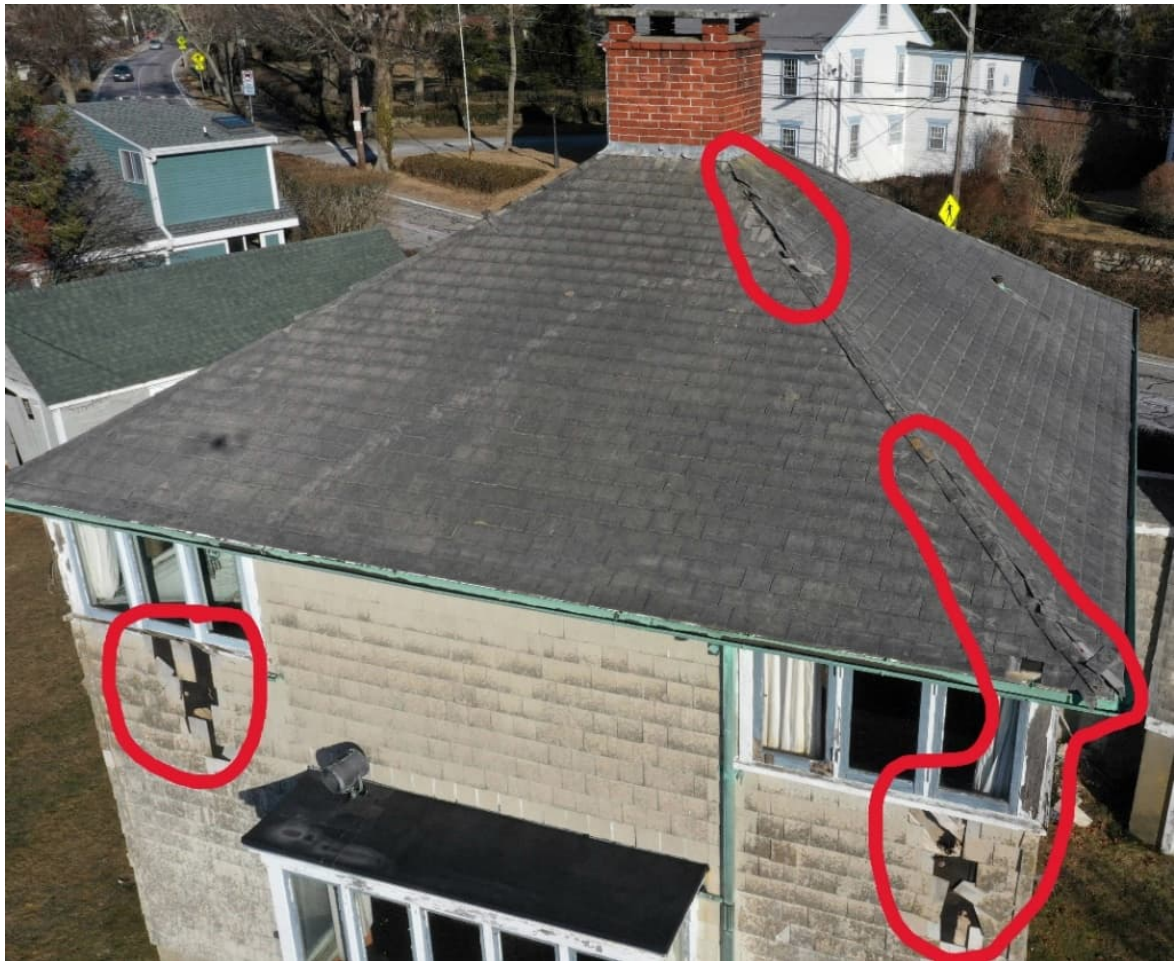
6. Holes in the roof and walls.

- Comments and recommendations: There are holes in the roof and exterior walls at various locations. These holes have been allowing weather to infiltrate the building envelope and have caused deterioration of the structural system. This is a structural hazard as failure of the roof or wall framing could allow collapse of the building. The roof framing is fully accessible; thus, it is recommended that a Structural Engineer be engaged to design appropriate repairs to be performed by a qualified contractor. The wall framing is not accessible; thus, the amount of deterioration is unknown. The exterior wall sheathing or interior finishes would need to be removed to determine the extent of the deterioration such that appropriate repairs can be designed and implemented.

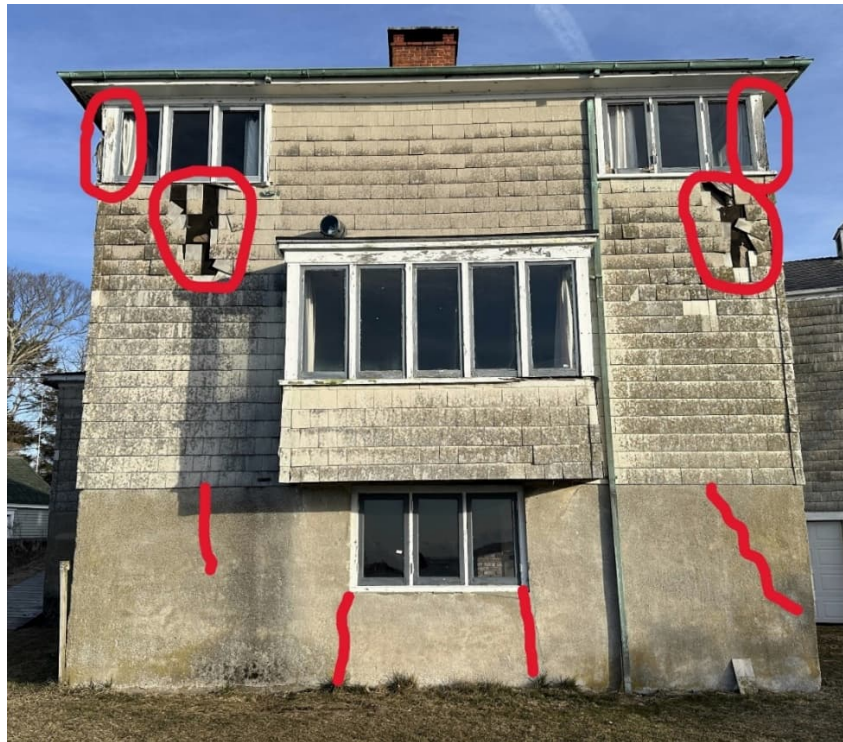
7. Exterior wall deterioration.

- Comments and recommendations: The exterior walls are showing signs of deterioration and cracking at various locations. The paint on the corner columns has peeled away and the wood appears to be rotting. Failure of the corner columns could allow the walls to move outward and/or the roof framing to collapse. It is recommended that the columns be removed and replaced.

- Wall shingles are missing which has exposed the wood sheathing and allowed weather to infiltrate the building envelope which may have allowed deterioration within the walls. Deterioration of the walls could lead to their failure. The exterior wall sheathing or interior finishes would need to be removed to determine the extent of the deterioration such that appropriate repairs can be designed and implemented.

- The concrete foundation walls have cracks at various locations. The cracks may be due to settlement (there are several sinkholes in the backyard). The cracks do not currently appear to be a structural hazard. However, the cracks may allow weather to infiltrate into the wall which may lead to additional deterioration. It is recommended that the cracks be repaired by qualified personnel.

- The size and location of wall openings create a discontinuity in the lateral force resistance system from the roof to the foundation. Lateral forces were not a consideration when the house was constructed. It is recommended that a Structural Engineer be engaged to design an appropriate lateral force resistance system.

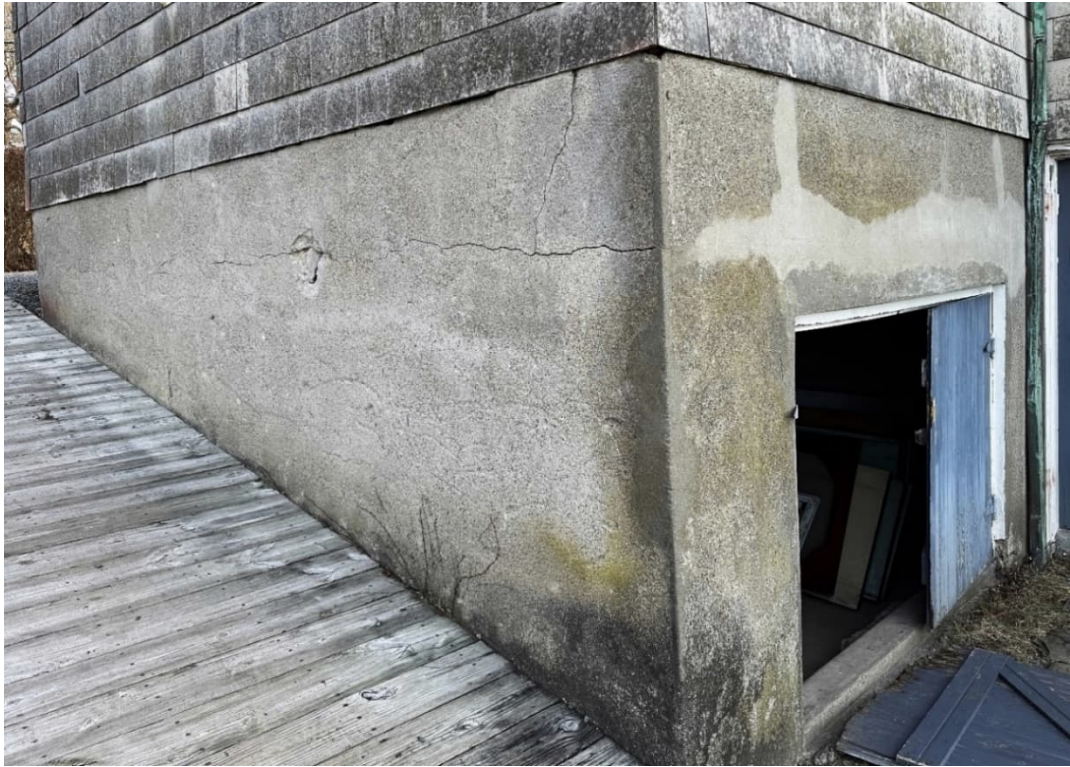
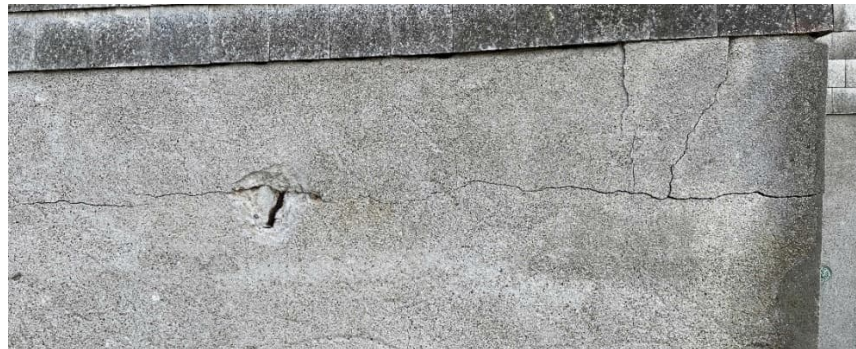
8. Foundation wall cracks with exposed rusting reinforcement.
- Comments and recommendations: The foundation walls below the northwest corner of the house bump-out (former garage, current laundry room) has large horizontal cracks and exposed rusting reinforcement. There also appears to have been previous repairs performed at the wall corner and over the crawlspace doorway opening. The cracks may be due to lateral forces, settlement, and/or building expansion/contraction from changes in temperature and humidity. The cracks may allow weather to infiltrate the wall and cause further damage. The exposed rusting reinforcement will expand and cause further cracking of the wall, thus, exposing more reinforcement and continuing the cycle. It is recommended that the cracks and exposed rusting reinforcement be repaired by qualified personnel using high-performance repair materials.

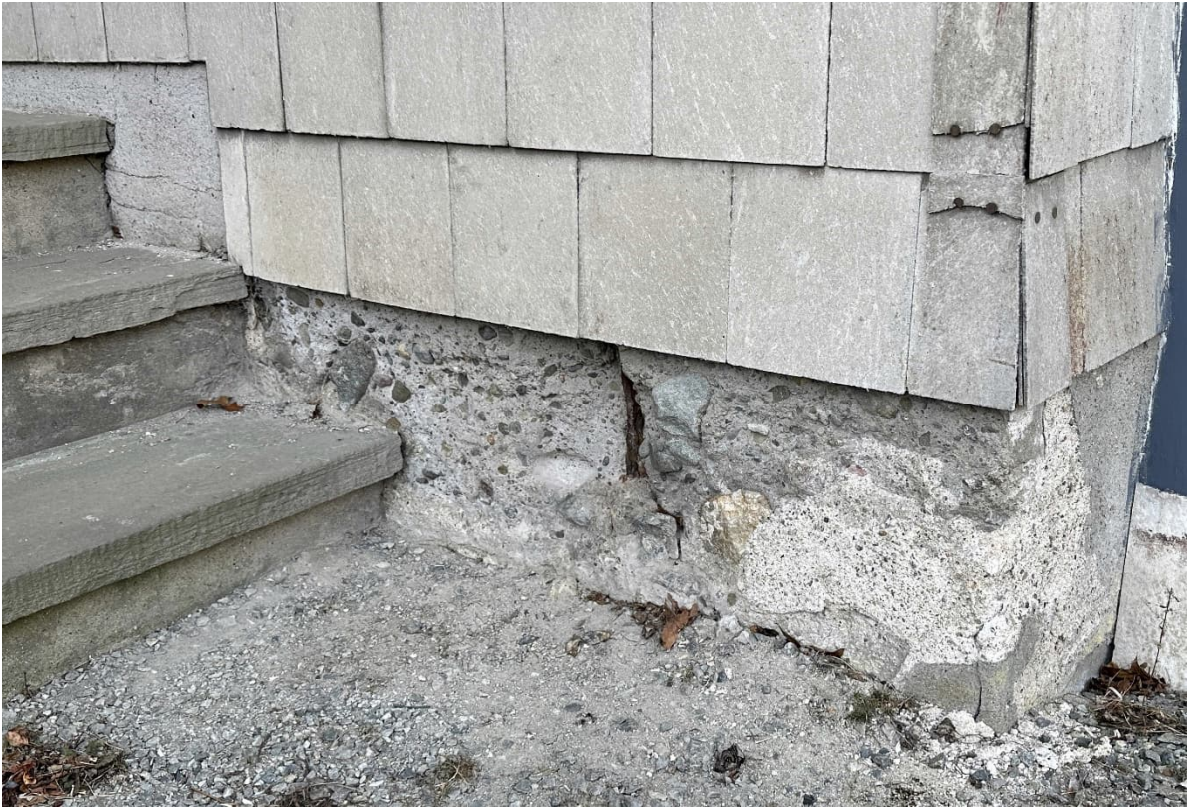
10. Spalled foundation wall, exposed rusting reinforcement.

- Comments and recommendations: The foundation wall adjacent to the main entrance stairs has large areas of spalling, some cracks and exposed rusting reinforcement. The spalling may be due to previous cracks that allowed weather to infiltrate the wall causing expansion of the concrete. The current cracks may allow weather to infiltrate the wall and cause further damage. The exposed rusting reinforcement will expand and cause further cracking of the wall, thus, exposing more reinforcement and continuing the cycle. It is recommended that the cracks and exposed rusting reinforcement be repaired by qualified personnel using high-performance repair materials.

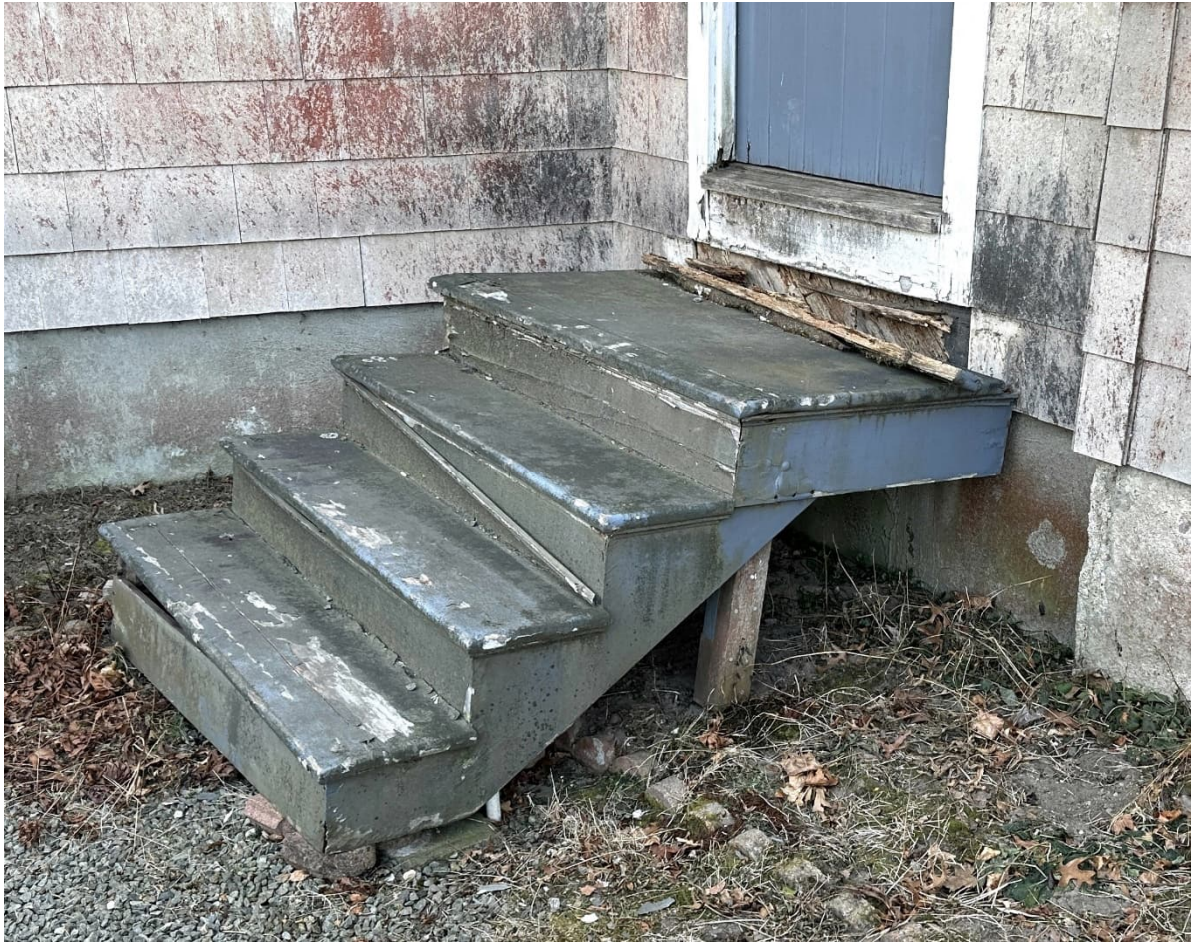
11. Deteriorated stairs.

- Comments and recommendations: The exterior stairs to the hallway between the house and east addition have deteriorated and are failing. The stairs are in a hazardous condition and should be replaced. Where the stair connected to the house appears to also be deteriorating and should be investigated further.

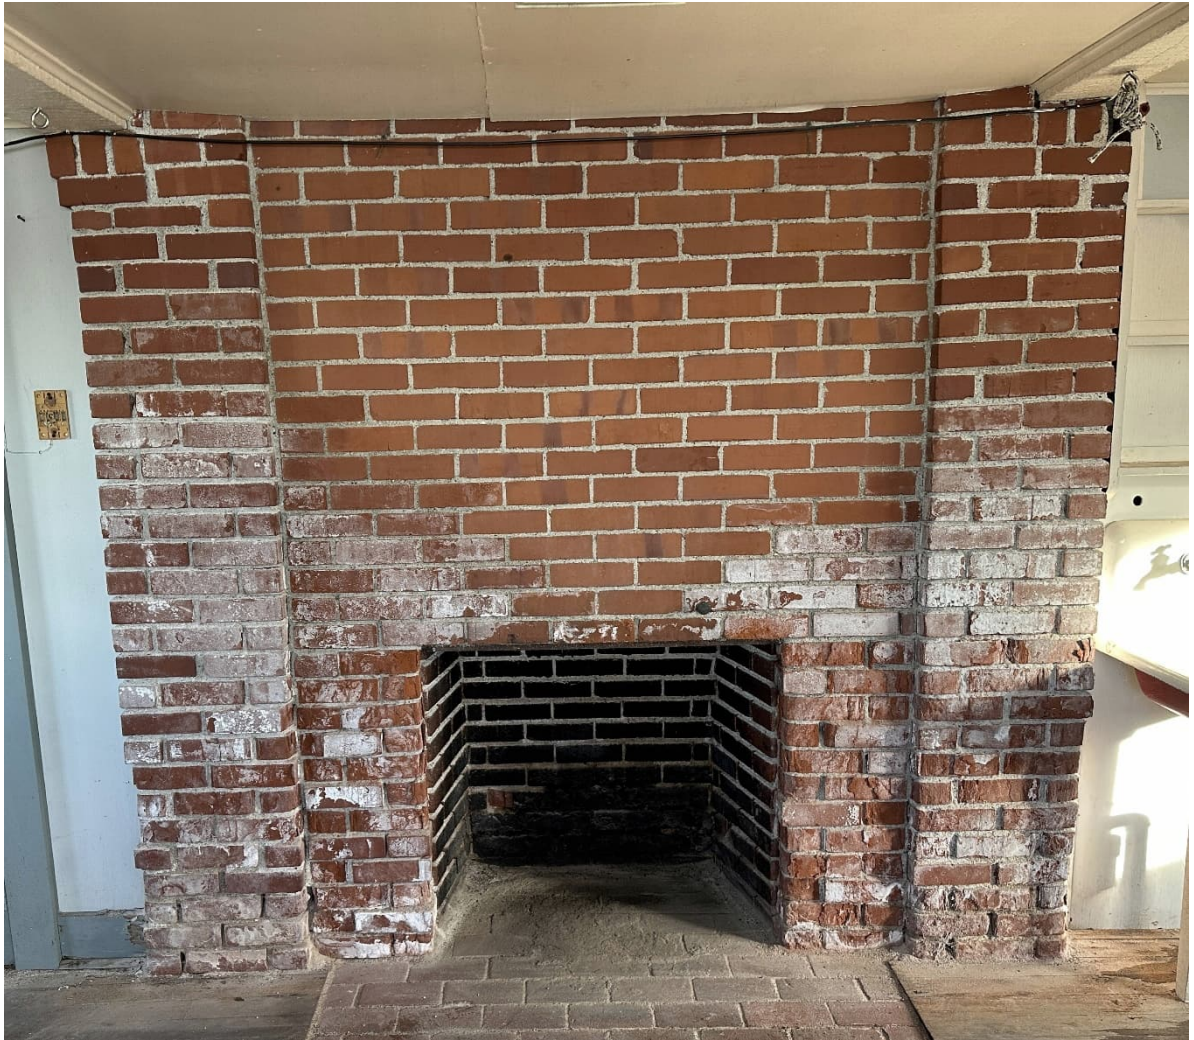
13. Efflorescence at fireplace in basement.

- Comments and recommendations: The fireplace in the basement is showing signs of efflorescence and deterioration. Efflorescence is a sign of water infiltration into the building envelope which may lead to damage of the wall. It is recommended that a Building Envelope Specialist be engaged to determine the source of the water infiltration and the associated repairs. It is also recommended that the brick be repaired and/or replaced by a qualified mason.

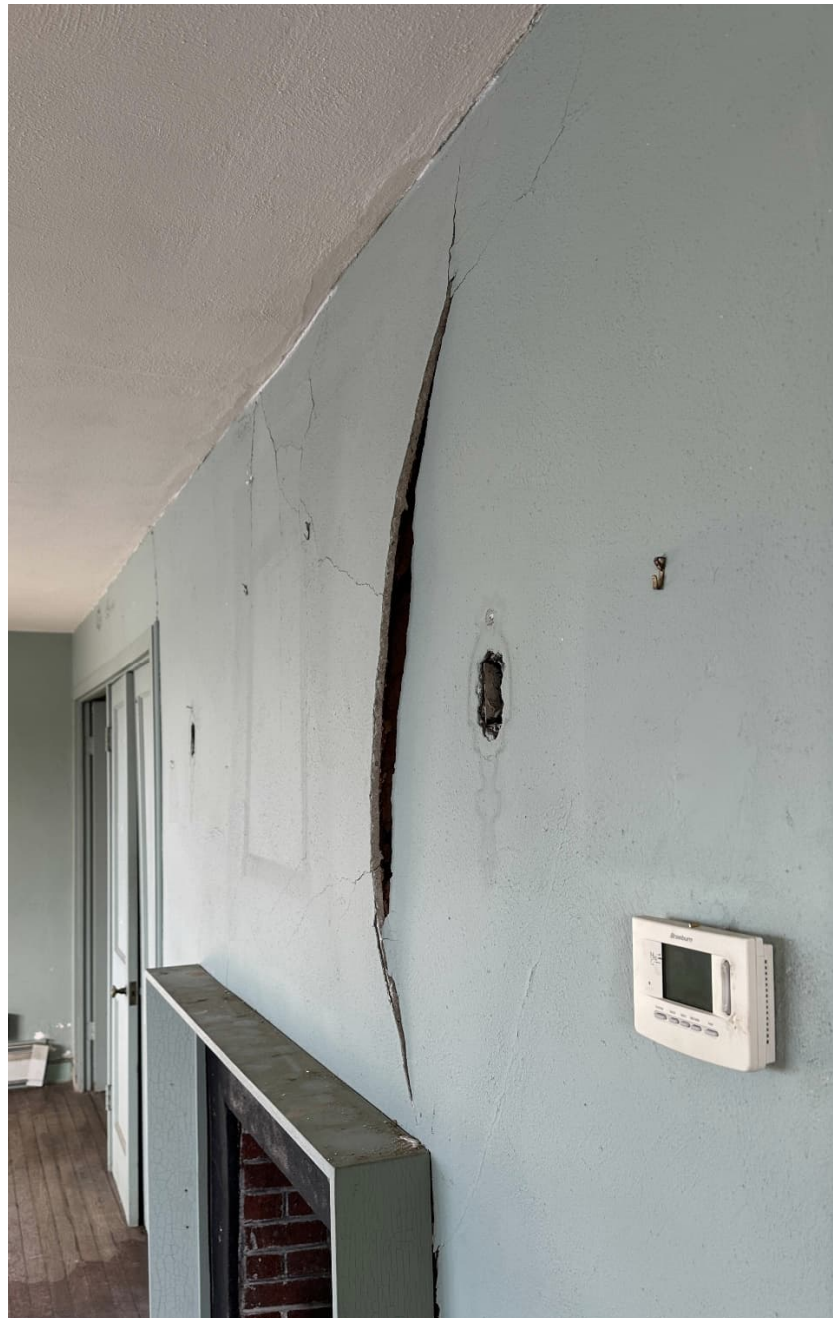
16. Interior wall finish buckling.

- Comments and recommendations: A portion of plaster on an interior wall of the house has detached and buckled outward. This is an indication that the wall behind the plaster may have moved. It is recommended that further investigation of the wall, requiring removal of the plaster, be performed to determine the structural stability of the wall.

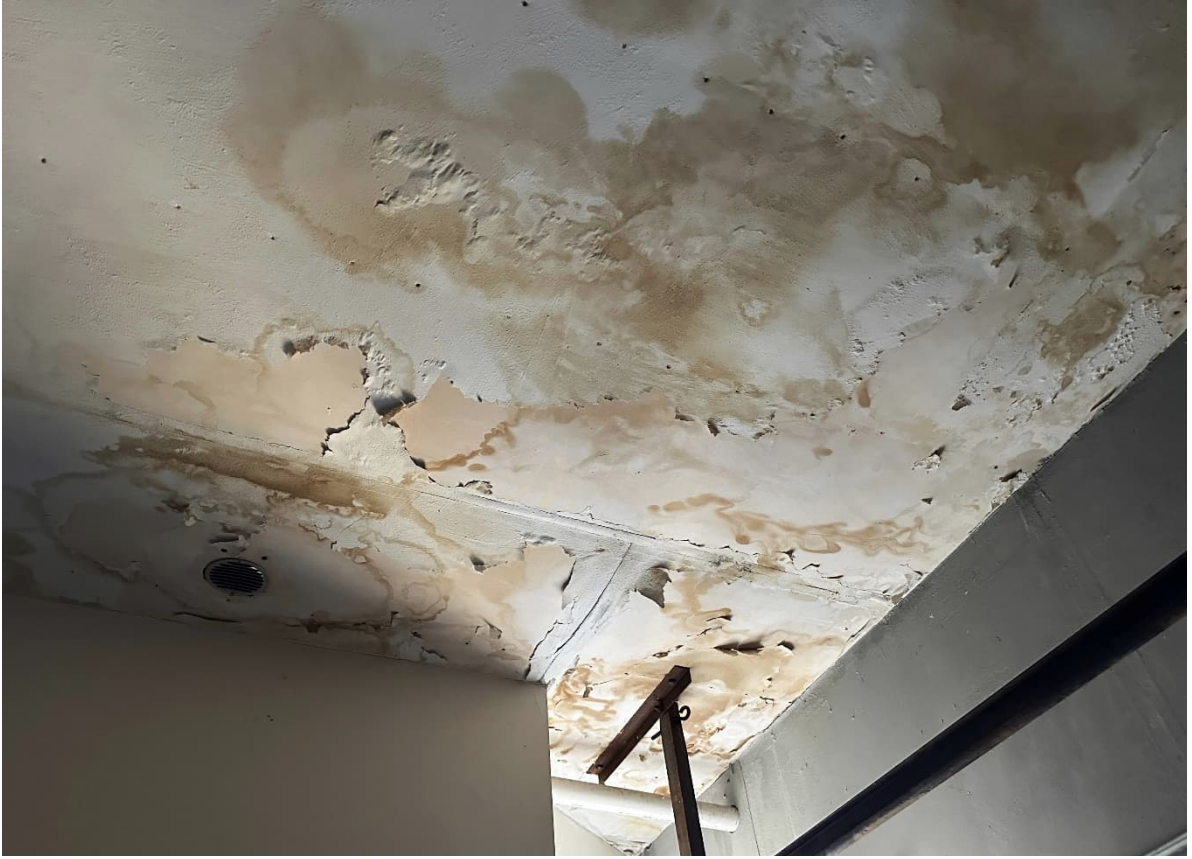
17. Staining on laundry room ceiling.

- Comments and recommendations: There are stains on the laundry room ceiling which indicate the infiltration of water. Prolonged water infiltration may cause deterioration to the roof elements, structural system, and interior finishes. Further investigation is required to determine the cause of the water infiltration and if there is damage to the structure.

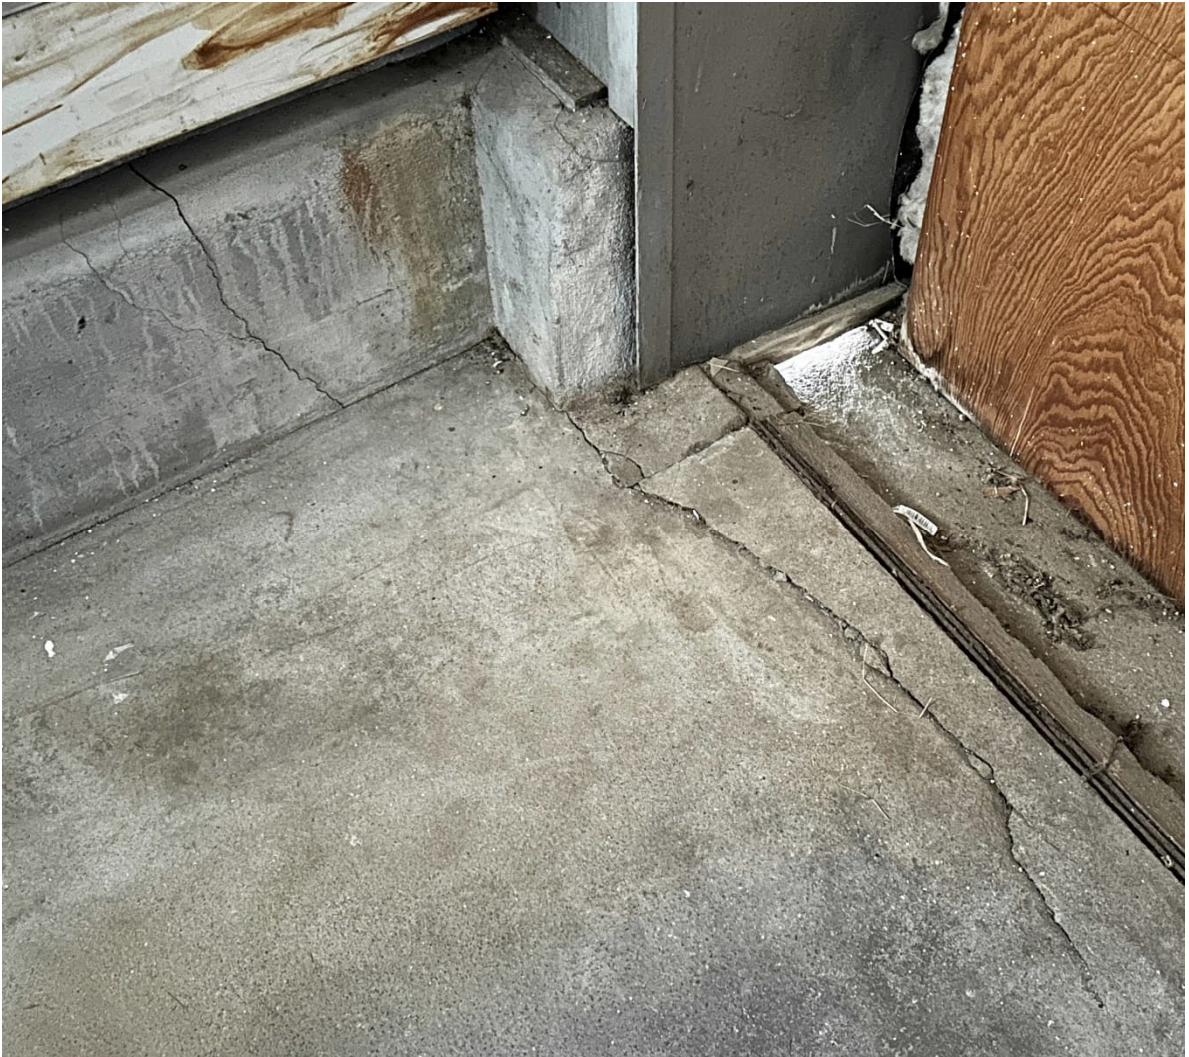
18. Laundry room concrete floor slab and wall cracks.

- Comments and recommendations: Cracks in the laundry room concrete floor slab and wall were observed. The cracks are most likely due to building movement and/or settlement. It is recommended that the cracks be repaired using high-performance materials by qualified personnel.

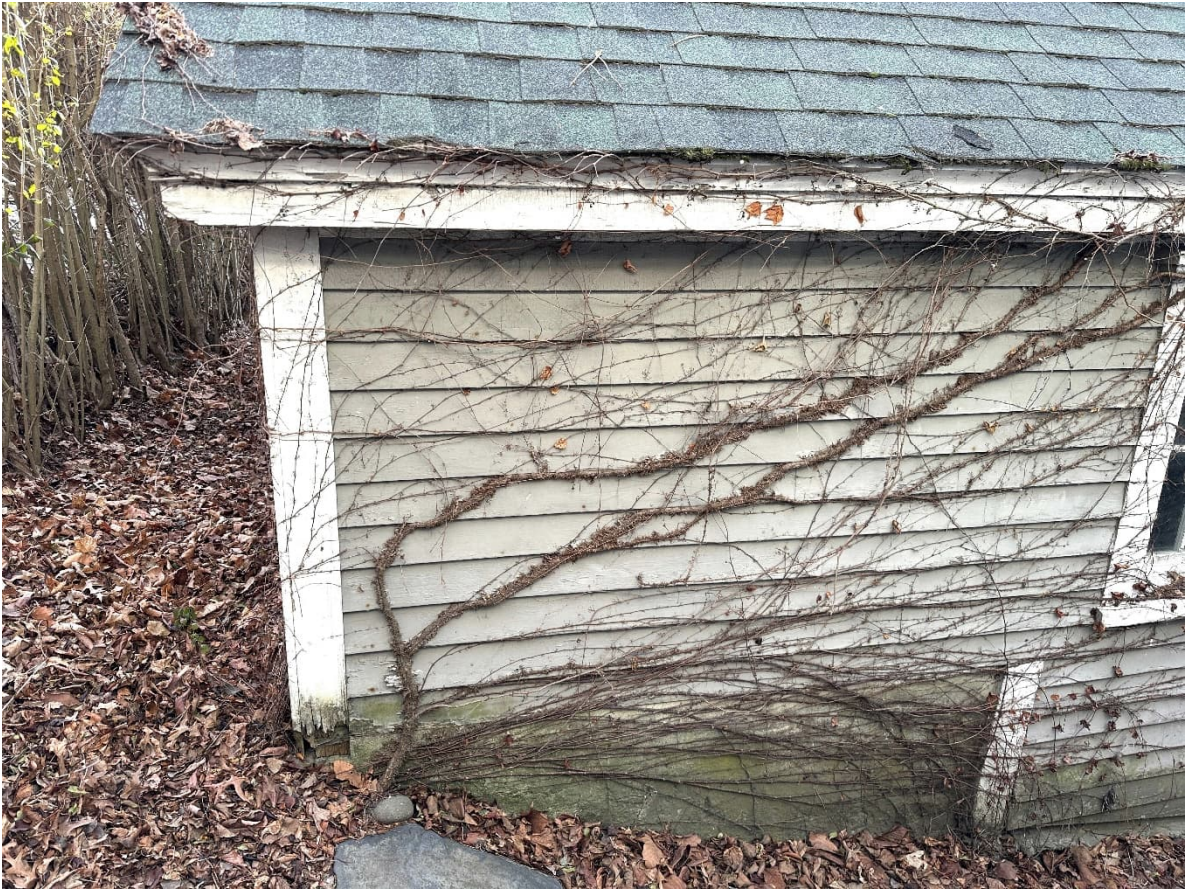
19. Deterioration and vegetation at shed exterior.

- Comments and recommendations: Deterioration of the exterior wood and attached vegetation on the shed was observed at various locations. It is recommended that the deteriorated parts be replaced in-kind and the vegetation be removed as it can create openings in the building envelope which may allow water and air infiltration that could cause damage to the structure and/or exterior of the shed.

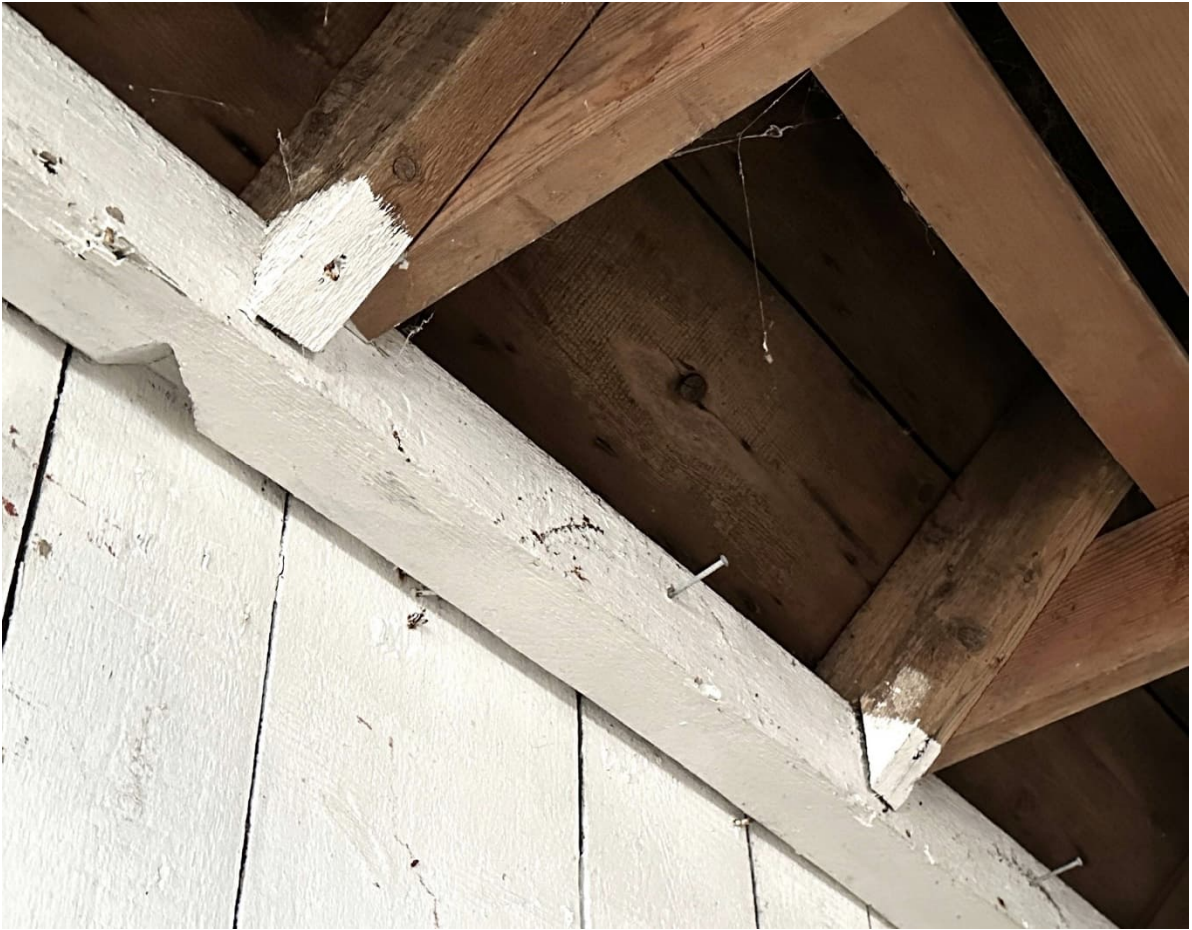
21. Shed roof framing connections potentially insufficient for uplift.

- Comments and recommendations: The shed roof framing appears to be connected to the perimeter beam by a single nail which is potentially insufficient to resist design wind uplift forces. It is recommended that joist hurricane straps be installed to connect the joist to the perimeter beam.

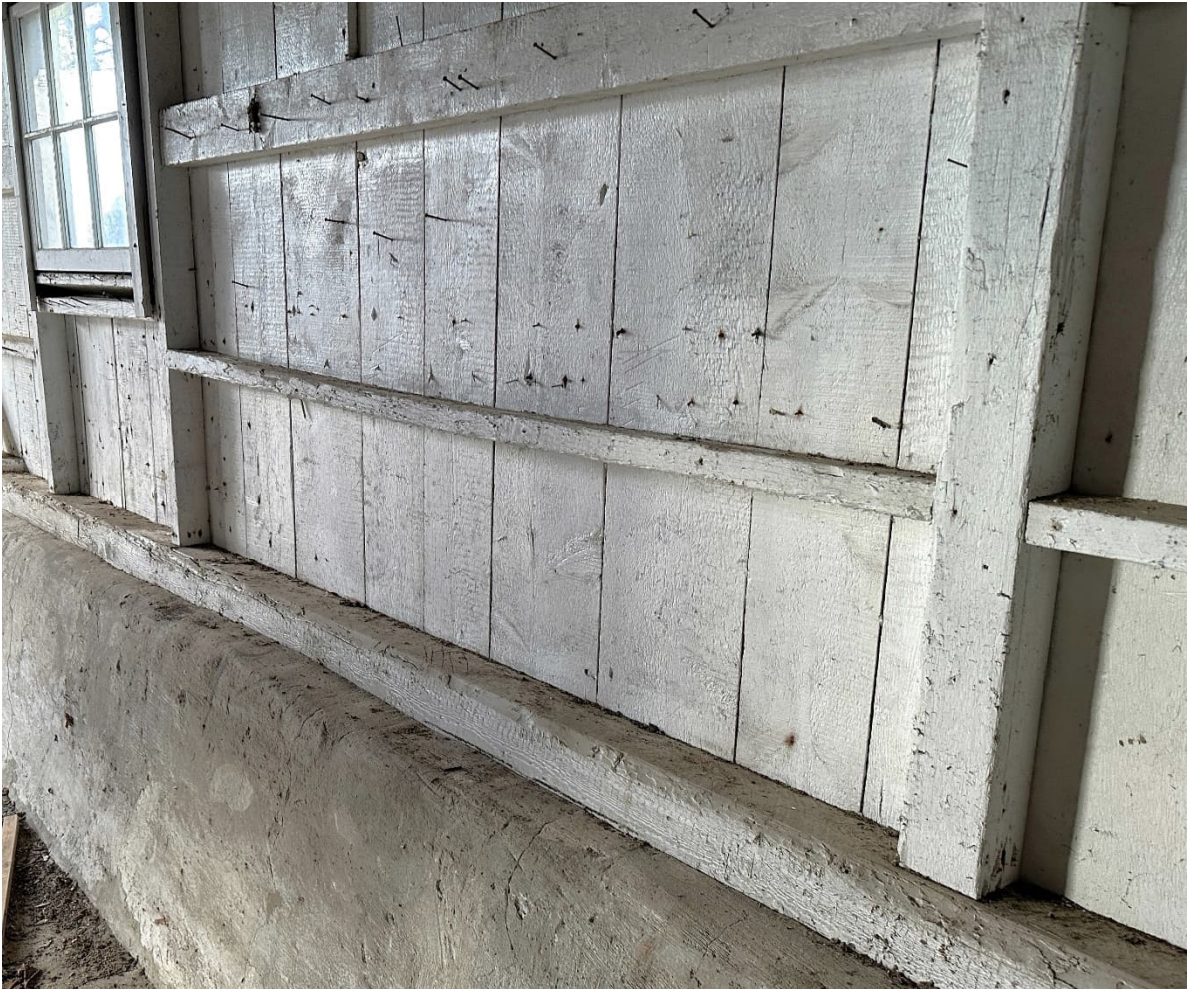
22. No sill anchors.

- Comments and recommendations: The shed sill plate does not appear to be anchored to the foundation wall. The purpose of the sill plate anchors is to prevent uplift of the building walls and columns, such as when experiencing lateral loads (wind and/or seismic). This is a structural hazard, and it is recommended that appropriate anchorage be designed by a Structural Engineer and installed by a qualified contractor.
