# Bristol Historic District Commission

## Application for Review of Proposed Work - Printable Application

Project Address	Assessor's Plat	Assessor's Lot
125 Hope Street	16	51

125 HOPE STREET, BRISTOL, RHODE ISLAND  
STRUCTURAL INSPECTION, JANUARY 16, 2025

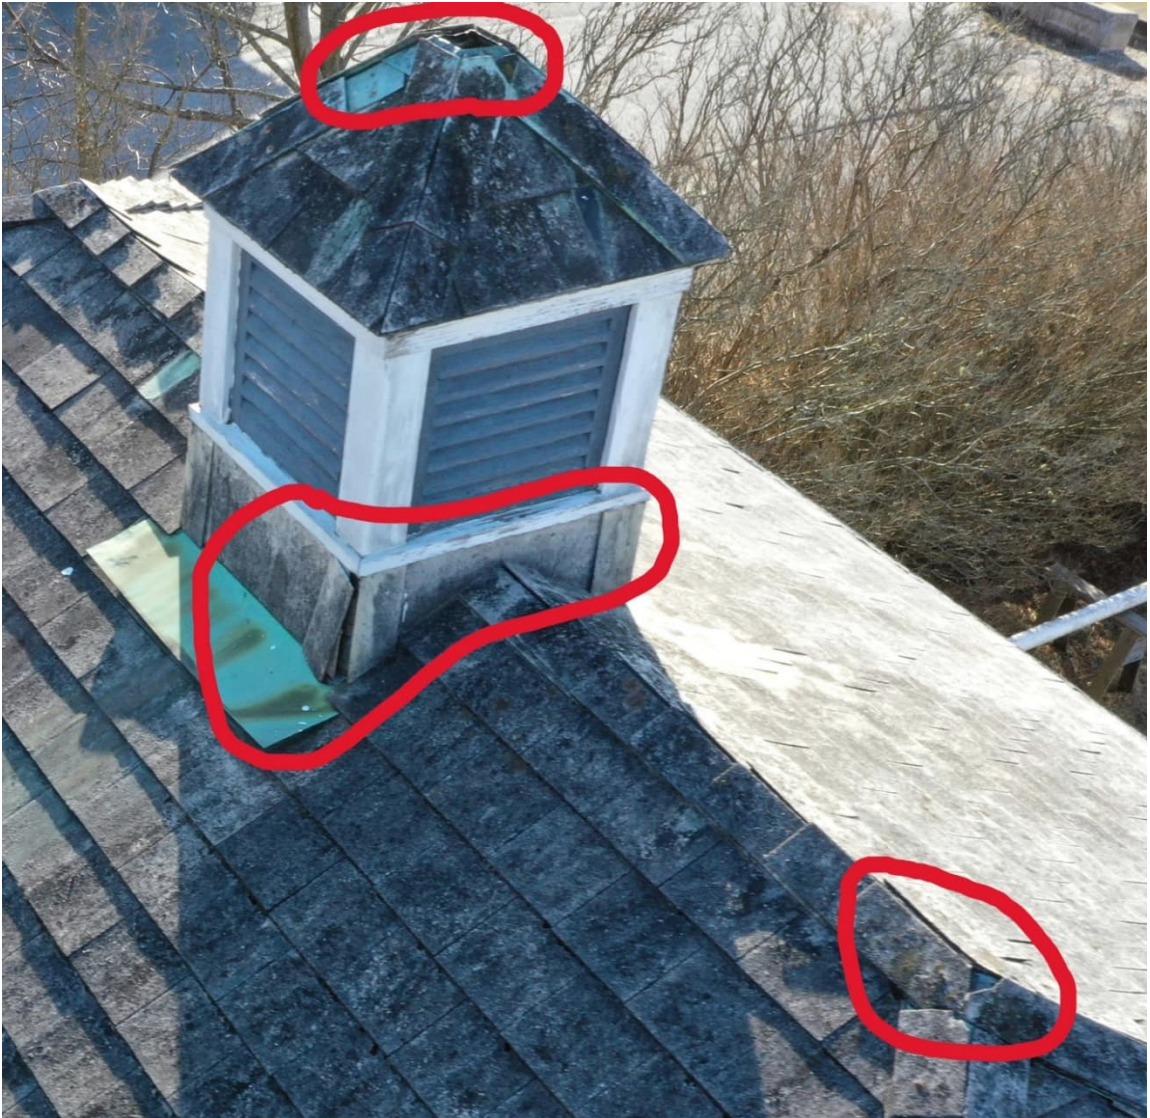
1. Openings in east addition roof.
  - Comments and recommendations: The east addition roof has gaps and/or missing components which may allow weather to infiltrate the building envelope which may cause deterioration to the structural system and/or interior finishes. It is recommended that the deficiencies be repaired by a qualified contractor to ensure weather-tightness of the building envelope and structural integrity of the building.

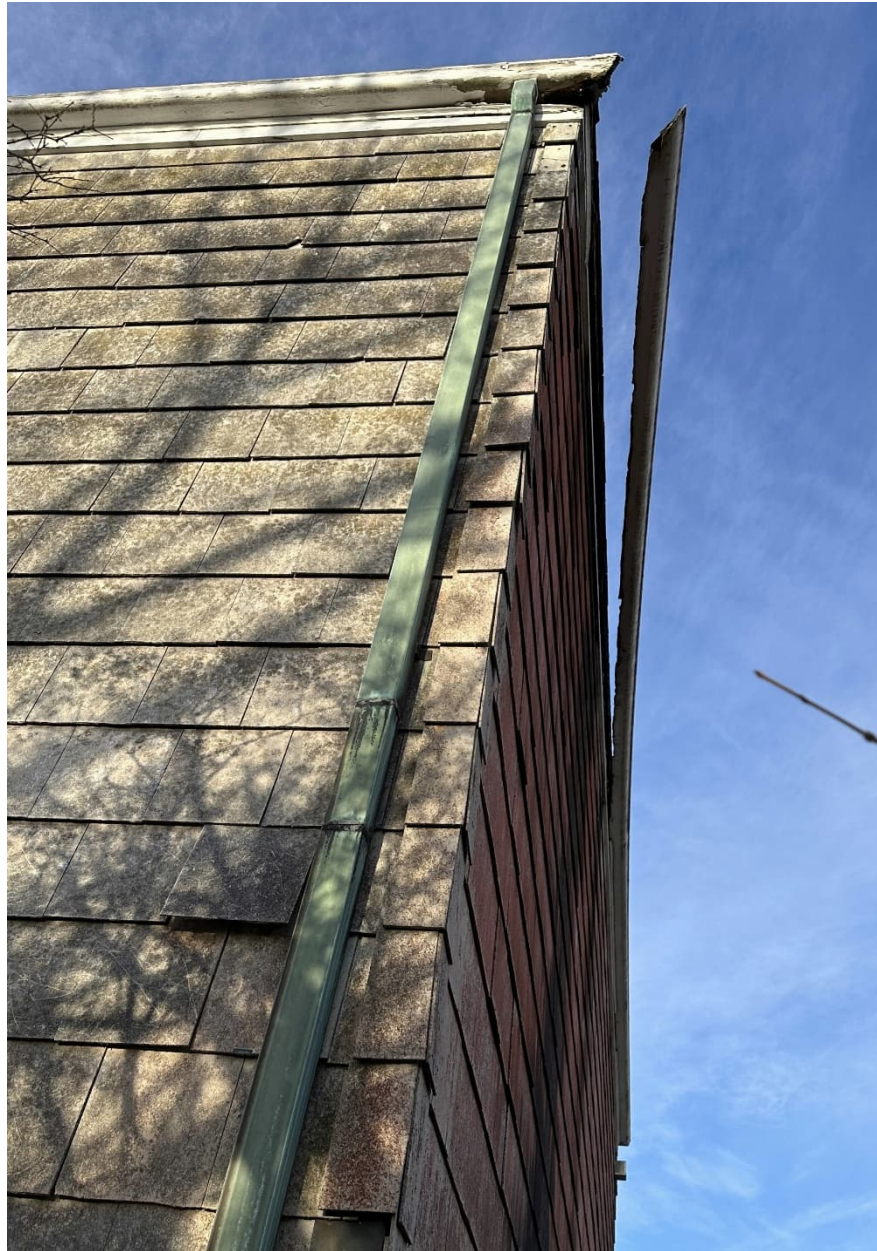
2. Detached gutter on east addition.
  - o Comments and recommendations: The gutter along the north side of the east addition has detached at the east end. This is a sign of potential deterioration along roof eave and/or top of wall and may be allowing weather to infiltrate the building envelope which may cause deterioration to the structural system and/or interior finishes. Additionally, if the gutter were to fall from the building it may cause damage to property or injure people. It is recommended that the deficiencies be repaired by a qualified contractor to ensure weather-tightness of the building envelope and structural integrity of the building.

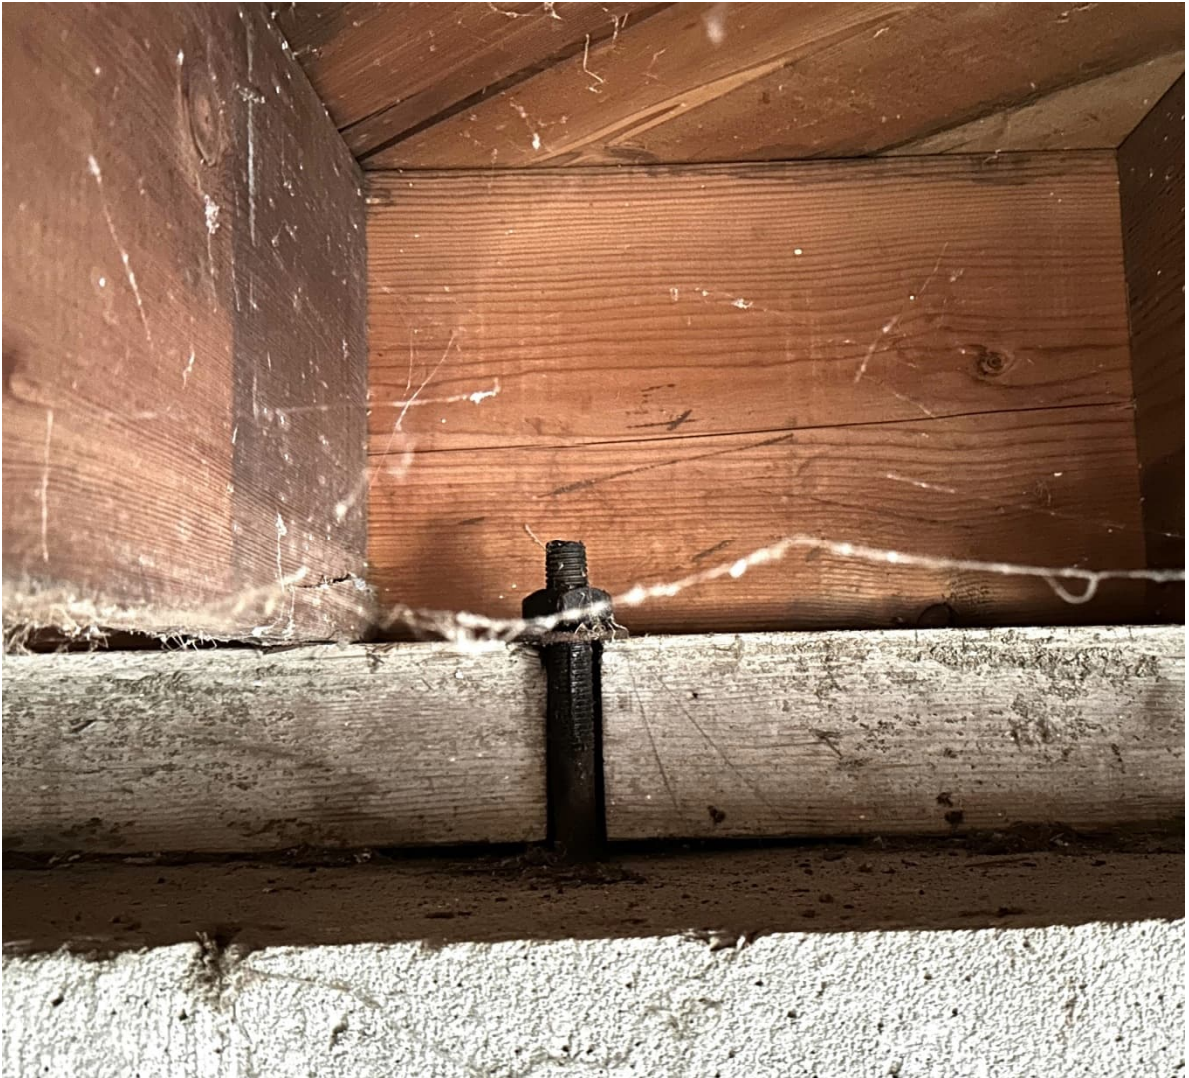
3. Insufficient anchorage of east addition wall.
  - o Comments and recommendations: The east addition wall sill plate which supports the floor joists and exterior walls above is not properly anchored to the concrete foundation wall. The anchor appears to be partially contacting the sill plate at the edge, rather than being centered upon the sill plate. The purpose of the anchors is to prevent uplift of the building walls, such as when experiencing lateral loads (wind and/or seismic) or buoyancy due to flooding. This is a structural hazard and it is recommended that appropriate anchorage be designed by a Structural Engineer and installed by a qualified contractor.

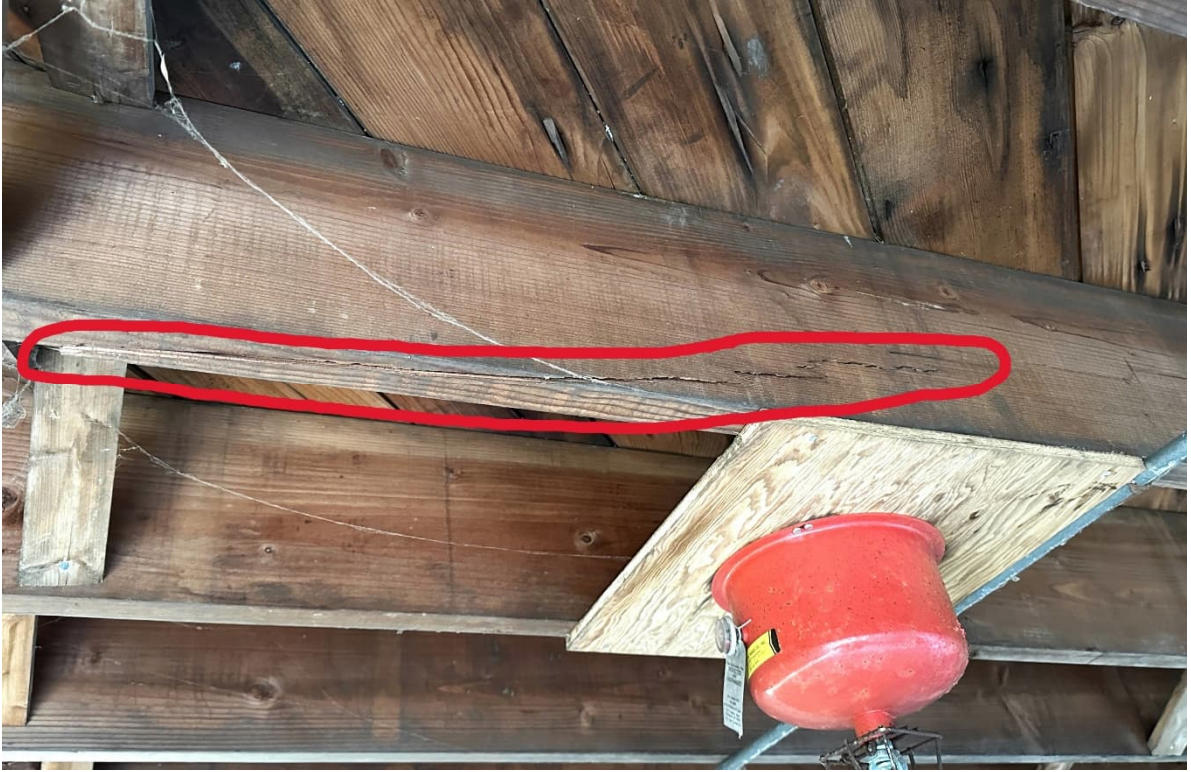
4. Floor joist in east addition has split.
  - o Comments and recommendations: A floor joist in the east addition has split from its bottom edge to approximately halfway up its depth. This is a structural hazard as the load carrying capacity of the joist has been greatly reduced which can cause load to be redistributed to the adjacent joists which may overstress them. It is recommended that a repair be designed by a Structural Engineer and installed by a qualified contractor.

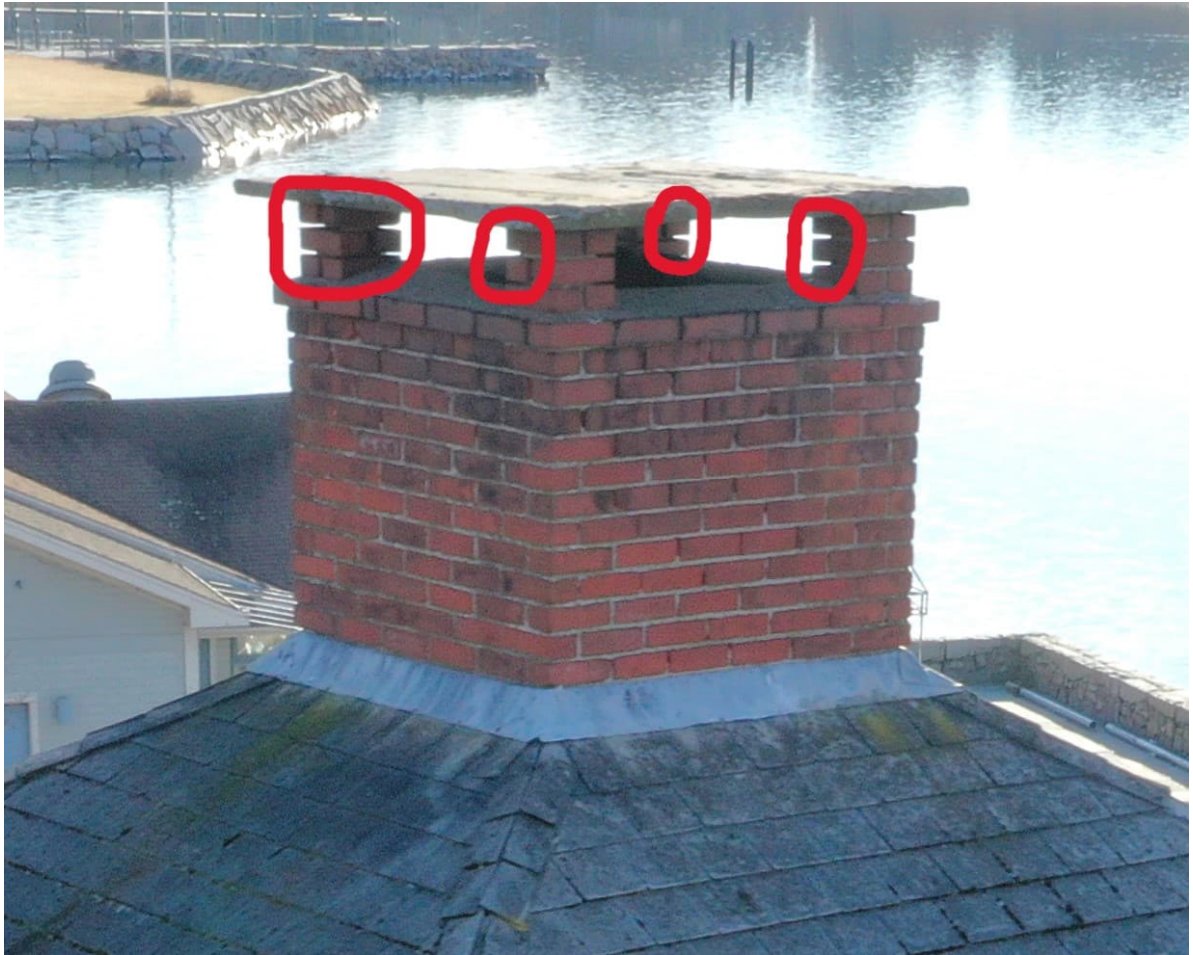
5. Mortar gaps at house chimney.
  - Comments and recommendations: The mortar joints of the brick columns which support the house chimney cap have significant deterioration. If the brick columns were to fail, the chimney cap could fall and possibly damage property or injure people. It is recommended that the mortar joints be repaired by a qualified mason.

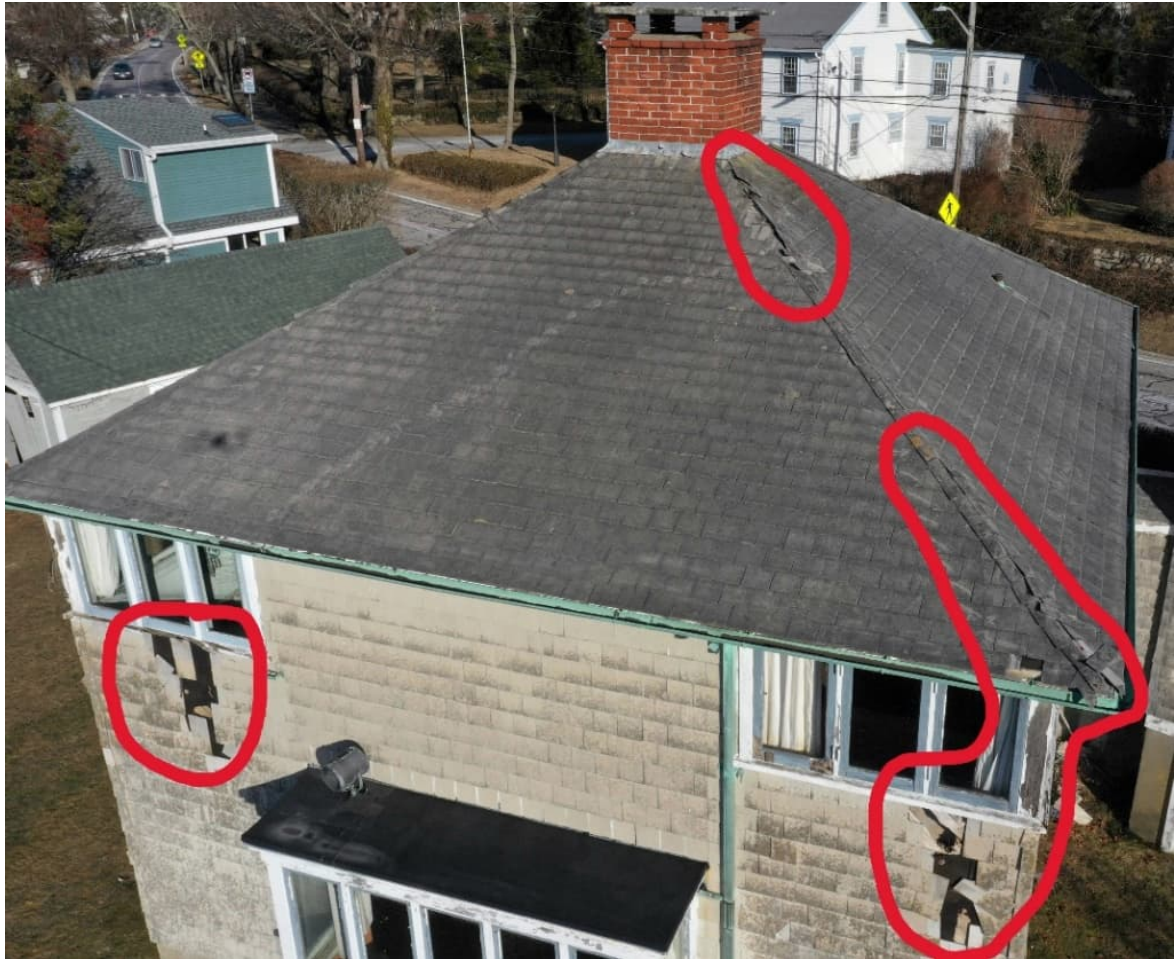
6. Holes in the roof and walls.

- Comments and recommendations: There are holes in the roof and exterior walls at various locations. These holes have been allowing weather to infiltrate the building envelope and have caused deterioration of the structural system. This is a structural hazard as failure of the roof or wall framing could allow collapse of the building. The roof framing is fully accessible; thus, it is recommended that a Structural Engineer be engaged to design appropriate repairs to be performed by a qualified contractor. The wall framing is not accessible; thus, the amount of deterioration is unknown. The exterior wall sheathing or interior finishes would need to be removed to determine the extent of the deterioration such that appropriate repairs can be designed and implemented.

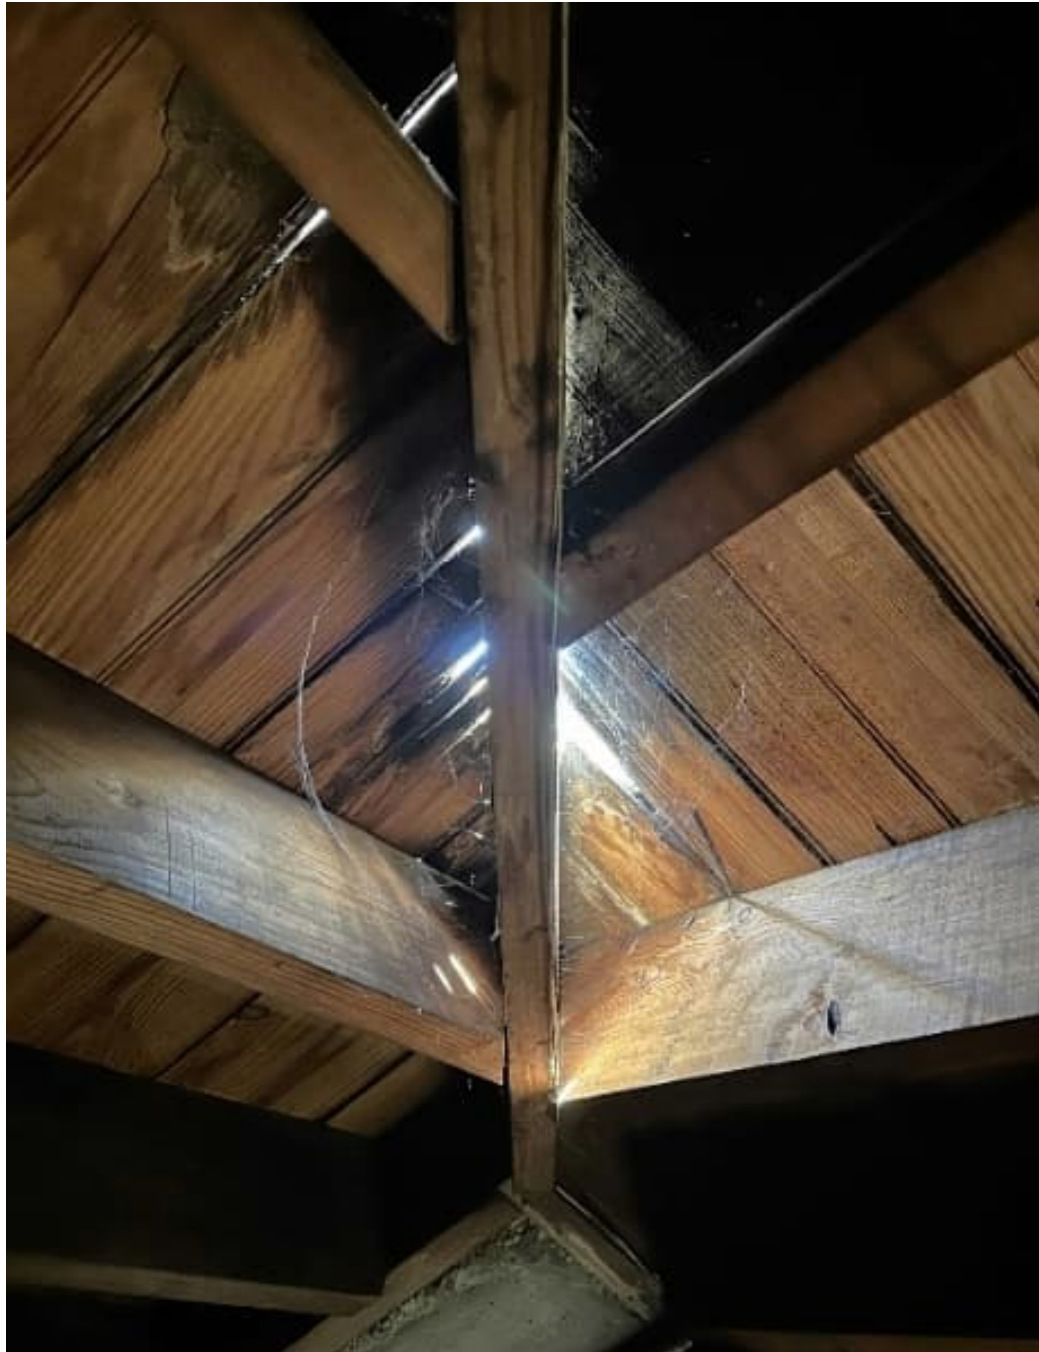
*This photo shows deterioration of the house roof framing due to holes in the roof.*

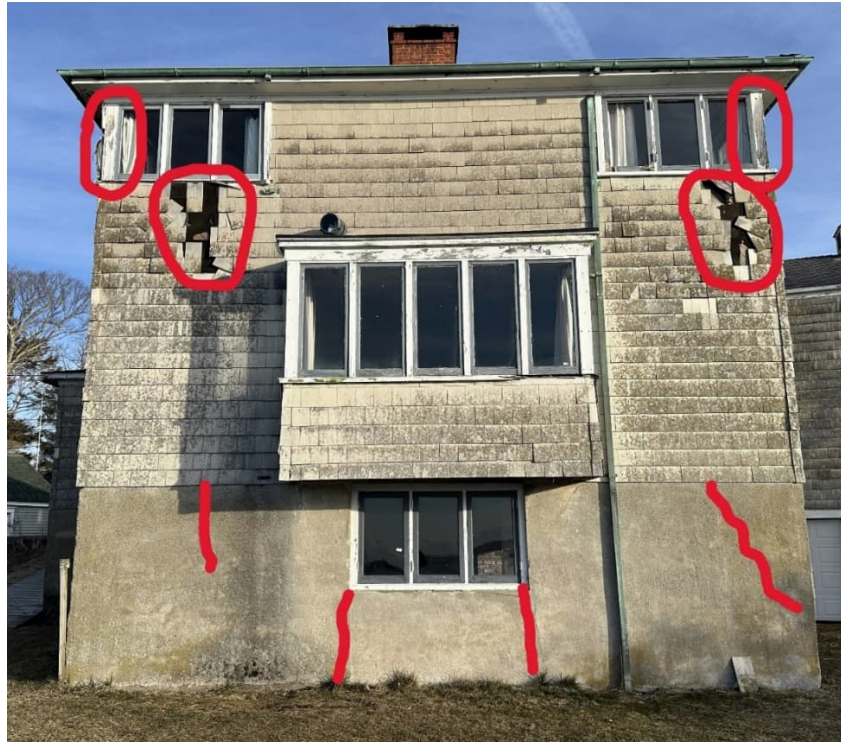
7. Exterior wall deterioration.

- Comments and recommendations: The exterior walls are showing signs of deterioration and cracking at various locations. The paint on the corner columns has peeled away and the wood appears to be rotting. Failure of the corner columns could allow the walls to move outward and/or the roof framing to collapse. It is recommended that the columns be removed and replaced.

- Wall shingles are missing which has exposed the wood sheathing and allowed weather to infiltrate the building envelope which may have allowed deterioration within the walls. Deterioration of the walls could lead to their failure. The exterior wall sheathing or interior finishes would need to be removed to determine the extent of the deterioration such that appropriate repairs can be designed and implemented.

- The concrete foundation walls have cracks at various locations. The cracks may be due to settlement (there are several sinkholes in the backyard). The cracks do not currently appear to be a structural hazard. However, the cracks may allow weather to infiltrate into the wall which may lead to additional deterioration. It is recommended that the cracks be repaired by qualified personnel.

- The size and location of wall openings create a discontinuity in the lateral force resistance system from the roof to the foundation. Lateral forces were not a consideration when the house was constructed. It is recommended that a Structural Engineer be engaged to design an appropriate lateral force resistance system.

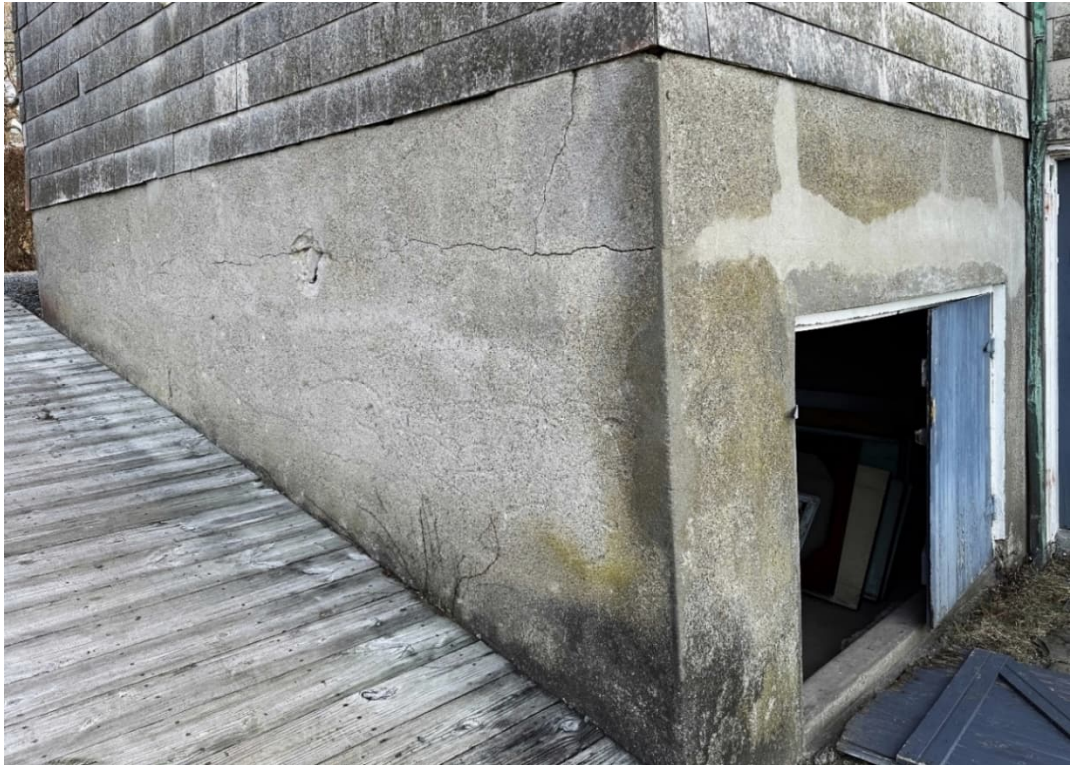
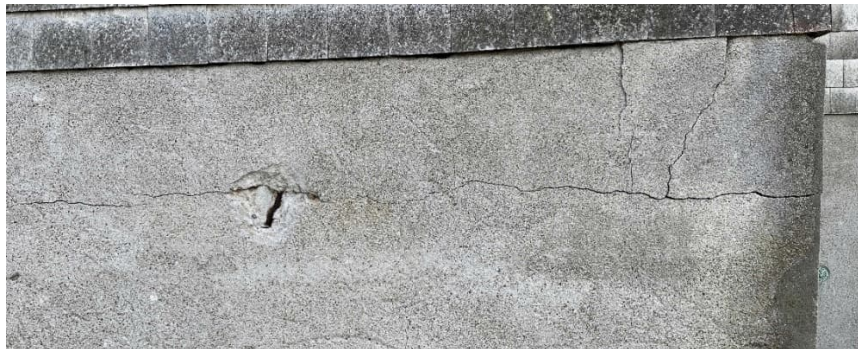
8. Foundation wall cracks with exposed rusting reinforcement.
  - o Comments and recommendations: The foundation walls below the northwest corner of the house bump-out (former garage, current laundry room) has large horizontal cracks and exposed rusting reinforcement. There also appears to have been previous repairs performed at the wall corner and over the crawlspace doorway opening. The cracks may be due to lateral forces, settlement, and/or building expansion/contraction from changes in temperature and humidity. The cracks may allow weather to infiltrate the wall and cause further damage. The exposed rusting reinforcement will expand and cause further cracking of the wall, thus, exposing more reinforcement and continuing the cycle. It is recommended that the cracks and exposed rusting reinforcement be repaired by qualified personnel using high-performance repair materials.

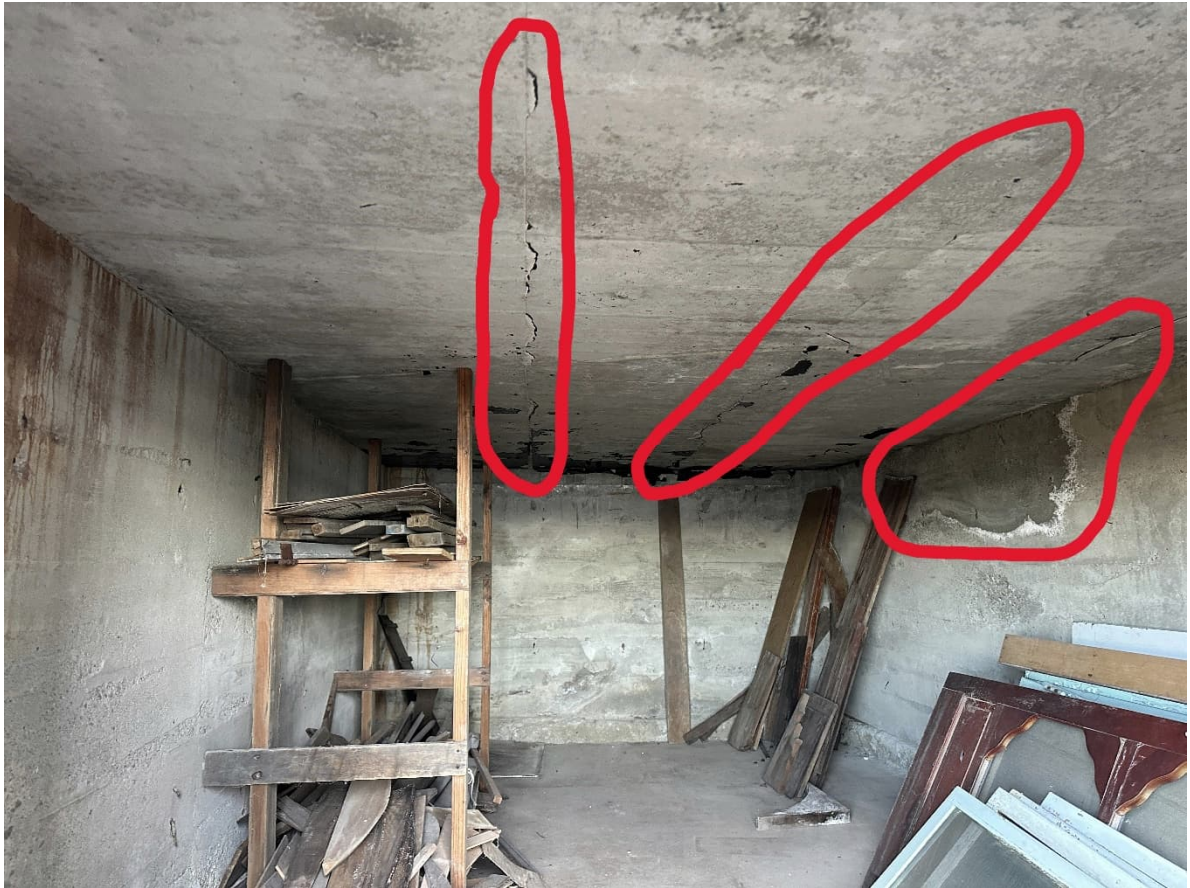
9. Slab cracks and deflection, efflorescence at previous repair.
- Comments and recommendations: In the crawlspace below the northwest corner of the house bump-out (former garage, current laundry room), the slab overhead has some longitudinal cracks and is visibly deflected. This is a structural hazard as the cracks and deflection are an indication that the slab may be failing. It is recommended that a Structural Engineer be engaged to design shoring to support the slab.
  - Efflorescence is visible around the edge of a previous wall repair. Efflorescence is a sign of water infiltration into the building envelope which may lead to damage of the wall. It is recommended that a Building Envelope Specialist be engaged to determine the source of the water infiltration and the associated repairs.

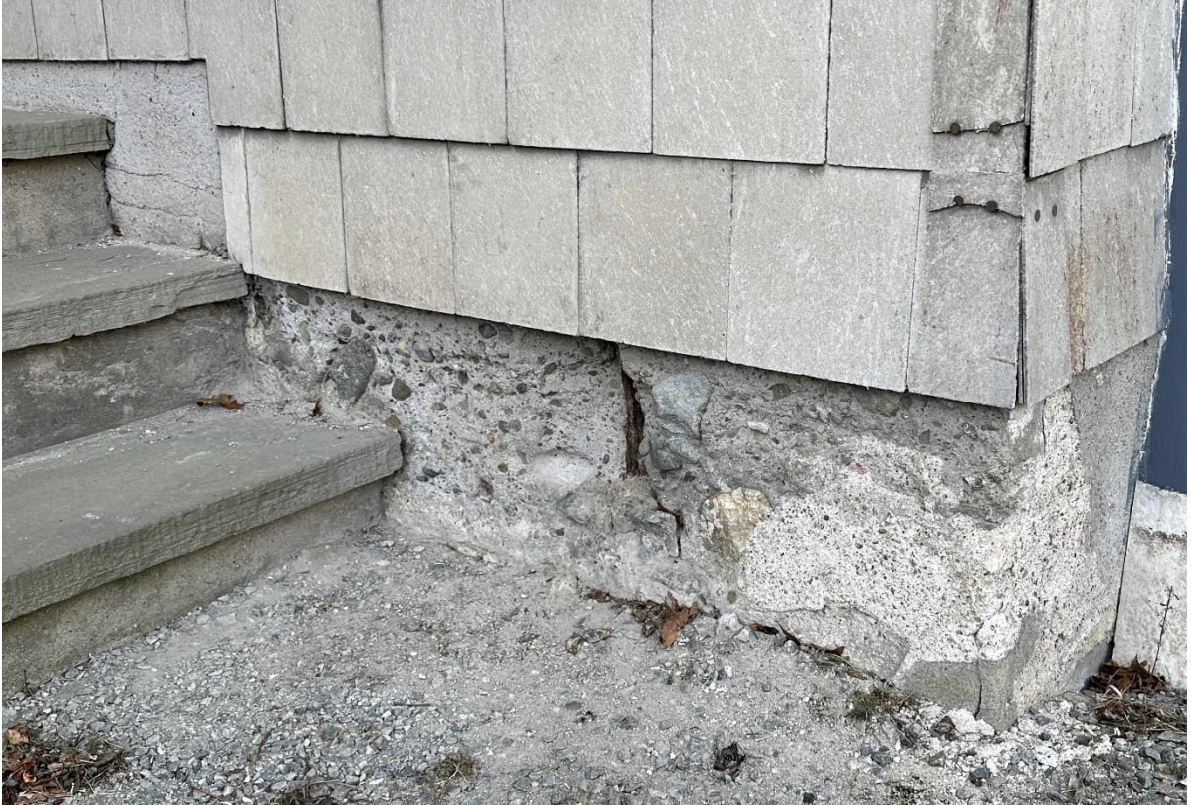
10. Spalled foundation wall, exposed rusting reinforcement.

- Comments and recommendations: The foundation wall adjacent to the main entrance stairs has large areas of spalling, some cracks and exposed rusting reinforcement. The spalling may be due to previous cracks that allowed weather to infiltrate the wall causing expansion of the concrete. The current cracks may allow weather to infiltrate the wall and cause further damage. The exposed rusting reinforcement will expand and cause further cracking of the wall, thus, exposing more reinforcement and continuing the cycle. It is recommended that the cracks and exposed rusting reinforcement be repaired by qualified personnel using high-performance repair materials.

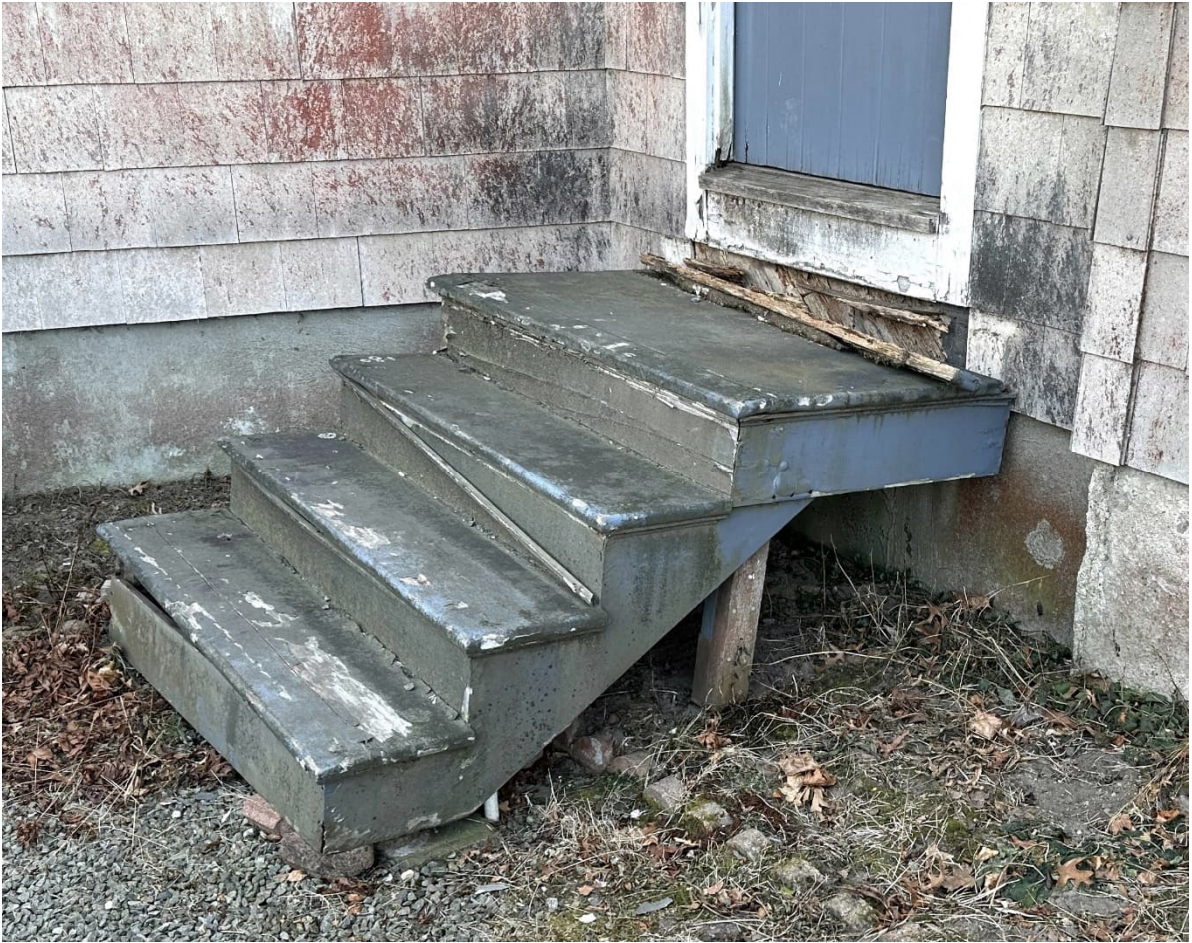
11. Deteriorated stairs.

- Comments and recommendations: The exterior stairs to the hallway between the house and east addition have deteriorated and are failing. The stairs are in a hazardous condition and should be replaced. Where the stair connected to the house appears to also be deteriorating and should be investigated further.

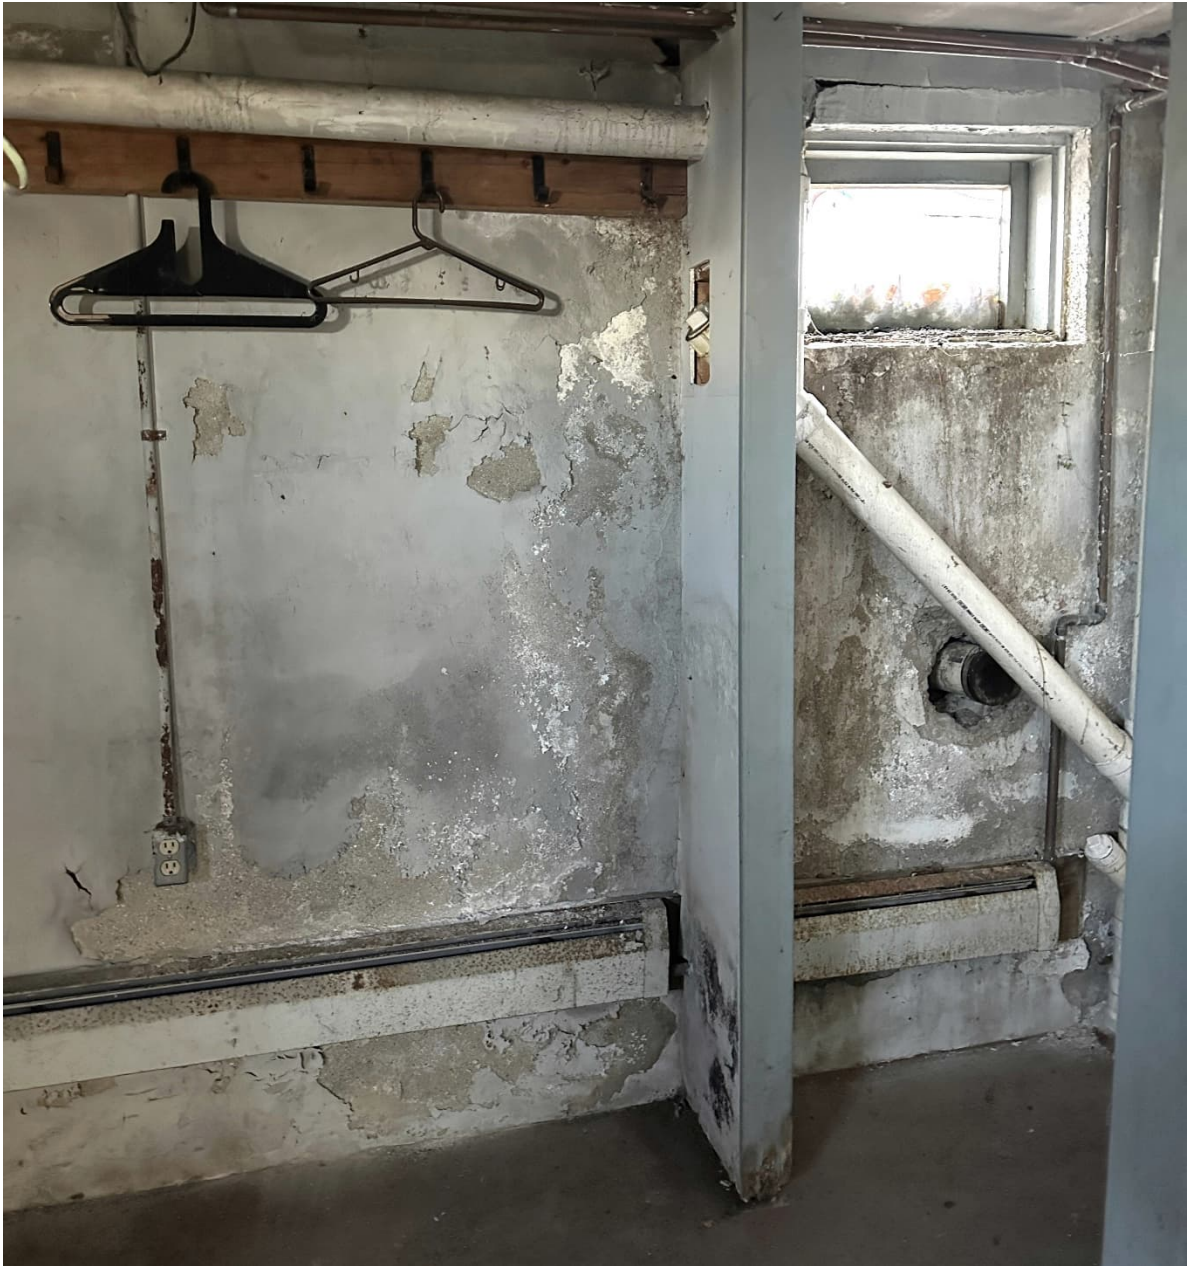
12. Peeling paint and efflorescence at interior foundation walls.

- Comments and recommendations: The interior foundation walls have various areas of peeling paint and efflorescence. Efflorescence is a sign of water infiltration into the building envelope which may lead to damage of the wall. It is recommended that a Building Envelope Specialist be engaged to determine the source of the water infiltration and the associated repairs.

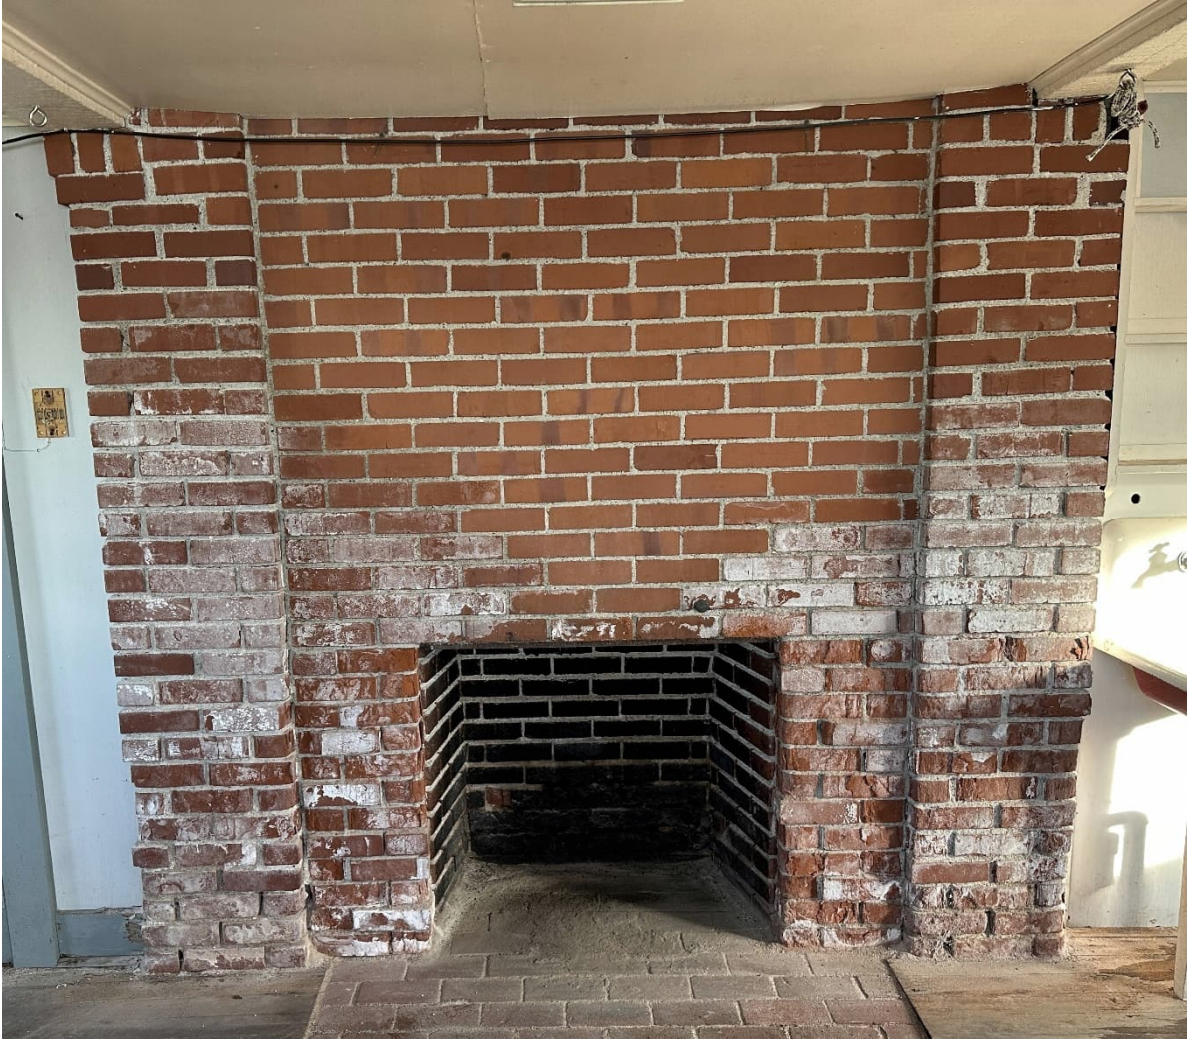
13. Efflorescence at fireplace in basement.

- Comments and recommendations: The fireplace in the basement is showing signs of efflorescence and deterioration. Efflorescence is a sign of water infiltration into the building envelope which may lead to damage of the wall. It is recommended that a Building Envelope Specialist be engaged to determine the source of the water infiltration and the associated repairs. It is also recommended that the brick be repaired and/or replaced by a qualified mason.

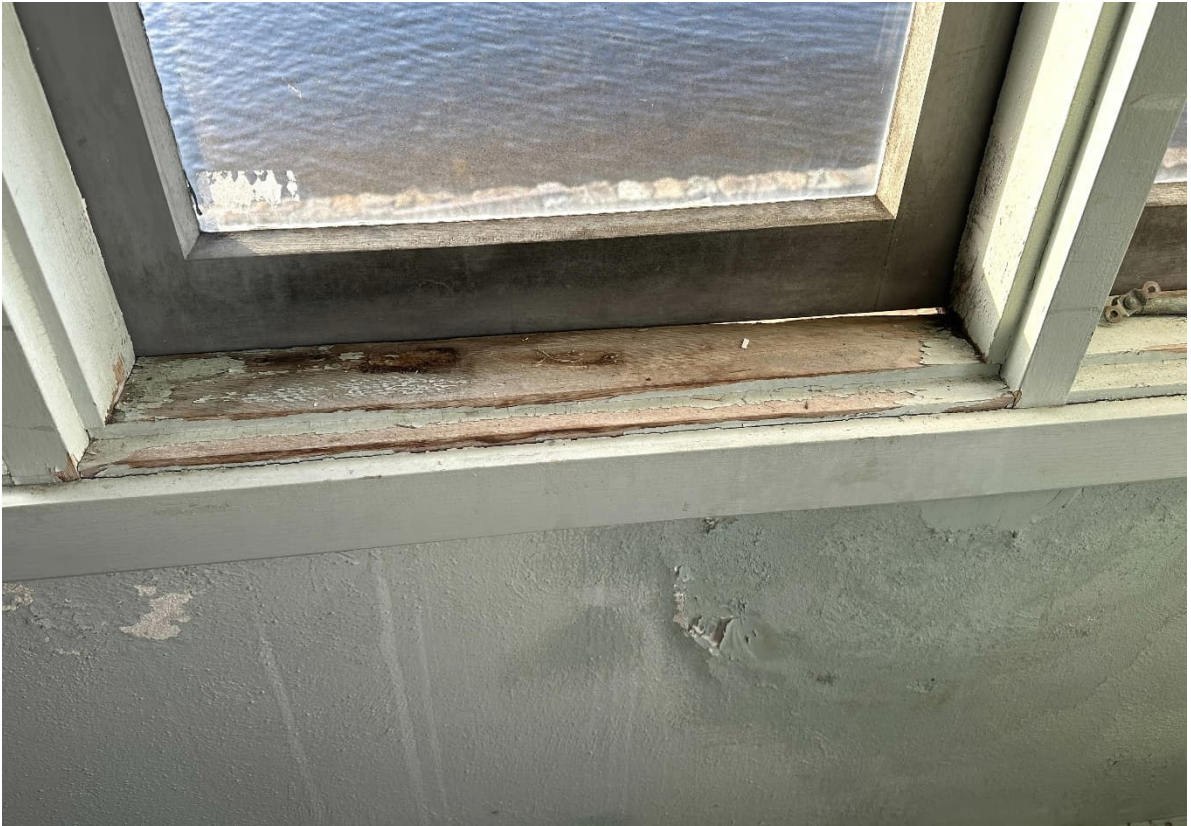
14. Gaps and deterioration at windows.

- Comments and recommendations: Gaps and deterioration was observed at most of the windows. The gaps allow weather to infiltrate the building envelope which can cause the deterioration. The deterioration of the window frames and sills may allow weather to get into the wall cavity which may allow deterioration of the wall structure. It is recommended that further investigation into the wall cavity be performed to determine its condition.

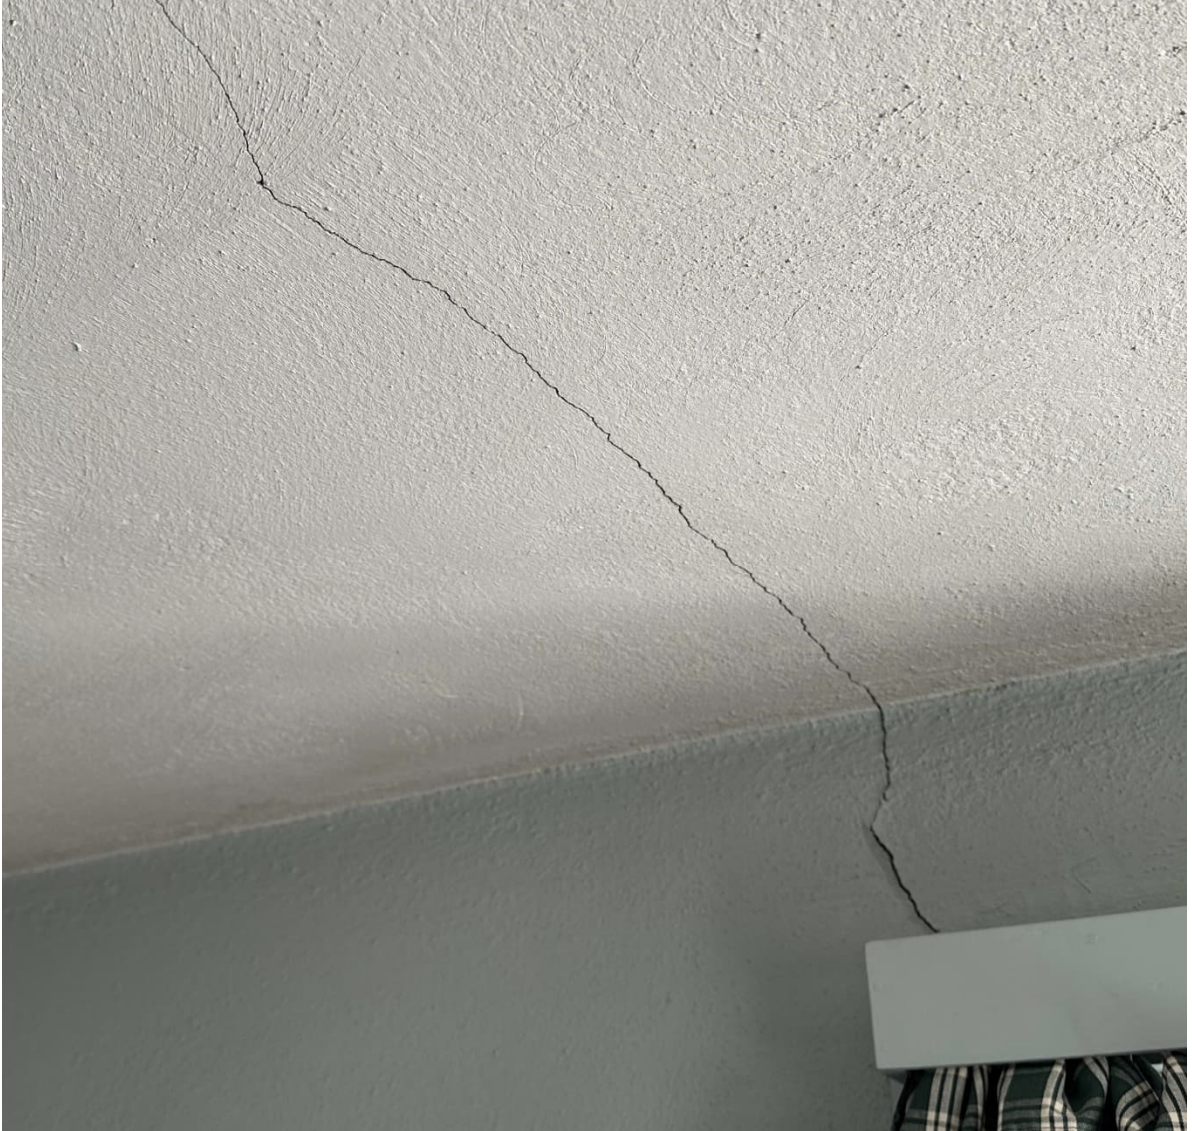
15. Wall and ceiling cracks at house corners.
- Comments and recommendations: The walls and ceilings are cracked at each of the house corners. The cracks are due to movement of the building. The exterior corner columns and walls are showing signs of deterioration which may be allowing the walls to displace. Please refer to comment D.7 for additional information.

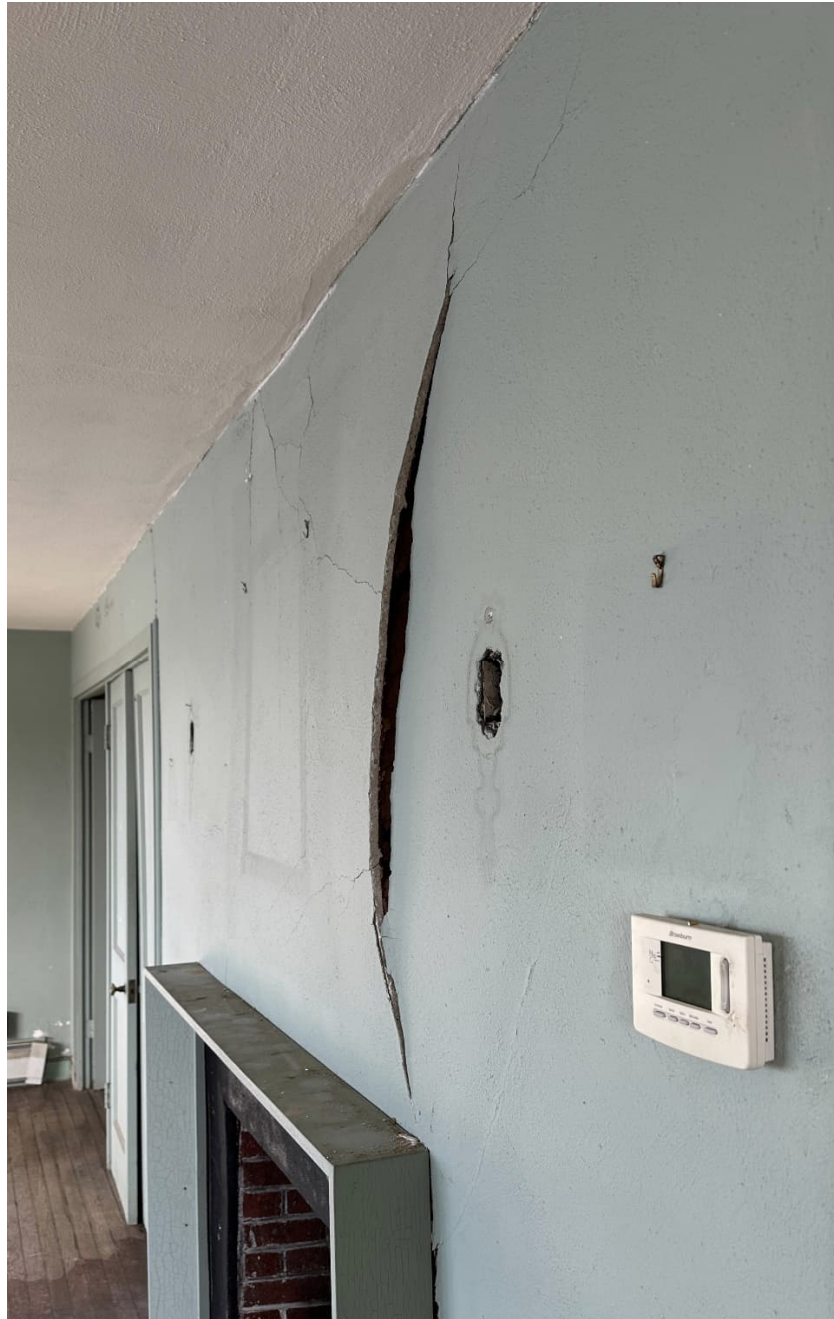
16. Interior wall finish buckling.

- Comments and recommendations: A portion of plaster on an interior wall of the house has detached and buckled outward. This is an indication that the wall behind the plaster may have moved. It is recommended that further investigation of the wall, requiring removal of the plaster, be performed to determine the structural stability of the wall.
