# Bristol Historic District Commission

## Application for Review of Proposed Work - Printable Application

Project Address	Assessor's Plat	Assessor's Lot
125 Hope Street	16	51

125 HOPE STREET, BRISTOL, RHODE ISLAND  
STRUCTURAL INSPECTION, JANUARY 16, 2025

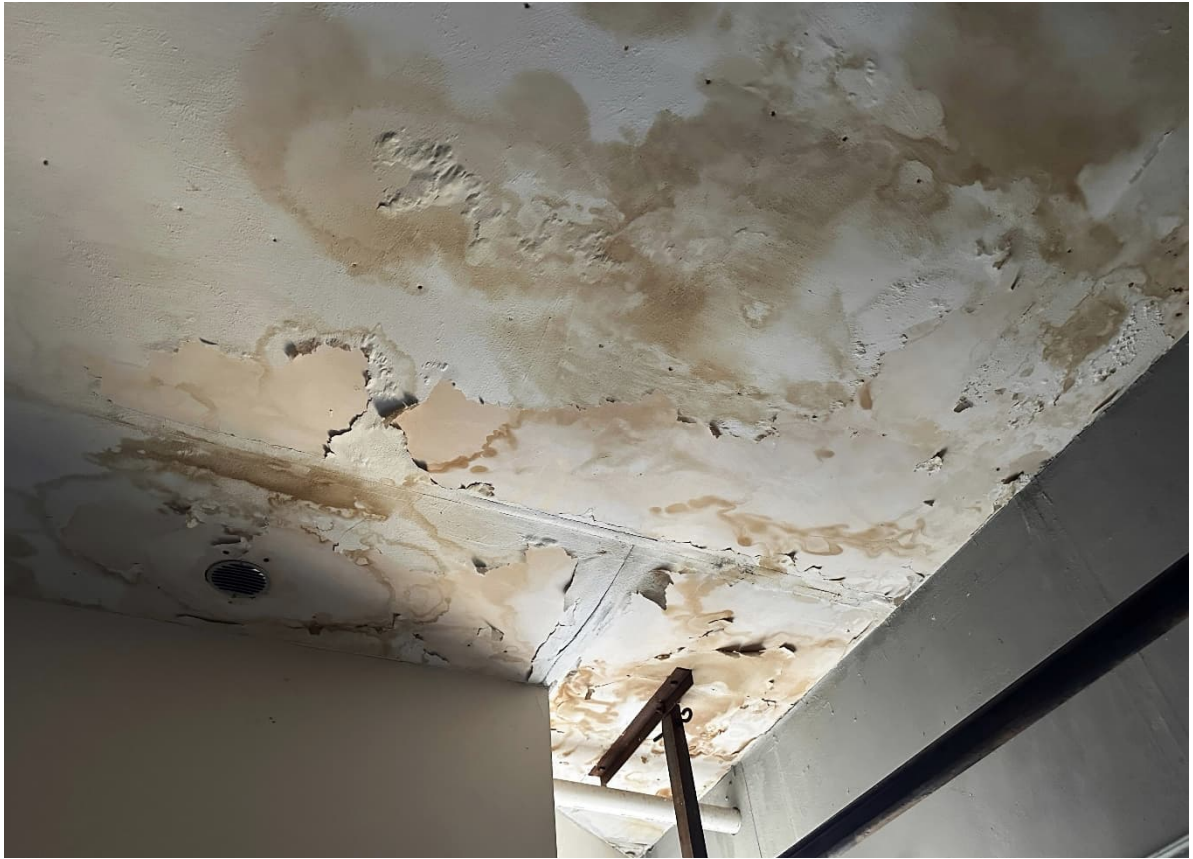
17. Staining on laundry room ceiling.

- Comments and recommendations: There are stains on the laundry room ceiling which indicate the infiltration of water. Prolonged water infiltration may cause deterioration to the roof elements, structural system, and interior finishes. Further investigation is required to determine the cause of the water infiltration and if there is damage to the structure.

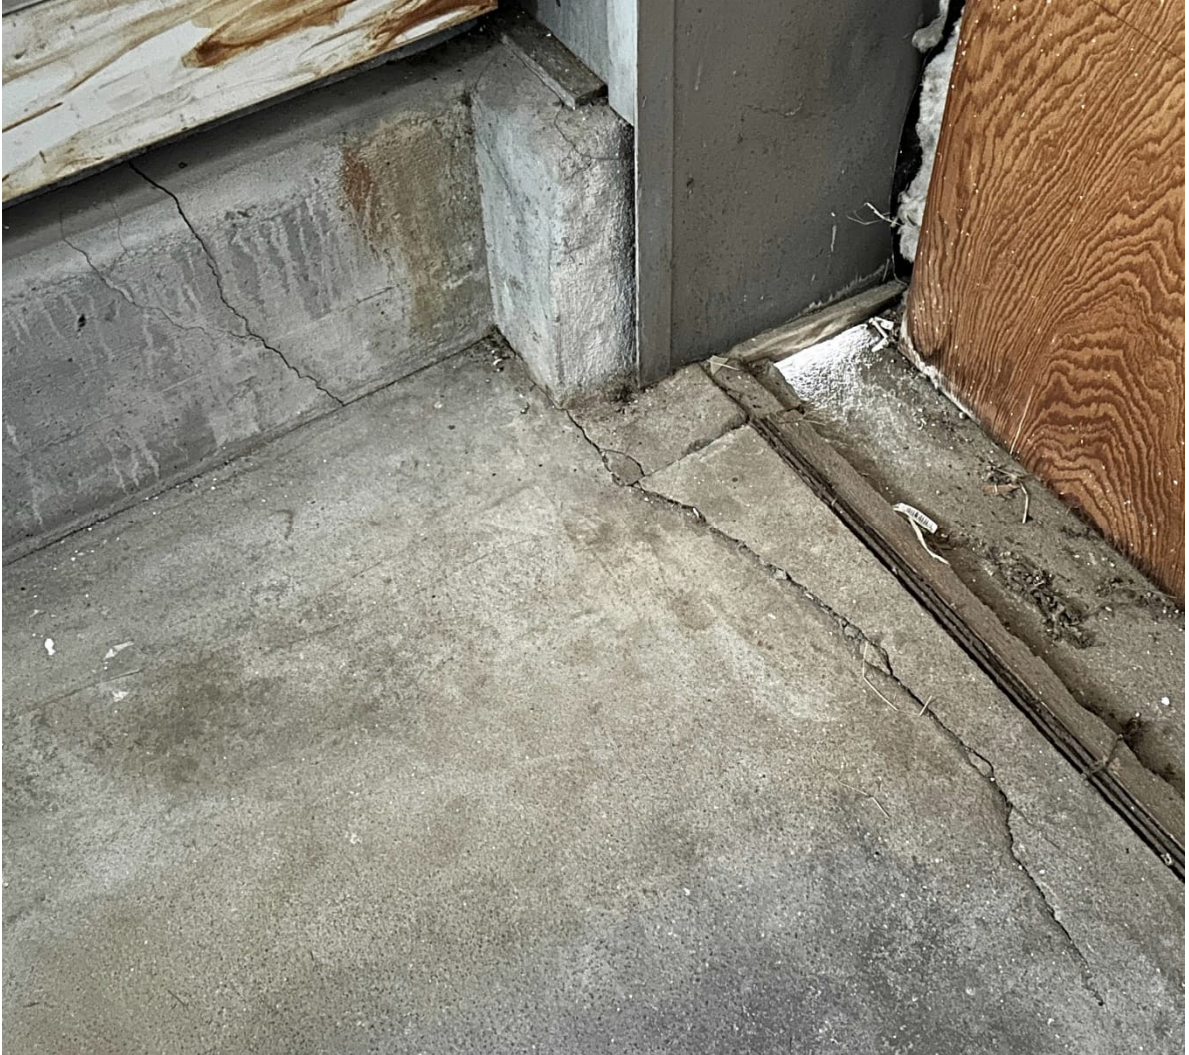
18. Laundry room concrete floor slab and wall cracks.

- Comments and recommendations: Cracks in the laundry room concrete floor slab and wall were observed. The cracks are most likely due to building movement and/or settlement. It is recommended that the cracks be repaired using high-performance materials by qualified personnel.

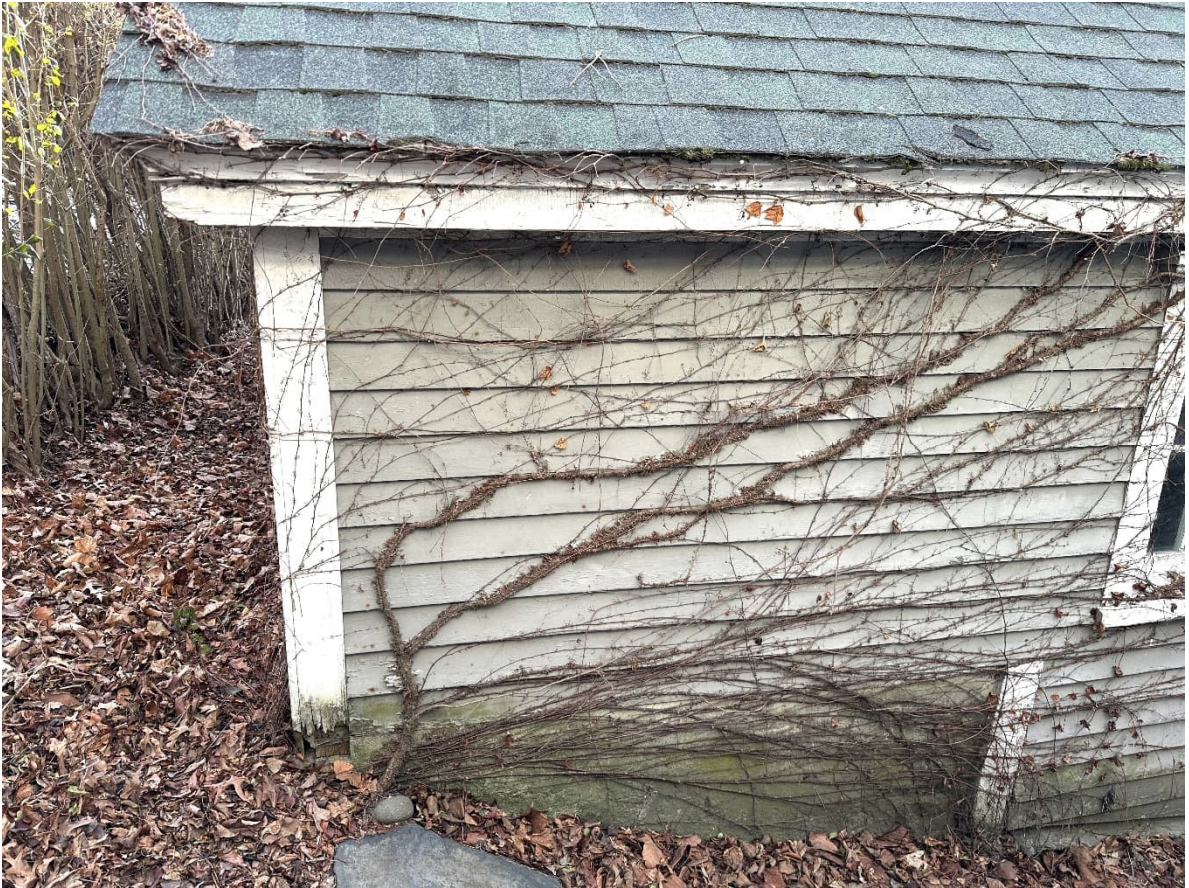
19. Deterioration and vegetation at shed exterior.

- Comments and recommendations: Deterioration of the exterior wood and attached vegetation on the shed was observed at various locations. It is recommended that the deteriorated parts be replaced in-kind and the vegetation be removed as it can create openings in the building envelope which may allow water and air infiltration that could cause damage to the structure and/or exterior of the shed.

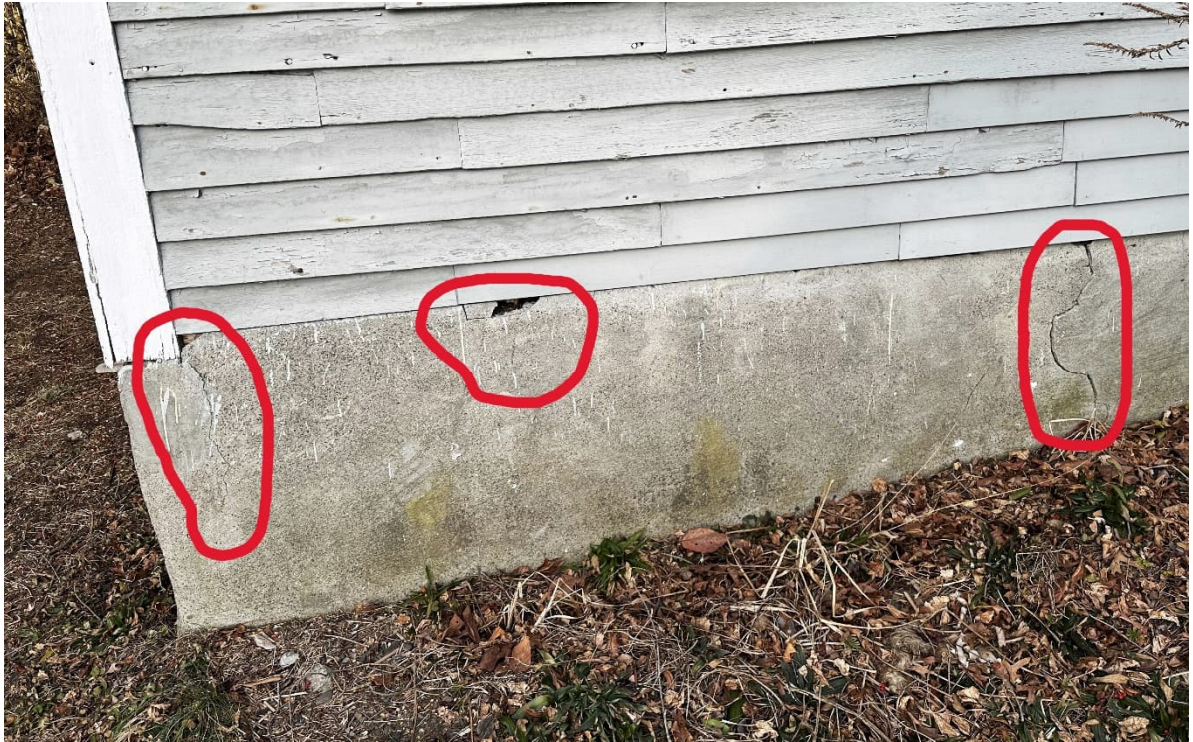
20. Shed foundation wall cracks.

- Comments and recommendations: The shed foundation wall has cracks at various locations. The cracks may be due to lateral forces, settlement, and/or building expansion/contraction from changes in temperature and humidity. The cracks may allow weather to infiltrate the wall and cause further damage. It is recommended that the cracks be repaired by qualified personnel using high-performance repair materials.

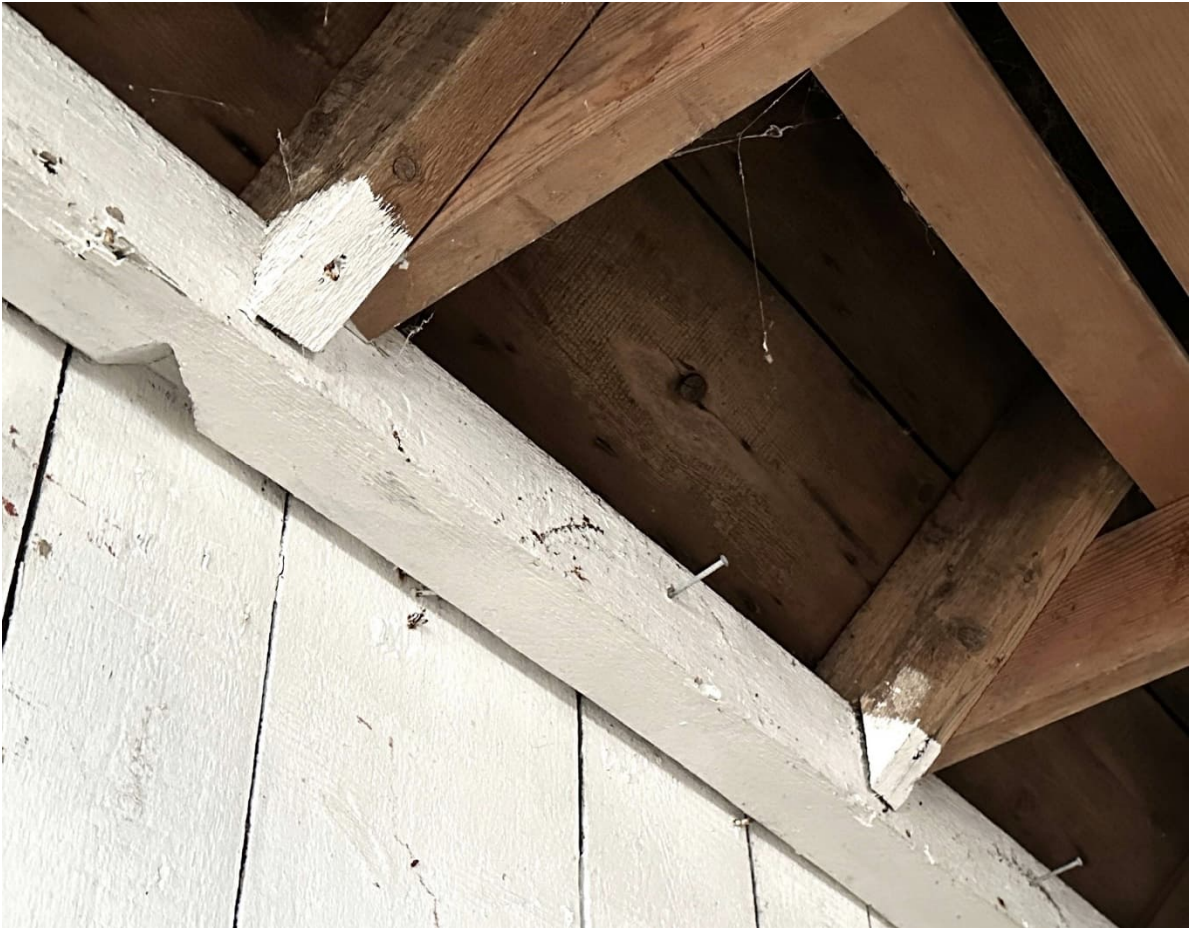
21. Shed roof framing connections potentially insufficient for uplift.
- Comments and recommendations: The shed roof framing appears to be connected to the perimeter beam by a single nail which is potentially insufficient to resist design wind uplift forces. It is recommended that joist hurricane straps be installed to connect the joist to the perimeter beam.

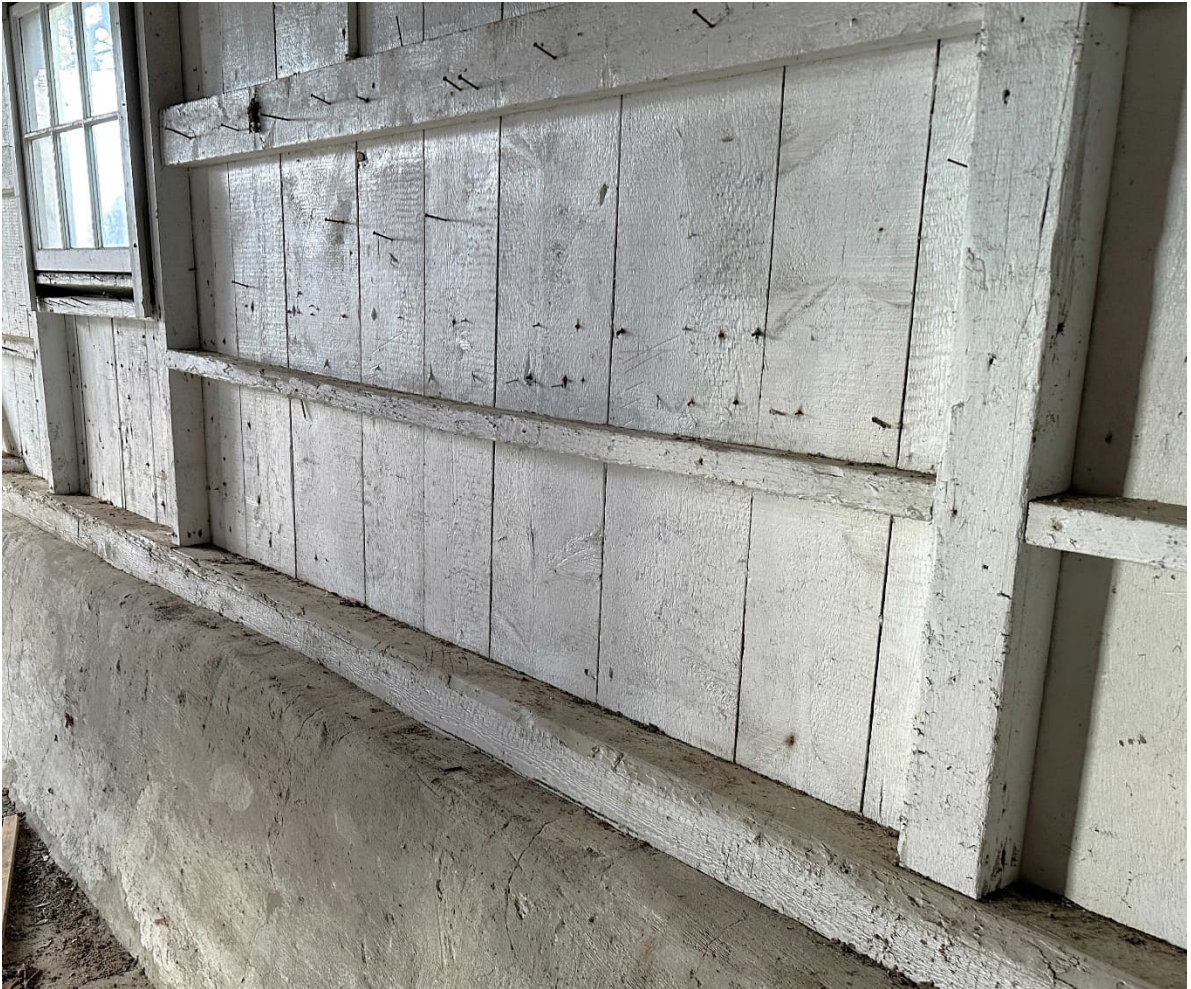
22. No sill anchors.

- Comments and recommendations: The shed sill plate does not appear to be anchored to the foundation wall. The purpose of the sill plate anchors is to prevent uplift of the building walls and columns, such as when experiencing lateral loads (wind and/or seismic). This is a structural hazard, and it is recommended that appropriate anchorage be designed by a Structural Engineer and installed by a qualified contractor.
