**Carriage House at The Belvedere, 423 Hope St., Bristol, RI 02809**

Plat: 10 Lot: 3

CORDTSEN DESIGN ARCHITECTURE, INC  
42 West Main Rd • Middletown • RI  
CordtsenDesign.com • 401.619.4689

August 8th, 2025

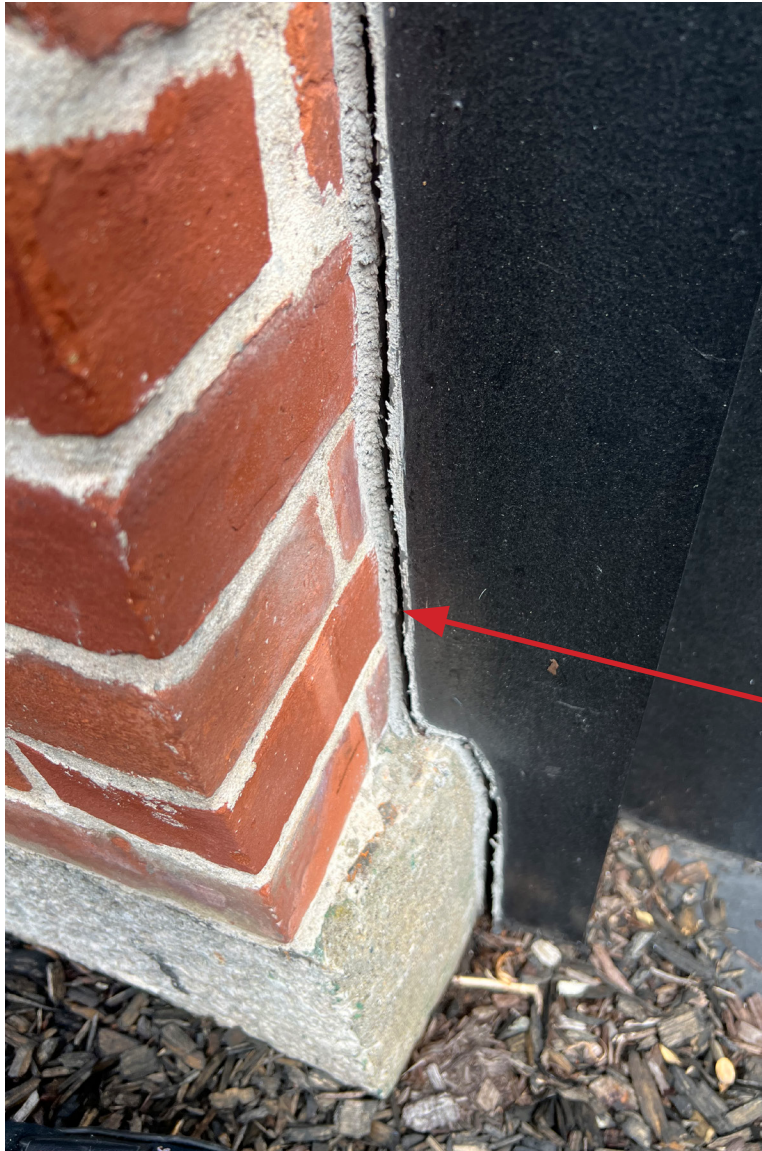
**Existing Conditions: Exterior Damage**

Separation of wood from stone due to water damage from improper installation practices

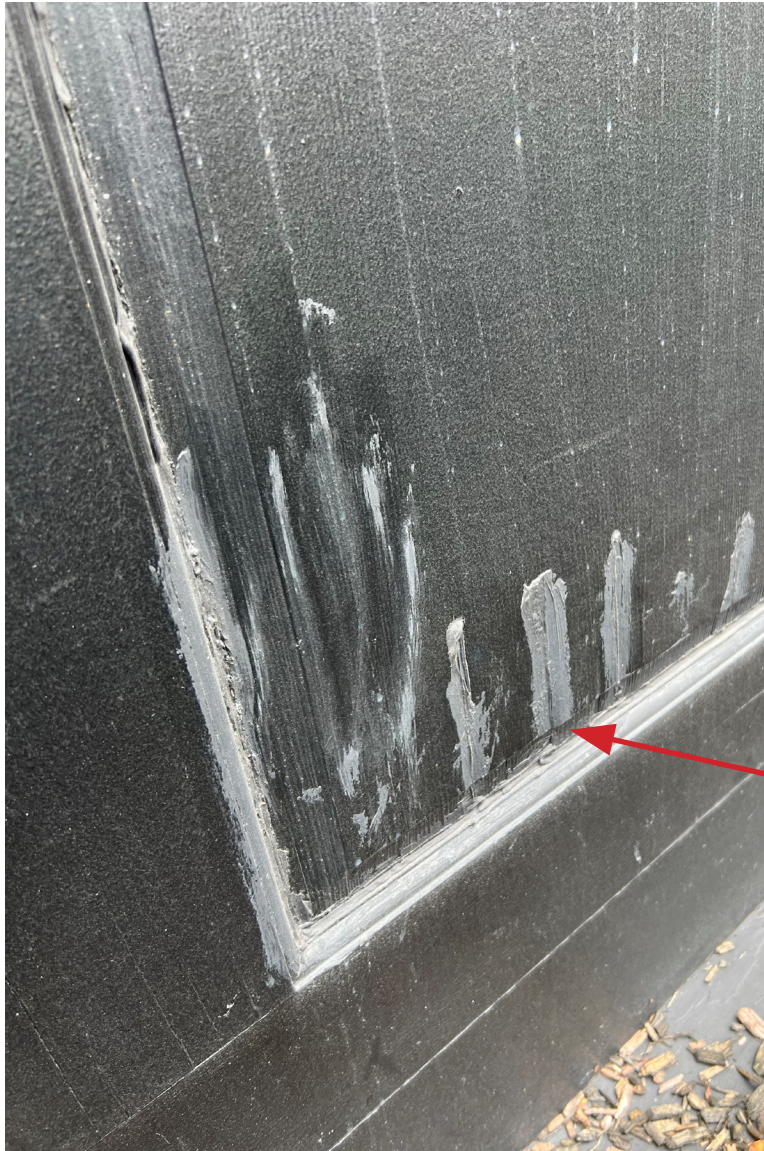
**Existing Conditions: Exterior Damage**

Water damage  
causing wood rot

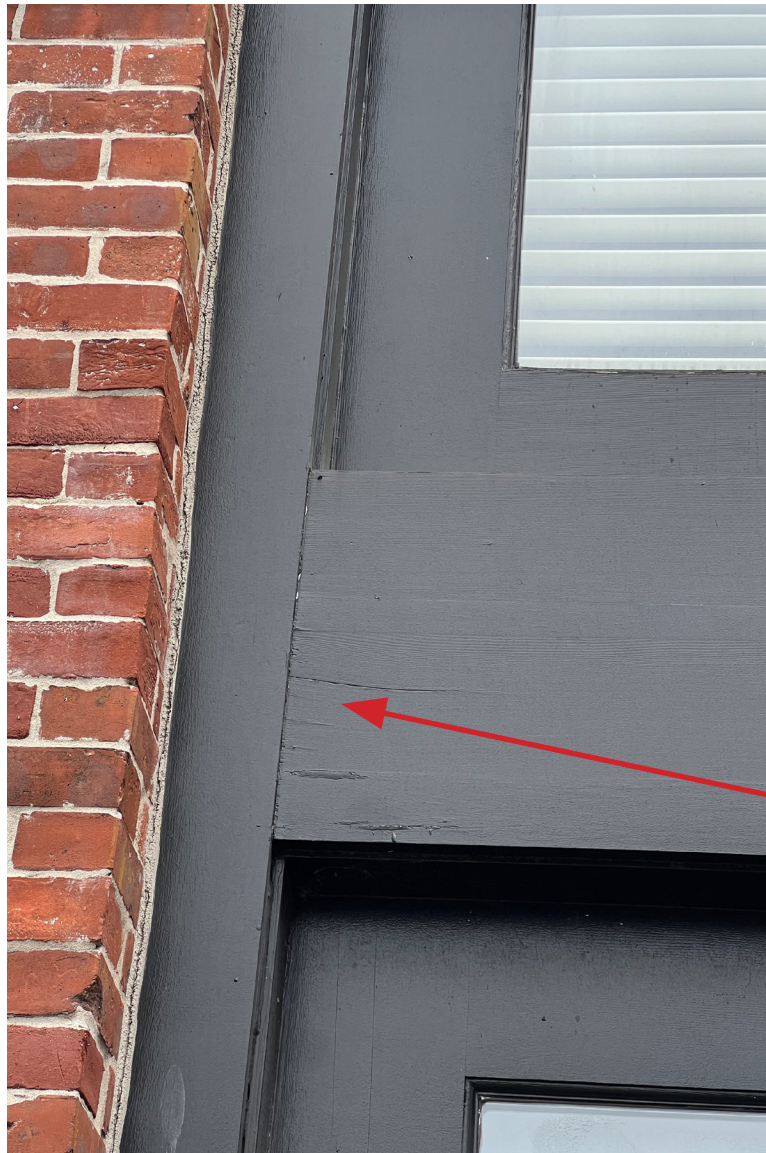
**Existing Conditions: Exterior Damage**

Water damage  
causing damage  
to framing  
members

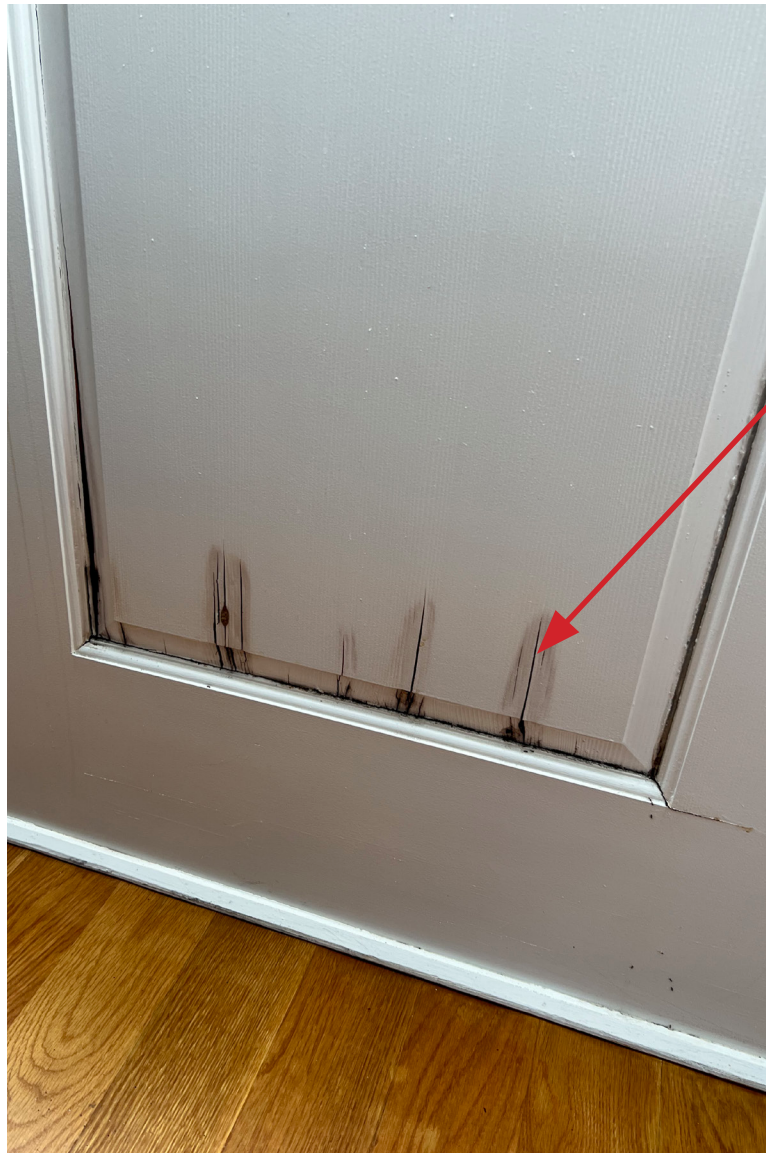
**Existing Conditions: Interior Damage**

Wood rot &  
growth of fungus  
due to water  
damage

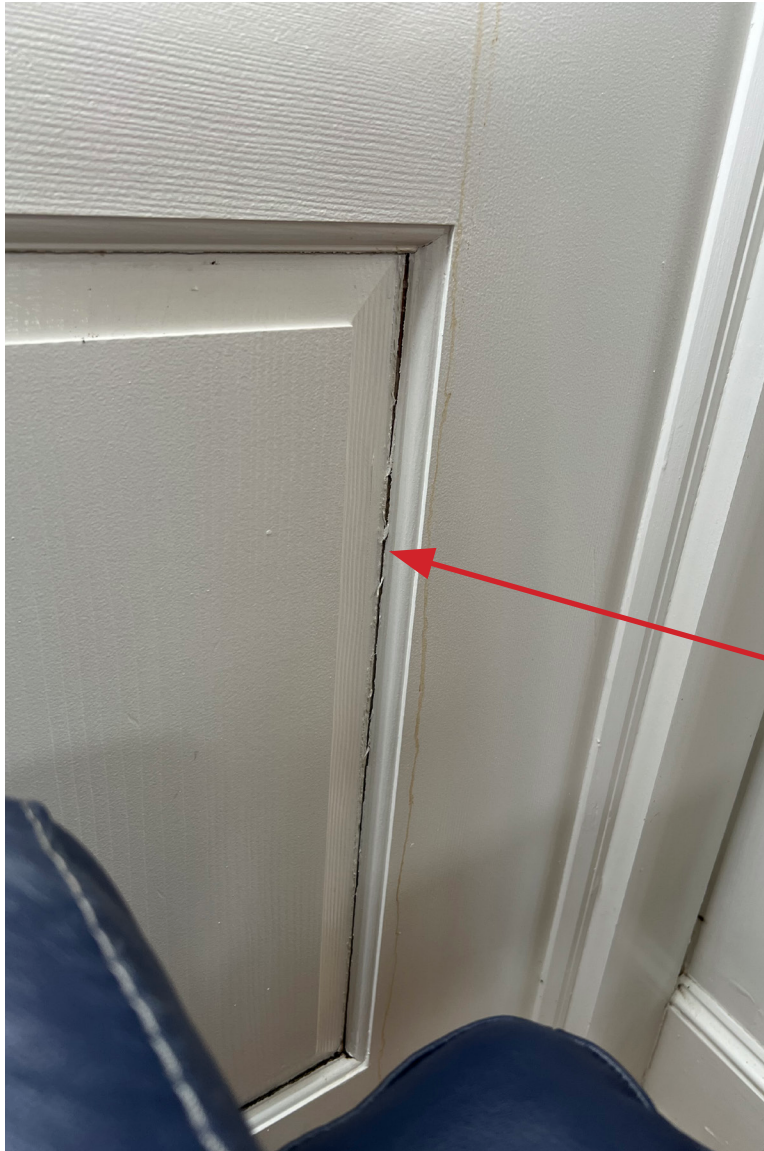
**Existing Conditions: Interior Damage**

Wood rot due to  
water damage
