## *HDC 186 Hope St Projects September 2025*

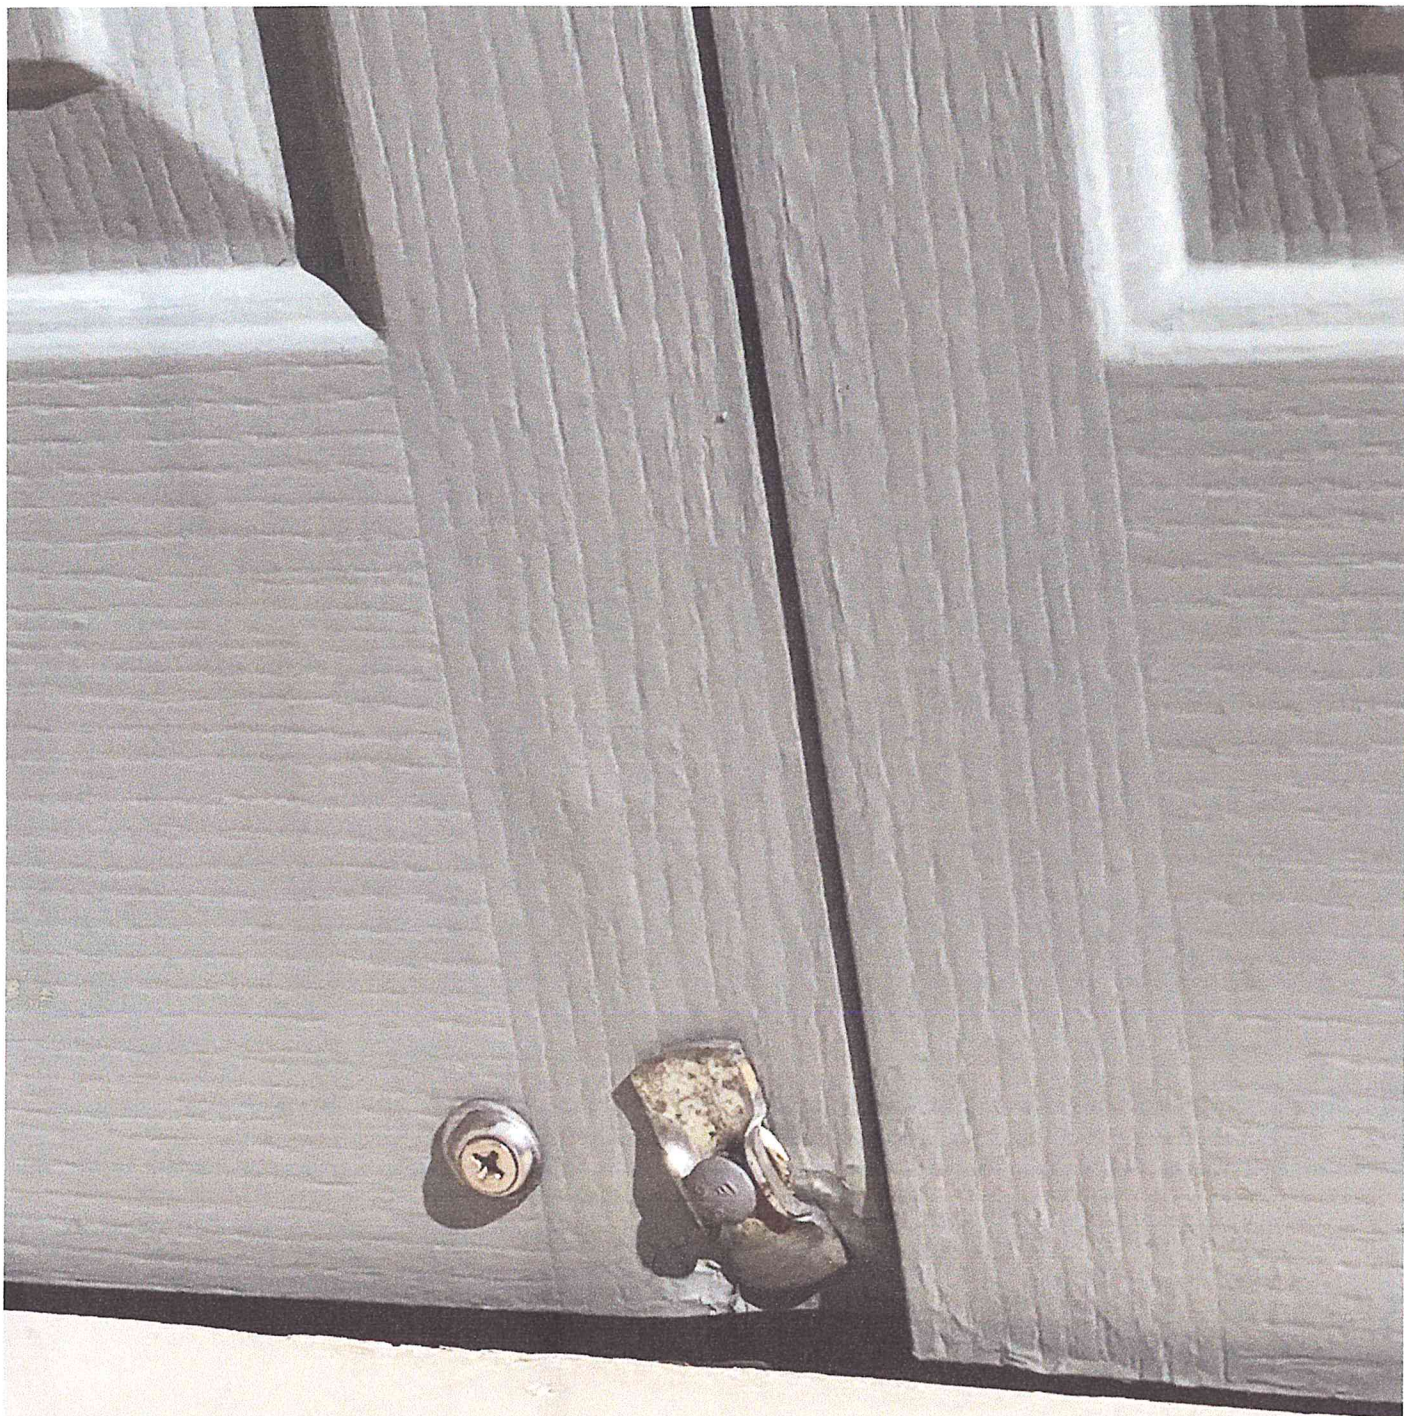
- 1 Garage Door. Replace door. (rot at right edge). Contractor supplier said cannot repair or replace lower panel. Must. replace entire door. Cut sheet attached.

Garage Door (New - 2005) Lower Panel Right Side Ret  
FACES BUETOW (BACK 60') / ~~PREVIOUSLY~~ DEPICTION

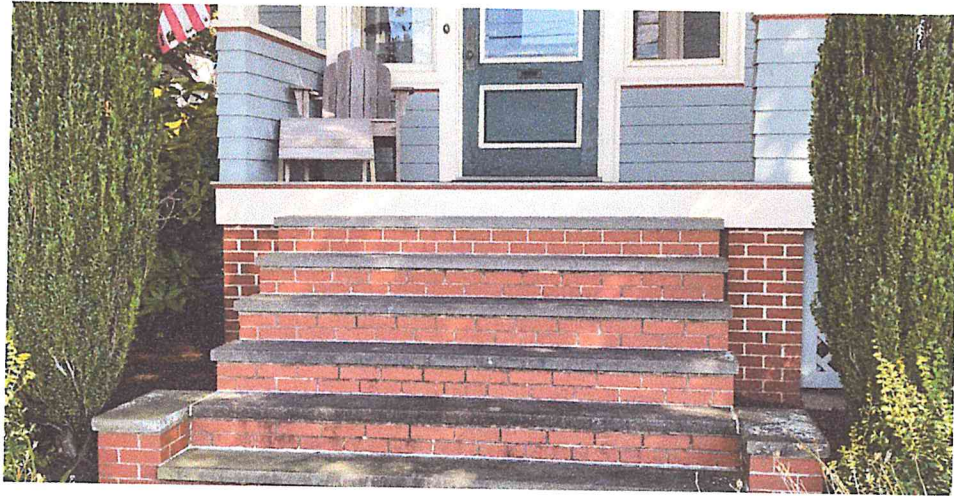
2005 SIDE ENTRANCE BURTON ST SIDE  
Porch Step Joists? Rot

- 2 Back porch stairs: replace decking and joists and posts in kind as necessary.
- 3 Front entry steps: (added in 2005) Install iron railing similar in material to pre 2005 railings but with straighter lines more in harmony with overall design of house and porch.

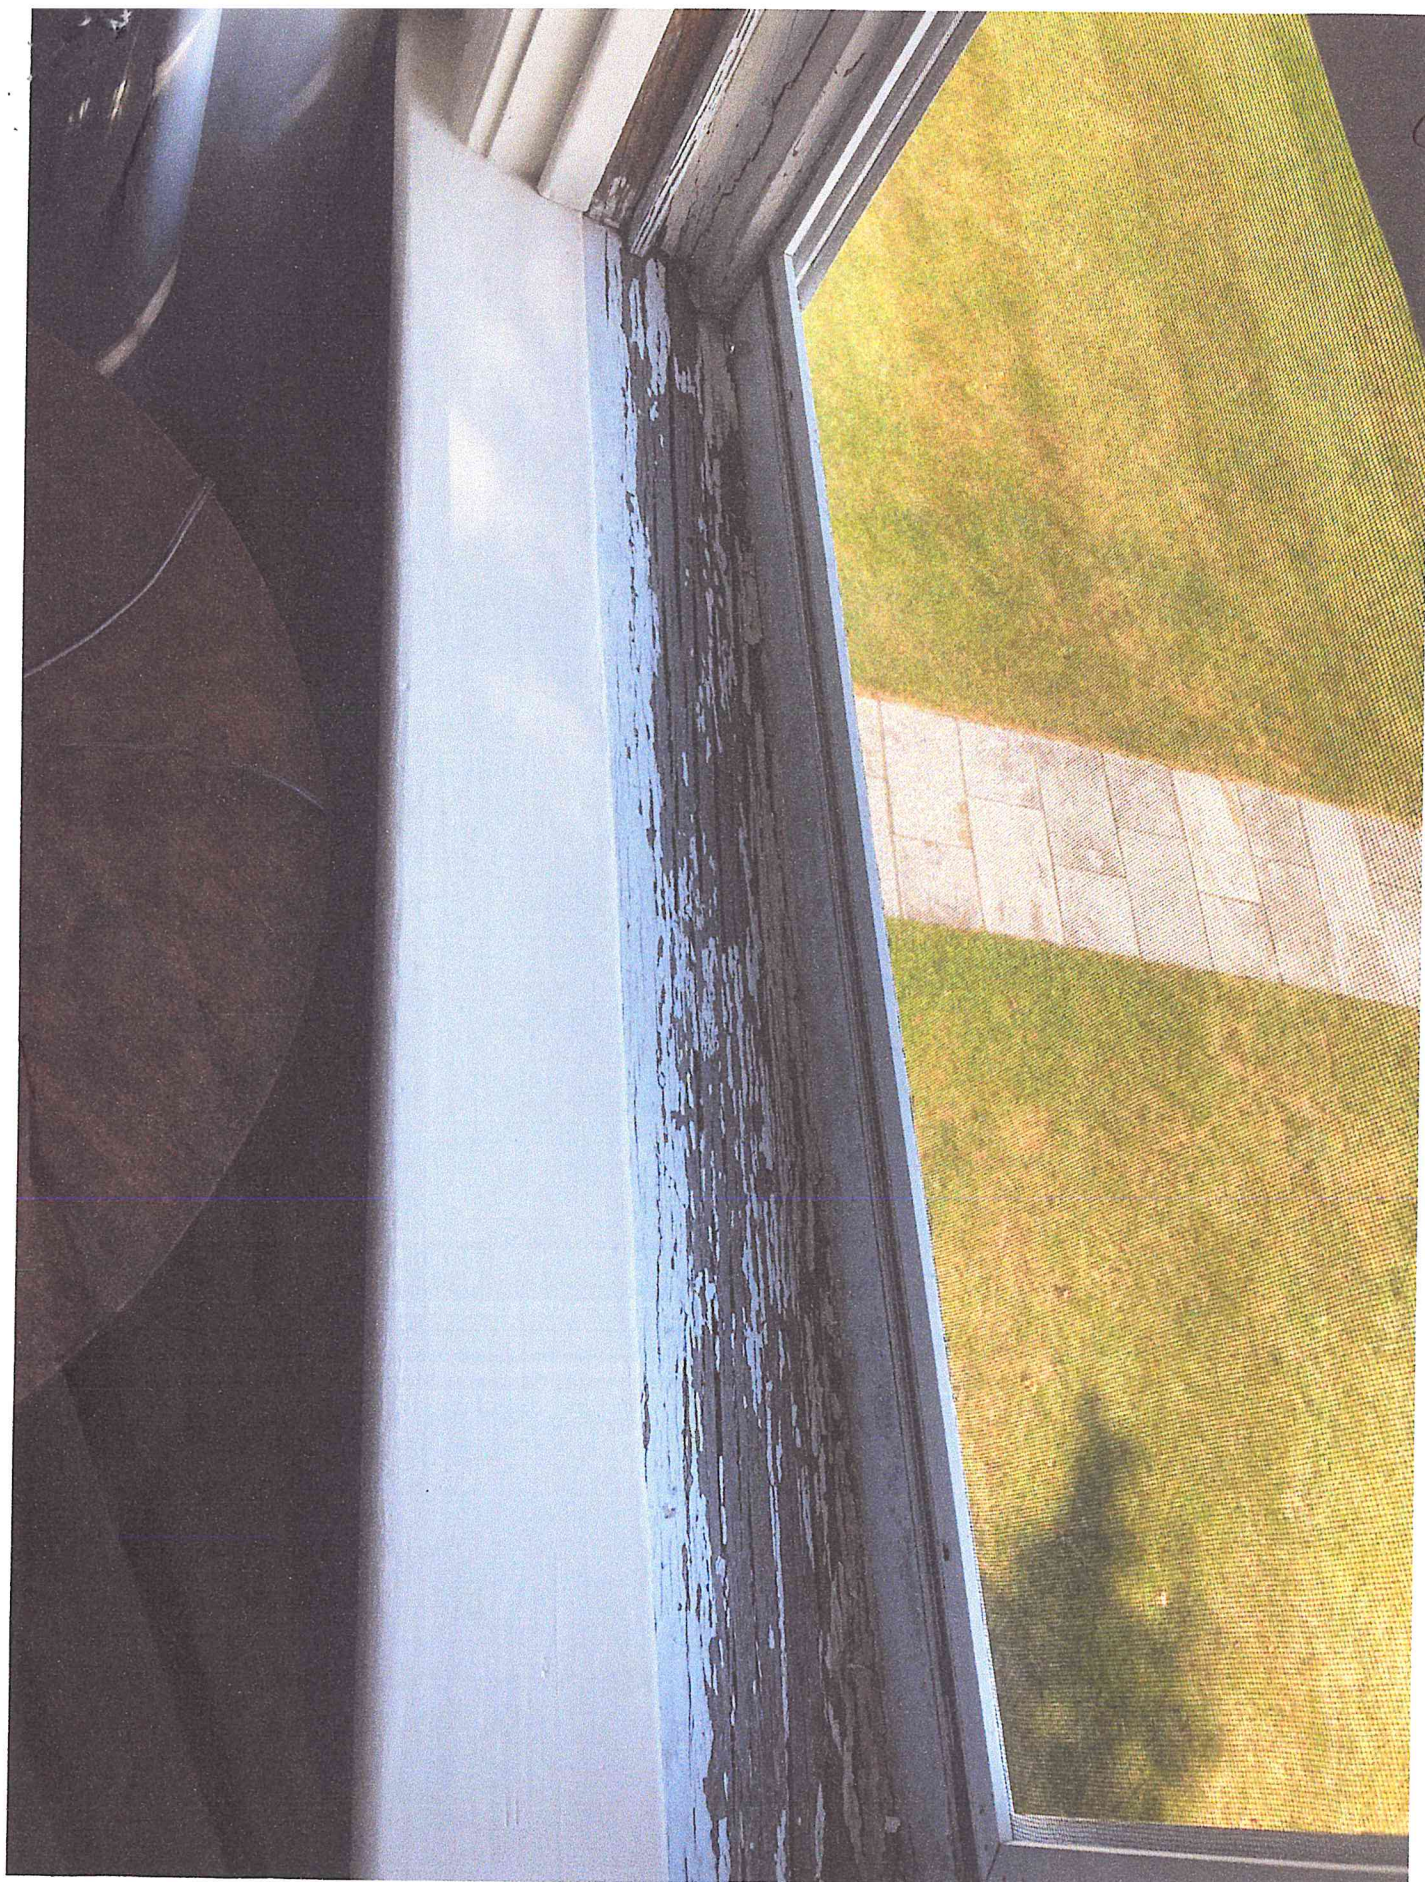
~~4~~  
4

2005 Addition 2nd Floor EAST WINDOW

FINGER JOINT SILL ROT

- 4 Window sill and trim, second floor East side (2005 Addition): replace rotted finger joint pine with mahogany.
- 5 Window, 2nd floor East bedroom, South face: replace in kind: sill, some trim pieces, parting beads and some internal frame pieces as needed, reglaze, saving original glass.

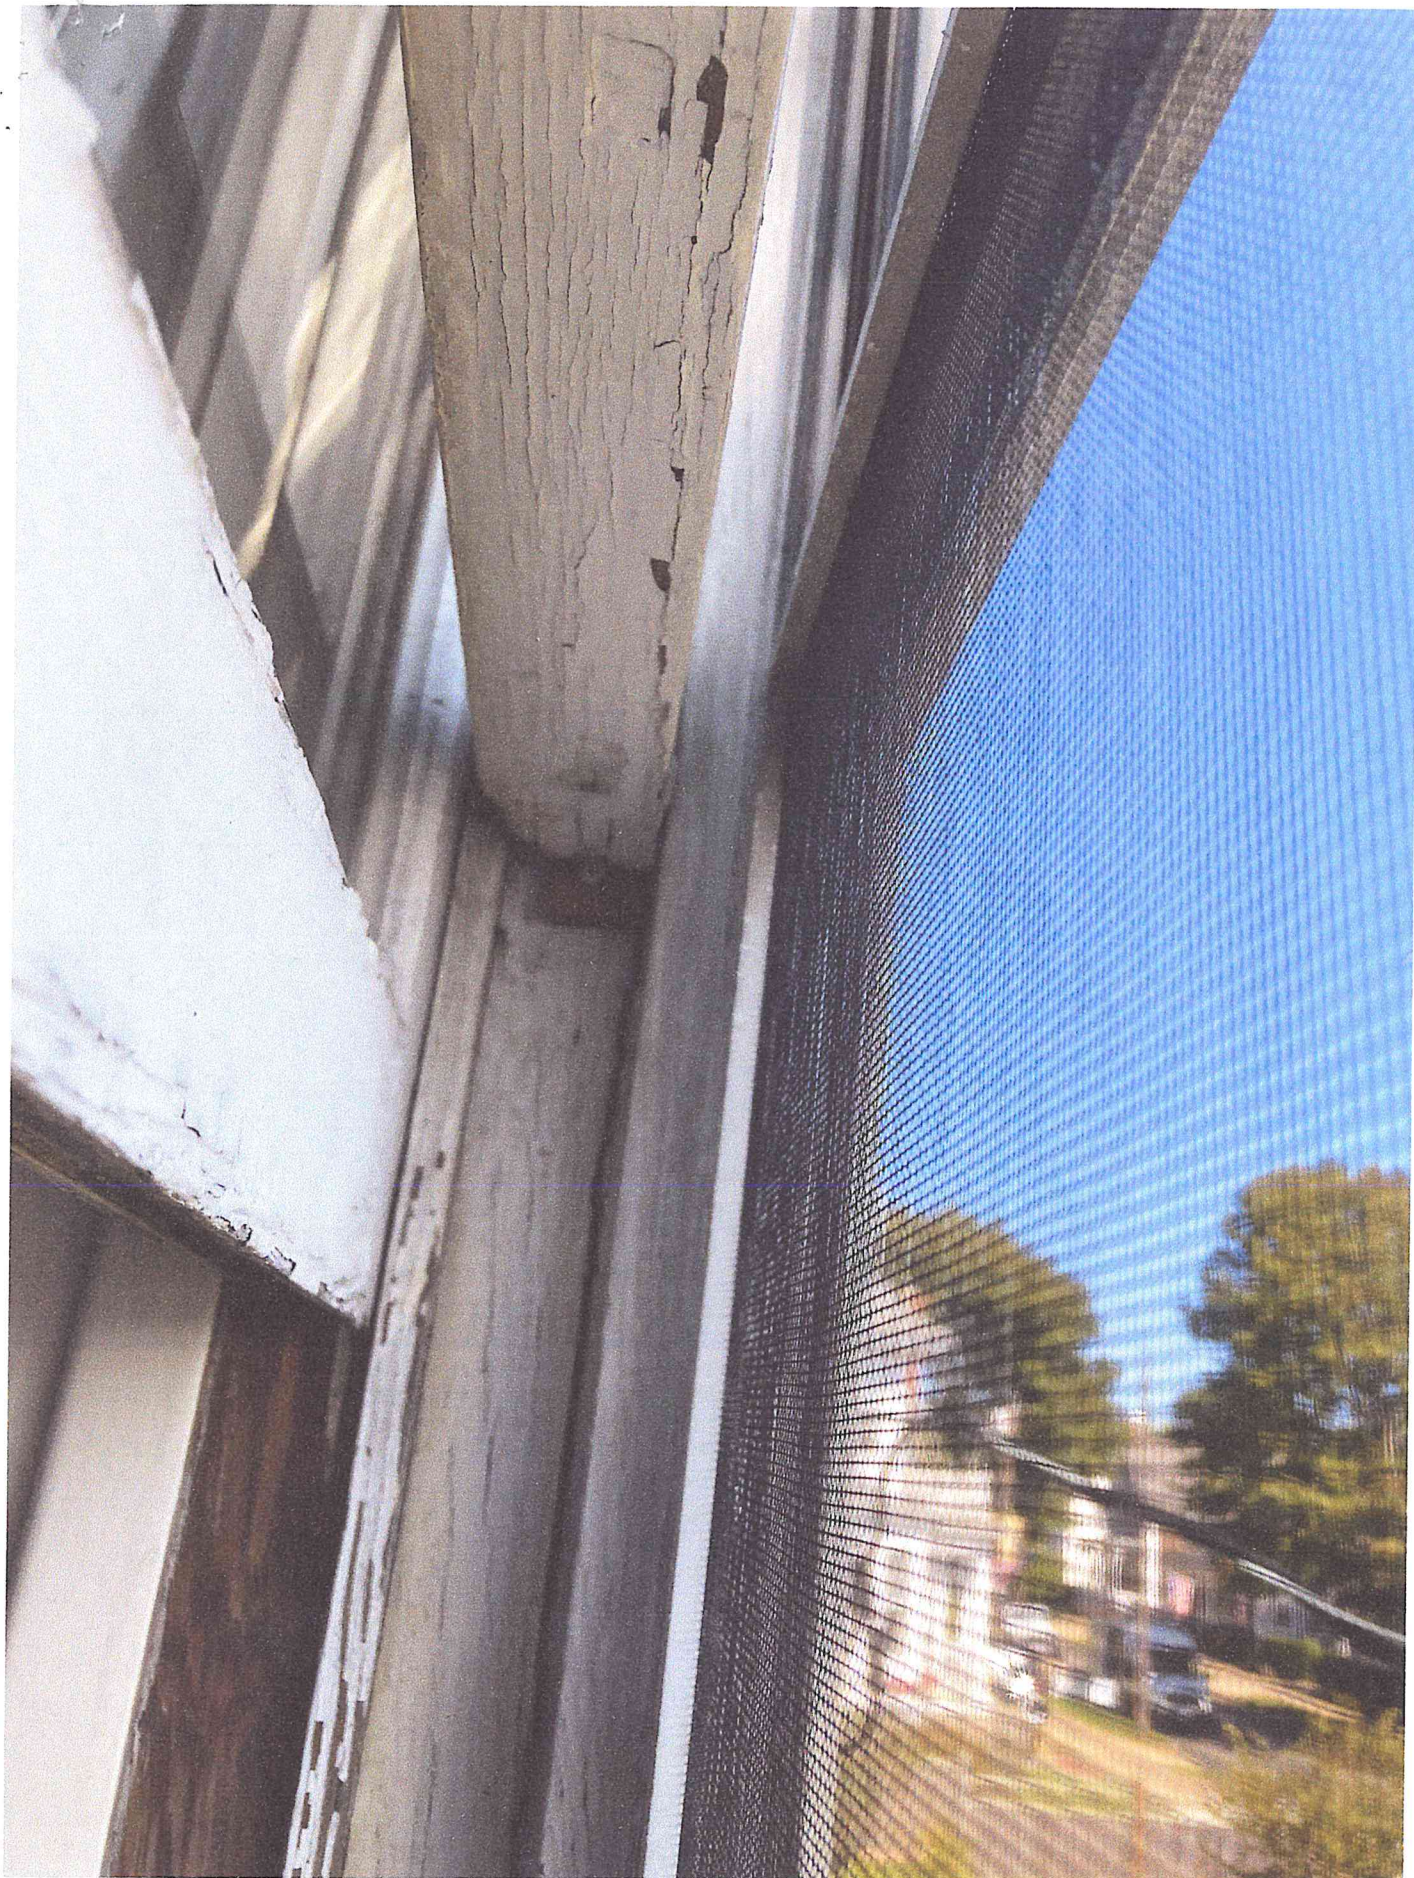
~~5~~  
5

(A) Sill 2ND FLOOR Burton St. S.E. Bedroom  
ORIGINAL : REPAIRED IN @ 2000

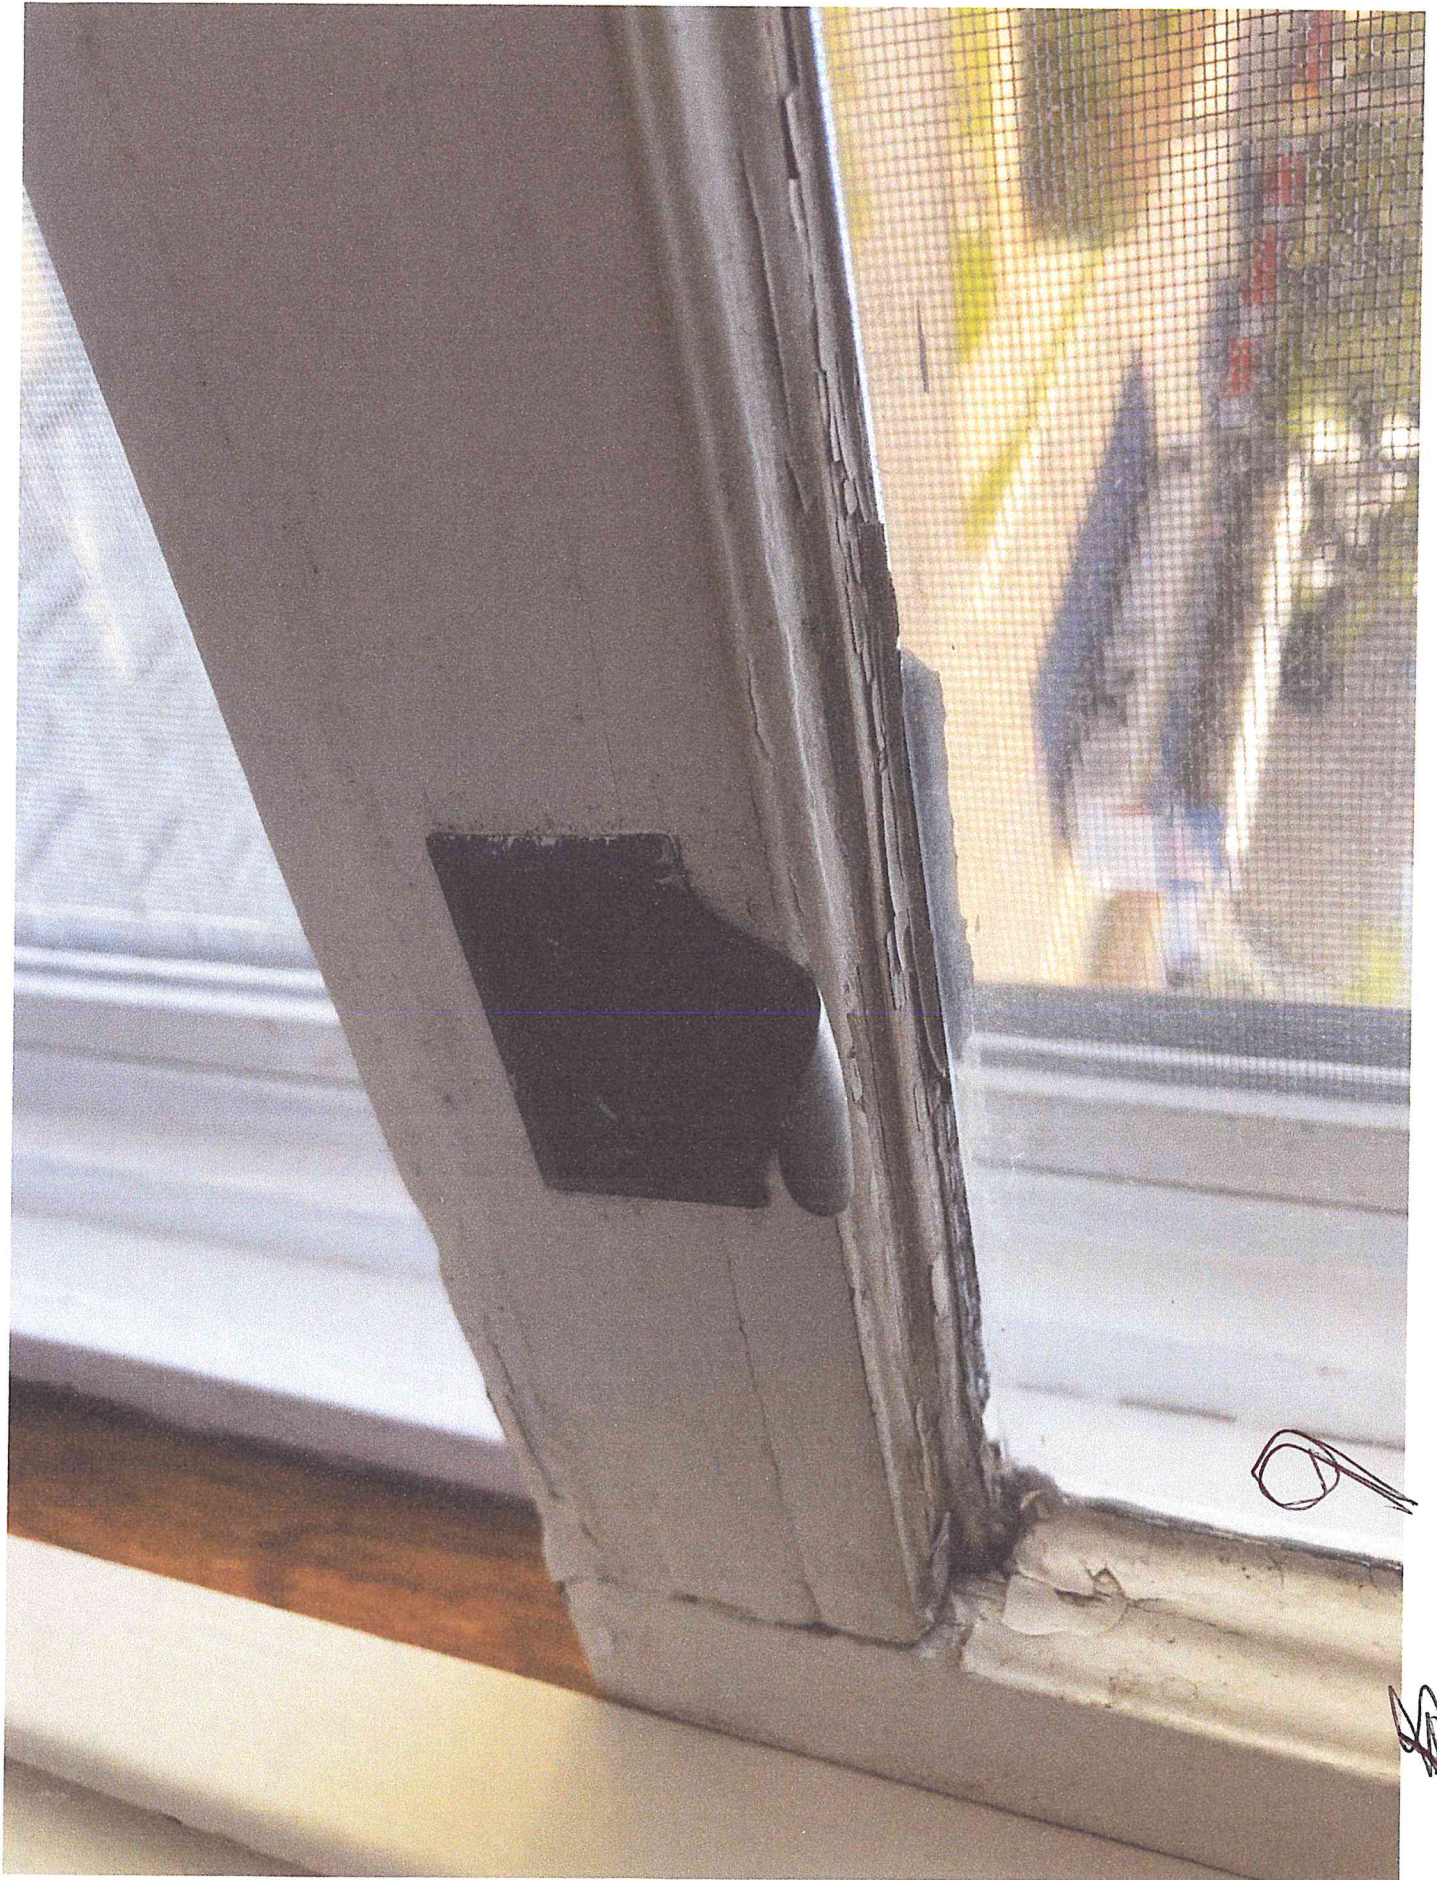
2ND FLOOR BORTON S.E. BR  
PARTING BEAD UPPER SASH LOWER RAIL  
BOTH SIDE TRACKS ??? ROT

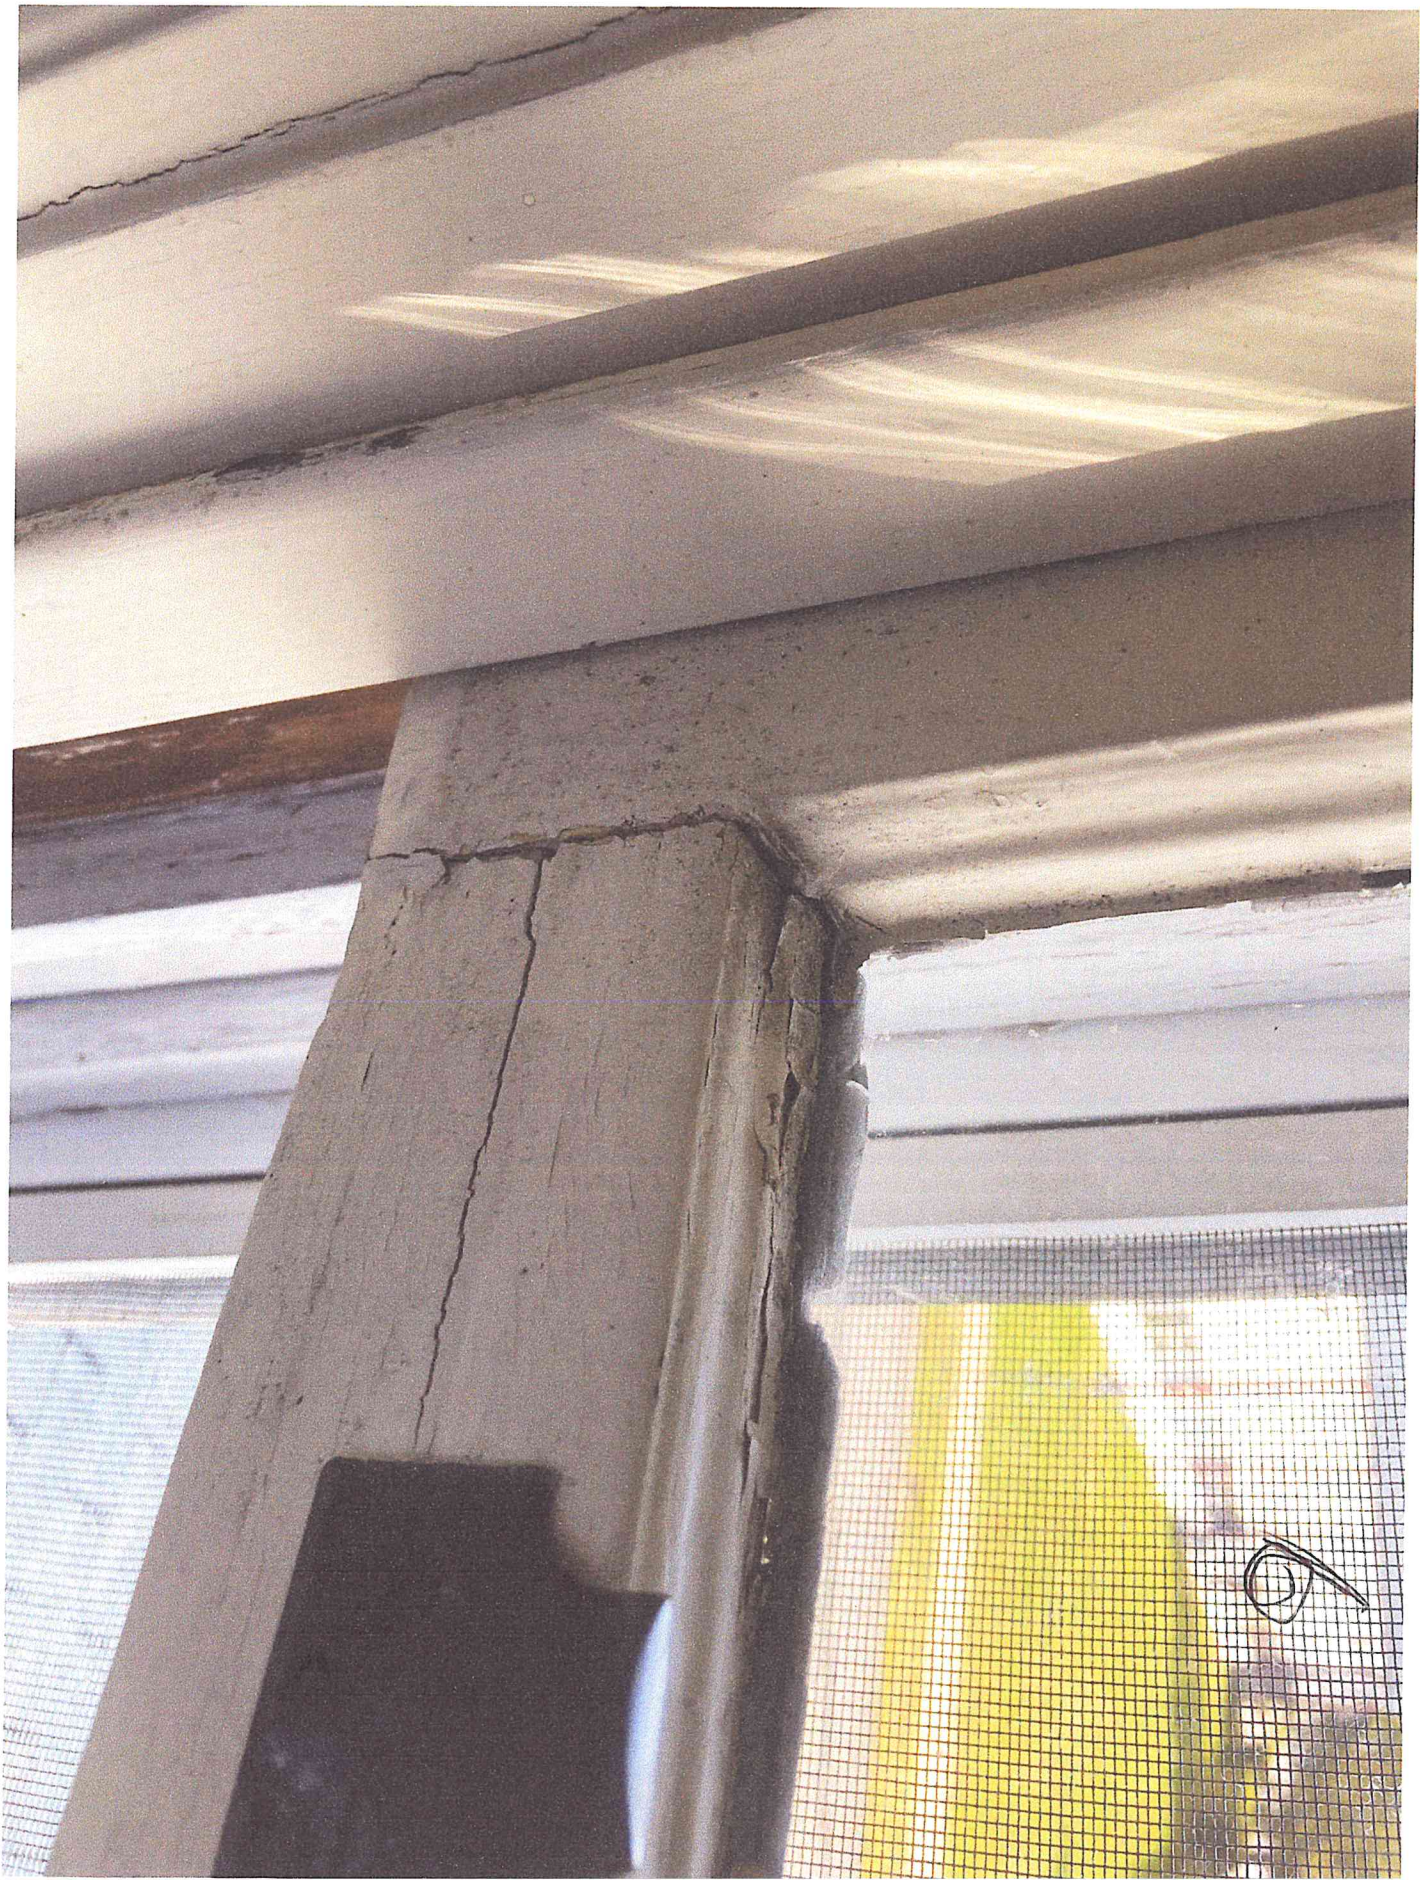
2ND FLOOR MASTER BR LEFT DOUBLE WINDOW RIGHT SIDE LOWER SASH

LEFT SIDE LOWER SASH  
11/18/11

- 6 Windows South and West side, first and second floor: repair/replace in kind some sash pieces; some frame and trim pieces with in kind materials. Reglaze saving original glass.

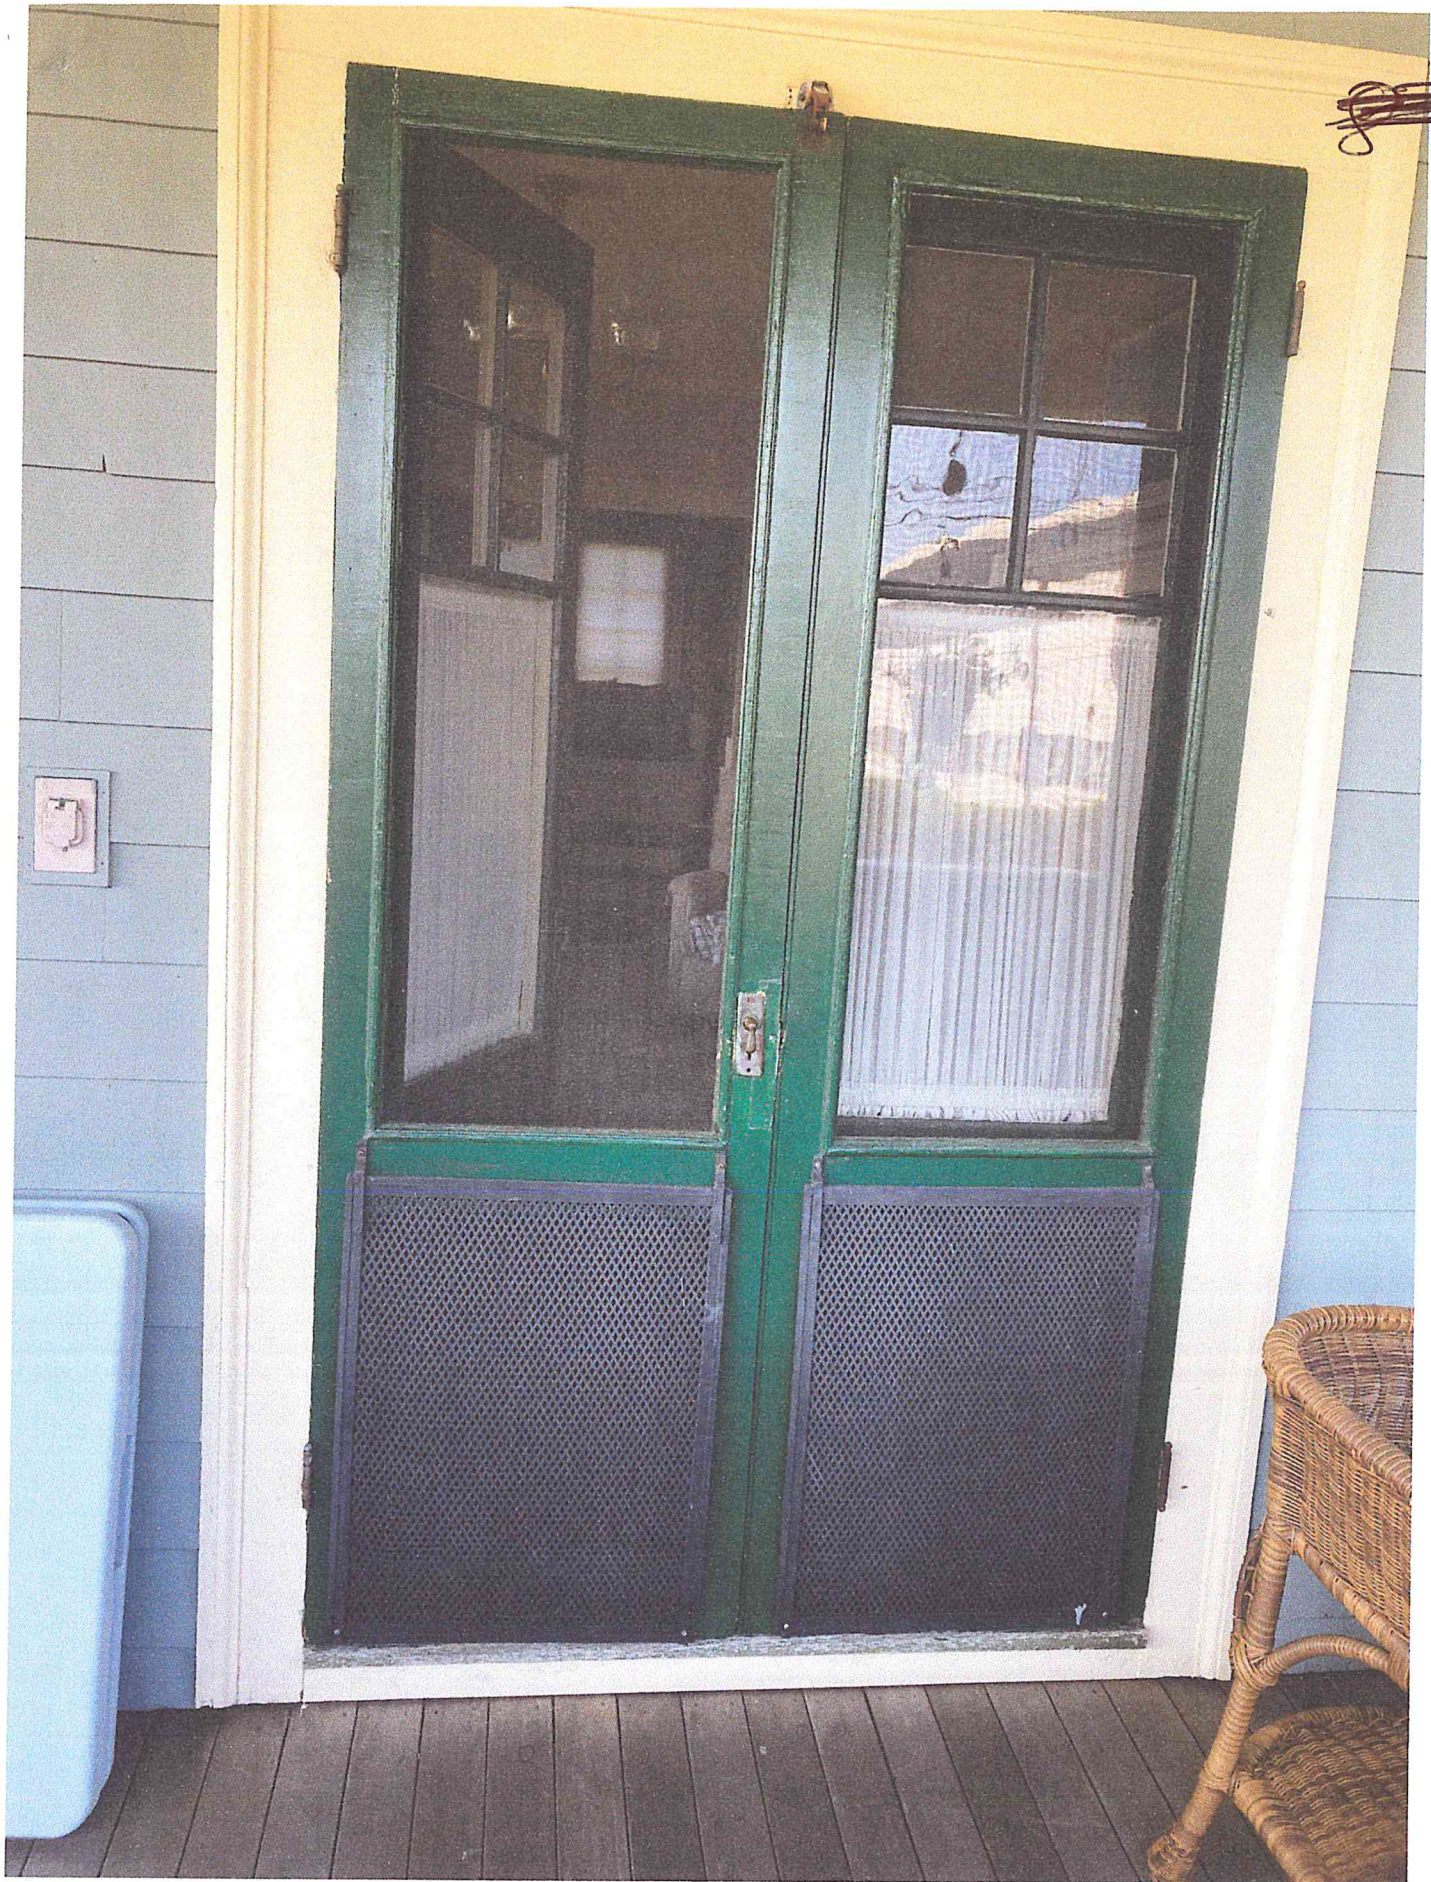
① DR LEFT OF 3 WINDOWS RIGHT SIDE OF LOWER SASH RAIL FROM BELOW: ROT
