# Bristol Historic District Commission

## Application for Review of Proposed Work - Printable Application

| HDC-25-12 | Contributing | February 11, 2025 |

125 HOPE STREET, BRISTOL, RHODE ISLAND  
STRUCTURAL INSPECTION, JANUARY 16, 2025

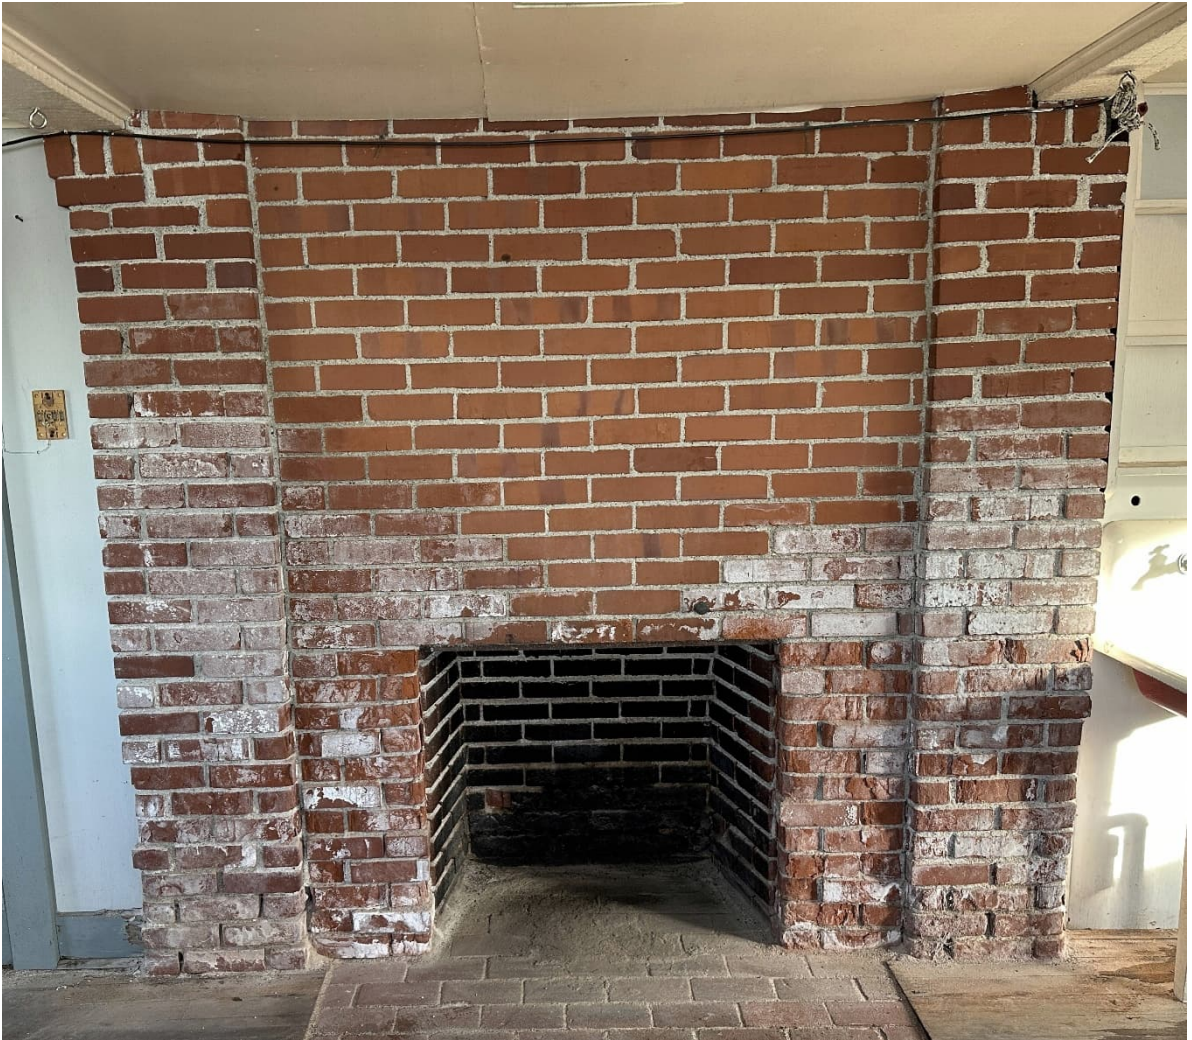
13. Efflorescence at fireplace in basement.

- o Comments and recommendations: The fireplace in the basement is showing signs of efflorescence and deterioration. Efflorescence is a sign of water infiltration into the building envelope which may lead to damage of the wall. It is recommended that a Building Envelope Specialist be engaged to determine the source of the water infiltration and the associated repairs. It is also recommended that the brick be repaired and/or replaced by a qualified mason.
