**Architectural Evaluation**

**125 Hope Street, Bristol RI**

August 18<sup>th</sup>, 2025

Report Prepared by Madeline Melchert R.A.

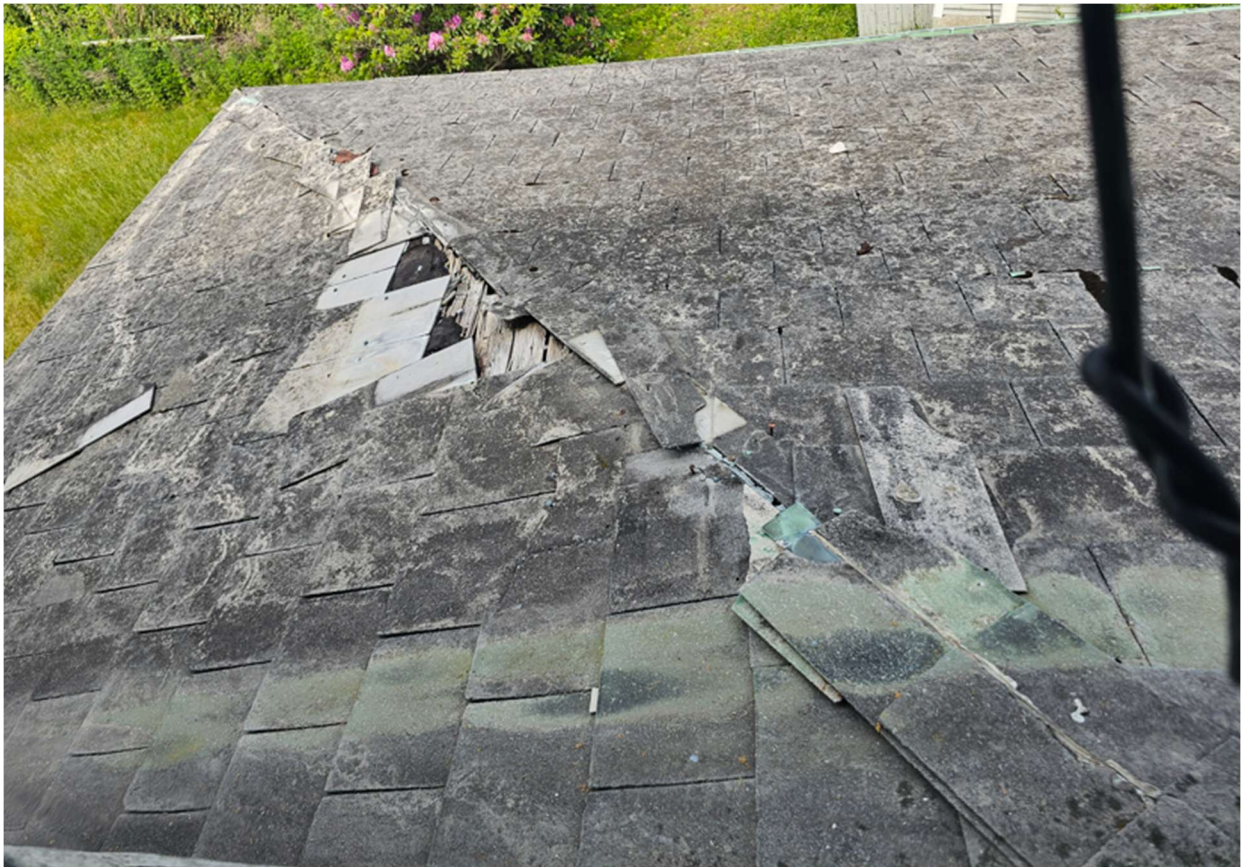
The roof finish is a light gray rectangular asbestos shingle. Asbestos shingles were marketed to be lightweight, economical and fireproof as an alternate to traditional roofing materials. In 1975 asbestos was declared a carcinogen and is now an EPA banned material. Underneath the shingles is a layer of tar paper, on top of  $\frac{3}{4}$ " thick wood plank sheathing. To meet current building codes - asphalt roof shingles would be used in lieu of asbestos, the tar paper would be replaced with roofing felt.

Image of garage roof, missing asbestos shingles reveal tar paper and plank sheathing.

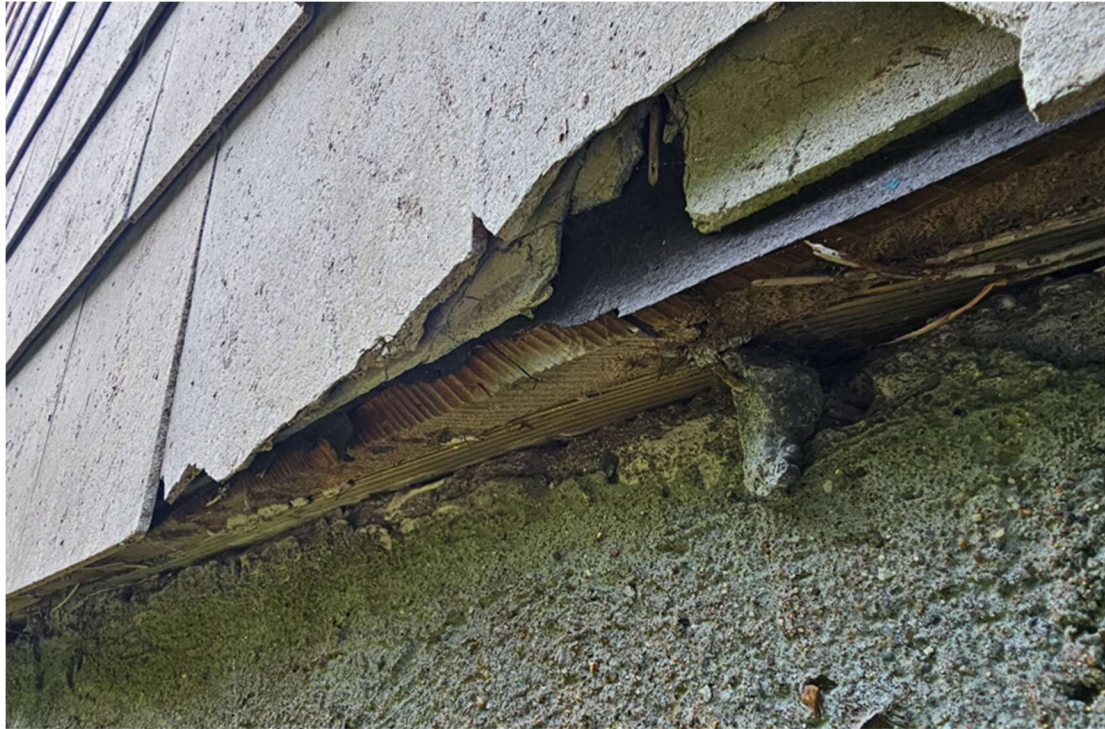
The exterior walls are clad with a light gray asbestos siding (appears red due to red algae), on top of a layer of tar paper, on top of  $\frac{3}{4}$ " thick wood plank sheathing. To meet current building code – the siding would be replaced with a composite and the tar paper replaced with new house wrap.

Image taken at exterior wall sill plate – note exposed wood framing is more prone to rot.

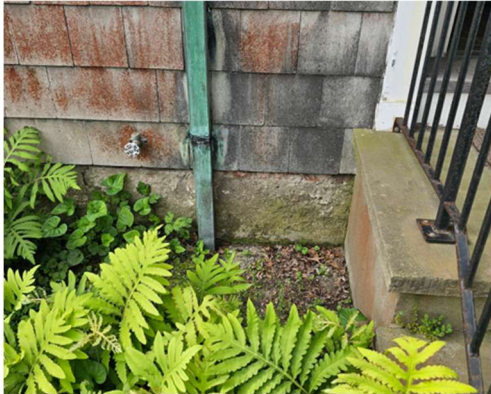
The foundation is roughly 10" thick poured concrete (no applied finishes). To meet current building code, the foundation would need to be redesigned for flood zone and would contain concrete piers with breakaway walls. It would not be possible to reinforce the existing foundation - the footings are not deep enough. The new, reinforced concrete foundation would be compliant with RISBC flood zone requirements as described in the structural report. Cast in place insert anchors would be provided to attached wood framing with suitable capacity for wind uplift to meet building code requirements.

Image at street facing foundation wall.

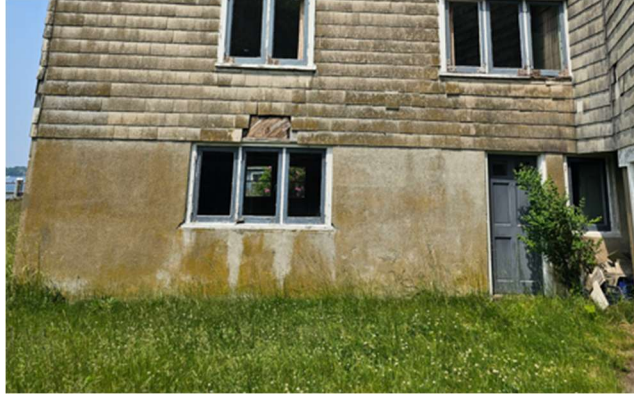
Image at rear of house, east facing foundation wall.

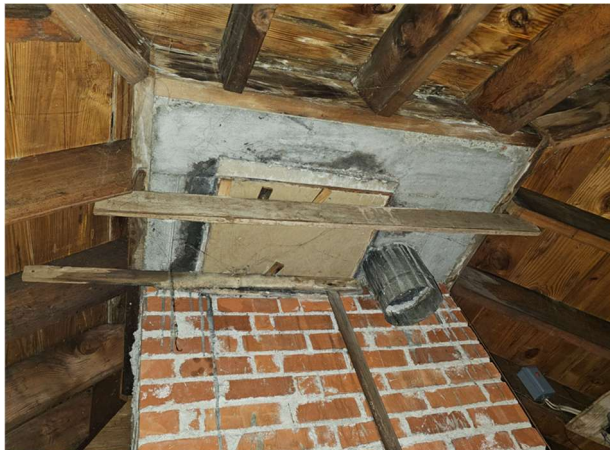
Roof framing & second floor ceiling joists are 2x8's at 16" o.c. with  $\frac{3}{4}$ " thick plank sheathing. The main house has a chimney integral to the peak of the roof framing. In a reconstruction, the entire chimney would be dismantled and the roof framing would need to be temporarily supported and/or dismantled. The roof framing is undersized and would need to be reinforced with sistered 2x8s with application of a new layer of plywood on top of the plank sheathing (for diaphragm) with approved hurricane ties and strap anchors. The chimney at the peak would require steel support for a re-built chimney (above the roof only).

Image at main house chimney to roof connection.

In a reconstruction, the chimney would be re-built above the roofline using existing bricks, and removed below the roofline (used for aesthetic purposes only).

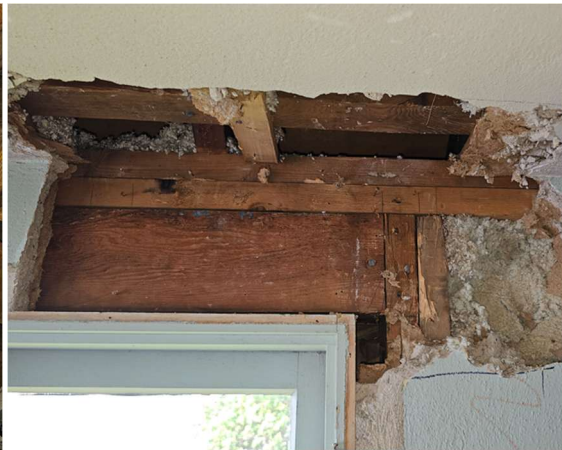
Image at second floor top plate & window header.

Below the top plate, the exterior walls are balloon framed 2x4's at 16" o.c. with double 2x6 headers at windows (no jack studs). Balloon framing creates a fire hazard due to the continuous wall cavities between floors. Exterior corners of the house consist of continuous 4x4 wood posts (balloon framed). Much of the corner framing has deteriorated due to water infiltration. **Exterior walls would need to be reinforced for wind load by including appropriate strap ties at the second floor, all studs would be sistered with new 2x4's and the plank sheathing would need to be covered with new 5/8" plywood. 4x4 corner posts would be replaced with HSS4x4 steel posts from foundation to roof. Any framing around windows would need to be re-worked to add jack studs (new header required to maintain window size).**

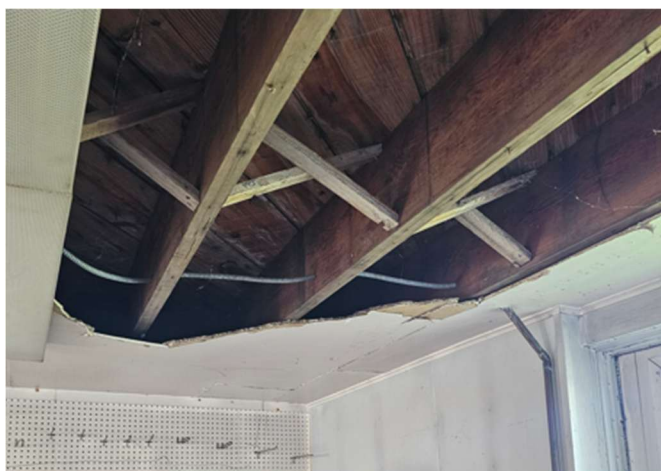
Image at first floor framing.

The rear facing "bay window" walls are framed with 2x3's at 16" o.c. and are deteriorated significantly. The first floor and second floor framing both consist of 2x10's at 16" o.c. with 3/4" thick plank sheathing. The floor framing is relying on the chimney for structural support, which does not meet building code due to fire hazard. **The floor framing at both floors would utilize W10 steel beams where necessary (with HSS steel posts for support) and the floor joists would be sistered or replaced with new 9-1/4" LVL's. Alternatively, the first floor framing would be most structurally flood resistant if replaced with an 8" thick reinforced concrete slab.**

There are no metal connectors at critical load path transitions – roof to wall, floor to wall, or wall to foundation – all of which would be required to meet current building codes. **Again, due to the significant amount of structural reinforcing required in every aspect of the structure (walls, floors, roof, connections) with the insertion of steel - the means and methods required to physically complete this work realistically requires a complete dismantling of the structure.**

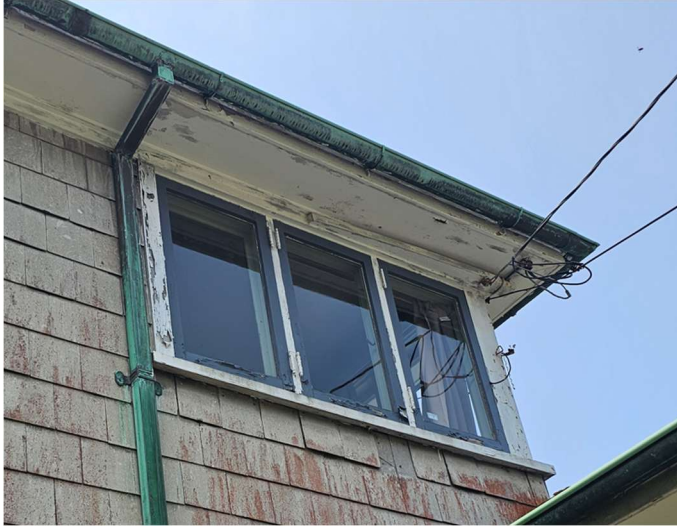
Image at second floor windows facing Hope Street.

Gutters are rectangular copper with decorative brackets and gutters are half round copper. **In a reconstruction, these materials would be replaced in kind.**

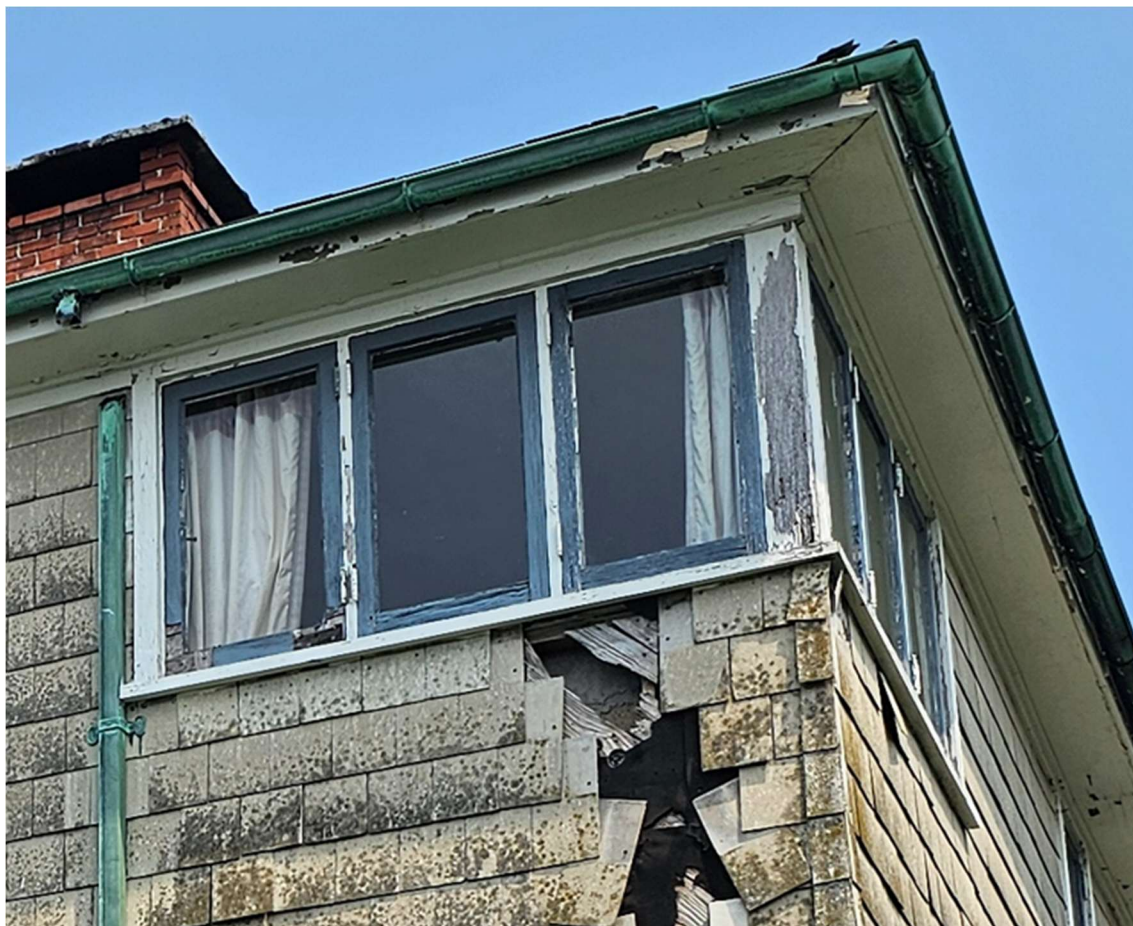
Image at second floor rear facing corner window.

There are double hung, casement and picture windows present. All are solid wood construction, single pane, 1.5" thick sashes. The front door is a vertical v-groove panel. Most weatherstripping is missing. Trim is generally painted wood flat stock. Very little of these materials could be salvaged. In a reconstruction, windows and doors would need to be stripped of paint to determine rotted wood that would require patching or replacement. All glazing would need to be removed and re-set. In many cases replicas would be produced to replace windows, doors, and much of the exterior trim.

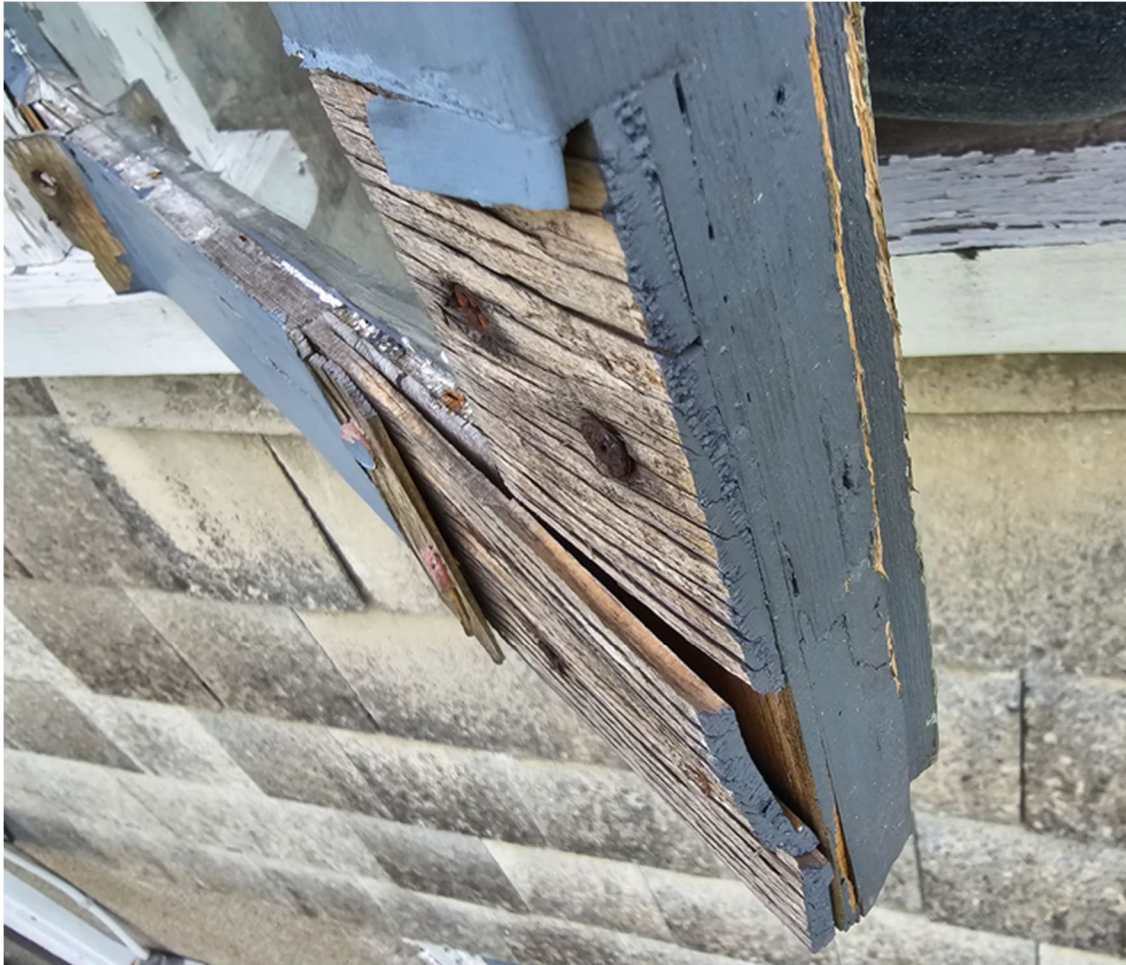
Image at side detail of second floor casement window patch.

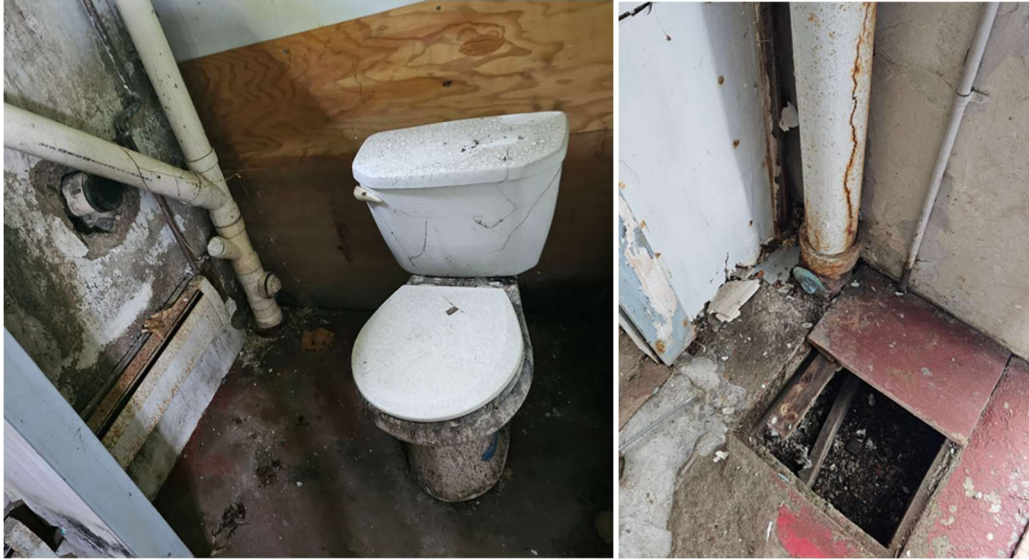
Image of basement waste lines.

The house has recently had interior water damage due to burst pipes, rendering existing plumbing and electrical in disrepair. There are multiple waste line locations, which should be investigated to determine the quality of the connection to city sewer. To meet current building codes, all MEP items would need to be new.
