# **165 High Street Carriage House**

## **Restoration-Rebuild Concept Review**

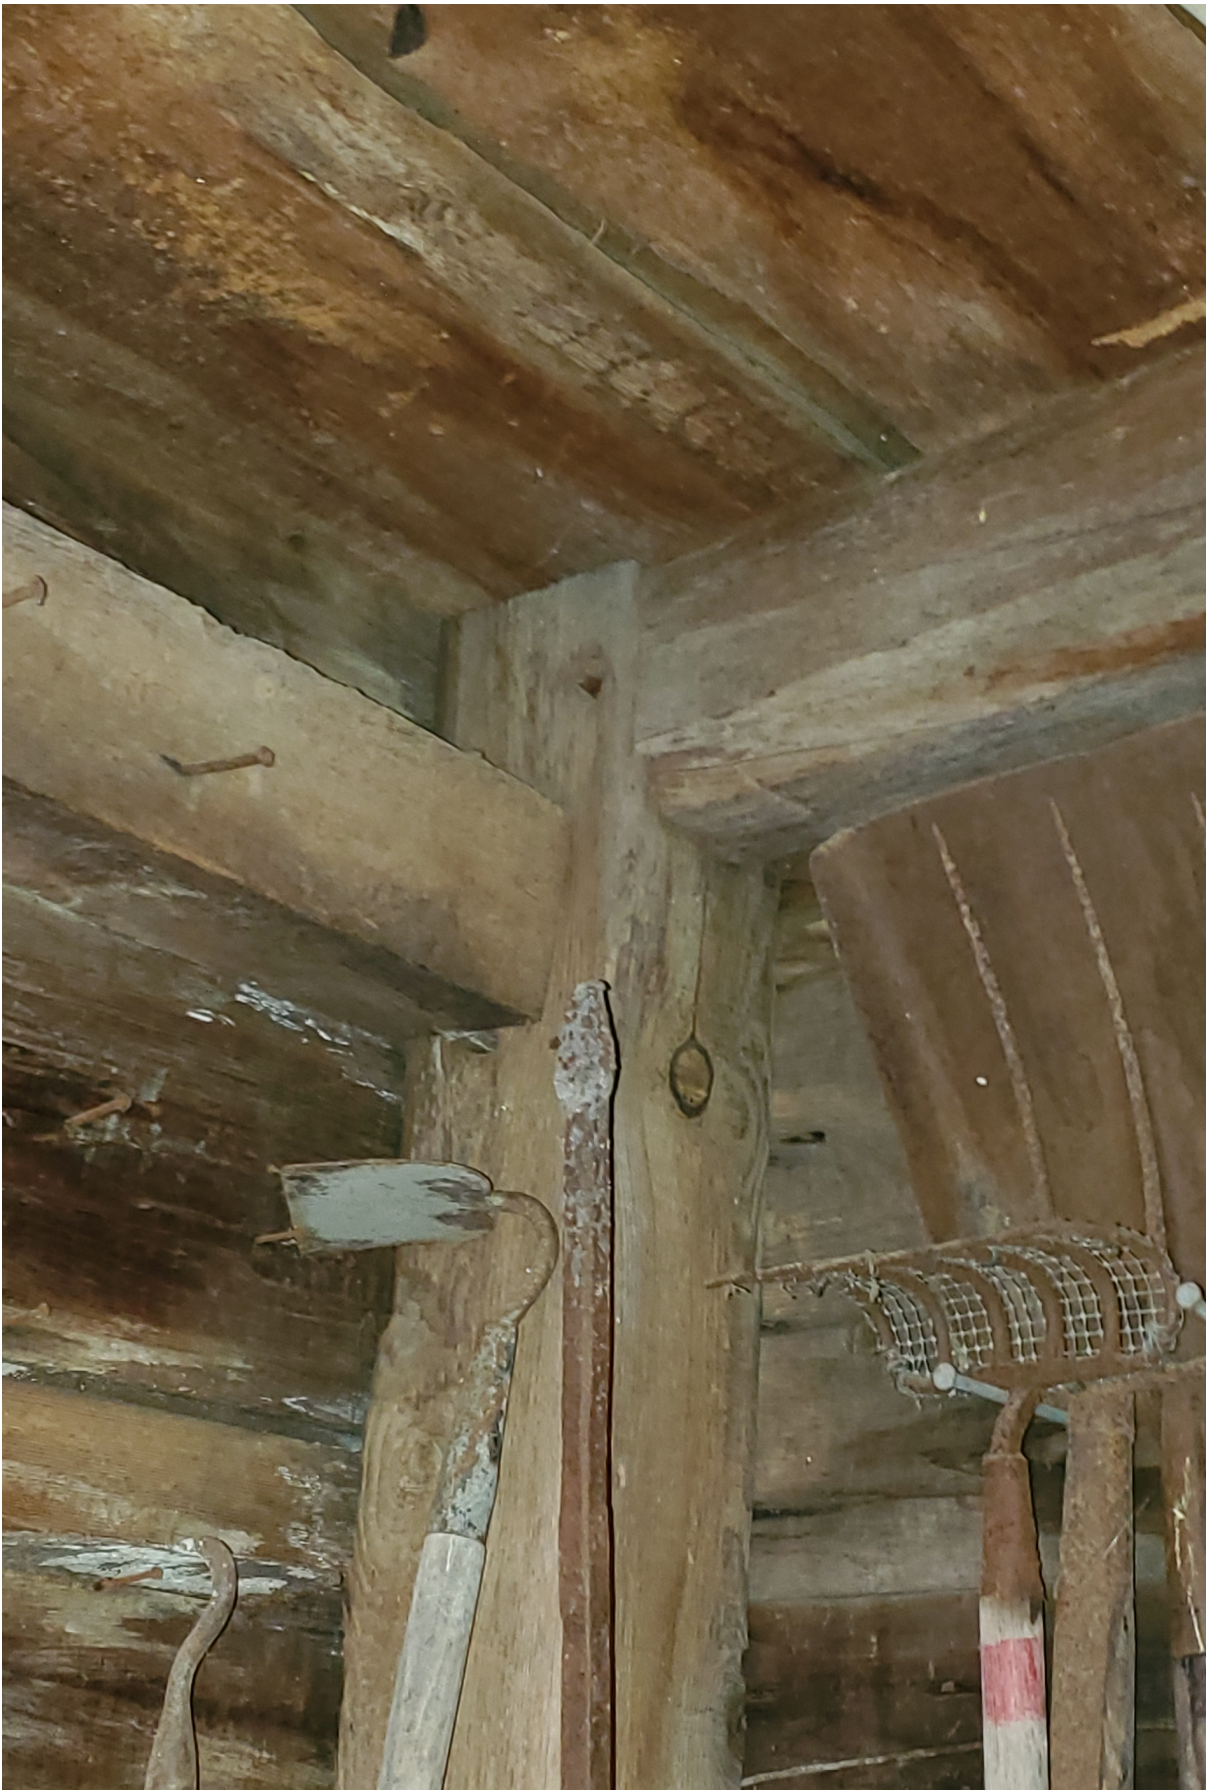
The post and beam frame joinery consists of early pegged mortise and tenon joints (Figure 4). There is no evidence of braces used in the original construction (typical of barns built in this period).

Due to the lack of corner post timber bracing in the original construction, and deterioration of the beam sills, the barn leans to the south. As of today, the barn leans approximately 4 degrees.

*Figure 4: Corner post showing joinery and lack of corner bracing.*

Our plan is to rebuild the Carriage house from ground up using the existing planks, and where they can be salvaged, posts/beams/and joinery. The building will retain its original look including; period clapboard siding, oak barn doors w/iron strap hinges, and 12x12 true shash wood windows. New posts and/or beams will be used and the joinery replicated. Struts and braces will be included in the new post-and-beam frame to prevent any racking of the building.

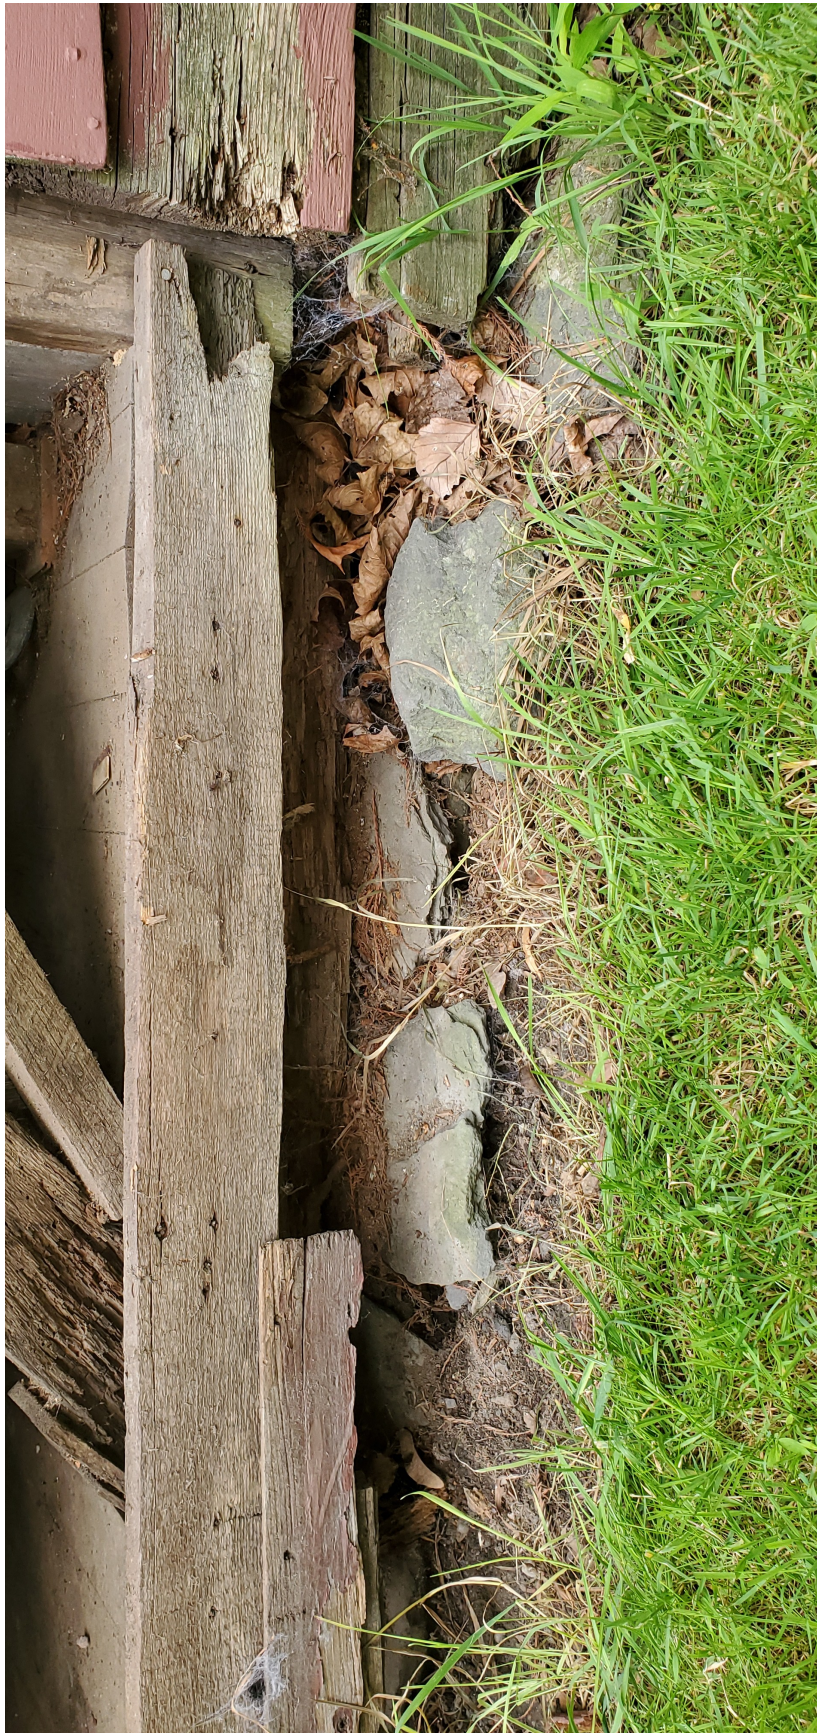
The stone foundation has settled, and in various sections along the outer walls, the stone foundation is no longer visible. This has resulted in the sill beams being in contact with the ground (Figure 6) resulting in extensive rotting of the sill beams. Much of this damage was hidden from view as the clapboard and plank siding covered the sill beams and extended to the ground (where the stone foundation was not visible).

*Figure 6: Stone foundation and horizontal sill beams in contact with ground.*

A new stone foundation would be laid to support the rebuilt post and beam frame. The new foundation will raise the sill beams off the ground by at least 6 inches preventing any future sill beam and corner post rot.

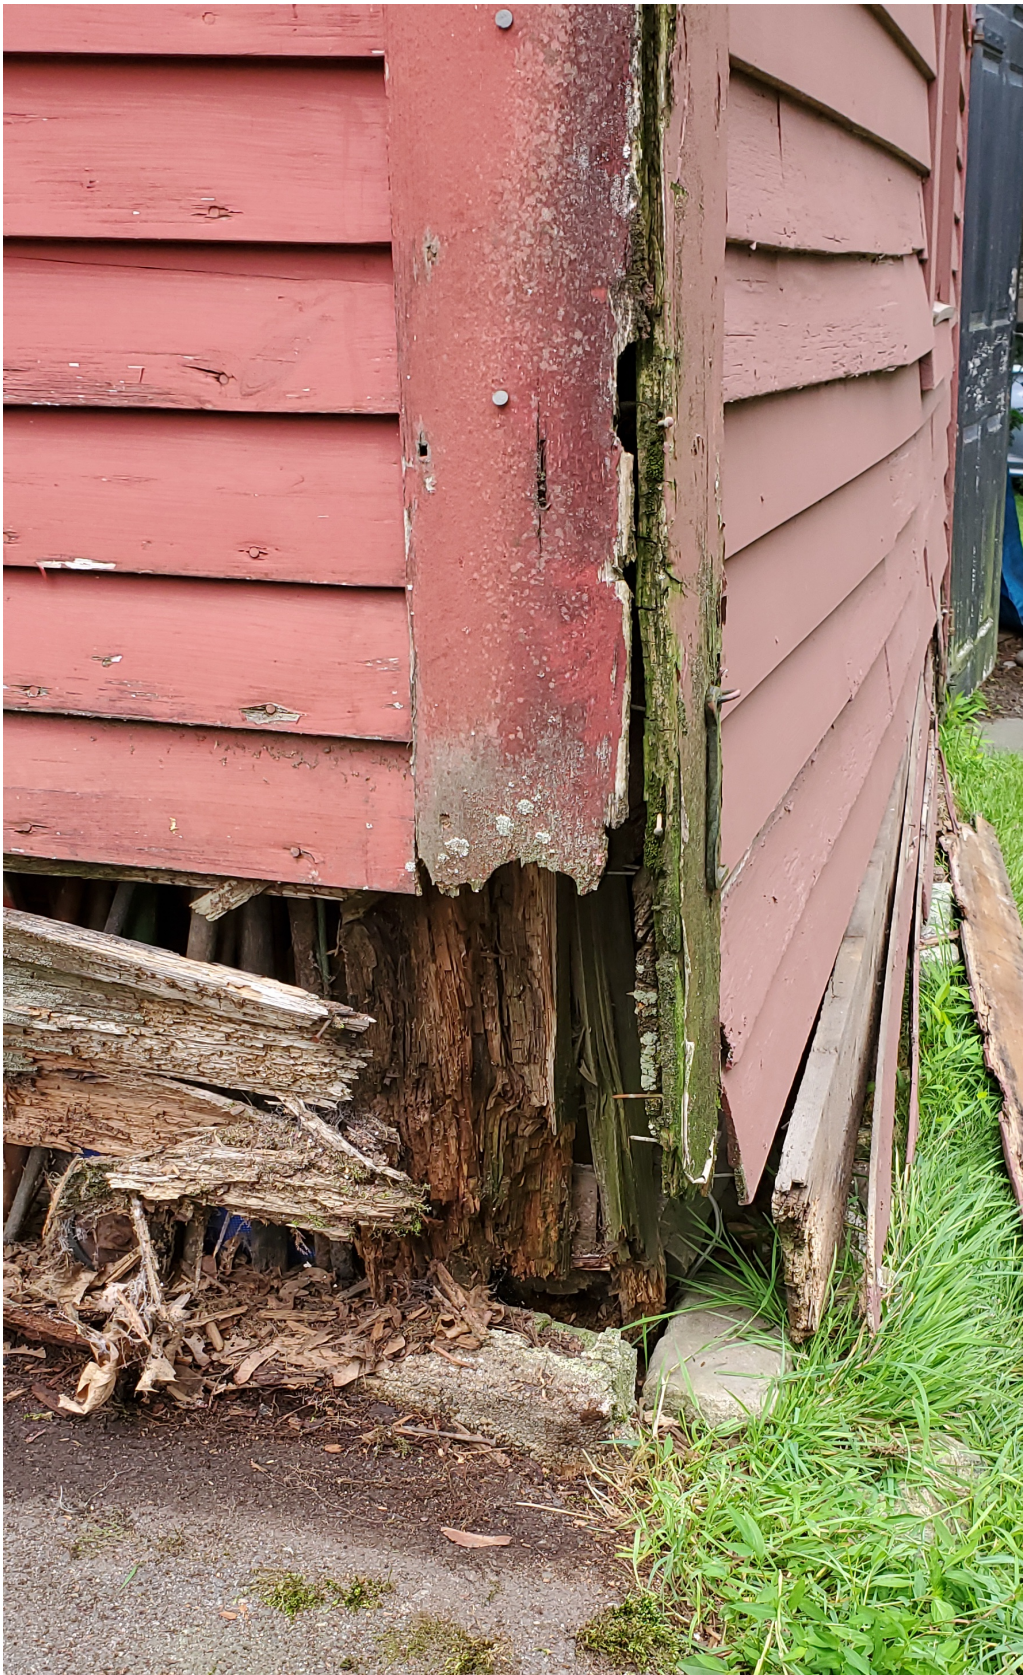
The corner posts have experienced a severe wicking of moisture due to post end contact with the ground and rotted sill beam (Figure 7). This moisture saturation has resulted in rot extending a significant section into the corner posts.

*Figure 7: Corner post showing extensive rot from being in contact with rotted sill beam and ground.*

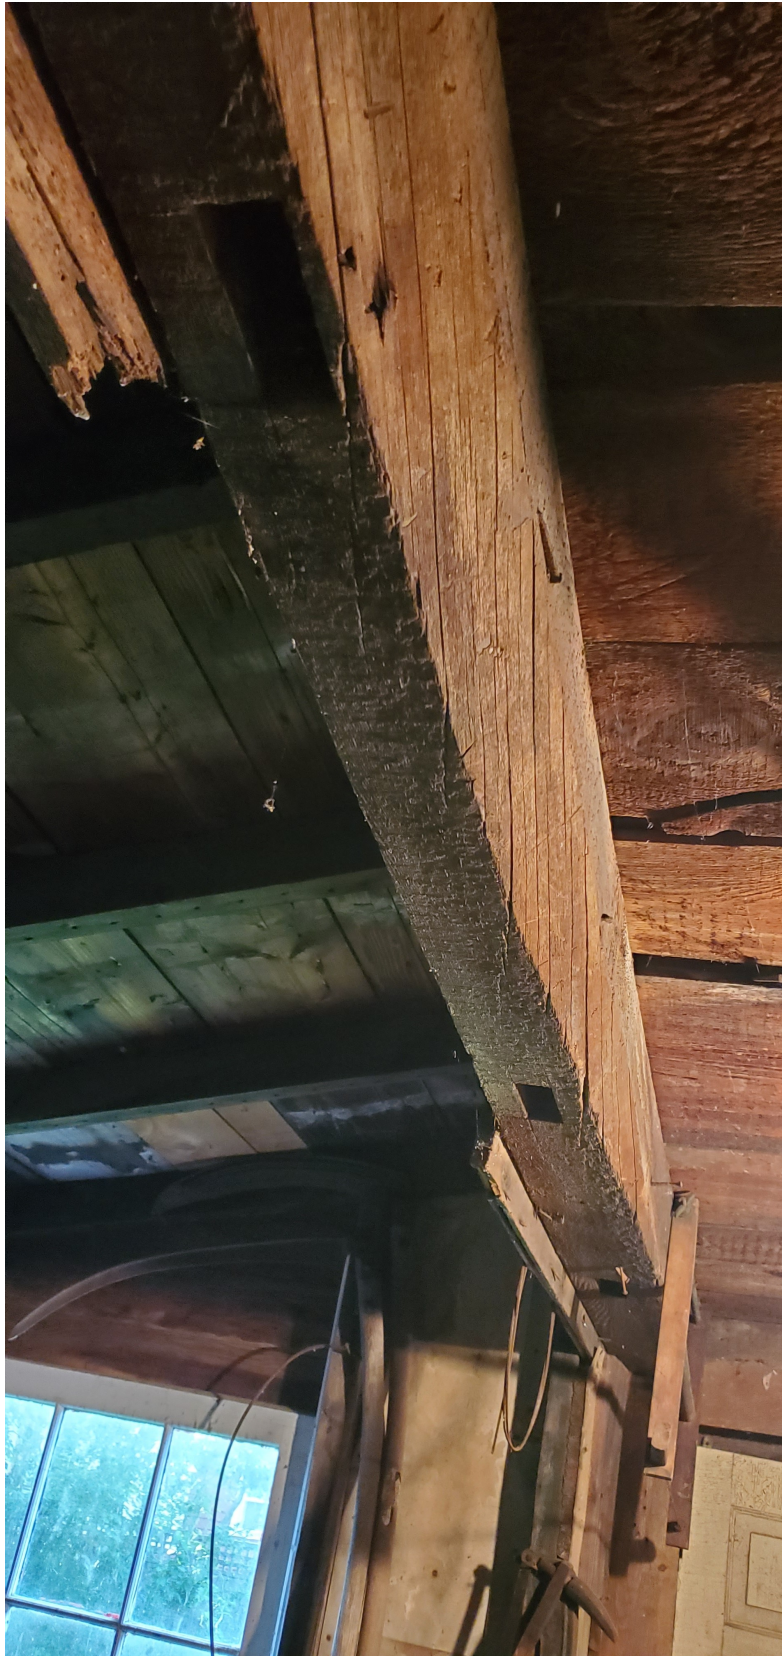
Modifications were made to the rear of the barn in 1930's (I was told, to accommodate a large automobile). These modifications included removal of the rear wall framing timbers (Figure 8).

*Figure 8: Rear wall showing the beam pockets where framing timbers were removed when building was lengthened in the early 1900s*
