## EXTERIOR VIEWS

## WINDOWS

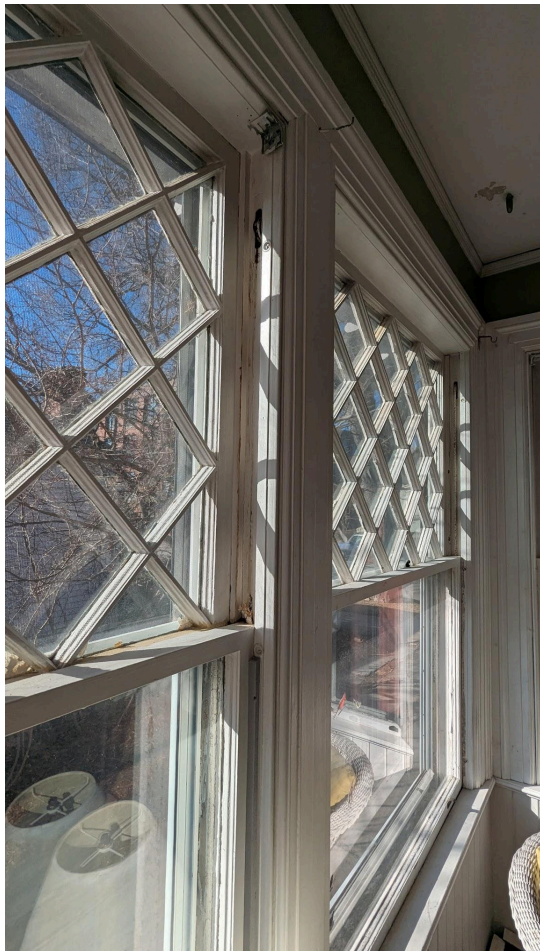
- Predominantly single hung, single pane wood windows with diamond light pattern in top sash and aluminum frame storm windows.
- East elevation = 2-over-1 divided light pattern (bathroom, kitchen, stair, living room)
- Many are inoperable due to misalignment in frames and/or broken sash weight cords. Some have broken/chipped muntins; cracked/loose/missing glazing compound; and broken glass.

Missing sash cords

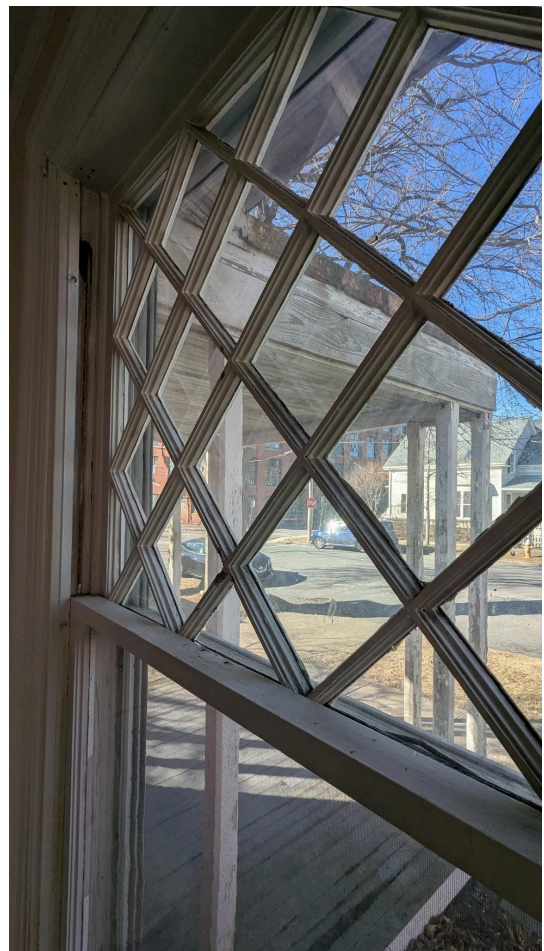
Broken muntin

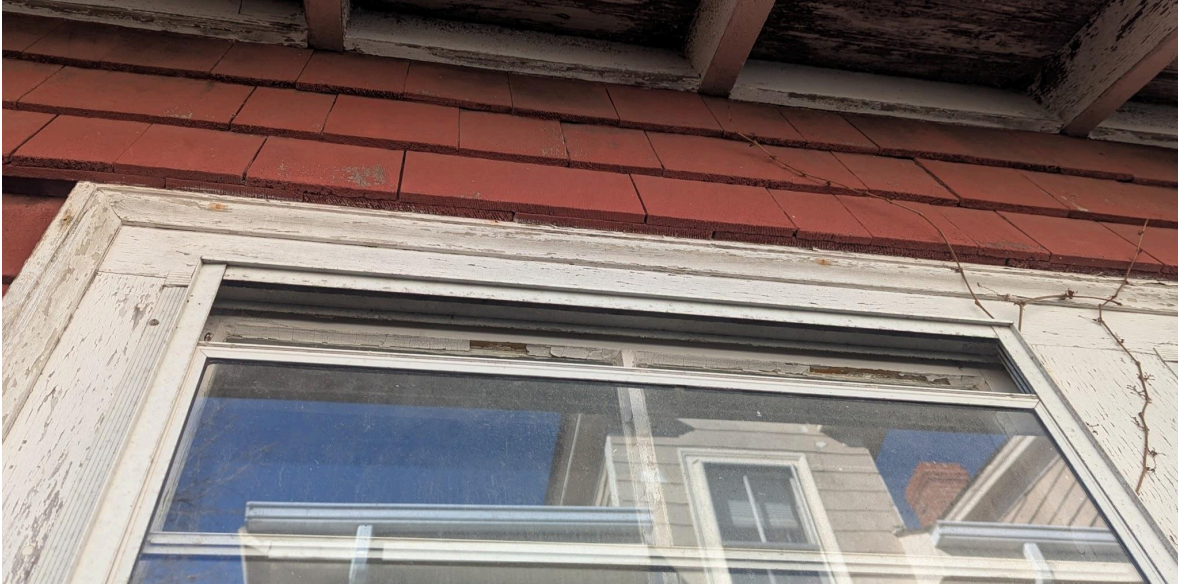
Cracked/missing glazing compound

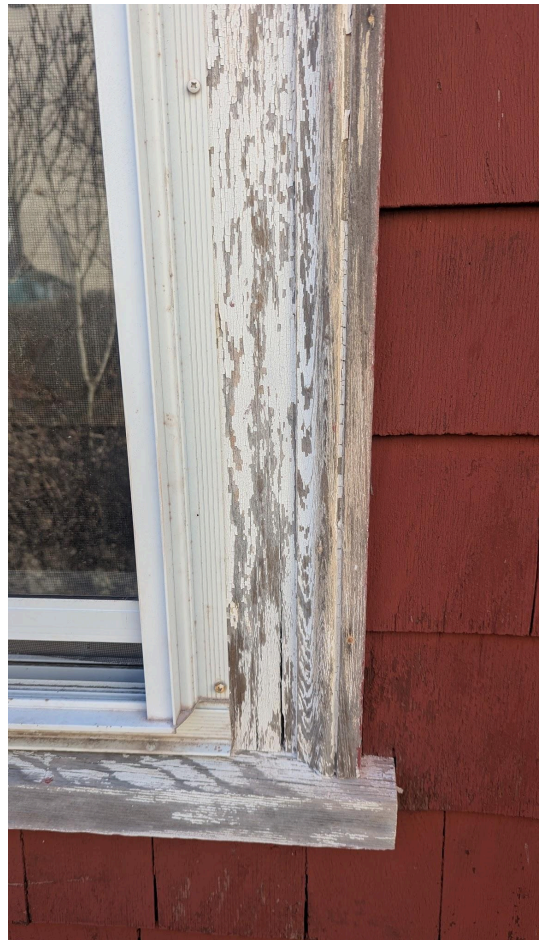
Exterior trim(split)/Storm Window
