125 HOPE STREET, BRISTOL, RHODE ISLAND
STRUCTURAL INSPECTION, JANUARY 16, 2025

At your request, this office has conducted a structural inspection of the buildings located at 125 Hope Street in Bristol, Rhode Island. This inspection included a visual inspection of the accessible areas of the building's interior and exterior. The following is a report of our findings and recommendations.

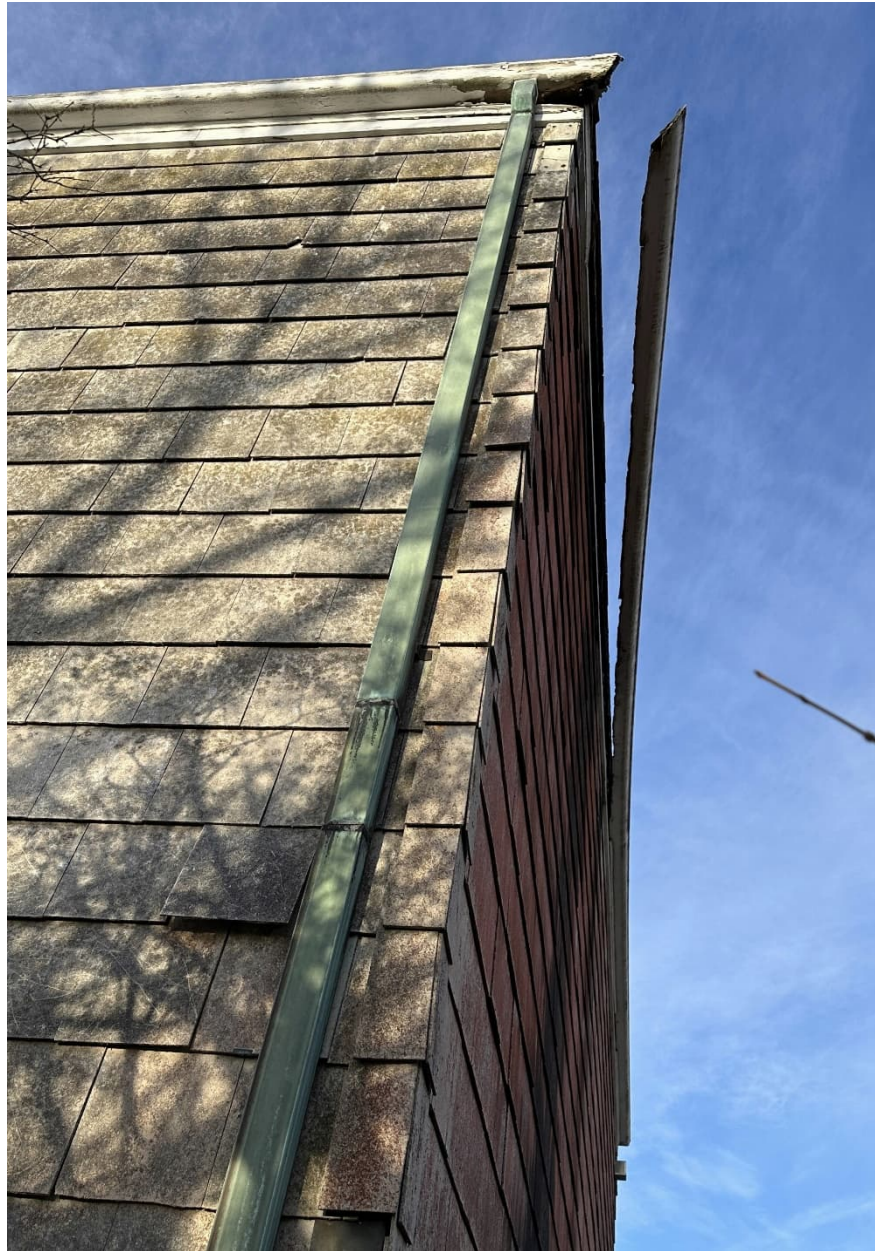
2. Detached gutter on east addition.
 - o Comments and recommendations: The gutter along the north side of the east addition has detached at the east end. This is a sign of potential deterioration along roof eave and/or top of wall and may be allowing weather to infiltrate the building envelope which may cause deterioration to the structural system and/or interior finishes. Additionally, if the gutter were to fall from the building it may cause damage to property or injure people. It is recommended that the deficiencies be repaired by a qualified contractor to ensure weather-tightness of the building envelope and structural integrity of the building.

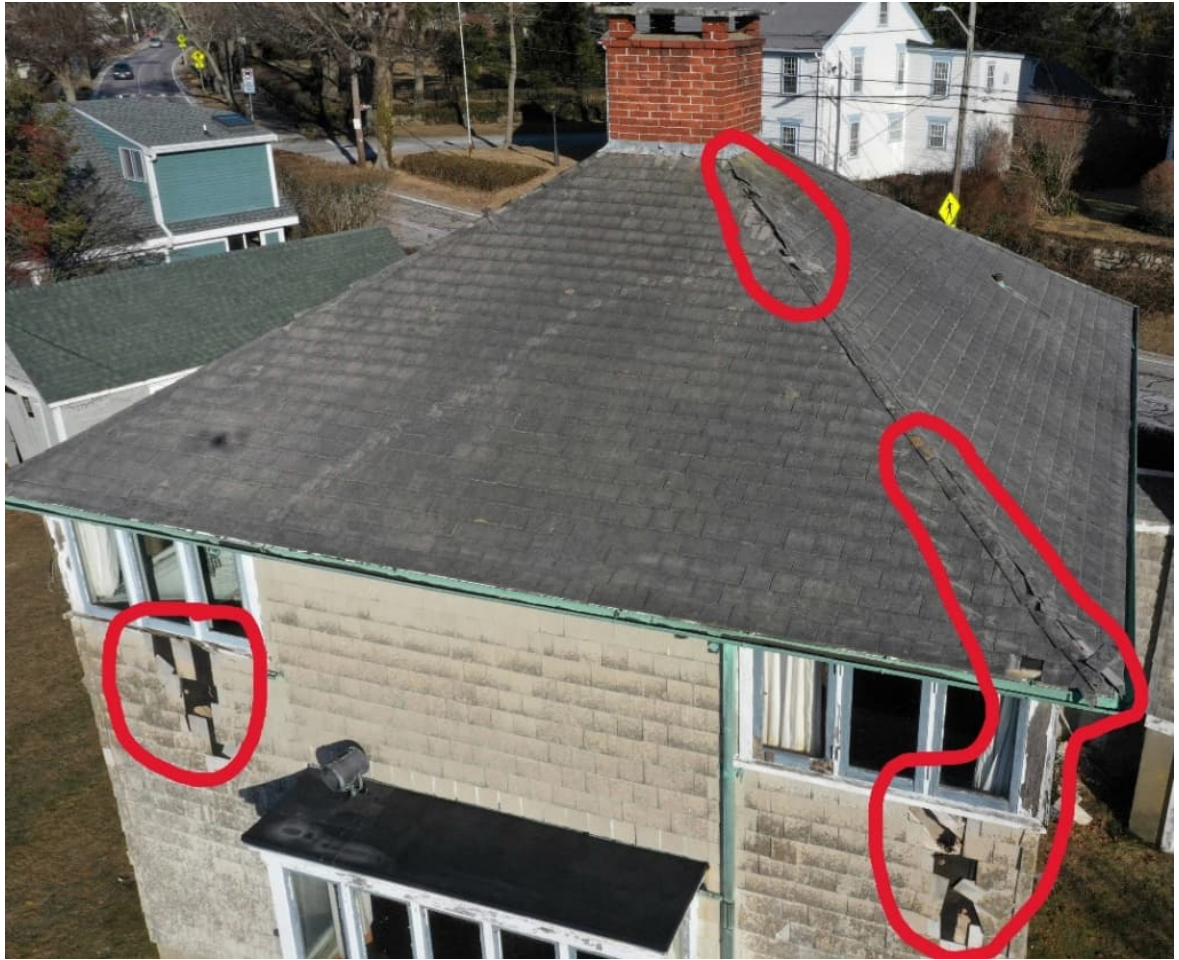
6. Holes in the roof and walls.

- Comments and recommendations: There are holes in the roof and exterior walls at various locations. These holes have been allowing weather to infiltrate the building envelope and have caused deterioration of the structural system. This is a structural hazard as failure of the roof or wall framing could allow collapse of the building. The roof framing is fully accessible; thus, it is recommended that a Structural Engineer be engaged to design appropriate repairs to be performed by a qualified contractor. The wall framing is not accessible; thus, the amount of deterioration is unknown. The exterior wall sheathing or interior finishes would need to be removed to determine the extent of the deterioration such that appropriate repairs can be designed and implemented.

It is our professional opinion that there are several areas of significant structural damage in the building as described above. The most important area of concern is the lateral force resisting system of the structure (exterior walls, floors and roofs). For example, deficiency D.6 suggests that the exterior wall boards (which provide lateral stability) are in very poor condition in critical areas of the building. Also, deficiency D.21 shows inadequate anchorage of the roof framing in some areas for wind uplift forces. Given the location of the house with direct exposure to the waterfront, even the original design of the building is not in compliance with the wind loading provisions of the current IRC – thus repair of the deficiencies should be designed to upgrade the entire structure to meet modern hurricane resistant standards per RISBC-2.

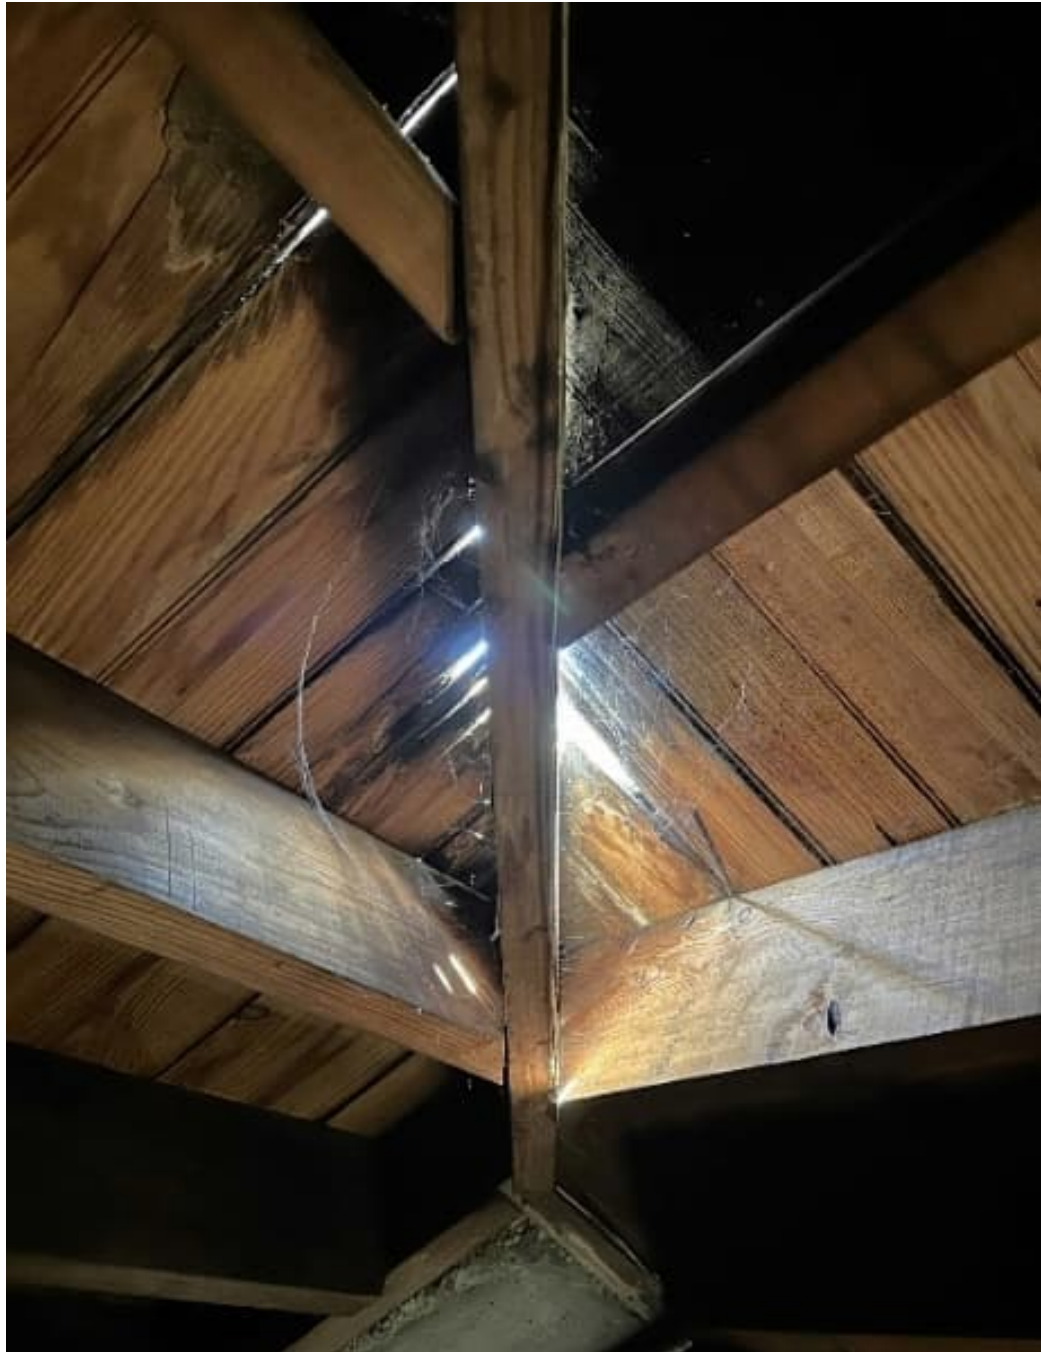
This photo shows deterioration of the house roof framing due to holes in the roof.

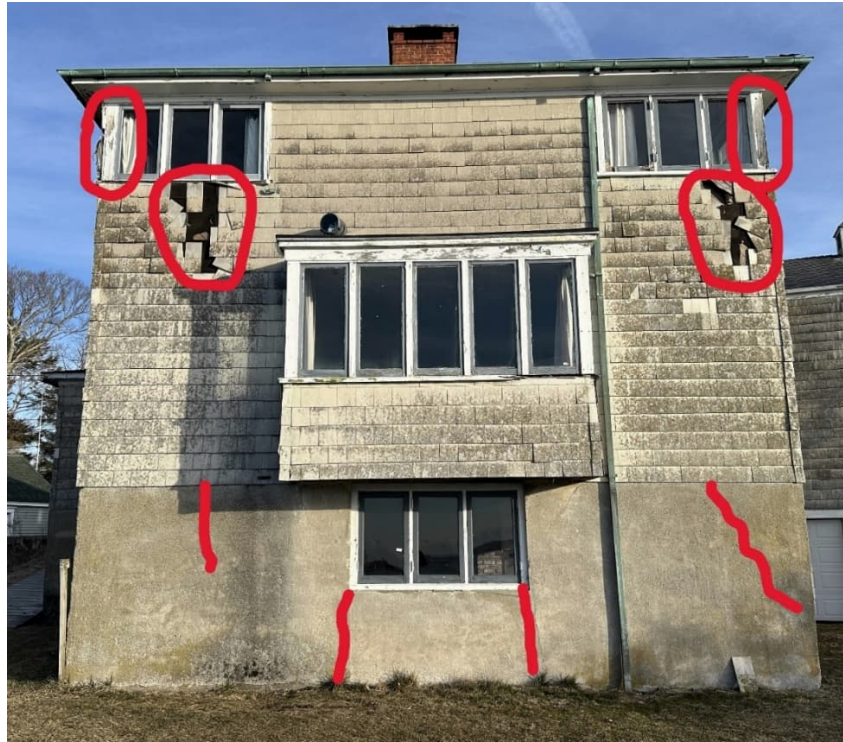
7. Exterior wall deterioration.

- Comments and recommendations: The exterior walls are showing signs of deterioration and cracking at various locations. The paint on the corner columns has peeled away and the wood appears to be rotting. Failure of the corner columns could allow the walls to move outward and/or the roof framing to collapse. It is recommended that the columns be removed and replaced.

- Wall shingles are missing which has exposed the wood sheathing and allowed weather to infiltrate the building envelope which may have allowed deterioration within the walls. Deterioration of the walls could lead to their failure. The exterior wall sheathing or interior finishes would need to be removed to determine the extent of the deterioration such that appropriate repairs can be designed and implemented.

- The concrete foundation walls have cracks at various locations. The cracks may be due to settlement (there are several sinkholes in the backyard). The cracks do not currently appear to be a structural hazard. However, the cracks may allow weather to infiltrate into the wall which may lead to additional deterioration. It is recommended that the cracks be repaired by qualified personnel.

- The size and location of wall openings create a discontinuity in the lateral force resistance system from the roof to the foundation. Lateral forces were not a consideration when the house was constructed. It is recommended that a Structural Engineer be engaged to design an appropriate lateral force resistance system.

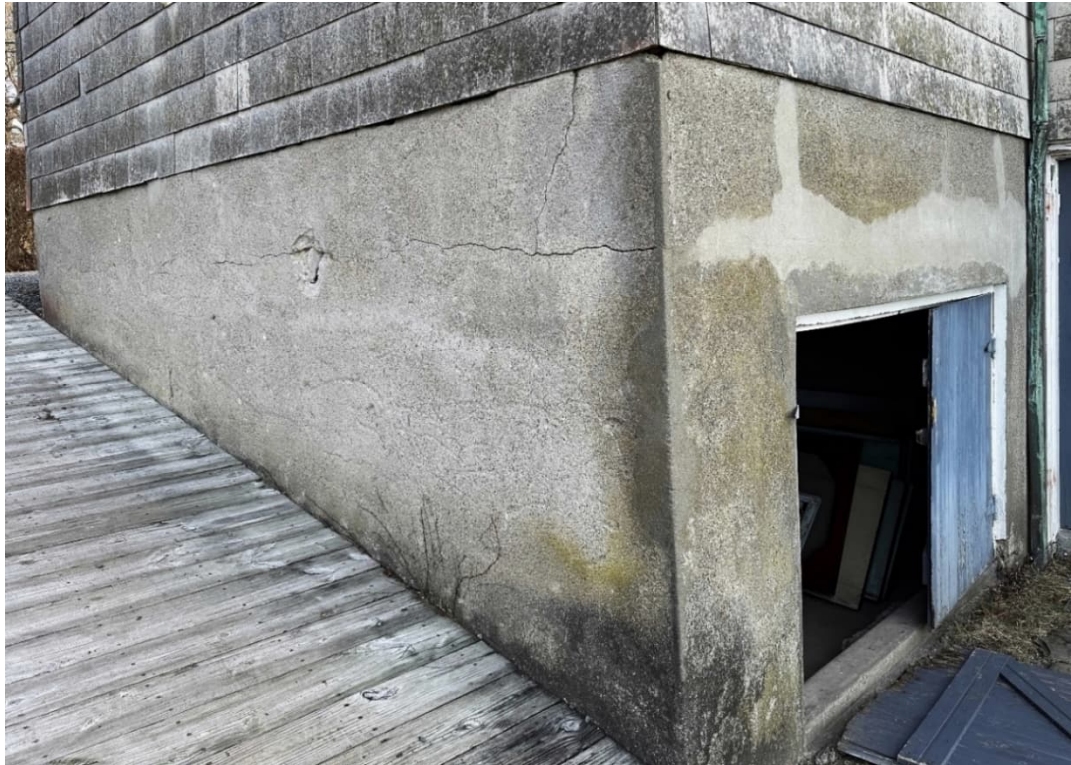
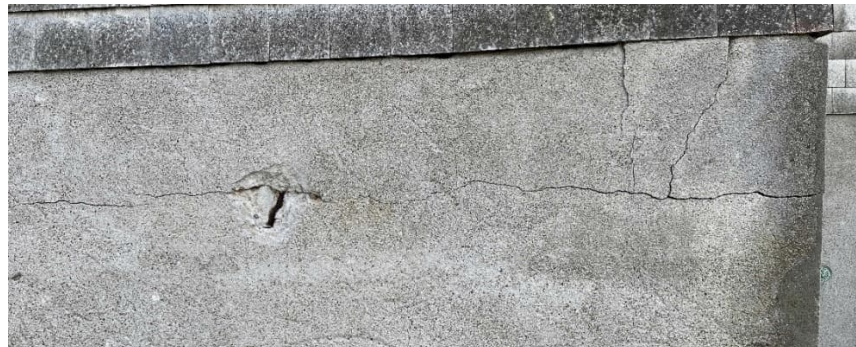
8. Foundation wall cracks with exposed rusting reinforcement.
 - o Comments and recommendations: The foundation walls below the northwest corner of the house bump-out (former garage, current laundry room) has large horizontal cracks and exposed rusting reinforcement. There also appears to have been previous repairs performed at the wall corner and over the crawlspace doorway opening. The cracks may be due to lateral forces, settlement, and/or building expansion/contraction from changes in temperature and humidity. The cracks may allow weather to infiltrate the wall and cause further damage. The exposed rusting reinforcement will expand and cause further cracking of the wall, thus, exposing more reinforcement and continuing the cycle. It is recommended that the cracks and exposed rusting reinforcement be repaired by qualified personnel using high-performance repair materials.

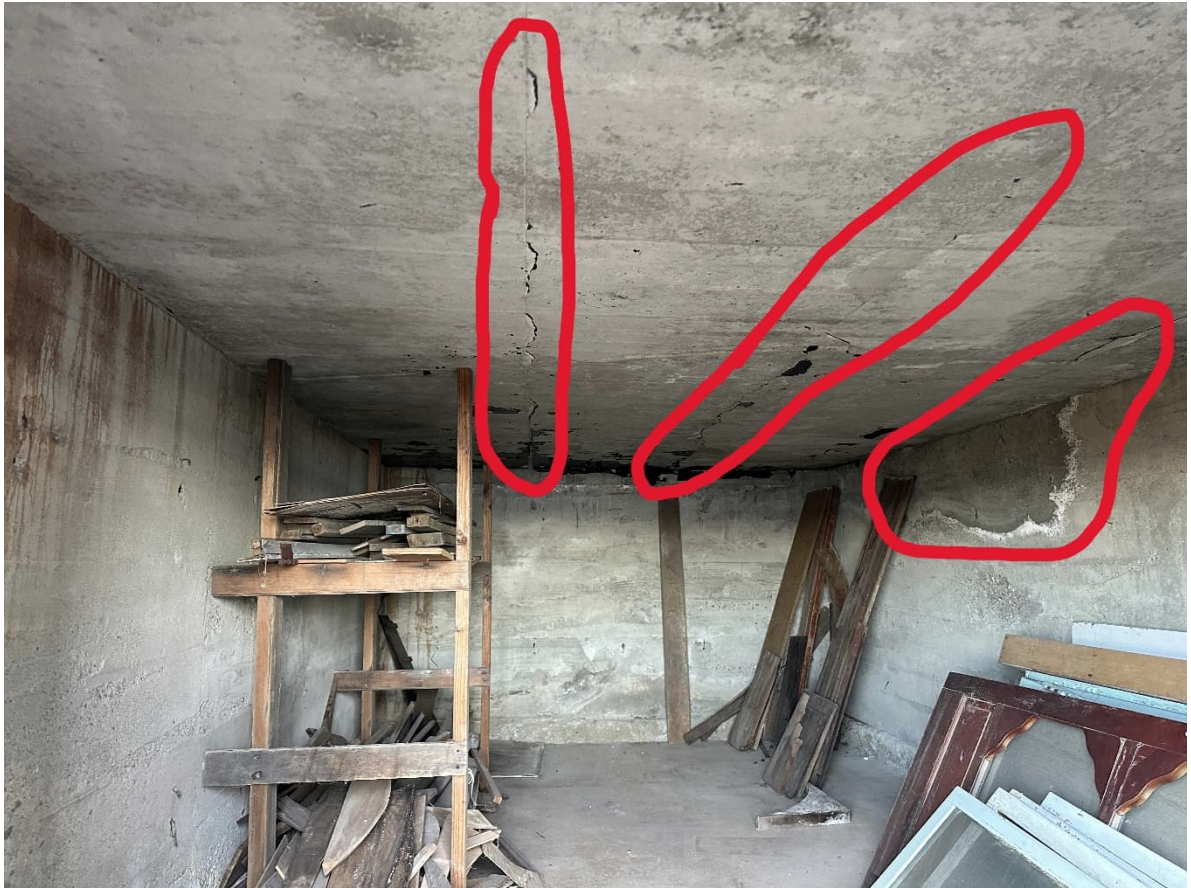
9. Slab cracks and deflection, efflorescence at previous repair.
- Comments and recommendations: In the crawlspace below the northwest corner of the house bump-out (former garage, current laundry room), the slab overhead has some longitudinal cracks and is visibly deflected. This is a structural hazard as the cracks and deflection are an indication that the slab may be failing. It is recommended that a Structural Engineer be engaged to design shoring to support the slab.
 - Efflorescence is visible around the edge of a previous wall repair. Efflorescence is a sign of water infiltration into the building envelope which may lead to damage of the wall. It is recommended that a Building Envelope Specialist be engaged to determine the source of the water infiltration and the associated repairs.

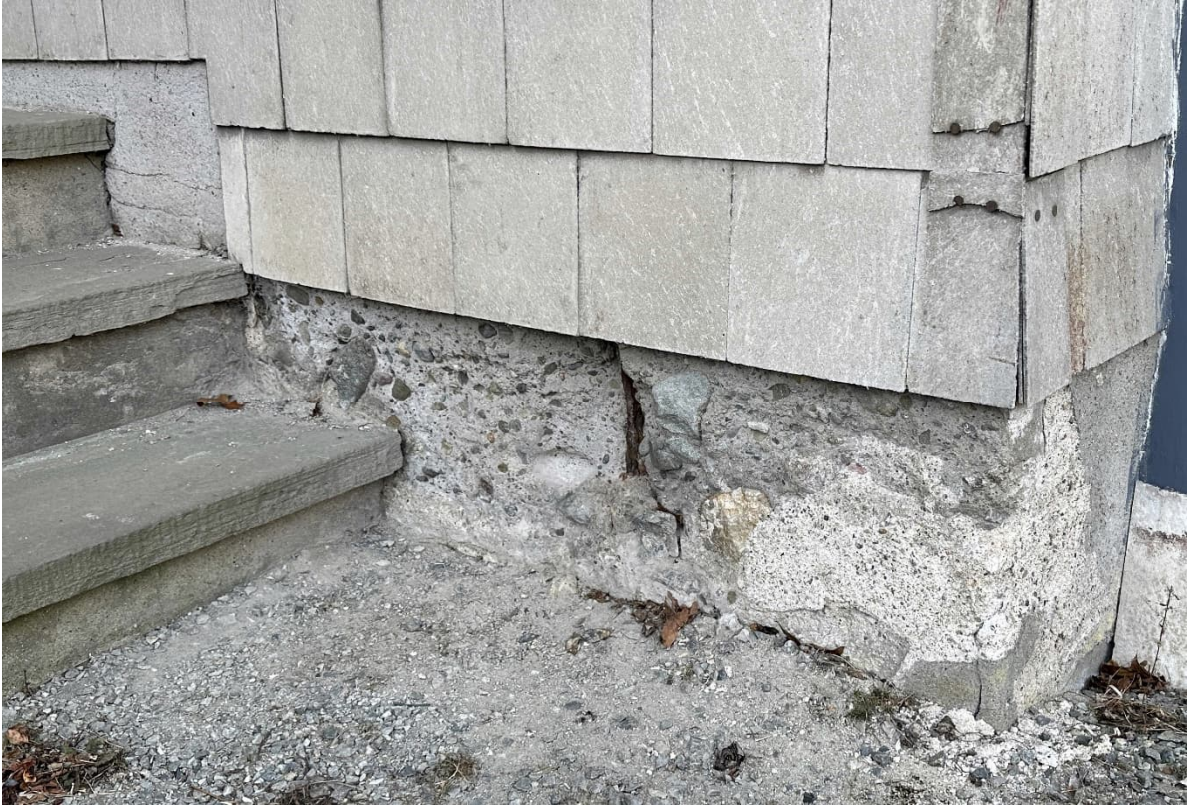
10. Spalled foundation wall, exposed rusting reinforcement.

- Comments and recommendations: The foundation wall adjacent to the main entrance stairs has large areas of spalling, some cracks and exposed rusting reinforcement. The spalling may be due to previous cracks that allowed weather to infiltrate the wall causing expansion of the concrete. The current cracks may allow weather to infiltrate the wall and cause further damage. The exposed rusting reinforcement will expand and cause further cracking of the wall, thus, exposing more reinforcement and continuing the cycle. It is recommended that the cracks and exposed rusting reinforcement be repaired by qualified personnel using high-performance repair materials.

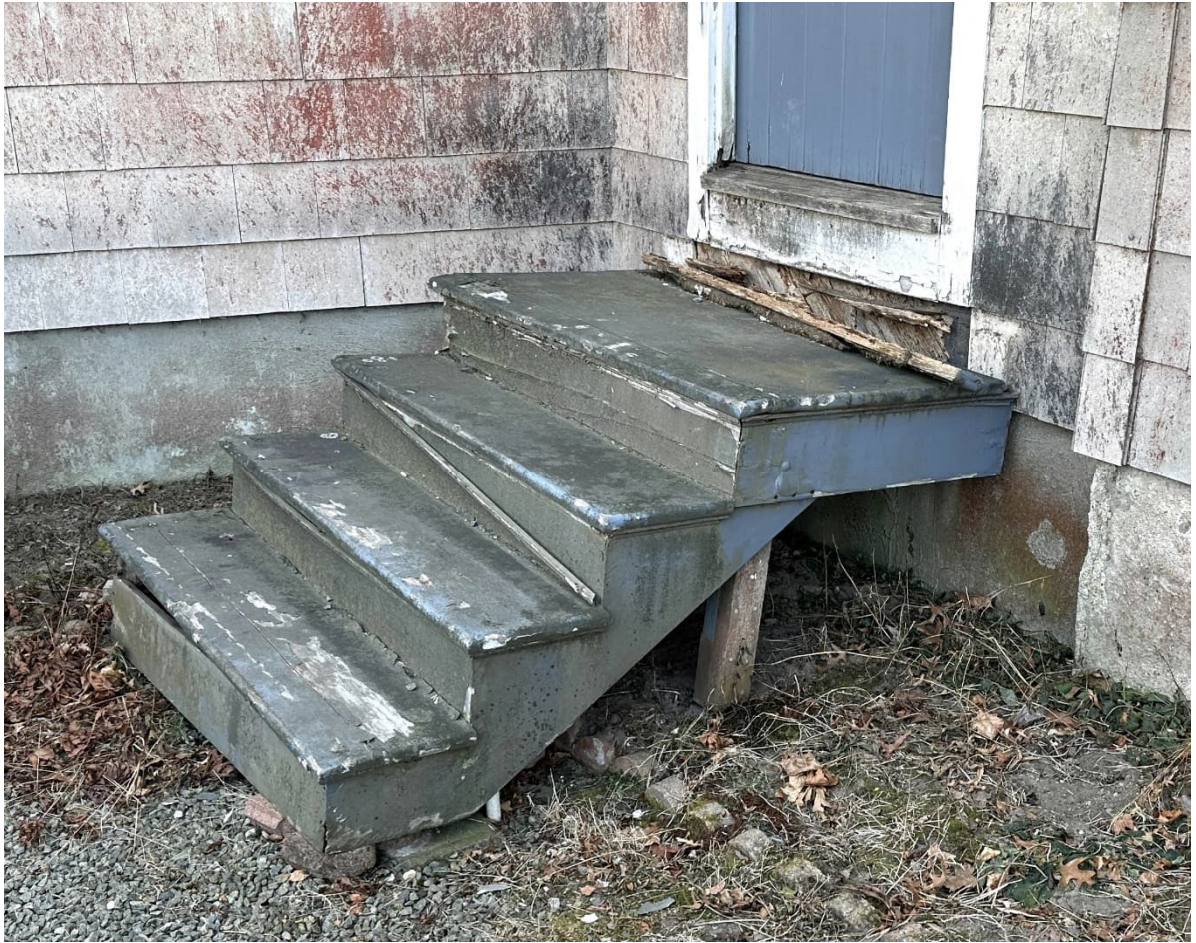
11. Deteriorated stairs.

- Comments and recommendations: The exterior stairs to the hallway between the house and east addition have deteriorated and are failing. The stairs are in a hazardous condition and should be replaced. Where the stair connected to the house appears to also be deteriorating and should be investigated further.

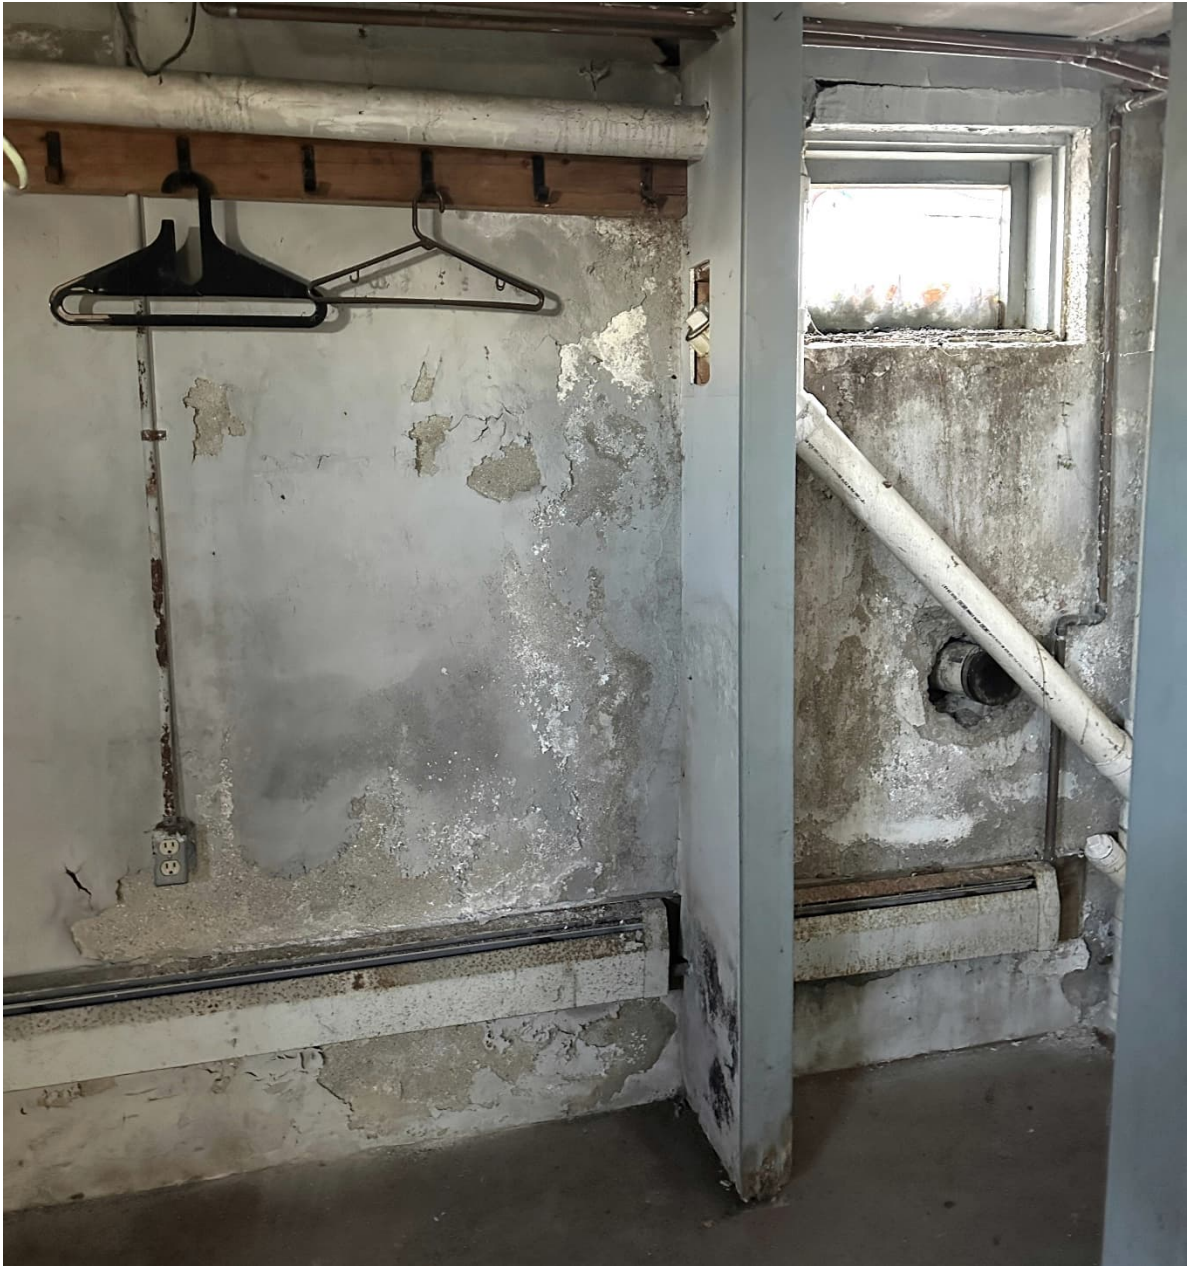
12. Peeling paint and efflorescence at interior foundation walls.

- Comments and recommendations: The interior foundation walls have various areas of peeling paint and efflorescence. Efflorescence is a sign of water infiltration into the building envelope which may lead to damage of the wall. It is recommended that a Building Envelope Specialist be engaged to determine the source of the water infiltration and the associated repairs.

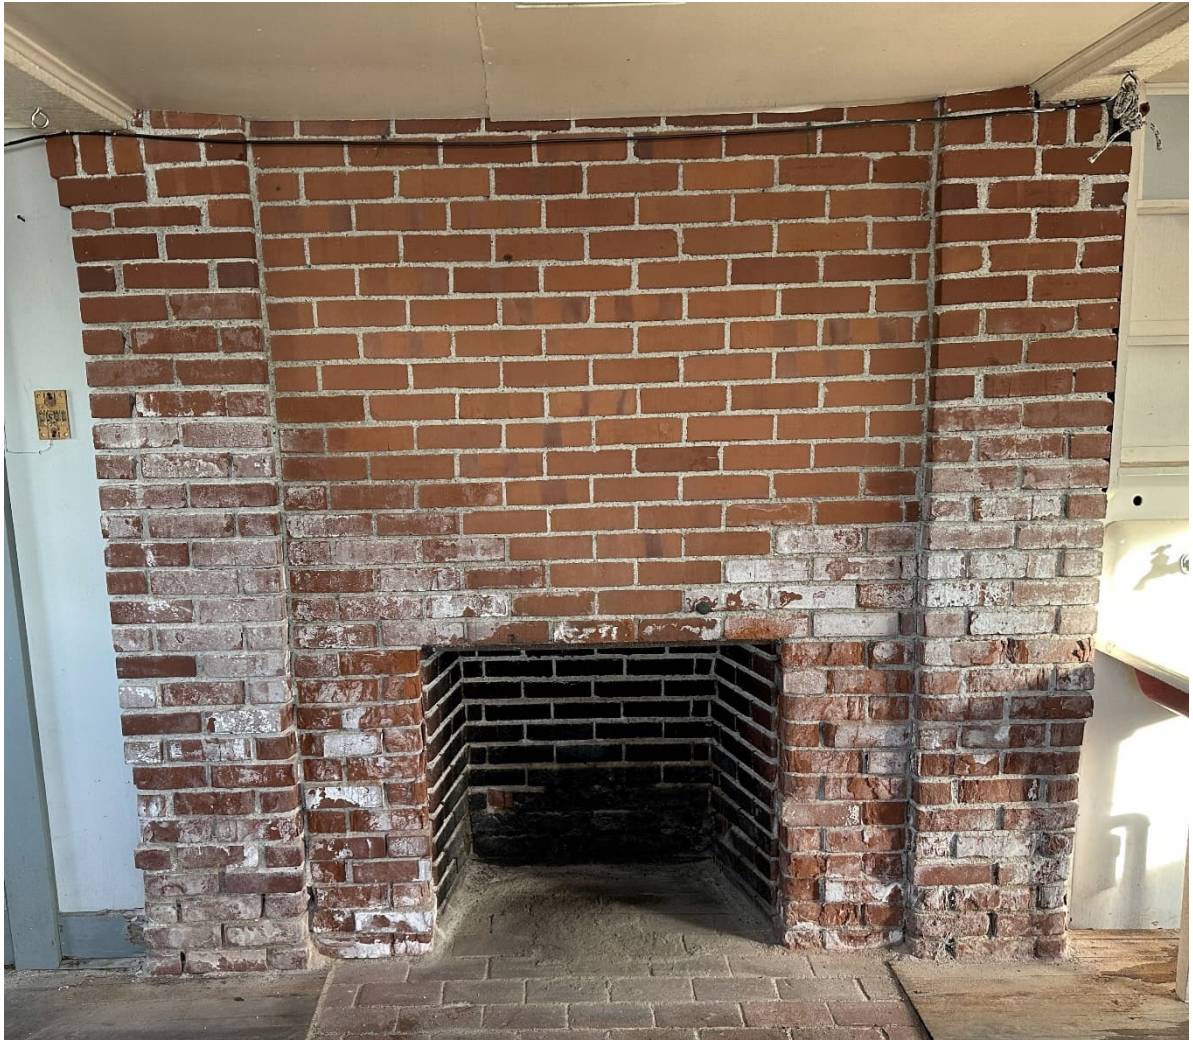
13. Efflorescence at fireplace in basement.

- Comments and recommendations: The fireplace in the basement is showing signs of efflorescence and deterioration. Efflorescence is a sign of water infiltration into the building envelope which may lead to damage of the wall. It is recommended that a Building Envelope Specialist be engaged to determine the source of the water infiltration and the associated repairs. It is also recommended that the brick be repaired and/or replaced by a qualified mason.

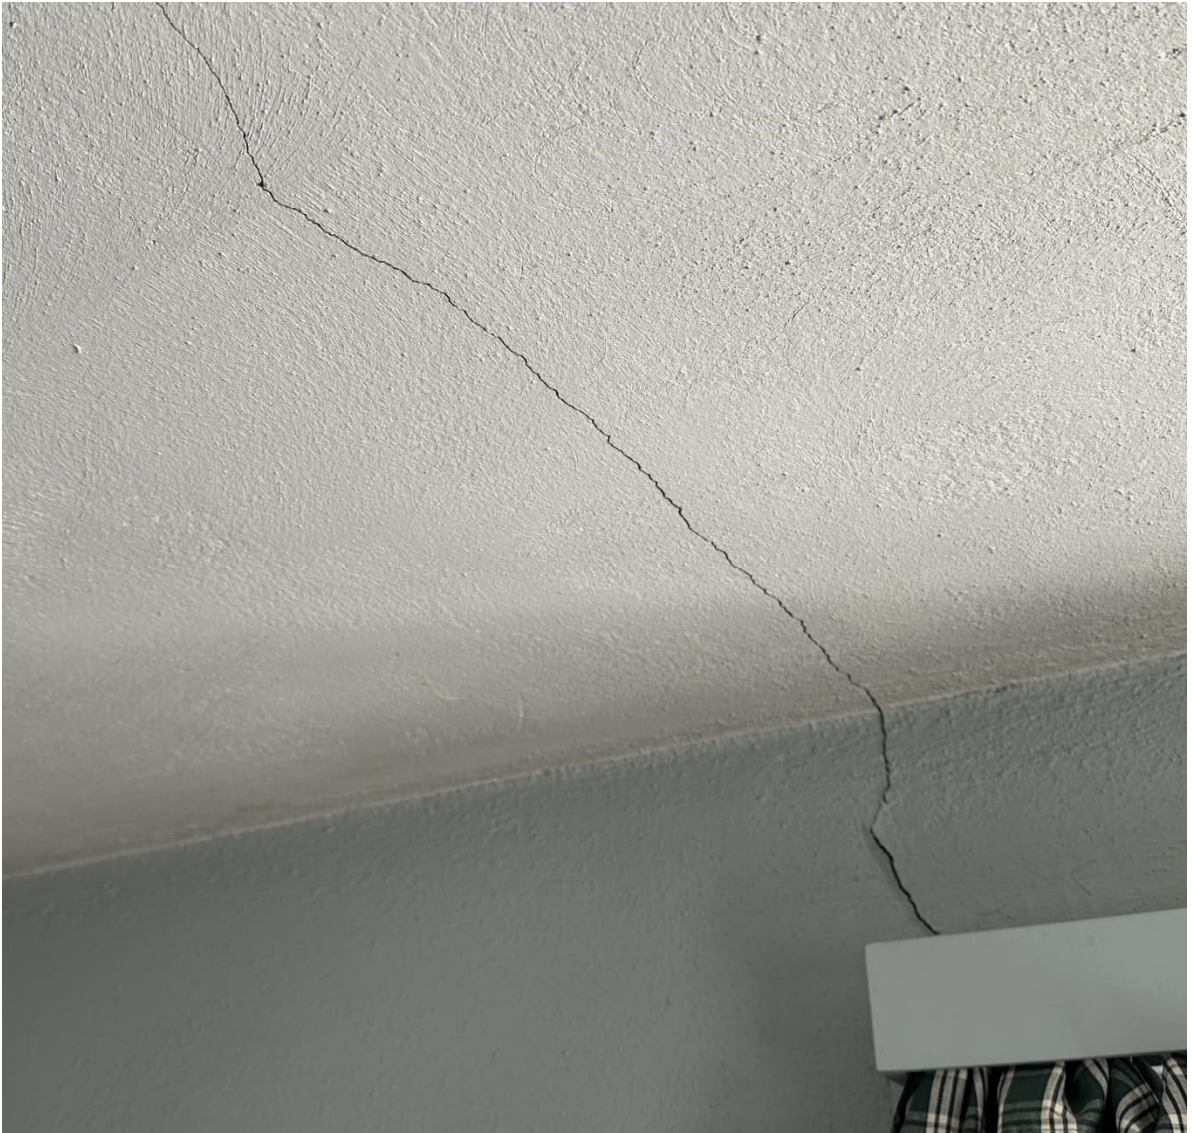
15. Wall and ceiling cracks at house corners.
- Comments and recommendations: The walls and ceilings are cracked at each of the house corners. The cracks are due to movement of the building. The exterior corner columns and walls are showing signs of deterioration which may be allowing the walls to displace. Please refer to comment D.7 for additional information.

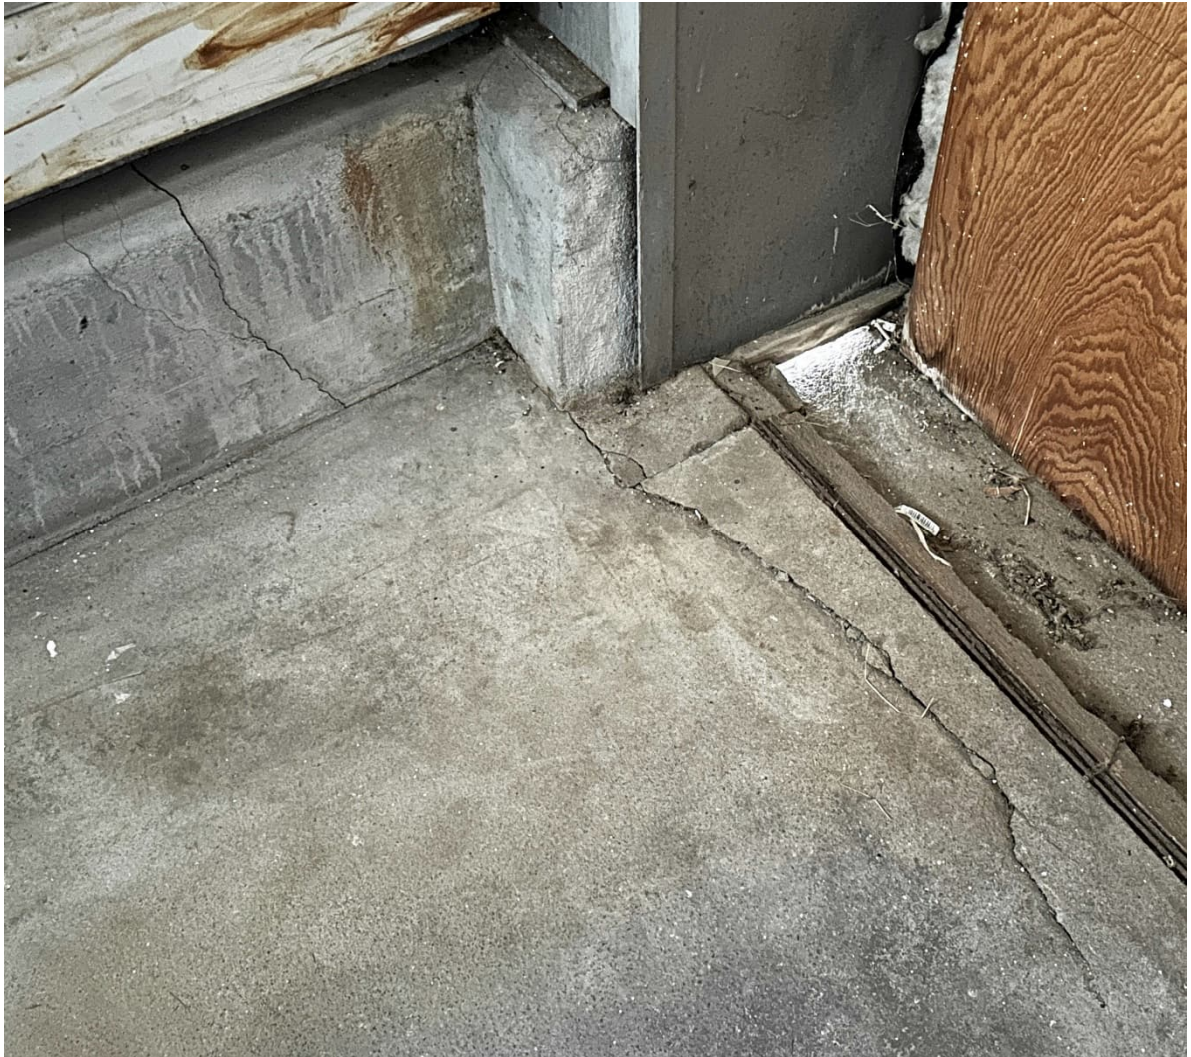
18. Laundry room concrete floor slab and wall cracks.

- Comments and recommendations: Cracks in the laundry room concrete floor slab and wall were observed. The cracks are most likely due to building movement and/or settlement. It is recommended that the cracks be repaired using high-performance materials by qualified personnel.

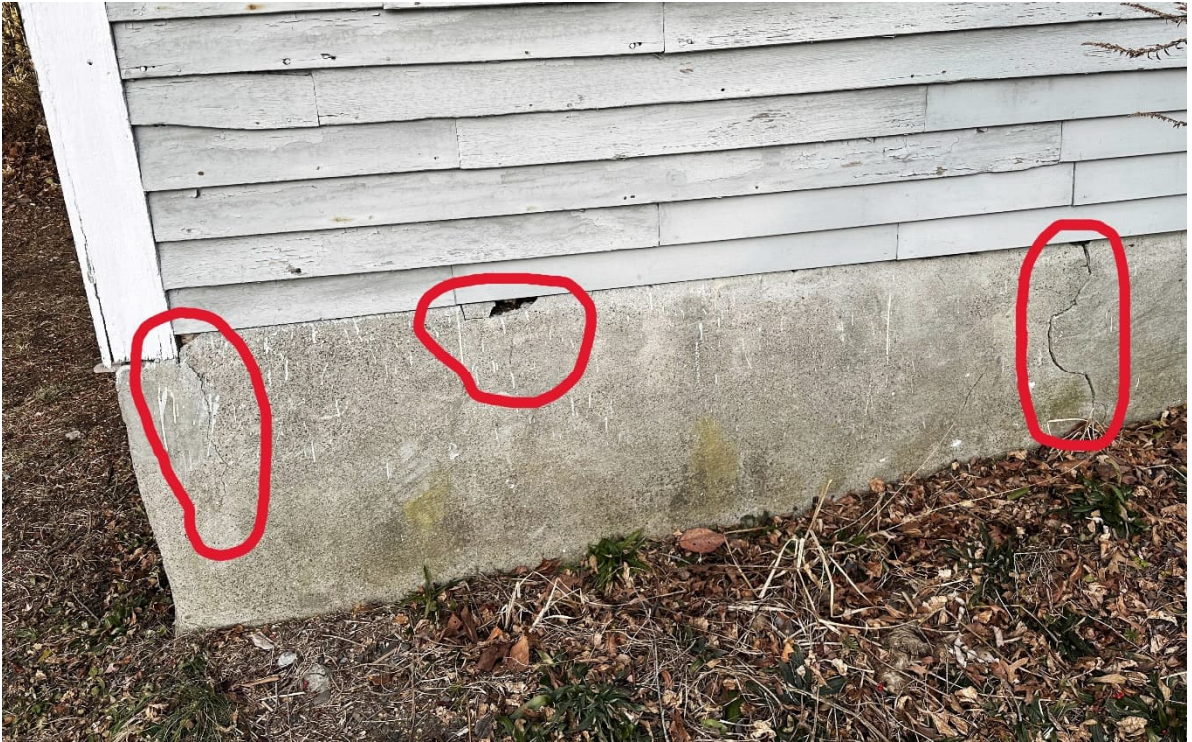
20. Shed foundation wall cracks.

- Comments and recommendations: The shed foundation wall has cracks at various locations. The cracks may be due to lateral forces, settlement, and/or building expansion/contraction from changes in temperature and humidity. The cracks may allow weather to infiltrate the wall and cause further damage. It is recommended that the cracks be repaired by qualified personnel using high-performance repair materials.

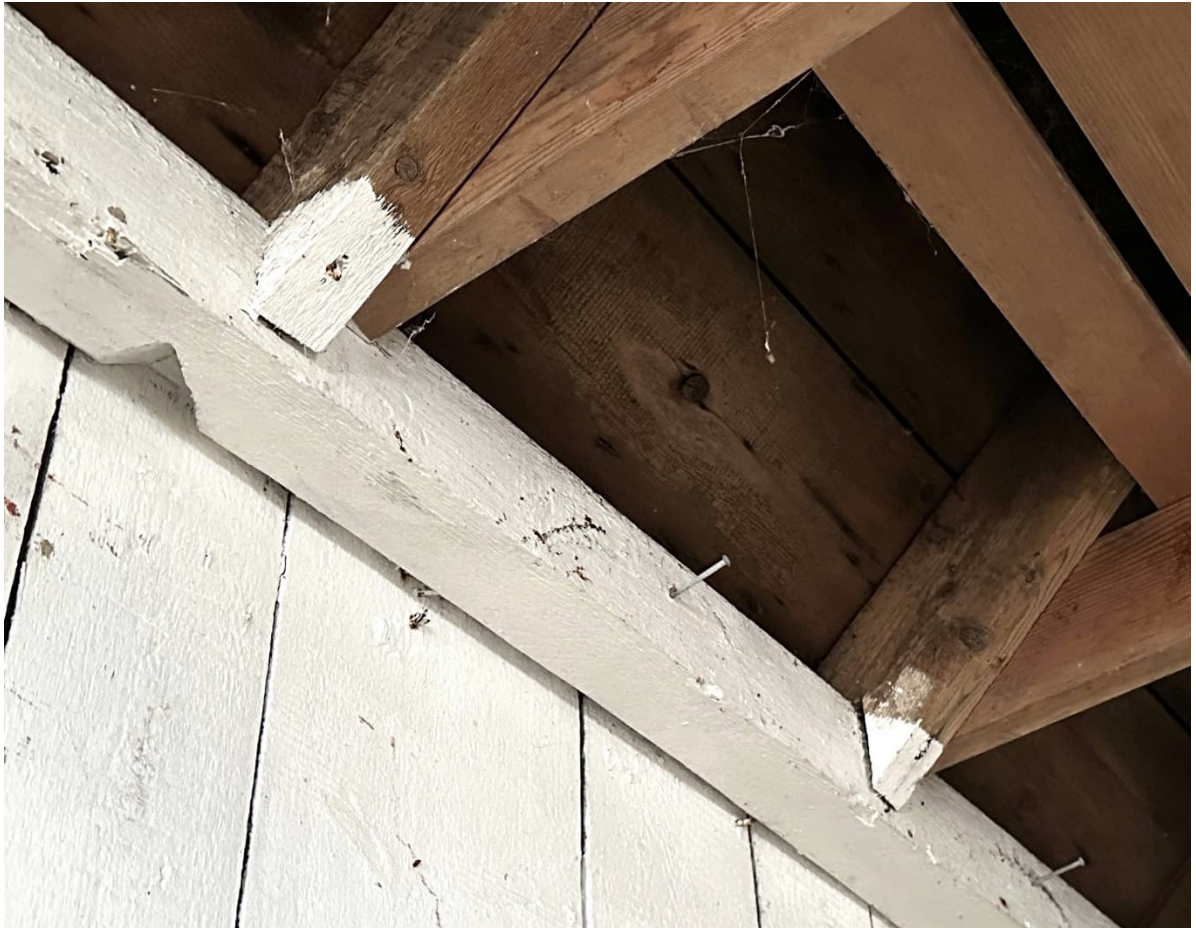
21. Shed roof framing connections potentially insufficient for uplift.
- Comments and recommendations: The shed roof framing appears to be connected to the perimeter beam by a single nail which is potentially insufficient to resist design wind uplift forces. It is recommended that joist hurricane straps be installed to connect the joist to the perimeter beam.

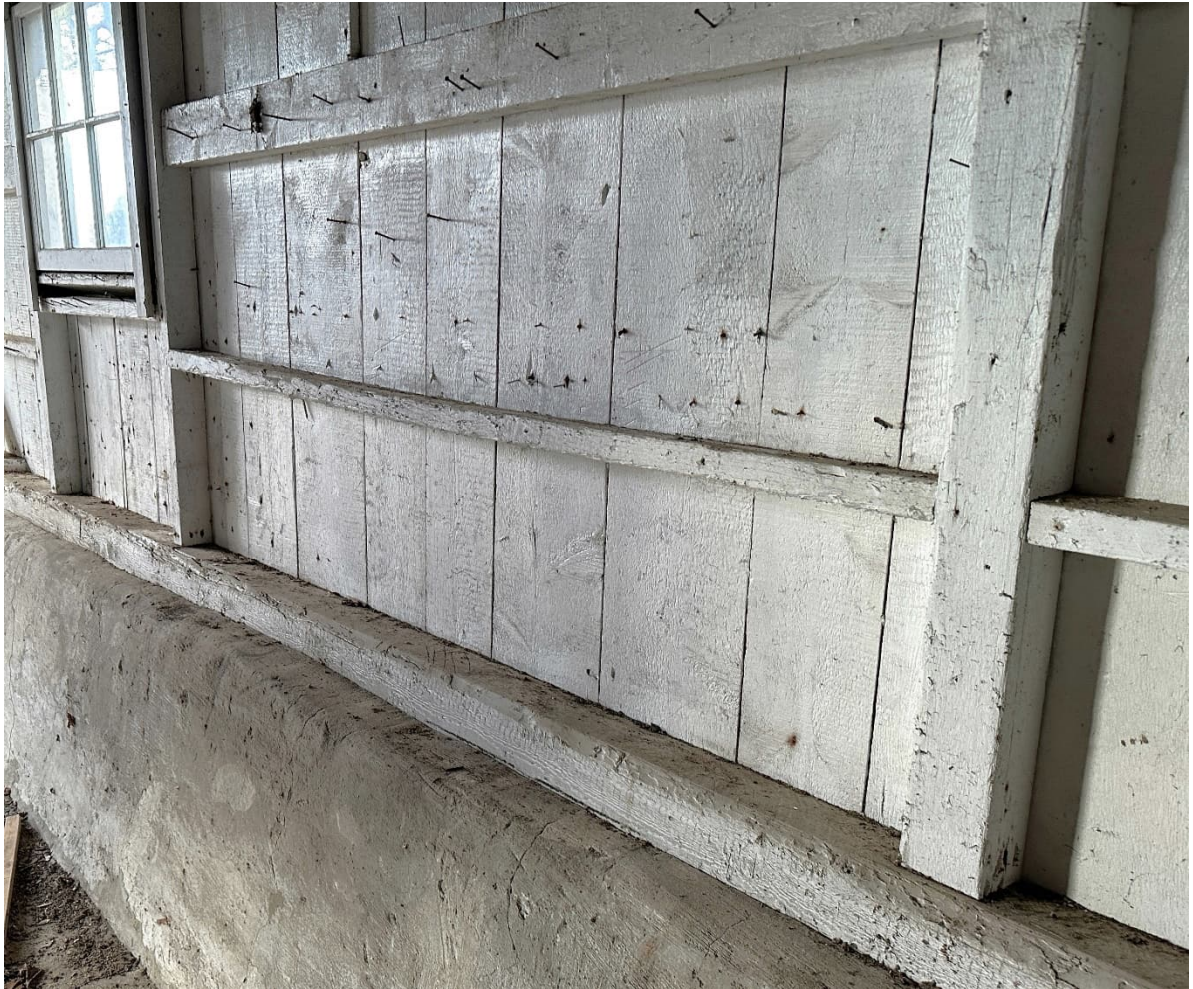
22. No sill anchors.

- Comments and recommendations: The shed sill plate does not appear to be anchored to the foundation wall. The purpose of the sill plate anchors is to prevent uplift of the building walls and columns, such as when experiencing lateral loads (wind and/or seismic). This is a structural hazard, and it is recommended that appropriate anchorage be designed by a Structural Engineer and installed by a qualified contractor.
