Town of Bartonville

Landfall Circle Rehabilitation

Date: July 20, 2023

Landfall Circle Culvert Rehabilitation

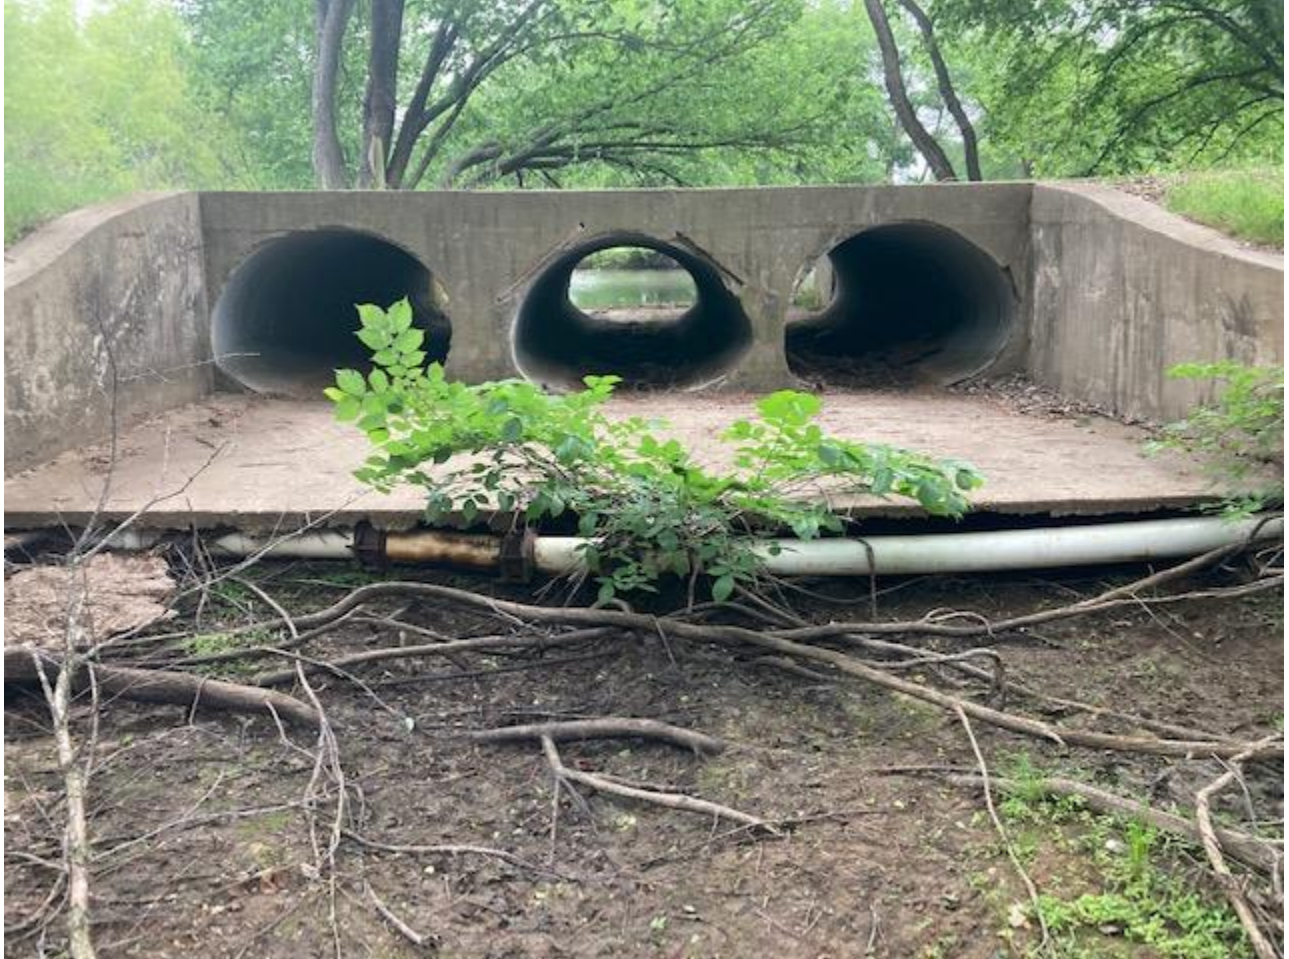
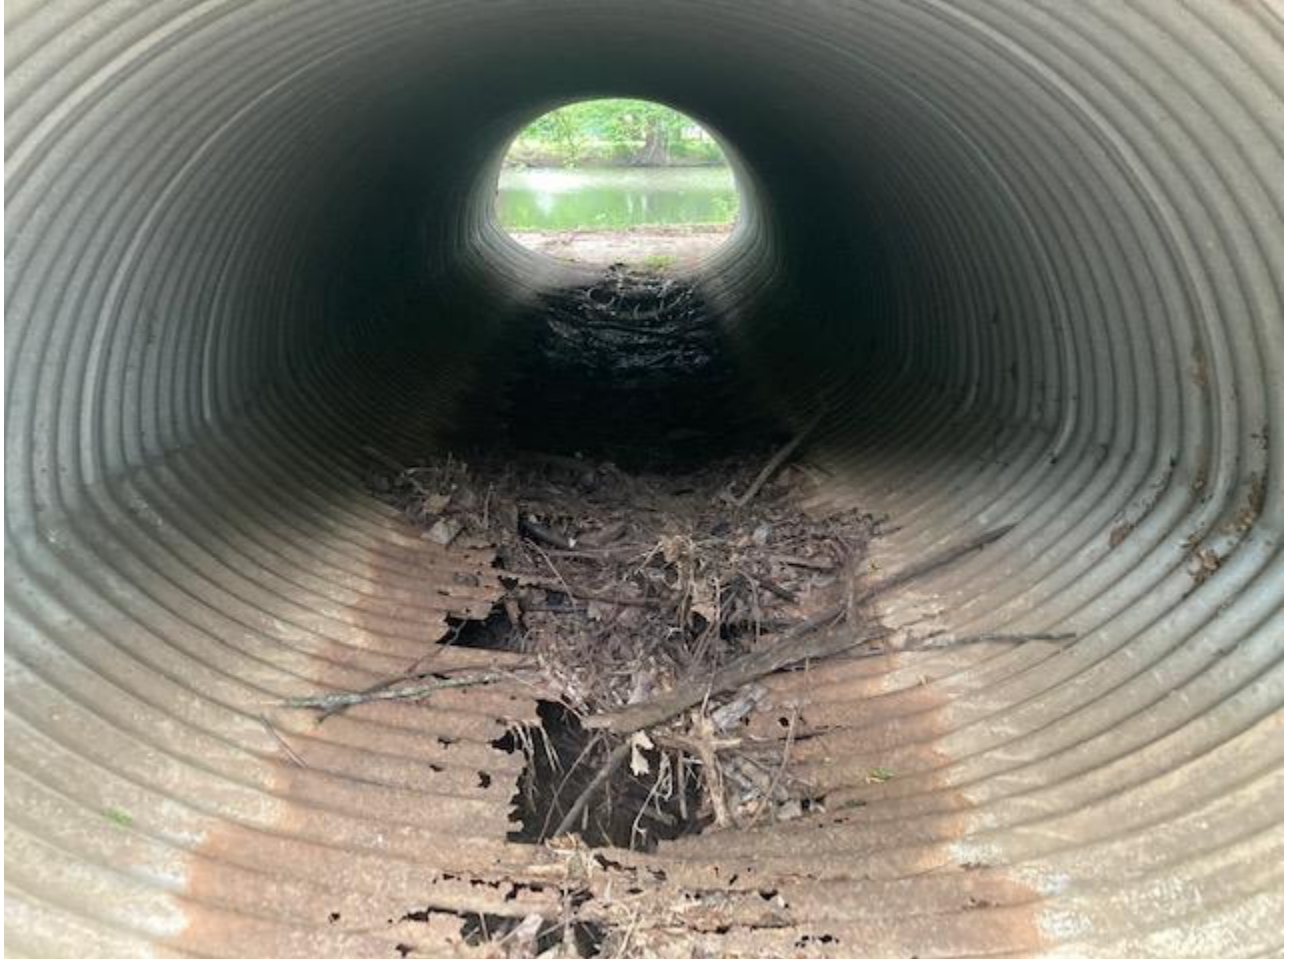
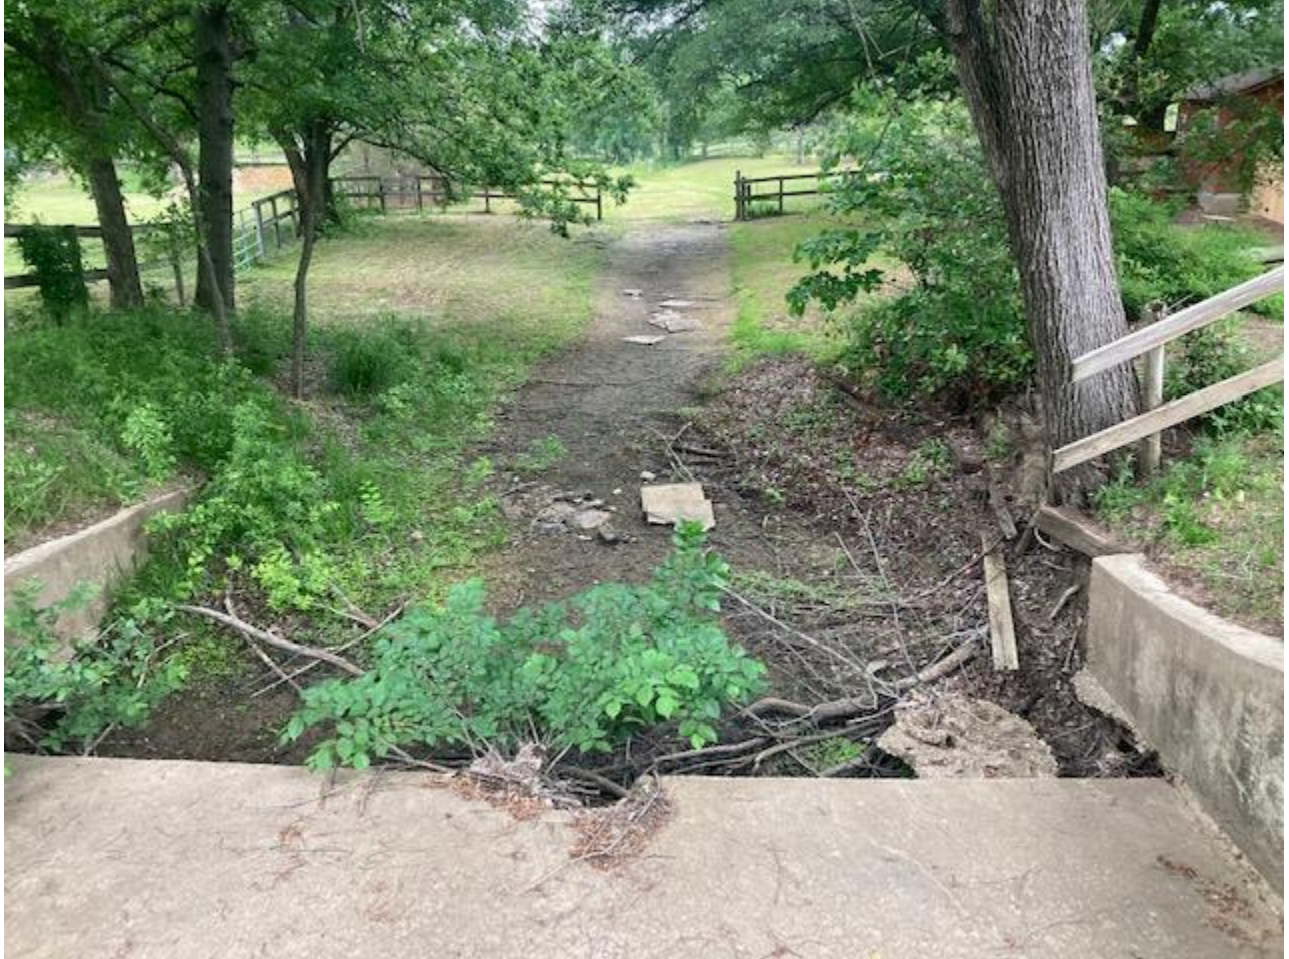
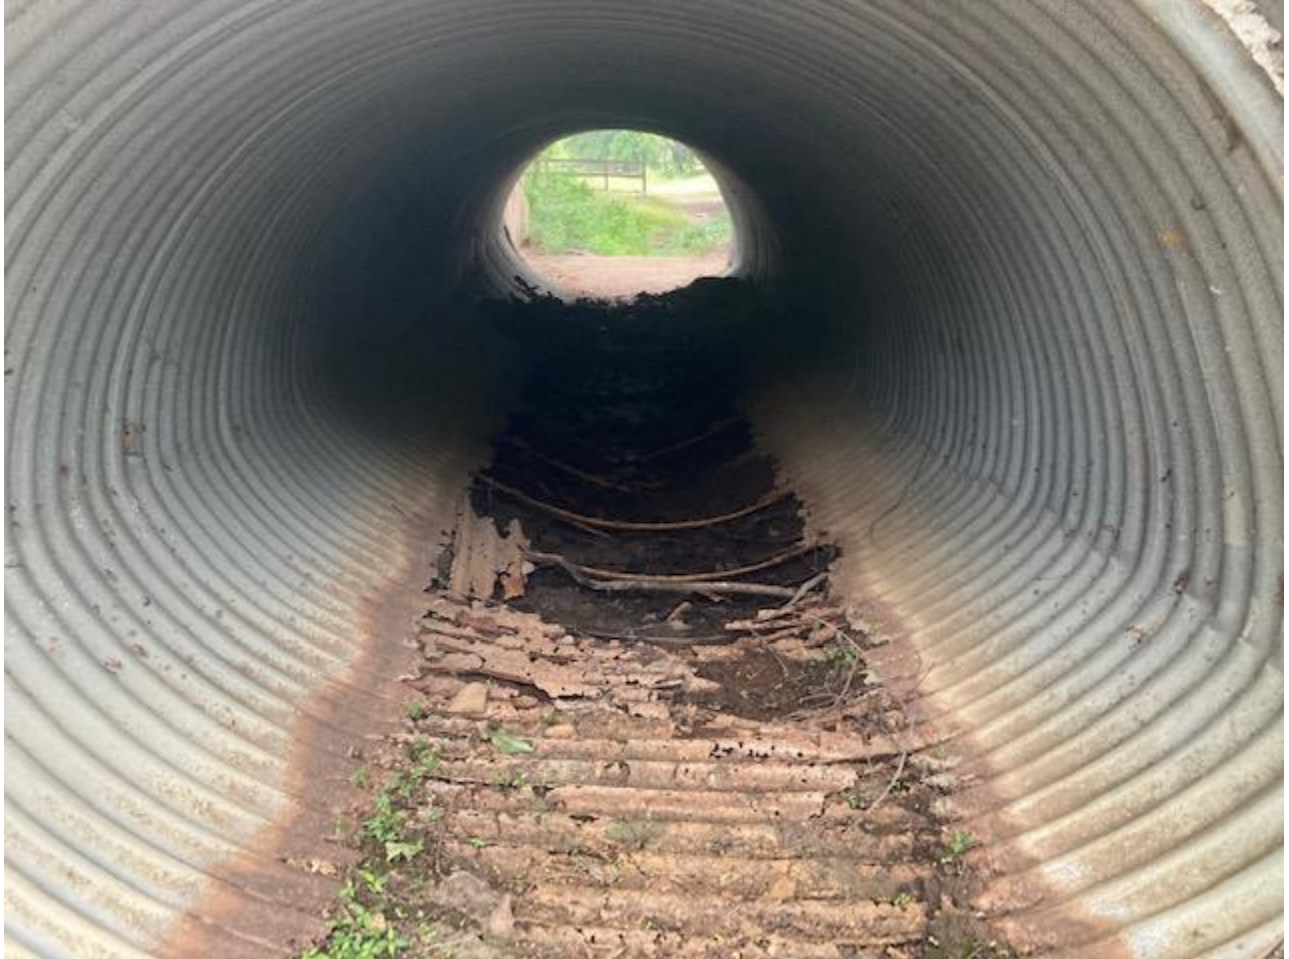
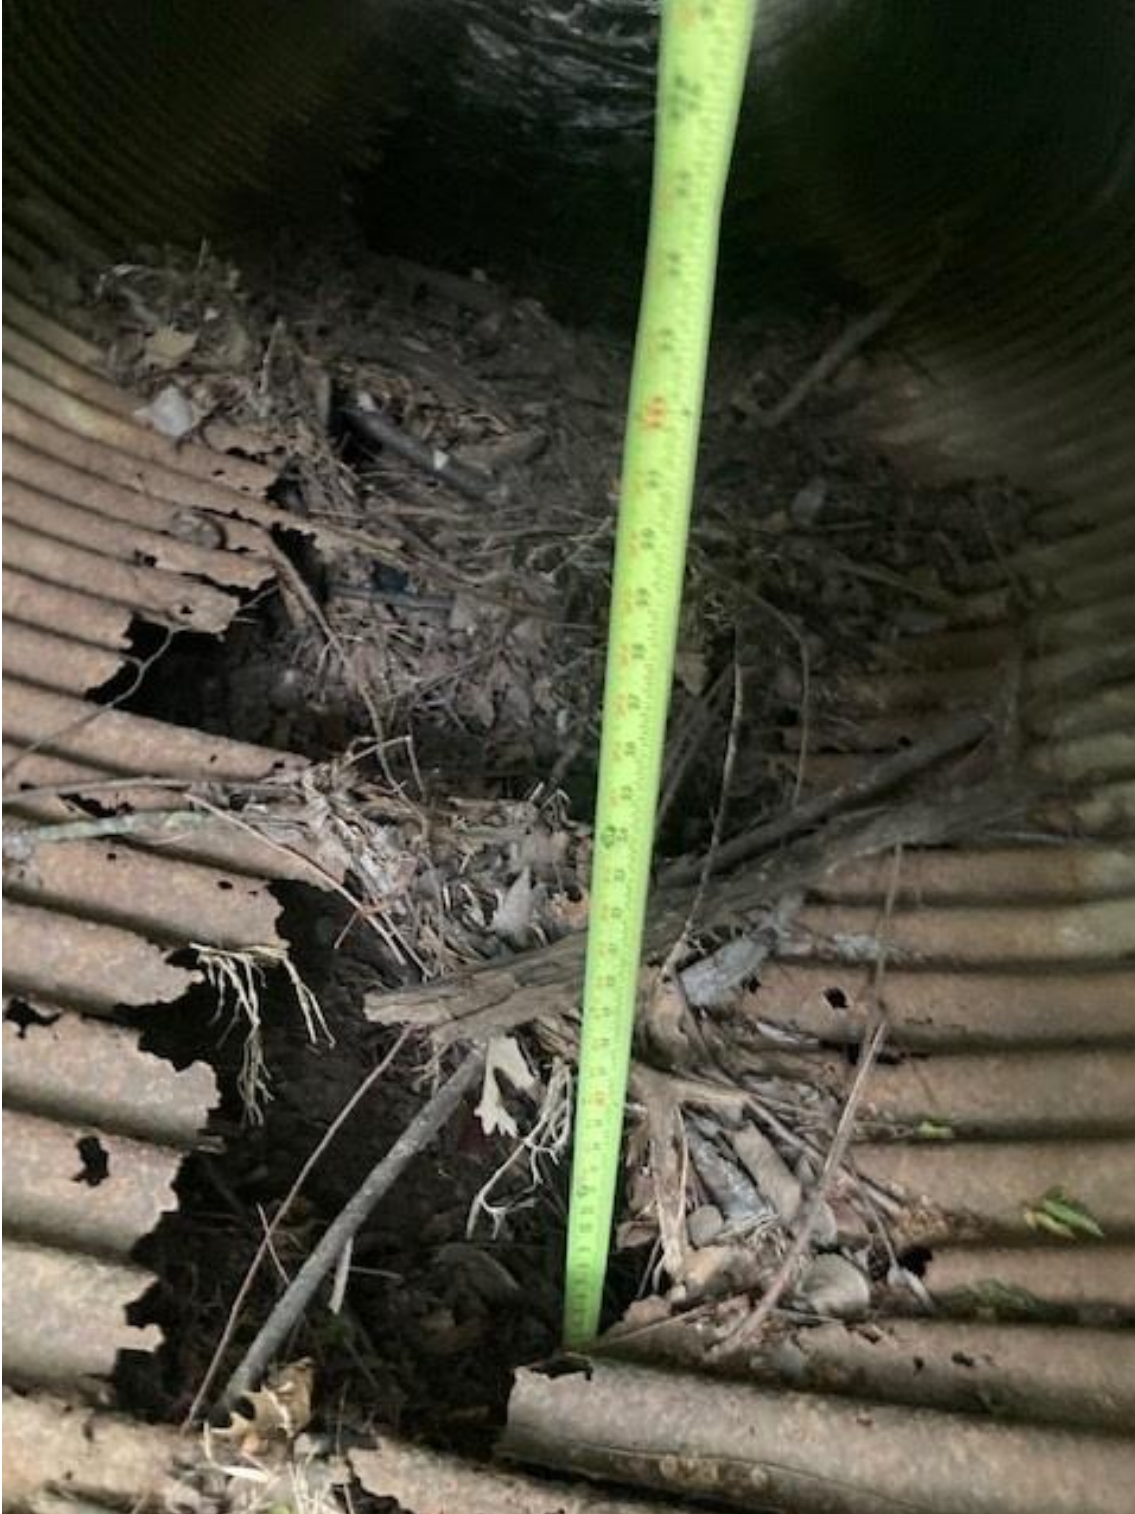
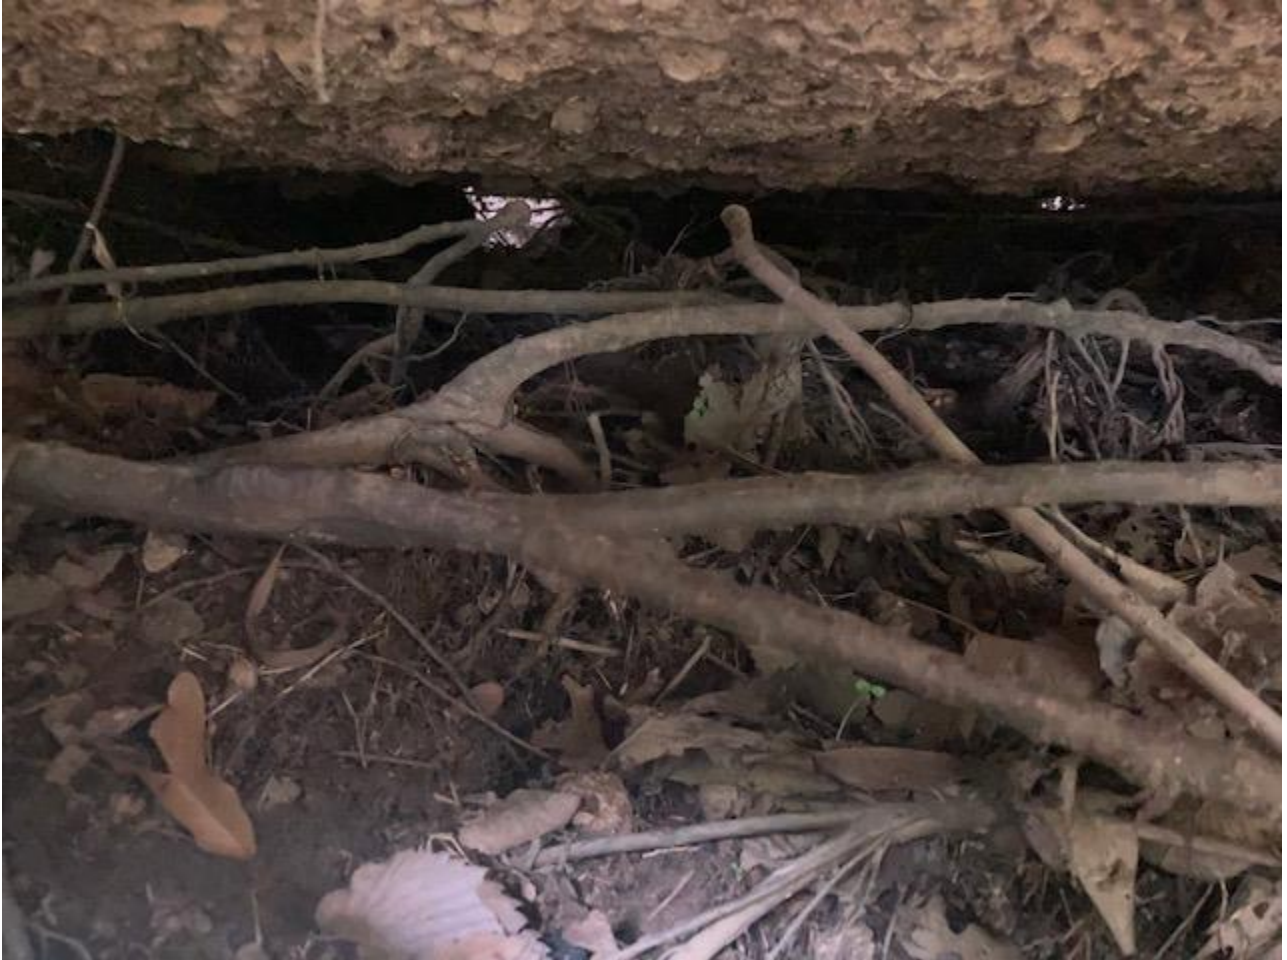
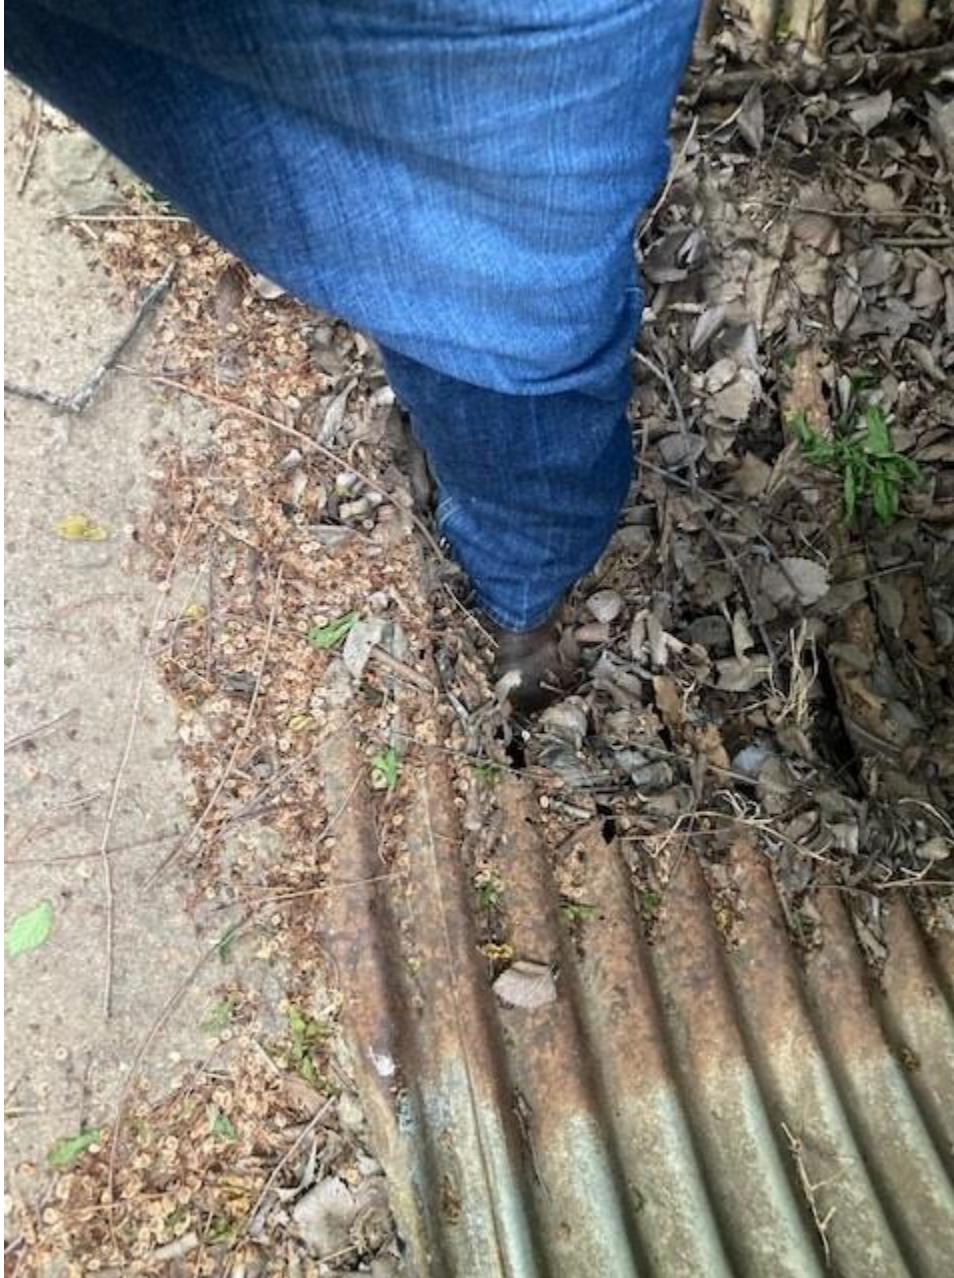
- There was significant erosion and voids noted at the culvert crossing of Landfall Circle near 1501 Landfall Circle. Westwood investigated and the pictures shown below show significant void space. There appear to be two options available, one a more temporary fix and the other complete reconstruction. Given the significant cost of the reconstruction the temporary fix was selected. The drawback of this approach is that it is less certain the time in which the improvements will work. The improvement would be filling the void space with flowable fill which is a cement based material where cementitious material is mixed with aggregate and pumped into the void space. It hardens similar to concrete and provides protection. The drawback is that the void space may propagate outside of the areas that are treated by flowable fill. The flowable fill should not wash away but given it is a hard surface, it may push water upwards which could washout fines above the treated area. This is the drawback but it does come at a significant cost savings. Westwood estimated that approximately 180 cubic yards of flowable fill may be needed. This assumes 40' x 30' space wide (the width and length of the culverts) and a depth of 4'. A quote was provided of \$400/cyd by SPI Asphalt and mobilization and adjusting of the headwall to access the area was included. Thus a cost of \$82,000 was estimated which included \$5,000 for mobilization and \$5,000 for headwall adjustment and 180 cyd of flowable fill at \$400/cyd or \$72,000. It is recommended a not to exceed amount and different quotes could be explored.
