Deer Hollow Development
Town Of Bartonville
Residential Construction Inspection Checklist
June 12, 2023

Inspector: Bart Wilson- Westwood

Contractor: Randy Petty

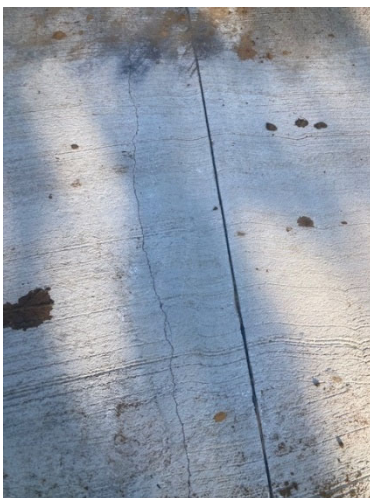
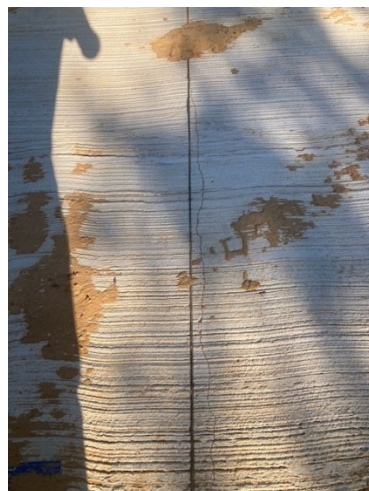
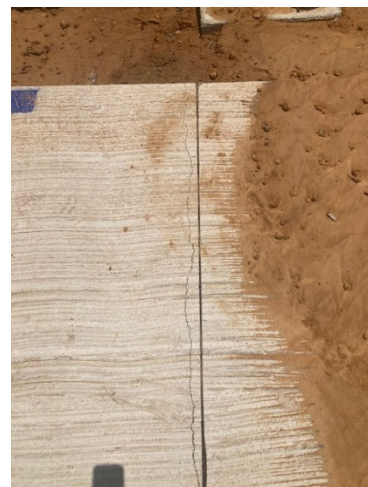
- The first 500 ft of Ginger Rd. has cracks following each transverse joint throughout this entire section.

- The cracking adjacent to the expansion joints will create future maintenance issues based on what we have witnessed on past projects. This could be caused by a delay of saw cutting of the pavement after placement
- Areas around the ditches are currently bare and could erode in extended rainfall conditions.

- Extend maintenance terms of the contract to monitor pavement conditions. While this may not be extended to a period that would encompass future issues it would allow monitoring. Anything short of replacement could possibly make the condition worse. Epoxy sealing could also be explored
- For erosion control, either seeding or erosion control blankets could be utilized.
