**BUCHANAN PRESERVATION SOCIETY**

22 June 2022

A short portion of the mill race wall west of Oak Street has collapsed. A longer portion is deteriorated, leaning, and at risk of collapse as well.

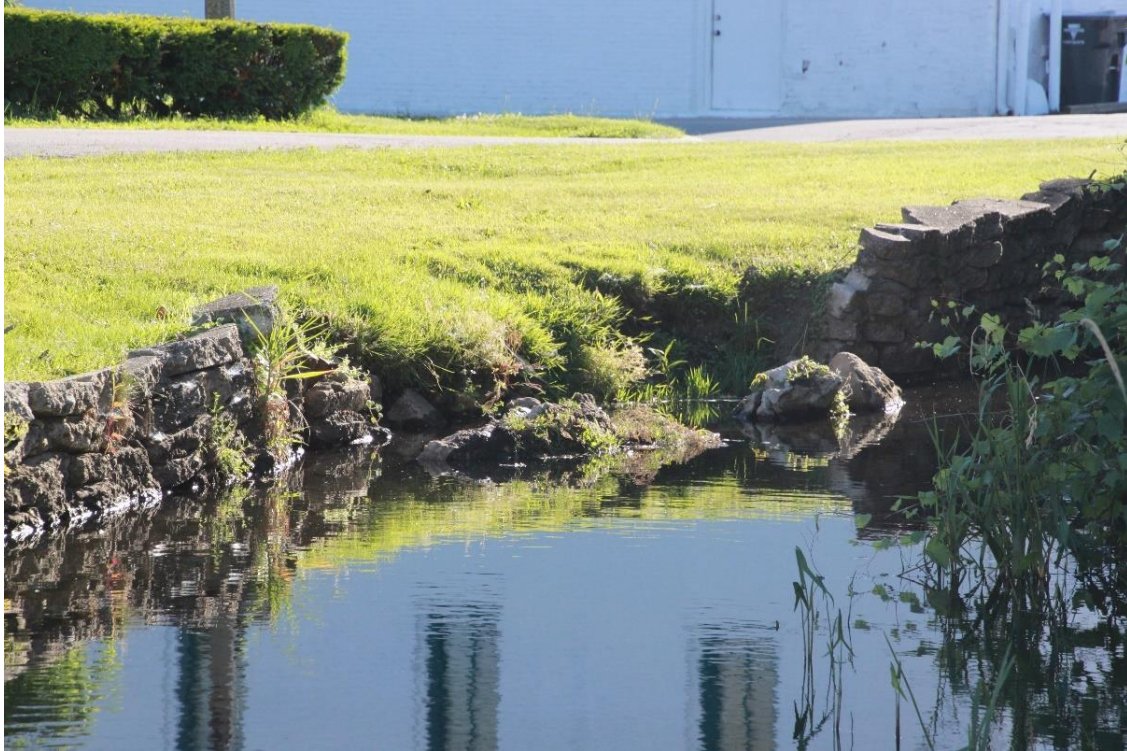
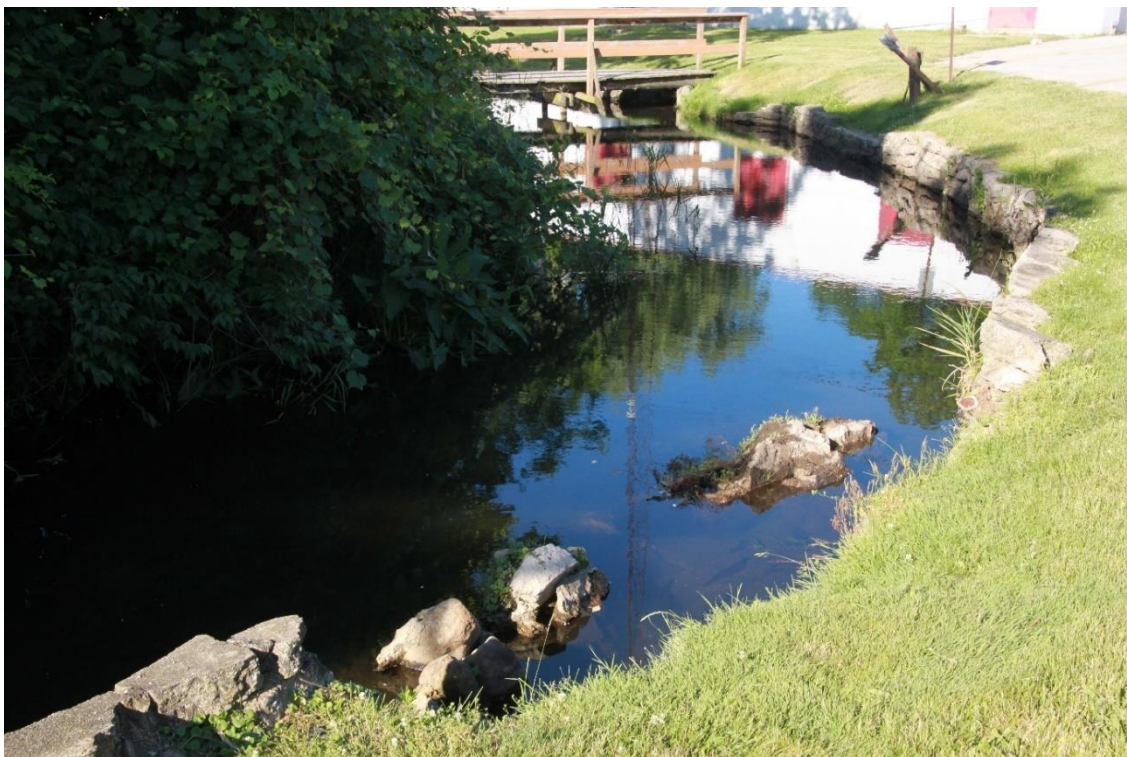
We believe that the first hundred feet of the northerly wall west of Oak (the part behind the park and Ross-Sanders House) was built sometime between 1936 and 1961 – it probably wasn't there in 1936 but we know it was there in 1961 – so it is between 60 and 85 years old. This is the part of the wall where the collapse has occurred.

All three sections of the wall are built of stacked and mortared pieces of broken concrete sidewalk or pavement.

Here are some pictures of the collapsed part of the millrace wall:

The Buchanan Preservation Society asks that the City rebuild both the collapsed and the deteriorated portions of the northerly mill race wall; and since the race is a contributing resource to the Downton Historic District and an integral component of Pears Mill operations, the Society also asks to be a partner in the design and execution of this work.

The length of wall that requires immediate attention is about 60 feet. Salvaged materials should be reused and similar materials procured if necessary. The end result should be a wall similar in appearance to the original wall. The height of the new wall could be made lower by removing some of the existing bank and grading it similar to the slope of the bank parallel with the fire station. Lowering the height of the wall should increase its stability.

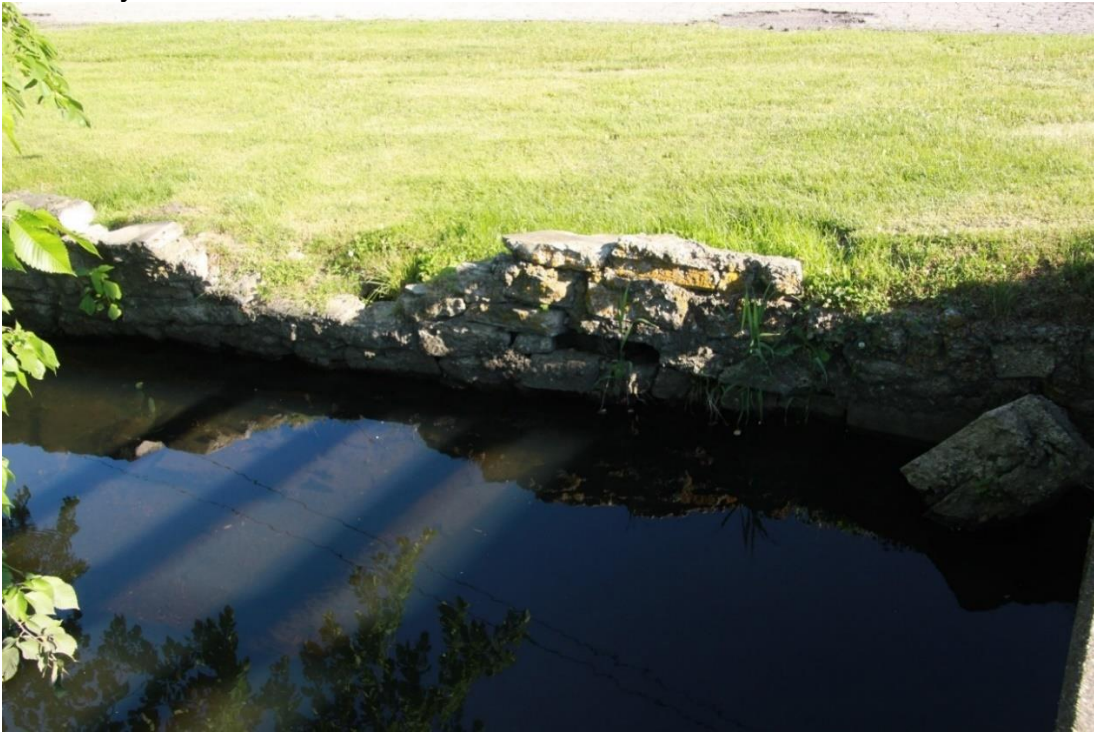
Here is a photo of where the next collapse seems likely. It's hard to get a good photo of this, but if you visit the site the deterioration and current lean is clearly visible:

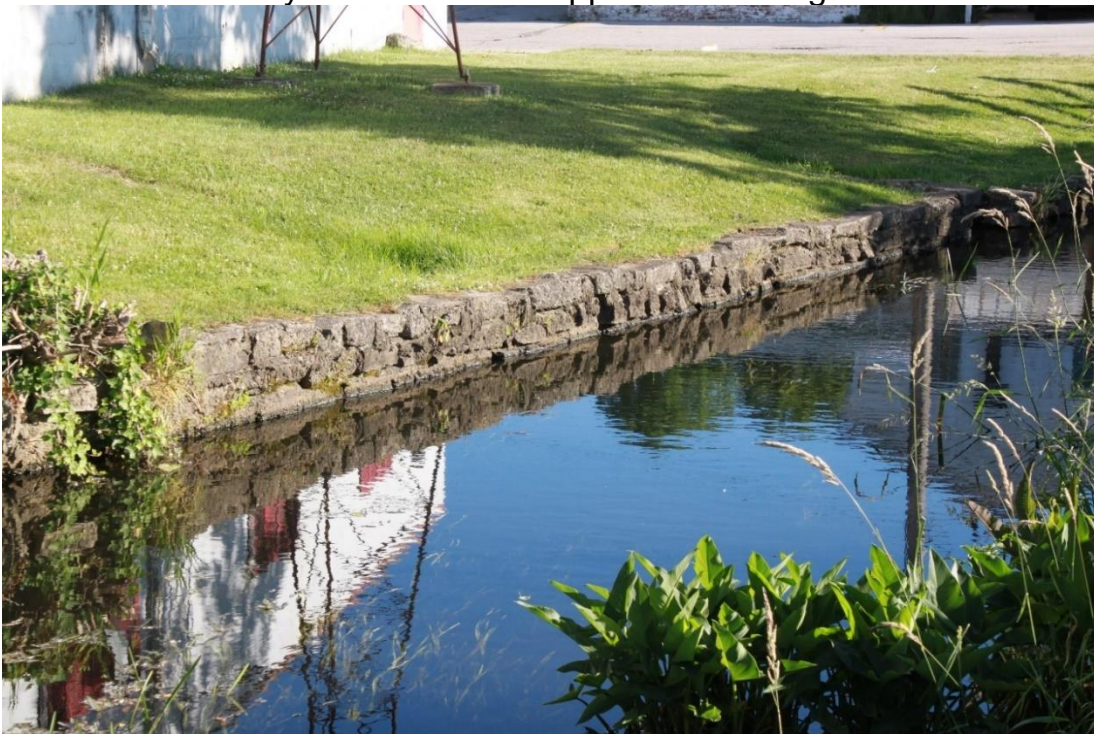
The next hundred feet of wall (next to the fire station) was built by City employees in 1975 – 47 years ago. It appears to be in good condition, or at least not obviously at risk.

Here is a picture of a part of the wall constructed by the City in 1975. The wall is considerably lower here and appears to be in good condition:
