REQUEST FOR PROPOSALS

REQUEST FOR PROPOSALS FOR PURCHASE OF THE CITY OF BUCHANAN'S ROSS-SANDERS HOUSE LOCATED AT 107 WEST FRONT, BUCHANAN, MICHIGAN

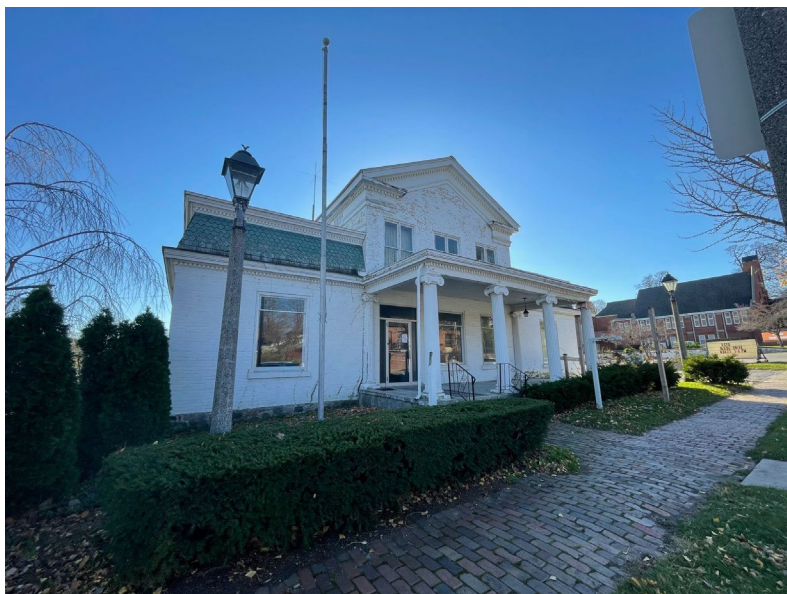
The City shall review all proposals through the City Commission appointed RFP Committee (“Committee”). The Committee may request written clarification from respondents, and will forward all proposals and non-binding recommendations on proposals to the City Commission for final consideration and award of bid and request to enter into a Purchase Agreement and the Historic Preservation and Conservation Easement Deed (Attachment 1), which includes the Ross-Sanders Historic Building Elements document (Attachment 2). The City of Buchanan reserves the right to terminate the RFP process at any point prior to the approval of a proposal.

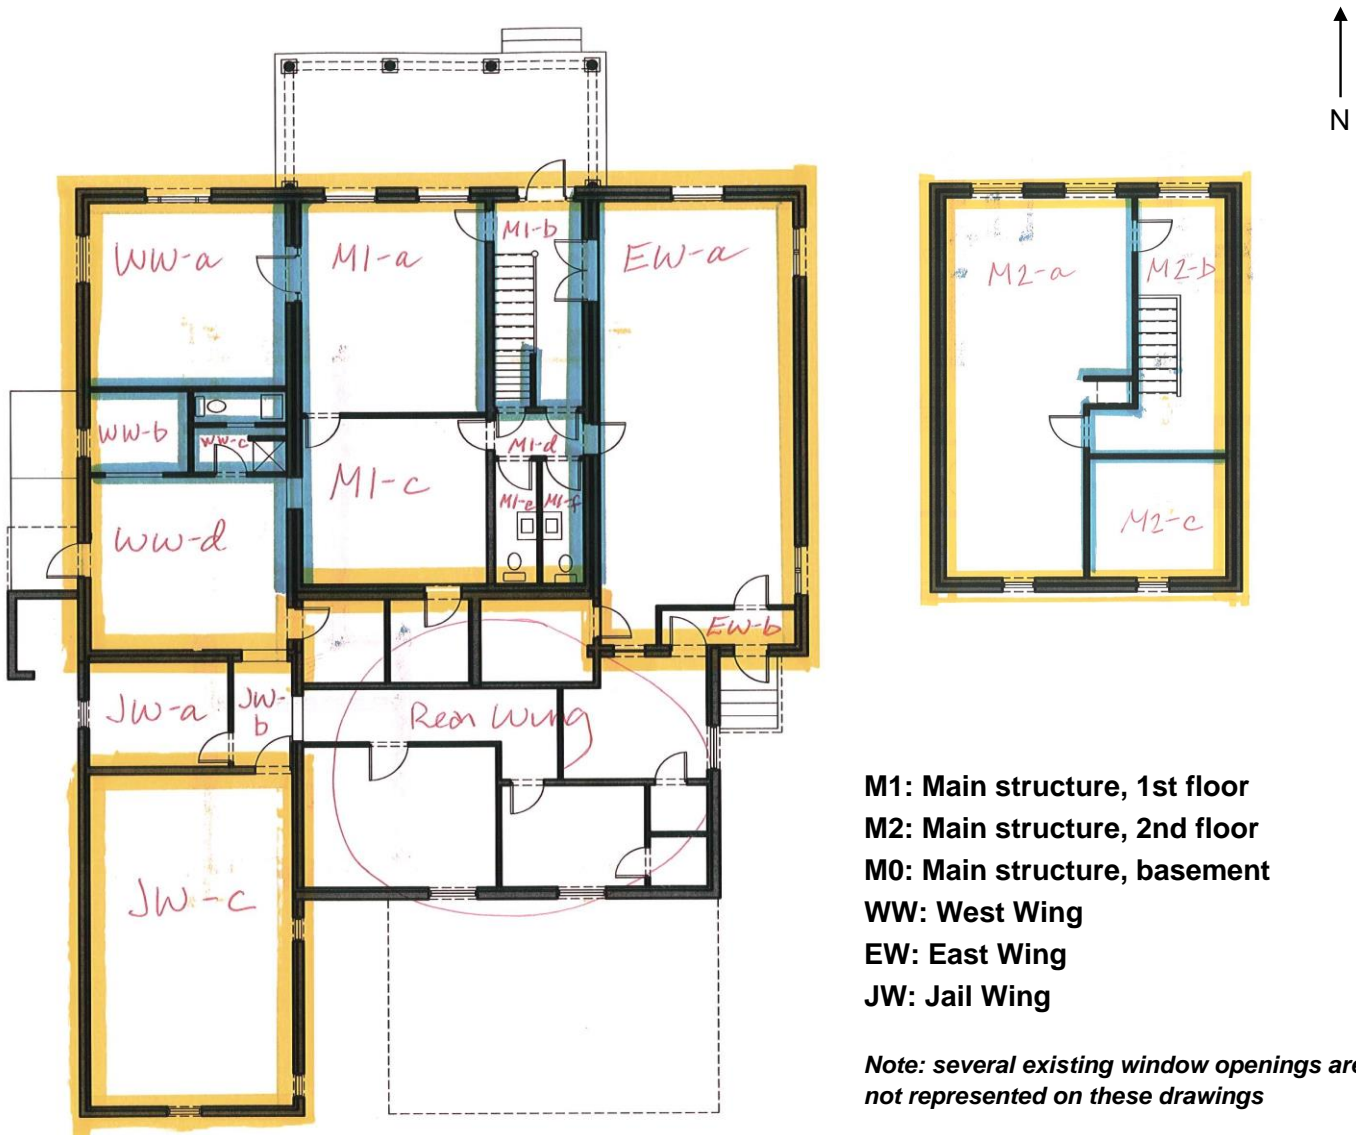
ROSS-SANDERS HOUSE EXTERIOR

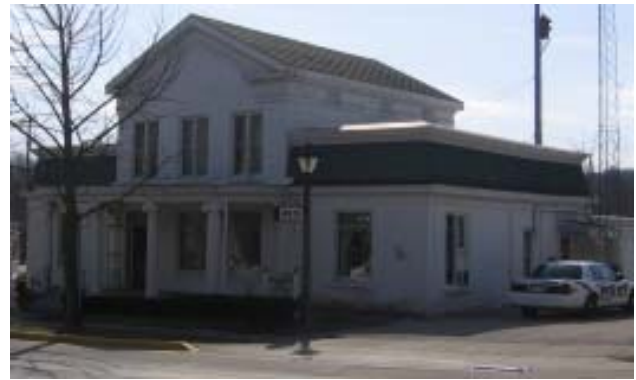
Fig 1: North elevation

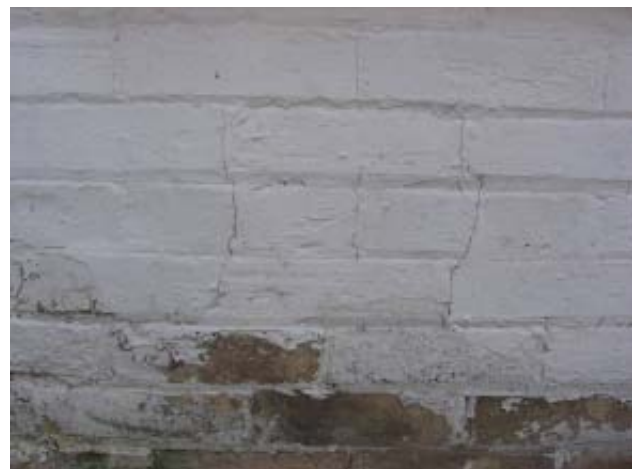
Fig 2: *Cracking in exterior brick north wall west wing*

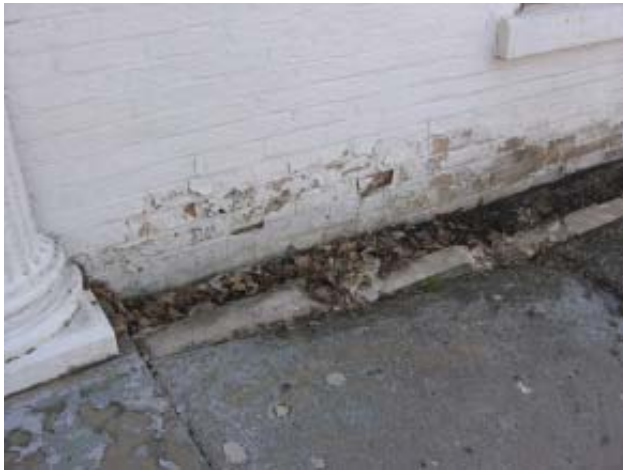
Fig 3: Deteriorating exterior brick north wall west wing

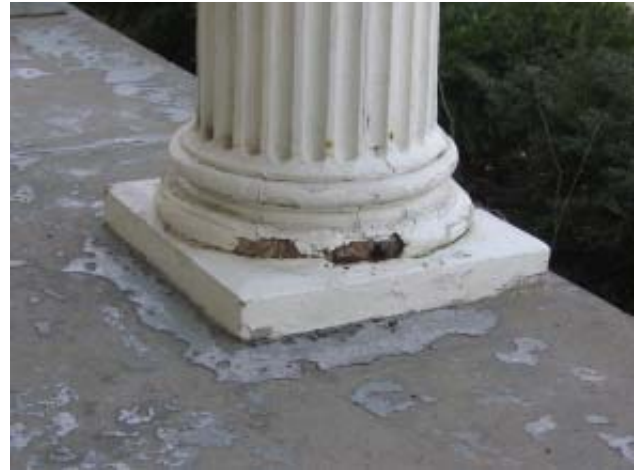
Fig 4: Deteriorating column bases at north porch

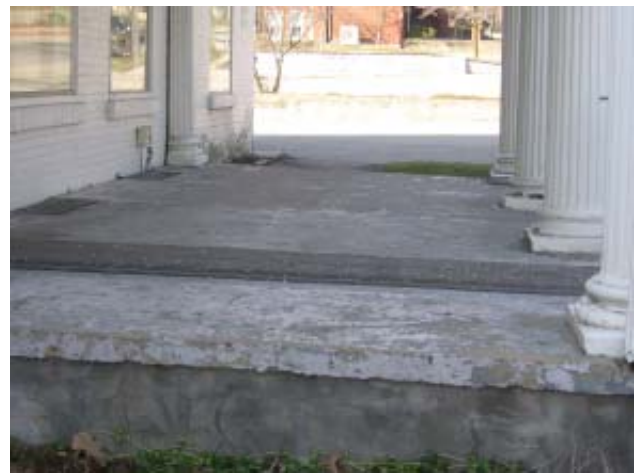
Fig 5: Concrete slab of north porch

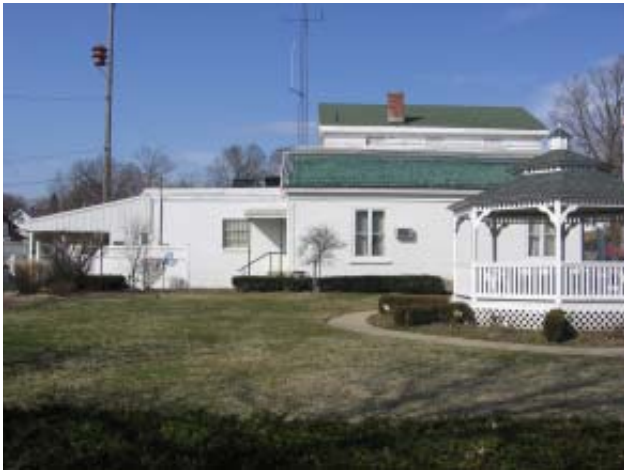
Fig 6: East elevation

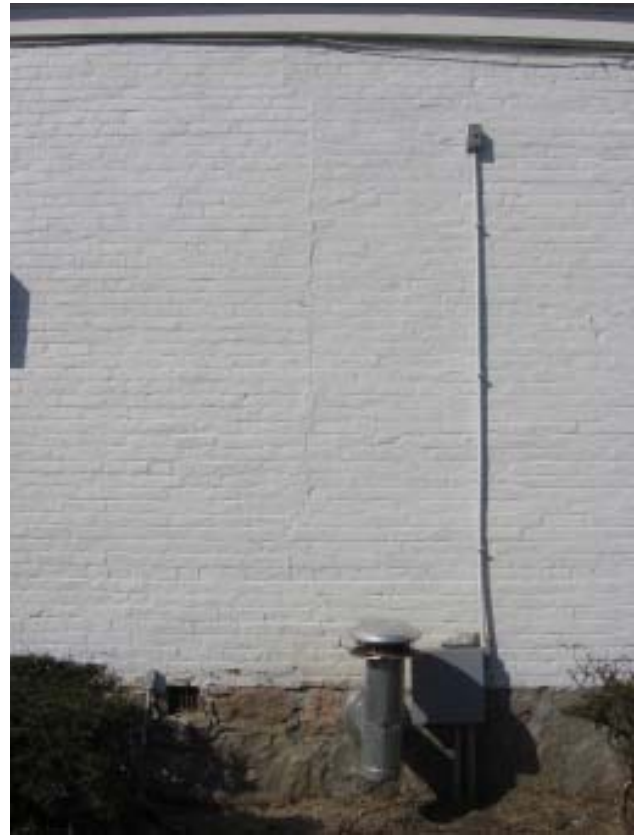
Fig 7: East elevation - Vertical cracked joint

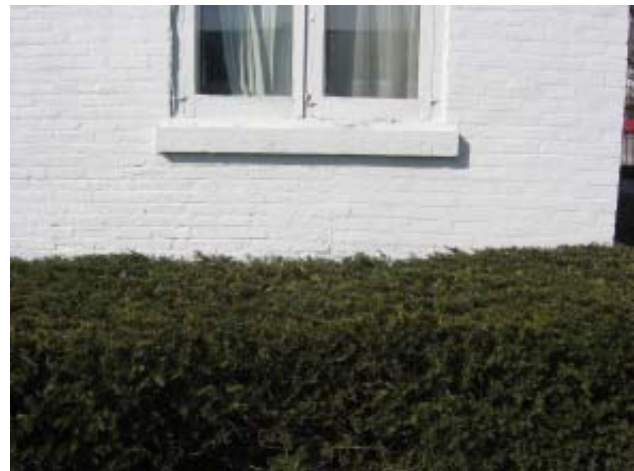
Fig 8: East elevation - Cracking below window

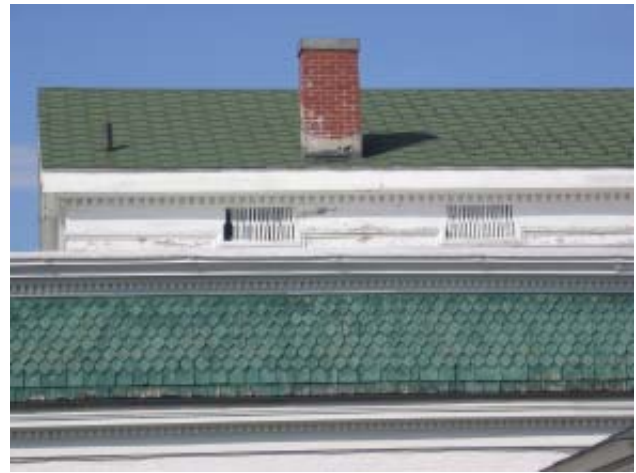
Fig 10: East elevation - Missing iron bar

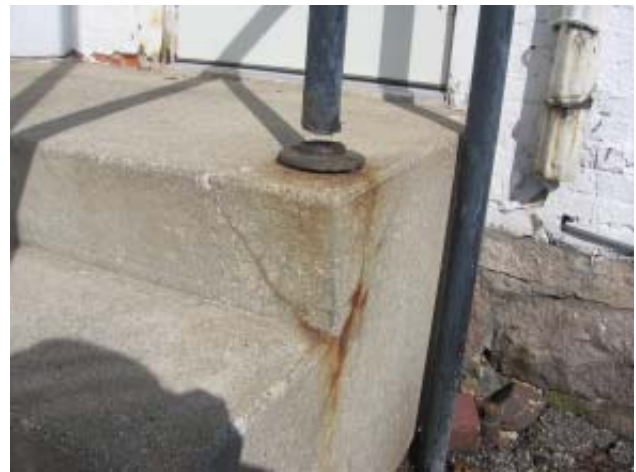
Fig 11: East elevation - Handrail support with no bearing

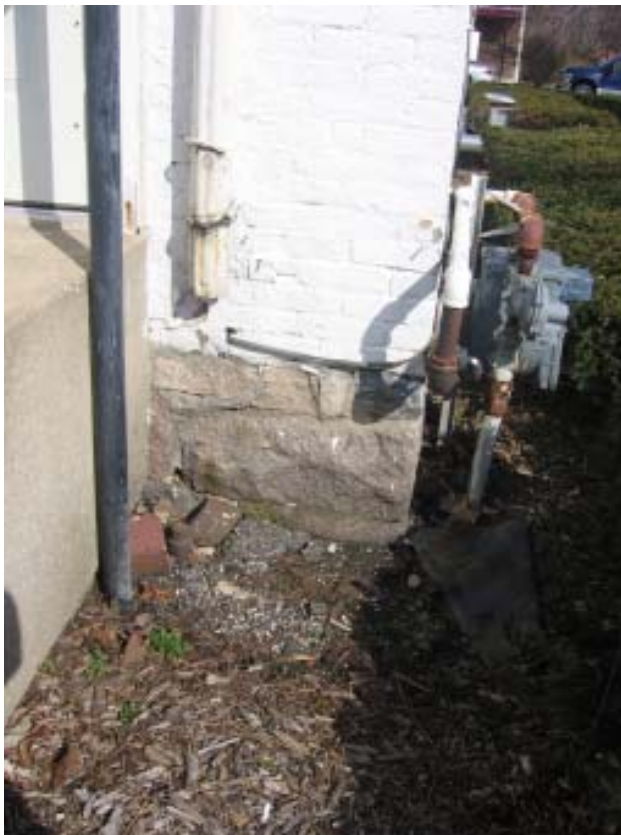
Fig 9: East elevation - Downspout discharging directly against foundation

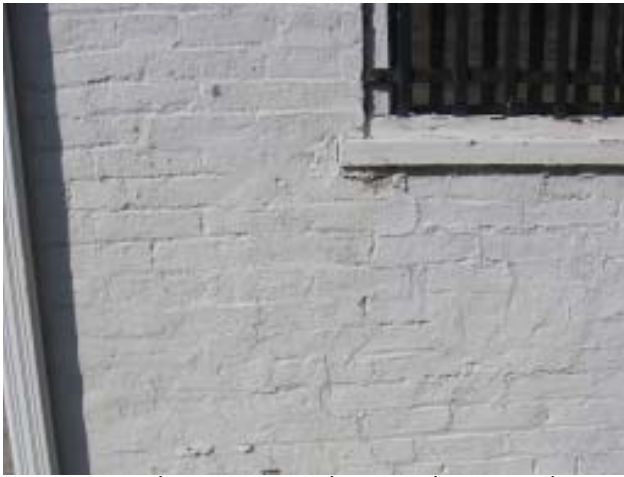
Fig 12: East elevation - Mainly vertical step crack

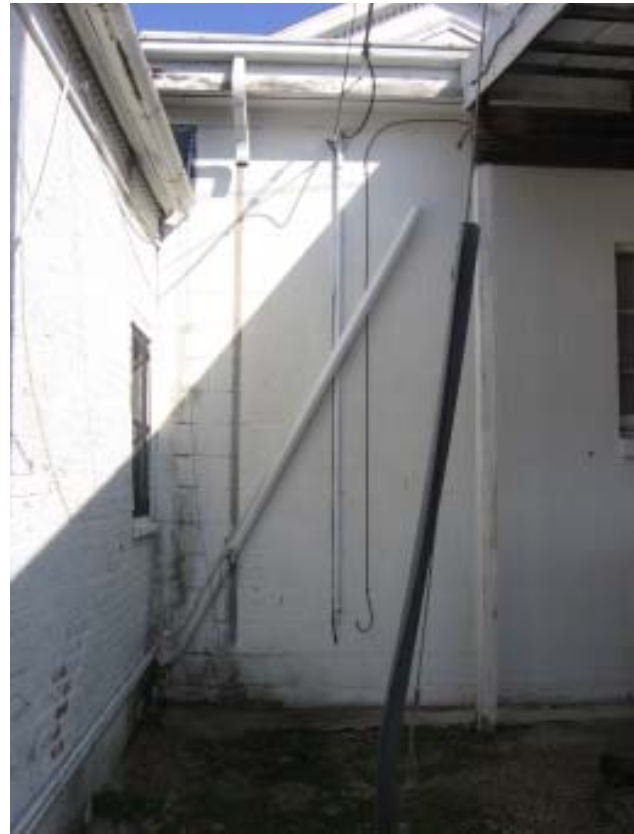
Fig 13: South elevation - Downspouts at corner of 1949 Addition and Jail

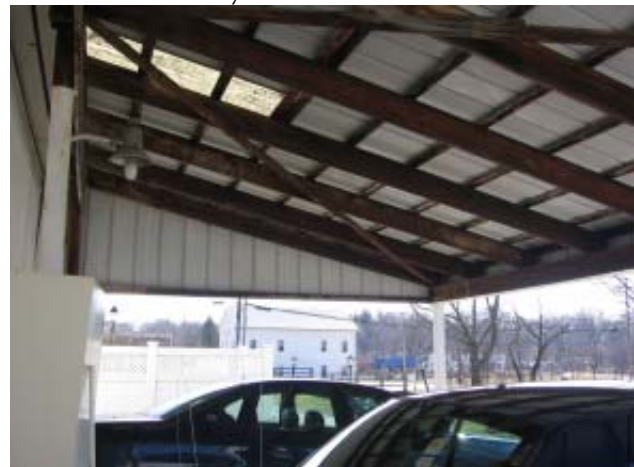
Fig 14: Carport overall

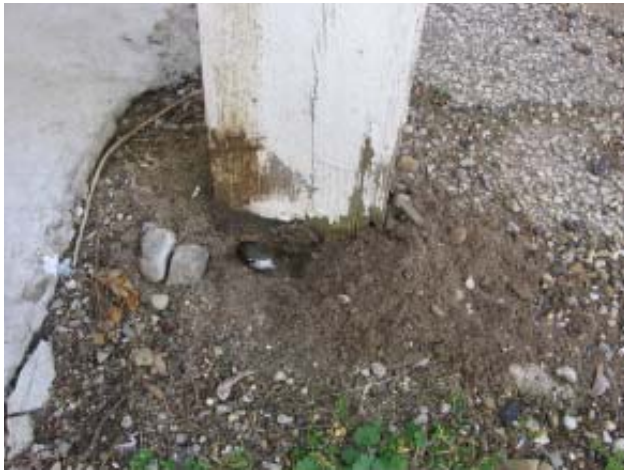
Fig 15: Carport column condition

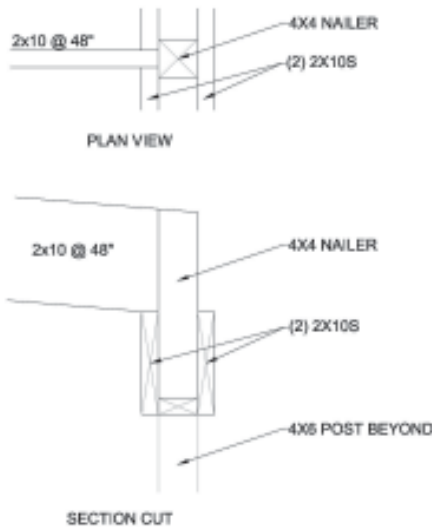
Fig 16: Carport - South beam detail

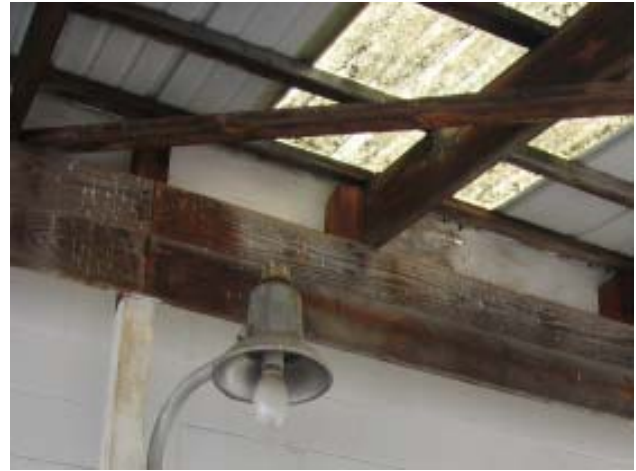
Fig 17: Carport - North beam detail

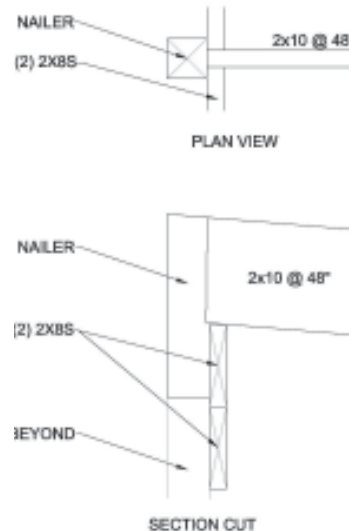
Fig 18: Carport - North beam detail

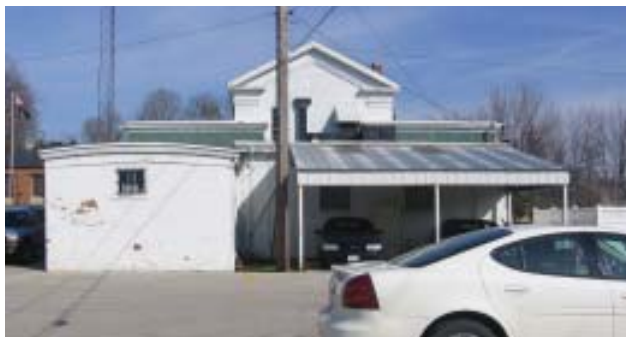
Fig 19: South elevation

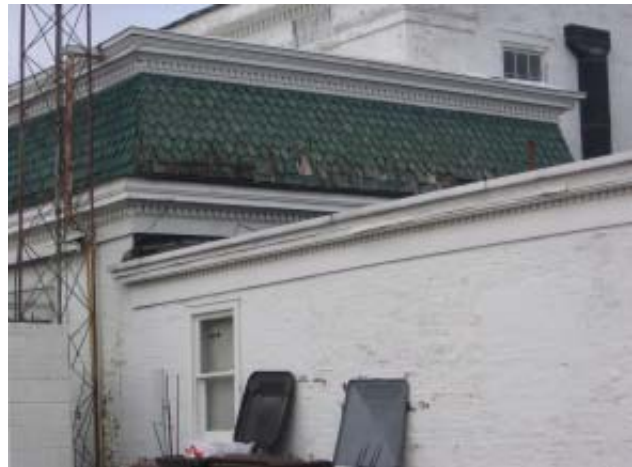
Fig 20: South elevation - Deteriorated shingles

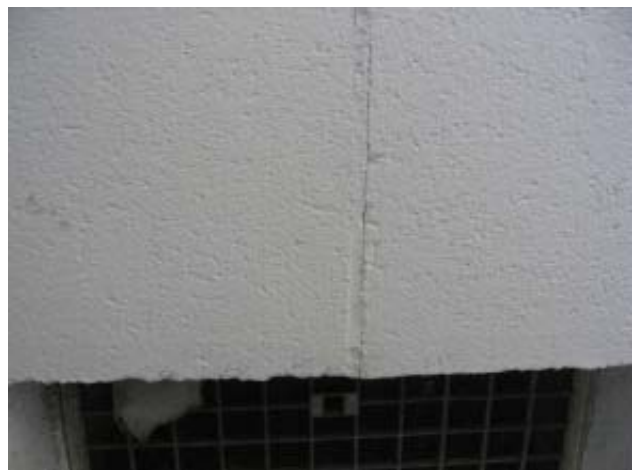
Fig 21: South elevation - Cracked cmu over vent

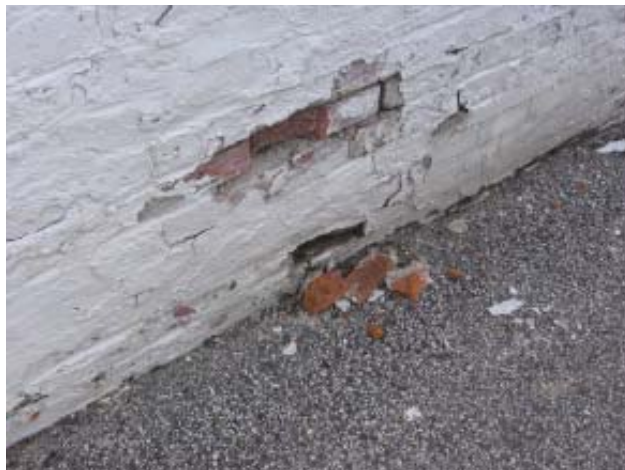
Fig 22: West elevation - Severely deteriorated brick

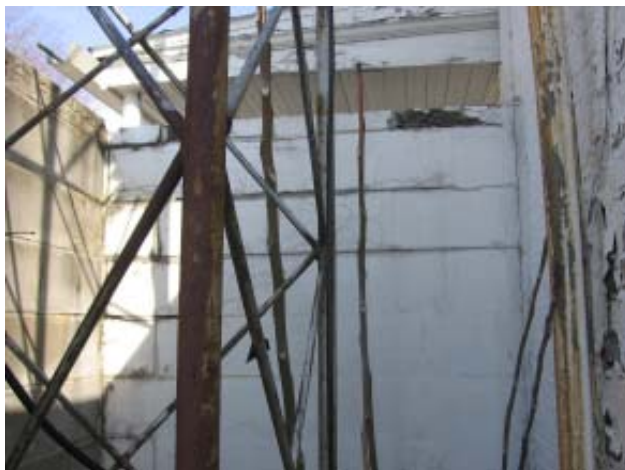
Fig 23: West elevation - Deterioration of top courses of antenna enclosure cmu walls

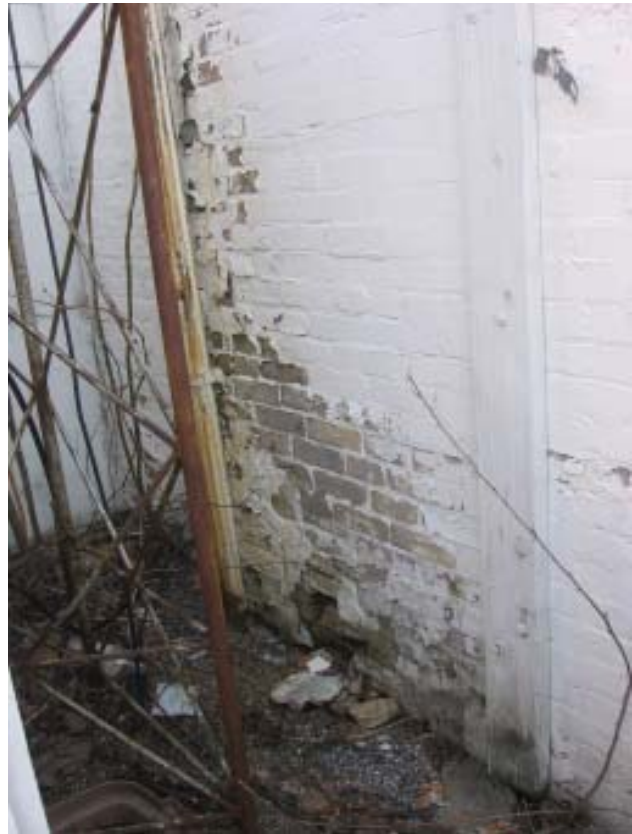
Fig 24: West elevation - Deterioration of brick at antenna enclosure

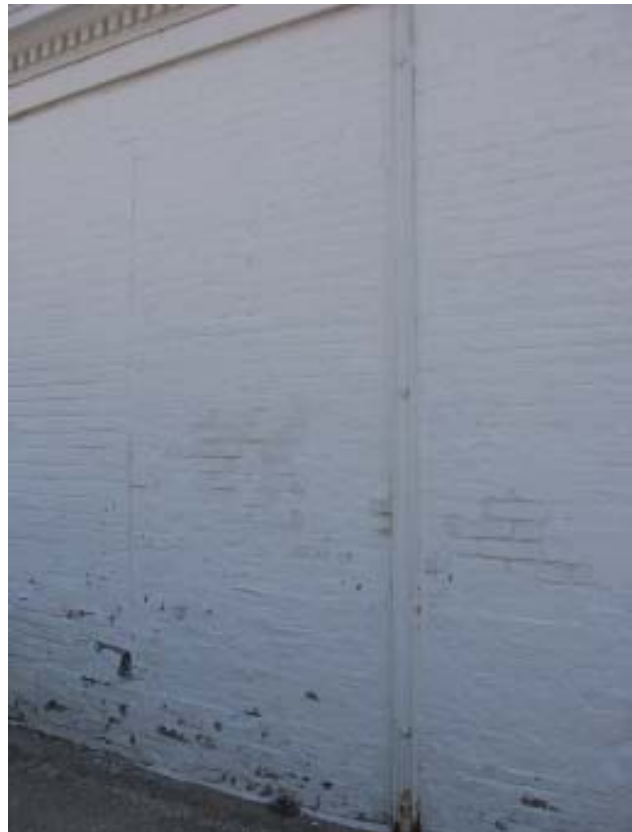
Fig 25: West elevation - Existing channel brace

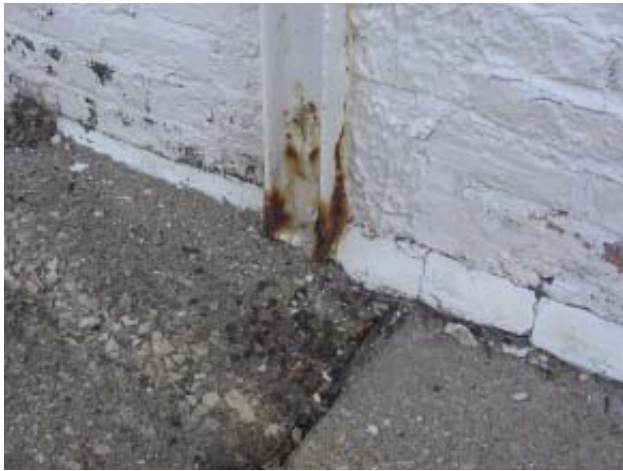
Fig 26: West elevation - Existing channel brace rusting

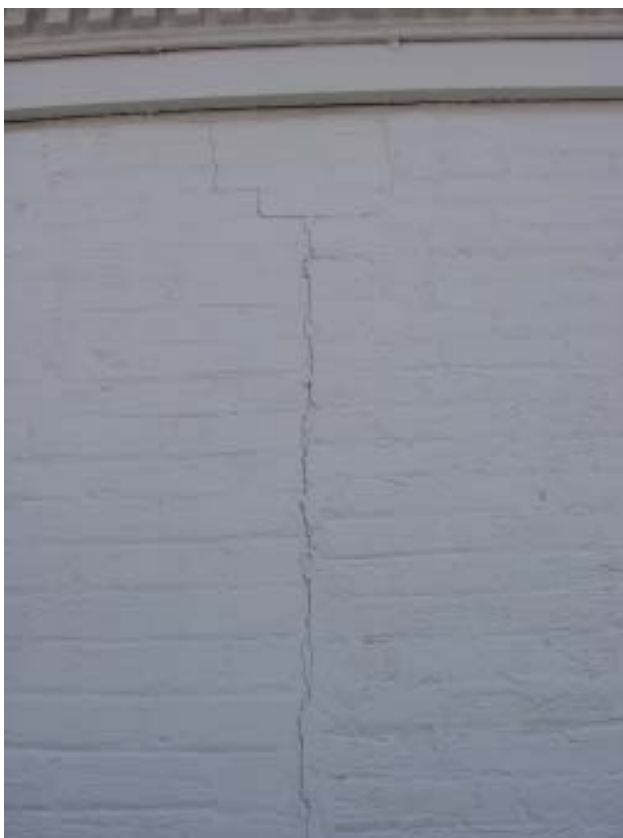
Fig 27: West elevation - Vertical crack at construction joint

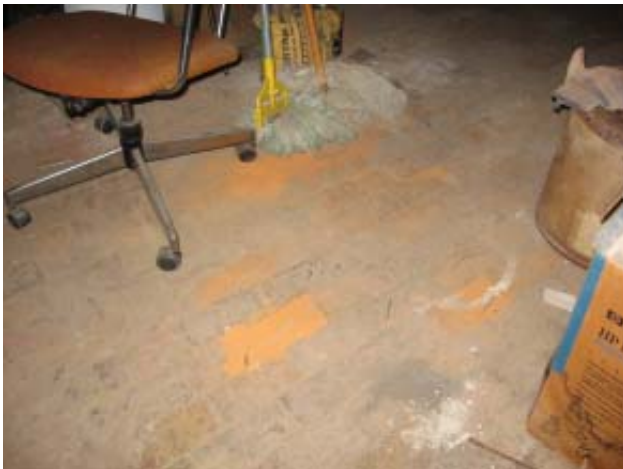
Fig 28: Basement - Deteriorated floor pavers

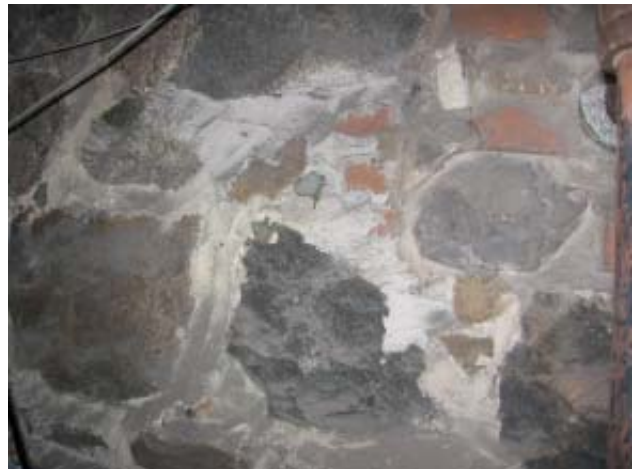
Fig 30: Basement - Cut stone masonry walls repointed

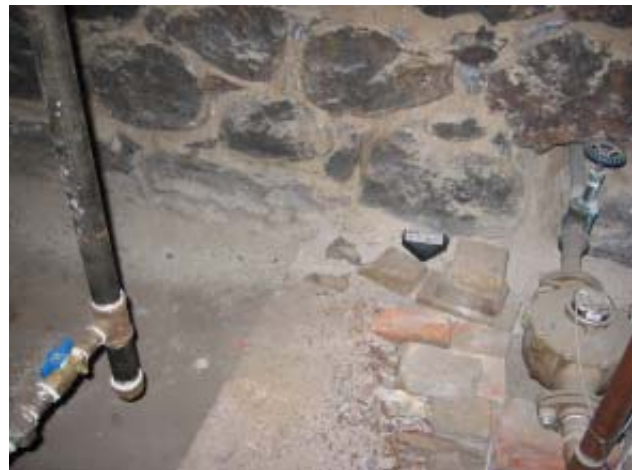
Fig 31: Basement - Mortar dust at base of south wall

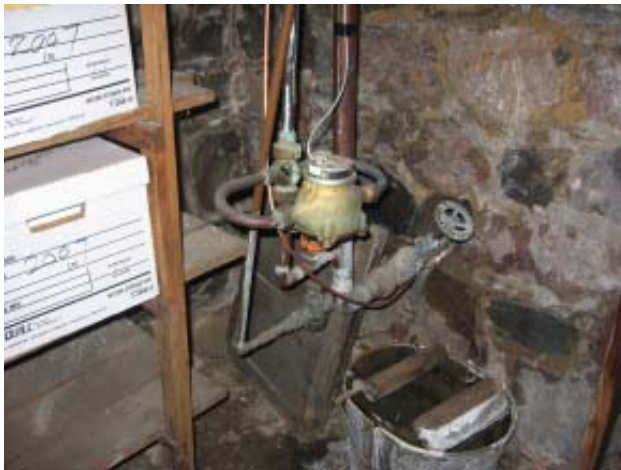
Fig 32: Basement - Leak near a utility meter captured into overflowing bucket below

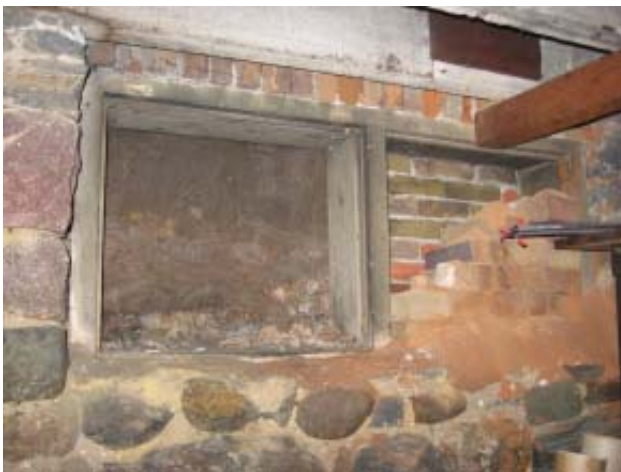
Fig 33: Basement - Window infill and deteriorating brick at north wall

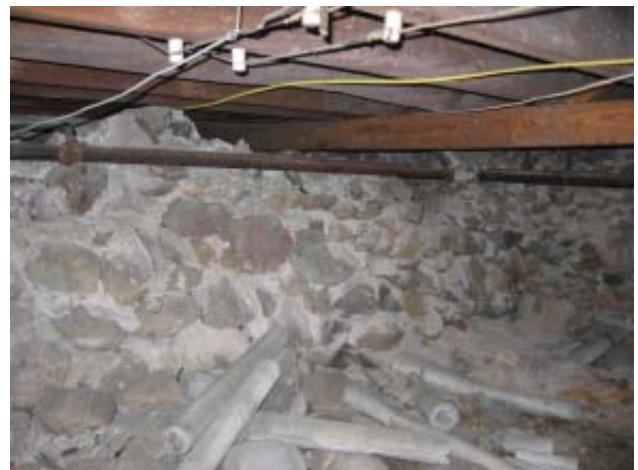
Fig 34: East Crawl Space - Stone masonry walls, excessive masonry dust presumed asbestos insulation

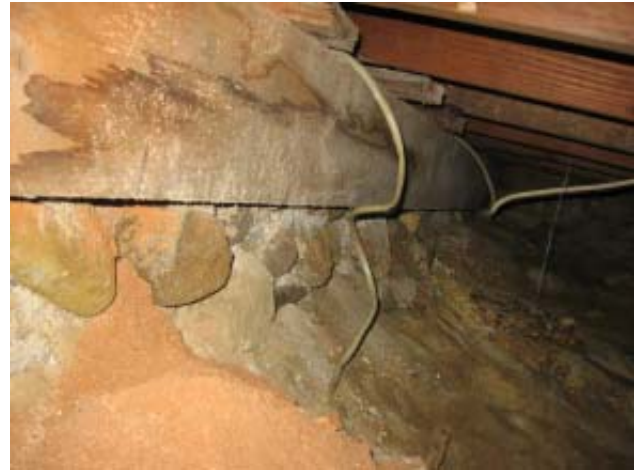
Fig 38: West Crawl Space - Excessive brick masonry dust at base of walls; loose stones in foundation wall

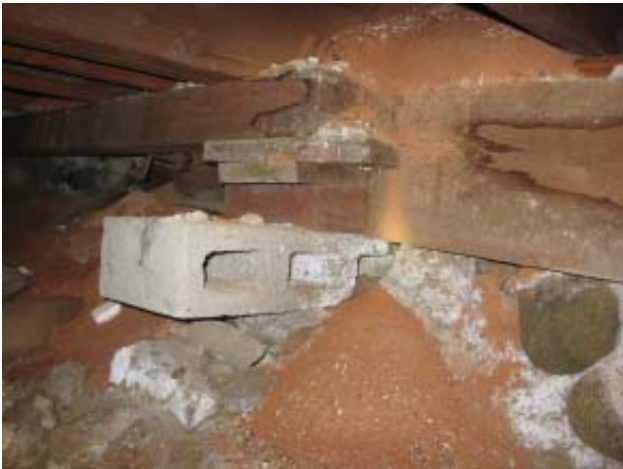
Fig 37: West Crawl Space - Excessive brick masonry dust at base of walls

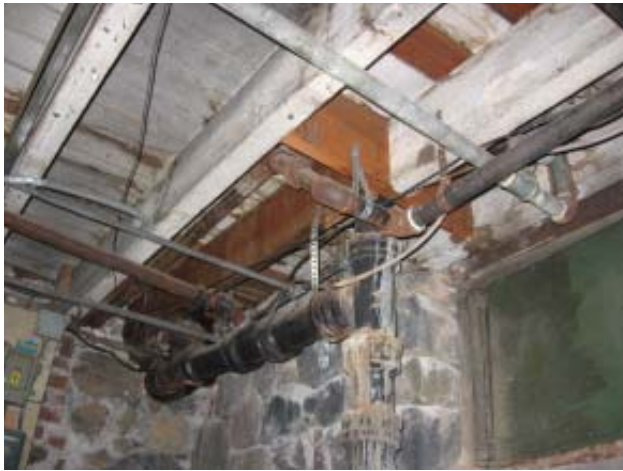
Fig 40: First Floor Structure - Floor infill at previous floor opening in southeastern corner

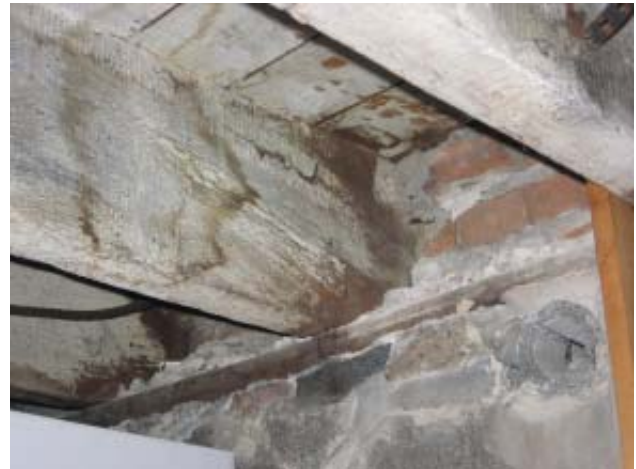
Fig 43: First Floor Structure - Cracked floor joist in northwest corner

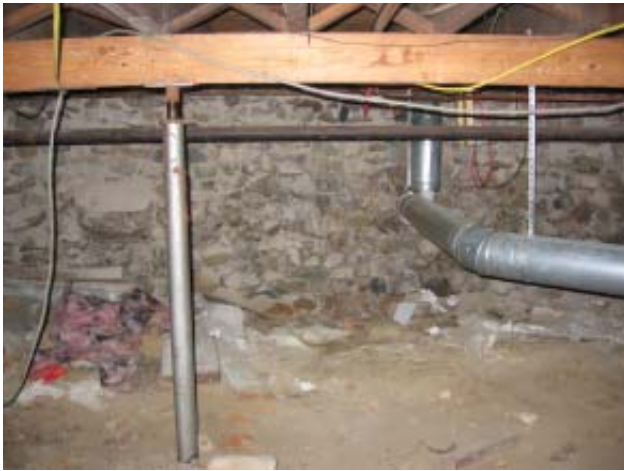
Fig 44: First Floor Structure - Visual curvature in center beam in east wing

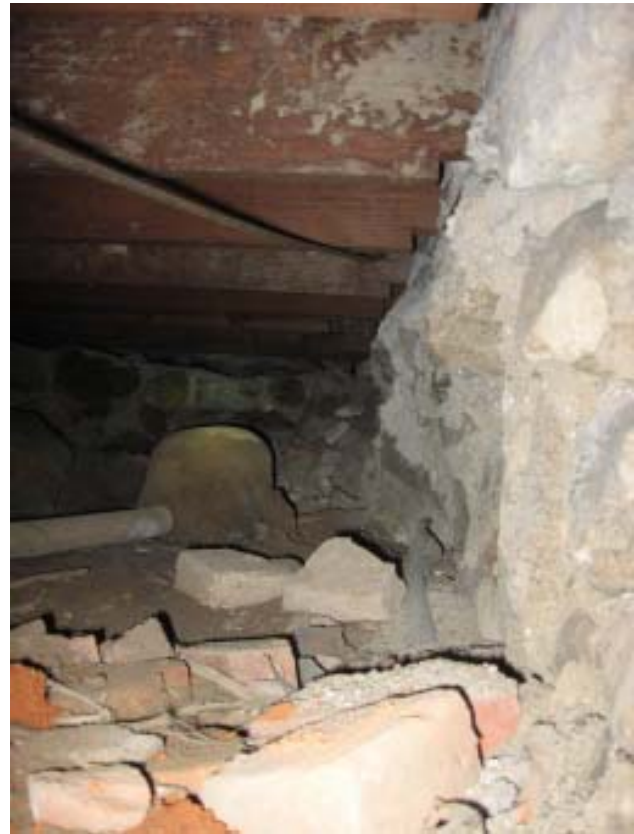
Fig 45: First Floor Structure - Notched joists at east bearing in west wing

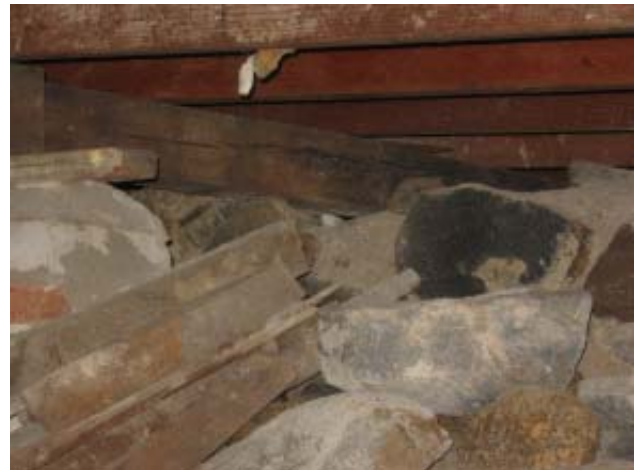
Fig 46: First Floor Structure - Deteriorated center beam in west wing

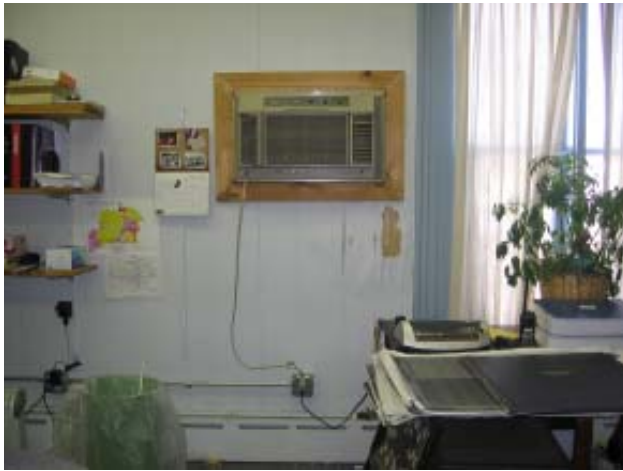
Fig 47: First Floor Level - Water damage below air conditioning unit in east exterior wall

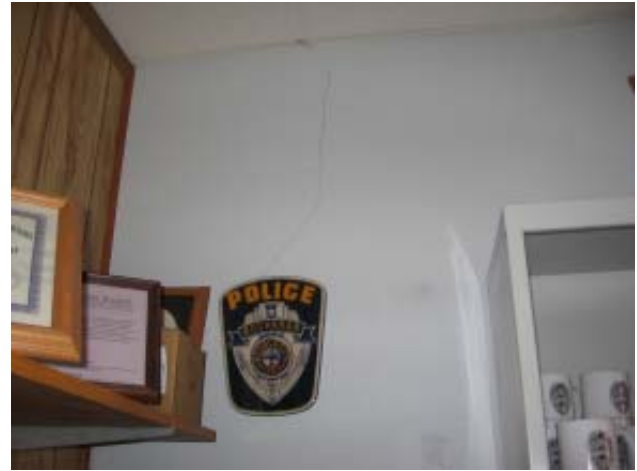
Fig 49: First Floor Level - Crack in west wall, north end of west wing

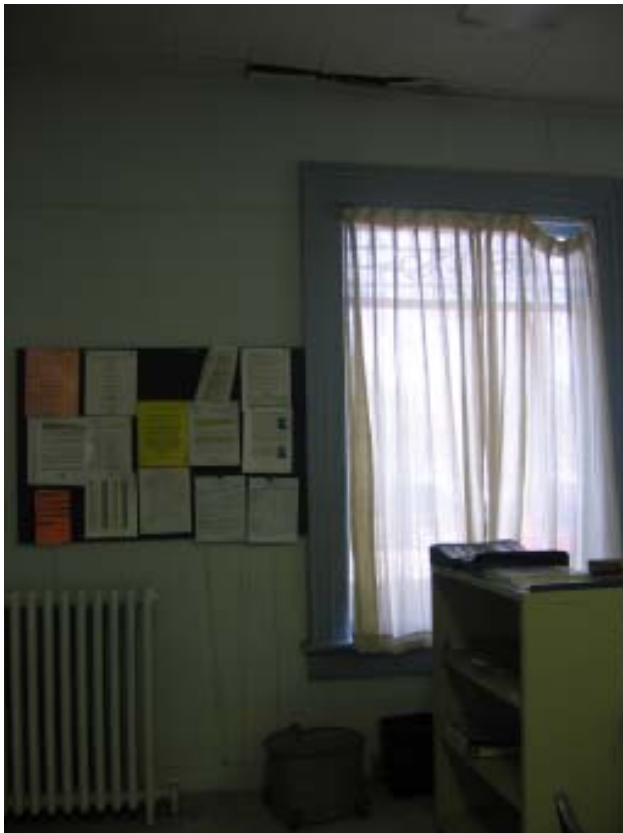
Fig 48: First Floor Level - Water damage at north wall of the east wing

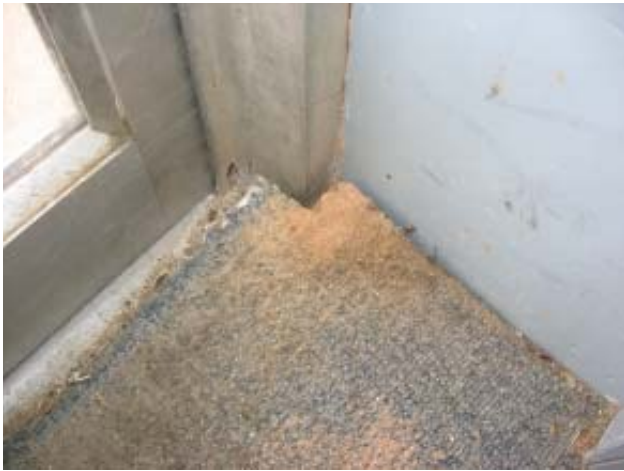
Fig 50: First Floor Level - Brick dust at man door in west wing

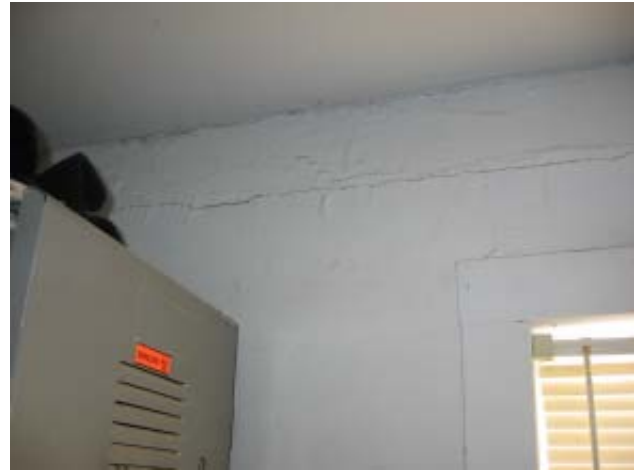
Fig 51: First Floor Level - Horizontal crack at top of jail west wall

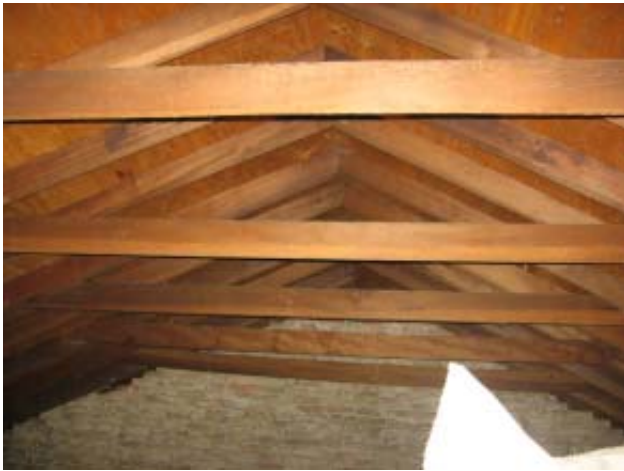
Fig 53: Attic and Roof Structures- Butt jointed rafters and collar ties in central attic

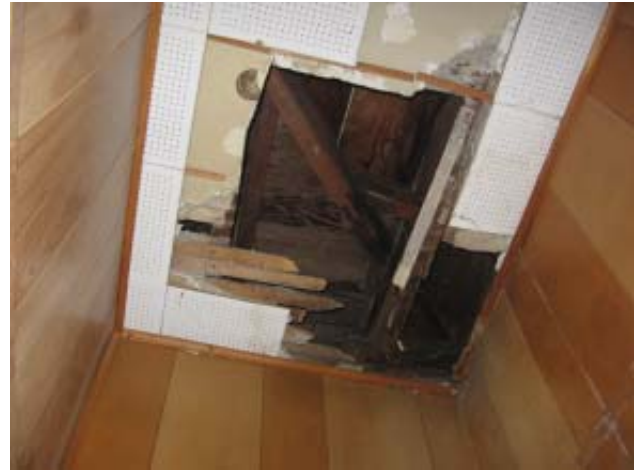
Fig 54: Attic and Roof Structures- Water staining in southeast corner of the east wing

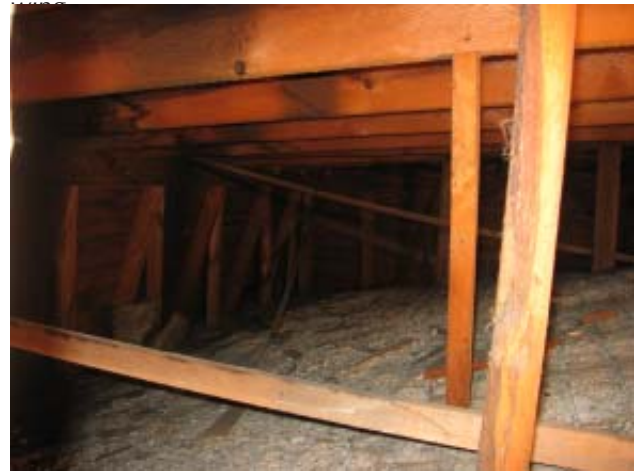
Fig 58: Attic and Roof Structures- Bracing of mansard roof construction of west wing

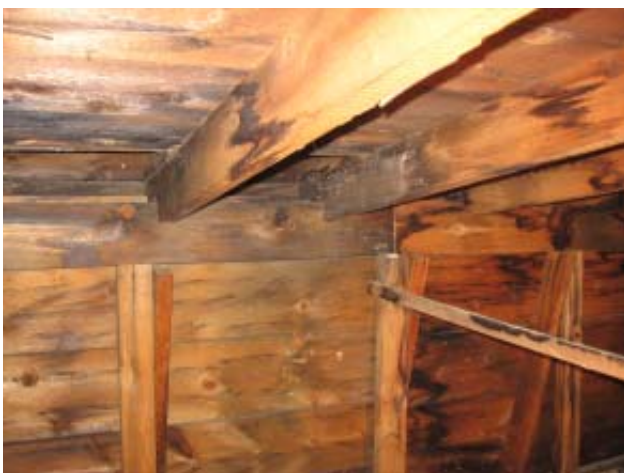
Fig 59: Attic and Roof Structures- Mansard roof construction details, note water staining in wood members in west wing

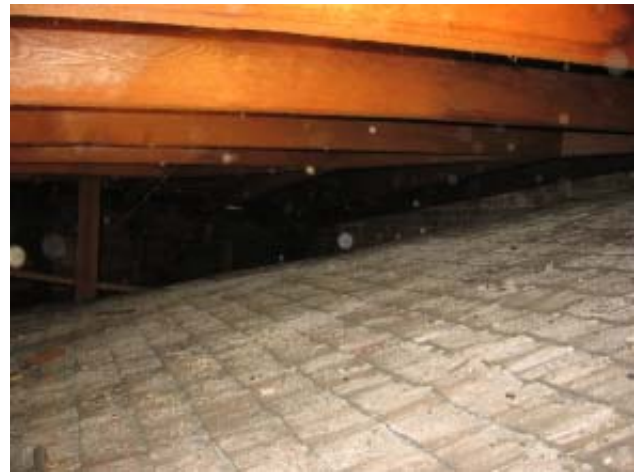
Fig 60: Attic and Roof Structures- Long span rafter splitting in west wing

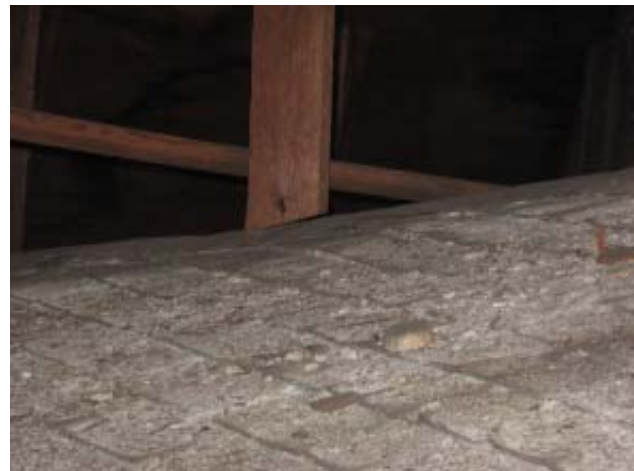
Fig 61: Attic and Roof Structures- Gap observed between bottom of stud supporting hip ridge and top of original hipped roof in west wing

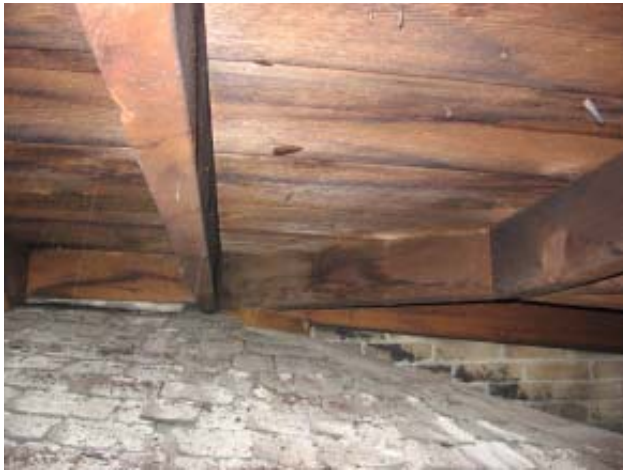
Fig 62: Attic and Roof Structures- Ledger board at masonry wall supporting rafters in west wing

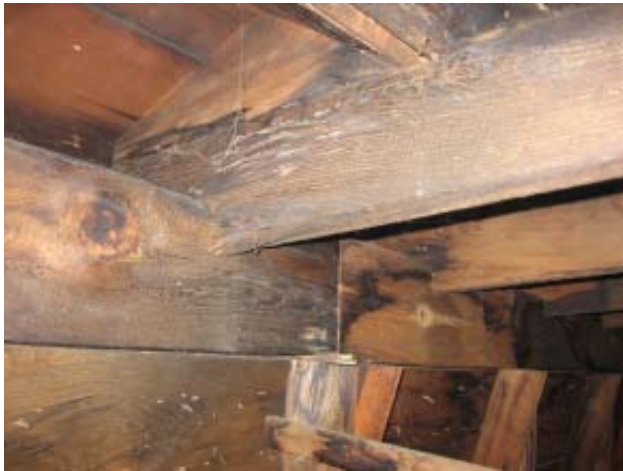
Fig 63: Attic and Roof Structures- Extensive water damage at mansard wall framing in west wing

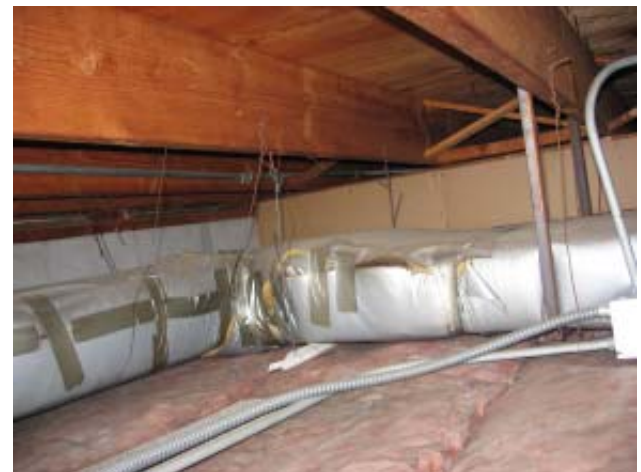
Fig 64: Attic and Roof Structures- Rafters over 1949 addition in good condition

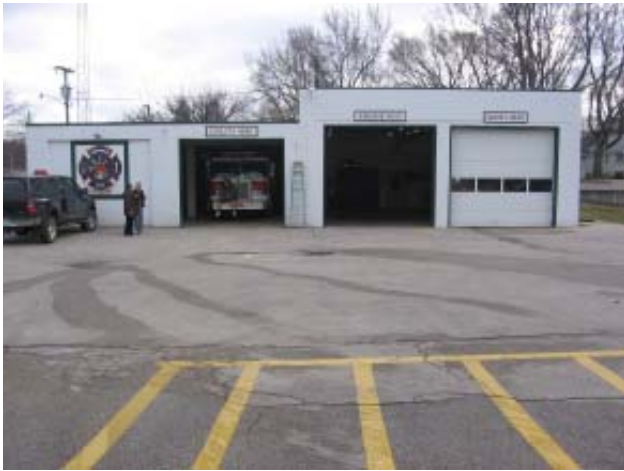
Fig 65: Garage- North elevation

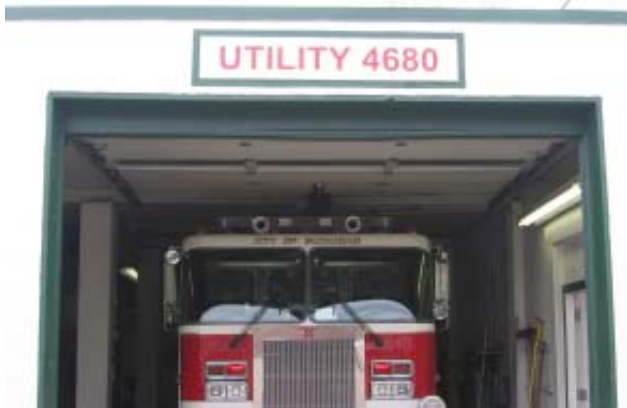
Fig 66: Garage- North elevation, visual sag in lintels

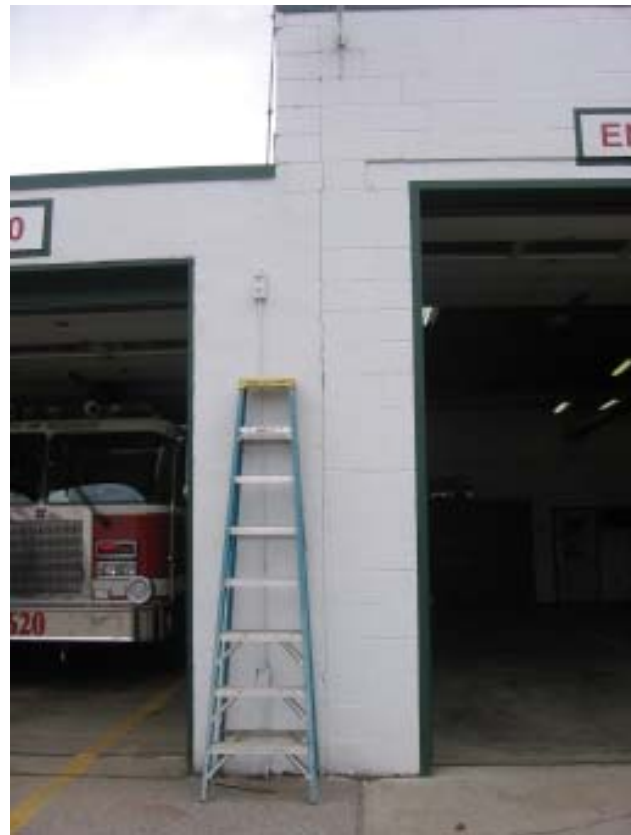
Fig 67: Garage- North elevation, vertical crack at joint between original and addition constructions

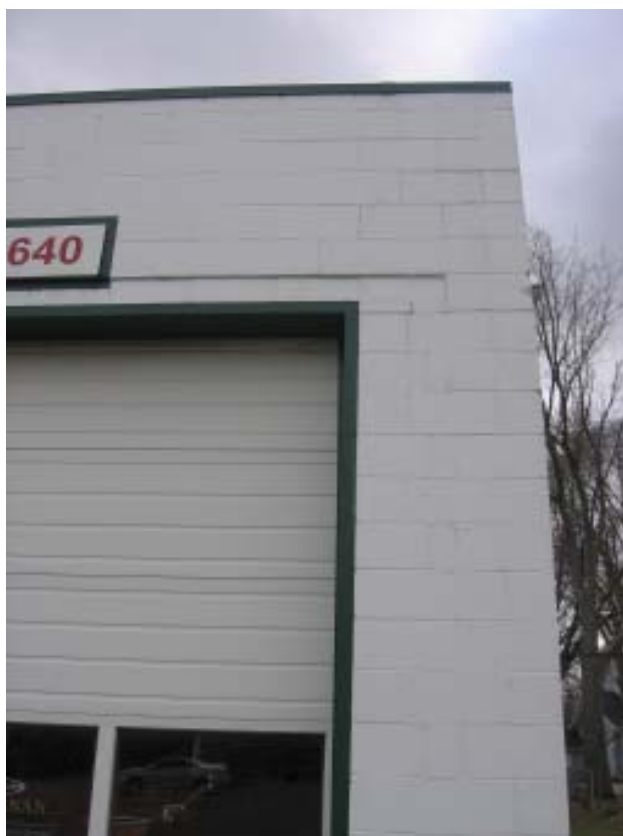
Fig 68: Garage- North elevation, step cracking at lintel bearing and western corner of wall

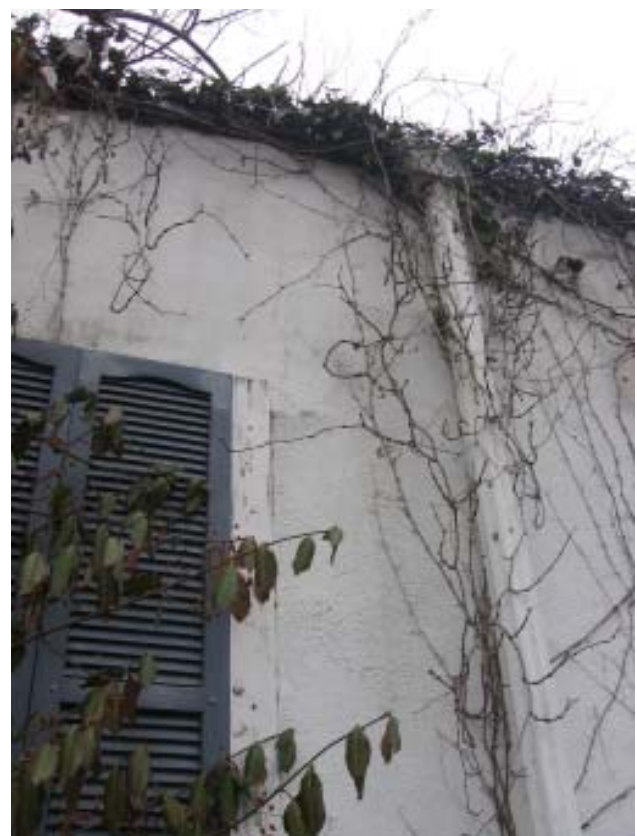
Fig 69: Garage- East elevation, heavy vegetation growth in gutter system
