REQUEST FOR PROPOSALS

REQUEST FOR PROPOSALS FOR PURCHASE OF THE CITY OF BUCHANAN'S ROSS-SANDERS HOUSE LOCATED AT 107 WEST FRONT, BUCHANAN, MICHIGAN

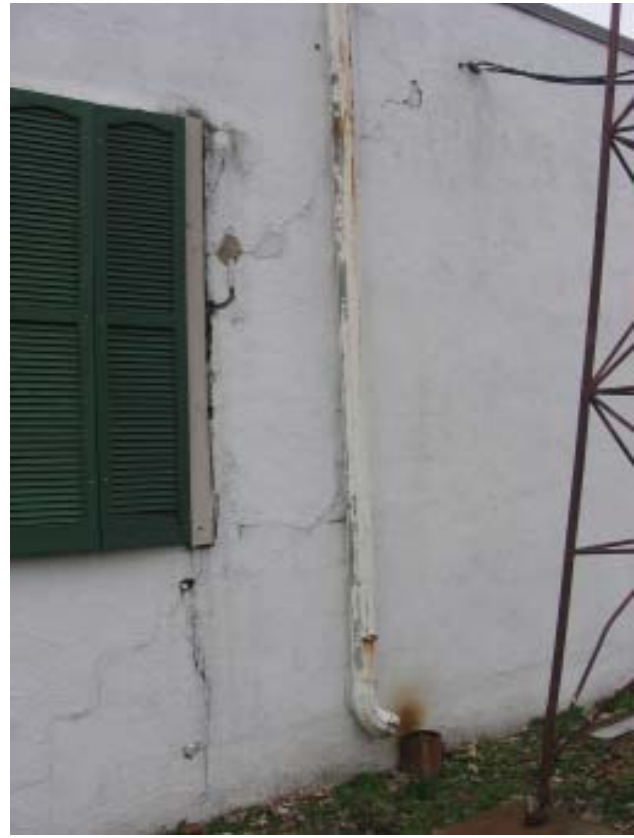
Fig 71: Garage- East elevation, downspout discharging against exterior wall and step cracking in masonry

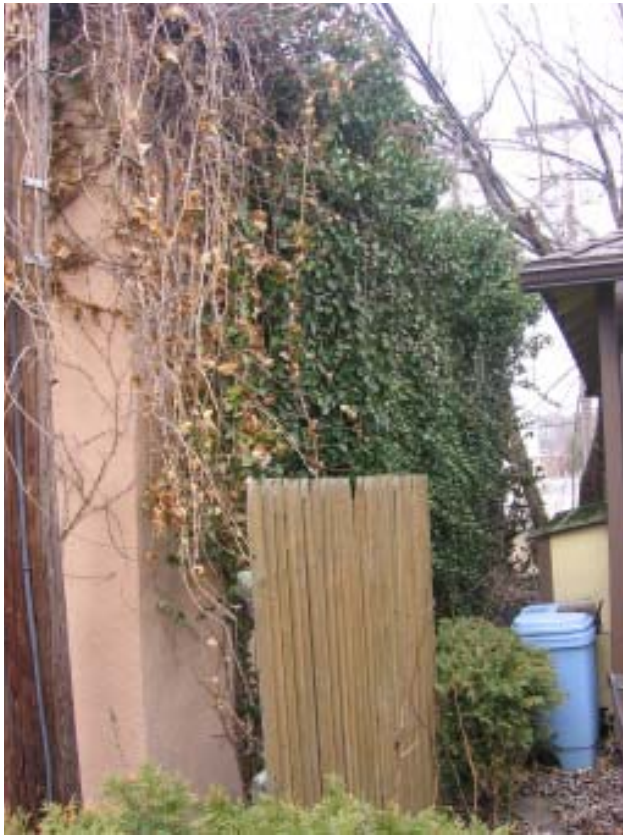
Fig 72: Garage- South elevation, heavy vegetation on wall prohibiting inspection of wall

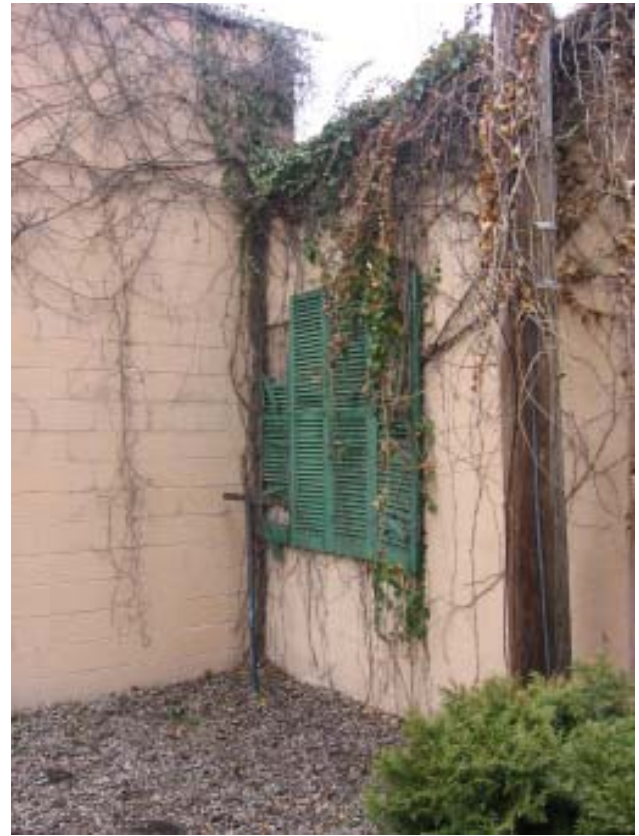
Fig 73: Garage- South elevation, south wall of addition and west wall of original building

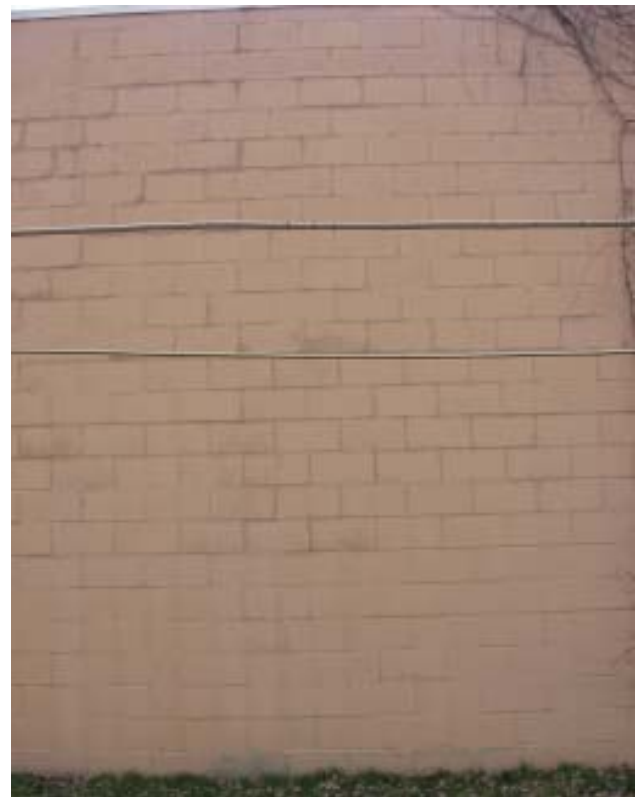
Fig 74: Garage- South elevation, south wall of addition cracking and moisture shown

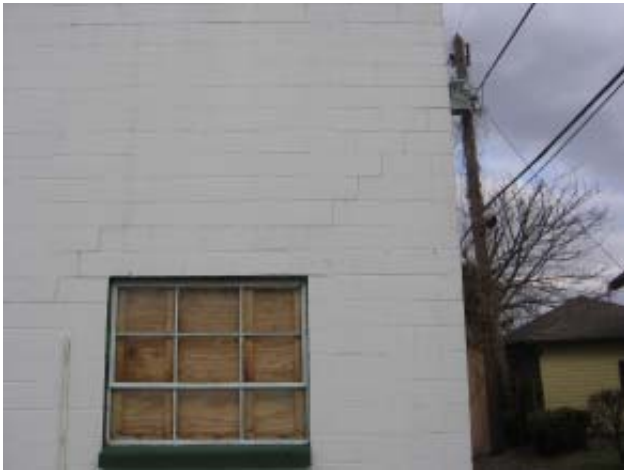
Fig 75: Garage- South elevation, step cracking south of southern window

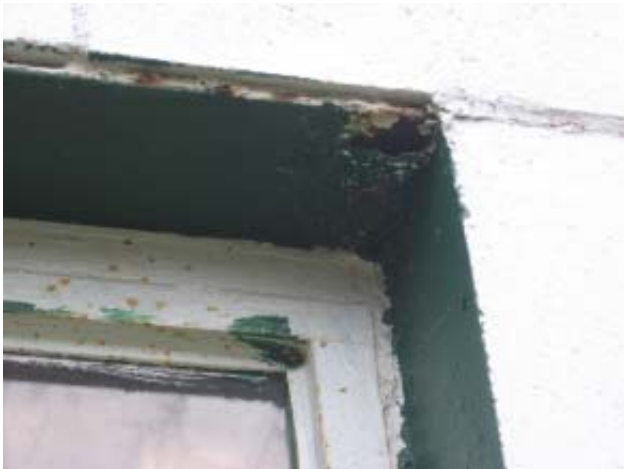
Fig 76: Garage- South elevation, rusting of steel lintel at man door

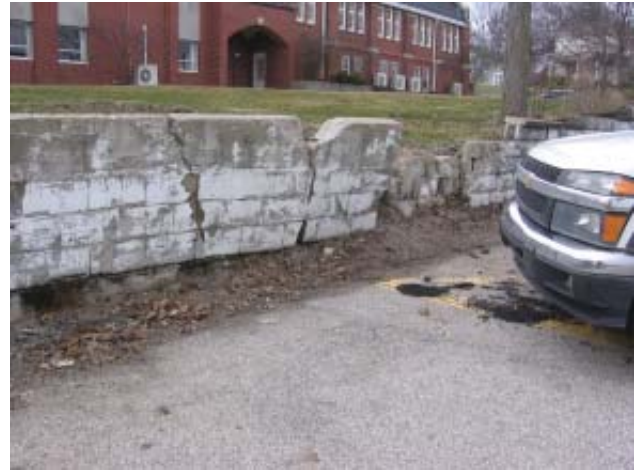
Fig 77: Failing retaining wall at west edge of property

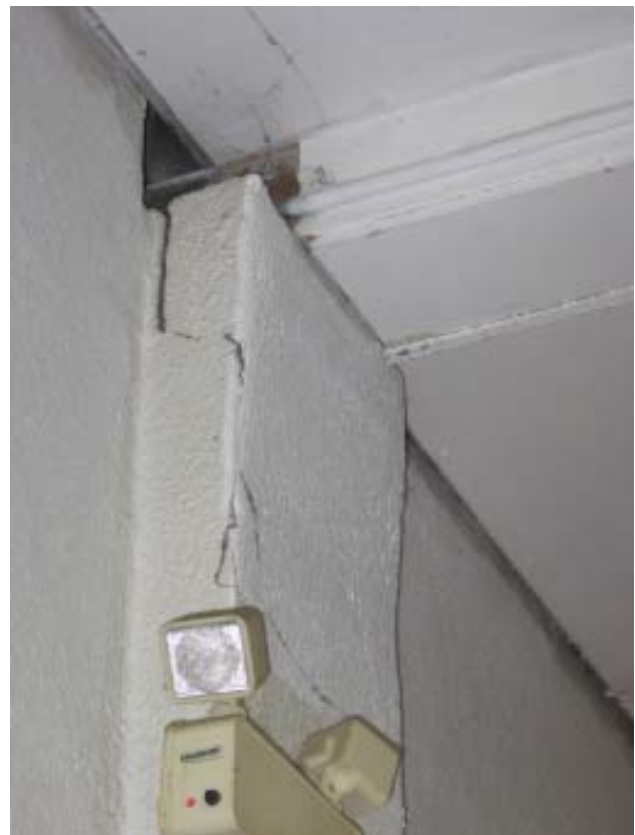
Fig 78: Garage - Masonry pier for roof beam bearing is cracked and rotating inward

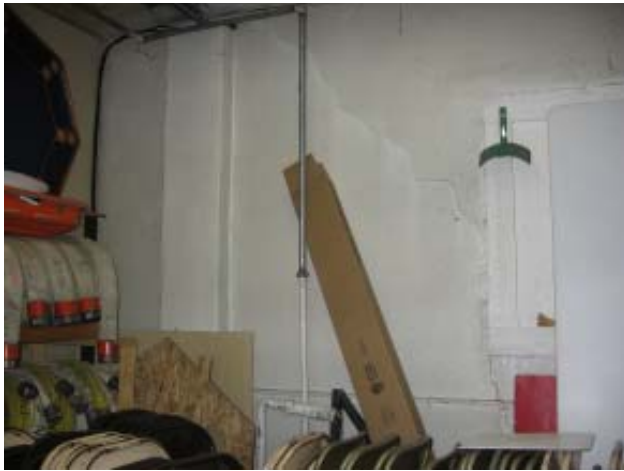
Fig 79: Garage - Masonry cracking on interior that relates to cracking on east exterior wall

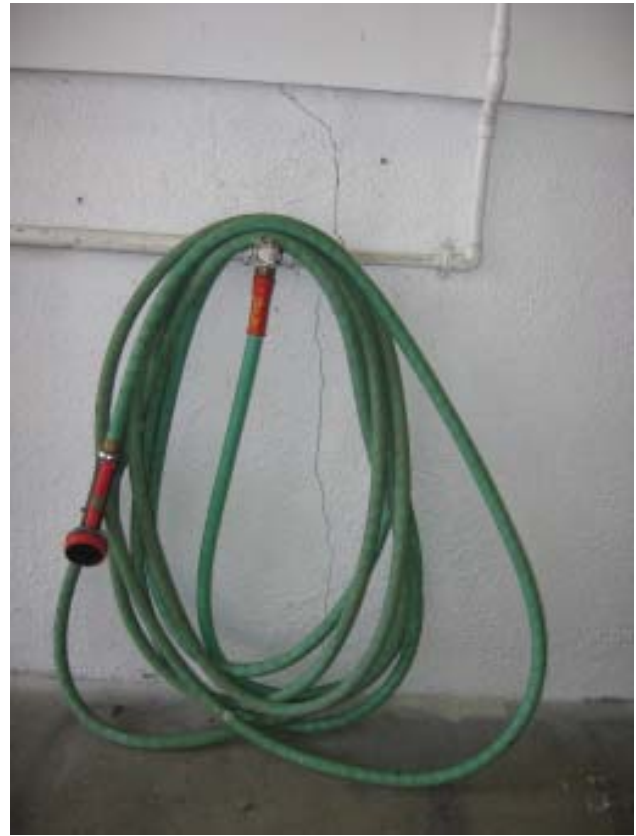
Fig 80: Garage - Vertical masonry crack in common wall between original and addition buildings

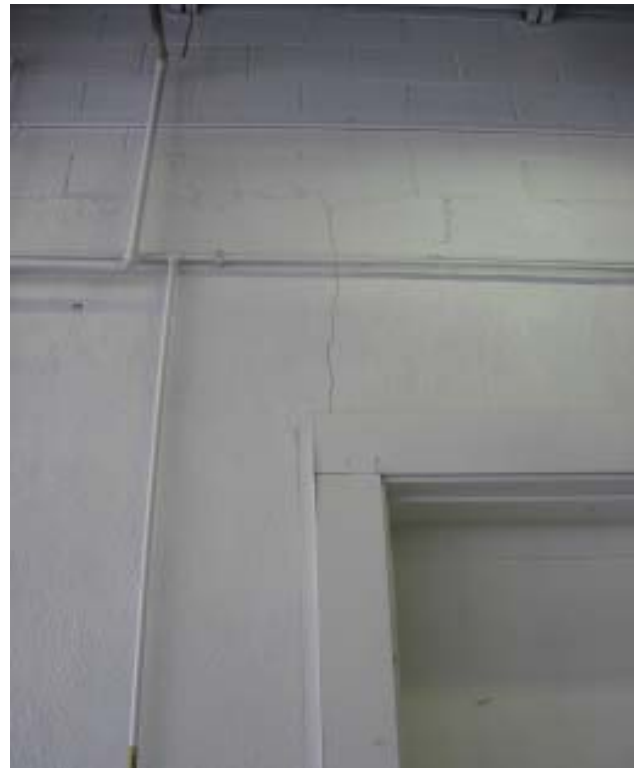
Fig 81: Garage - Vertical masonry crack in common wall between original and addition buildings; note stucco is discontinuous at new addition wall coursing

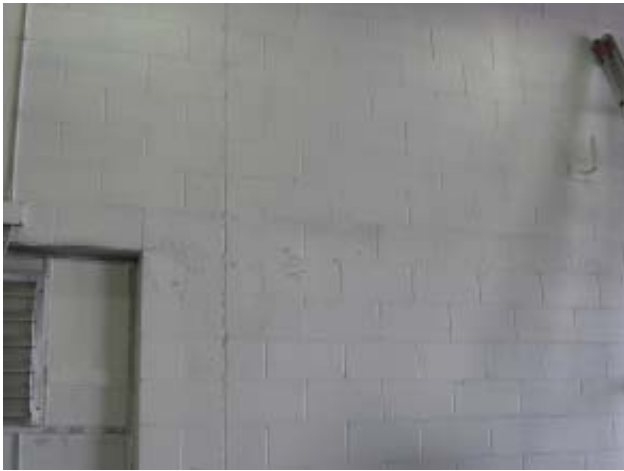
Fig 82: Garage - Vertical masonry crack in expansion joint on both interior and exterior surfaces of west wall

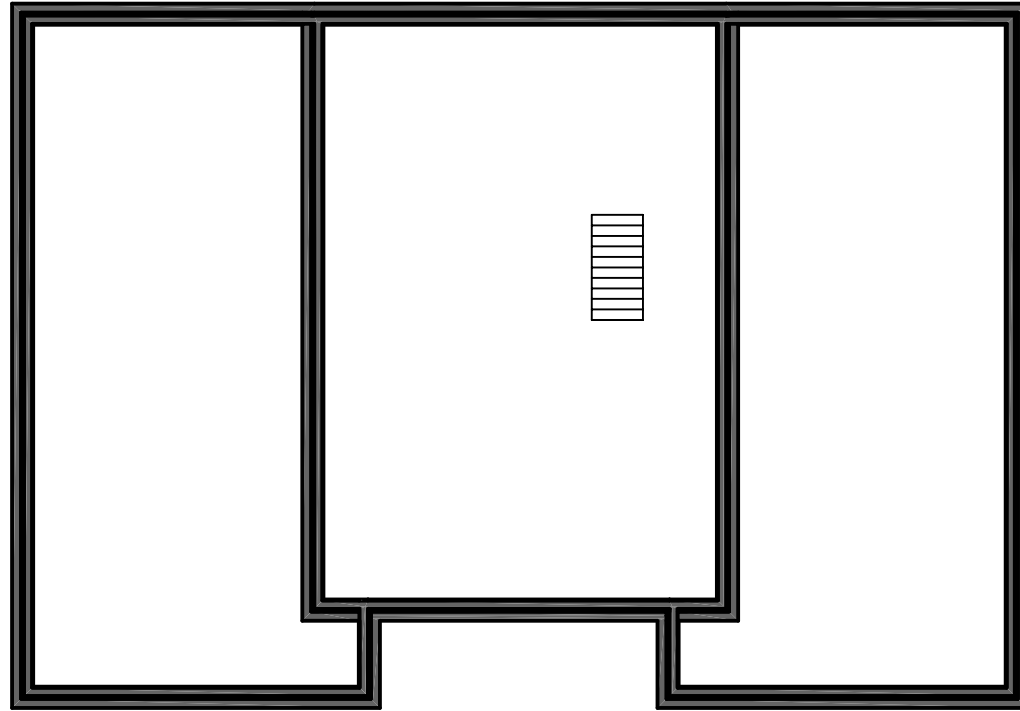
North
PLAN LAYOUT
Scale: 3/32" = 1'-0"

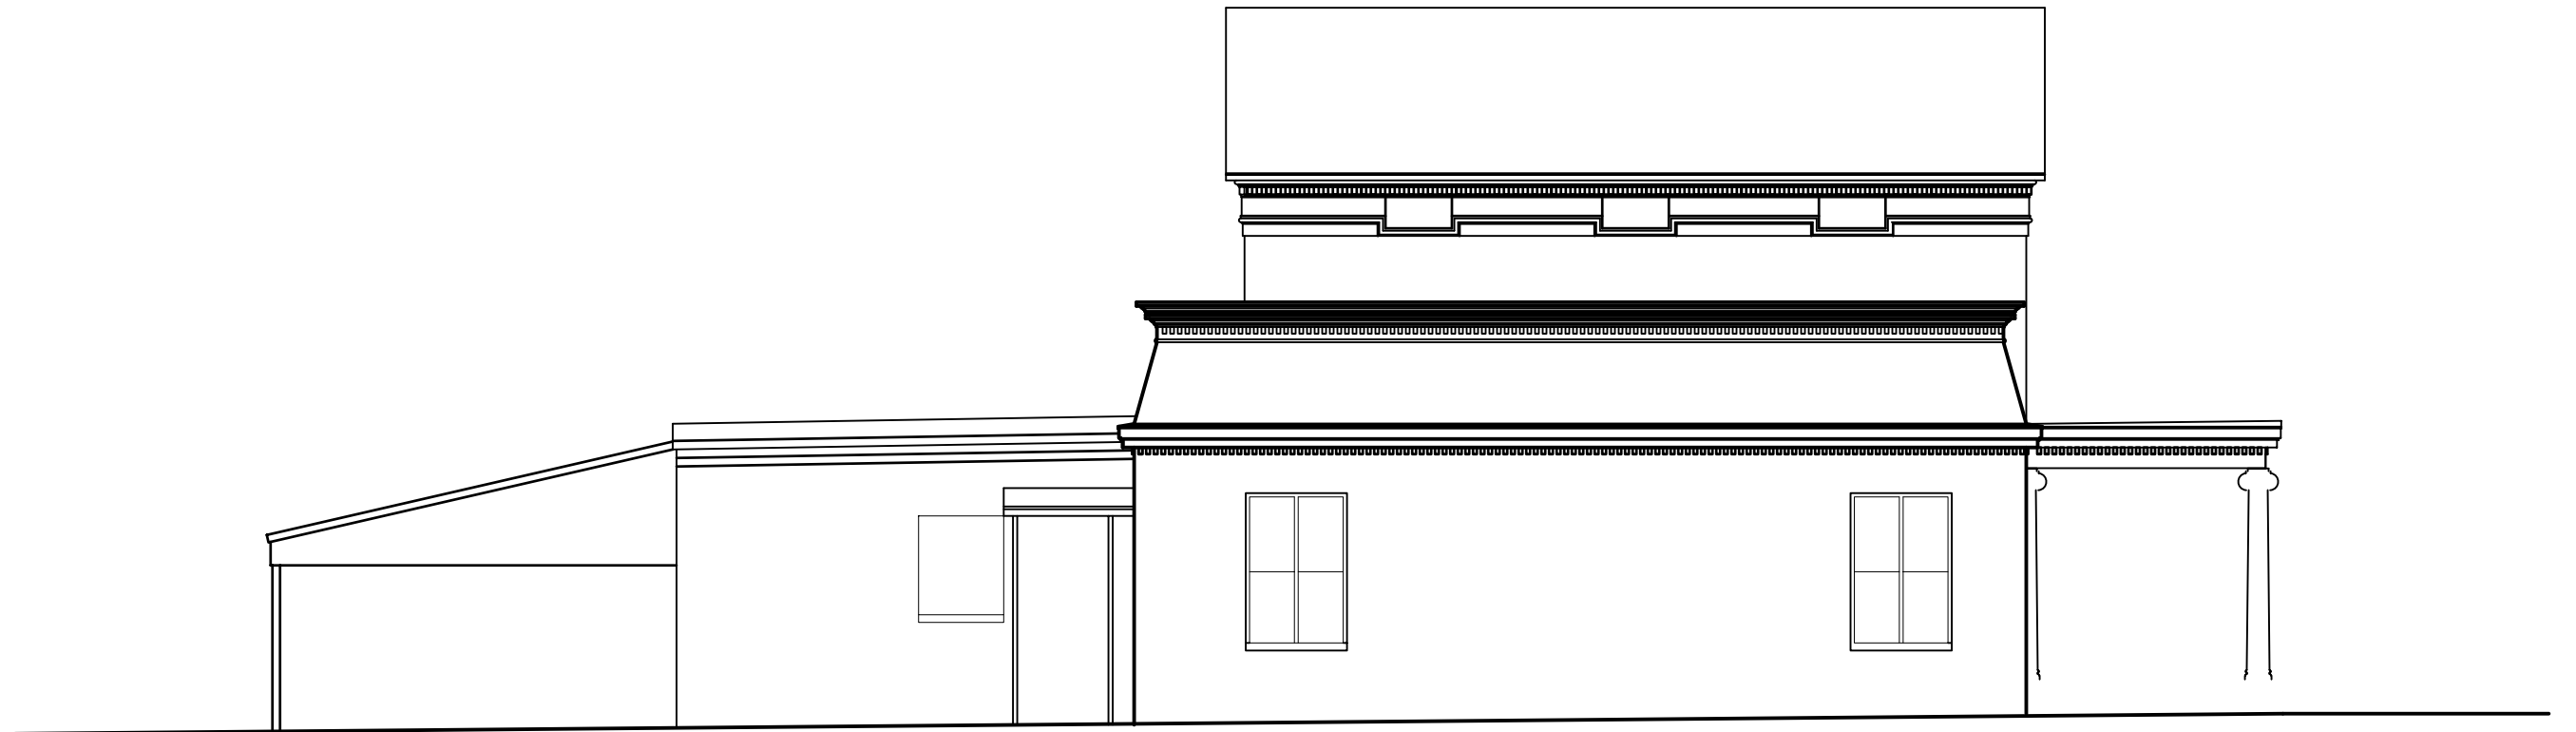
EAST ELEVATION
Scale: 1/8" = 1'-0"

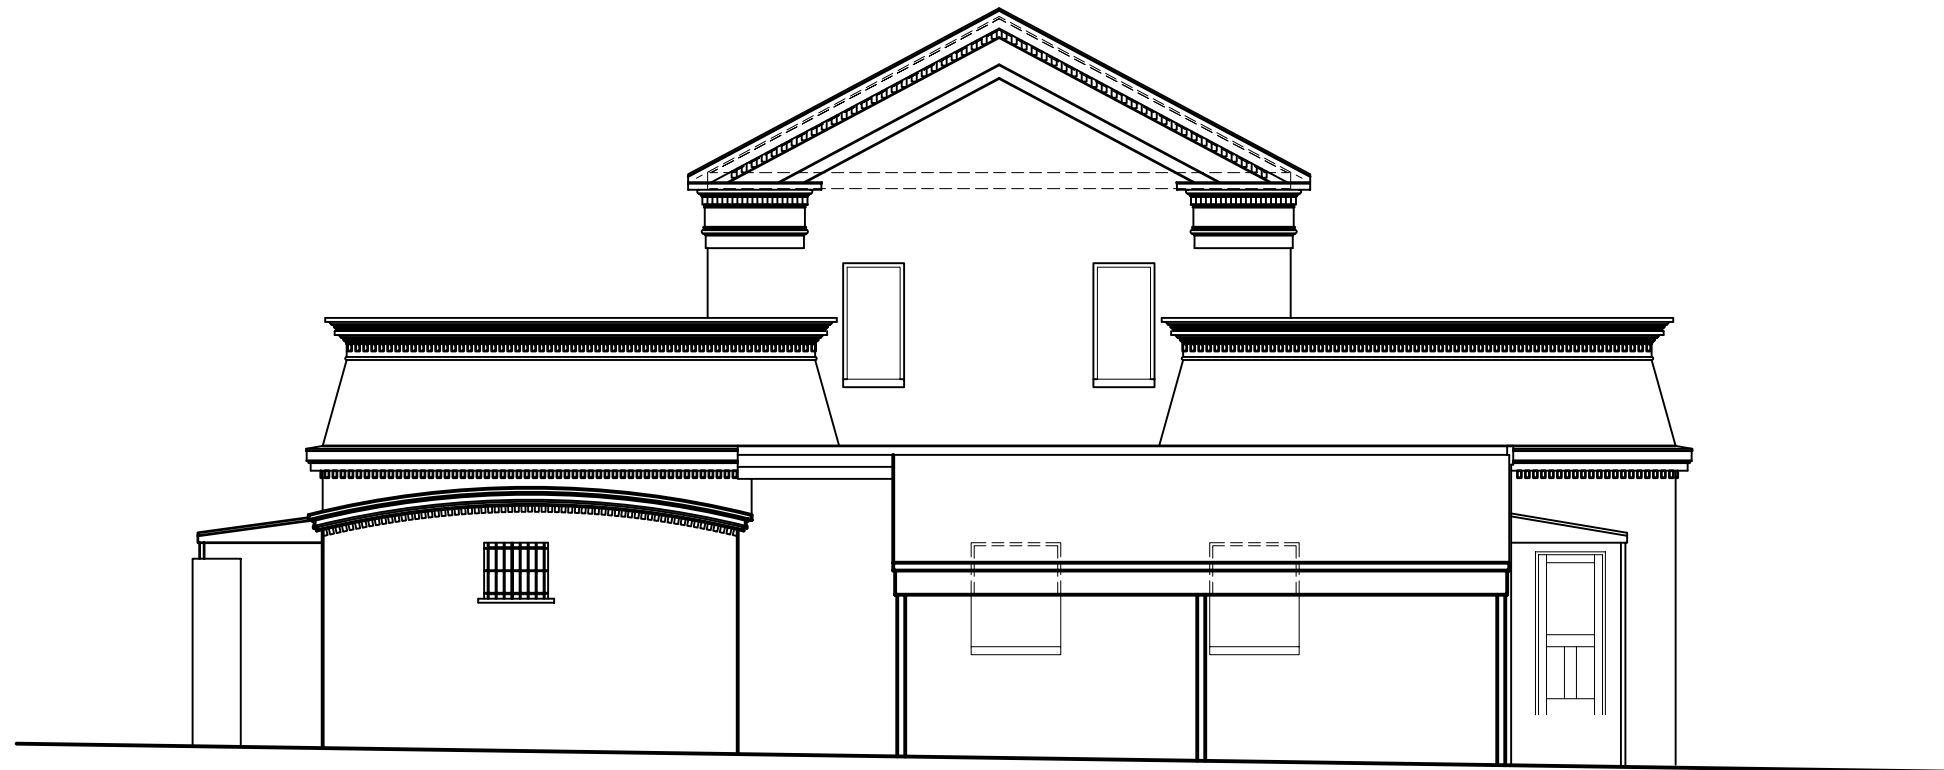
SOUTH ELEVATION
Scale: 1/8" = 1'-0"

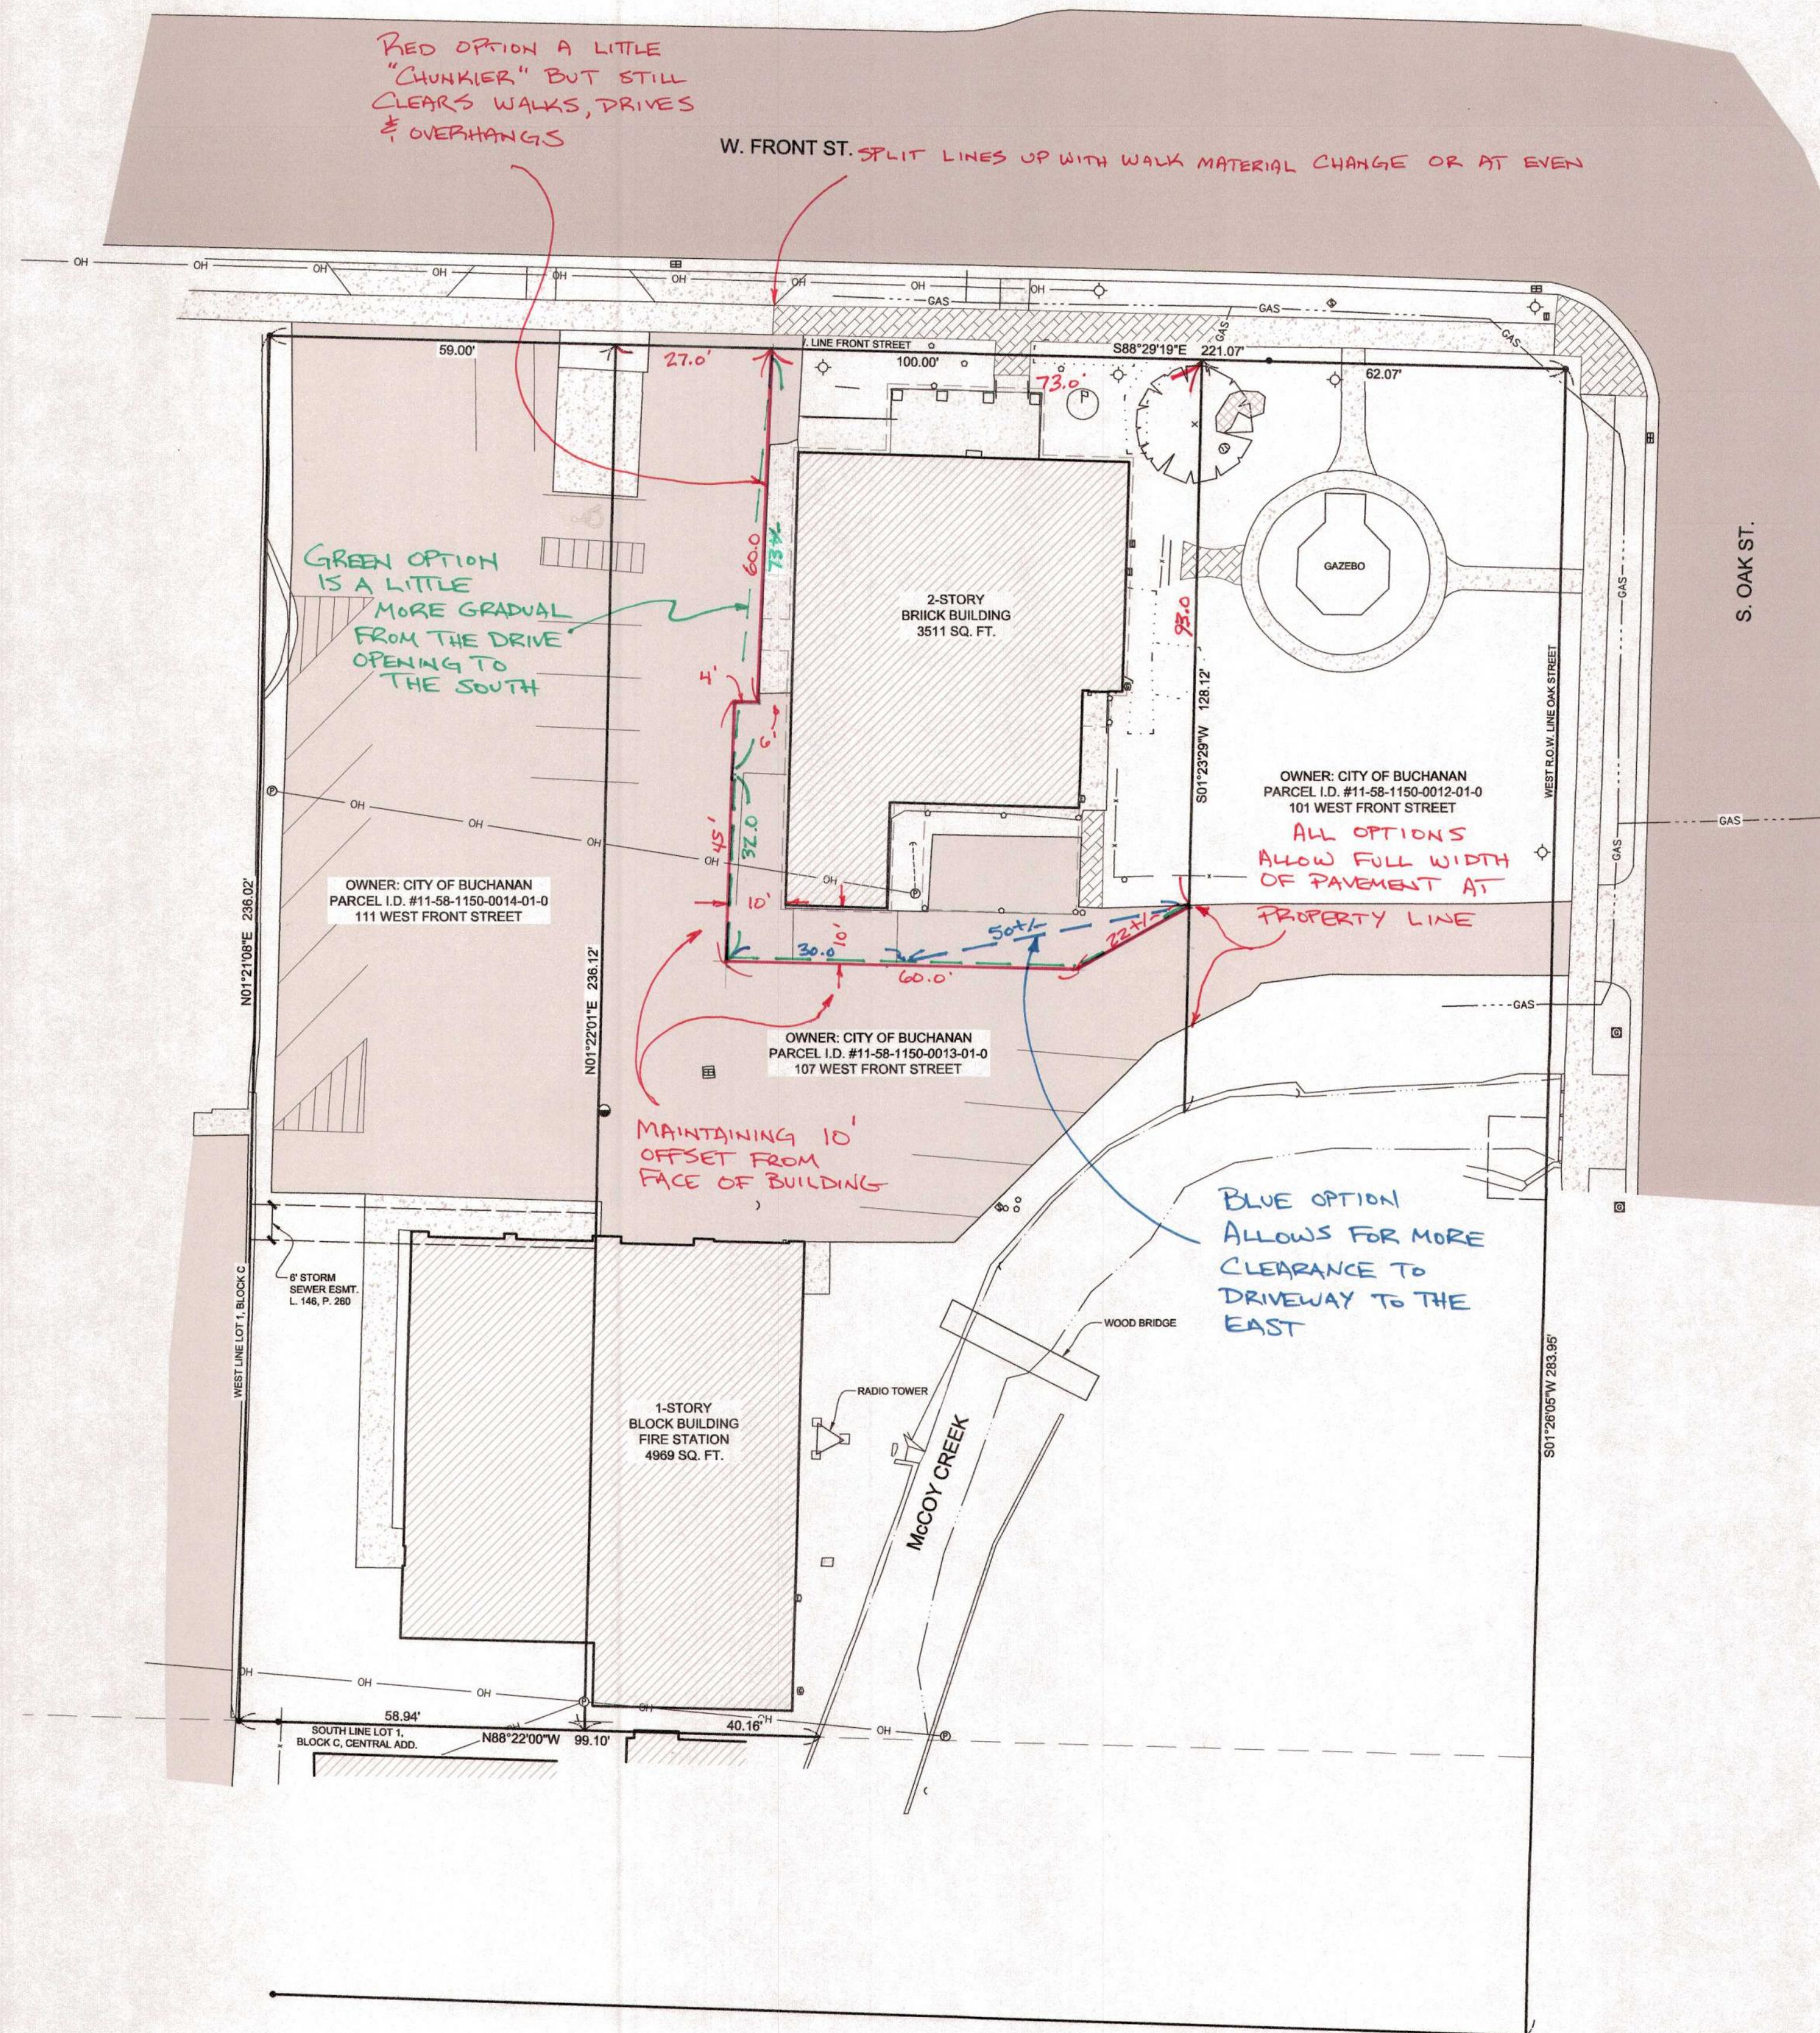
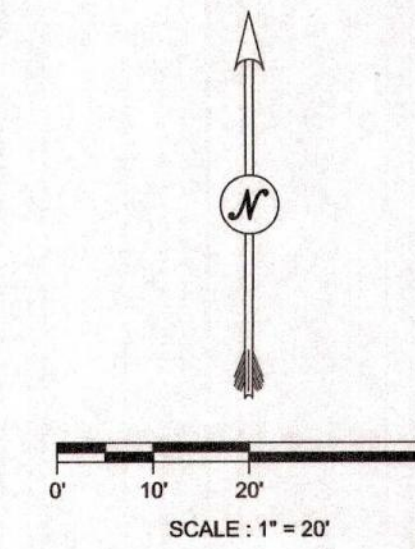
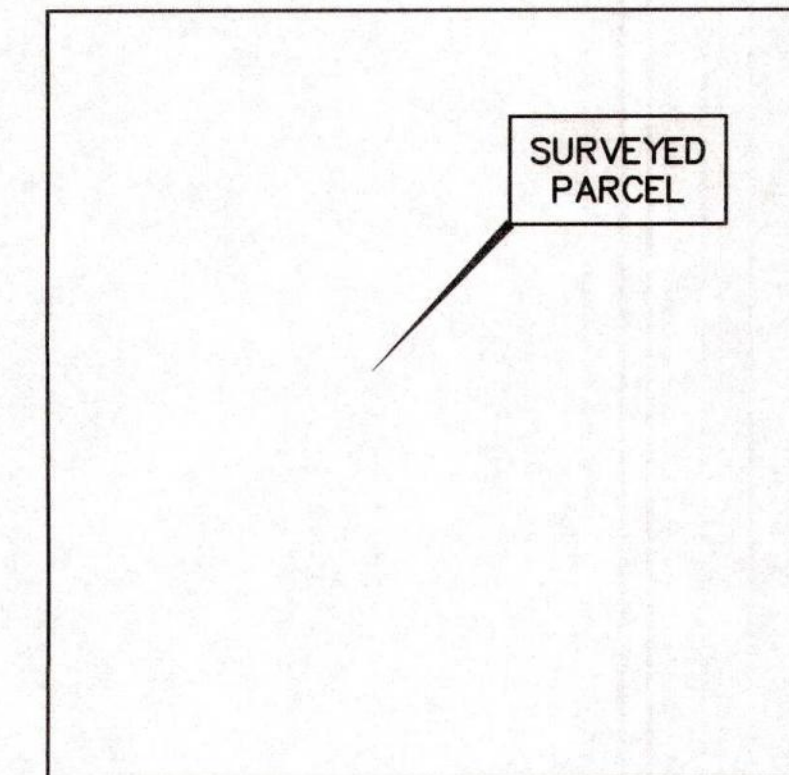
TASK	QT.	UNIT	UNIT \$	MAT.	LAB HR	LAB \$	TOTAL
GARAGE							
EXTERIOR							
WEST ELEVATION							
R141 - Paint lintel	3						\$150
