Water and Wastewater Leak Detection Update

Infrastructure & Development Committee
February 4, 2026

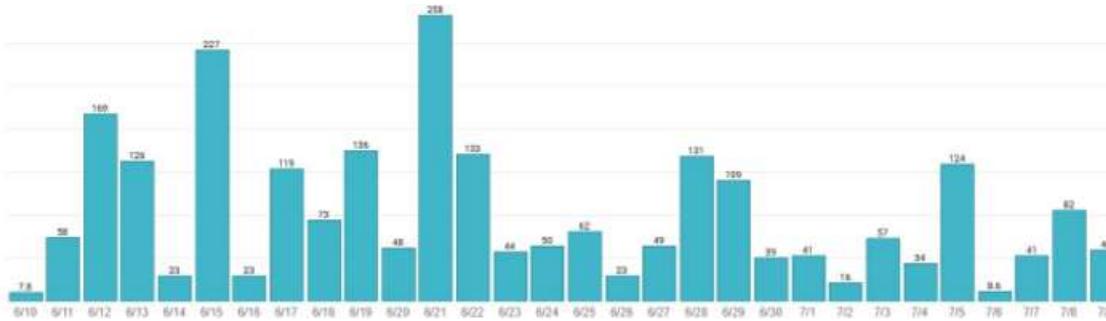
Normal Usage over 30 days

Example of Normal vs. Continuous Consumption

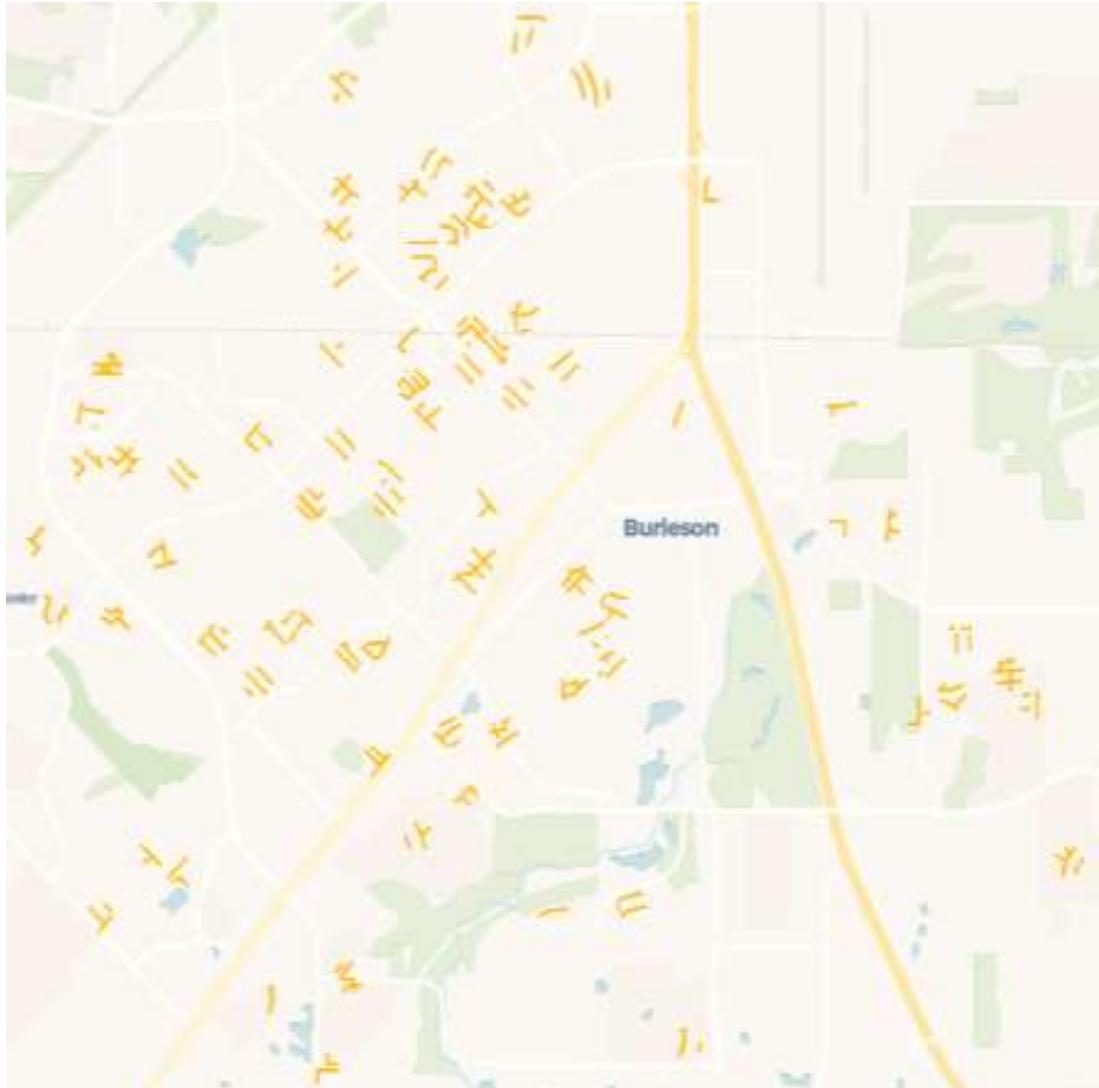
Satellite Wastewater Leak Detection

- 21 miles of sewer mains identified for inspection (100 segments or Areas of Interest (AOIs) identified)
- Validation through a combination of smoke testing, CCTV, and visual checks
- Field investigations found no evidence of Sanitary Sewer Overflows
- Acoustic detection is much less effective for gravity flow wastewater mains

- CCTV inspection completed for approximately nine of 21 miles identified
- Smoke testing completed for six of 21 miles identified
- Corrective actions resulting from activities above:
 - Five manholes rehabilitated to address structural issues and infiltration
 - 100 manhole rain guards installed
 - 35 broken/missing sewer cleanout caps replaced
