March 10, 2025 - **DRAFT**

Re: Staircase Structural Evaluation at the BRiCk

Freese and Nichols, Inc. (FNI) was asked by the City of Burleson (City) to provide a structural evaluation of the staircase in the pool area of the Burleson Recreation Center (BRiCk). On March 5, I performed a site visit to assess the structural integrity of the staircase.

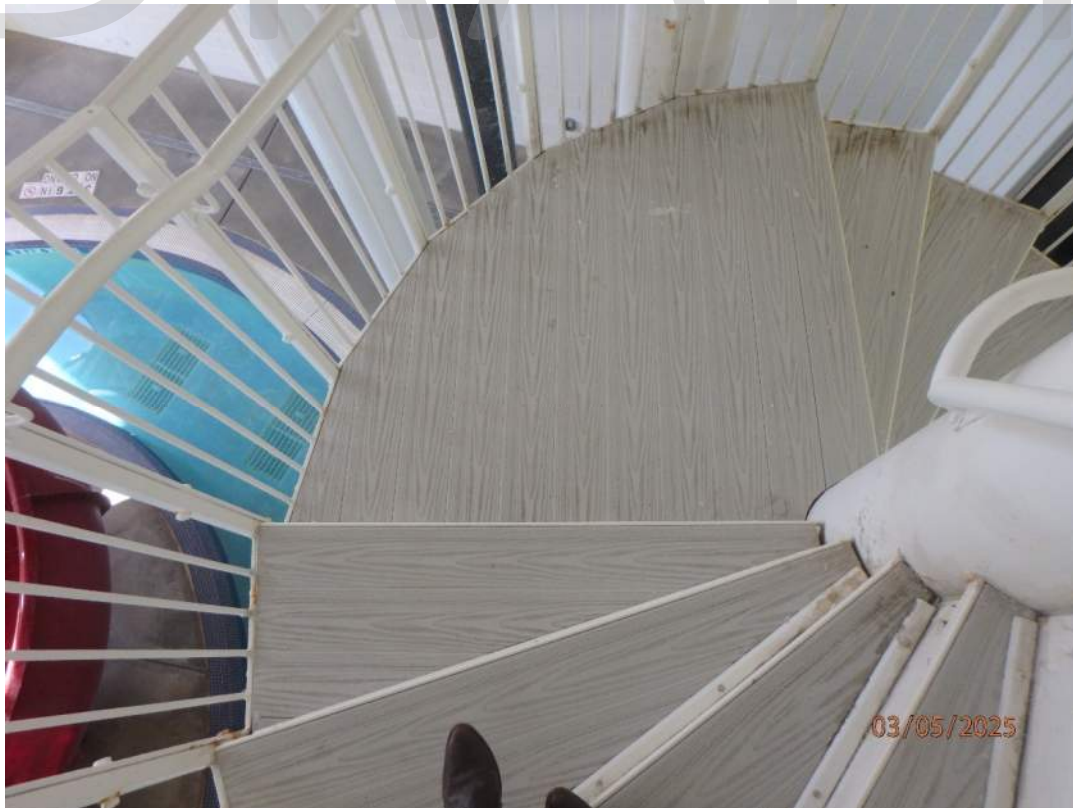
The subject staircase is a circular spiral staircase wrapping around a central steel pipe column. The structural is all carbon steel with the exception of FRP treads. The treads are contained in removable steel gage metal pans and appeared to be removable, Figure 1. The staircase had significant rust staining and localized rust damage that appeared to be significantly more pervasive than other structure steel in the pool area. It is our understanding that the staircase had recently undergone an inspection by, or in support of, the City's insurance carrier and the staircase was identified as needing a structural evaluation by a qualified Professional Engineer.

Figure 1: Typical Treads and Landing

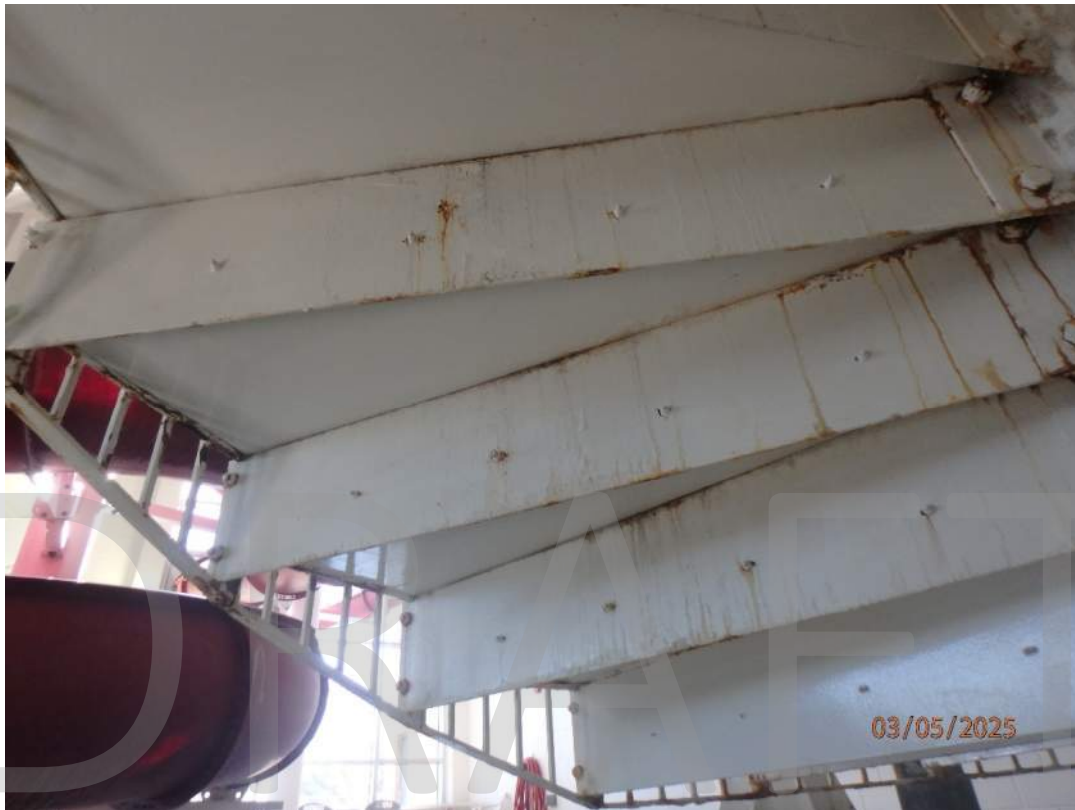
- The most visually obvious rust staining originated at the top of the rises at the contact point with the tread pans, Figure 2. While highly visible, the corrosion was not a significant structural concern.

Figure 2: Typical Corrosion Stains at Back of Risers

- Insert a neoprene or plastic strip between the risers and tread pans to reduce coating damage due to foot traffic.

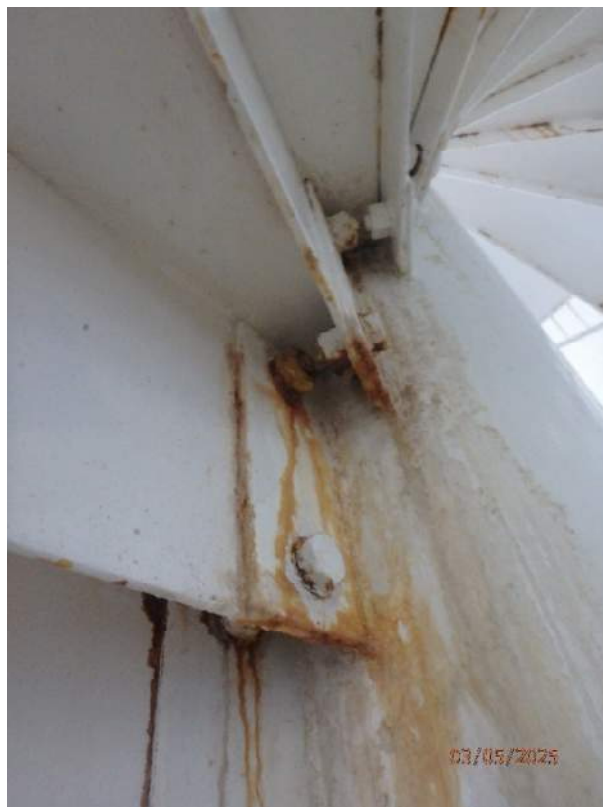
- In general, the bolts appeared to be very corroded and a close second in terms of visual impact, Figure 3 to Figure 6.
- Some localized heavy corrosion and scaling was observed on the face of a few risers, Figure 7.

Figure 3: Typical Corrosion of Bolts at Central Support Column

- Consider replacement with a more corrosion resistant material. Bolt head markings were not visible during my site visit but should be verified by removing the coating. If the bolts are not high-strength, consider replacement with Type 316 stainless steel. If high-strength bolts were used, the bolts should be replaced in kind but should be hot-dip galvanized.

- Replace the bolts between the risers and the central column with welds. It appears that a 4-sided seal weld could be provided between the riser plates and the gusset plates welded to the central column. These welds will be easier to clean and coat than bolts. Additionally, the groin between the riser plates between the columns would be more accessible for future clean and coating operations.

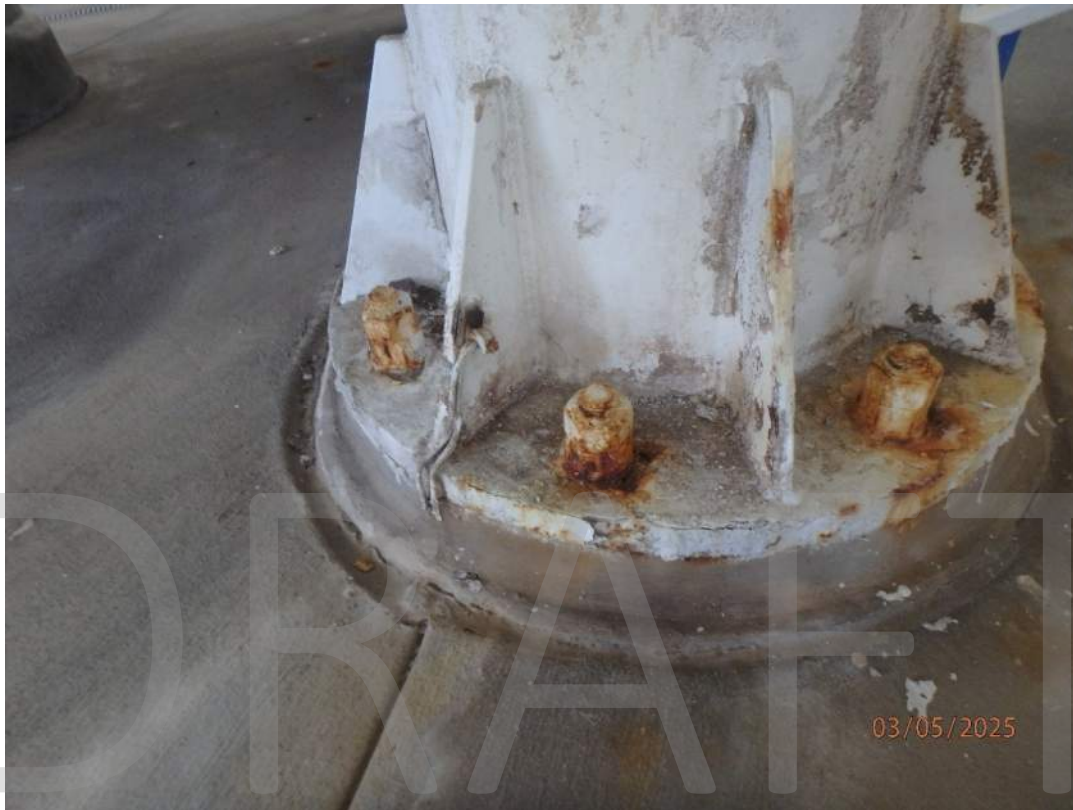
Figure 4: Typical Corrosion at Foundation Anchors

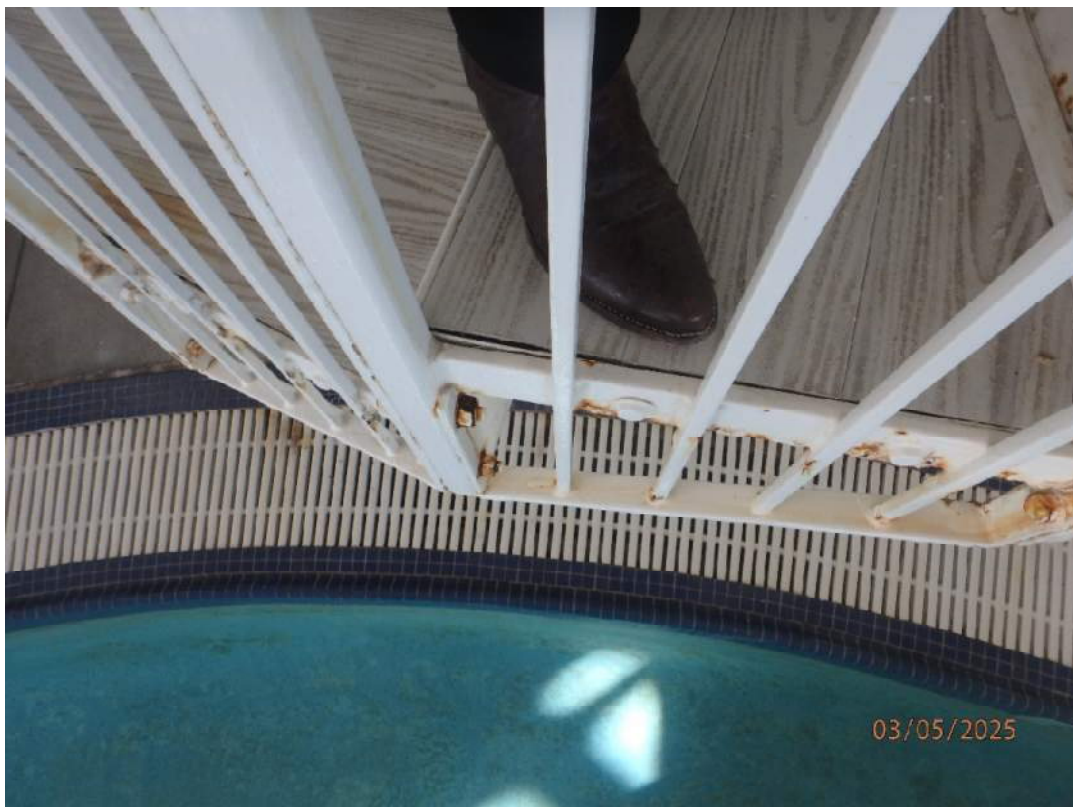
Figure 5: Typical Bolts at Spiral Guardrails

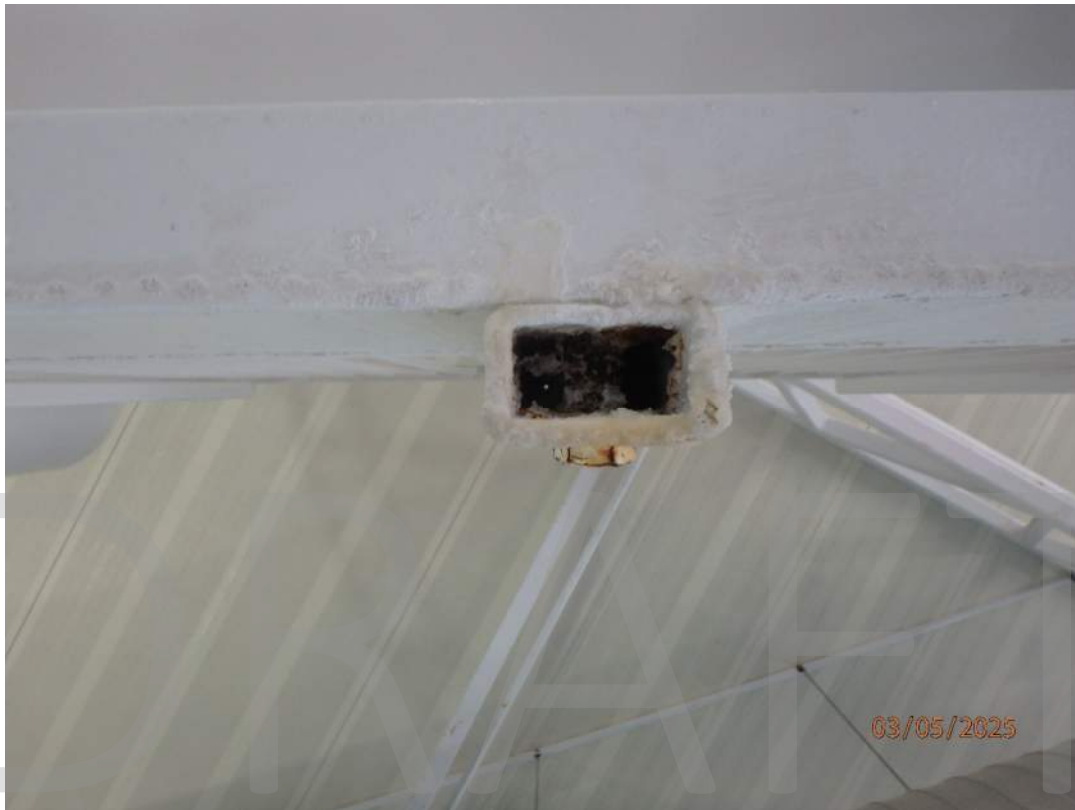
- The bolts at the upper landing guardrail appeared to have significant exposure and significant corrosion inside the post, Figure 6. While the guardrails did not have signs of incipient bolt failure, we recommend bolt removal for inspection and replacement as appropriate.

Figure 6: View of Upper Platform Guardrail Bolt – View Inside Post from Below

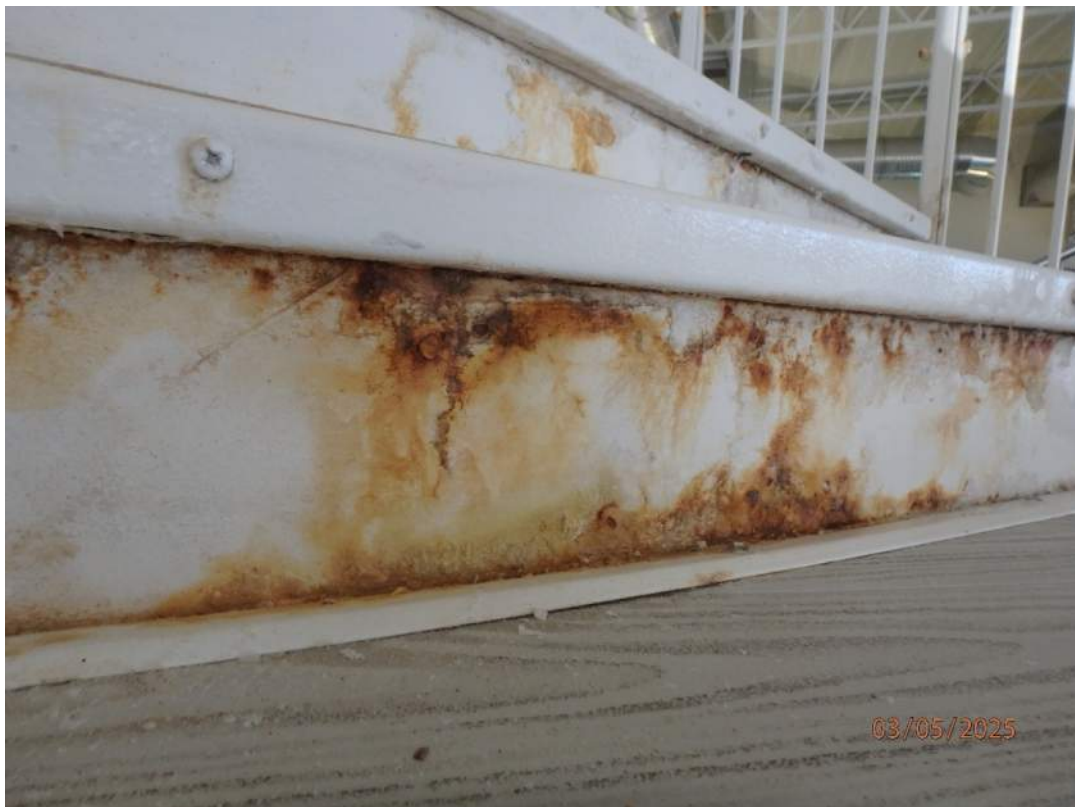
Figure 7: Heavy Corrosion with Scaling at Face of Riser

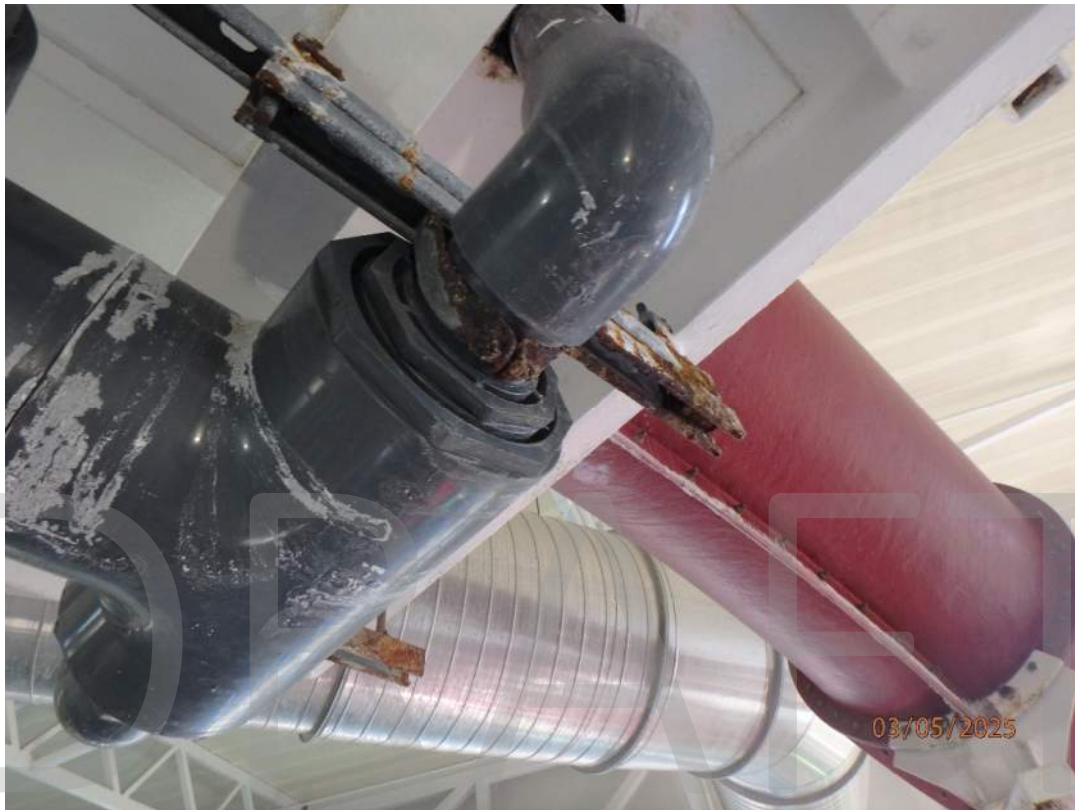
- The galvanized and non-galvanized pipe supports below the upper landing were heavily corroded, Figure 8.

Figure 8: Typical Heavy Corrosion at Pipe Supports below Upper Platform

- When recoating, the treads should be removed to improve the surface preparation and coating between the treads and risers.
- Replace the heavily corroded galvanized pipe supports below the upper landing.

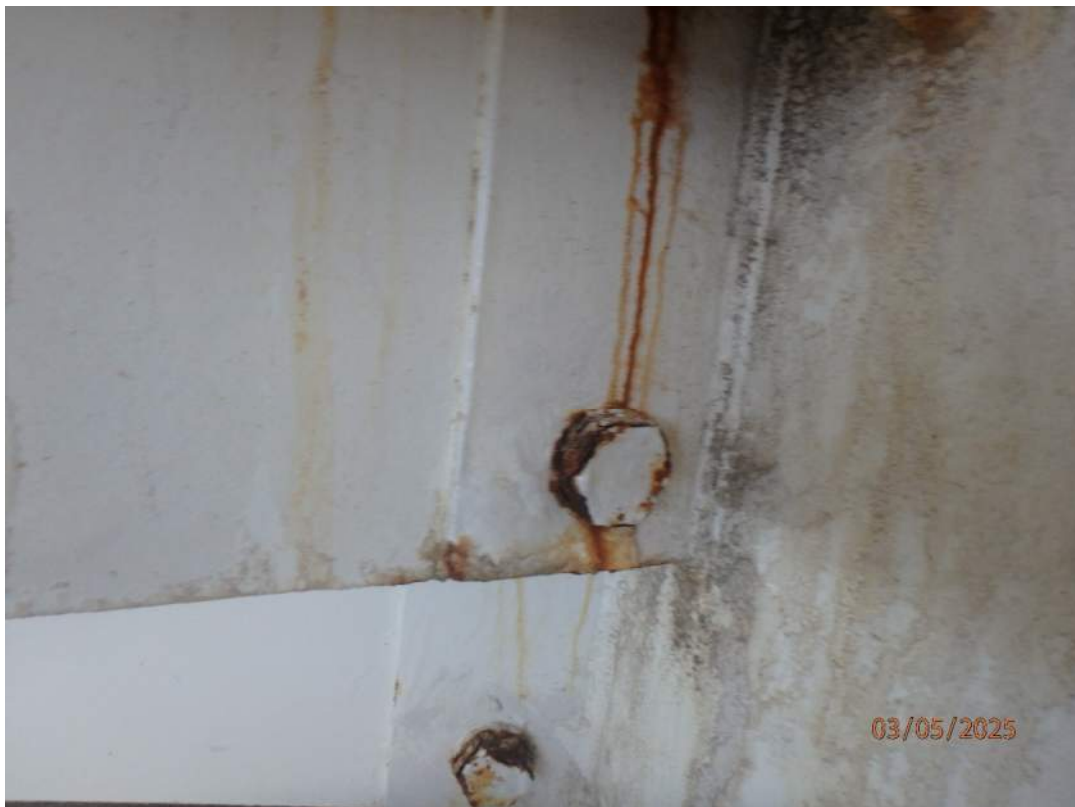
- In general, bolts should be replaced before the face of the bolts begins to scale off. The scaling is usually a sign of advanced corrosion and, as a practical matter, removal of the bolt after scaling becomes much more difficult. Examples of such scaling is included in Figure 9 and Figure 10. When the bolts are removed for replacement, the shanks of the bolts should be inspected for section loss. If the bolts are experiencing significant section loss, a more stringent basis for bolt replacement should be used.

Figure 9: Heavy Corrosion of Bolt at Central Column

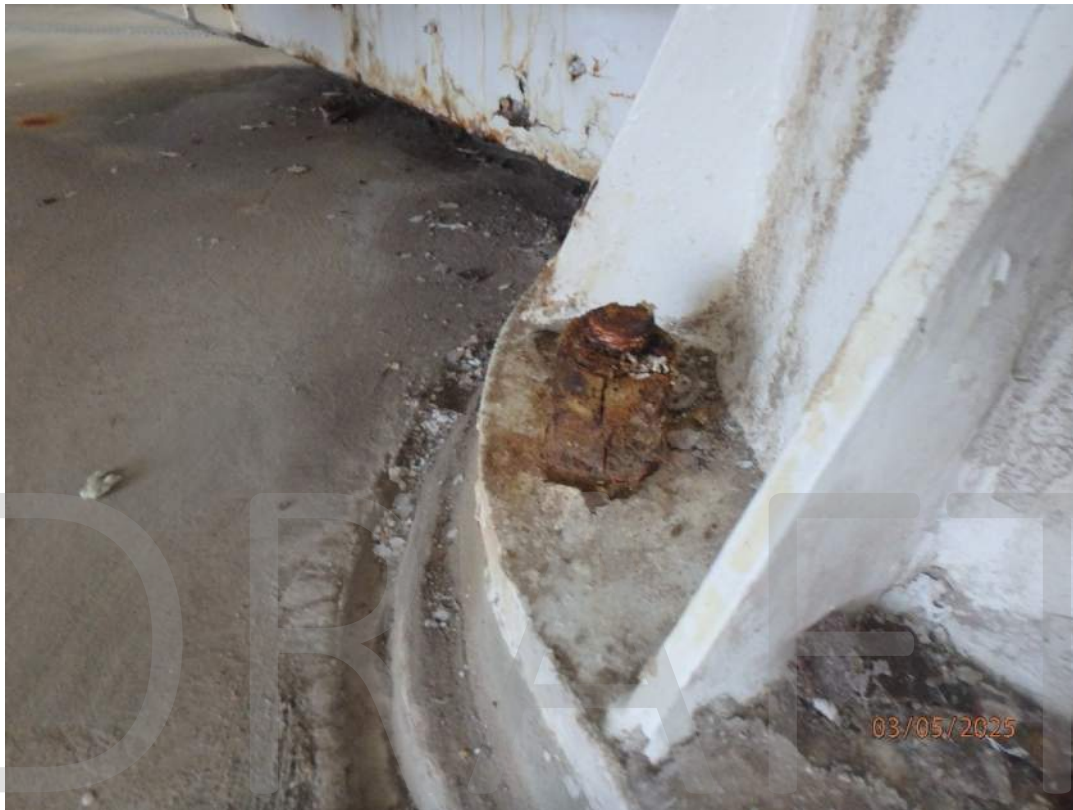
Figure 10: Heavy Corrosion at Foundation Anchors
