CRITICAL AREA REPORT FOR

PARCEL # 253124-000

**Submitted to:
City of Camas**

Camvest GM LLC

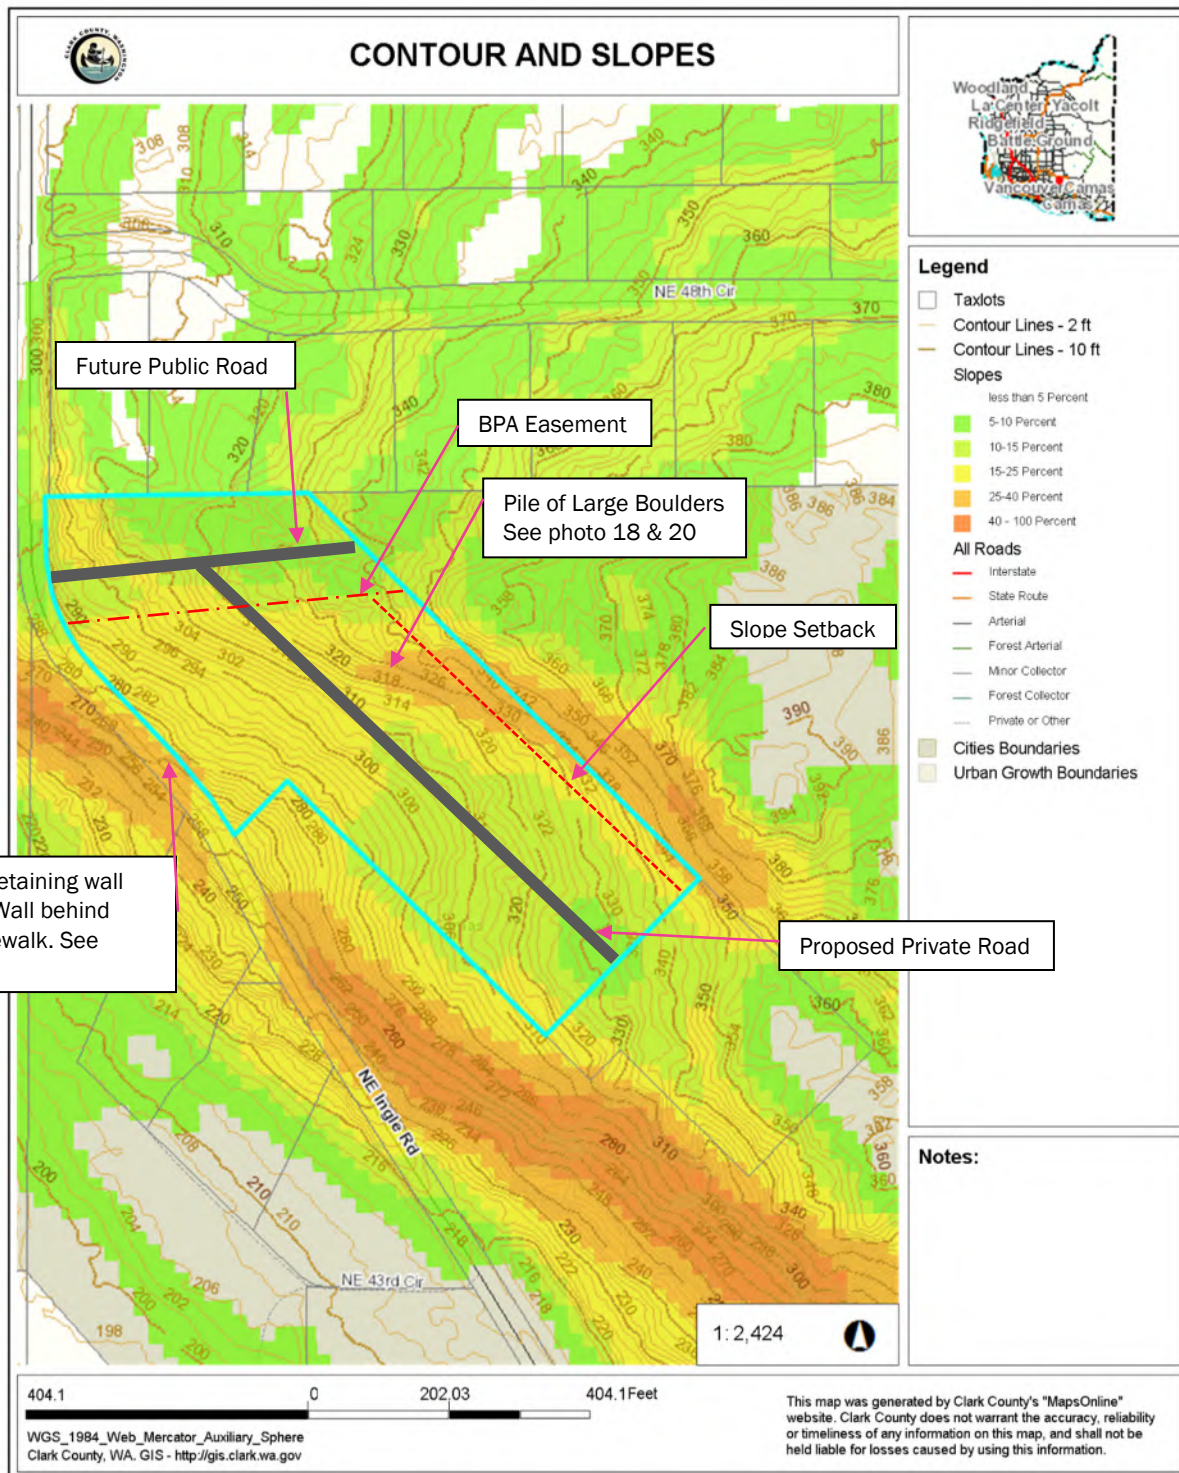
GIS Contour and Slope Map

The proposed home and septic system will be built on an area containing 8% slopes. The slopes 100 feet down hill of the proposed home and septic system is based on filed measurements. The slope on the subject site range from more than 5% (green) to greater than 40% (dark orange) with the intermediate slope broken into categories including 5-10% (green), 10-15% (yellow-green) 15-25% (yellow) and 25-40% (light-orange).

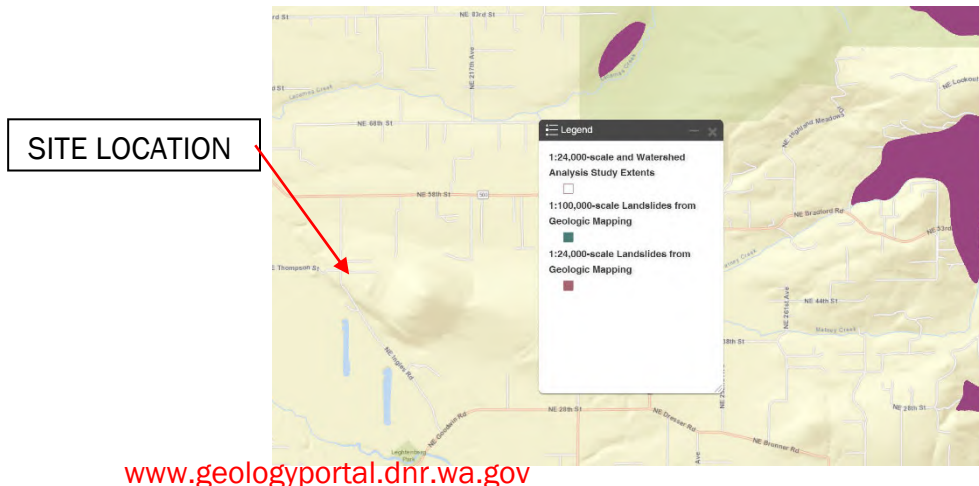
There are no potential instability, historical or active landslides on the parcel. The nearest known landslide area is located 1.5 miles to the east of the project site.

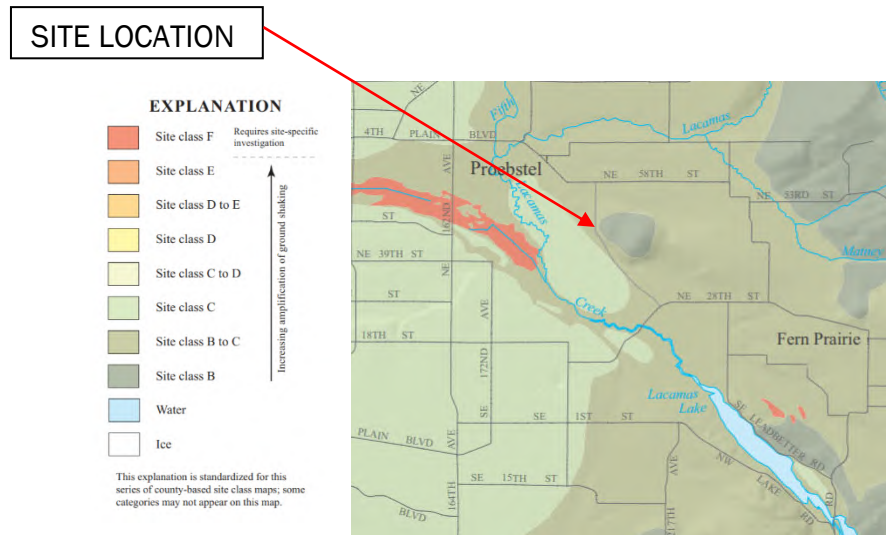
Site class map of Clark County Washington indicated is project is located within site class B to C.
